INSPECTION REPORT: N. MIANUS SCHOOL, OLD GREENWICH SCHOOL, RIVERSIDE ELEMENTARY SCHOOL, AND JULIAN CURTISS SCHOOL

February 24, 2021

Job No. 21211.00

RE: Ceiling collapse at N. Mianus School (309 Palmer Hill Rd.) and subsequent inspections of the ceiling systems at N. Mianus, Old Greenwich School (285 Sound Beach Ave.), Riverside Elementary School (90 Hendrie Ave.), and Julian Curtiss School (180 E Elm St.).

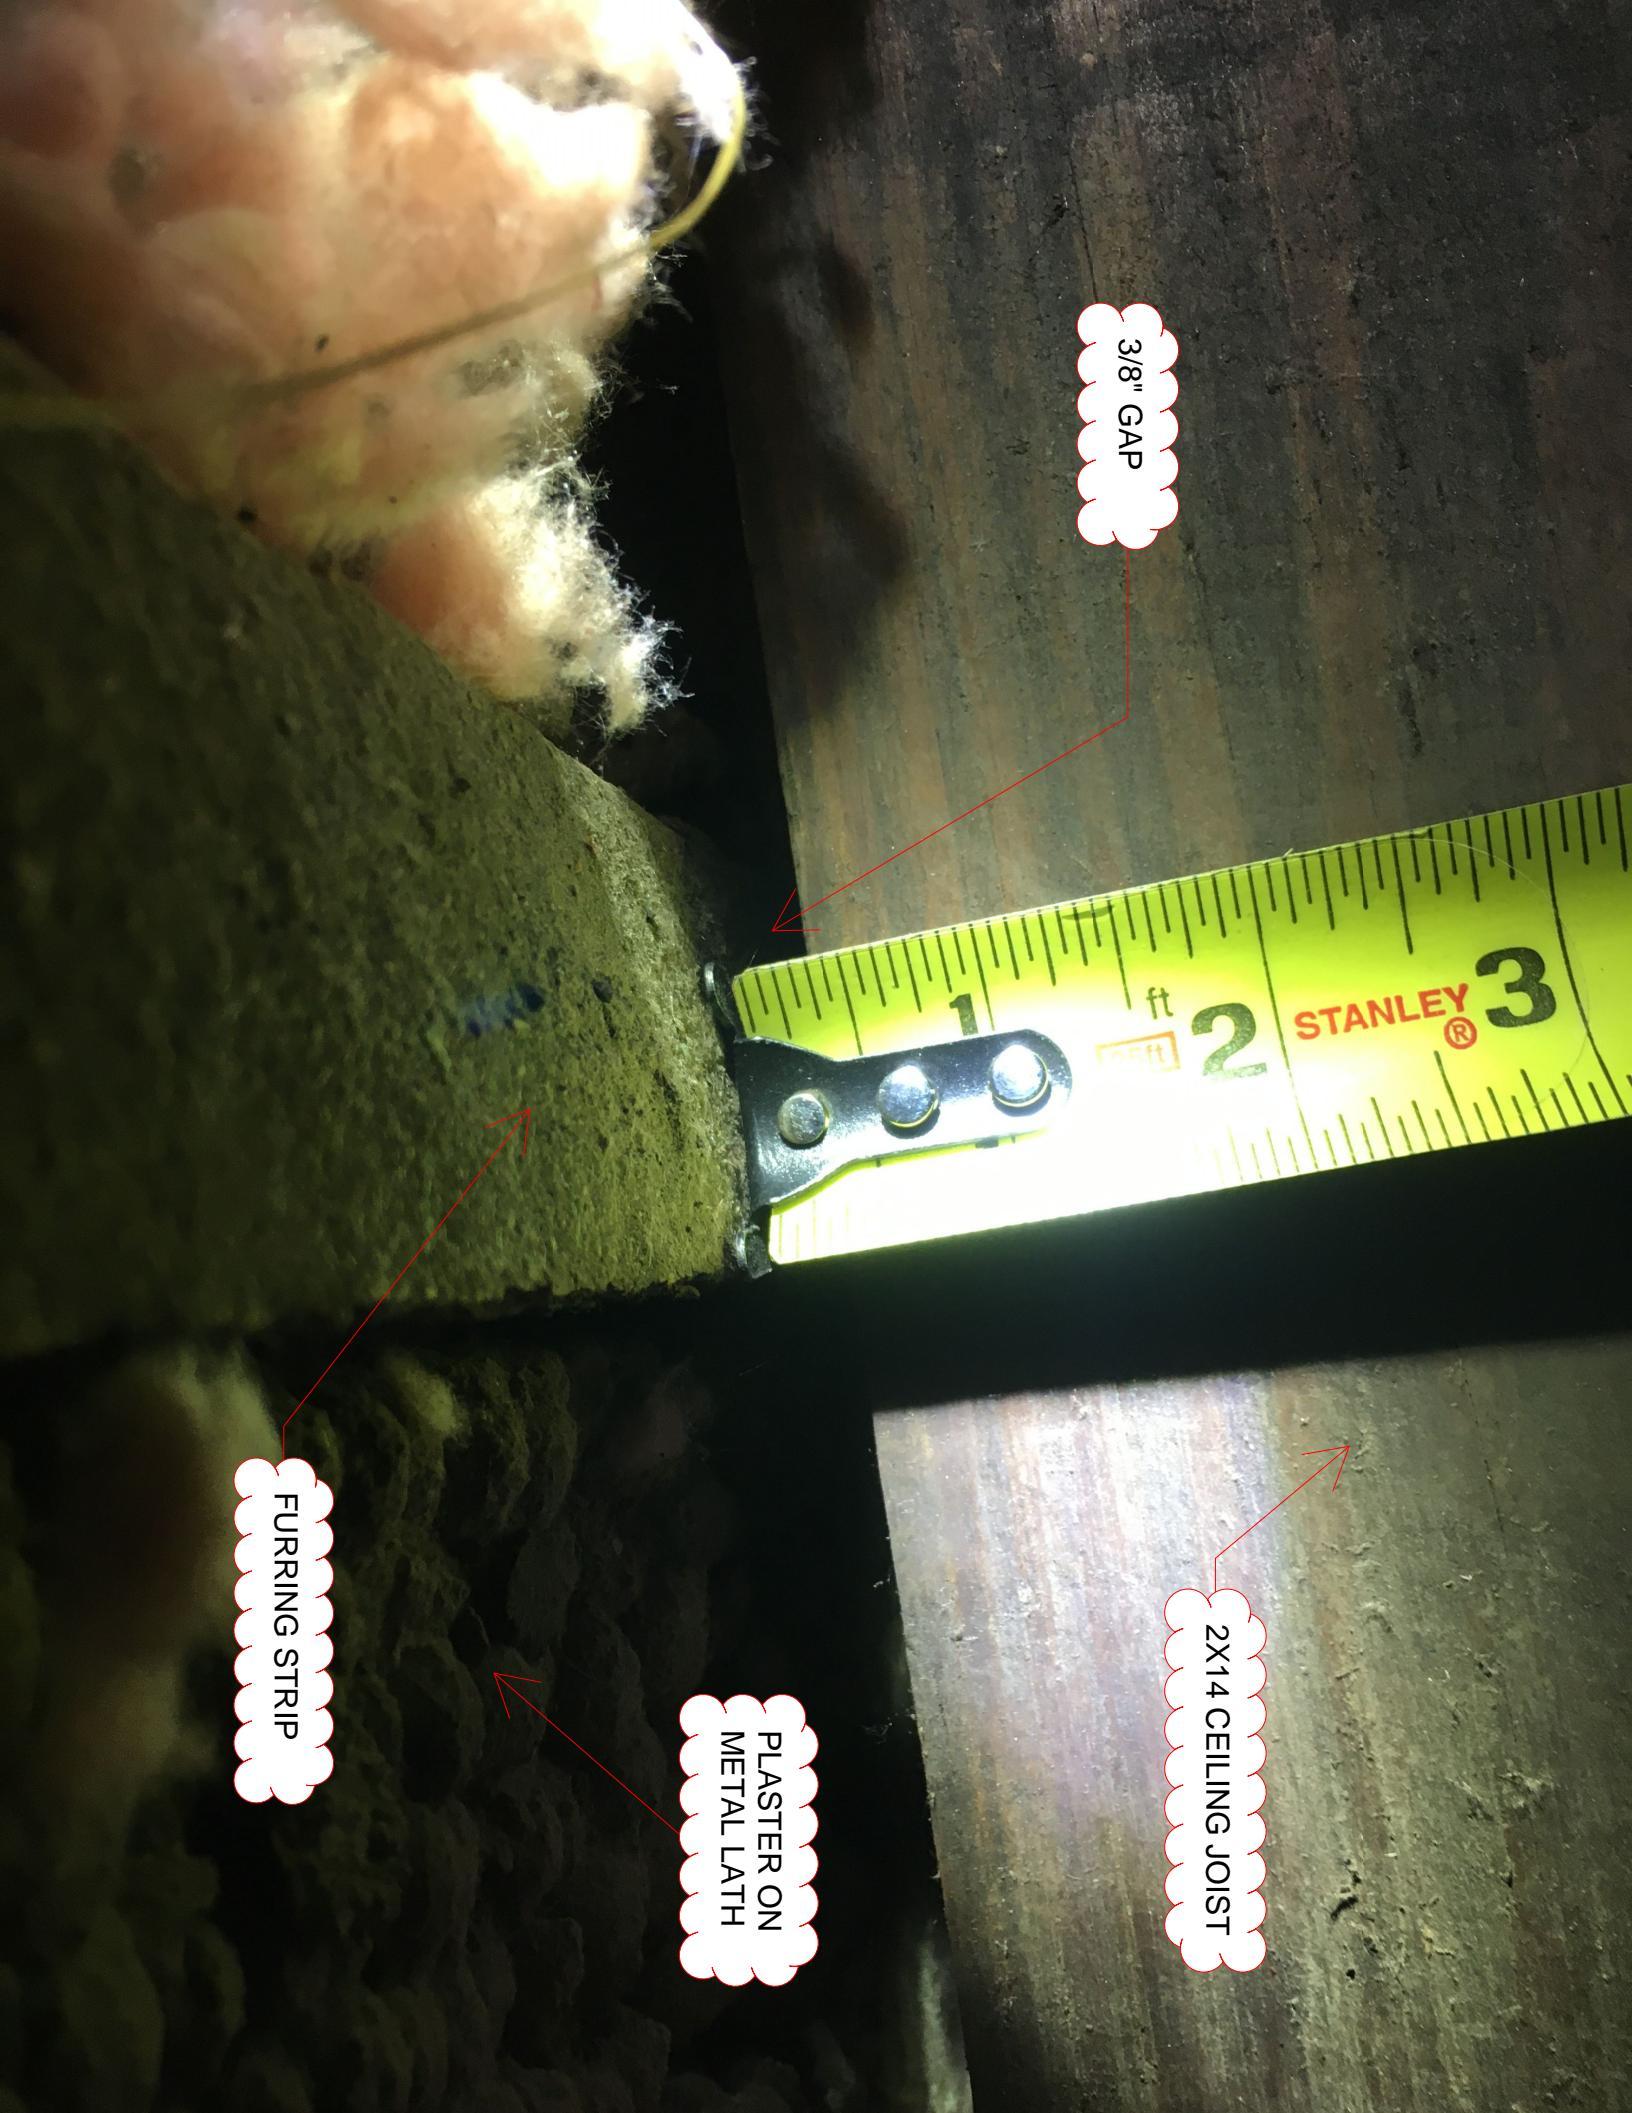
The extent of this ceiling assembly is shown shaded in red on the attached floorplan. These areas are currently not safe, the plaster ceiling assembly should be removed and replaced with a properly installed drywall ceiling (thickness and assembly type TBD by current architectural, fire and building codes), and all hanging loads should be re-installed and secured to the ceiling structure.

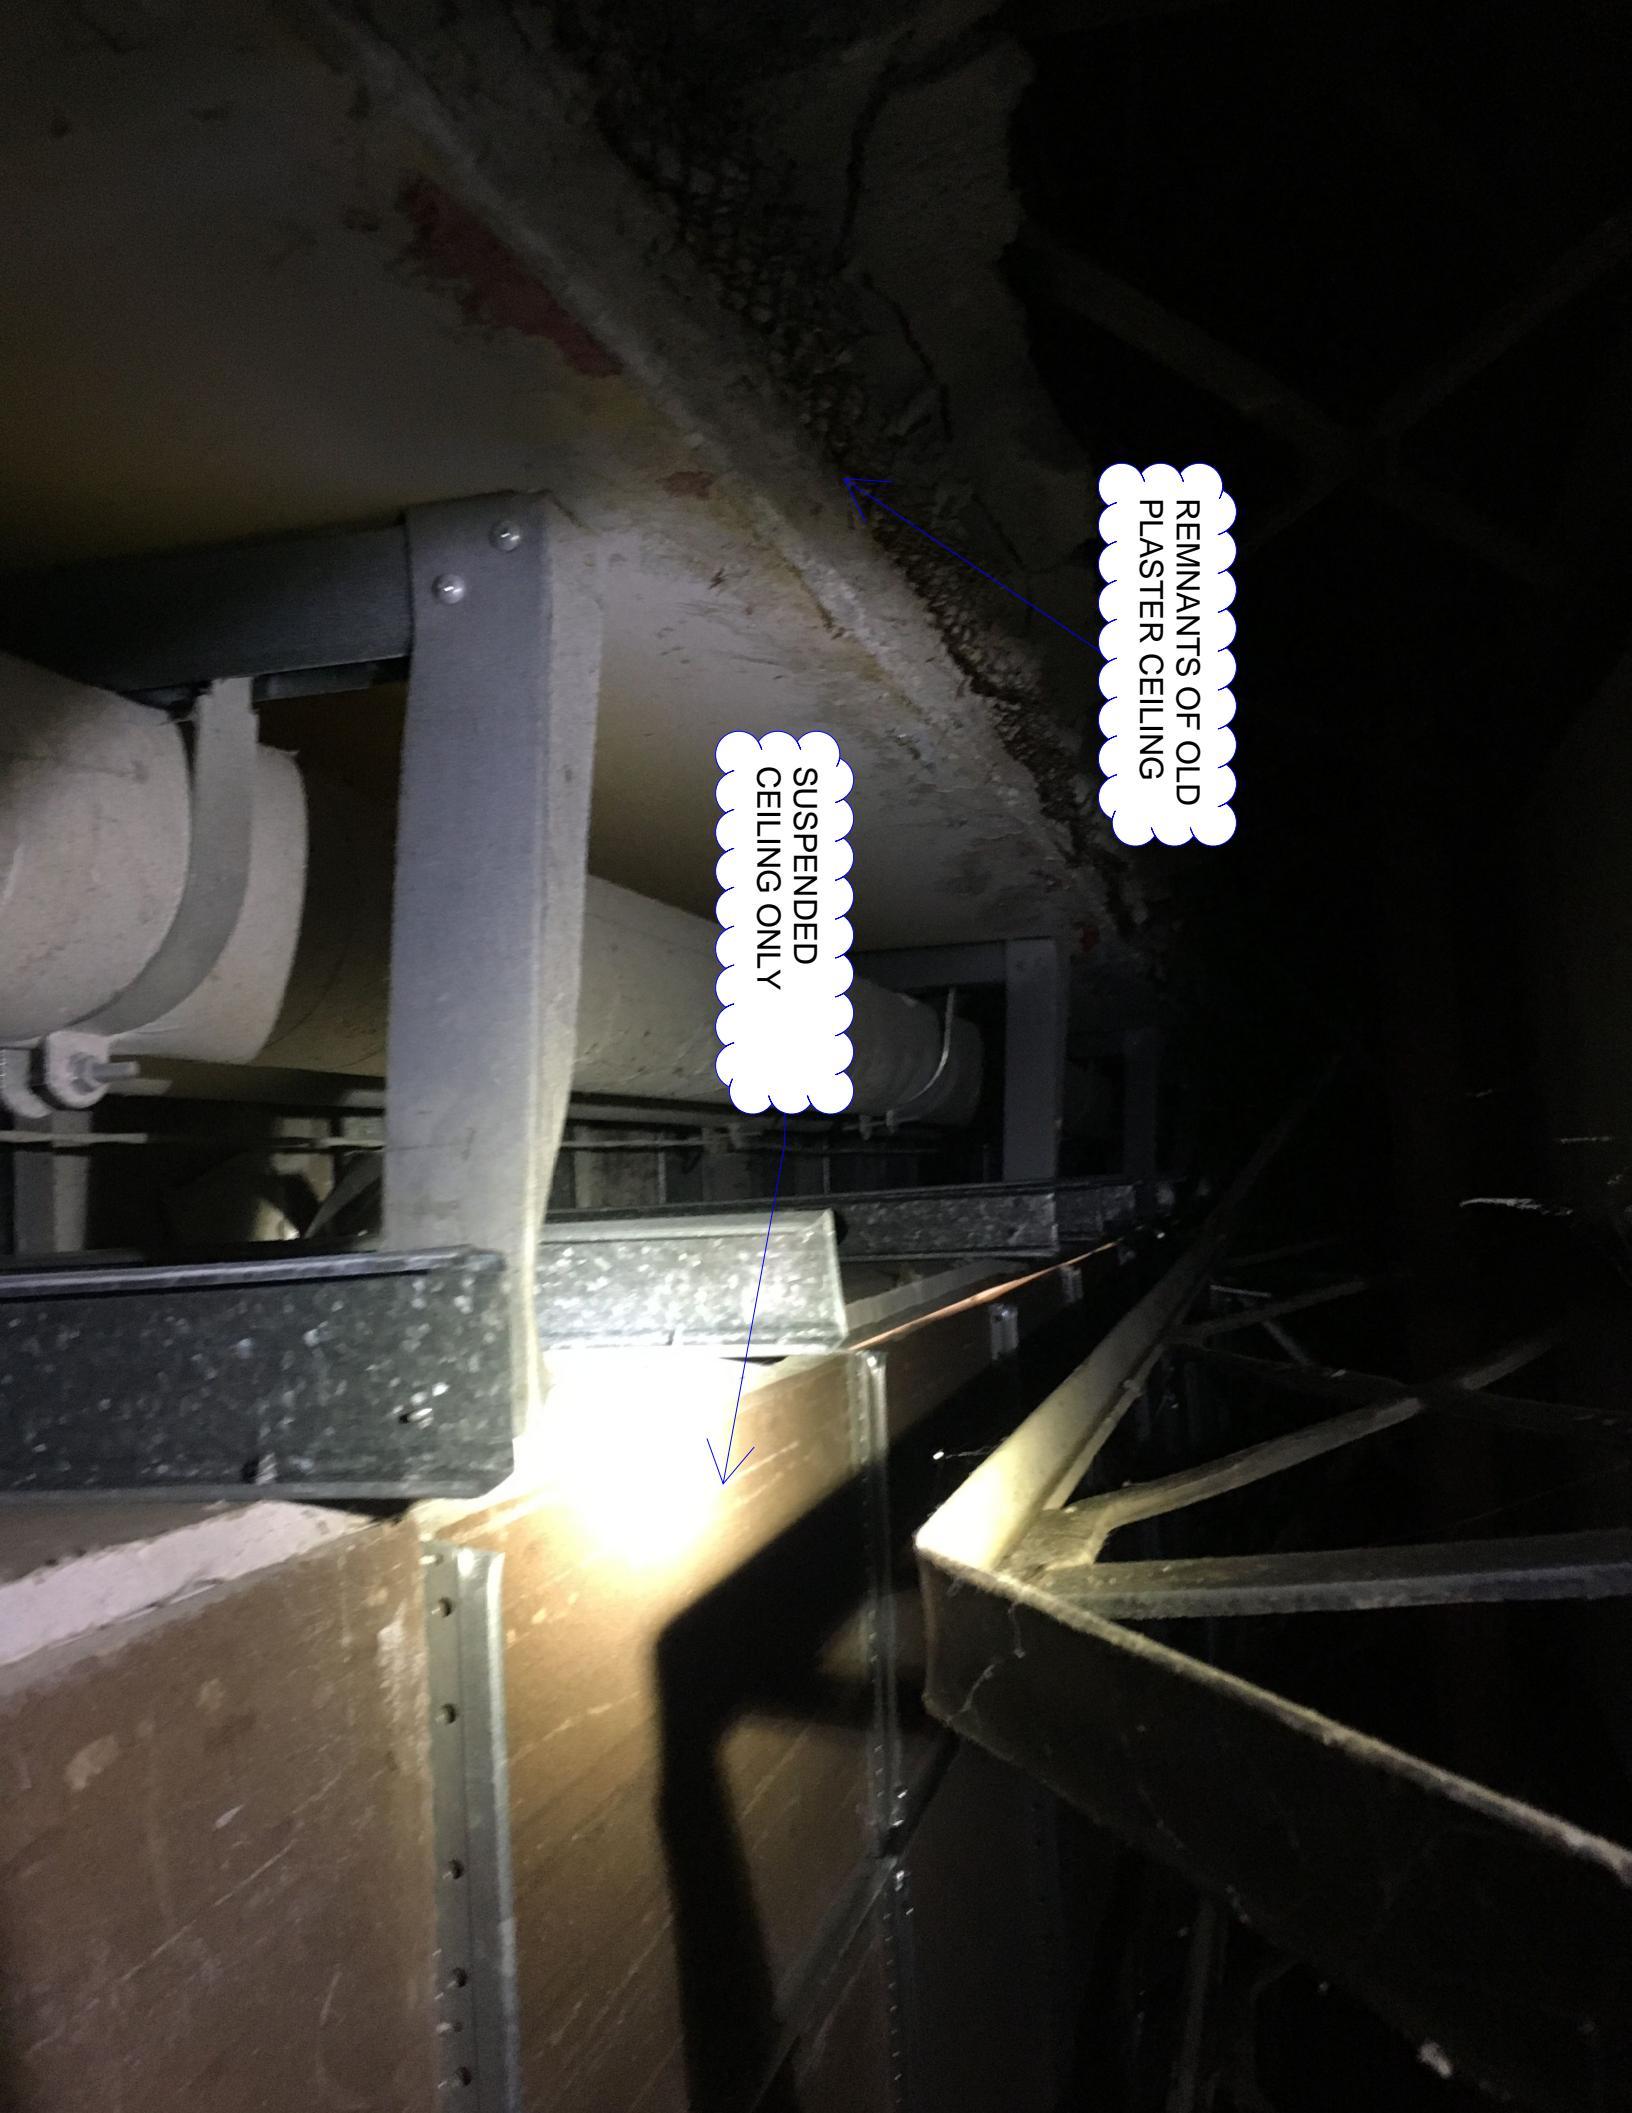
SUSPENDED CEILING ONLY
