Existing Conditions Assessment -

Executive Summary

February 23, 2018

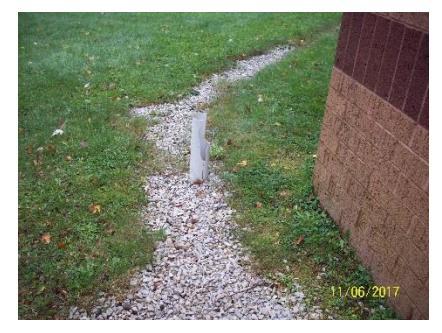
EXPOSED AND DAMAGED PIPE

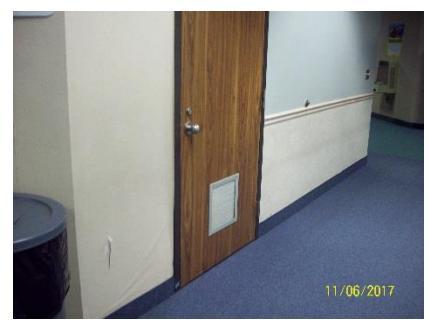
DAMAGED WALL PAPER IN CORRIDOR

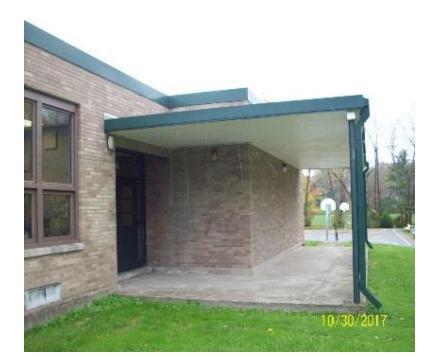
STAINS ON BRICK AND THE BACK STEP AT THE EXIT DOOR

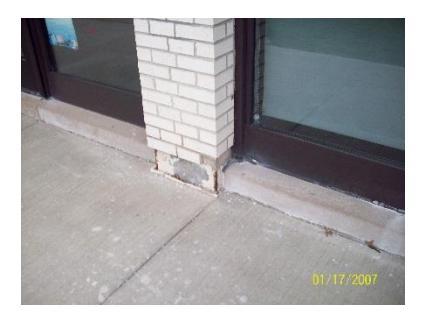
DAMAGE AT DECORATIVE BRICK

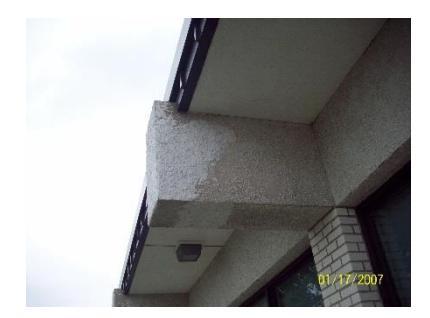
REPAIRED DAMAGE AT CONCRETE PANELS

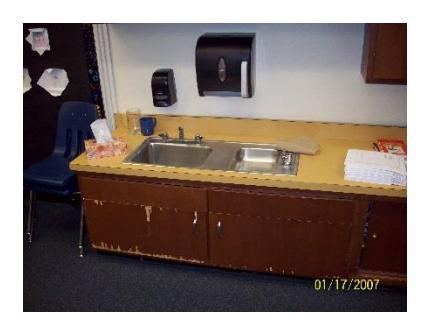
DAMAGED CASEWORK

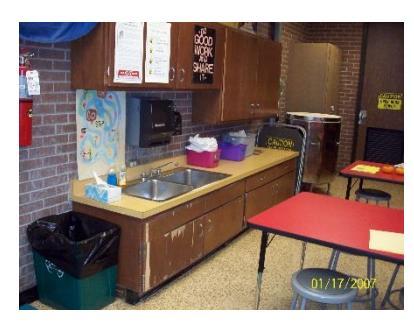
DAMAGED ART CASEWORK

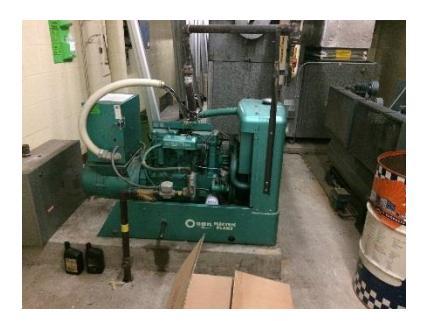
EXISTING ABANDONED EMERGENCY GENERATOR

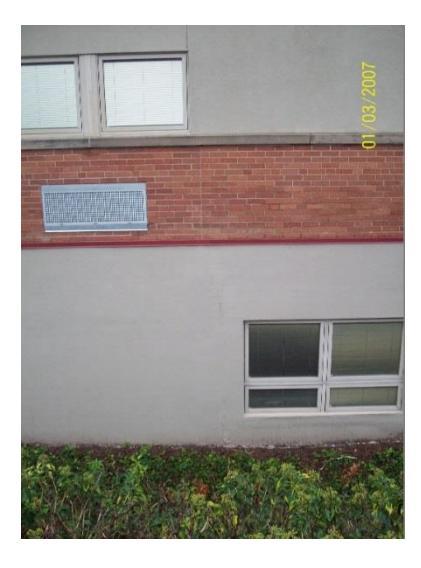
EIFS at grade in the areaway – watch for water infiltration and deterioration.

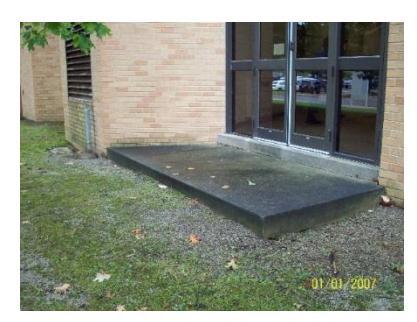
NOT AN "AT GRADE" EXIT

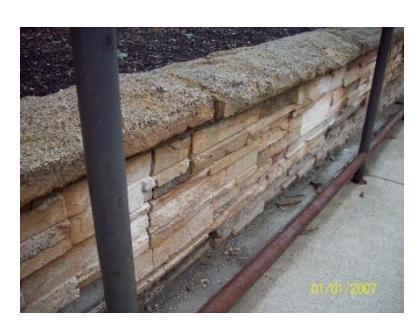
FAILING WALL AND RUSTING HANDRAIL

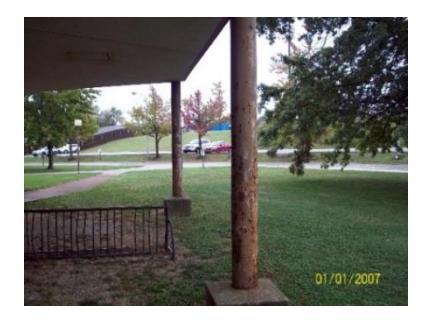
RUSTING COLUMNS

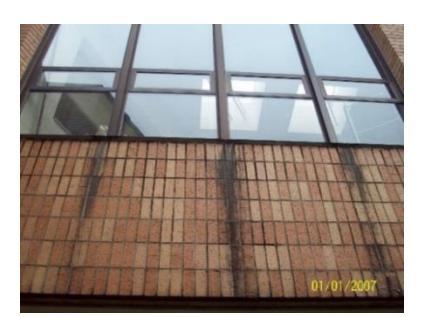
STAINED BRICK

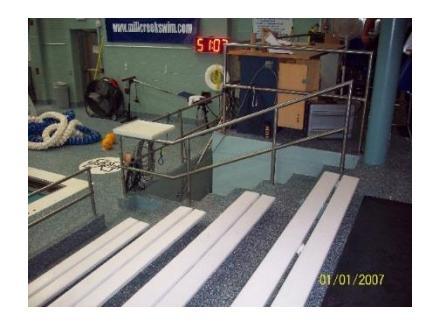
The guard from the upper level to the lower level does not meet current codes.

NON-COMPLIANT RAILING AT POOL

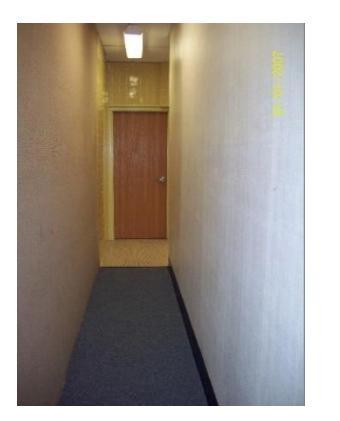
NARROW CORRIDOR TO TOILETS

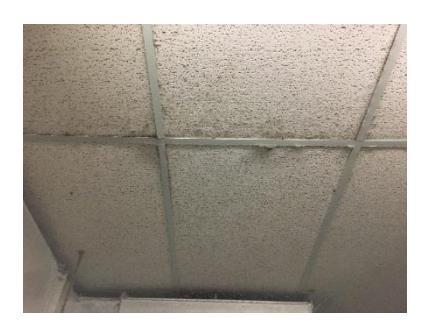
to clean. The mechanical room lay-in ceiling has indications of moisture problems.

POOL MECHANICAL ROOM CEILING

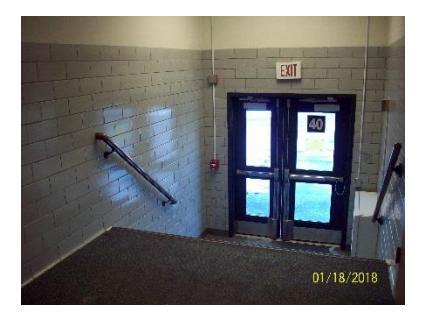
EGRESS EXIT – NON ADA ACCESSIBLE

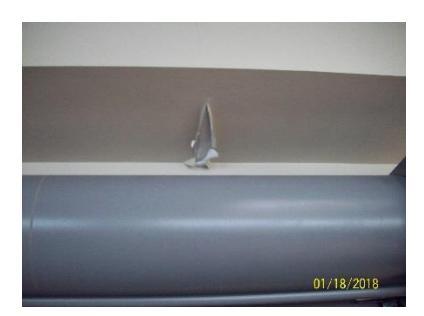
WATER DAMAGE AT BULKHEAD IN CAFETERIA

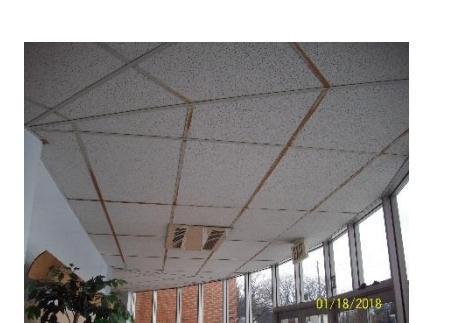
RUSTED CEILING GRID AND SINGLE PANE WINDOWS IN ROTUNDA

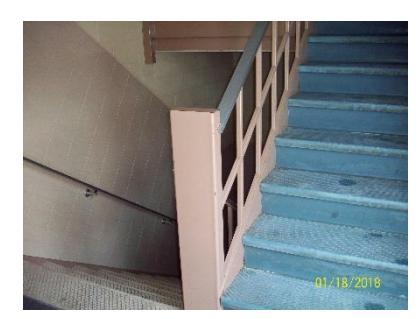
GUARDRAIL AND HANDRAIL NOT UP TO CURRENT CODE

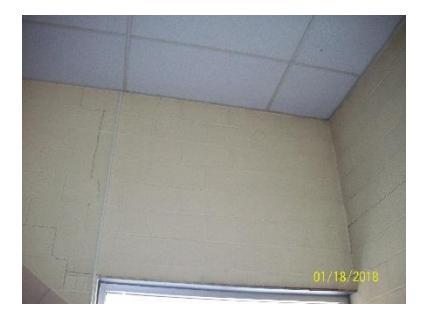
CRACKED MASONRY IN STAIRWELL

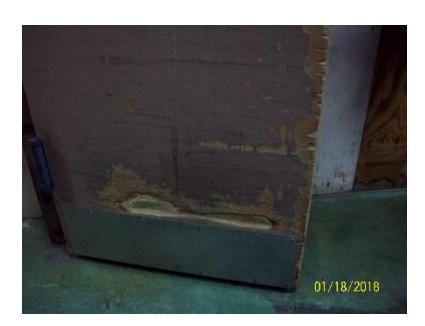
DAMAGED DOOR ON LOWER LEVEL

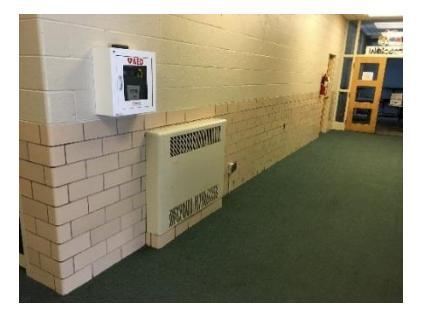
CABINET UNIT HEATER

Admin area, Kitchen, Faculty rooms, Corridors. Heated with cabinet unit heaters. The units appear to be original to the building and are in poor condition. A window AC unit is present in the admin area for use as-needed.

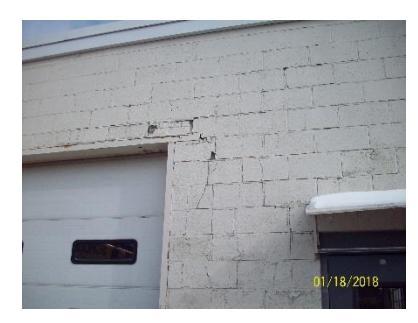
WEST WALL - CRACKED MASONRY
