# Carrollton-Farmers Branch ISD **cfb BOND** **DOLLARS AT WORK**

**GOOD ELEMENTARY SCHOOL**

# FCI Update

Good ES  
Assessment

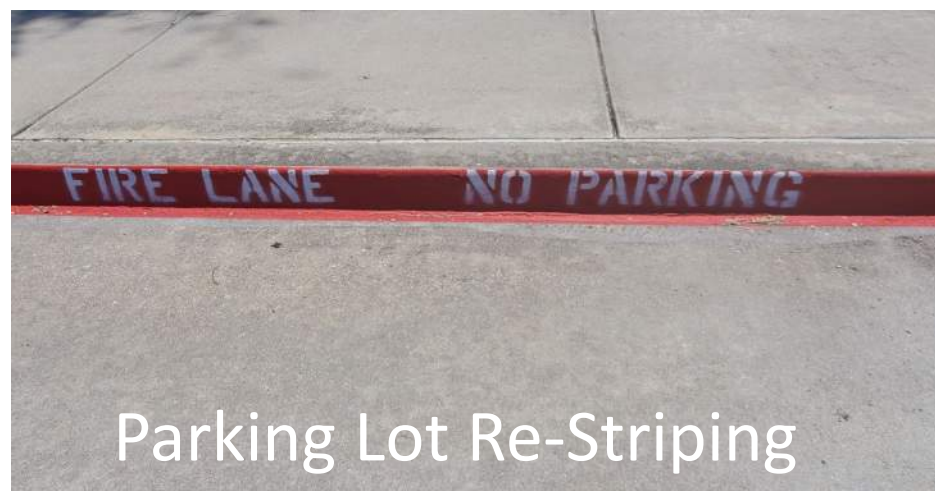
Parking Lot Re-Striping

| Building Element | Type/Material | Previous Condition | Current Condition | Description | Previous Comments | 2021 Reno Comments |
|---|---|---|---|---|---|---|
| Striping - Parking lot and fire lane | | Fair | Good | Minor to moderate signs of age and deterioration but still visible. Handicapped spaces incorrectly marked or striped. | | Repainted |

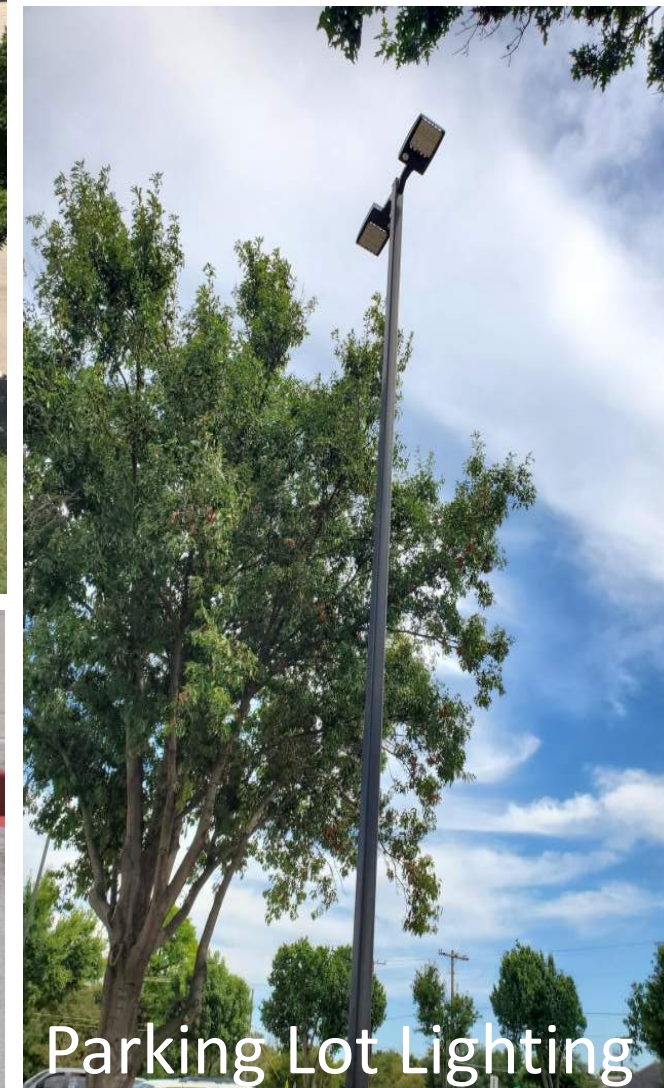
Parking Lot Lighting

| Building Element | Type/Material | Previous Condition | Current Condition | Description | Previous Comments | 2021 Reno Comments |
|---|---|---|---|---|---|---|
| Site Lighting - Parking Lots | | Good | Good | | | Replacement of light packages in the parking lot power poles |

| | | | MEP Facility Grade | |
|---|---|---|---|---|
| EXTERIOR LIGHTING | Task: Renovate all exterior parking lot lighting to LED. | Task: Renovate all exterior parking lot lighting to LED. | 95 | 99 |

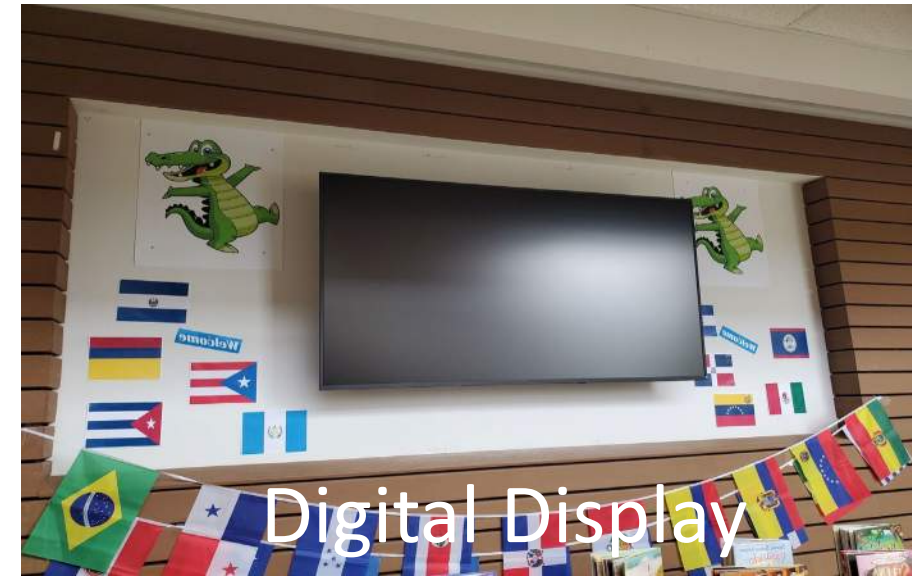
Digital Display

| AV Equipment - Large TV Display | | | Poor | Good | | Existing A/V solution is not operable<br>Replacement of digital display |
