# **Educational Master Facility Plan - Board Update**

**September 19, 2017**

### Phase 1 – Facility Assessment

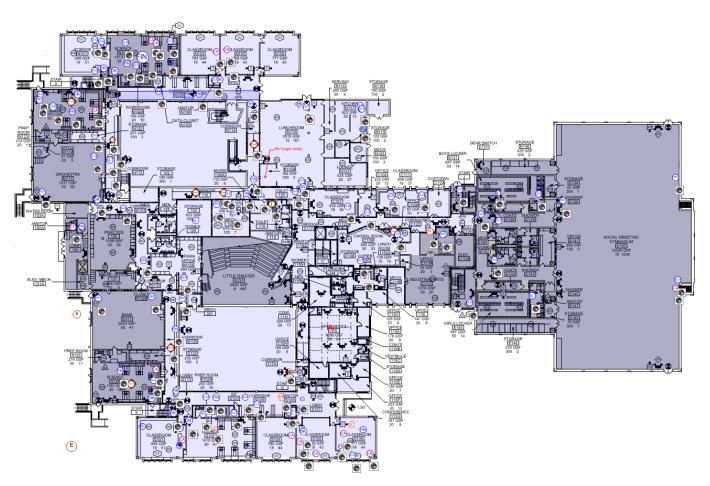
#### **Carleton Washburne**

#### 273 items found

- 67 remaining Health Life Safety
- 27 related to Accessibility
- 21 related to Mechanical, Electrical and Plumbing

Cracks in CMU (Orchestra / Band) Possible Settlement – north hall Accessibility improvements Cause of water damaged tiles

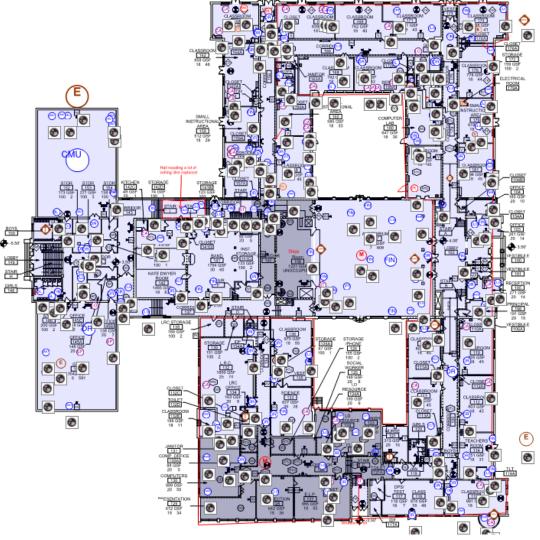
#### 450 items found

- 70 remaining Health Life Safety
- 31 related to Accessibility
- 29 related to Mechanical, Electrical and Plumbing

Masonry / CMU cracking at Gym Slab cracking at auditorium Accessibility improvements Cause of water damaged tiles

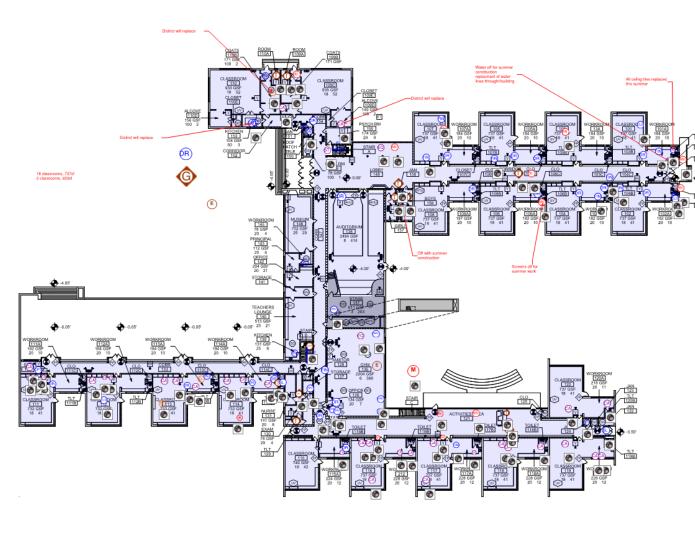
### **Crow Island**

#### 203 items found

- 22 remaining Health Life Safety
- 25 related to Accessibility
- 22 related to Mechanical, Electrical and Plumbing

Egress from music room Accessibility Improvements

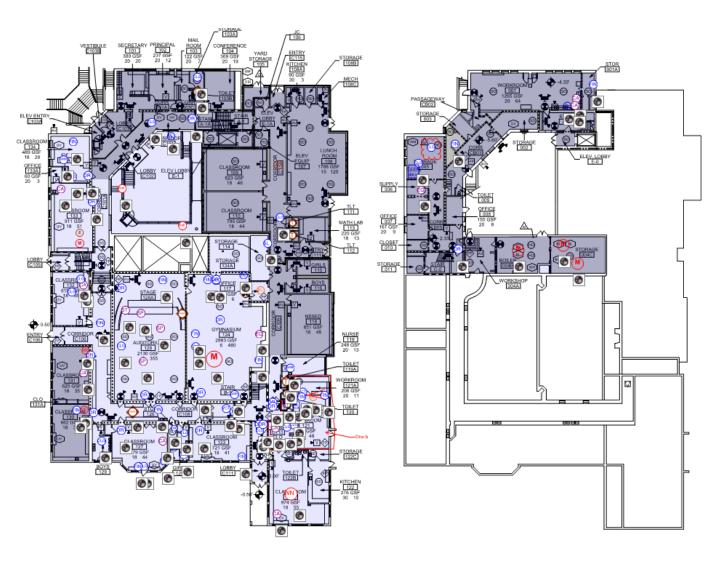
### **Greeley School**

#### 199 items found

- 60 remaining Health Life Safety
- 15 related to Accessibility
- 20 related to Mechanical, Electrical and Plumbing

Egress from Gym Missing exhaust from Rm 133 Cause of water damaged tiles

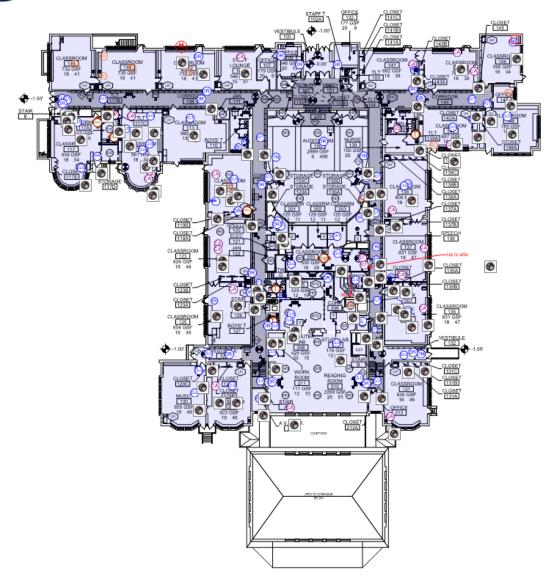
### **HW**Hubbard Woods

#### 211 items found

- 15 remaining Health Life Safety
- 16 related to Accessibility
- 28 related to Mechanical, Electrical and Plumbing

Vertical crack in masonry
Loose / missing roofing
Exhaust at boiler room
Cause of water damaged tiles
