## PROPERTY CONDITION ASSESSMENT Long Lots Elementary School

Colliers Project Leaders USA NE, LLC ("CPL") is pleased to present the Property Condition Assessment (PCA) for Westport Public Schools. The purpose of this PCA is to determine the current condition of Long Lots Elementary School and provide recommendations for repairs and upgrades.

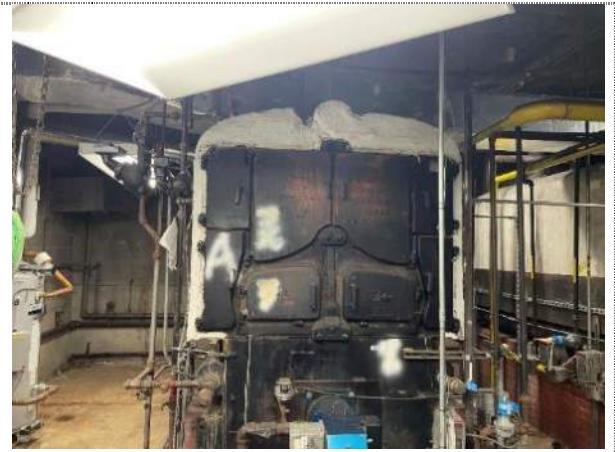
The building is heated by two (2) H.B Smith H.B. Smith Series 440-20 sectional CI dual fuel, steam boilers B-1 and B-2. Another third Weil-McLain steam boiler B-3 is abandoned in place due to problems related to installation and operation of the boiler. The boilers were manufactured in 1953 and are served by updated Power Flame burners. Although the burners are dual fuel the boilers now predominantly operate on natural gas. The boilers, condensate pump systems, fuel oil pumps and accessories are past their useful life and installation is aged. The steam piping is more than 60 years old.

Figure 3: Steam boilers original to the building (cr 1953).

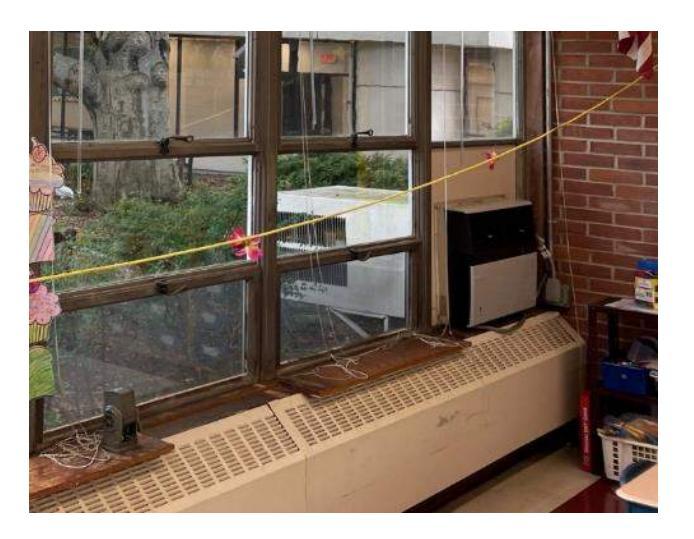
The original 1953 building is heated with steam radiation which are controlled via digital thermostats. The digital thermostats can be monitored and controlled by the BMS. The thermostats send digital signal to a controller that uses EP switches to control pneumatic valves serving the steam radiators.

Figure 7: Steam radiation and window AC unit in the original building

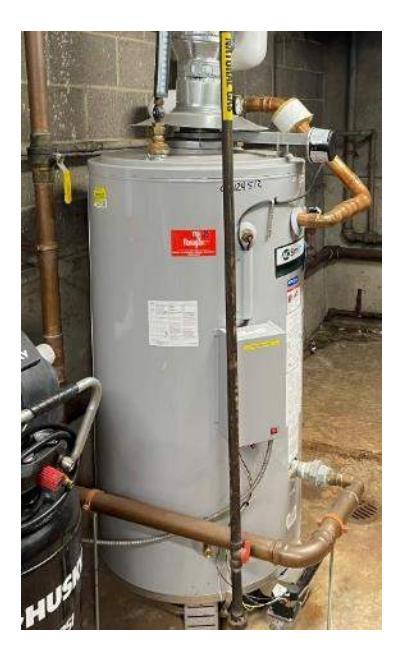
Domestic hot water (DHW) is generated by an AO Smith manufactured BTR-120 gas fired water heater. The heater has an input capacity of 120MBH and recovery rate of 120 gal/hr. The DHW is circulated by a Bell & Gossett recirculating pump. The DHW heater appears new and has a built year of 04/2019.

Figure 12: AO Smith 120MBH domestic hot water heater.

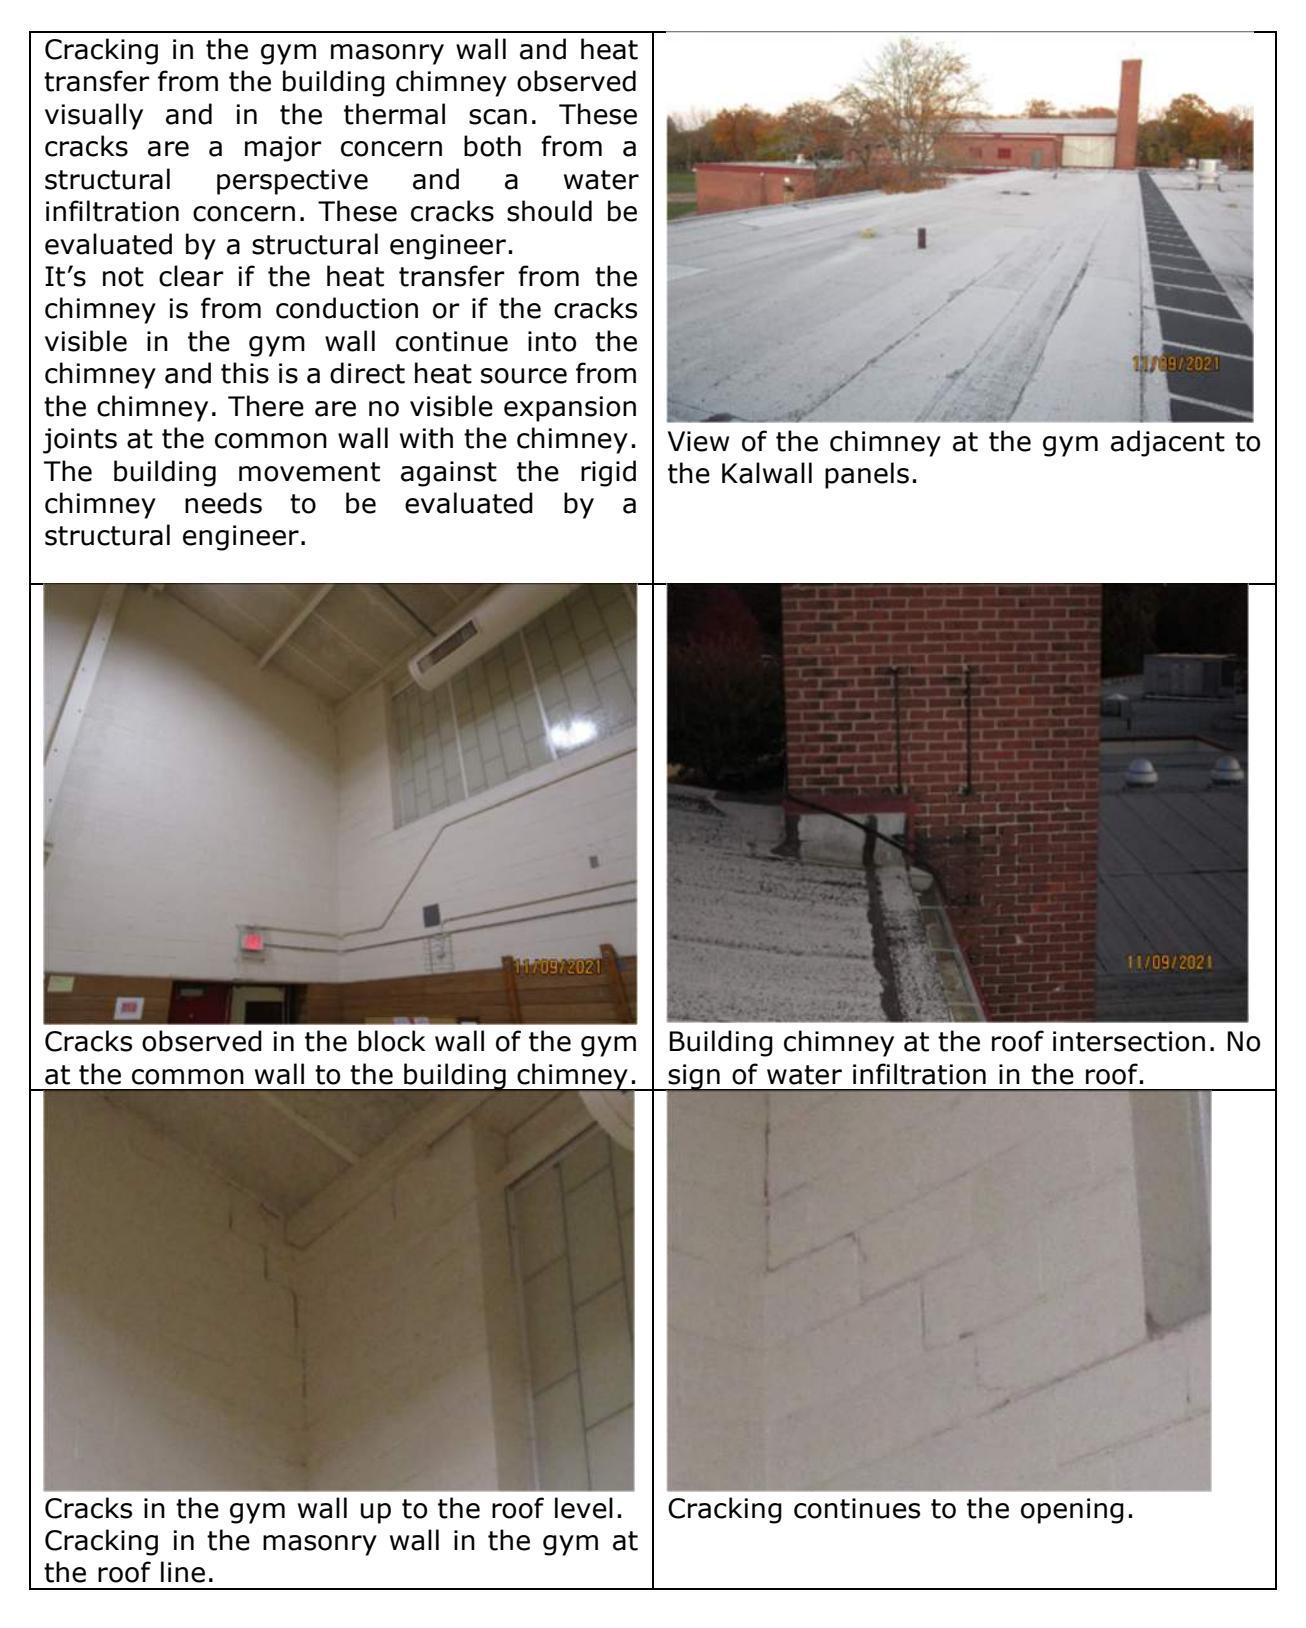
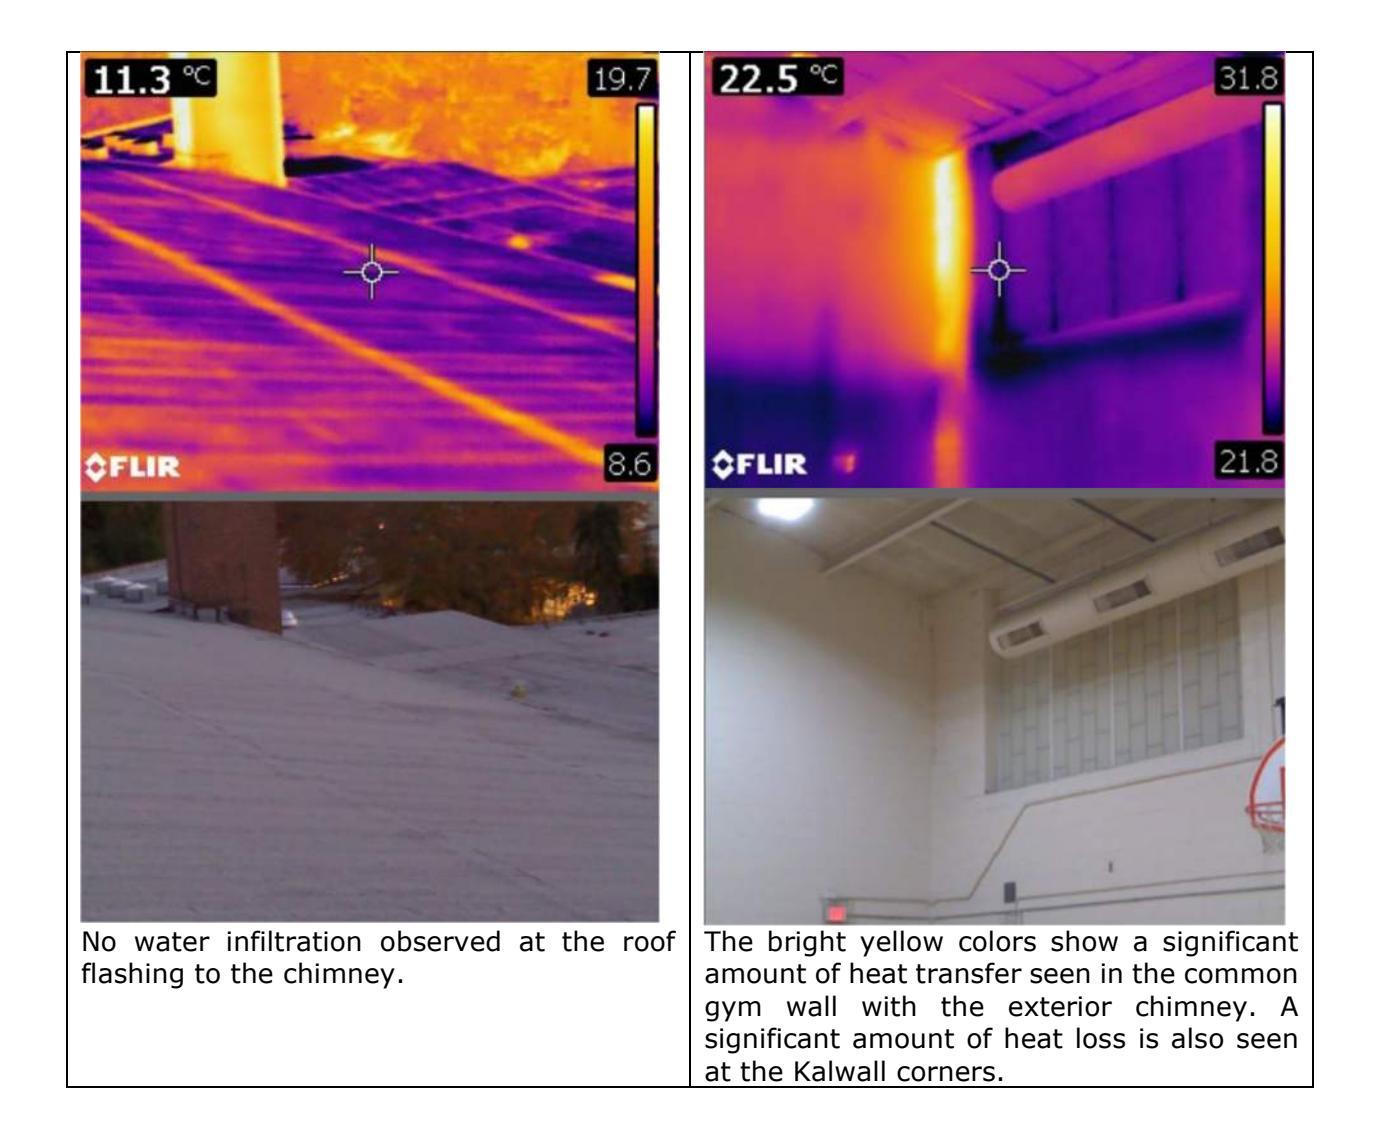
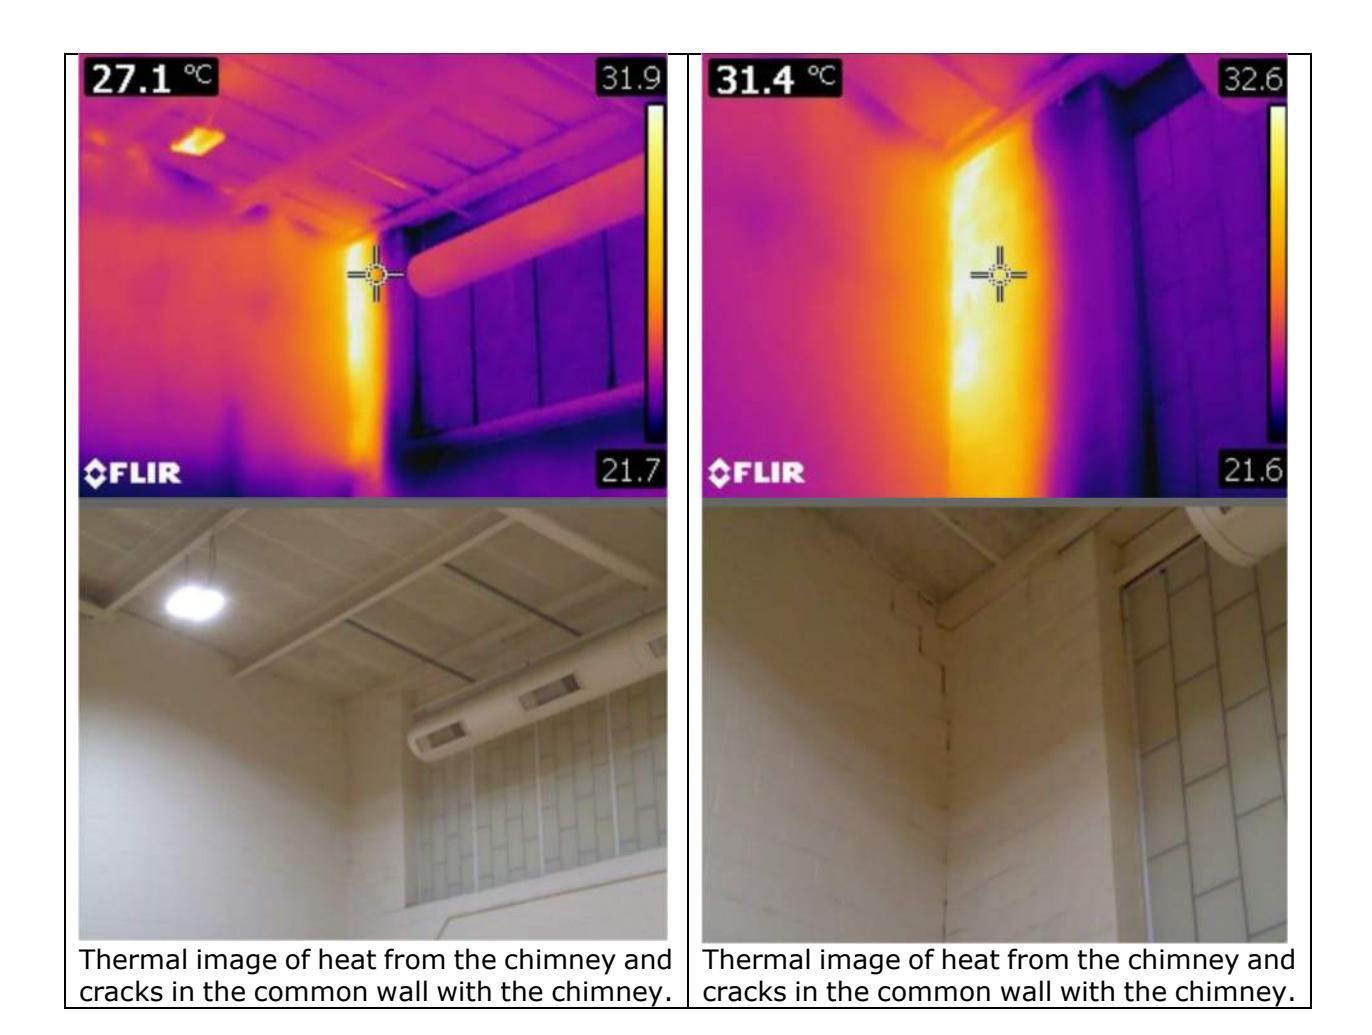
#### Structural Failure at the building Chimney

Sr.#	Equipment / System	<b>Observation Narrative</b>	Recommendation
1	Building Structure	<ul> <li>Structural block cracks observed inside the gym at the Building Chimney</li> </ul>	<ul> <li>Have the cracks and chimney evaluated by a structural engineer. Possibly replace the chimney and or the interior blocks laminated over the chimney at the interior gym wall section adding a thermal break. Provide movement joint between the chimney and the interior block wall.</li> </ul>
2	Building Structure	<ul> <li>Tunnel unexcavated with no vapor barrier.</li> </ul>	<ul> <li>Encapsulate soils with a vapor barrier.</li> </ul>
3	Building Structure	<ul> <li>Surface water infiltration into the building.</li> </ul>	$\circ$ Regrade building grounds and add yard drains.
4	Foundation and masonry repairs	<ul> <li>Correct flooding into building from the courtyard.</li> </ul>	<ul> <li>Excavate and install courtyard foundation waterproofing, insulation around the entire perimeter, footing drains and yard drains, revise grading.</li> </ul>

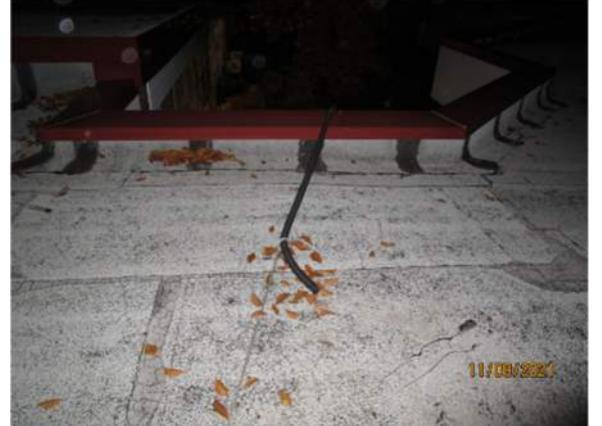
The sump pump discharges onto the roof as there is no drain in the courtyard.

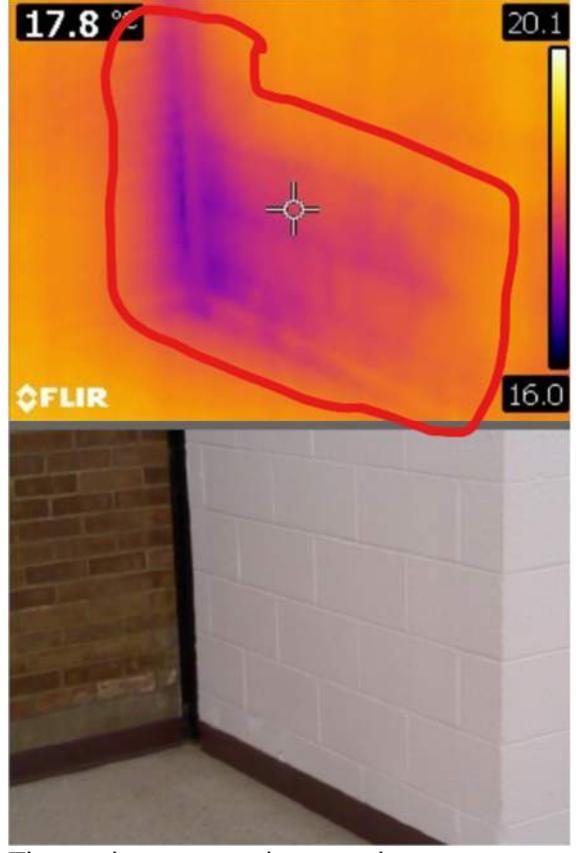
Thermal patterns show cooler temperatures at the foundation wall. This thermal pattern is consistent with missing foundation insulation, wet block, condensation. Efflorescence can be seen on the brick which is an indication of moisture in the masonry wall.

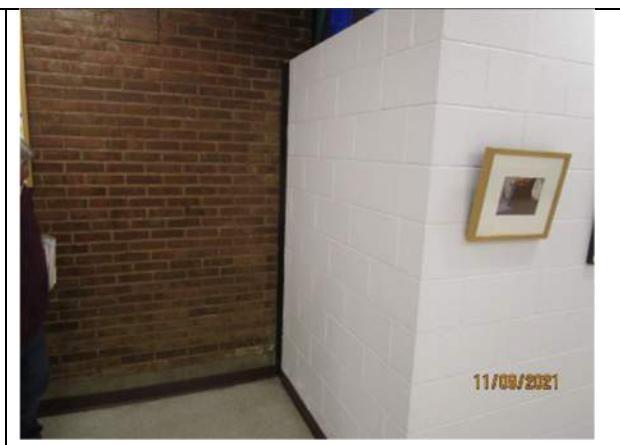
This corner near the ramp is where the water was actively observed entering the building.

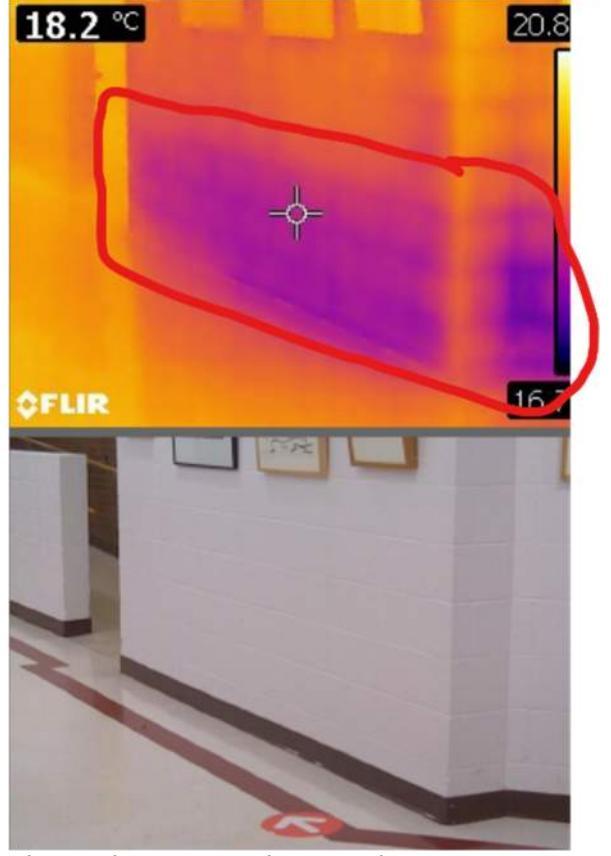
Thermal patterns show cooler temperatures at the foundation wall. This thermal pattern is consistent with missing foundation insulation, wet block, condensation.

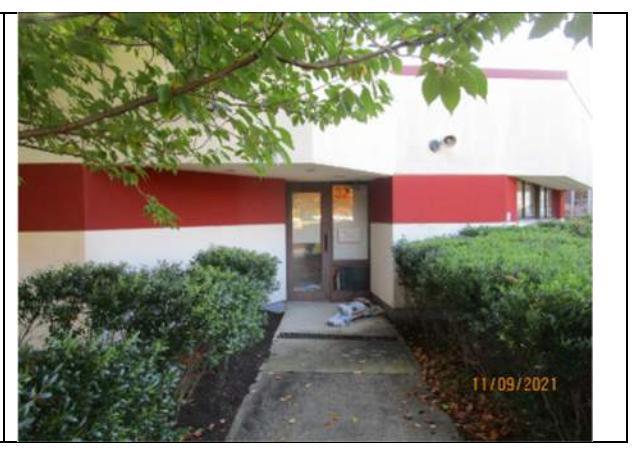
Sandbags observed in place to prevent surface water from infiltration the building. Site grading changes will be needed to correct water infiltration plus the addition of area drains.

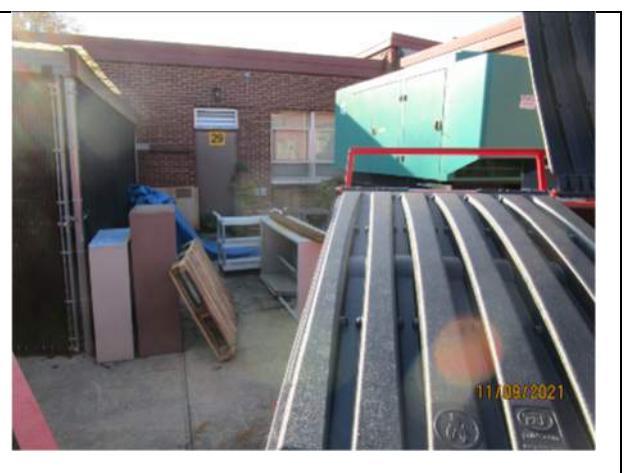
It was reported when the diesel generator is operating the diesel smell is evident in the kitchen. This is a sign of a failed building enclosure and improper balancing of the ventilating system allowing outside air to be pulled into the kitchen. It is reported that the kitchen exhaust hood has no control link between the cooking line hood and makeup air. The kitchen exhaust is likely causing negative air pressure in the kitchen and the poor building enclosure construction is likely allowing these fumes to be drawn into the building through the walls, windows, gaps around the doors and the window air conditioning unit.

The generator exhaust stack should be extended and directed above the roof level. The windows, doors and exterior wall system should be replaced with an airtight building enclosure.

A makeup air unit should be provided to correct the negative air balancing issue in the kitchen.

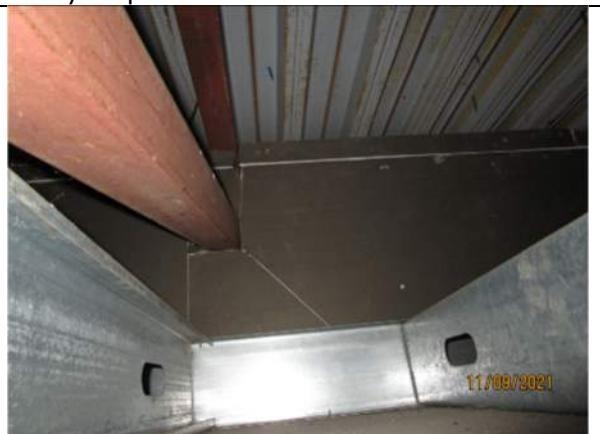
Vent into finish system soffit.

View inside the finish system soffit reveals that the gypsum sheathing on the exterior wall has no vapor barrier allowing drafts of outside air into the building.

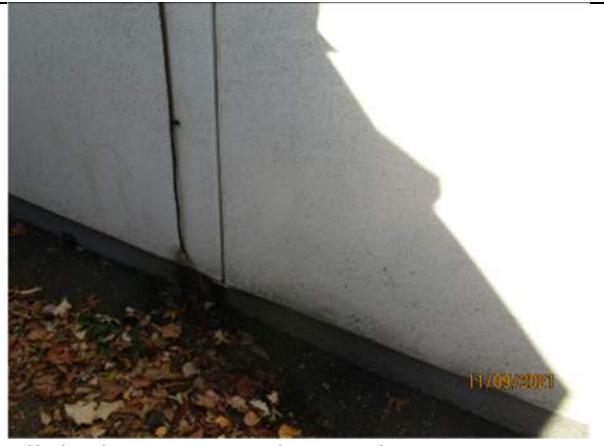
All the base trim and control joints appear to have expansion damage from water exfiltrating the system and expanding when leaving the system.

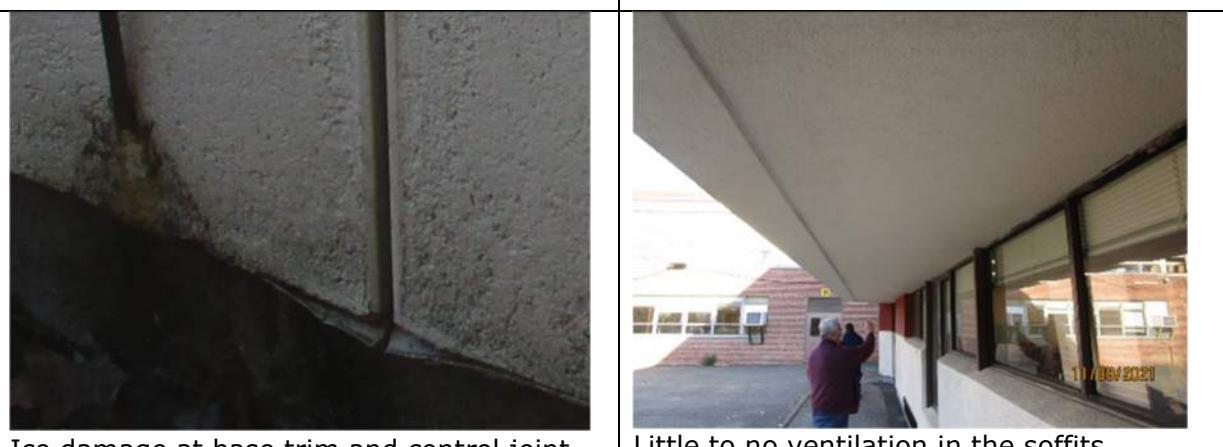
Ice damage at base trim and control joint.

Little to no ventilation in the soffits.

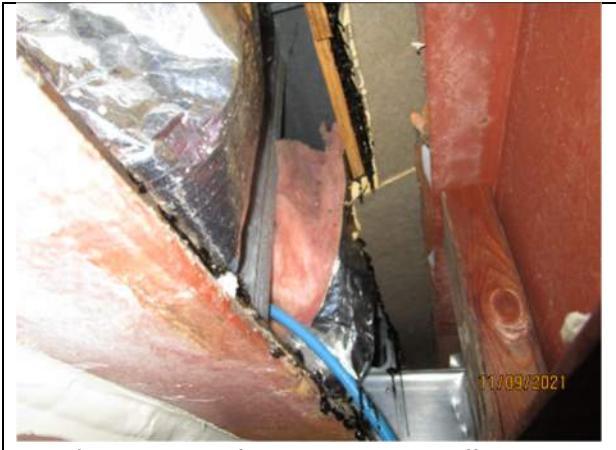
Insulation in the exterior walls is not properly installed. The vapor barrier should be overlapped and sealed from each section of insulation. Without the continuous vapor barrier airflow is free to infiltrate and exfiltrate the building.

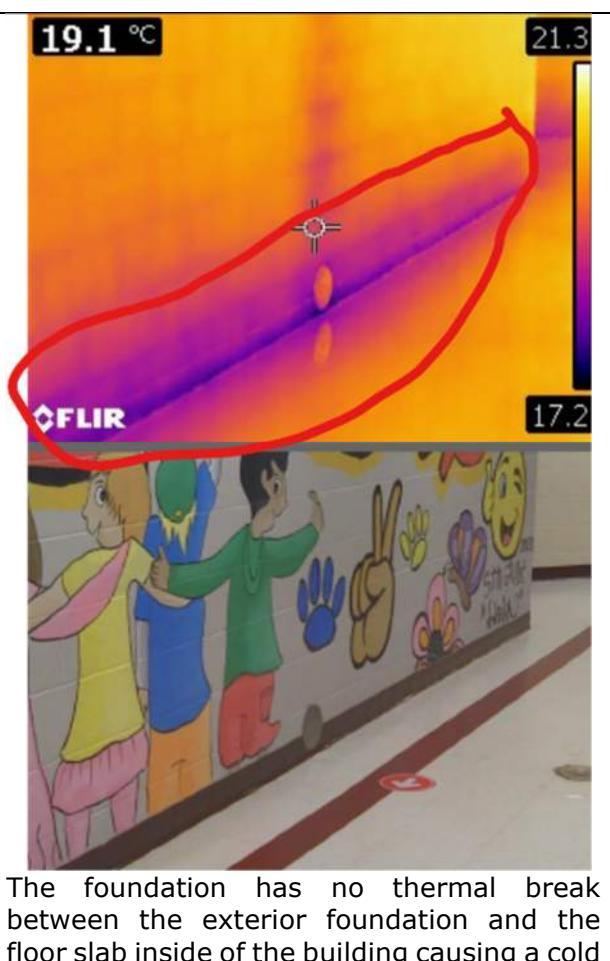
A damp patch on a wall is usually much cooler that the surrounding surface and when moisture-laden air meets a colder surface, it causes condensation. Several areas with thermal images with a temperature variation that are consistent with condensation have been identified. Condensation damp areas can lead to microbial growth. If condensation is not delt with it will go on to cause mold growth.

floor slab inside of the building causing a cold spot on the walls and floor that can lead to condensation.

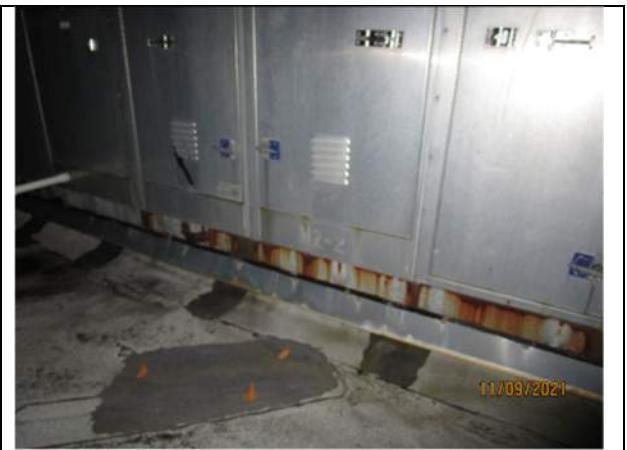
The rooftop units have been reported to have corroded pans that have rusted through and caused leaks into the building. The housing itself does not leak but the internal collection pans for condensation have failed. The RTU pans have been re-gasketed and

caused extensive water infiltration into the auditorium. This resulted in a major project to mitigate the mold caused by this water infiltration into the auditorium.

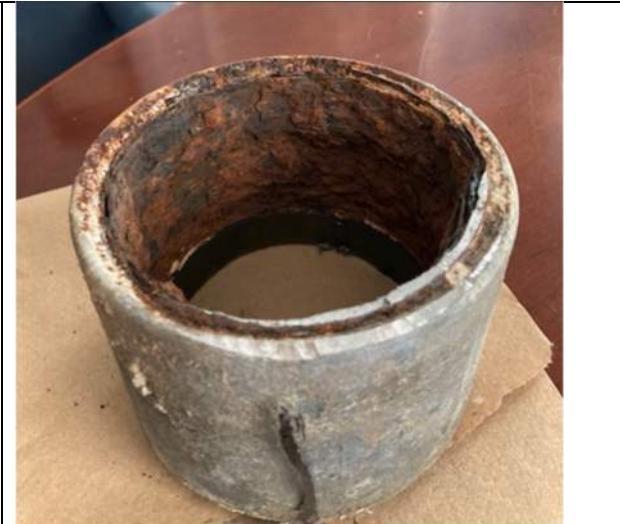
A roof drain body and piping that had been replaced was observed in the office. There was a hole in the pipe indicating that the roof drain system has exceeded its lifespan.

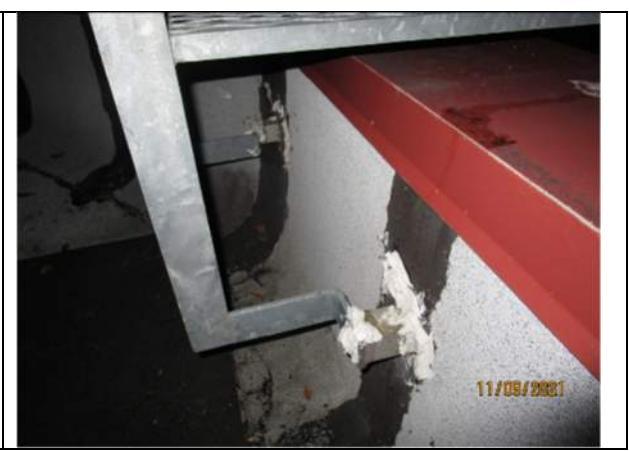
The access ladders on the roof levels have failed anchoring systems. The anchors have pulled out of the building and as a result the ladders are very loose. This is causing a potential water infiltration issue at both ladders.

Roof ladder pulling away from the building causing the sealant around the anchors to tear allowing water into the wall.	Thermal pattern consistent with water infiltration at the roof ladder possibly caused by the movement of the ladder due to the loose anchors.
21.3 °C 21.6 21.6 21.6 21.6 7.3 Thermal pattern consistent with water infiltration at the roof ladder possibly caused by the movement of the ladder due to the loose anchors.

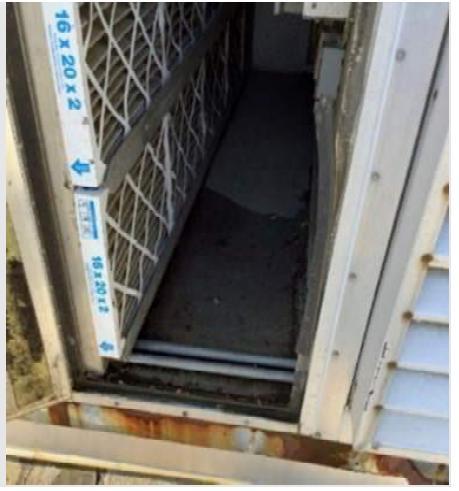
RTU-MZ-2 filters

- 1. HV units are located on the bulkhead above the gymnasium.
- The chiller and the constant volume chilled water pump operates continuously when the OA temp goes above 67°F. Only one chiller runs at a time, and the chillers are rotated every 168 hours (approximately 1 week).
- 3. All units' filters are MERV 8 and have been replaced on 04/21. RTU MZ-2 filters were observed to be dirty, and stalled water was observed at the base of the unit.

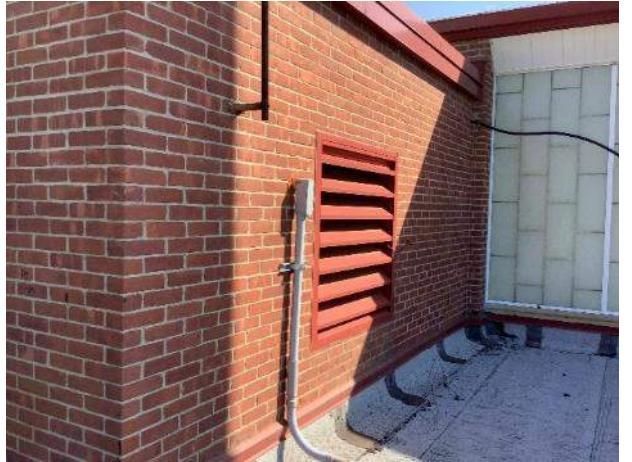
OA louvers on the exterior of wall of the building as observed from the roof.
