#720 12/1/9
RFP Fox Hill Tower
FILE
EXISTING CONDITION SURVEY
&
SCOPE OF PROPOSED RESTORATION WORK

FOR
MEMORIAL TOWER AT FOX HILL
VERNON, CT

October 9, 2003

HUBBARD & ASSOCIATES ARCHITECTS LLC
159 Hubbard Street, Middlefield, Ct 06455

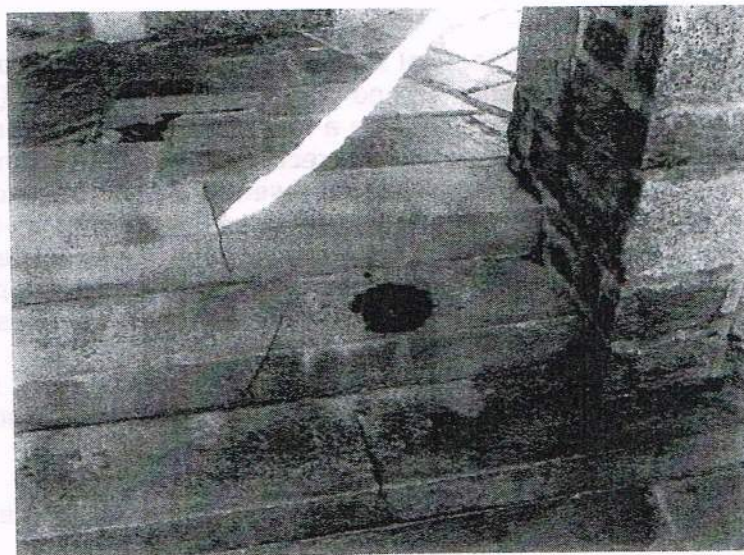
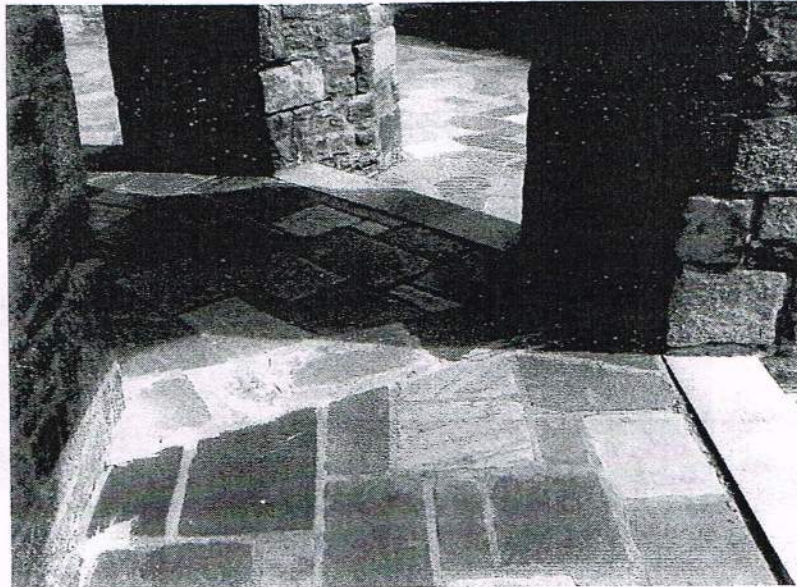
The flagstone walk between the inner and outer first floor walls is in poor condition. The flagstones are multi-colored, irregular in shape and are laid in a random pattern in a concrete setting bed. Some of the flagstones are loose or missing. There have been sloppy, inappropriate repairs to this surface in the past, which have been unsuccessful in treating the underlying problems. The surface doesn't pitch well to the steps, which is the only route that water has to exit the platform. The entire flagstone surface should be removed and replaced with a new surface material that is easier to walk on and pitched correctly for drainage. (See Photo E above and Photo F below).

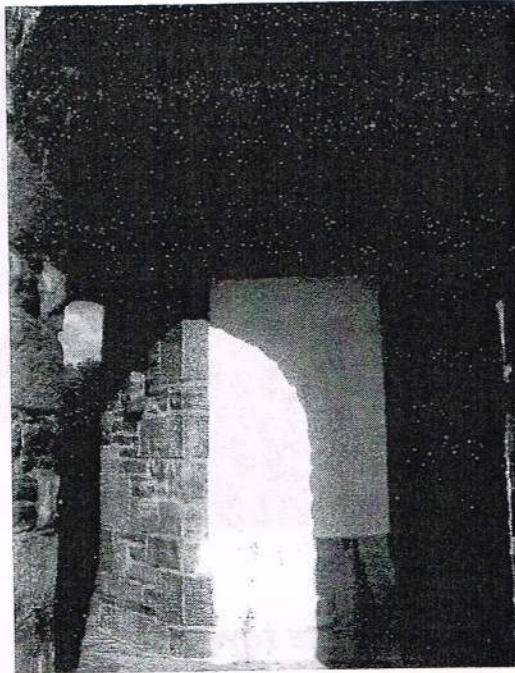
The rectangular sections of wall should have the existing paint surface removed. There is an area below one section that has white stains on the stone wall that should be cleaned (probably spilled paint that was wiped off - See Photo G below).

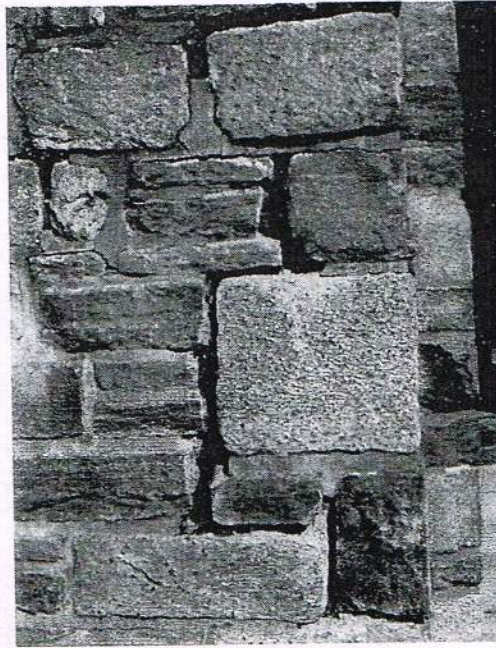
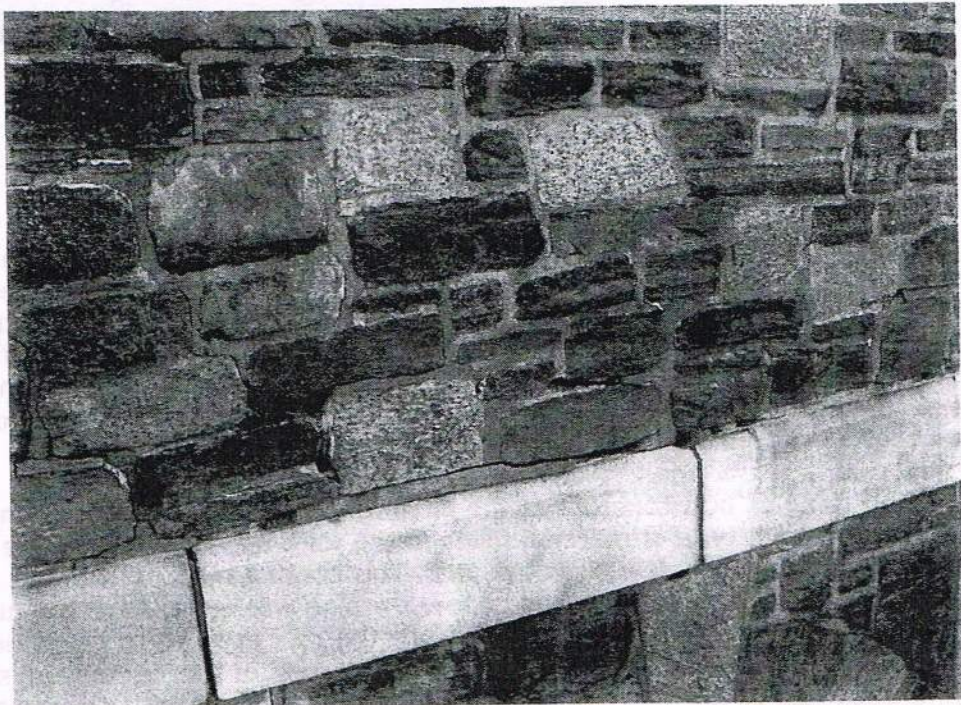
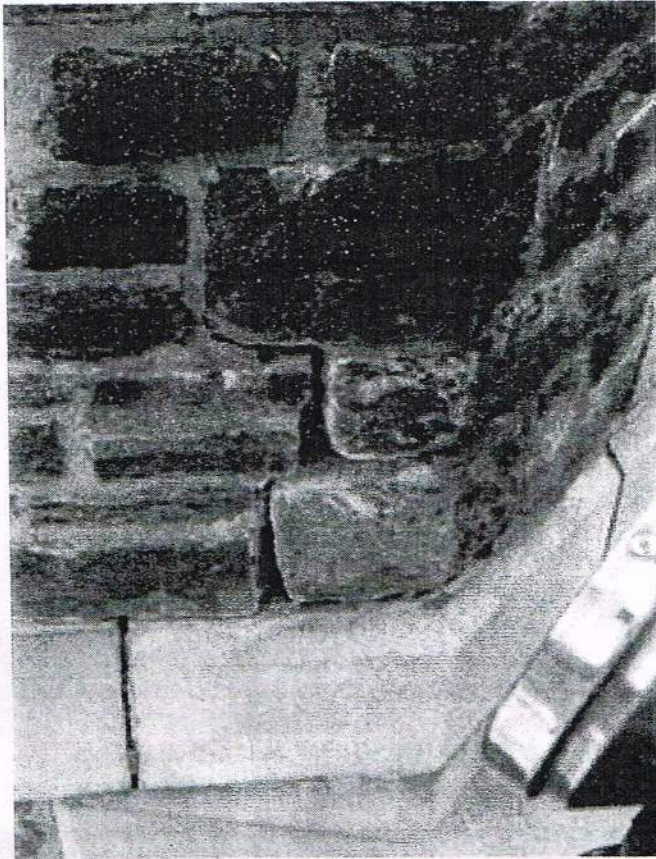
Photo J

In general, the stone itself is in very good condition. There is some staining on the walls with efflorescence present in many areas (See Photos above and Photos J, K, and L below). The Tower should be cleaned, but it should be done by a low impact power water wash, with chemical cleaners utilized only where necessary to remove stubborn stains and salt deposits.

Many mortar joints in the walls are deteriorating due to the continuing presence of moisture, some with moss actually growing within the joint. Much of the mortar originally used for the joints in the walls has been removed and re-pointed to some depth into the joints in the past – the last time in 1986. The re-pointing work was sloppy and mortar or some other substance was left on the building in some locations. The mortar used to re-point the joints in the past was not compatible in terms of color and mix with the original mortar and has left the walls with a patched appearance. It's also probable that this past re-pointing mortar is harder (in terms of compressive strength) than the original mortar. The use of harder mortar can create stresses needing to be relieved within existing masonry walls, leading to permanent cracking and spalling. It can also break the bond between the mortar and the stone, allowing water to penetrate into the resulting cracks, which has occurred in many areas. As such, the use of inappropriate mortar to re-point joints in the past has probably led to significant moisture penetration into the walls.

Photos J, K and L below illustrate many of the problems associated with the exterior stone walls at the Tower. Notice the efflorescence in several locations, the lumpy appearance of the mortar due to sloppy re-pointing work in the past, the moss growing in the joints, and the spalling joints in several locations. Also notice mortar missing in joints, cracks between the stones and surrounding mortar joints demonstrating the loss of bonding between the materials, and the rust

stains on the granite bands. There does not appear to be any flashing above the granite bands as typically used to drain water out of a masonry wall.

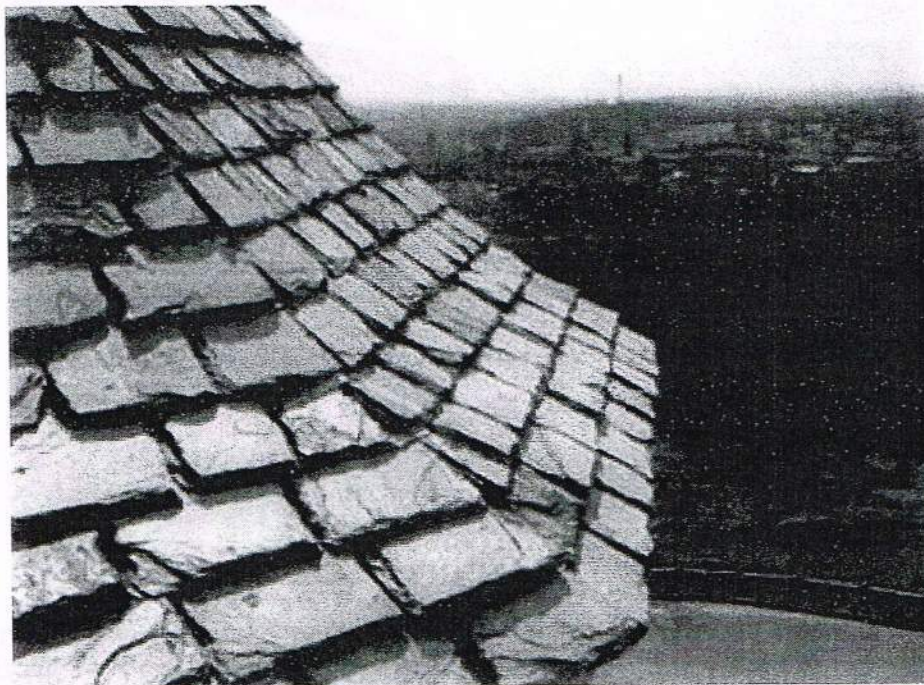
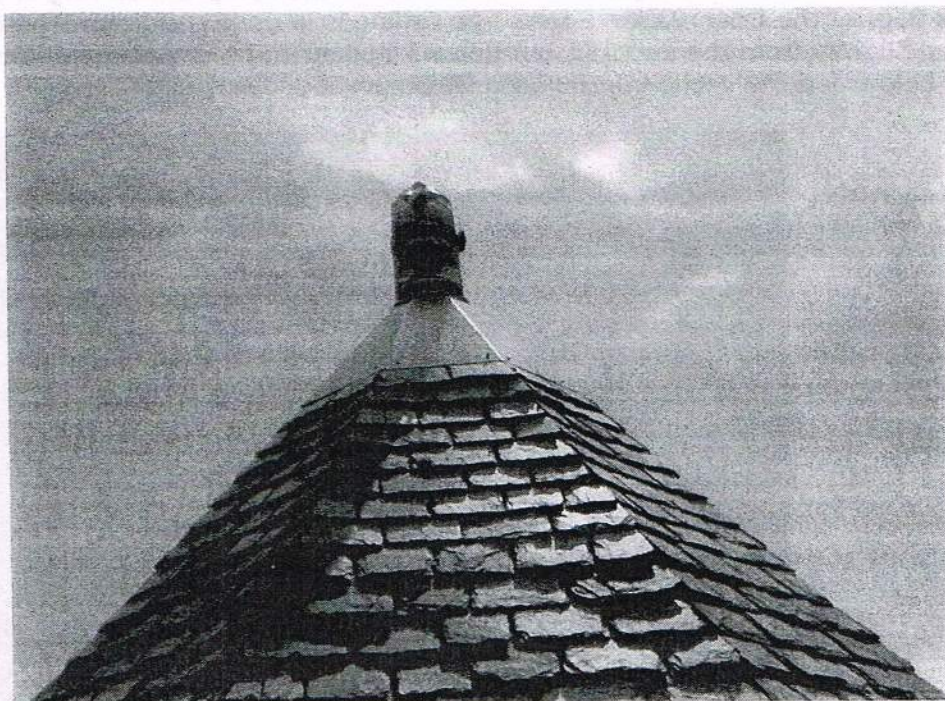
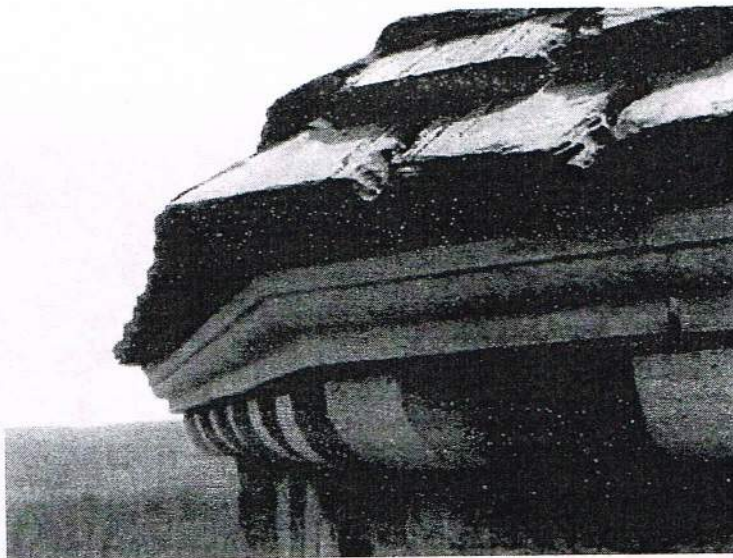
Photo M

The Tower Roof is an octagonal slate roof with a beacon light set in a metal cap at the apex. The slates are in relatively good condition but are 65 years old and approaching the end of their lifespan. The slates vary in thickness from about 2 inches thick at the fascia to about $\frac{3}{4}$ inches thick at the apex. Thicker slates were installed moving down towards the fascia to prevent uplift of the slates during high winds. There is a starter course of slate shingles. There is a granite band with dentils at the intersection of the roof and exterior stone wall with an oak trim board at the upper edge. The joints in this band should be raked and re-pointed.

The shingles butt together at the hip intersections of the sides of the roof. There is a coating of a roofing cement type of material filling in the joint between the shingle intersections in some areas, indicating a possible leak in the past. This coating material was not tested for the presence of hazardous materials. Lead coated copper flashing was installed at the hip intersections in overlapping courses under the shingles. While the roof appears to be sound at this time, a new slate roof should be installed as part of any restoration of the Tower, and should copy the existing varying thickness of the slates. There are no gutters at the roof, so rain washes down onto the Promenade approximately sixty feet below. See Photos M, N, & O below for views of the slate roof.

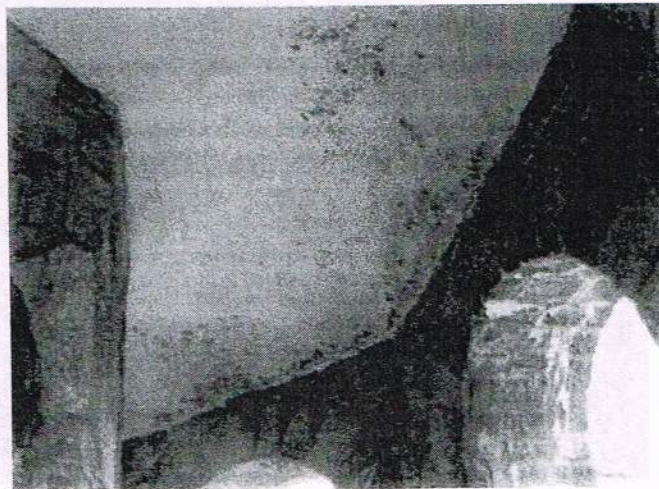
The floors/ceilings of the Tower are approximately 6 inch thick concrete slabs. The second floor overhangs the inner walls of the first floor of the Tower and connects to the outer walls as previously described. As such, there is an exposed exterior arched underside of floor at this level that has a coat of parging covering it. This exterior parging is peeling and flaking off, and at a minimum should be scraped and repaired. This exposed floor contributes to an uneven heat loss situation because part of the floor is exposed to the outside temperature and the rest of the floor is contained within the interior of the Tower and exposed to the interior temperature of the Tower. This condition may result in moisture migration thru the floor, leading to the peeling condition. One solution to this condition could be to try to even out the temperature differential by applying a one inch thick spray-on insulation to this exposed part of the floor, with an application of a type of exterior cementitious coating covering the insulation. See Photo R below for this condition.

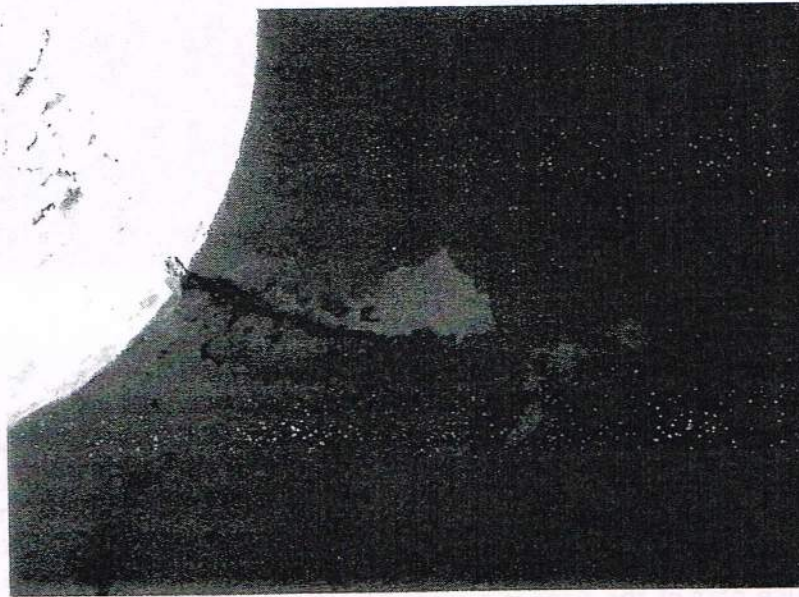
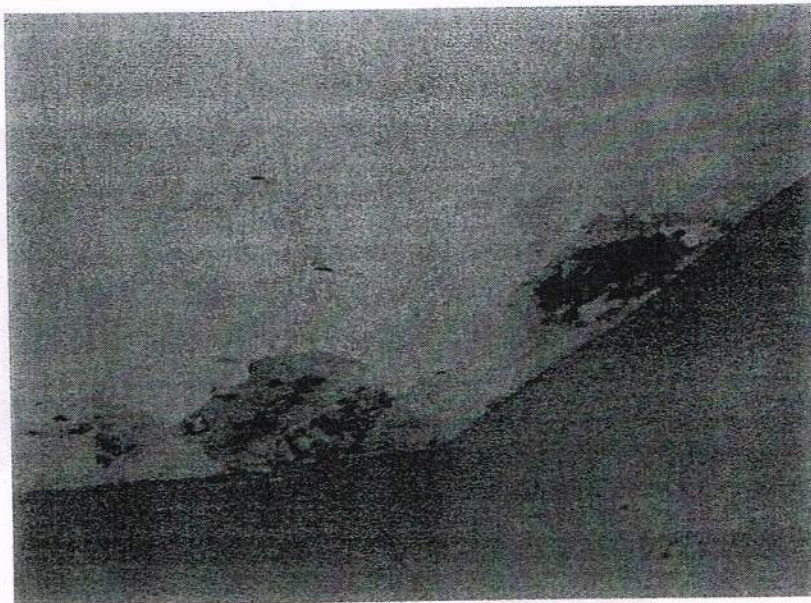
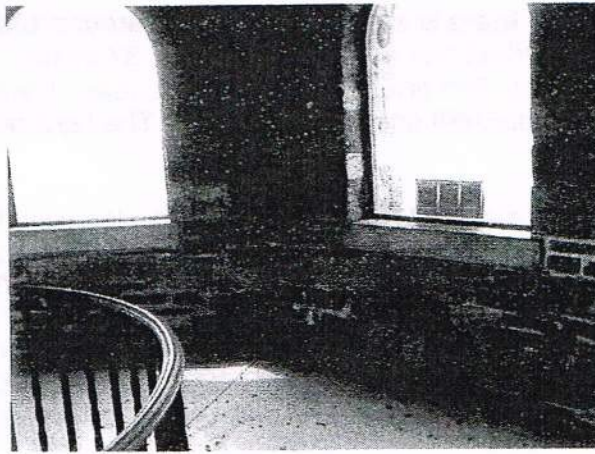
Photo S

The other floor/ceiling assemblies are contained within the Tower walls. They are in fairly good condition, except for a few areas that need repair work at cracks and areas of spalling. There are rust stains in the ceiling in some areas, indicating that the steel reinforcing in the structure has been exposed to moisture. The floors are painted on the walking surfaces and there is a coating of what appears to be paint on the ceilings. These coatings on the floors/ceilings should be removed in order to better assess the condition of the concrete slabs for needed repair work. See Photos S – Z below for examples of the condition of the floors/ceilings.

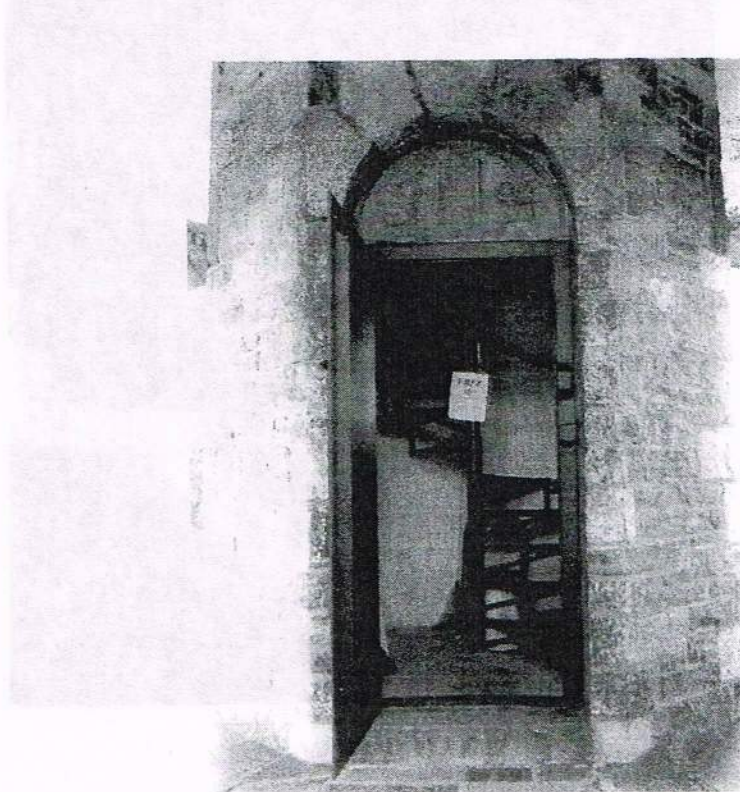
Different types of stairs connect the four floors. The first floor is 6-1/2 inches above the flagstone walk between the inner and outer Tower walls. A painted six foot diameter metal circular stair connects the first floor to the second floor. It has 8-1/4 – 8-1/2 inch risers, balusters at every third tread, and a railing at 32-1/2 inches above the treads (See Photo V below). There is just enough room inside the inner walls at the first floor to accommodate the stair. This entire stair is painted with lead-based black paint, which should be encapsulated or removed. It is approximately 12'-7" from the first floor to the second floor. This stair doesn't conform to code.

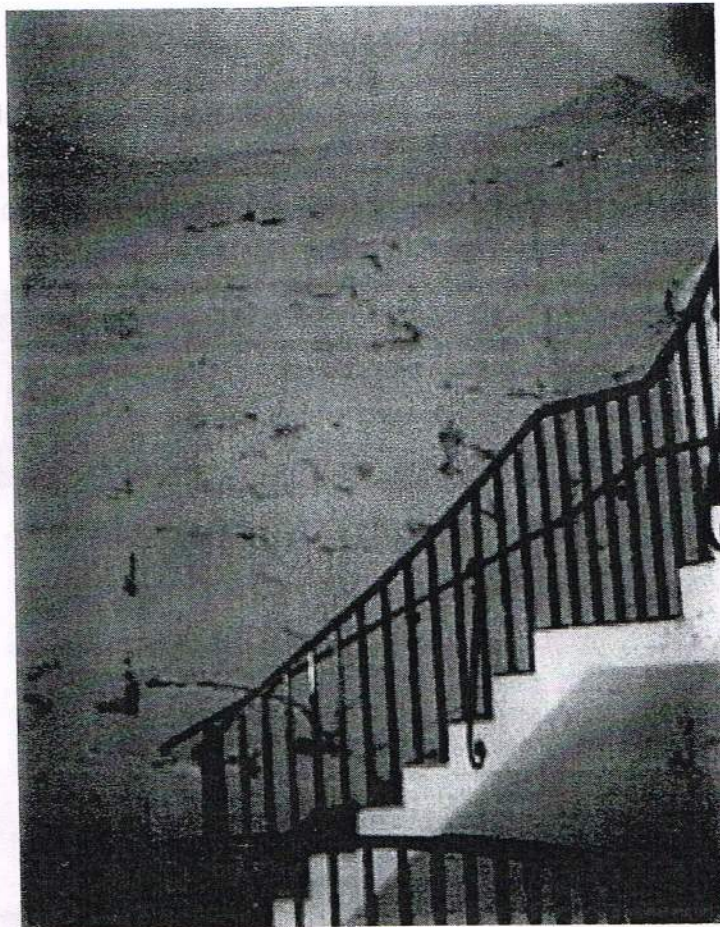
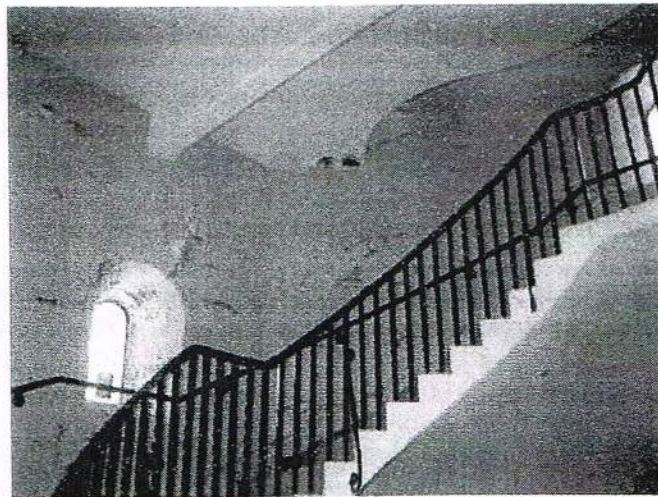
Photo W

There is an approximately 47 inch wide cast-in-place winding concrete staircase with 6-3/4 inch risers and 10-1/2 inch treads (measured at the center) from the second to third floors. This staircase has two intermediate landings and spans 16 feet from floor to floor. There is a bronze railing at 39 inches high on the wall side of the stair and another one at 37 inches high with metal balusters at the opposite side. The bronze alloy contains lead. There is a 3-1/2 inch clearance between the balusters, which are painted with lead-based black paint. The lead-based paint should be removed or encapsulated. This stair does not conform to code. See Photos W and X for this staircase.

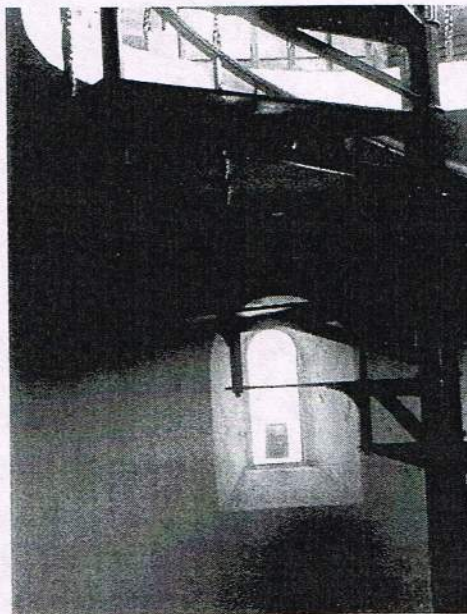
There is 6'-0" diameter metal circular stair from the third to fourth floors. This stair also doesn't conform to code and is painted with black lead-based paint, which should be removed or encapsulated. It is approximately 8'-0" from the third floor to the fourth floor. There is a baluster at each tread. See Photo Y below for this stair.

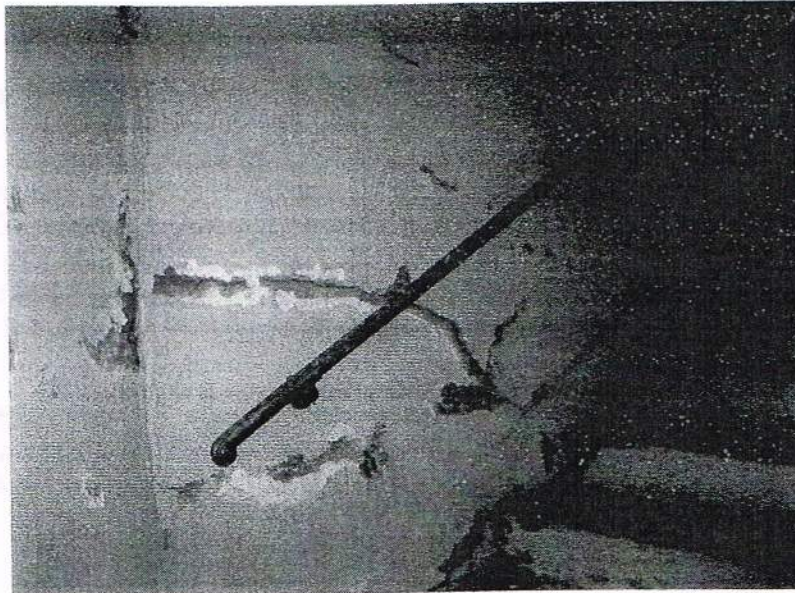
There is nineteen feet between opposite walls at the interior of the second and third floors. There is water penetrating through the walls, especially at the intersection of the stairs from the second to third floors (See Photo AA below).

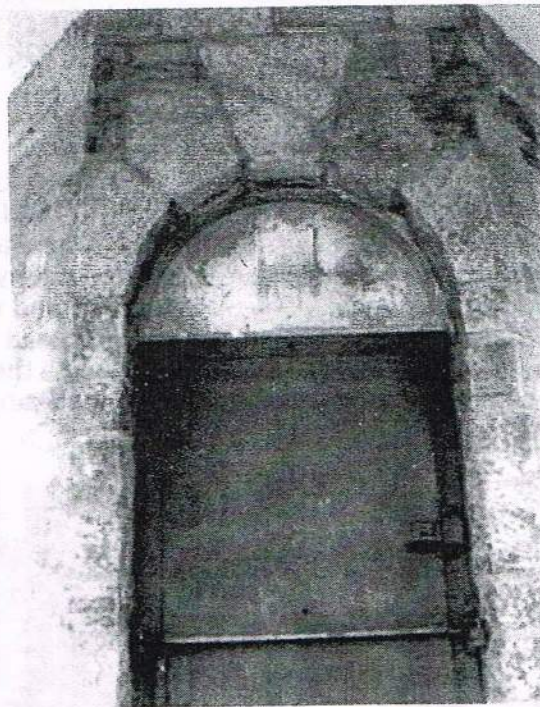
Photo CC

There is a painted cast concrete plaque above the entry door with the seal of the City of Rockville on it. It is in poor condition and should be repaired or replaced with a bronze plaque to match the other arched plaques at the other walls at this floor (See Photos V above and CC below).

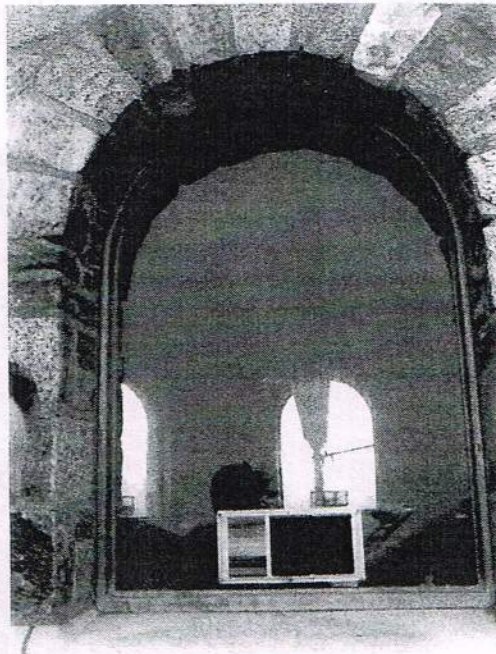
Photo EE

There is a 42 inch wide by 59 inch high arched window in each side of the Observation Room at the top of the Tower. These windows also have original bronze frames and have been modified with plexiglas glazing screwed to the interior side of the frame. Holes have been cut into the plexiglas to allow the installation of 5 inch by 8 inch thin flimsy metal vents. The windows have granite sills, the tops of which are 33 inches above the floor. See Photos U and BB above and EE below.

In general, the plexiglas is foggy and scratched with graffiti, the vents are coming loose or are missing, and water running off of the frames is staining the building. All windows should be removed and replaced with new with painted metal frames (which could match the aged patina of the existing bronze if desired). The glazing should be changed to safety glass to provide a safe view out of the windows. New metal vents can be installed instead of windows in the narrow windows in the lower levels for air intake and also at the bottom of the Observation Room windows for air discharge. This ventilation system may be sufficient to remove moisture from inside the Tower as described in the section regarding Mechanical systems below.

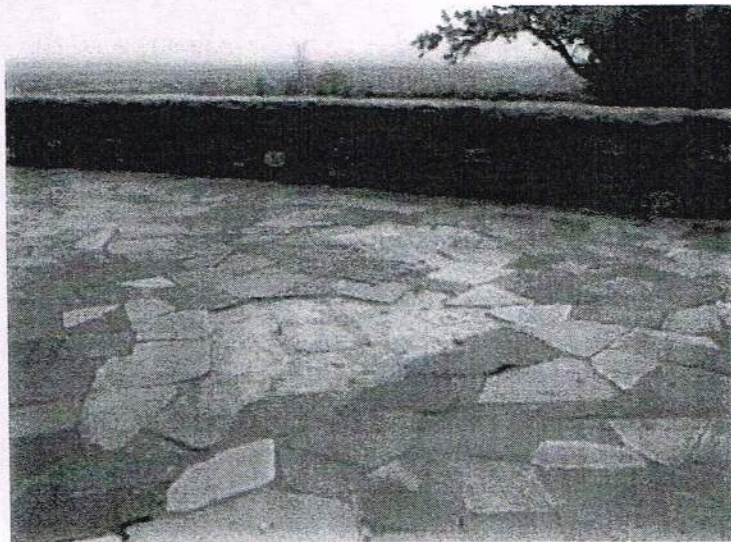
Surrounding the Tower is a semi-circular Promenade with a stone wall constructed of the same stones as the Tower. The wall is in good shape, but has the same problems as the exterior walls of the Tower: efflorescence, stains, loose or missing mortar in joints, moss growing in the mortar joints, poorly installed re-pointing work, etc. This wall should be cleaned and repaired/re-pointed as recommended for the Tower walls (See Photos FF and HH).

The walking surface of the Promenade consists of random size, random color flagstones set into a concrete setting bed. Approximately 75% of the flagstones are either in poor condition or have lifted out of the setting bed altogether. Numerous attempts have been made in the past to repair this surface, which has left the surface very uneven. The flagstones and setting bed should be completely removed. A new material, possibly a combination poured concrete setting bed/finish walking surface should be installed that will meet current codes.

A new walking surface will provide less joints for water to penetrate and will provide a more level, even walking surface. There is currently no accessibility for the disabled from the Promenade into the Tower. The deterioration of the walking surface is a continual maintenance issue due to the lack of pitch in the surface. Water works its way underneath the flagstones due to freeze/thaw cycles, which in turn cause the flagstones to lift out of the setting bed. This has created a hazardous condition for visitors to the Tower. See Photo FF below for an example of the condition of the Flagstone surface at the Promenade.

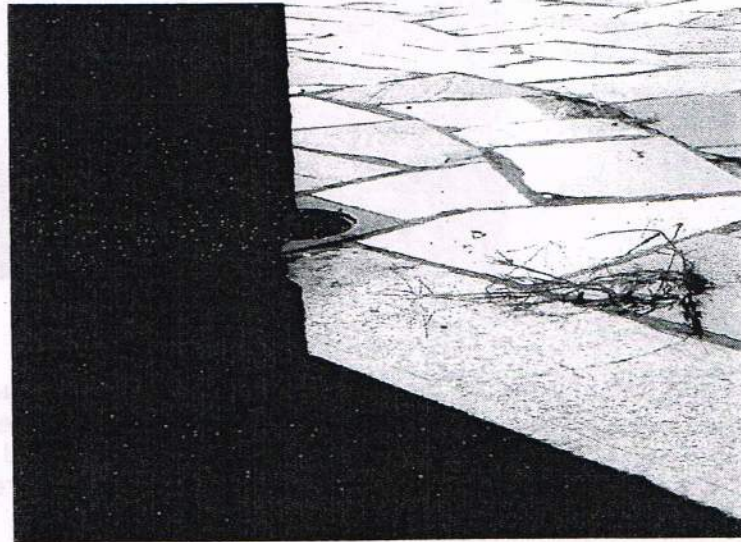
Photo GG

There is also a drain at each side of the stairs leading from the Promenade to the Walk. These drains connect into metal pipes that twist around and exit through the first riser of the stairs at the intersection of the granite plinth between the Promenade and Walk walls. The covers are missing from both drains. The drains are rusted and should be replaced. See Photos GG and II below.

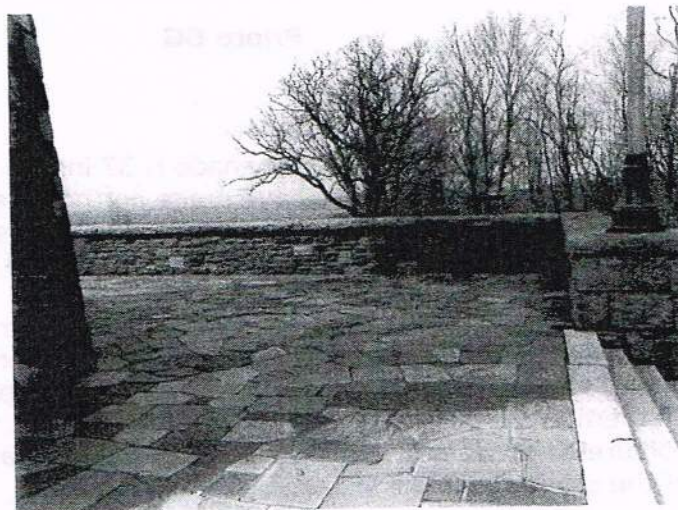
Photo II

There is a flagpole on the granite plinth where the walls surrounding the Promenade and Walk intersect (See Photos II and NN below and Appendix G). The base of the flagpole has lead in the alloy of the bronze finish. The flagpoles are painted metal and rusting in some locations, especially at the bases (See Photo JJ below). The rust should be removed and the flagpoles should be painted.

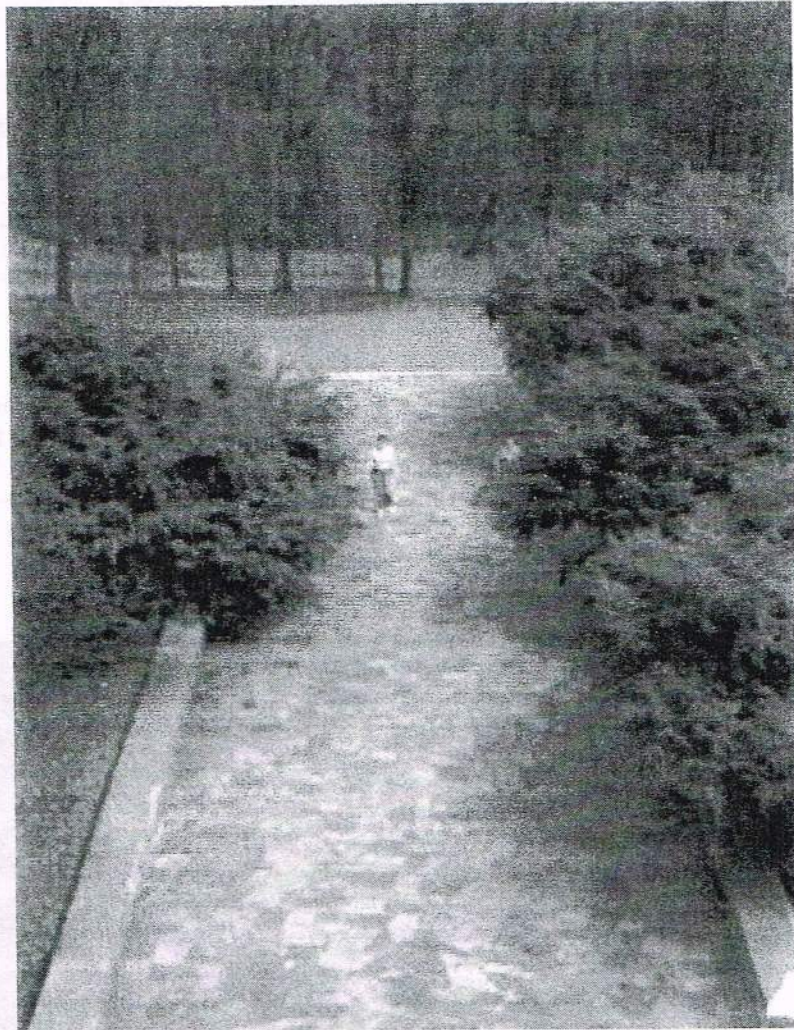
Photo LL

The entire flagstone surface of the walk and the setting bed below should be removed. A new walking surface/setting bed to match the surface at the Promenade should be installed with minimal joints to reduce the ability of water to work its way below the surface.

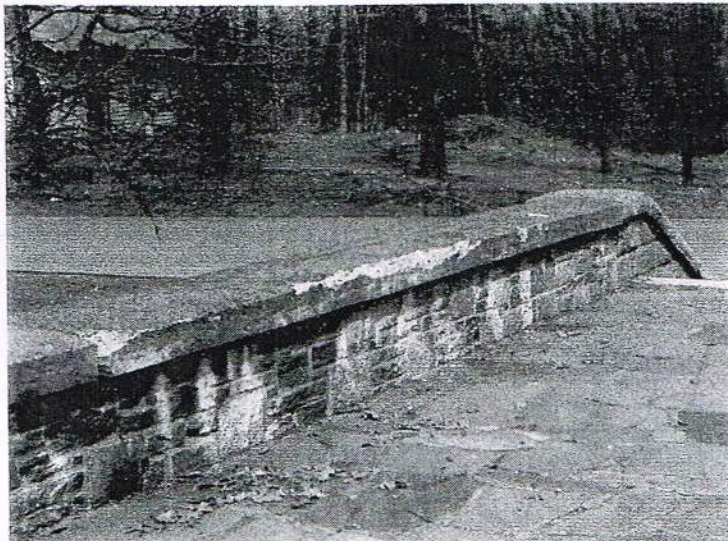
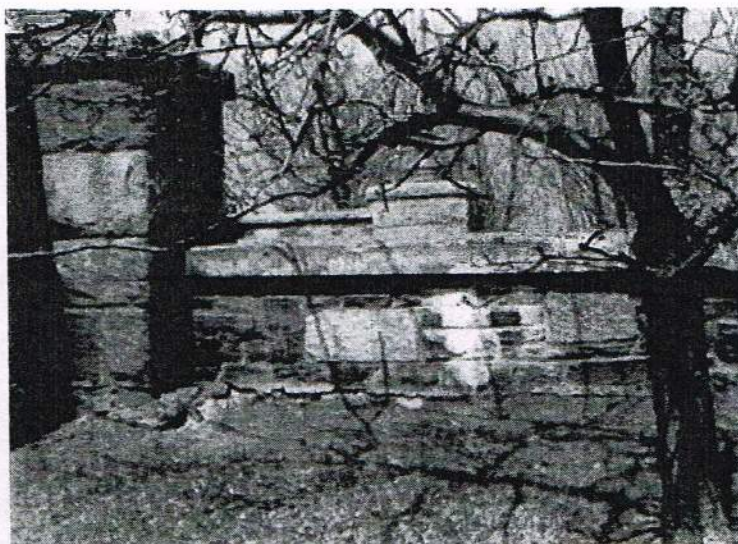
Photo MM

Concrete capstones cast to look like rough granite were used to cap the walls at each side of the Walk. These capstones are in poor condition, with pieces missing and reinforcing bars exposed to the weather, and should be replaced. It appears that the use of cast concrete capstones at these walls instead of granite capstones was a cost-saving measure at the time of construction. Since they haven't held up very well, it might be preferable to replace them with granite capstones.

instead of new concrete capstones. See Photos MM & NN for examples of the existing condition of the concrete capstones and stone walls at the Walk.

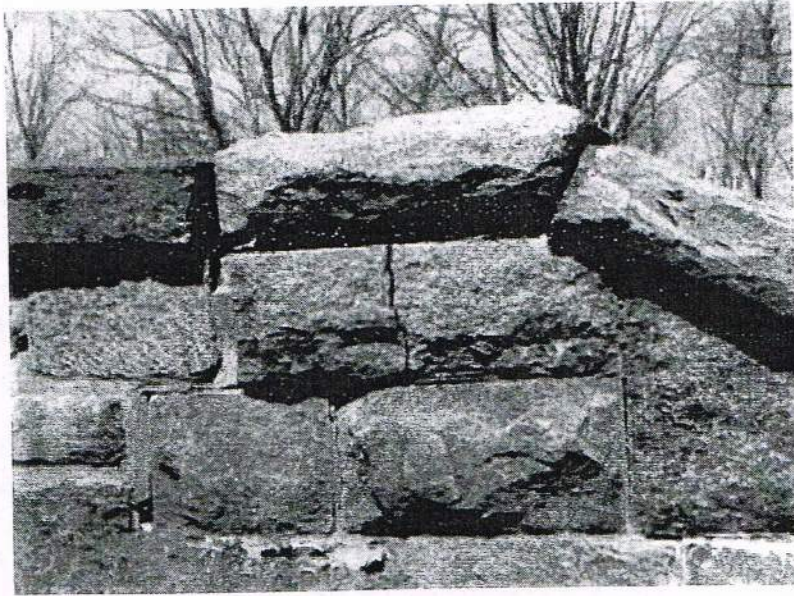
At the end of the Walk are stairs leading to a small paved area leading to the road. The stone wall at both sides of these stairs changes in construction from "jewel building stones" with concrete capstones to granite stones with granite capstones (See Photos MM above and OO below). The granite wall on the South side of these stairs is in poor condition due to water penetration. Stones have been dislodged and cracked which need to be replaced and re-set (See Photo OO below).

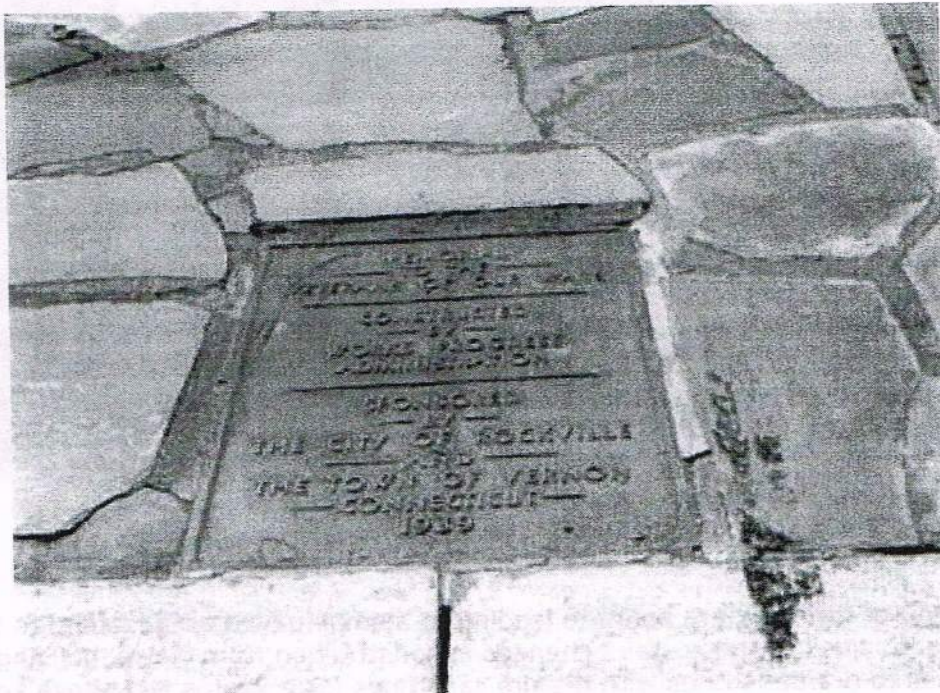
Photo PP

There is a bronze commemorative plaque set into the flagstone Walk where it meets the Stairs. This plaque should be removed and re-set into the new surface of the Walk (See Photos PP and QQ below). The alloy in this plaque contains lead.

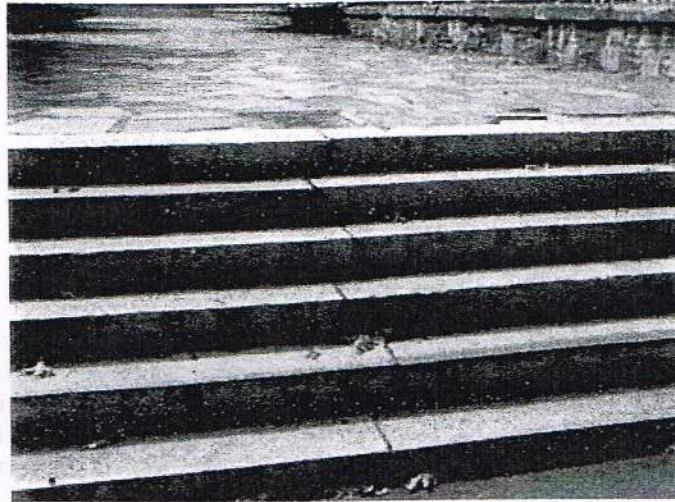
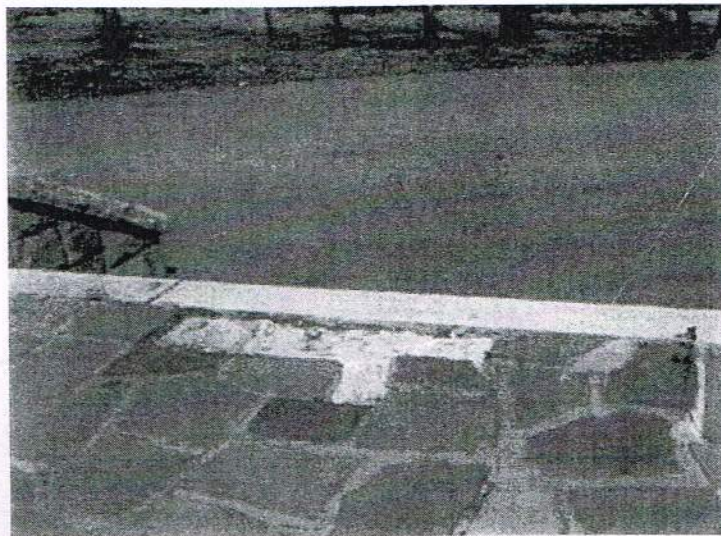
Photo QQ

The granite stairs leading from the Walk to the Promenade consist of six risers at approximately 6 inches each (at the top five risers) with 12 inch treads. The bottom riser slopes down from 1-1/2 inches high at the north end to 3-1/2 inches high at the south end. The width of the stairs is approximately 27 feet. There are no railings at these stairs, which should be installed. These stairs are in poor condition and need to be completely re-built. Water currently flows down the Walk into the intersection of the Walk and stairs, which is causing rapid deterioration of the base material below the stairs and for the stairs to shift out of alignment (See Photos QQ and RR below).

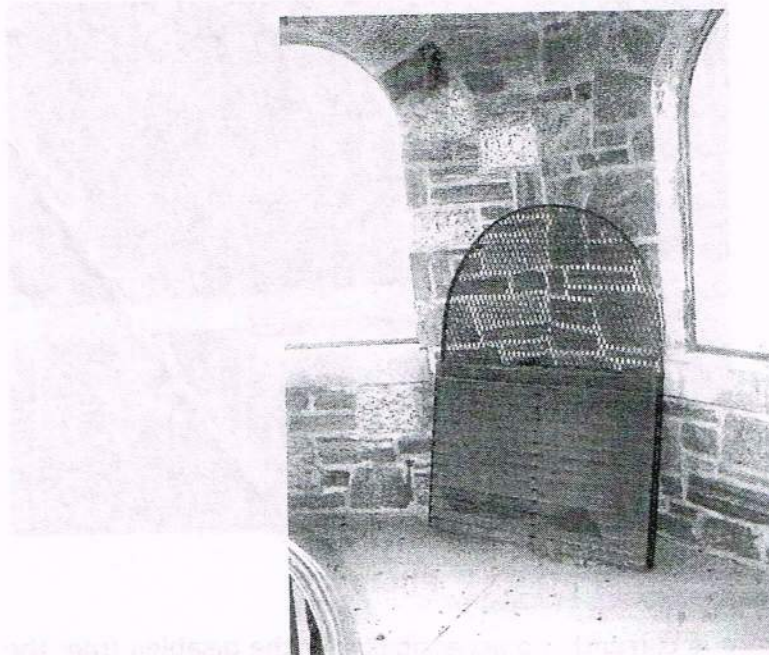
Due to the unavailability of construction documents, it is difficult to determine how sealed off to the weather the Tower was originally constructed. However, by taking a close look at the photo c. 1939 in Appendix G, it appears that the door into the Tower is either open or non-existent. The arched openings in the Observation Room appear to have windows and/or grilles contained within them. There is a horizontal band in the middle of these openings that is difficult to identify. There is currently an arched metal grille sitting against the wall in the Observation Room that appears to have been installed in one of the arched openings at some point in the past (See Photo SS below).

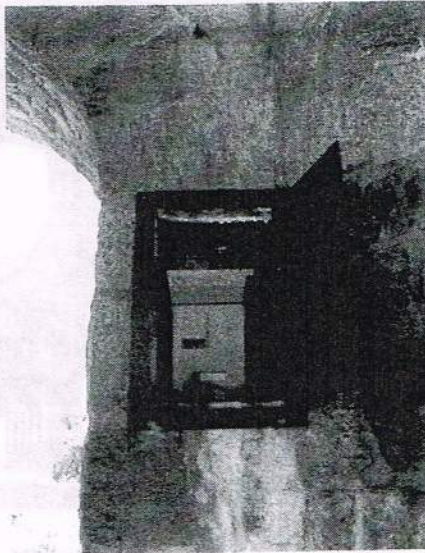
There is an electrical box recessed in the wall at the arch opposite the door into the Tower (See Photo TT below). There is 20 Amp service into the Tower, which is fed from the electrical junction box at the foot of the north side of the Promenade wall (See Photo UU below), which is in turn fed via an underground wire from a pole at the road (See Appendix B). There are no lights, exit signs, or other types of electrical fixtures in the Tower, except a large beacon type light on a pole that is inserted into the center post of the circular staircase at the fourth floor.

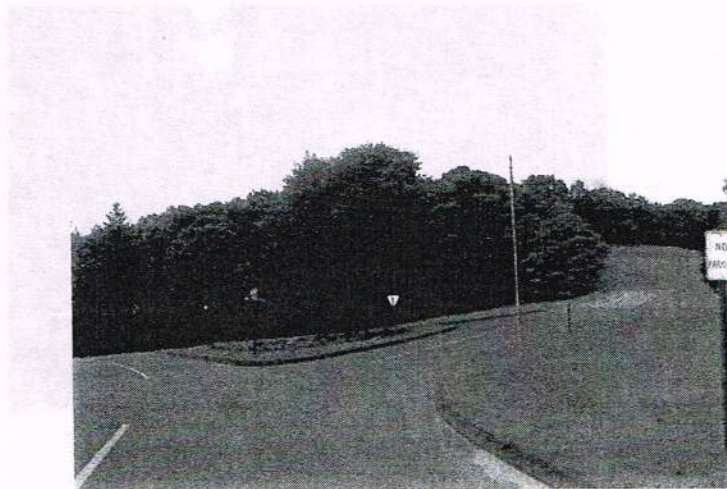
At the intersection shown in Photo XX above, there is a street sign for Tower Road, but no other signage to direct visitors to the Tower. Although the Tower is at the top of the hill behind this intersection, it is blocked from view by trees. At the intersection shown in Photo YY below, there is a sign for the Tower, but no information to tell you which way to go at this intersection to find the Tower.
