### FACILITY ASSESSMENT

# Central Intermediate School

## MAY 15, 2017

#### 1.1 CENTRAL INTERMEDIATE SCHOOL

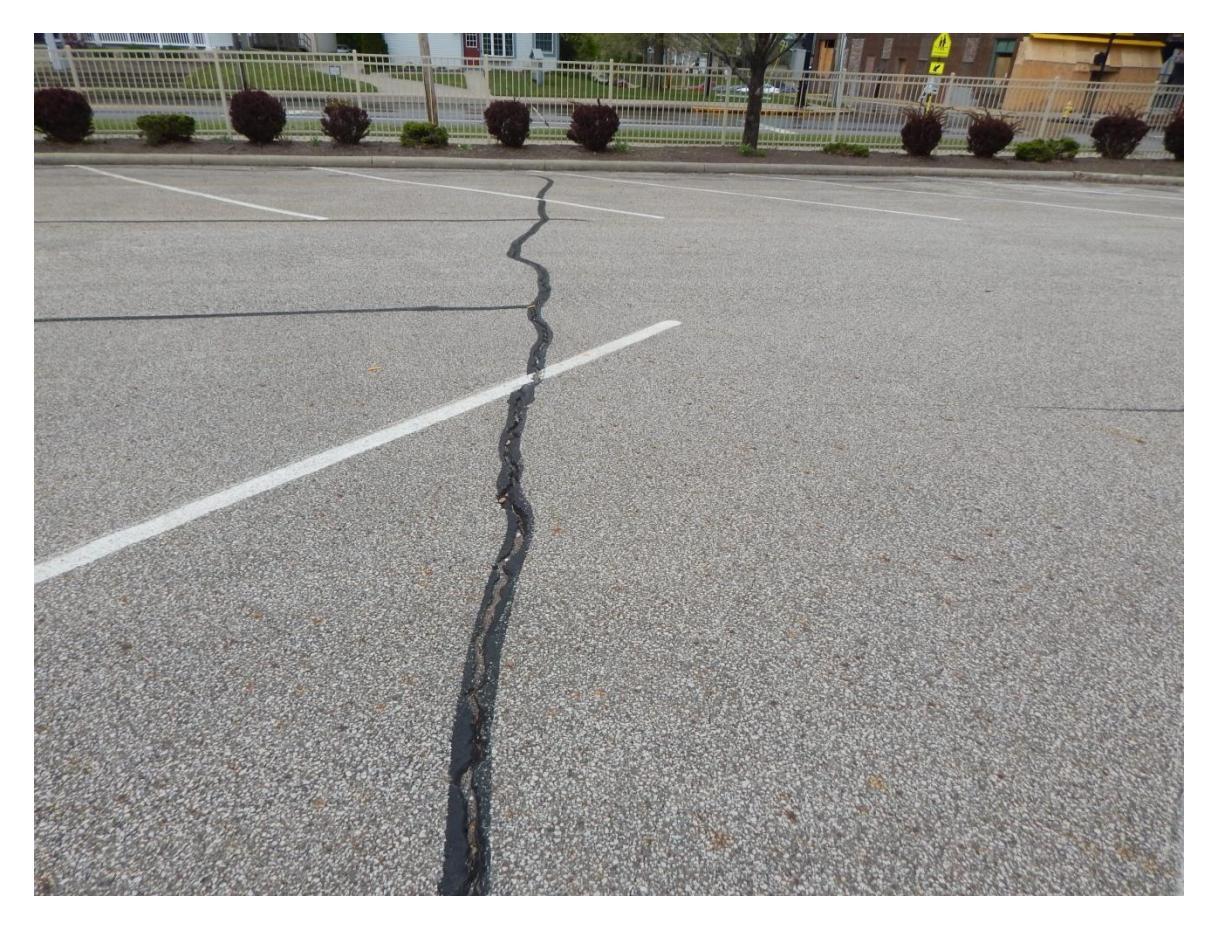
Front drive and parking area has previously had cracks filled. Some cracks are no longer filled and a few additional cracks have developed. (Fig. 1-1)

Cut and patch damaged asphalt and fill previously filled crack and new cracks with crack sealer and seal coat lot at the front of the building. Fill previously filled crack and new cracks with crack sealer and seal coat lot at the back of the building. Mill approximately 2" of existing asphalt at the lot across South Layman Street and apply stress absorbing membrane interlayer and 2" of asphalt. Concrete walks/aprons/islands/stairs -Description: There are approximately (35) sections of concrete sidewalks around the site that are damaged. (Fig. 1-5)

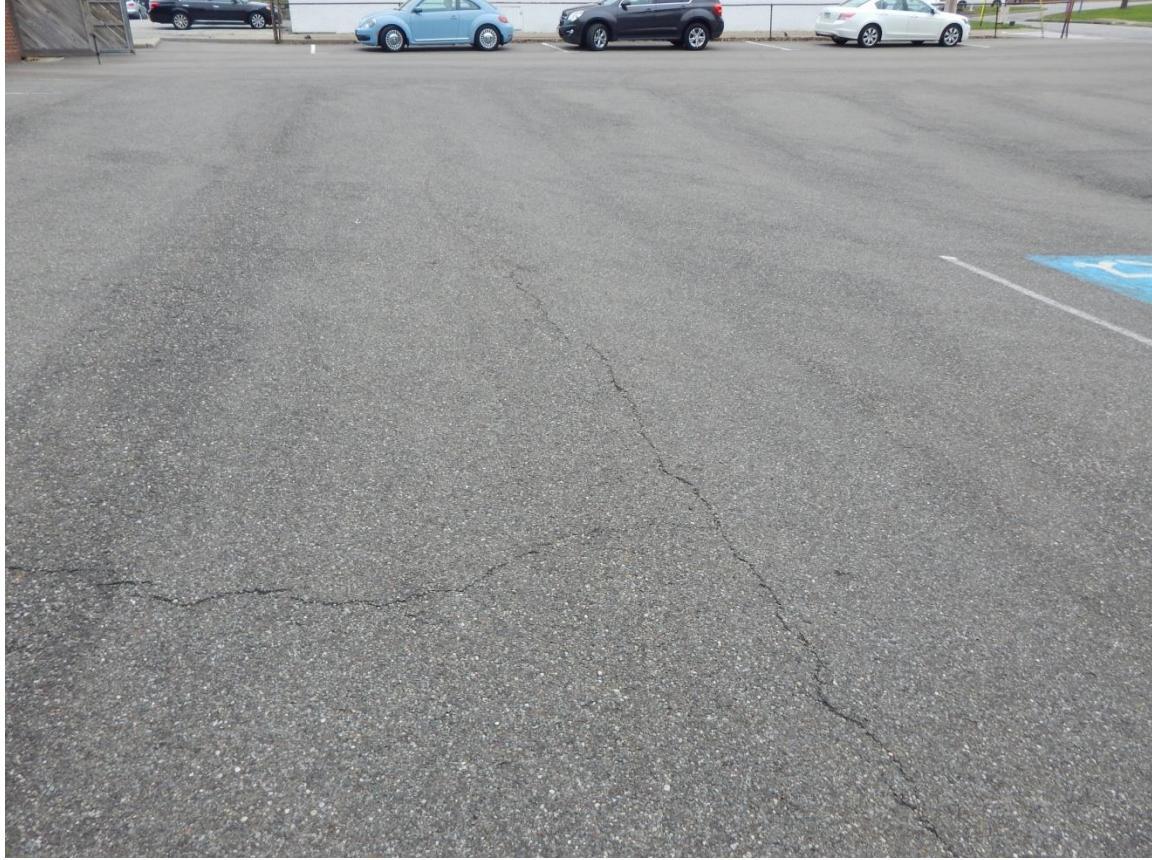
Figure 1-3

Rear parking area has previously had cracks filled. Some cracks are no longer filled and a few additional cracks have developed. (Fig. 1-3)

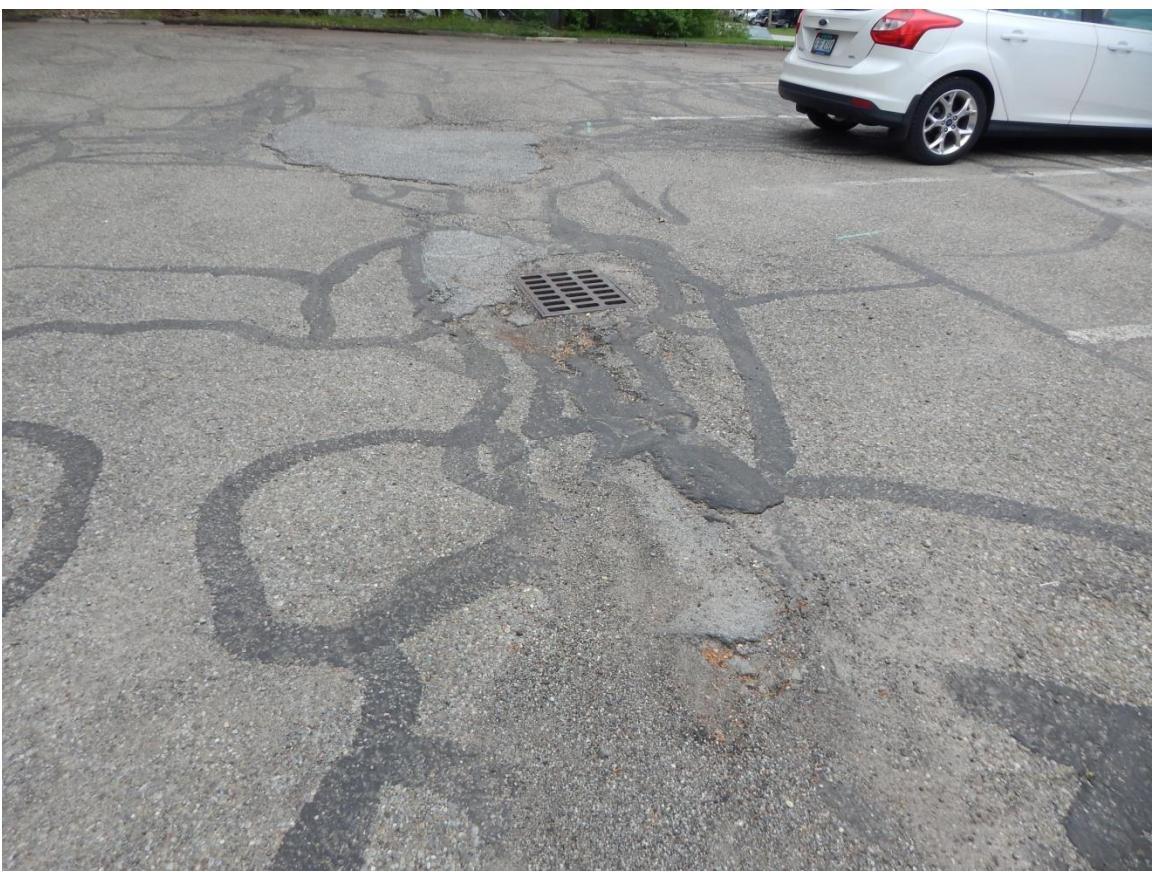
Figure 1-4

Parking area across South Lyman Street has previously had cracks filled. Some cracks are no longer filled and a moderate number of additional cracks have developed. There are a few areas where the asphalt is damaged. (Fig. 1-4)

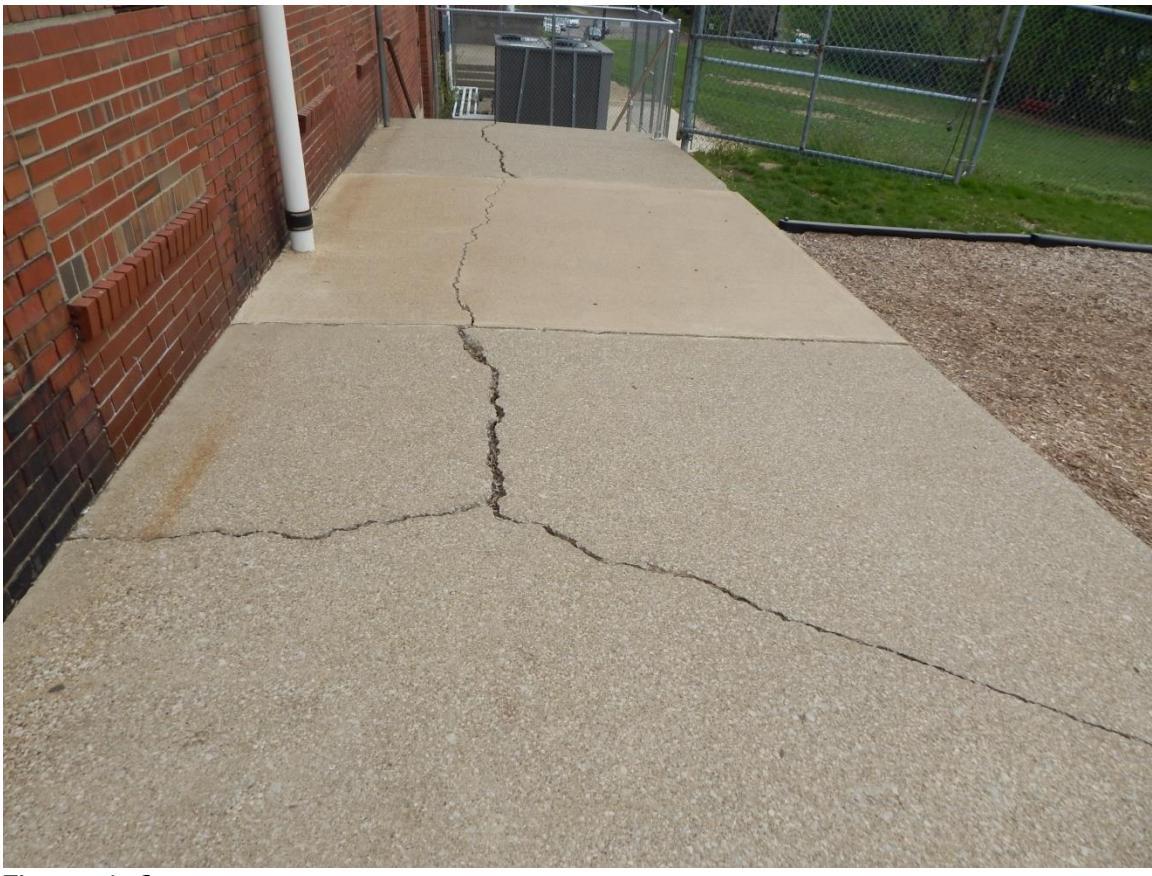
Figure 1-6

There are four large concrete walk sections along the south side of the building that are damaged. (Fig. 1-6)

Replace the damaged concrete sidewalk sections, the damaged concrete apron sections and the damaged concrete at the islands. Patch the concrete stairs where the reinforcing bars are exposed and provide railings along the east side. Paint the rusty railing at the other stairs along the east side.

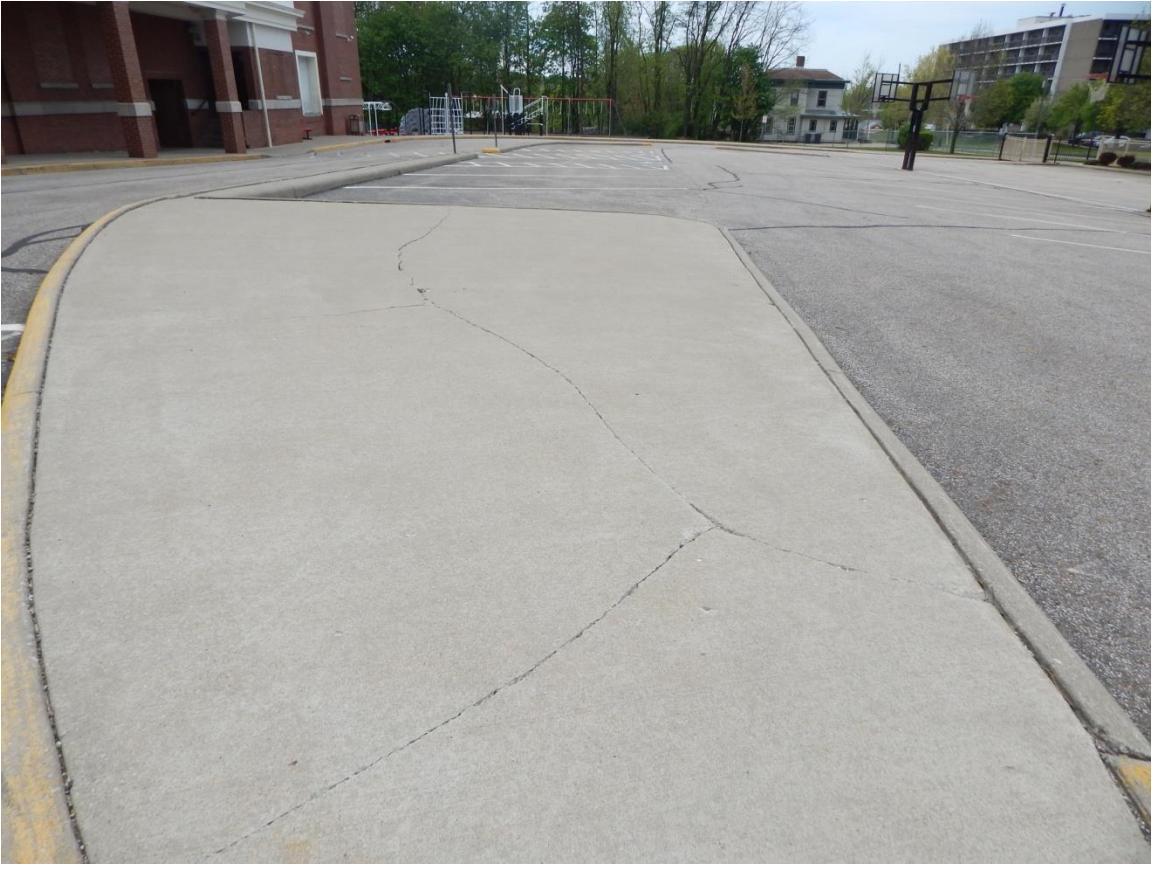
Figure 1-7

There are four sections of the concrete apron at the front entrance that are damaged. Two of the concrete islands at the front parking area do not have control joints and are cracked. (Fig. 1-7)

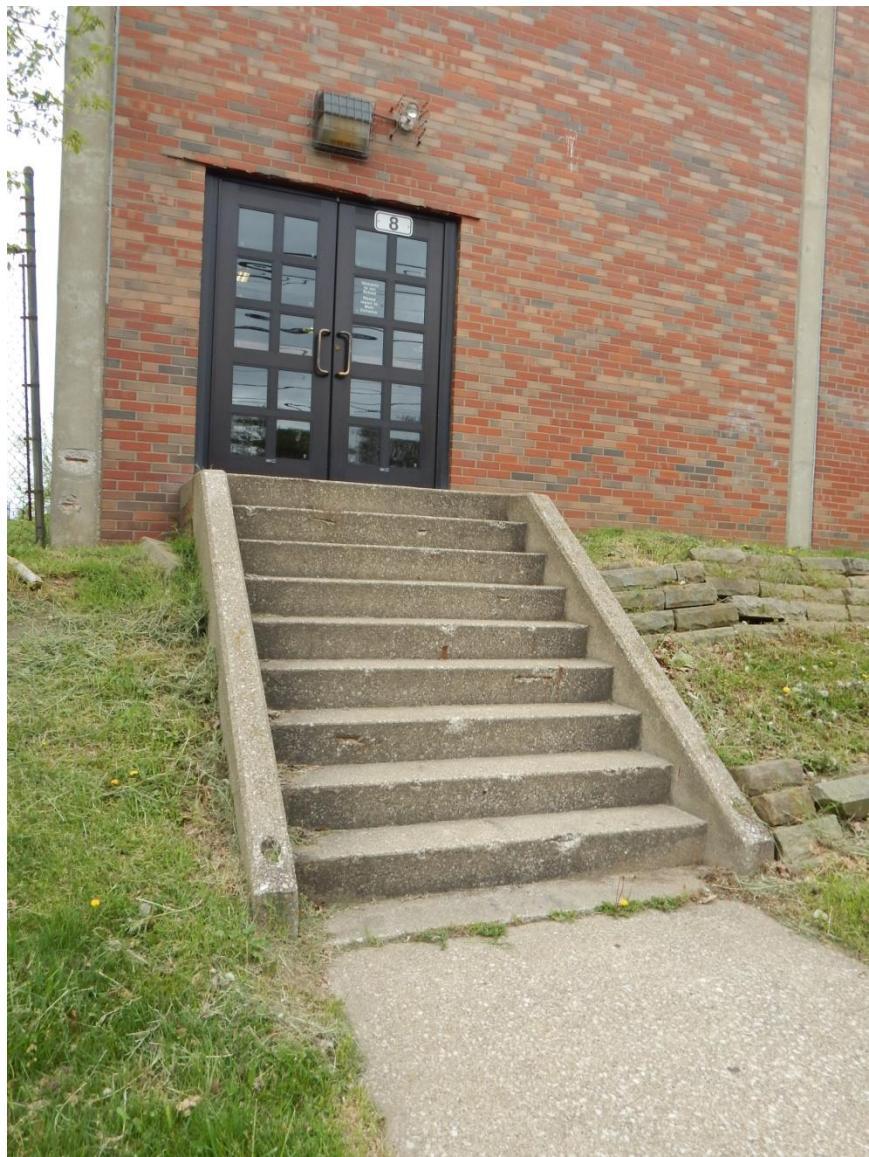
Figure 1-8

The third island has joints but two sections are damaged. There are reinforcing bars exposed at one of the concrete stairs along the east side of the building. There are no hand railings. (Fig. 1-8)

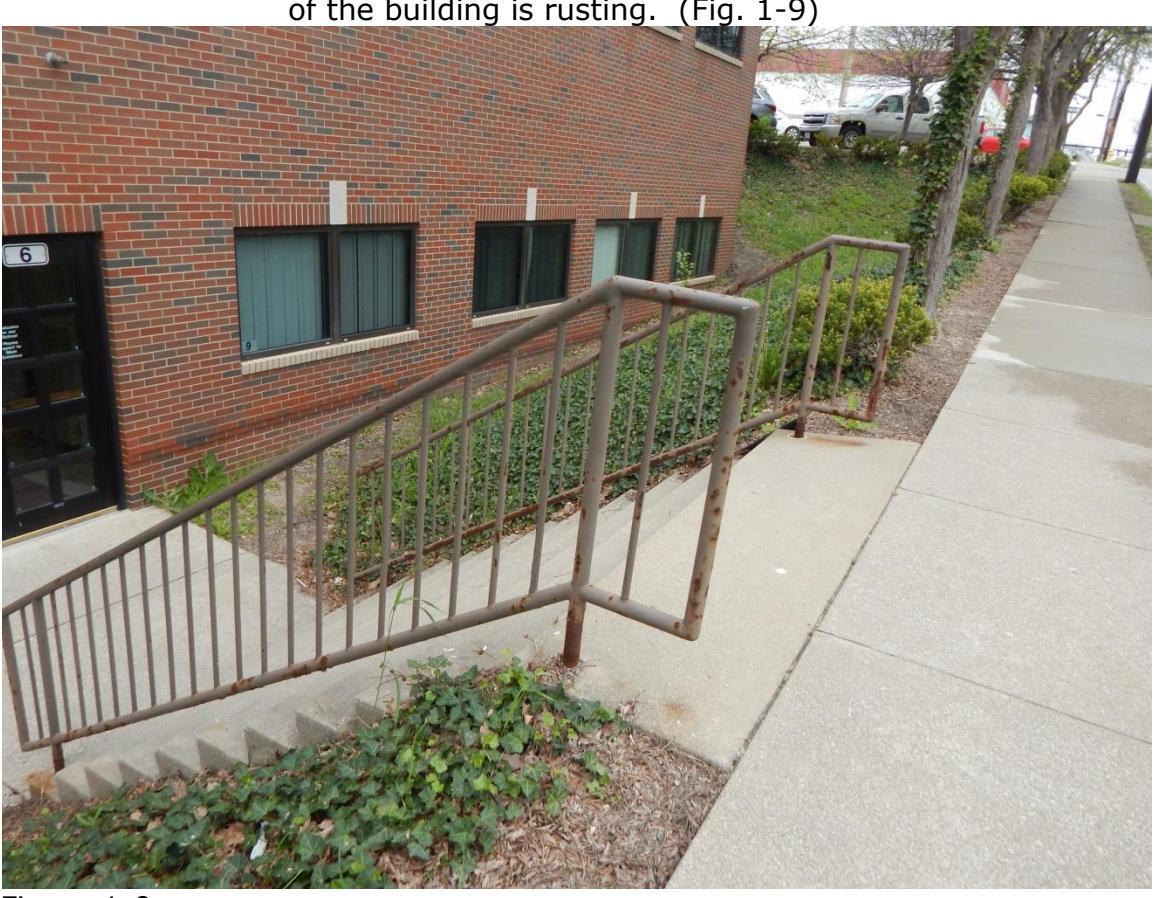
Figure 1-9

The railing at the other concrete stair along the east side of the building is rusting. (Fig. 1-9)

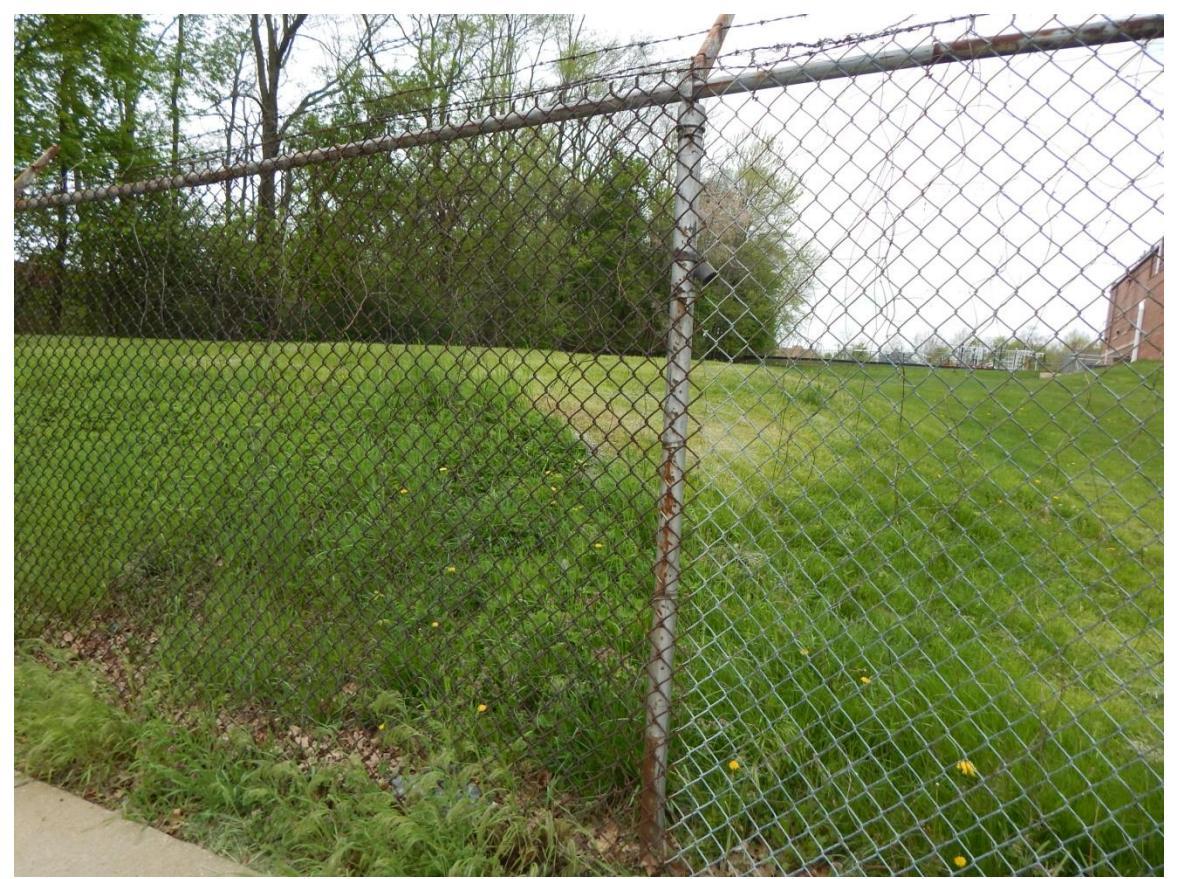
Figure 1-10

The posts and mesh at the 8' high chain link fencing from the southeast corner of the building over to the edge of the playground is rusting and damaged and there is barbed wire along the top. (Fig. 1-10)

Replace the chain link fencing from the southeast corner of the building over to the edge of the playground and between the walk and the back parking area. Repaint the mesh from the playground around to the south main entrance. Repaint the metal railing at the front of the site. Play Equipment -

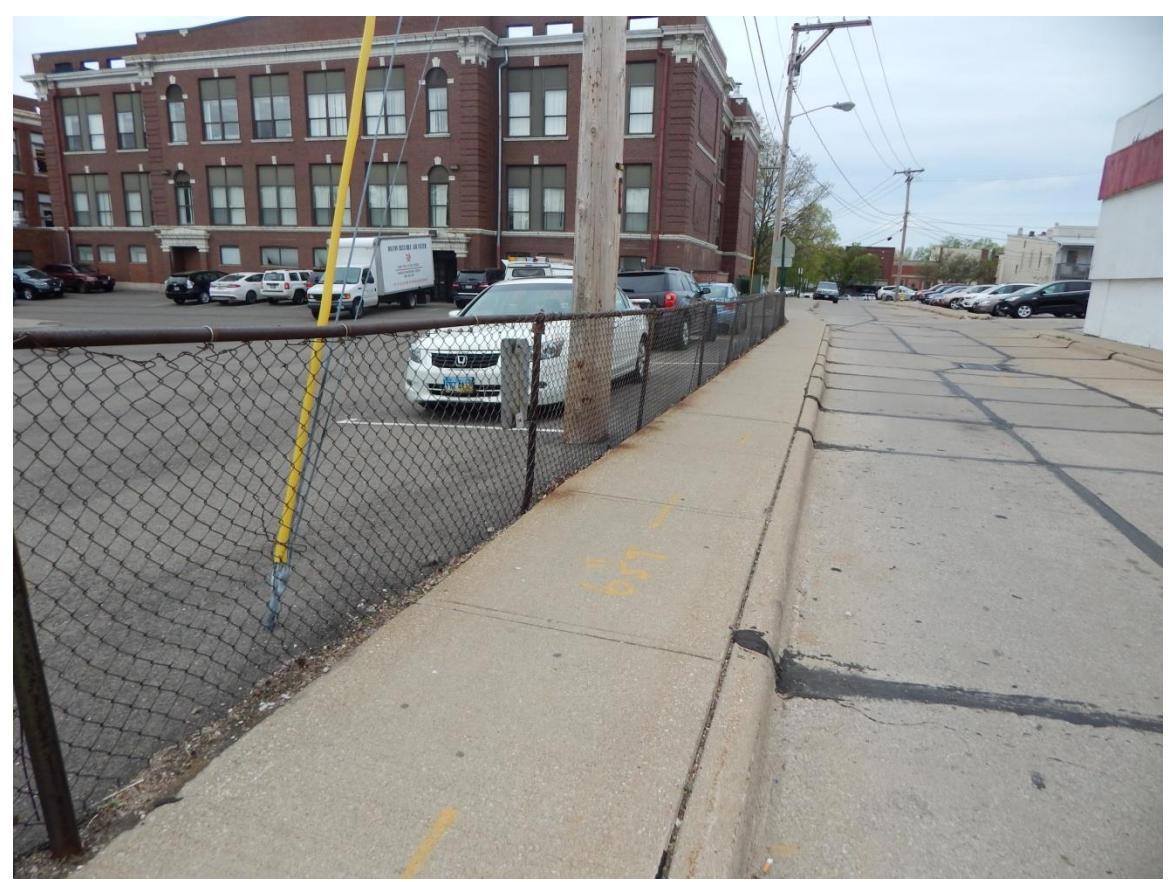
Figure 1-11

The posts and mesh at the 4' high chain link fencing between the walk and the back parking area is rusting and damaged. (Fig. 1-11)

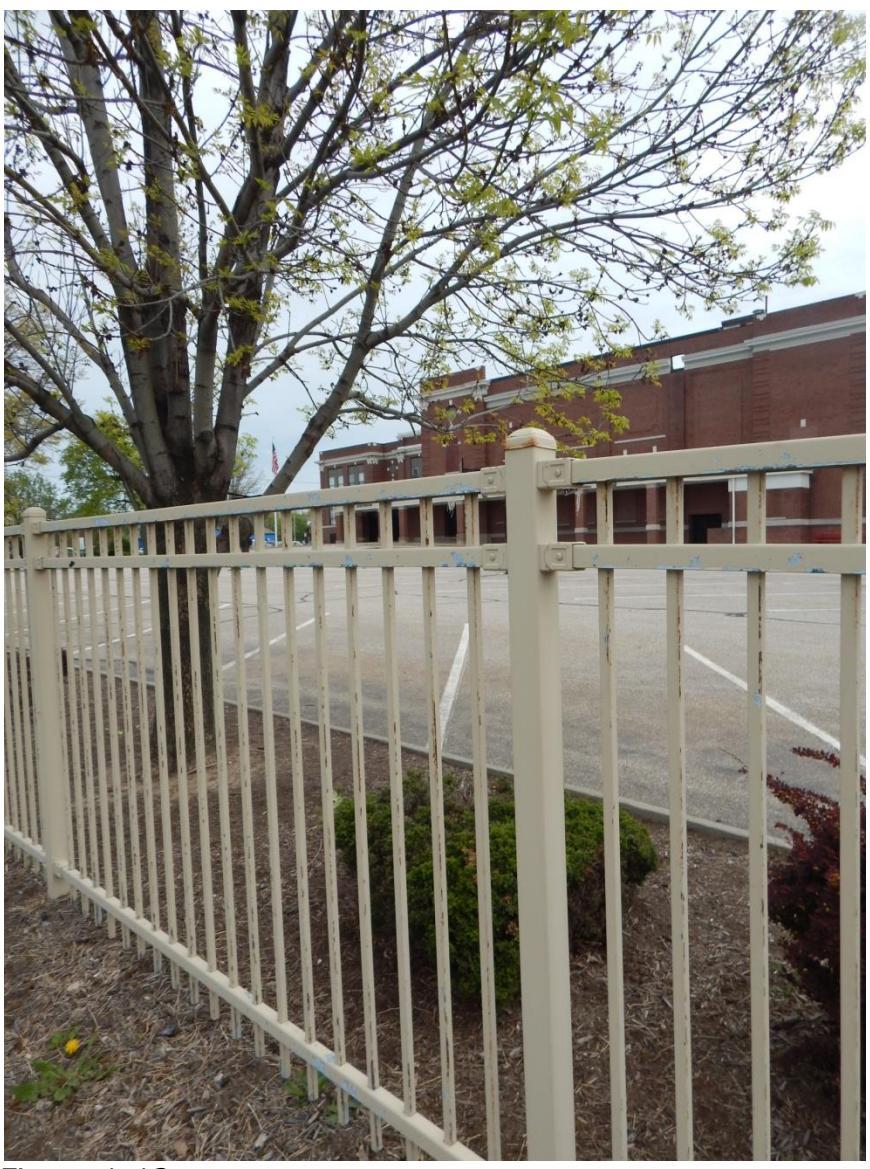
Figure 1-12

The mesh is starting to rust at the 8' high chain link fence from the playground around to the south main entrance drive. The 5' high metal fencing at the front of the site is losing its paint and starting to rust. (Fig. 1-12)

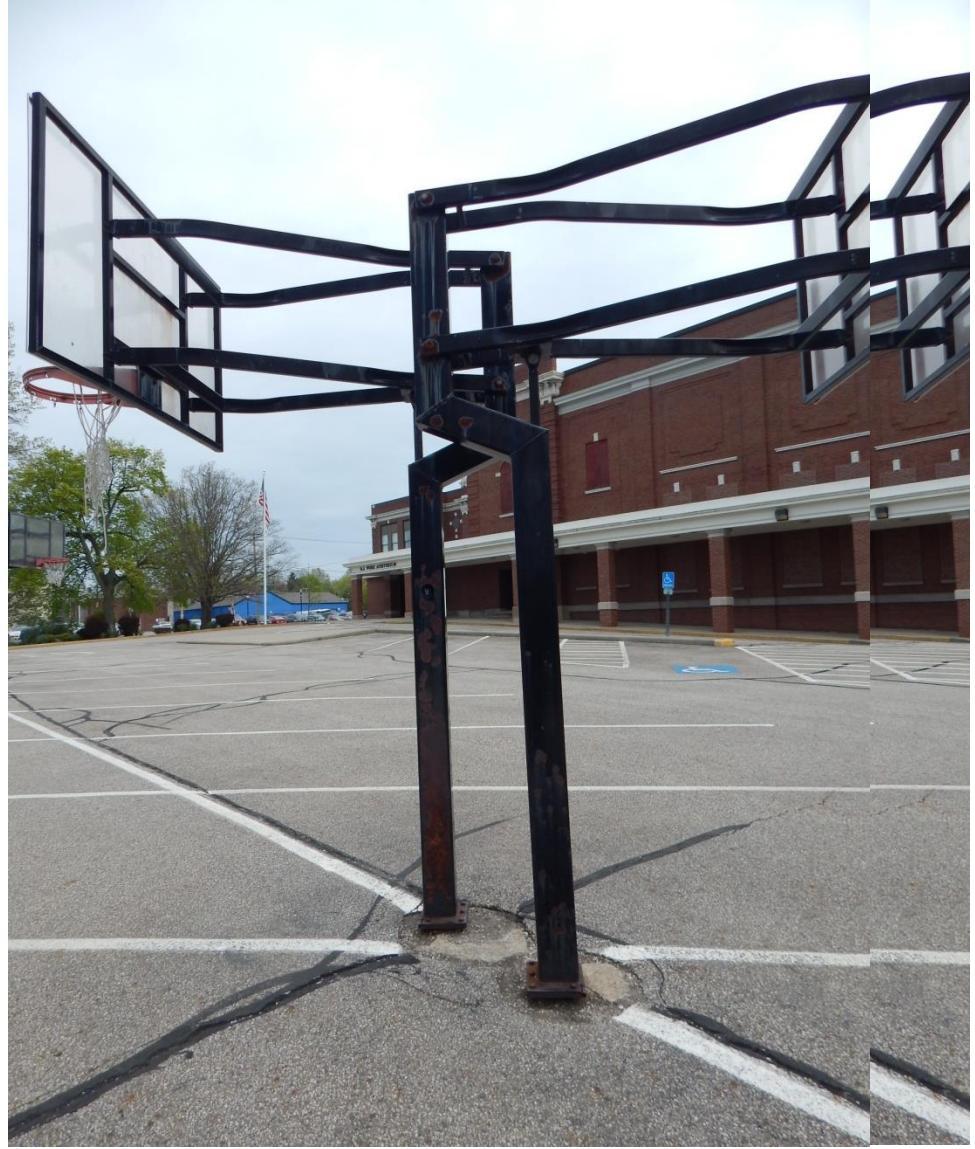
Figure 1-13

*Description:* The playground equipment is in fair condition. There is no handicapped accessible assess or equipment. The four basketball posts are rusting and the back boards and rims are worn. (Fig. 1-13)

Replace some playground equipment with handicapped accessible equipment and make an accessible access. Replace the basketball posts, back boards and rims. 2. Handicapped Accessibility

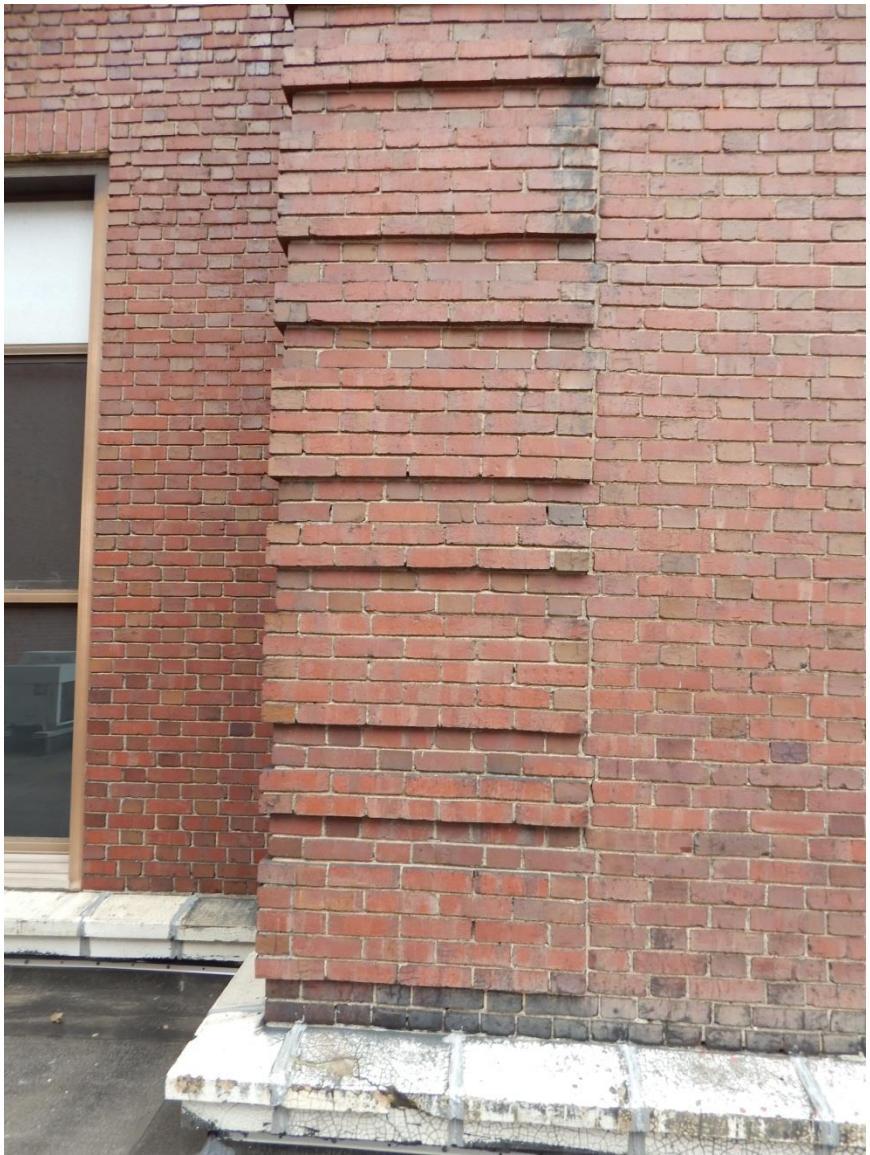
Figure 3-1

There are moderate amount of mortar joints that are missing or cracked. (Figs. 3-1, 3-2, 3-3)

Repoint all missing and crack brick mortar joints at brick. Saw cut brick to create vertical expansion joints at two locations. Remove brick were it has moved at two locations and replace in proper alignment. Replace damaged or missing brick. Replace damaged terra cotta and cover all with pre-finished metal. Replace painted galvanized metal detail with new pre-finished metal. Repair mortar joints at foundation walls. Replace brick where mismatched or where mortar has been installed with brick to match. Replace joint sealant at vertical expansion joints. Provide pre-finished metal soffit where concrete exposed and where plaster missing at south entrances. Cover all precast or stone copings with prefinished metal coping during roof replacement. Replace damaged wood boards at Auditorium entrance and repaint all wood trim. Power wash the entire building and apply water repellent.

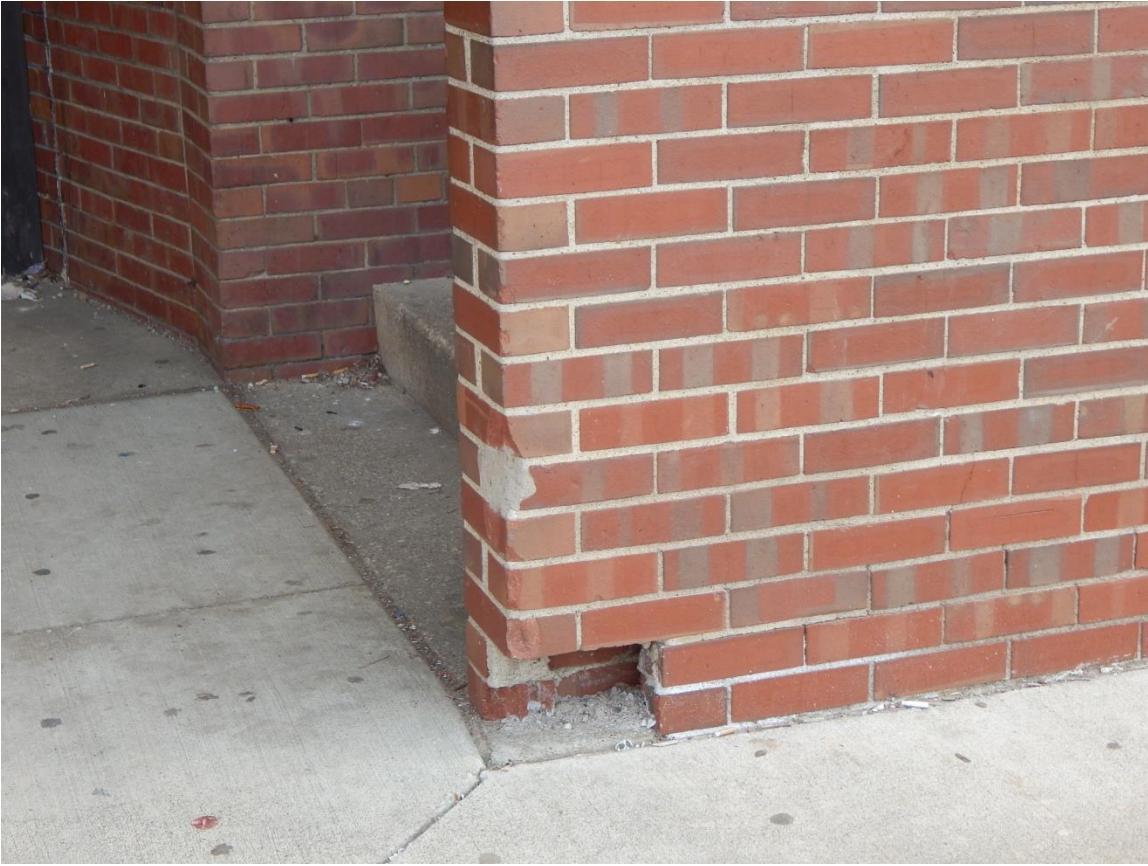
The brick is missing or damaged at a few locations. (Fig 3-7)

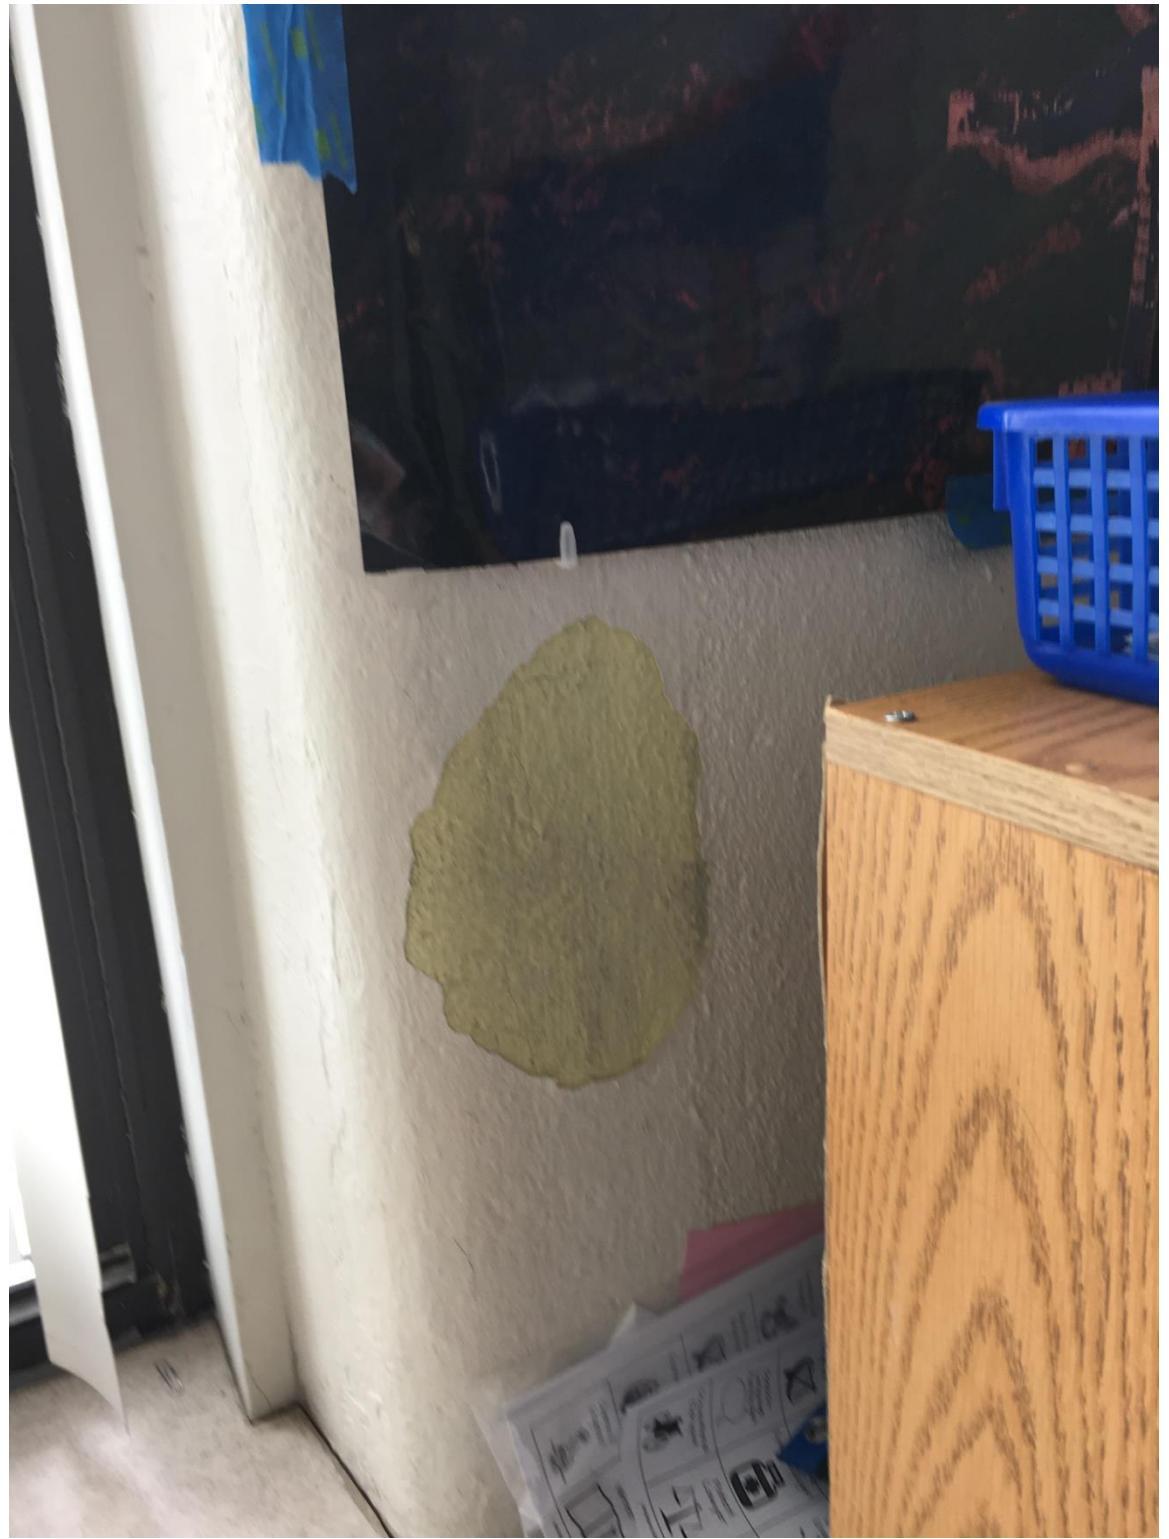
Figure 6-1

*Description:* The majority of interior wall surfaces consist of plaster, painted brick and concrete masonry units, glazed concrete masonry or gypsum board assemblies. The plaster wall finish at the 1907 and 1927 buildings are damaged in some areas. (Fig. 6-1, 6-2) The plaster surfaces at the lower level of the 1927 Auditorium addition are damaged in many areas and are in poor condition. The exterior masonry walls at this area also display evidence of moisture infiltration in some areas. (Fig. 6-3, 6-4) The concrete masonry walls of the gymnasium display evidence of movement and "stair stepped" cracking in multiple locations. (Fig. 6-5) There are a few cracks in the masonry and mortar joints in other areas of the complex, but the remaining walls are generally in good condition. (Fig. 6-6) The wall surfaces of the double volume corridor adjacent to Student Dining display evidence of water damage extending from the translucent panel skylight system within this space. (Fig. 6-7) The gypsum wall surfaces in high traffic areas display evidence of repeated repair. (Fig. 6-8) Unprotected wall corners and column enclosures have edge damage. (Fig. 6-9) There are intermittent locations of minor damage throughout all areas of the complex requiring repair. (Fig. 6-10)

*Recommendation:* Repair all cracks in concrete, concrete block, and brick masonry, repair mortar joints and clean brick surfaces of efflorescence. Repair/replace all damaged surfaces at the lower level of the Auditorium addition. Repair damaged plaster and intermittent damaged surfaces throughout the complex. Provide complete replacement of plaster surfaces at the 1907 and 1927 Additions in conjunction with abatement activities. Provide new rigid sheet protection panels, corner guards and chair rail at gypsum wall surfaces receiving continual abuse. Provide corner guards at unprotected edge locations.

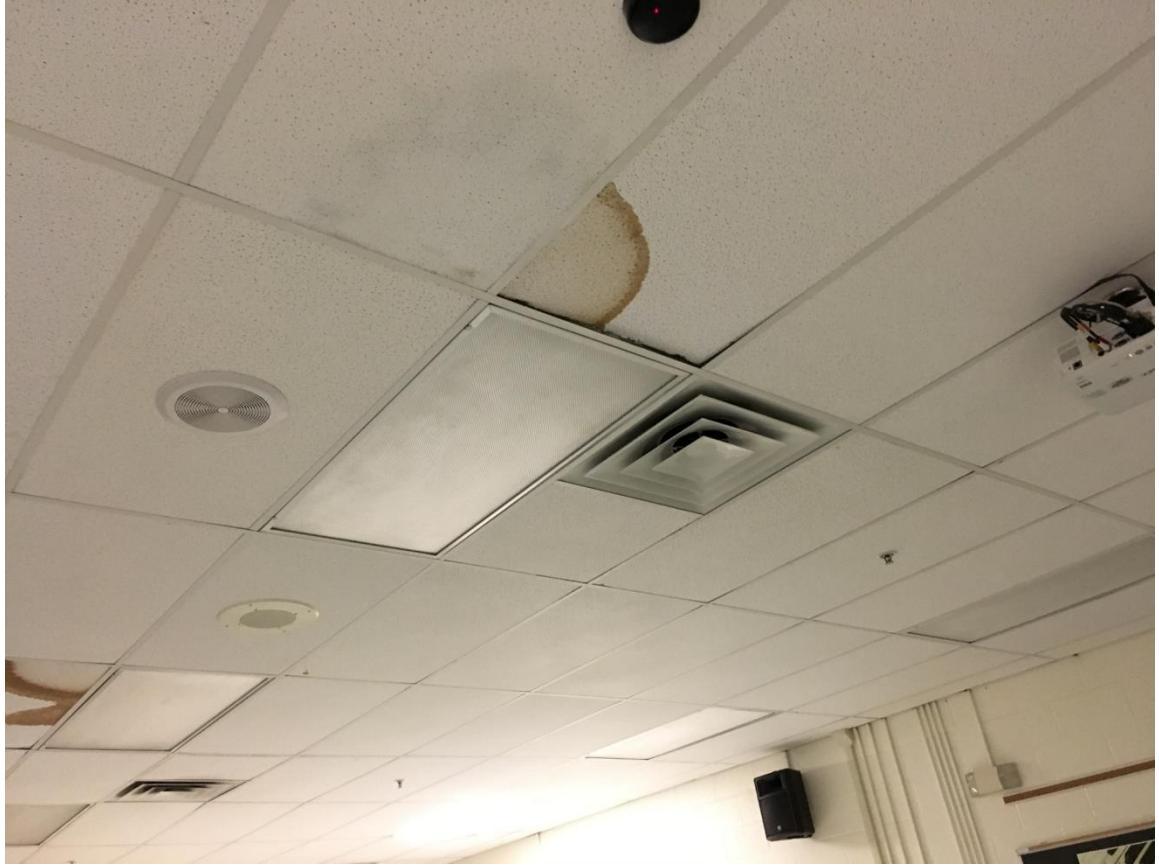
Figure 7-1

*Description:* The majority of rooms and spaces throughout the complex have a suspended  $2' \times 4'$ acoustical ceiling system. The ceiling system through-out the 1907-1973 additions is generally in good condition. The ceiling tiles are stained or display evidence of water damage in a few areas. (Fig. 7-1) The ceiling tiles at the 1990 Addition are often mismatched within room spaces throughout this addition and tiles are beginning to sag. A portion of the tiles are stained or damaged. (Fig. 7-2, 7-3) A limited area of the ceilings in the complex are painted concrete decking and exposed decks. The ceiling at the 1927 Auditorium House is acoustical plaster which has been well maintained. The ceilings at the lower level of the Auditorium Addition are plaster in fair to poor condition with damage in multiple locations. (Fig.-7-4, 7-5, 7-6, 7-7)

*Recommendation:* Provide gypsum/plaster ceiling repairs as required and paint throughout the lower level of the 1927 Auditorium Addition or replace in their entirety with new suspended acoustic. The addition of a new suspended acoustic ceiling system within this area will also require modification of the existing fire suppression system. Replace plaster ceiling surfaces at the 1907 and 1927 additions in conjunction with abatement activities. Clean exposed ceilings and paint as part of general maintenance. Replace interment damaged ceiling tile throughout the complex. Replace and upgrade ceilings at the 1990 Addition. Replace ceilings at the 1907-1973 additions, excluding the Auditorium, Student Dinning and Gymnasium in conjunction with HVAC improvements.

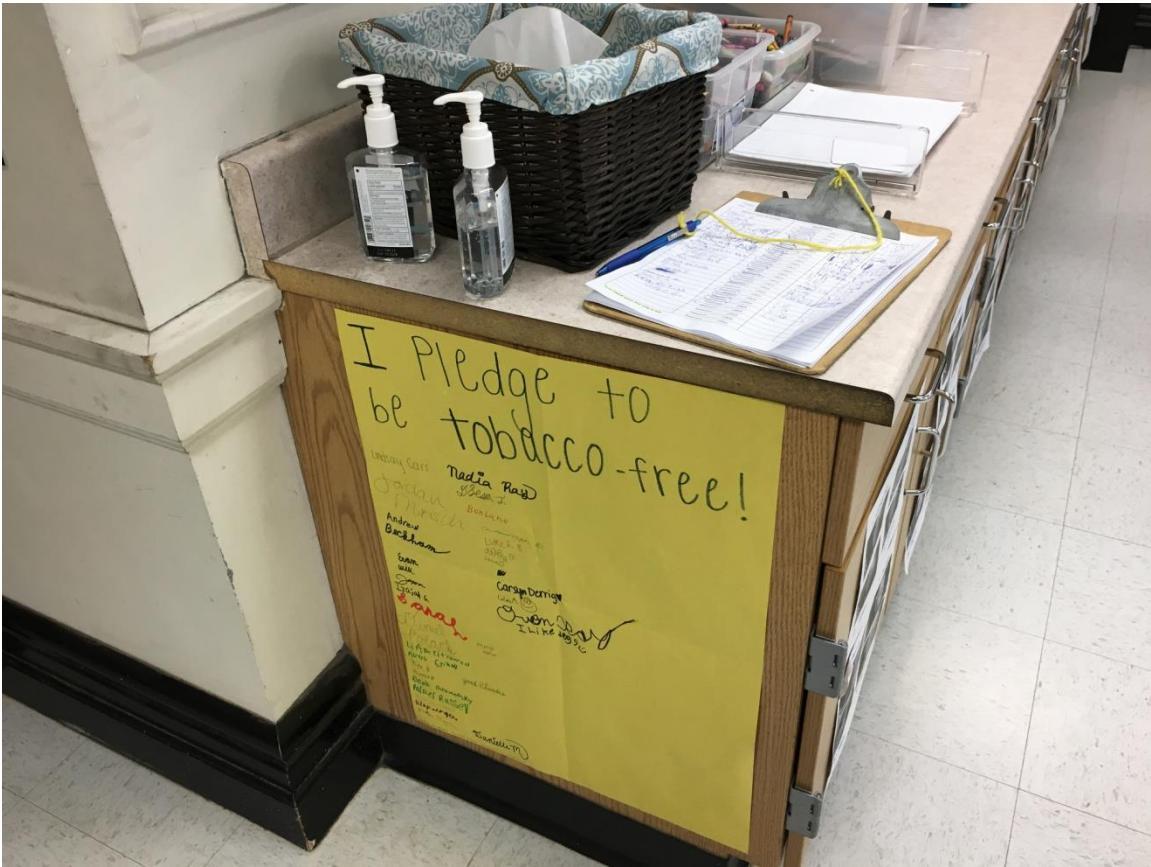
Figure 8-1

*Description:* Casework throughout the Complex is plastic laminate with plastic laminate counters and overall is in good condition. Occasional pieces of casework display minor intermittent damage. A portion of the plastic laminate counters are damaged typically at counter ends and missing edge veneer. (Fig. 8-1) Continuous plastic laminate window sills are provided above the built-in book shelving/casework along the exterior walls and are heavily damaged from water infiltration or condensation in many of the classrooms at the 1907/1927 Additions. (Fig. 8-1, 8-2)

*Recommendation:* Repair and/or replace damage counter assemblies. Replace the plastic laminate window sill with solid surface materials throughout the 1907 Original Building. Replace casework exceeding accessible height limitations or where lacking accessible work stations. All casework throughout the complex should be budgeted for replacement in the next five years as these materials are approaching there useful life expectancy.

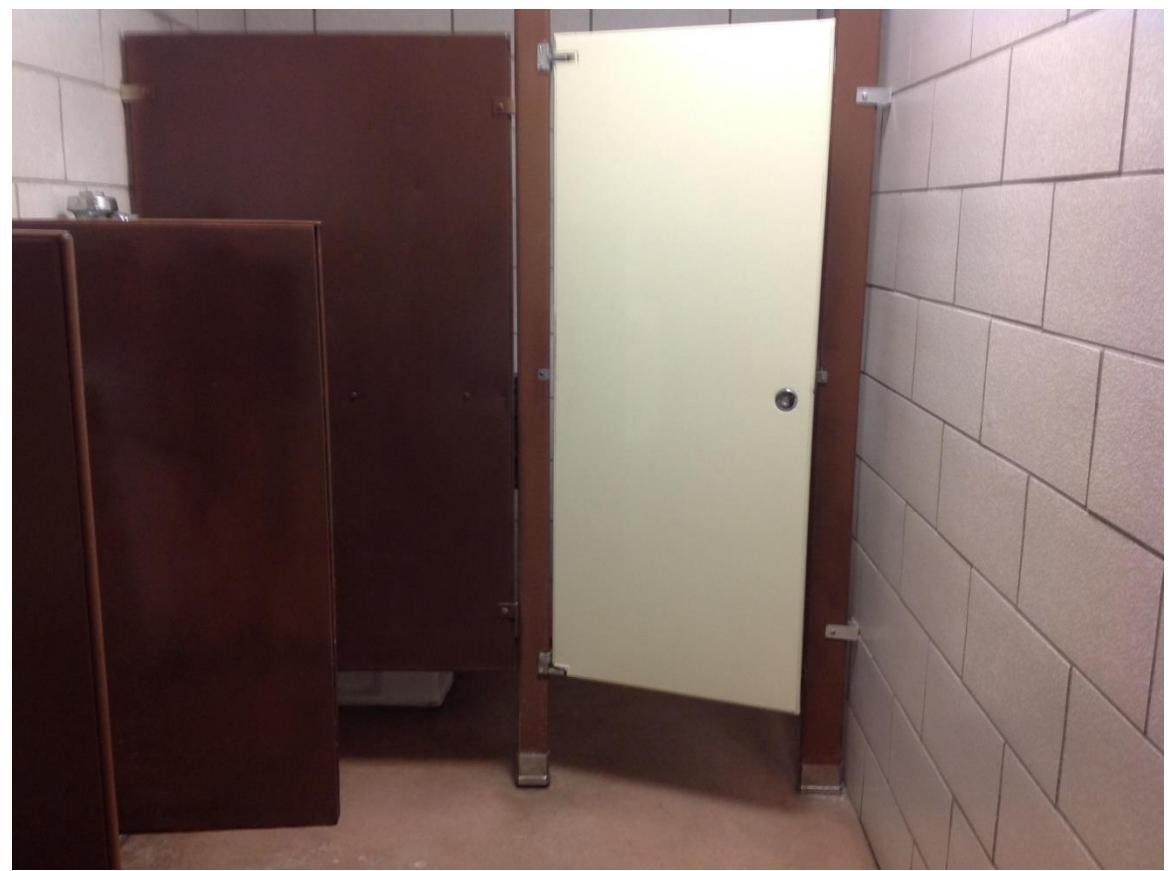
Figure 10-1

*Description:* Toilet partitions at the renovated large group restrooms at the Original 1907 have solid HDPE partitions in satisfactory condition. The toilet partitions at the reaming toilet facilities and locker rooms are metal or CMU partitions in fair to poor condition. Toilet accessories at a portion of the restrooms have been mounted outside accessible reach ranges or project more than 4 inches into the path of travel. (Fig. 10-1, 10-2)

*Recommendation:* Replace all toilet partitions and accessories in conjunction with accessibility renovations these include all dated metal and CMU assemblies. Remount accessories outside reach ranges and relocate accessory protrusion hazards at the 1907 Toilet Rooms, the partitions are satisfactory. Budget for replacement of all toilet partitions as these finishes are approaching there useful life expectancy.

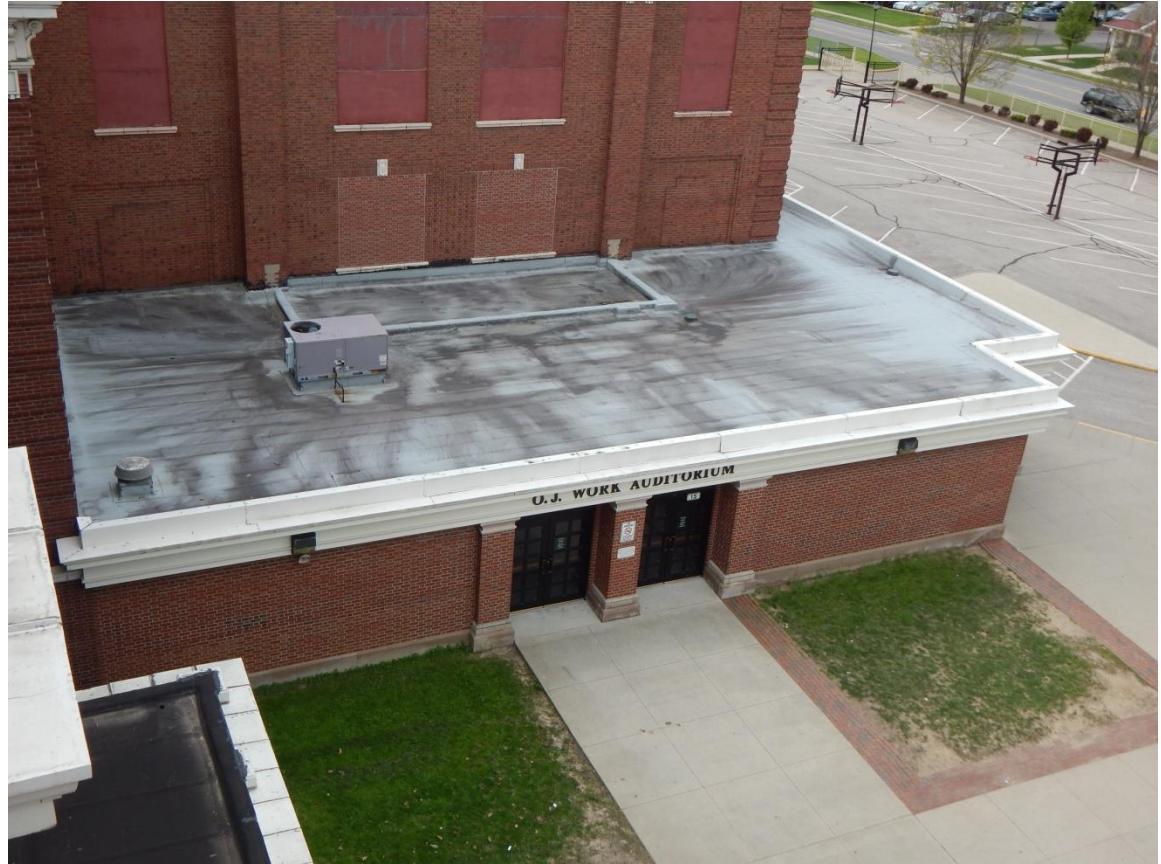
Figure 13-1

There currently no leaks. There have been various leaks over time. None of the roofs are under warranty. All roofs are reaching their life expectancy or have reached their life expectancy. A portion of the roofs are a modified bituminous roofing system. Some have a granular cap sheet, some have a smooth cap and some have a smooth cap sheet with an aluminum coating. (Figs. 13-1, 13-2, 13-3)

All roofing systems, including insulations need to be removed to decking. Any damaged decking needs replaced and new insulations and roofing systems need installed. Saddles need to be provided to eliminate ponding areas. Metal copings need to be provided at all parapet walls. All gutter and downspouts need replaced. The skylight system needs resealed or replaced. 14. Miscellaneous
