### FACILITY ASSESSMENT

# Central Intermediate School

## MAY 15, 2017

#### 1.1 CENTRAL INTERMEDIATE SCHOOL

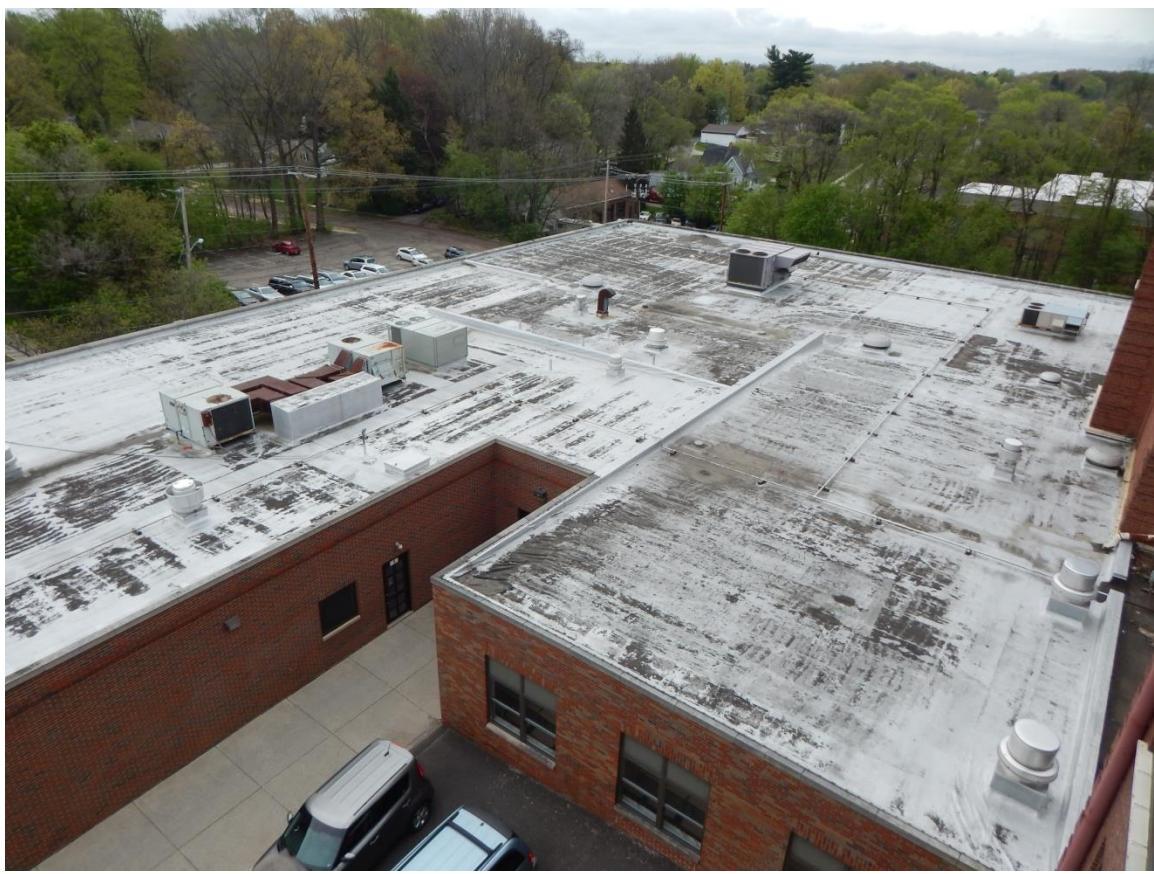
Figure 13-3

There currently no leaks. There have been various leaks over time. None of the roofs are under warranty. All roofs are reaching their life expectancy or have reached their life expectancy. A portion of the roofs are a modified bituminous roofing system. Some have a granular cap sheet, some have a smooth cap and some have a smooth cap sheet with an aluminum coating. (Figs. 13-1, 13-2, 13-3)

All roofing systems, including insulations need to be removed to decking. Any damaged decking needs replaced and new insulations and roofing systems need installed. Saddles need to be provided to eliminate ponding areas. Metal copings need to be provided at all parapet walls. All gutter and downspouts need replaced. The skylight system needs resealed or replaced. 14. Miscellaneous

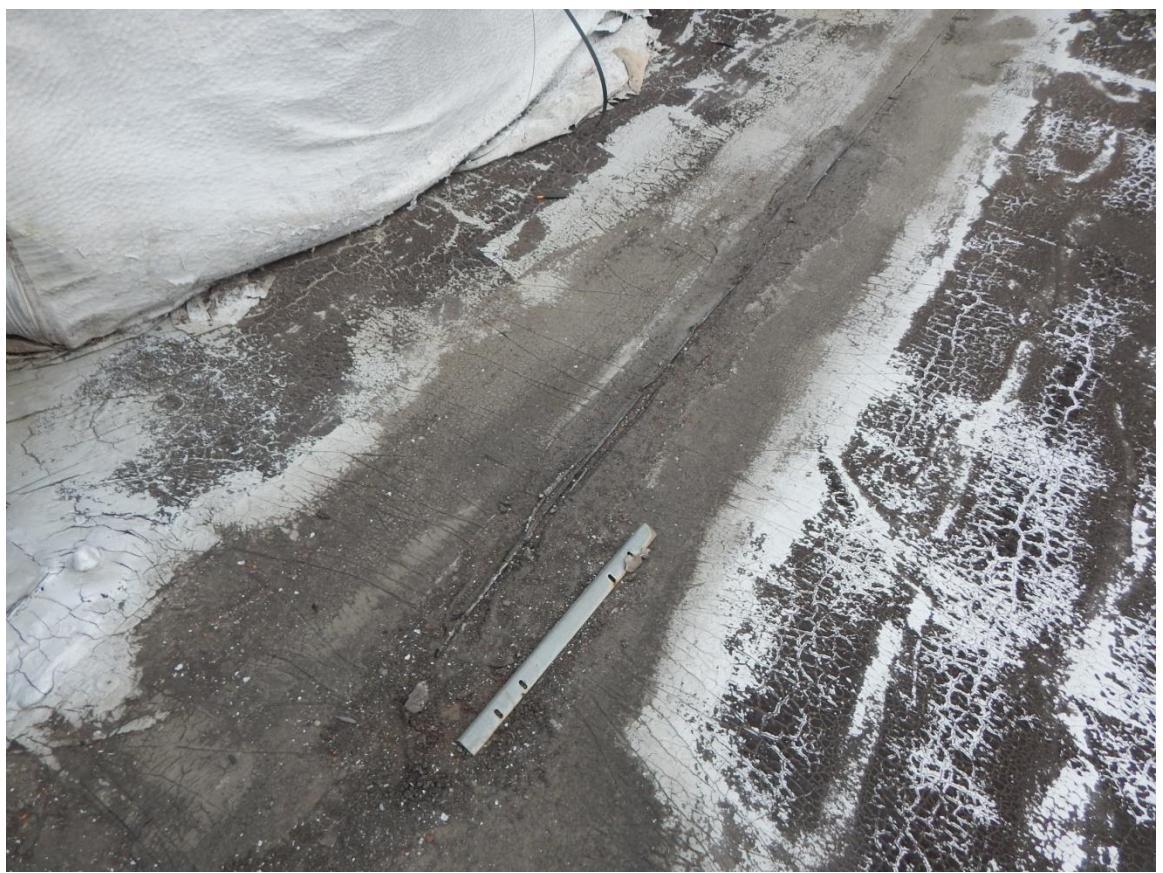
Figure 13-4

There is good slope towards drainage systems at most areas, but some areas pond water and thus the seams are deteriorating. (Fig. 13-4)

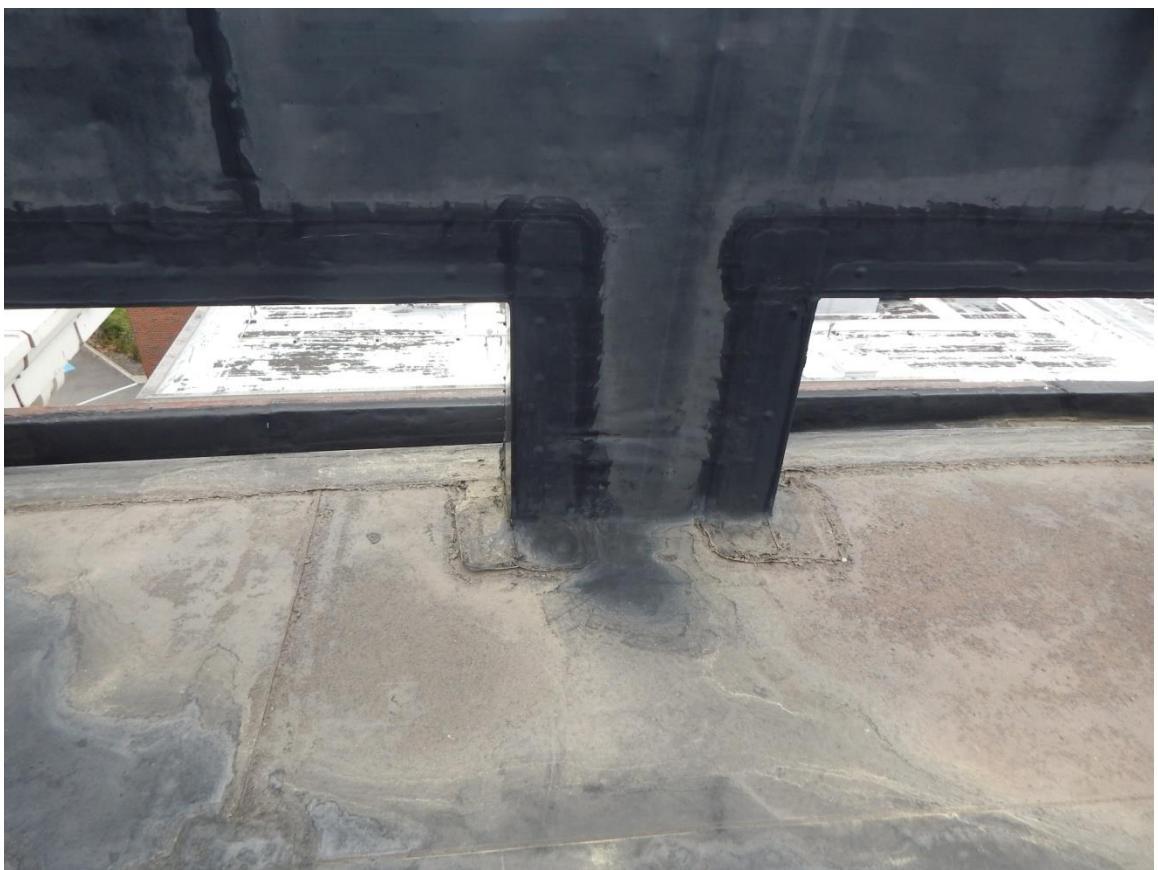
Figure 13-11

There is good slope towards drainage systems, but some ponding water and thus seams are deteriorating. (Fig, 13-11)

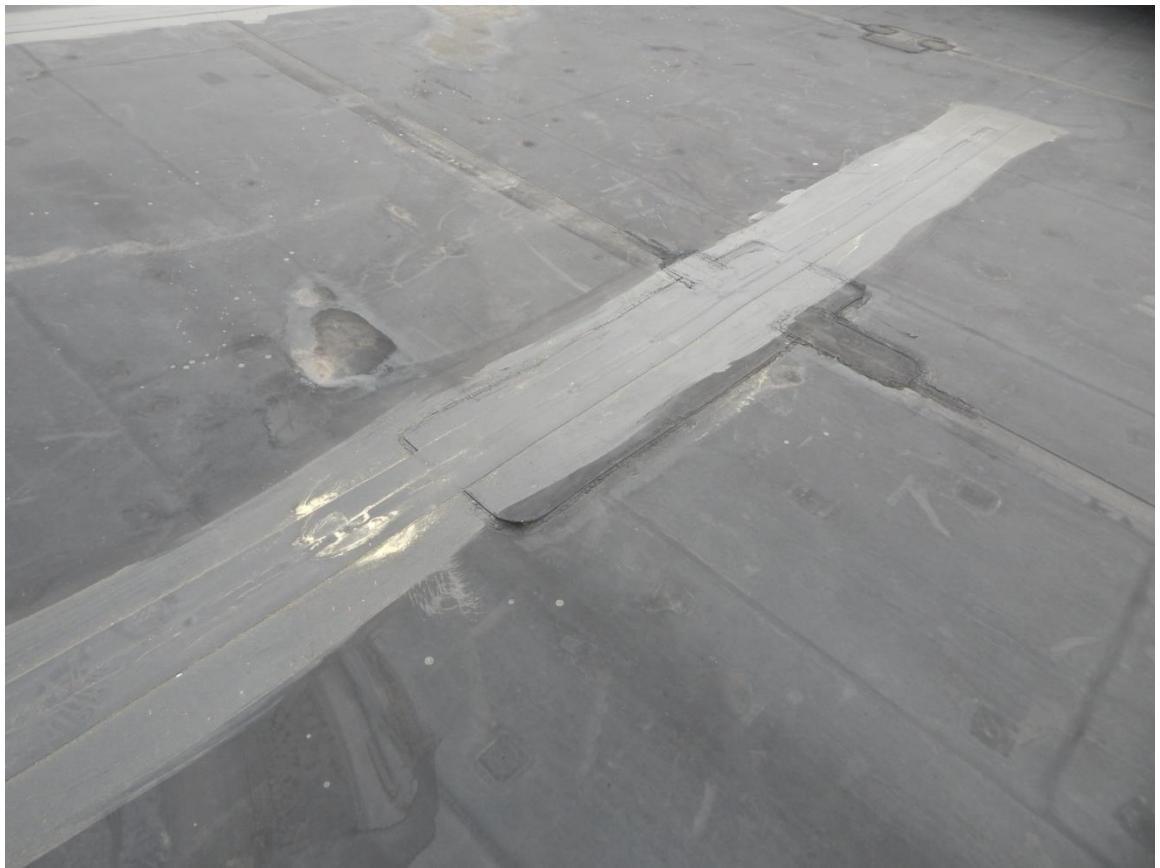
Figure 13-12

There have been patches at some locations. They are also starting to deteriorate. (Fig. 13-12)

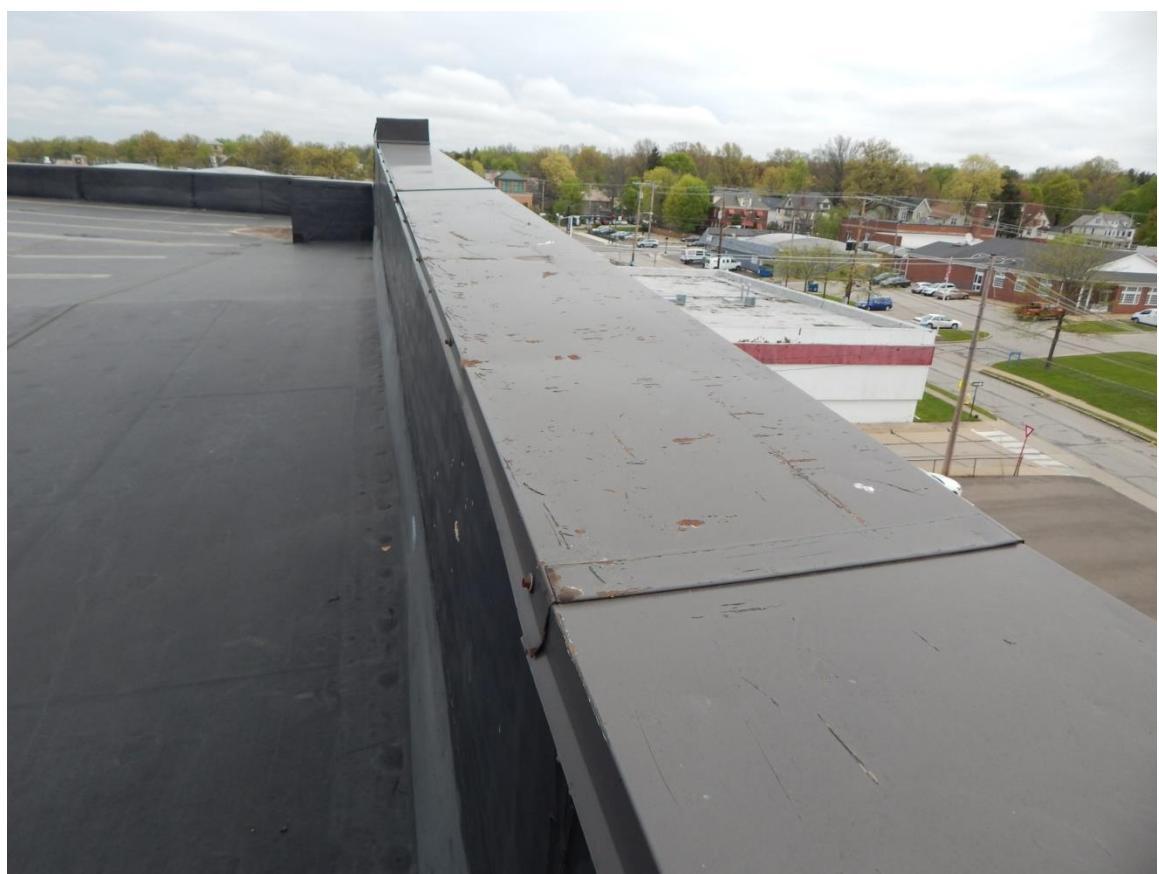
Figure 13-13

Metal copings are very rusty. (Fig. 13-13)

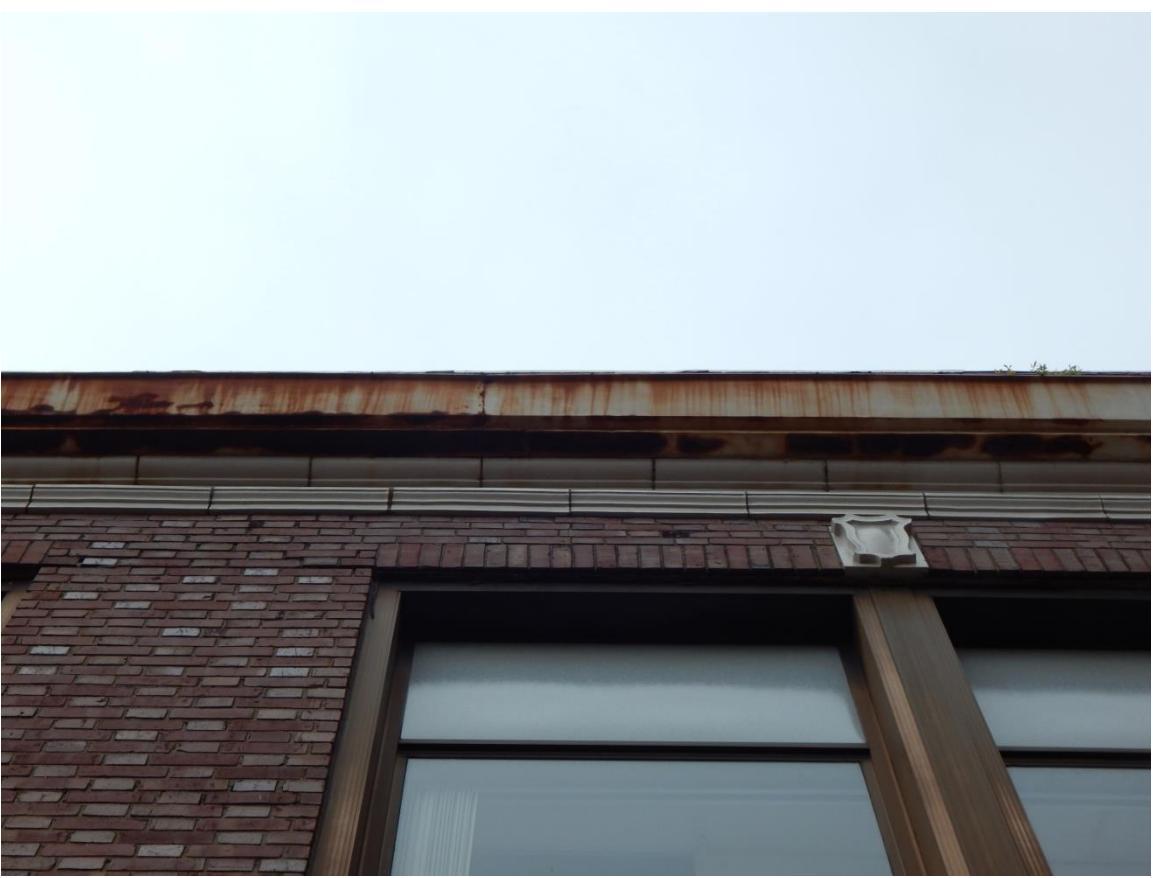
Figure 13-14

Gutters and downspouts are very rusty. (Figs. 13-14, 13-15)

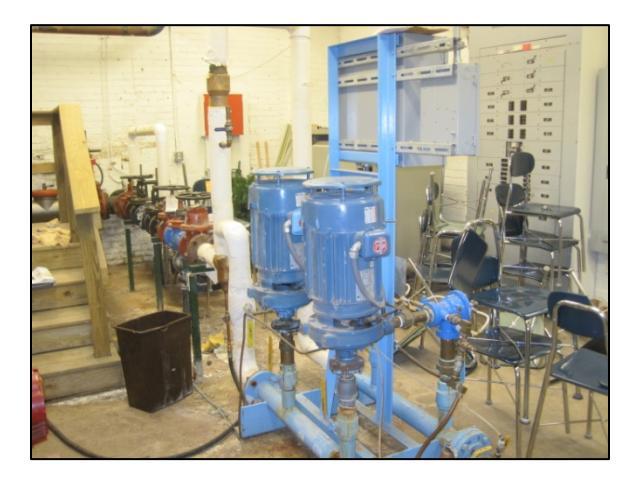
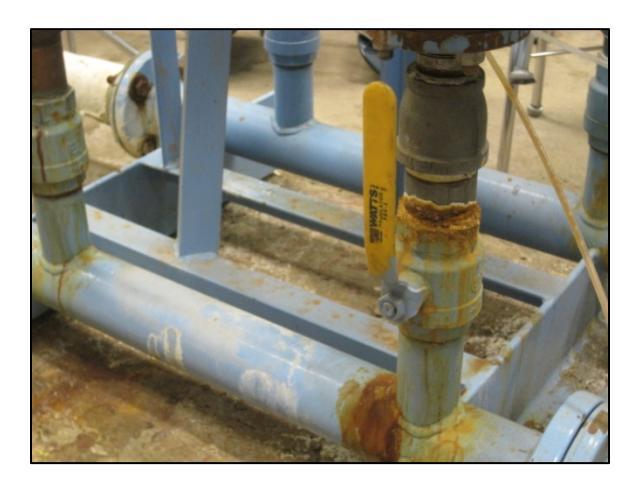
- 1. Water Service
  - A. Description:
    - 1.) A 6-inch combination domestic-water / fire-suppression water service serves the building. A 4-inch domestic water line then goes through a water meter, a reduced-pressure-zone (RPZ) backflow preventer, and a water booster pump package before serving the building.
    - 2.) The booster pump package is a SyncroFlo "Iron Heart" Model #2DD73 duplex unit with a remote pressure tank and 7-1/2 HP motors, manufactured in December 2001. The pump package and tank are in good condition; however, there is heavy corrosion at the suction piping at the pumps.

- 1.) The booster pump package should be serviced and all corroded fittings and piping replaced. Di-electric couplings should be utilized when connecting dissimilar materials.

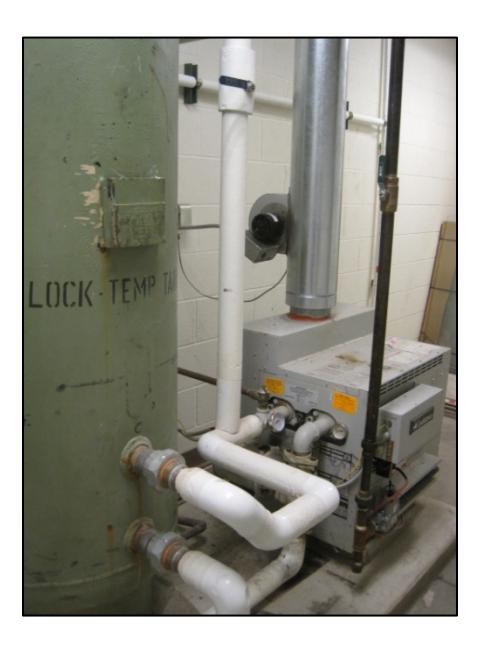
4.) The 1990 addition is served by a Lochinvar domestic water boiler and separate storage tank. The storage tank is severely corroded and leaking. The domestic hot water is not currently available in this part of the building. There is no TMV.

- B. Recommendations:
  - 1.) Replace all galvanized domestic water piping.
  - 2.) Replace the water heating boiler and storage tank in the 1990 addition. Add an ASSE-1070 TMV to this system.

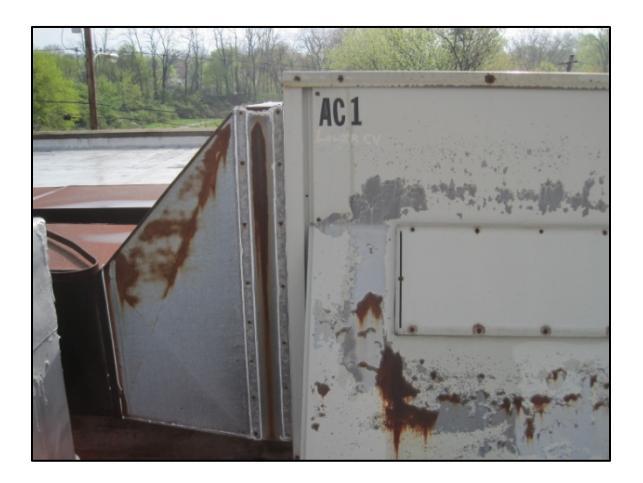
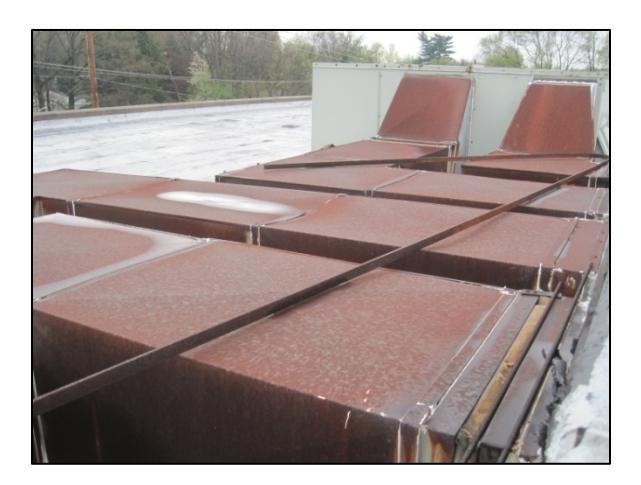
- 2.) The 1990 classroom addition is served by (4) RTUs. Each has gas-fired heating and DX cooling.
  - a.) Units AC-1 and AC-2, which both serve the lower level are Trane Model YCH120, nominal 10 tons each, and manufactured in July 1991. These units and the exposed above-roof ductwork are in poor condition.

- 6.) A gas-fired RTU serves the auditorium entrance lobby. This unit was not surveyed since the roof was not readily accessible.
- B. Recommendations:
  - 1.) Replace the (2) June-Aire AHUs and the dual-duct system. We have successfully designed a similar replacement for this system at another District. A dedicated outdoor air system (DOAS) AHU with an air-cooled condensing unit was installed, utilizing the existing hot deck ductwork to distribute outdoor conditioned air to the various zones. Individual zones, e.g., classrooms, office suites, etc., were served by variable refrigerant flow (VRF) fan coils and central air-to-air heat pumps. Other energy-efficient HVAC systems could also be considered for these spaces.

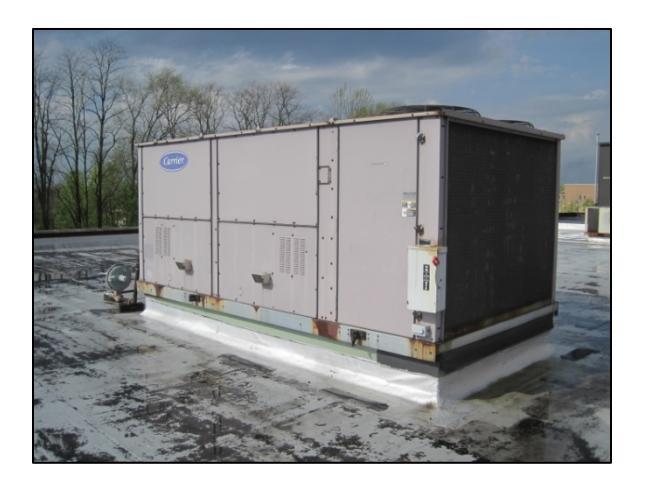
3.) The gymnasium is served by a single-zone RTU, Carrier Model 48EJE034, nominal 30 tons, manufactured in June 2001. This unit is in fair condition, but is showing some corrosion.
