CENTURY ELEMENTARY SCHOOL

FACILITY ASSESSMENT EXISTING BUILDING INVENTORY ARCHITECTURAL FINISHES MECH/ELEC ASSESSMENT EXISTING DEFICIENCIES COST ANALYSIS APPENDIX

A. EXISTING BUILDING INVENTORY

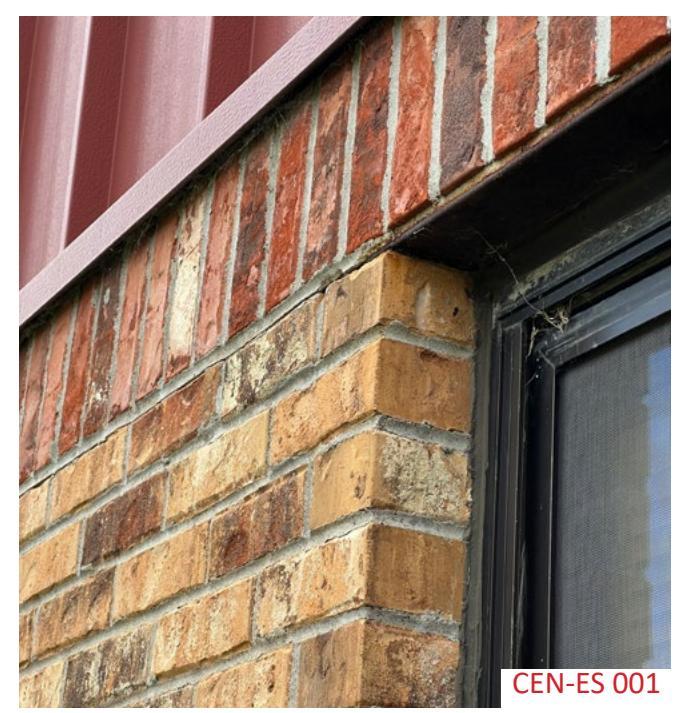
Mortar could be repaired in some areas as it is cracking and wearing, especially outside of the music room window.

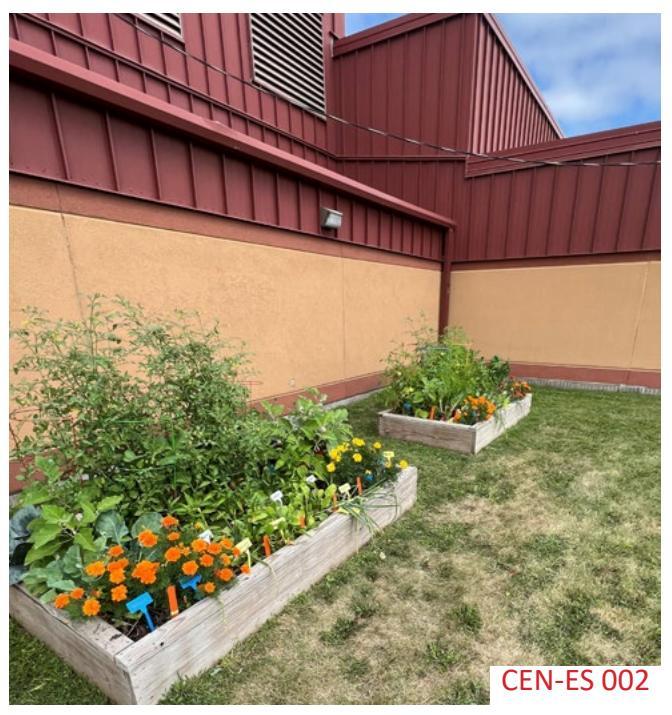
In addition to masonry, the exterior façade also consists of EIFS and metal siding.

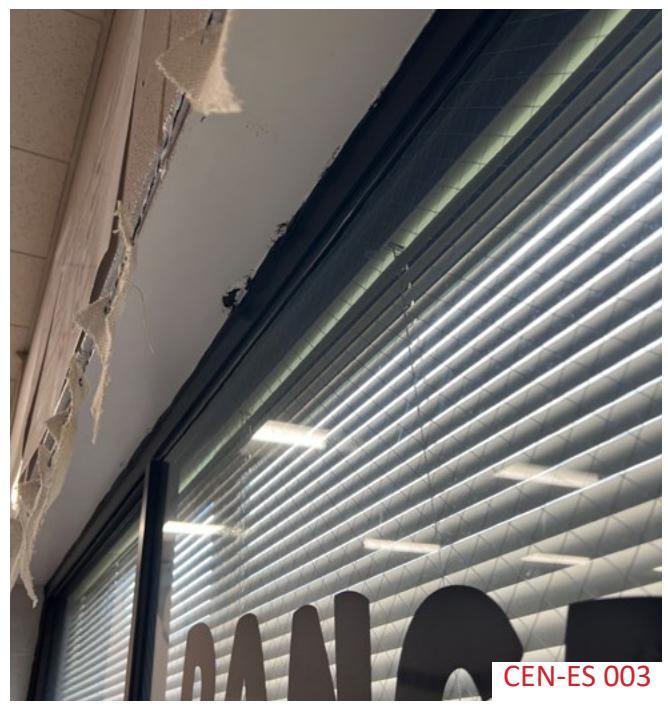
Windows are in good condition as well, but there has been water leakage above the window in the music room.

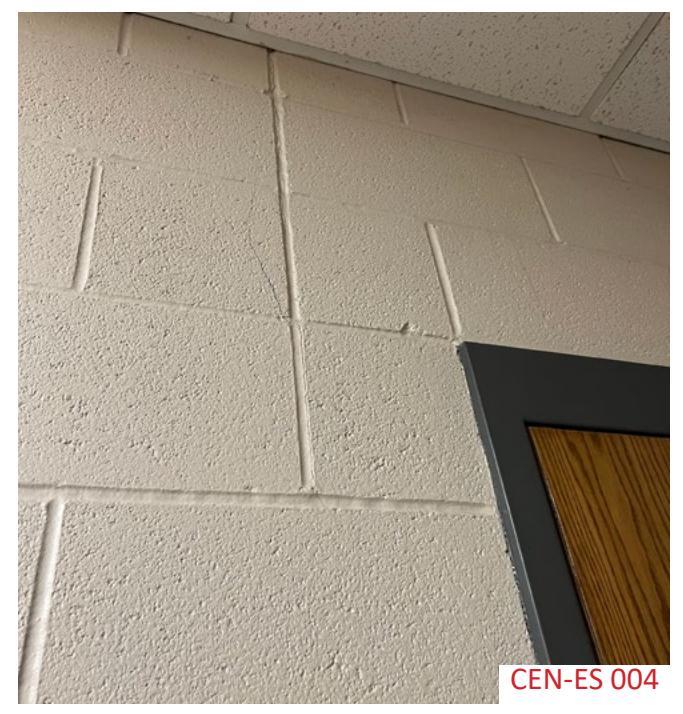
The most notable cosmetic issues consist of cracks in the wall between the kitchen and cafeteria, crack in the wall outside of the instrumental music room.

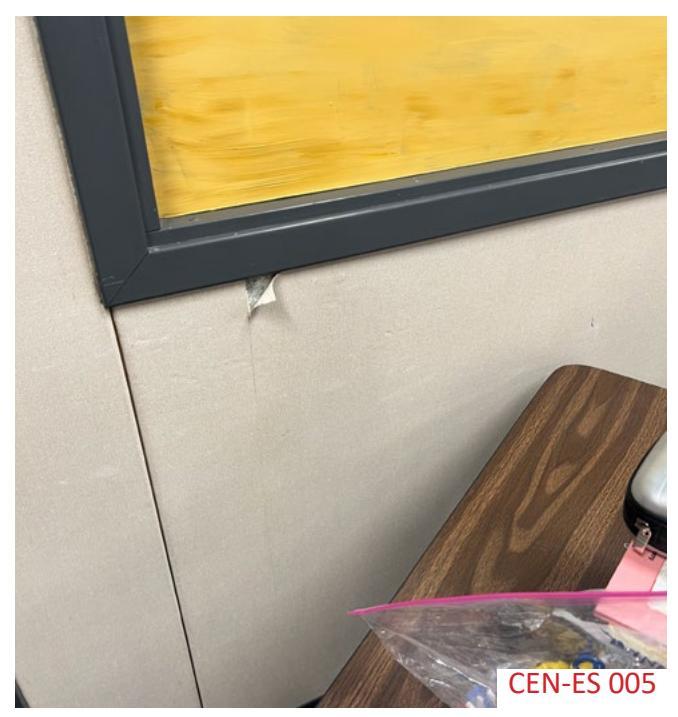
Some areas where the vinyl wall covering is releasing from the gypsum substrate.

Repair vinyl wall covering where it is peeling away from the wall	35	75,387 SF	\$0.36 /	SF		\$27,139				\$27,139
Interior Upgrades Subtotal		75,387 SF	\$2.14 /	SF						\$161,523
Exterior Upgrades										
Replace damaged sidewalk	36	800 SF	\$17.56 /	SF	\$14,046					\$14,046
Protect exposed outlets on the exterior of the building that are not. covered	37	1 Ea.	\$2,694.93 /	Ea.	\$2,695					\$2,695
Replace light outside of door 3 that is broken	38	1 Ea.	\$934.65 /	Ea.	\$935					\$935
Repair the gutter outside of the cafeteria that is broken and clean out all gutters	39	1 Ea.	\$3,671.15 /	Ea.	\$3,671					\$3,671
Repair the exterior brick masonry by a combination of tuckpointing, brick replacement and	40	75,387 SF	\$3.78 /	' SF	\$284,963					\$284,963
cleaning as needed Mroos seesses to be below seedel which docen't ellow for second derivers	11			0						C J
weeps appear to be below grade, writch doesn't allow for proper drainage. Domir domorad EEIC outsido of the cofessio	41	-	¢17 020 7E /		¢12 040					U¢ 040 C13

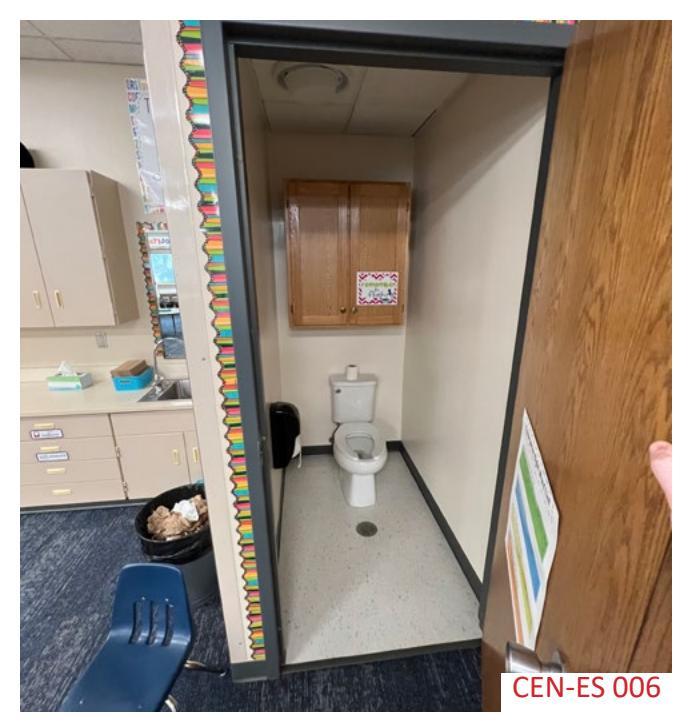
Restrooms in the building are not accessible. This includes restrooms in classrooms

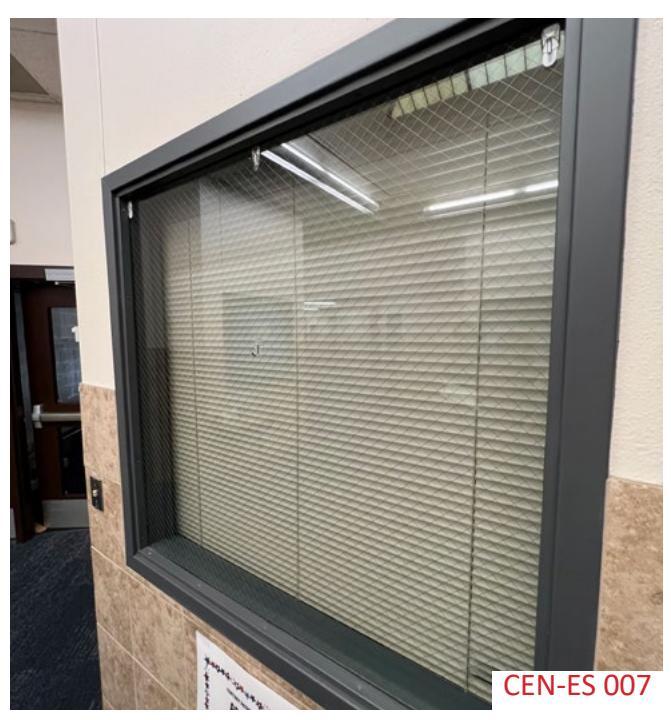
Traditional wire glass throughout the building is no longer to code as an acceptable type of safety glass

Replace wire glass throughout the building that is no longer up to code (frame to remain)	و	1,600 SF	\$33.65 /	SF	\$53,840					\$53 , 840
Replace casework (20lf of base, top, and upper) per room and sinks in classrooms, library work room. Jounge, and sick room that are not accessible	7	31 Ea.	\$26,939.88 /	Ea.	\$835,136					\$835,136
Remove vinyl wall coverings from the inside of exterior walls that is creating a double vapor barrier, skim coat existing sheetrock and paint	∞	12,000 SF	\$7.16 /	SF	\$85,920					\$85,920
Add sidewalk at door 7 that connects to a public way.	6	300 SF	\$17.56 /	SF	\$5,267					\$5 , 267
Total Code Compliance		75,387 SF	\$32.89 /	SF \$	2,479,397	0\$	0\$	0\$		\$2,479,397
Security										
Secure entrance and administration office remodel	10	820 SF	\$266.94 /	SF				\$218,891		\$218,891
Total Security		820 SF	\$266.94 <i> </i>	SF	\$0	0\$	\$0	\$218,891		\$218,891
Addition/Remodel (Educational Adequacy)

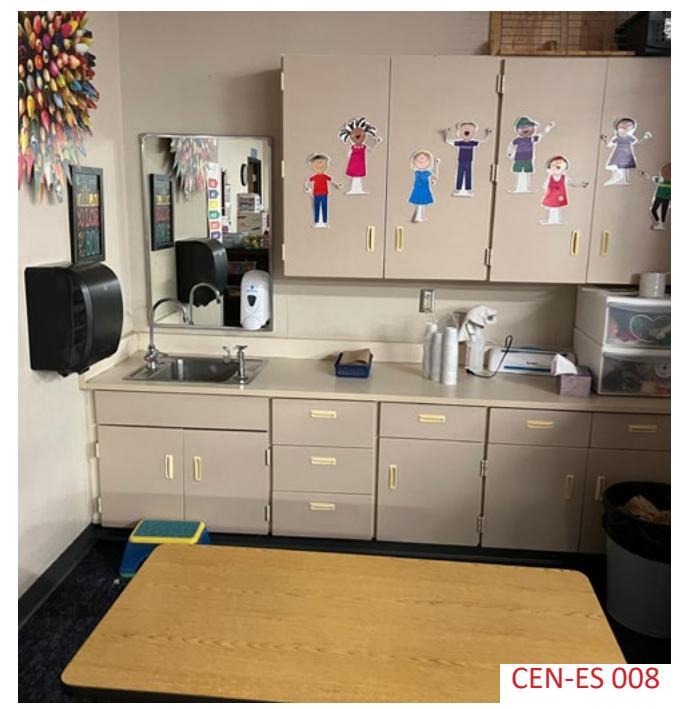
Several sinks in the building are not accessible, specifically in the resource room, library work room, lounge, sick room, classrooms, and restrooms.
