RHS RED RIVER HIGH SCHOOL

FACILITY ASSESSMENT

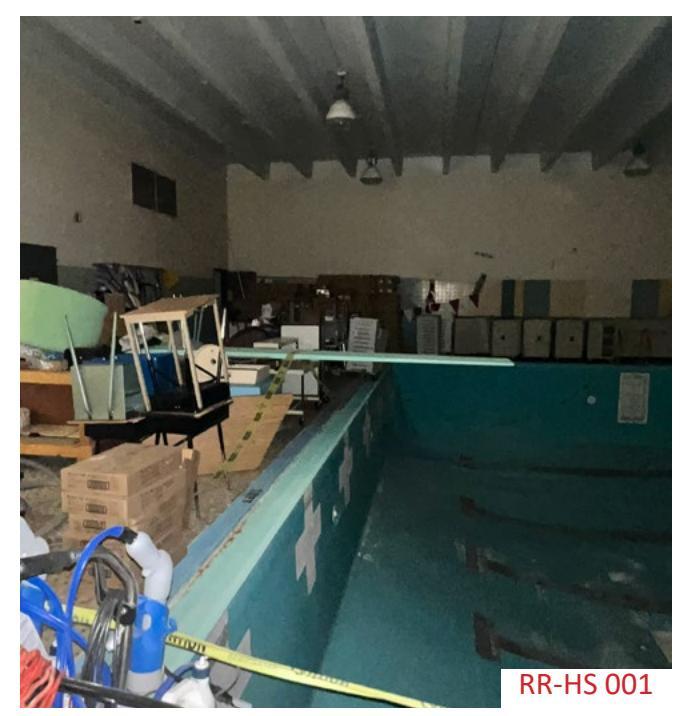
The aquatics room is currently being used as storage.

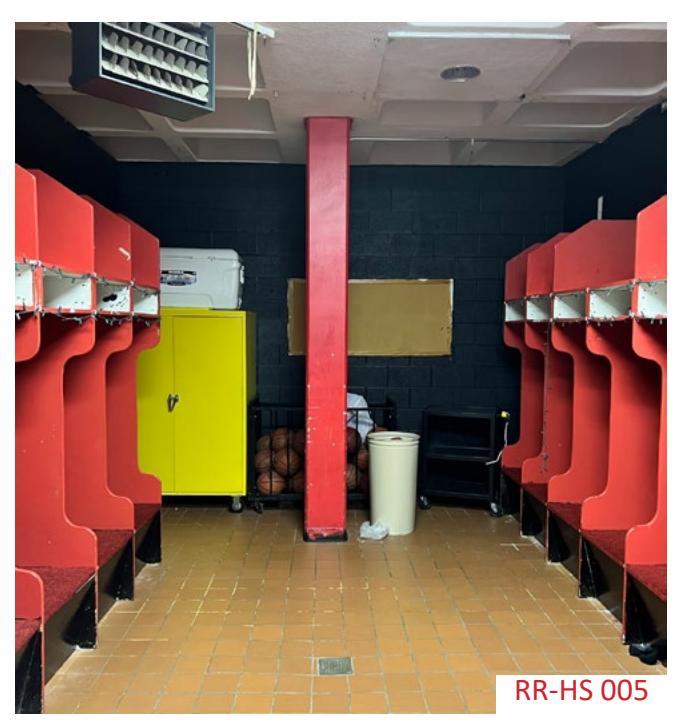
Renovation is recommended for the training room (Room 603) and the coaches office.

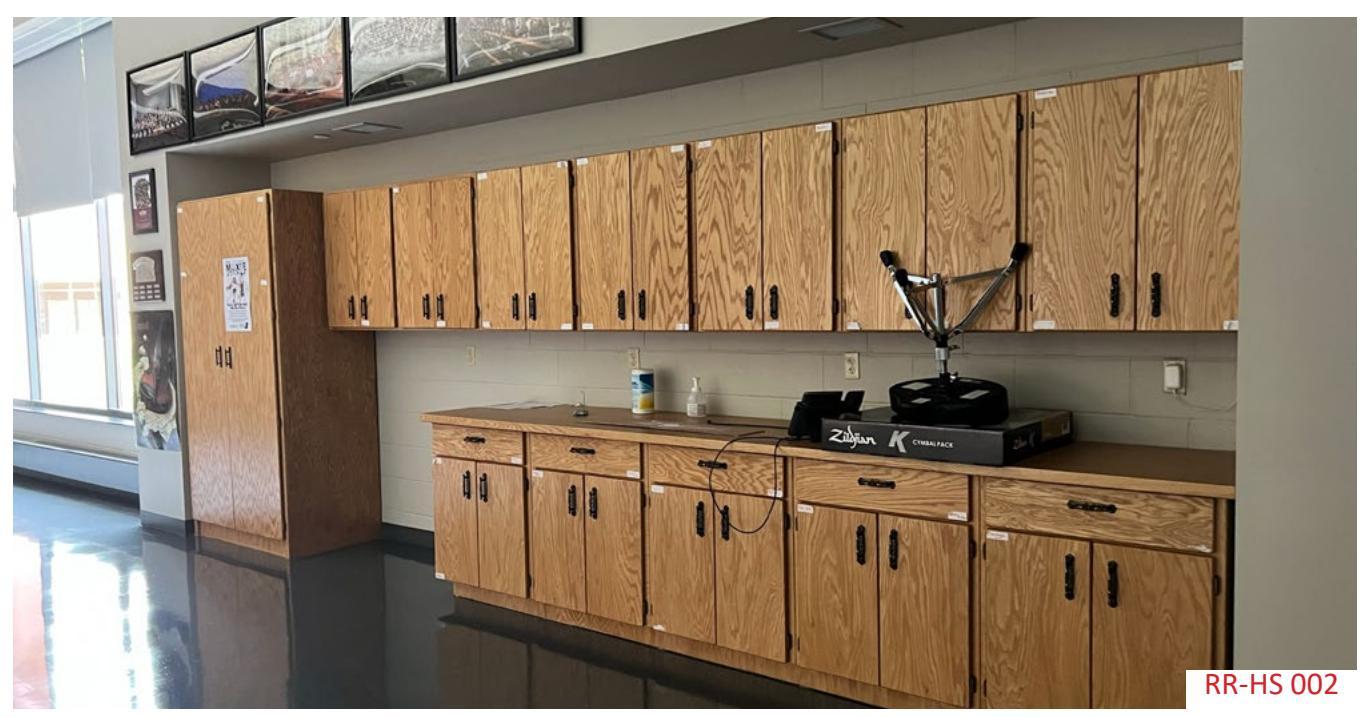
The original casework of the building and fixtures in the library are dated and replacement should be considered.

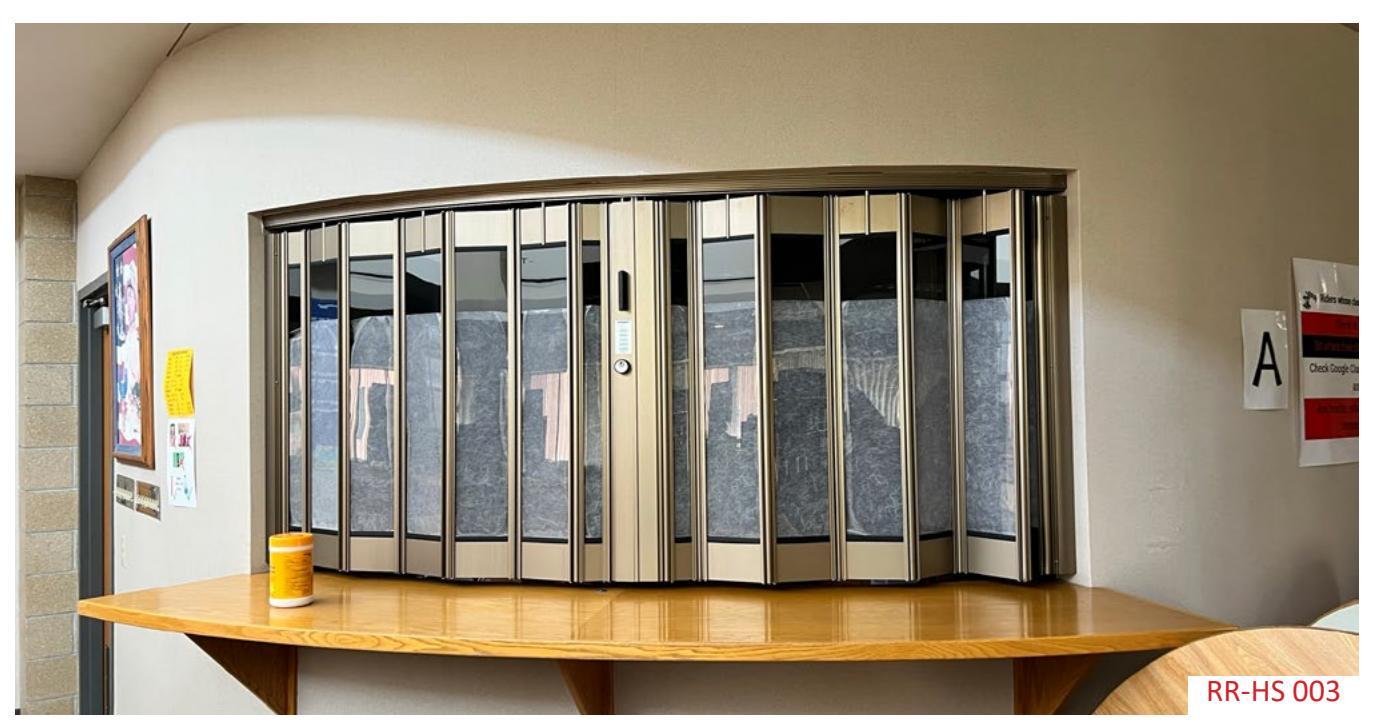
The original casework of the building and fixtures in the library are dated and replacement should be considered.

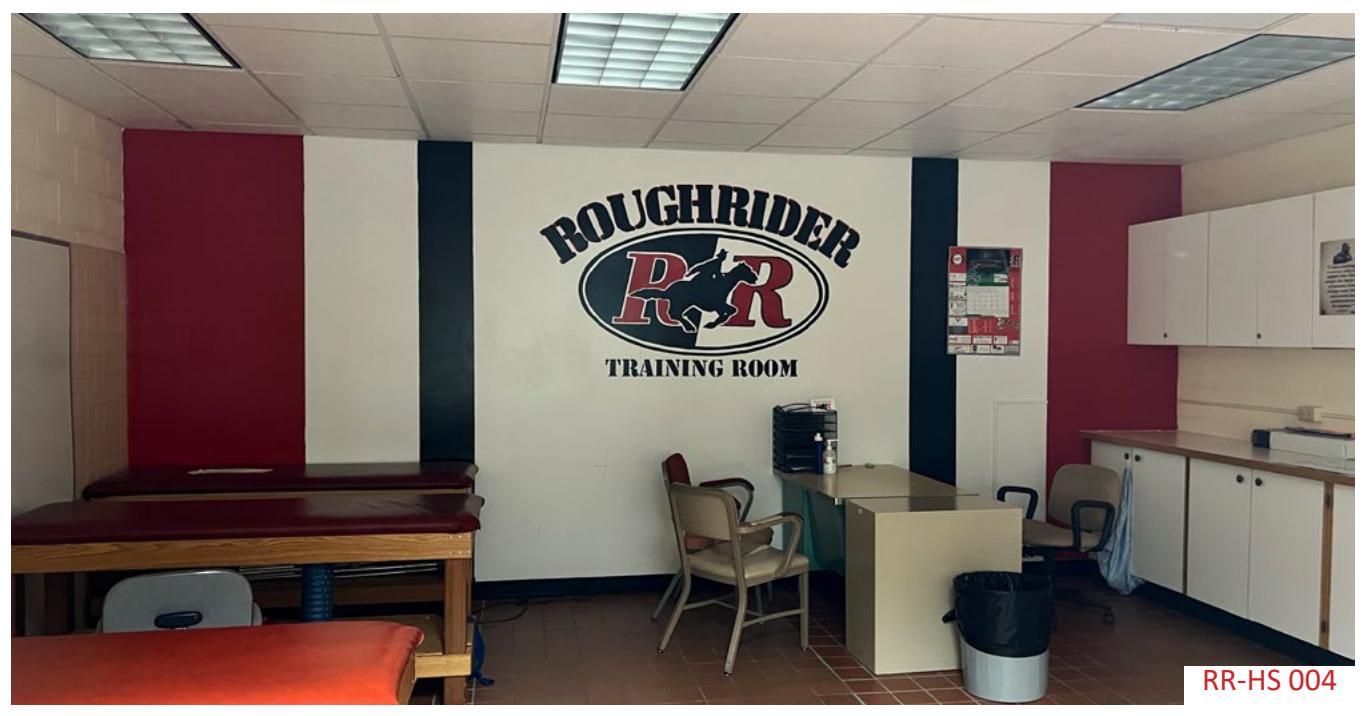
Renovation is recommended for the training room (Room 603) and the coaches office.

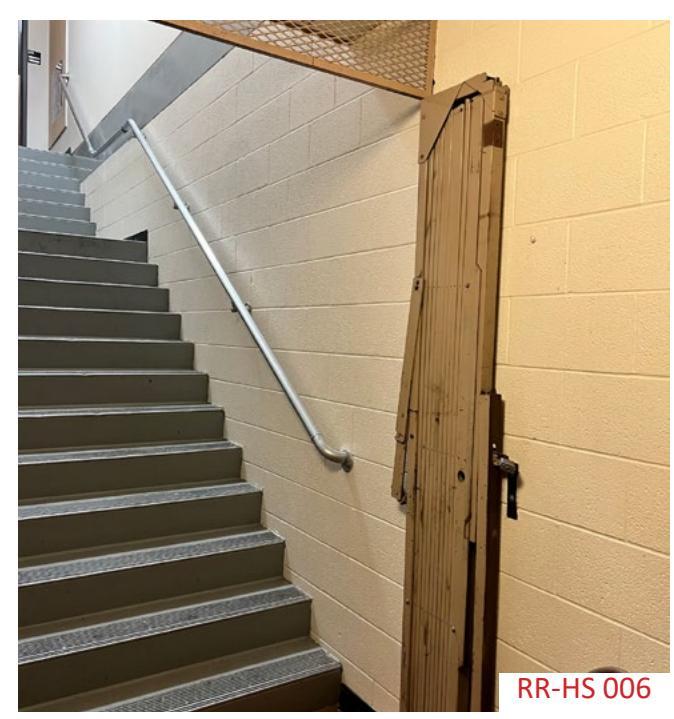
Metal partitions near the main gym should be removed to ensure the stairwell always stays open.

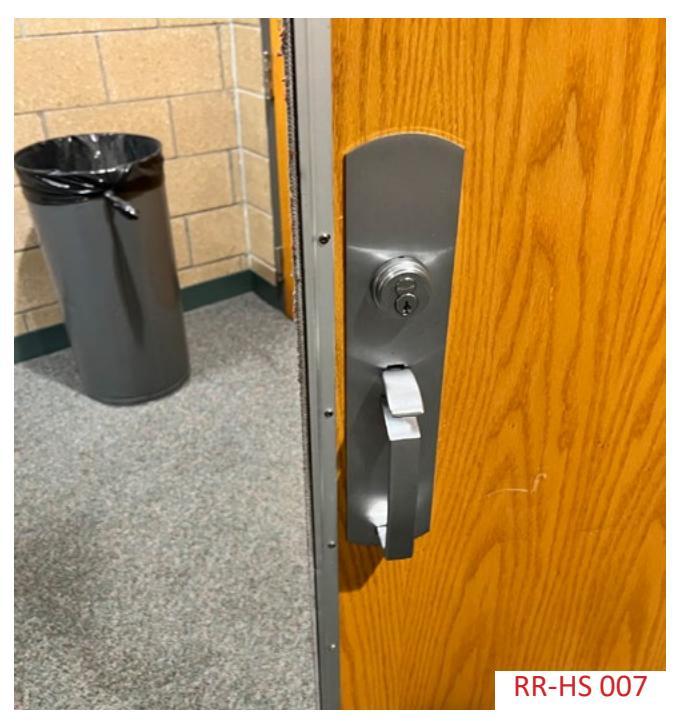
The Rider Room needs new hardware and seating as it is currently out of date.

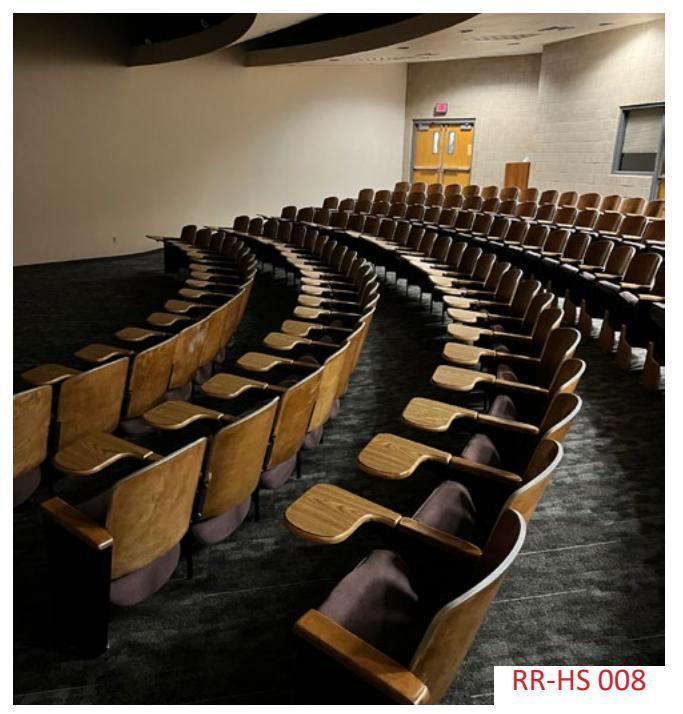
The Rider Room needs new hardware and seating as it is currently out of date.

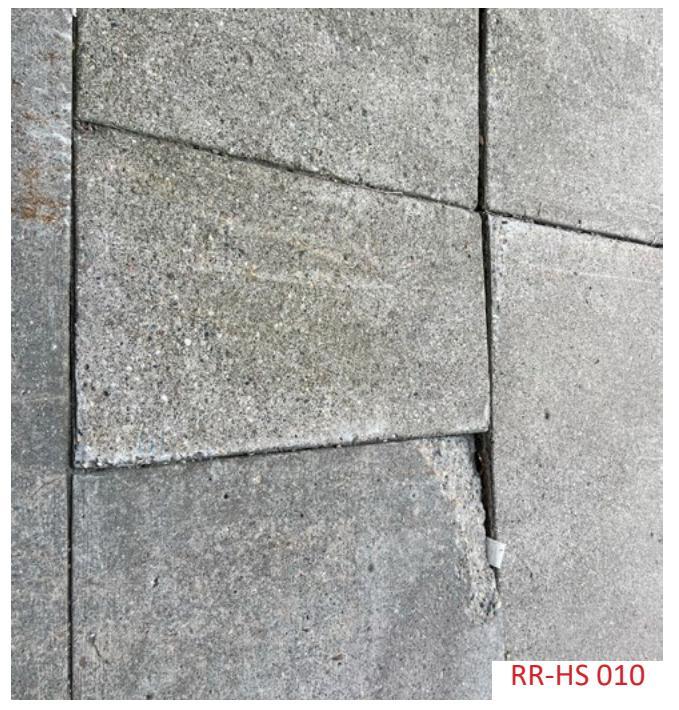
The concrete pads outside of doors 9, 10, and 16 are cracked and/or sinking, but all pads should be double checked to ensure adequate conditions.

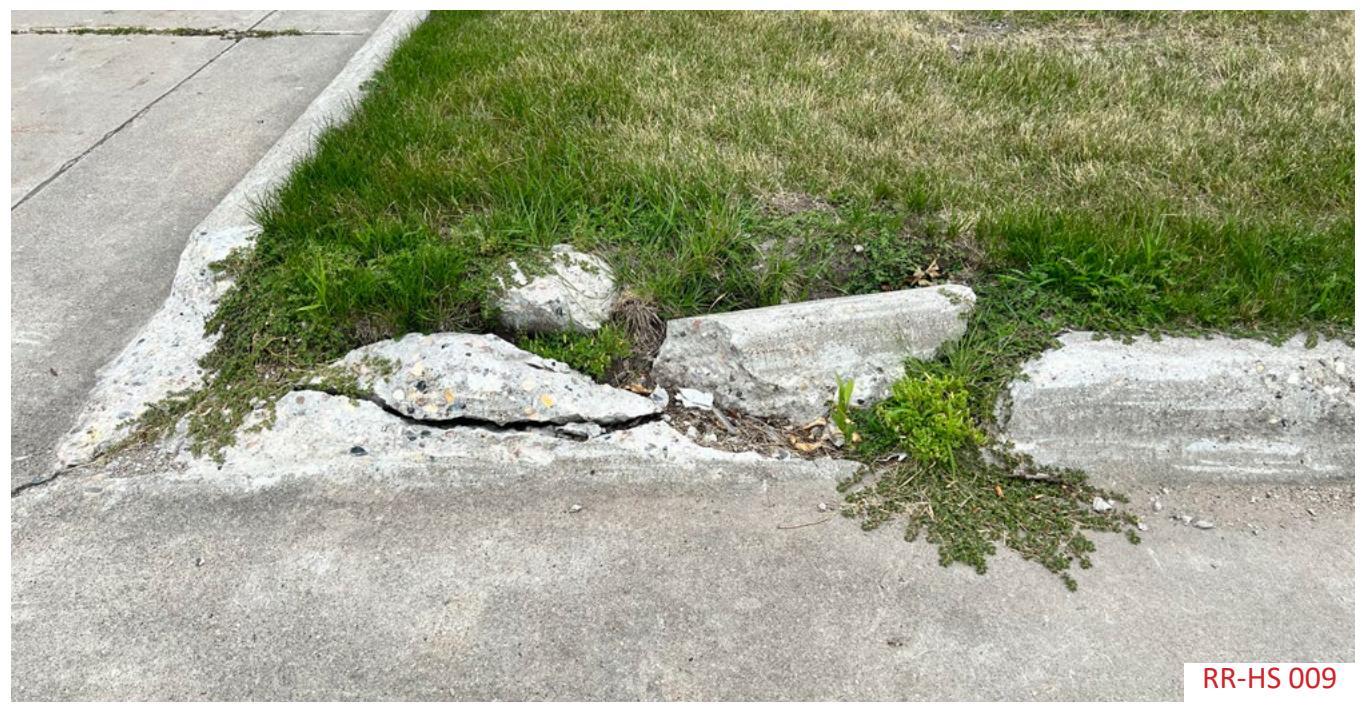
The concrete drives could use some attention, but the curb especially has been heavily damaged by snowplows and should be replaced or repaired.

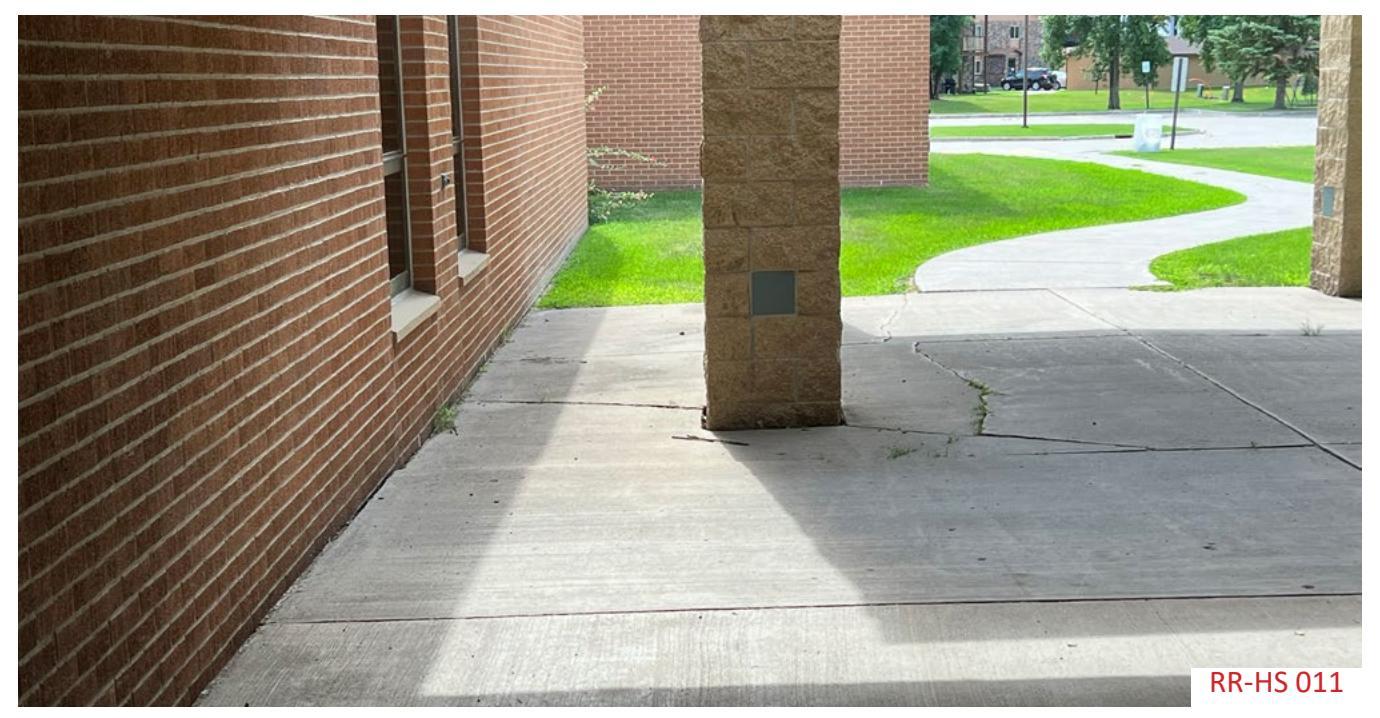
The concrete pads outside of doors 9, 10, and 16 are cracked and/or sinking, but all pads should be double checked to ensure adequate conditions (Door 9), (Door 16).

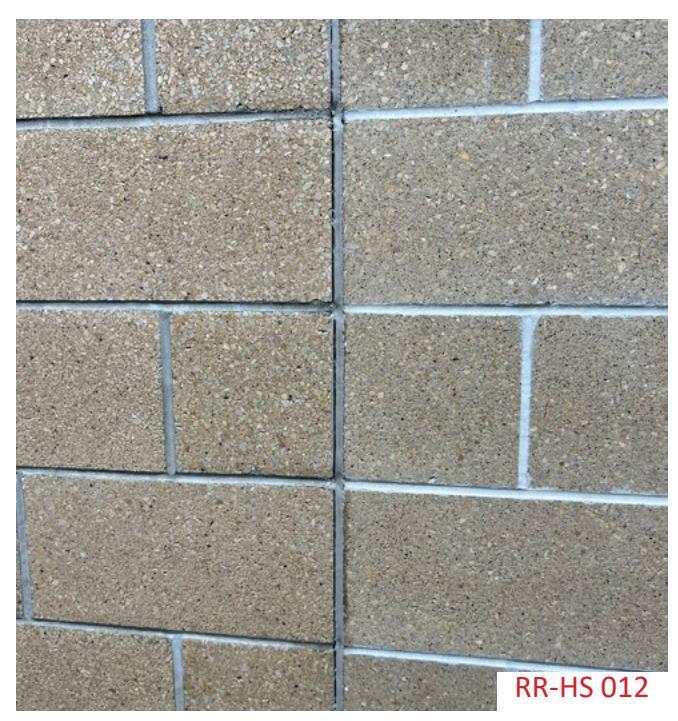
The caulking in the CMU near the music rooms appears to be lifting and should be redone.

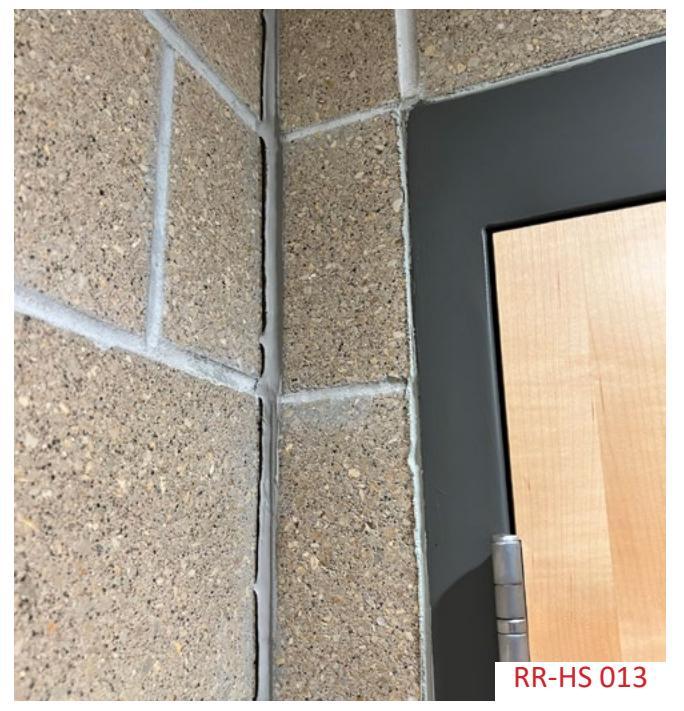
The caulking in the CMU near the music rooms appears to be lifting and should be redone.

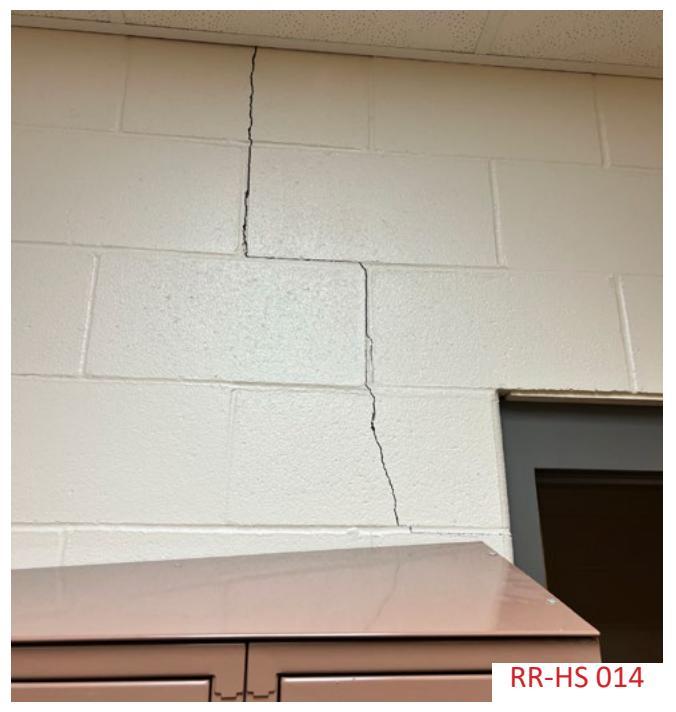
There is cracking in the CMU wall in the locker rooms that can be seen from both sides.

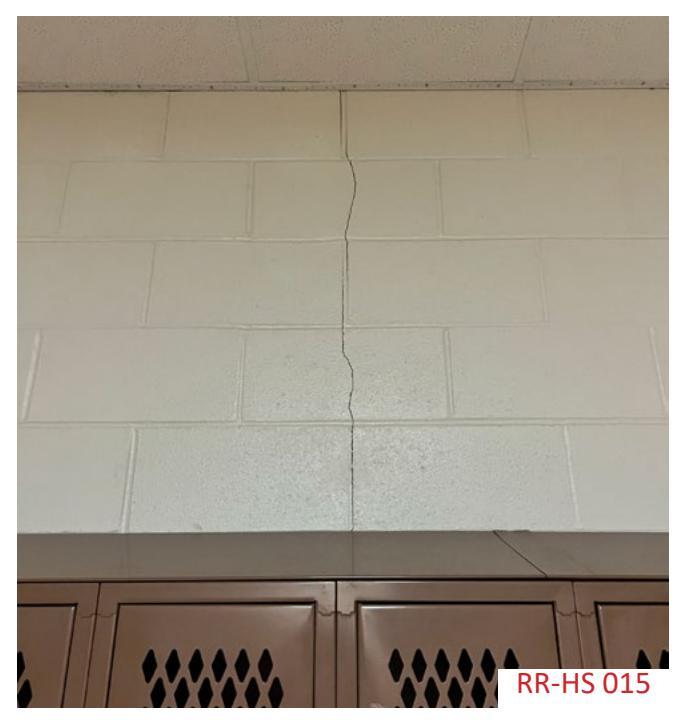
There is cracking in the CMU wall in the locker rooms that can be seen from both sides.

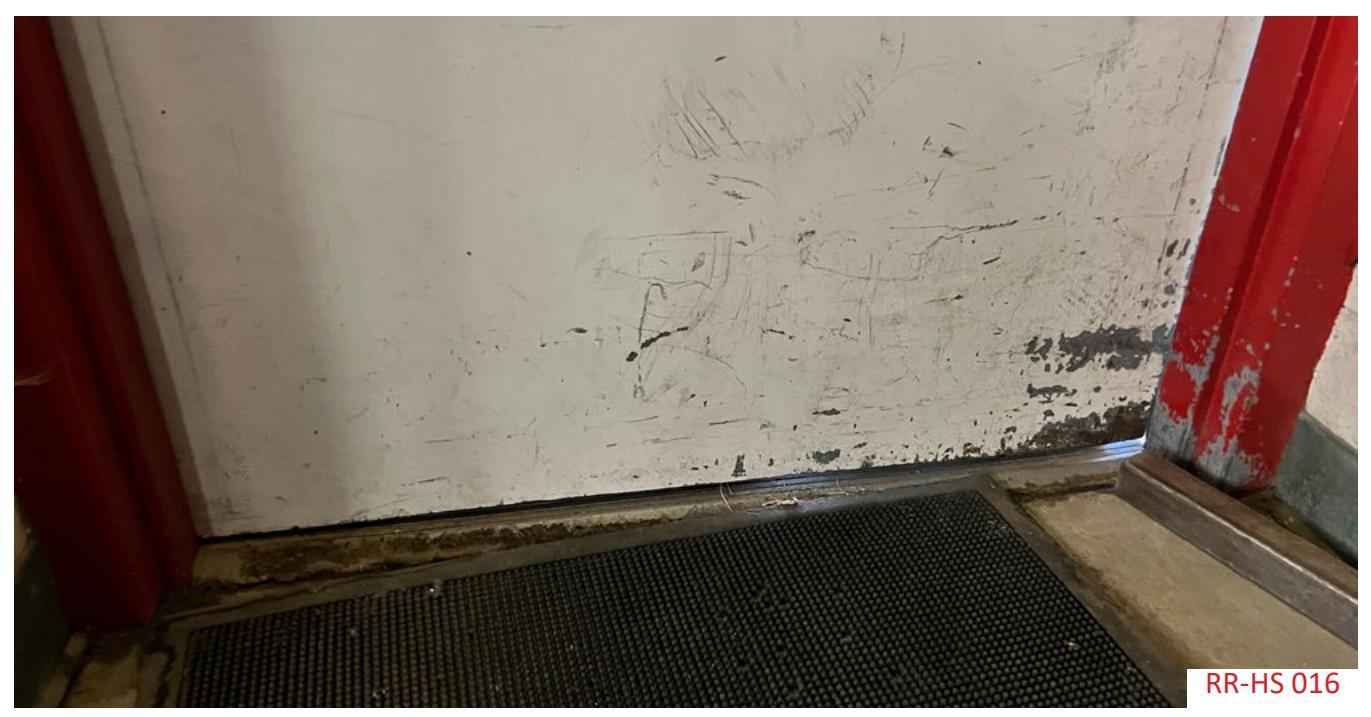
The weather stripping in the openings in the automotive and manufacturing/production classrooms are in poor condition and need to be redone.

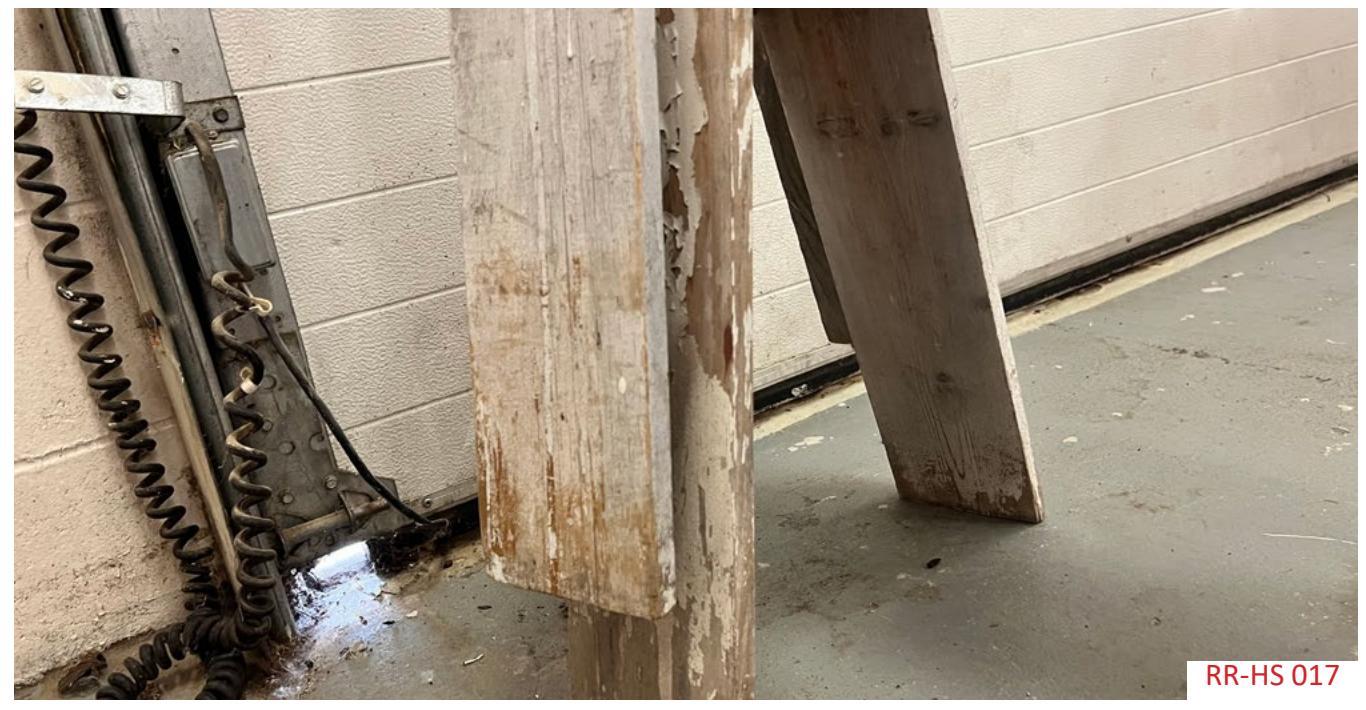
There is a large hole in the garage door in the automotive classroom as well.

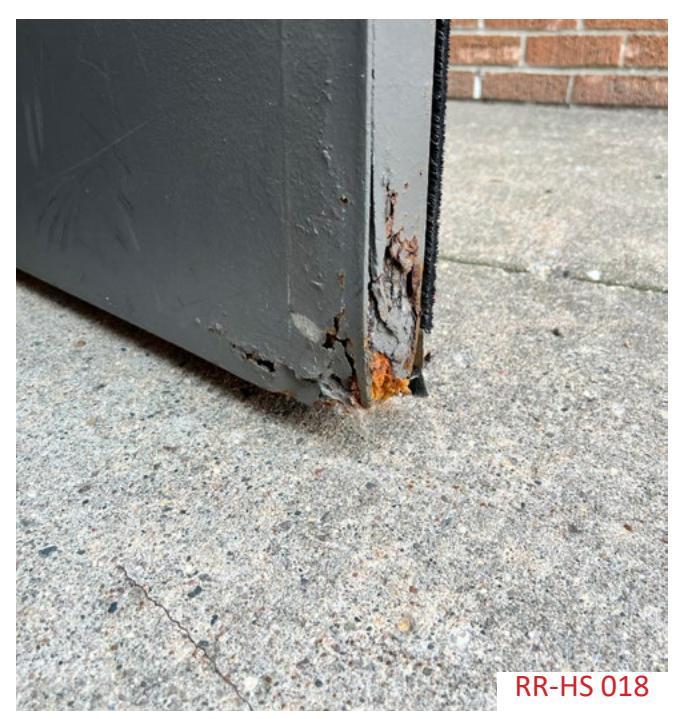
Many of the metal doors to the exterior are rusted badly on the bottom and should get replaced.

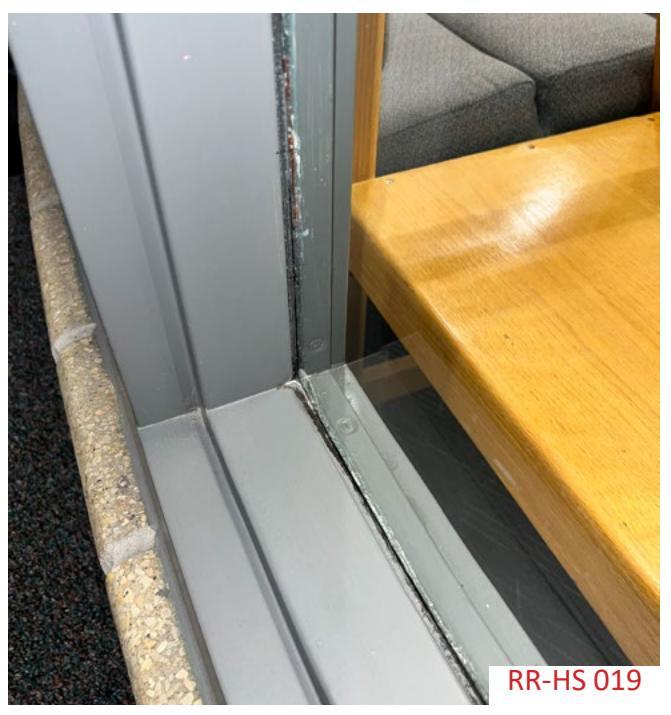
The interior windows to the main office have poor sealing that needs retouching.

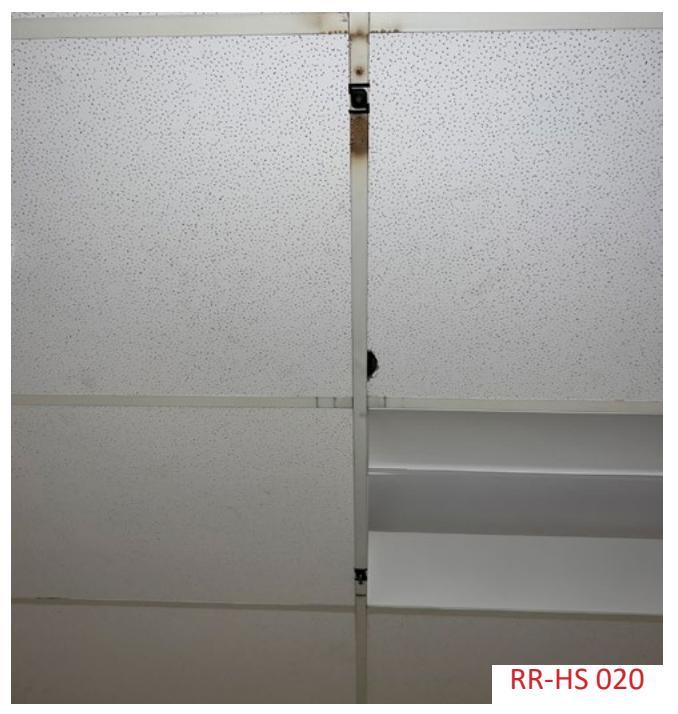
Rusting can be seen in the grids in the health classroom and numerous spots have noticeable water damage.

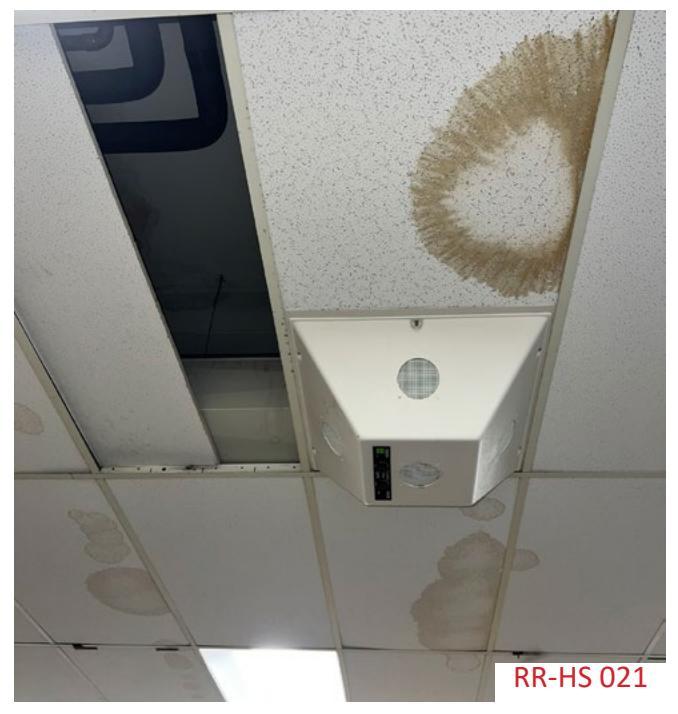
Rusting can be seen in the grids in the health and numerous spots have noticeable water damage.

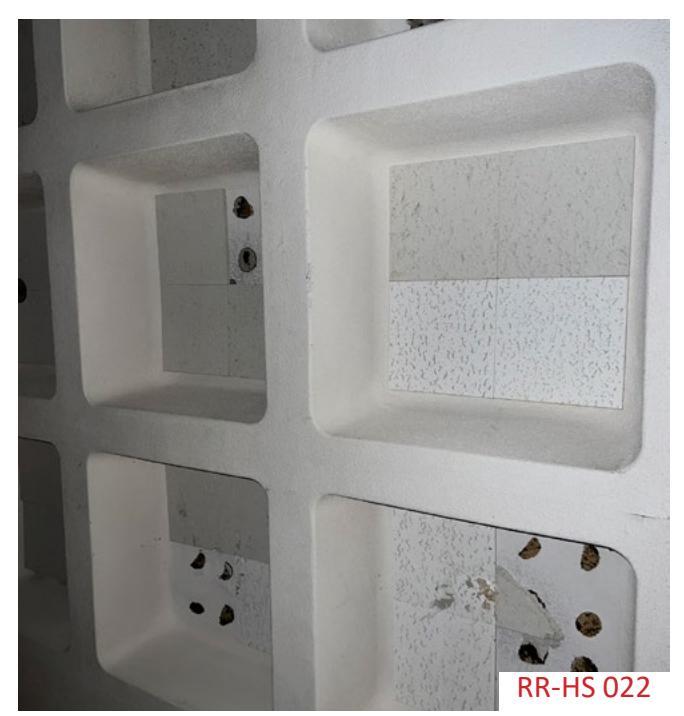
There are portions of ceiling that are damaged and falling off in the locker rooms and the original auditorium (Locker).

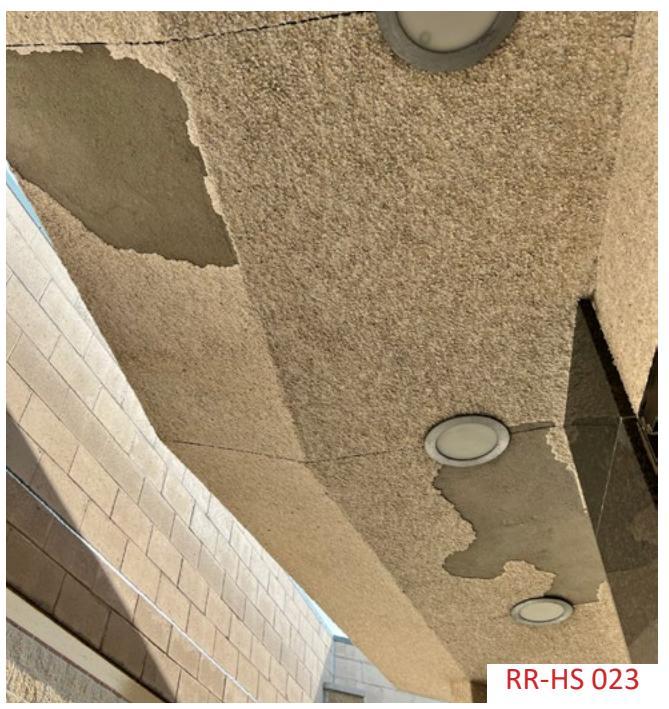
The soffits on the exterior portion of the main entrance are deteriorating and the gypsum board in the vestibule is also compromised.

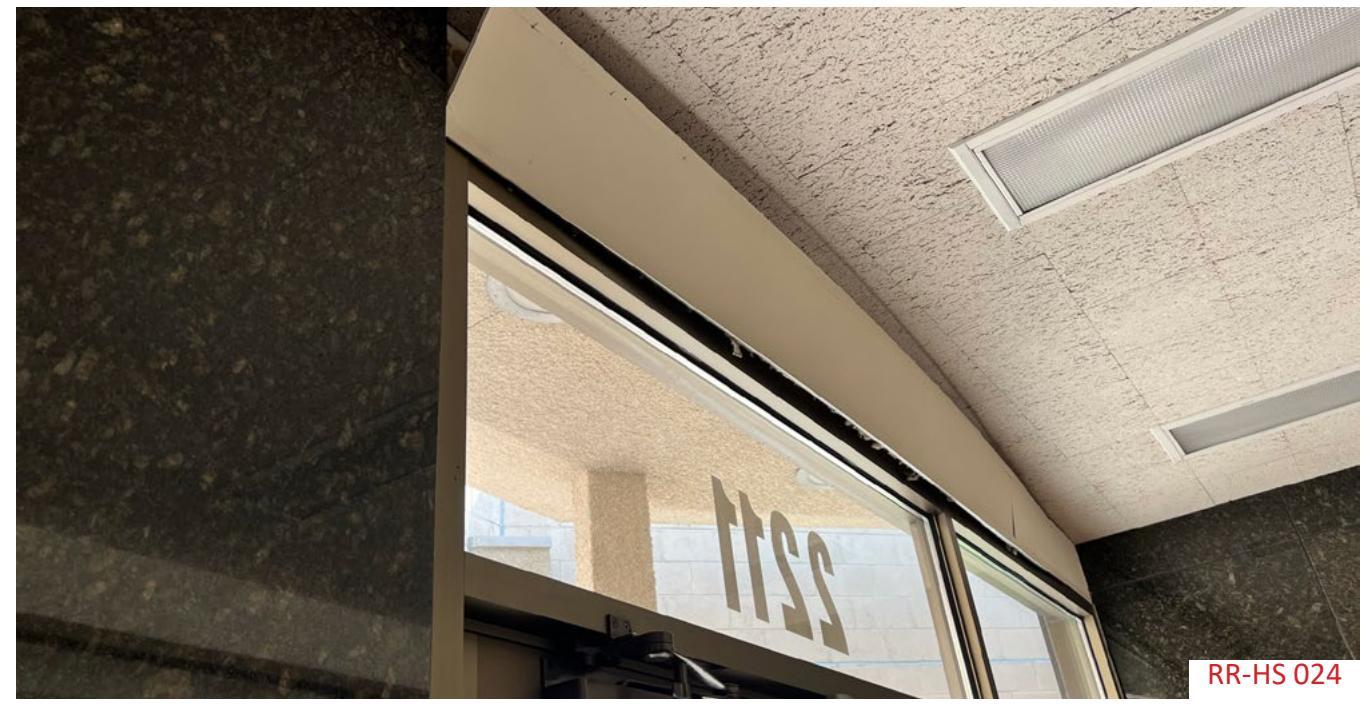
The soffits on the exterior portion of the main entrance are deteriorating and the gypsum board in the vestibule is also compromised.

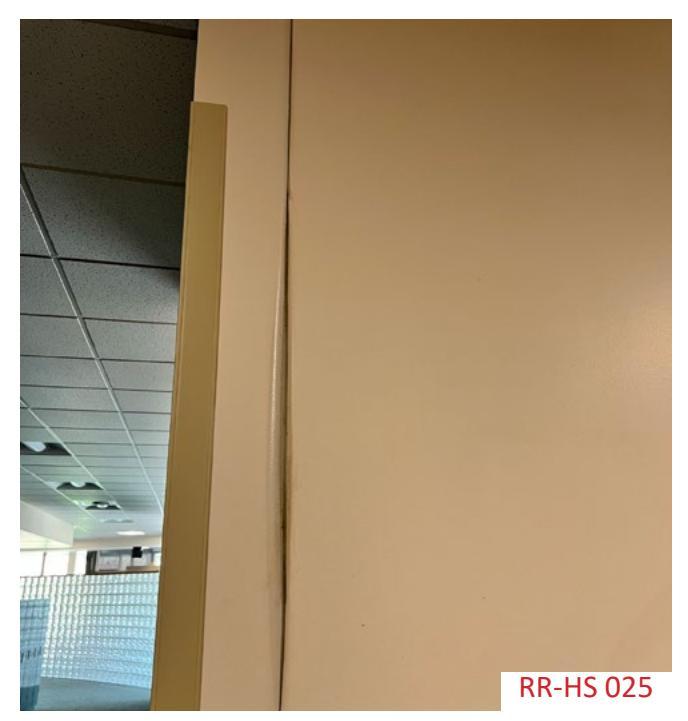
The vinyl wall covering should be removed as it is peeling up throughout the school.

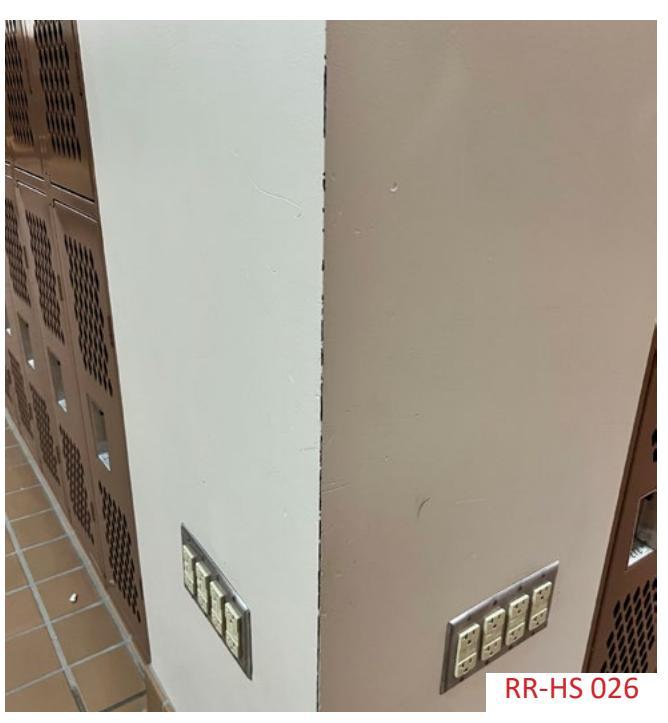
The women's physical education locker room could use corner guards and other corners should be inspected to see where future damage can be prevented.

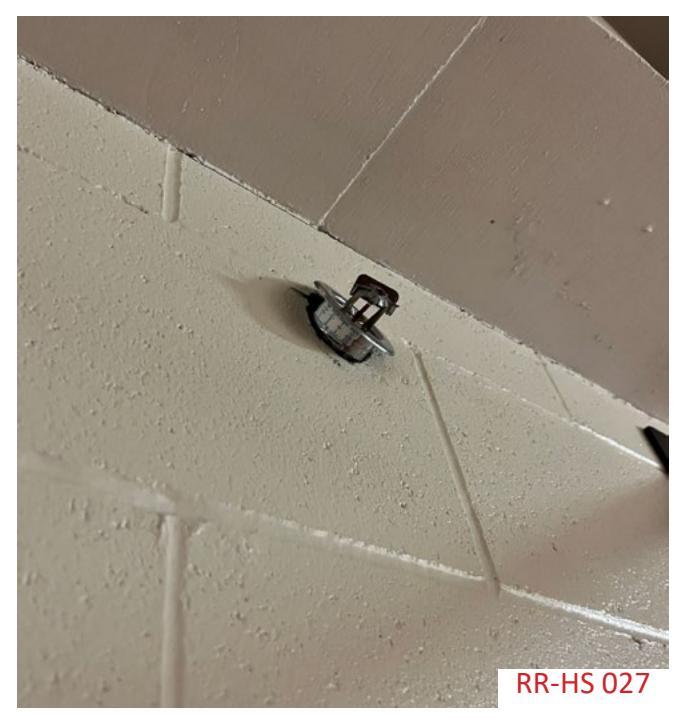
The piping and fire sprinklers in the basement walls have deteriorated the CMU walls where they are inserted.

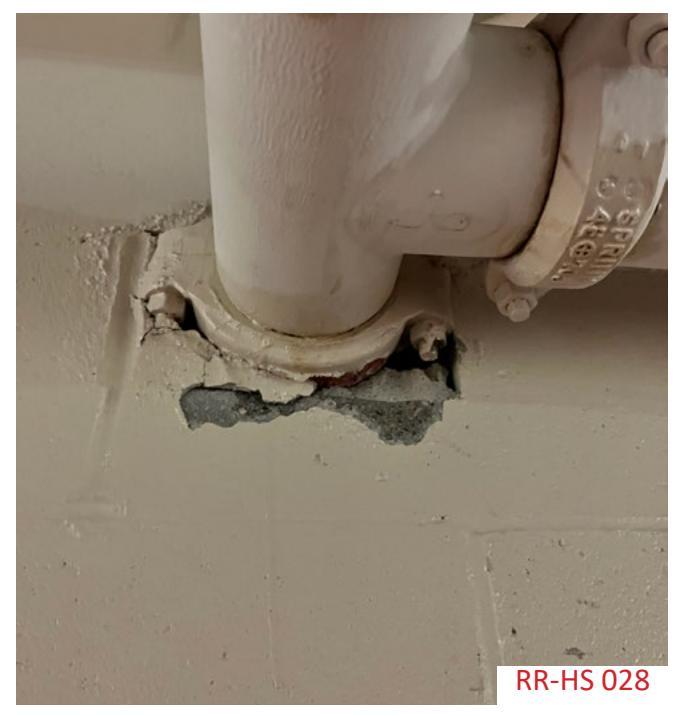
The piping and fire sprinklers in the basement walls have deteriorated the CMU walls where they are inserted.

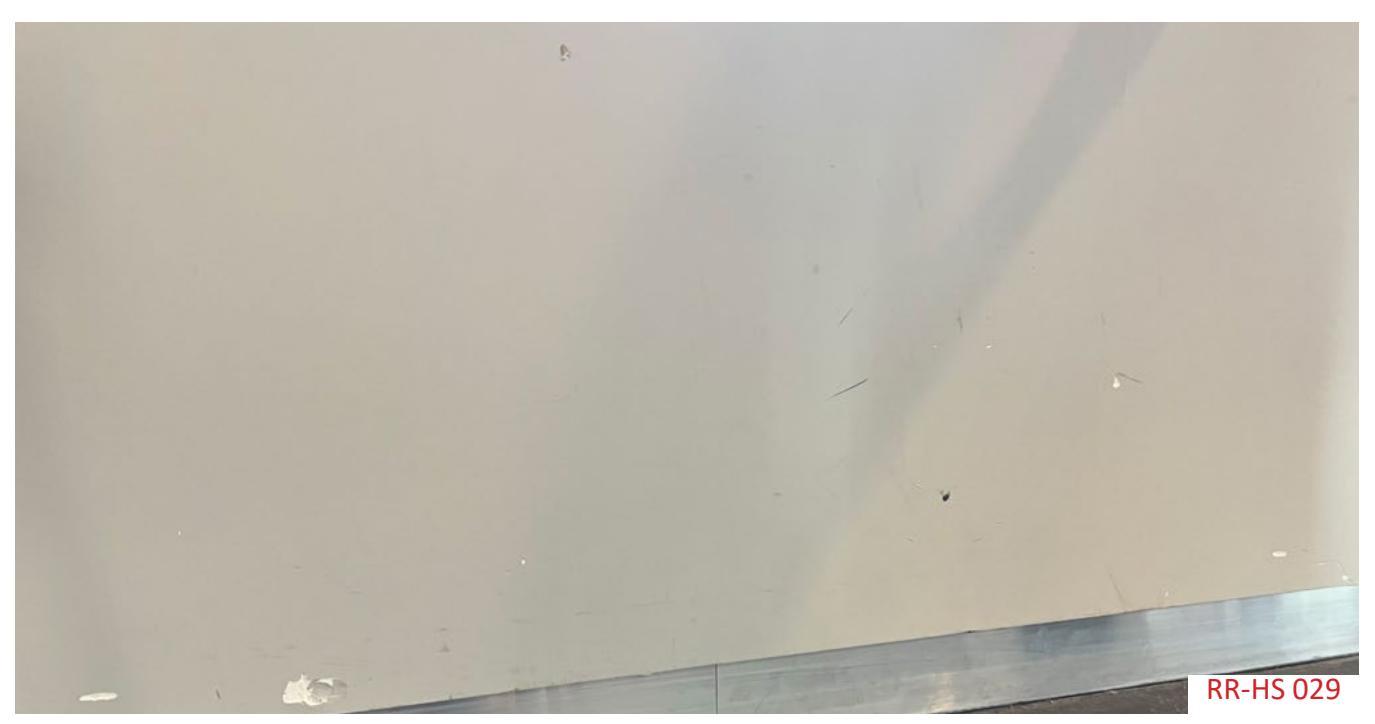
The painted gypsum board in the individual music practice rooms and outside the renovated auditorium need a general repair as they are damaged and chipping (Outside auditorium), (Practice room).

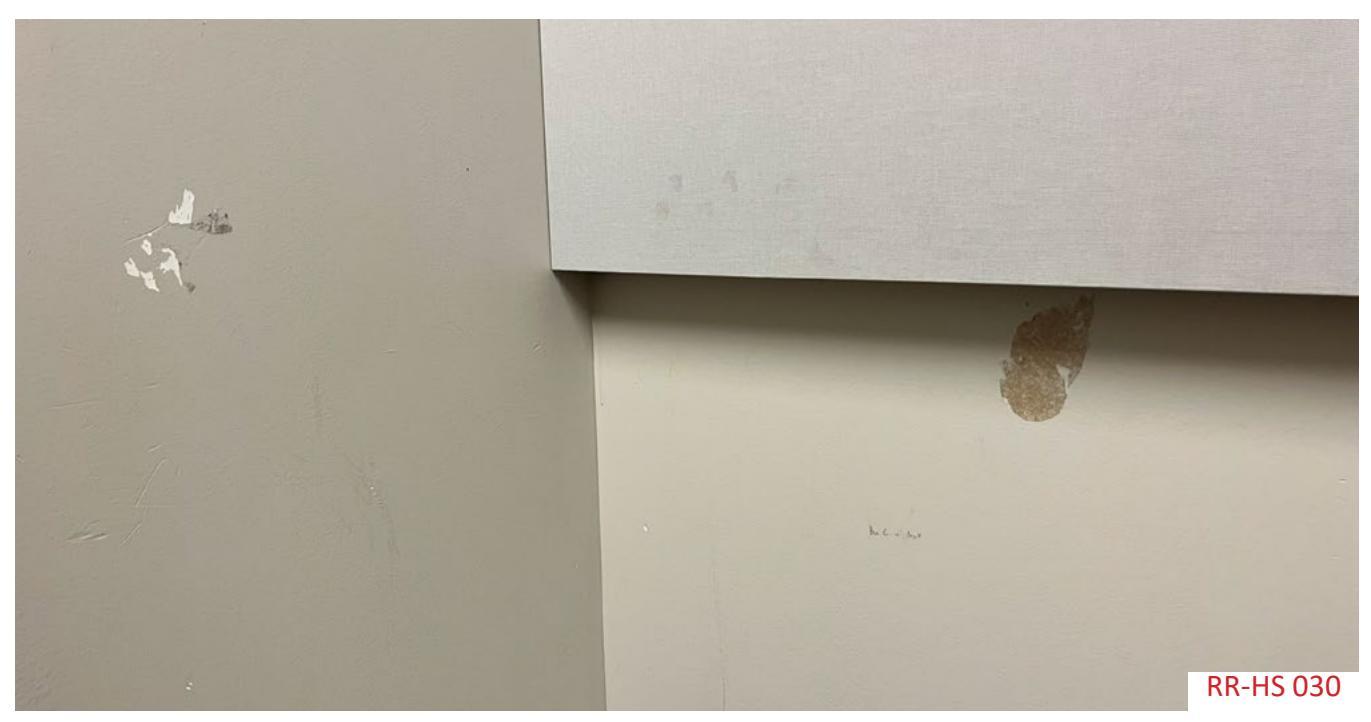
The painted gypsum board in the individual music practice rooms and outside the renovated auditorium need a general repair as they are damaged and chipping (Outside auditorium), (Practice room).

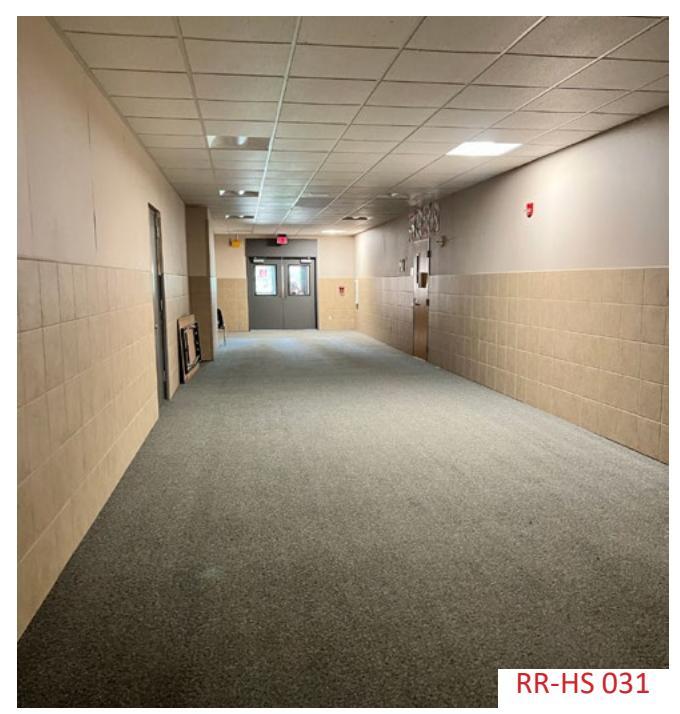
Much of the carpeting in the classrooms has been replaced, but the corridors still need to be redone.

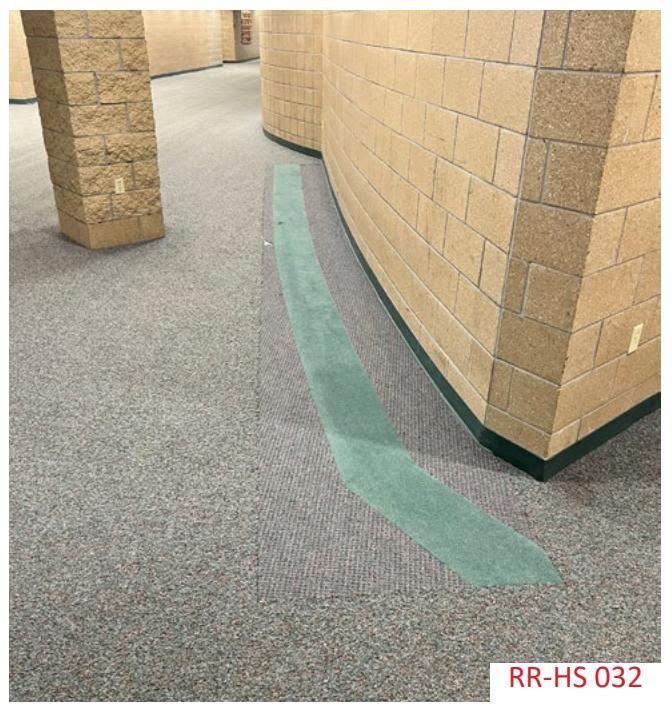
Much of the carpeting in the classrooms has been replaced, but the corridors still need to be redone.

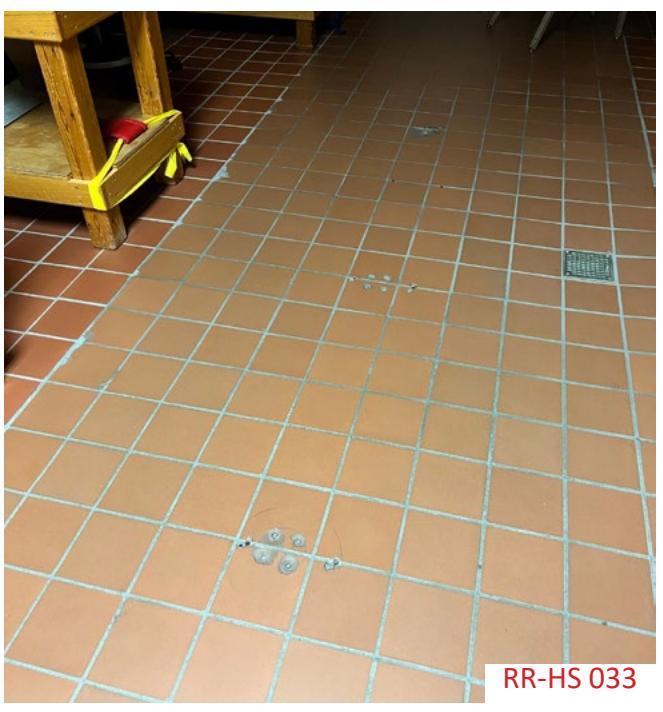
All of the brown ceramic and vinyl composition tile in the building is outdated and should get replaced.

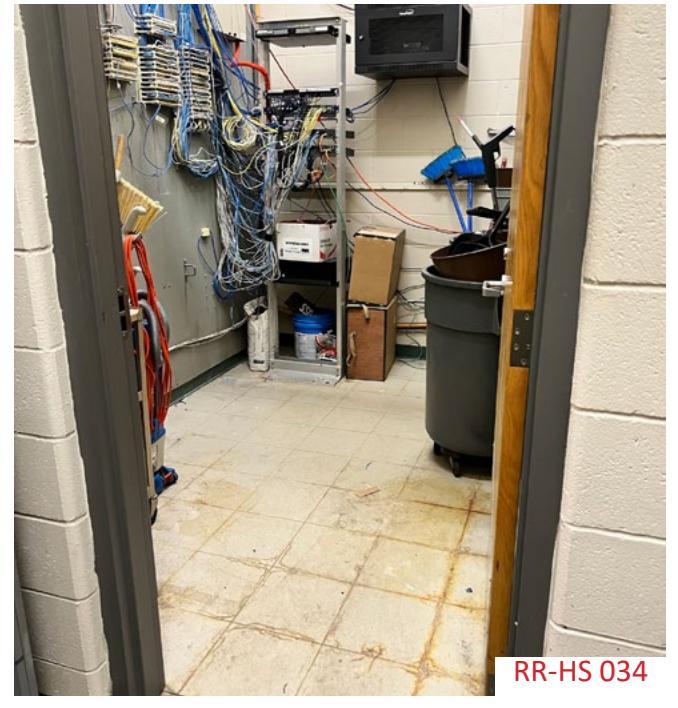
All of the brown ceramic and vinyl composition tile in the building is outdated and should get replaced.
