RHS RED RIVER HIGH SCHOOL

FACILITY ASSESSMENT

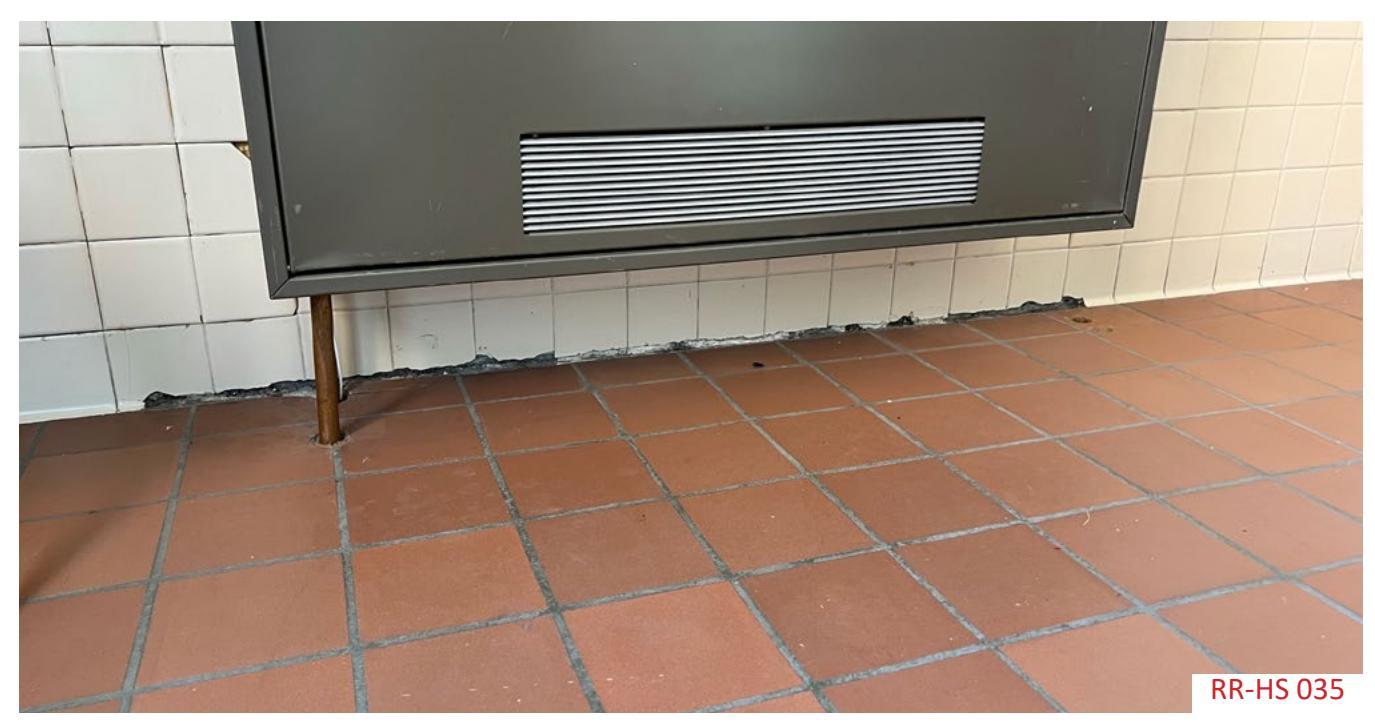
The vestibule tiles are especially in bad condition.

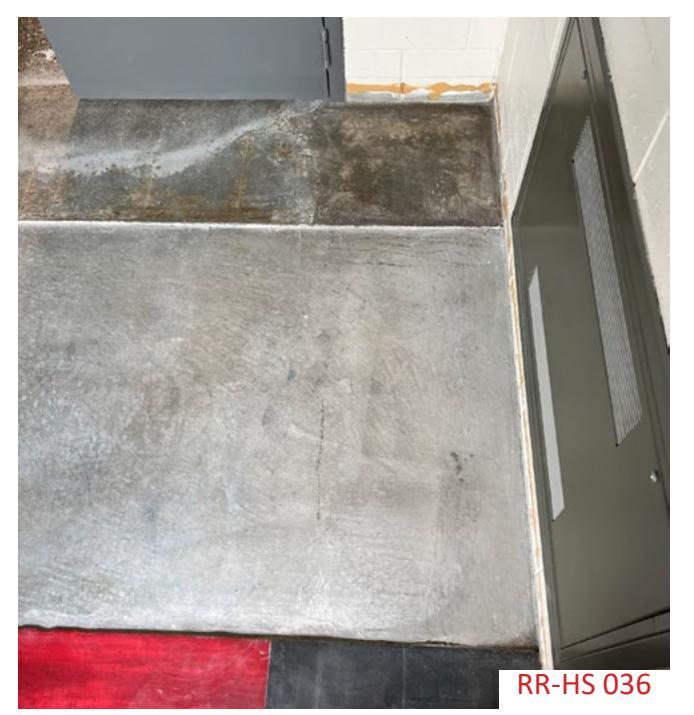
The vestibule tiles are especially in bad condition and the door 7 vestibule is partly missing tiles.

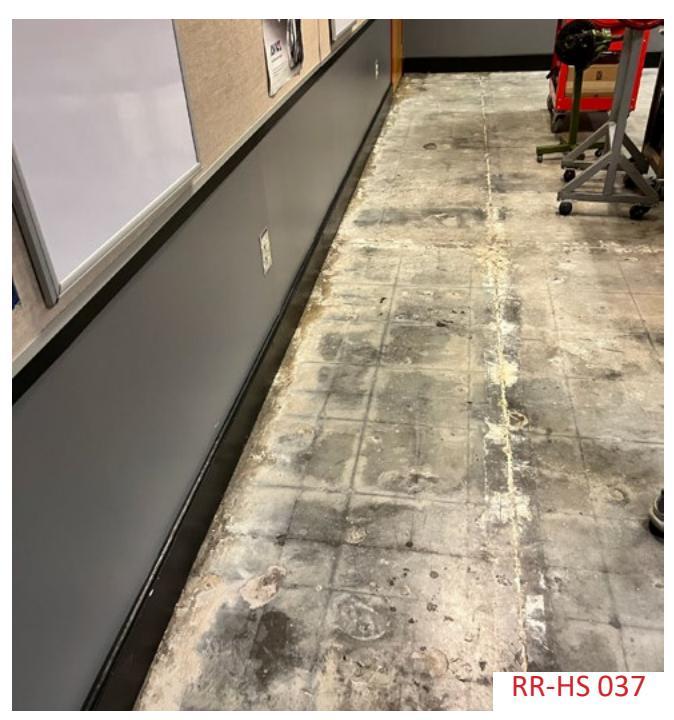
The tile is ripped up in numerous art and technological education classrooms because there was a chemical issue.

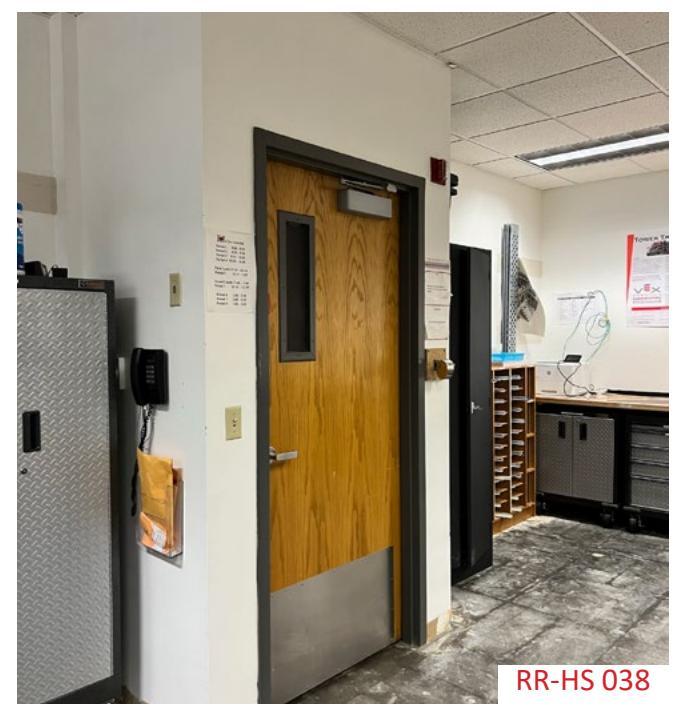
The tile is ripped up in numerous art and technological education classrooms because there was a chemical issue.

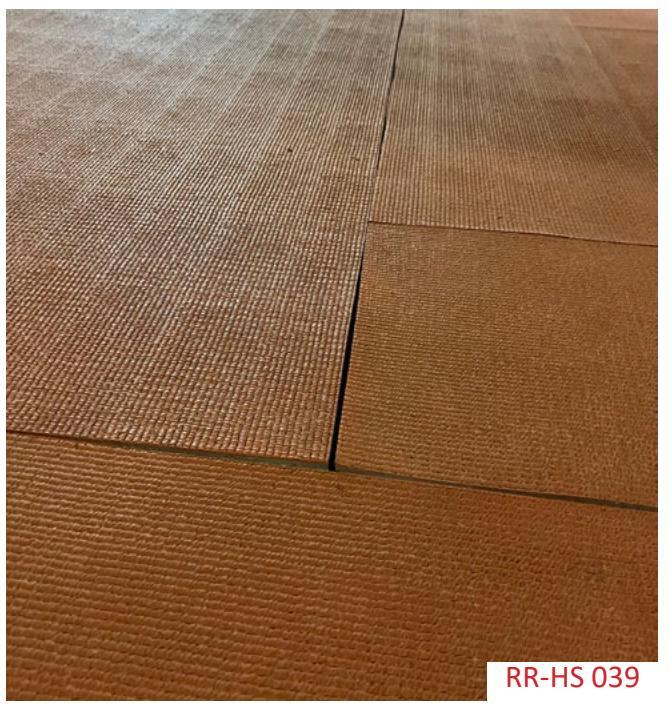
The running track material in the basement is lifting up in several spots and needs to be replaced.

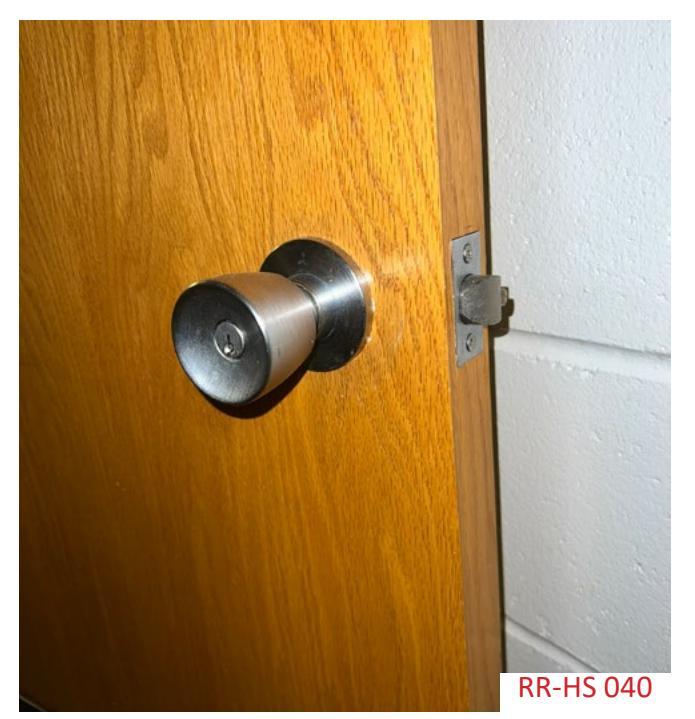
Door hardware on numerous doors throughout the building is not accessible

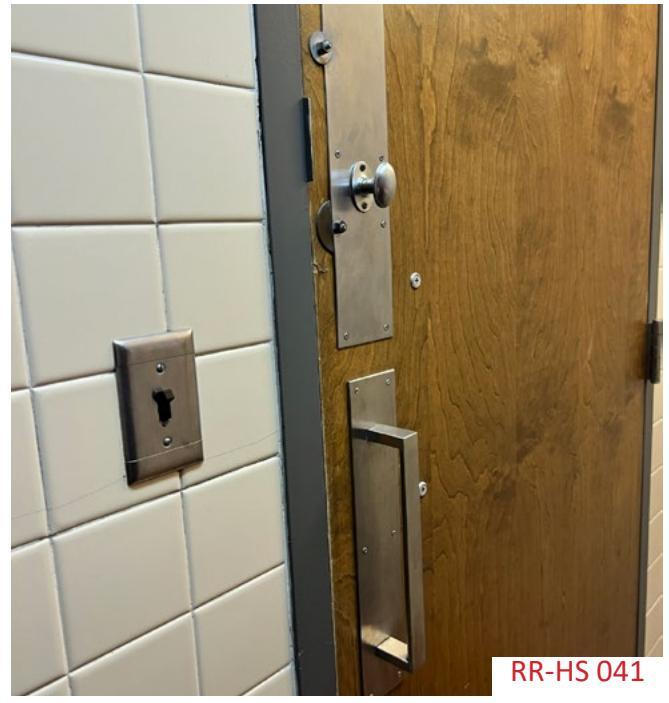
Door hardware on numerous doors throughout the building is not accessible

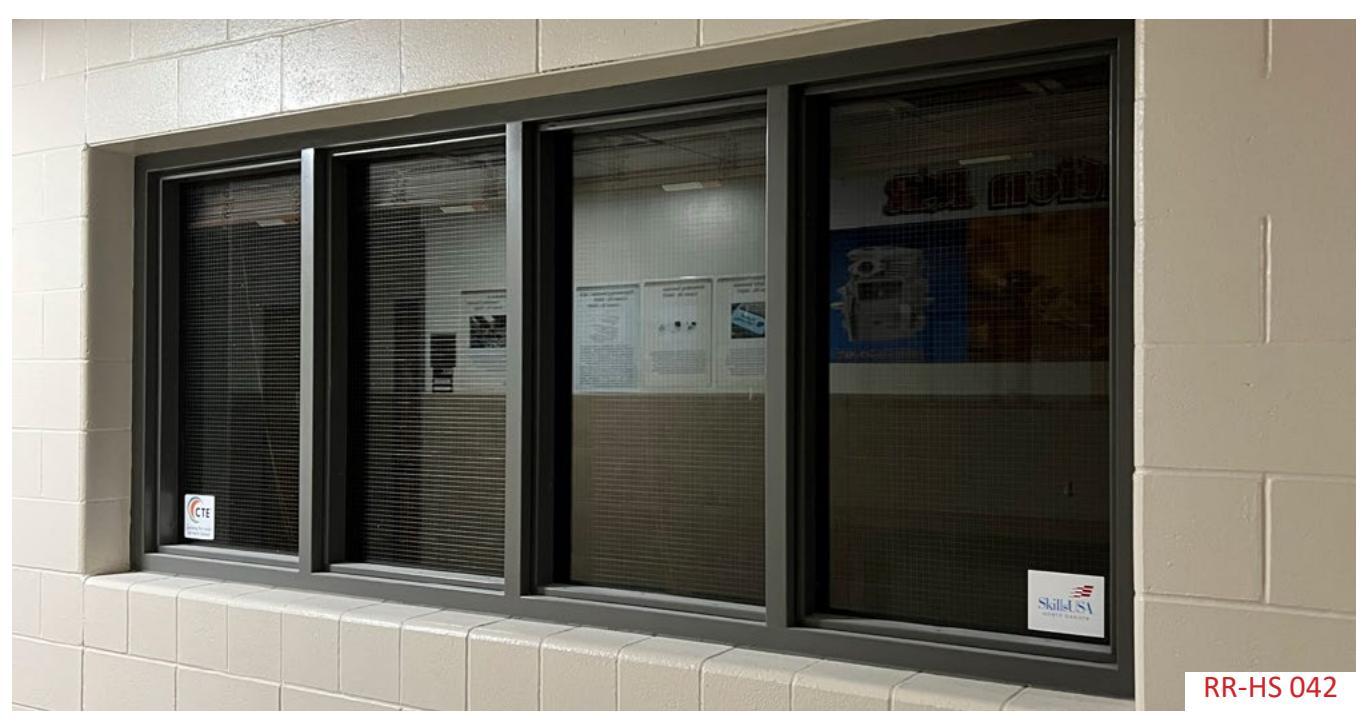
Traditional wire glass throughout the building is no longer to code as an acceptable type of safety glass.

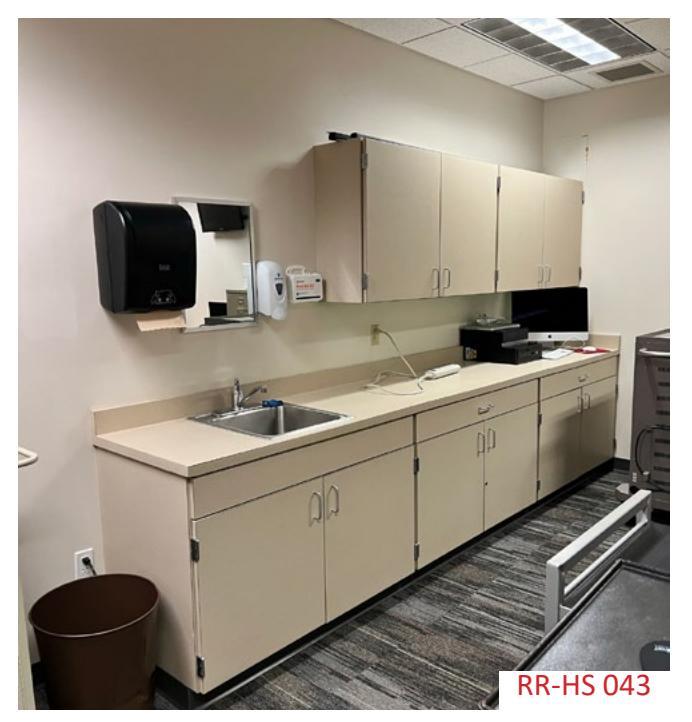
Sinks within classrooms and offices are not accessible.

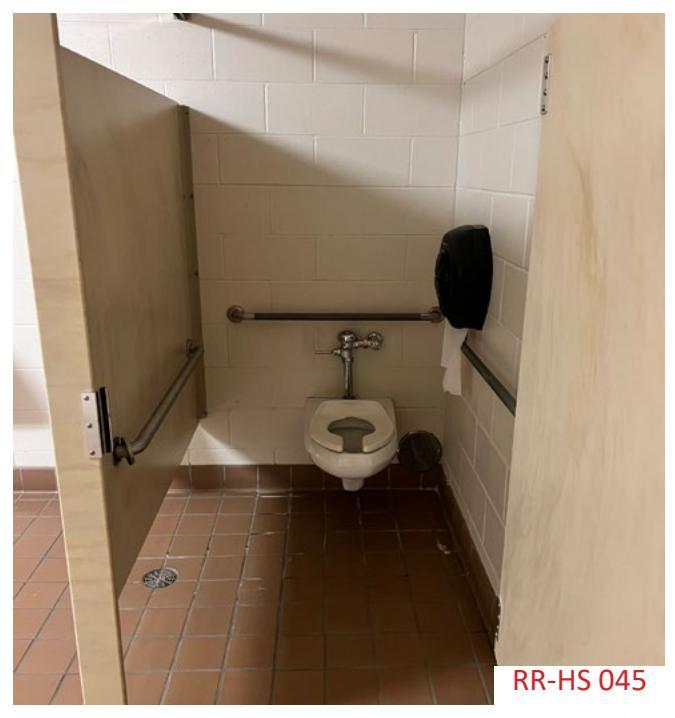
All men's and women's locker rooms are not accessible, as they do not have sufficient clearances at the entrances and do not have accessible stalls with the required turning space

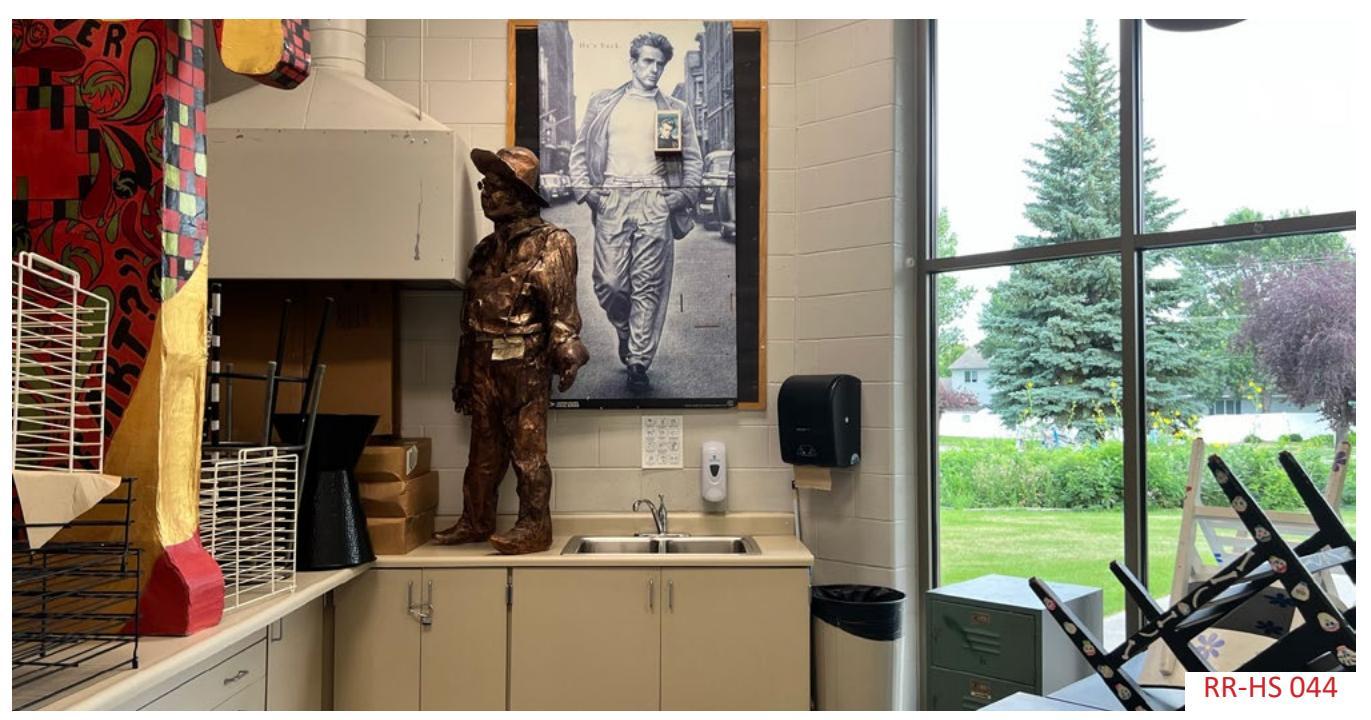
Sinks within classrooms and offices are not accessible.

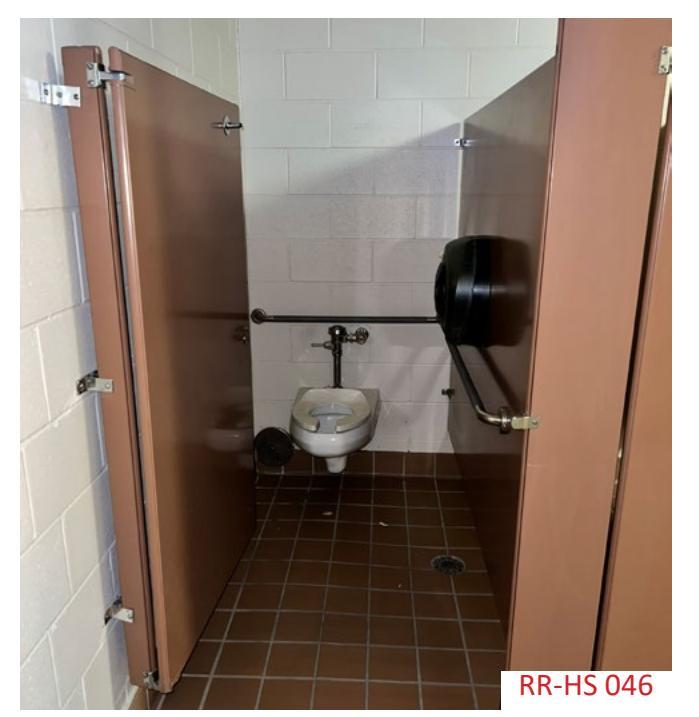
All men's and women's locker rooms are not accessible, as they do not have sufficient clearances at the entrances and do not have accessible stalls with the required turning space

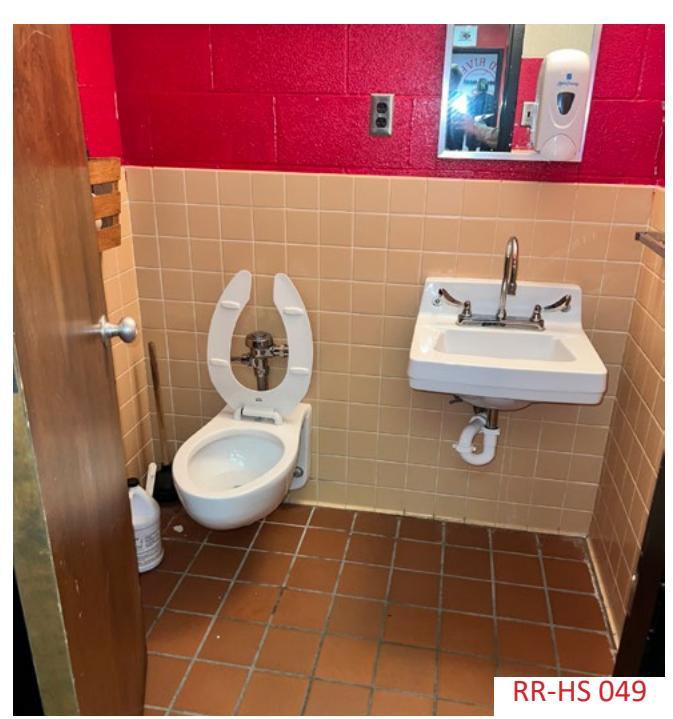
The restrooms in the men's and women's physical education staff offices are not accessible as they lack sufficient clearances and handrails.

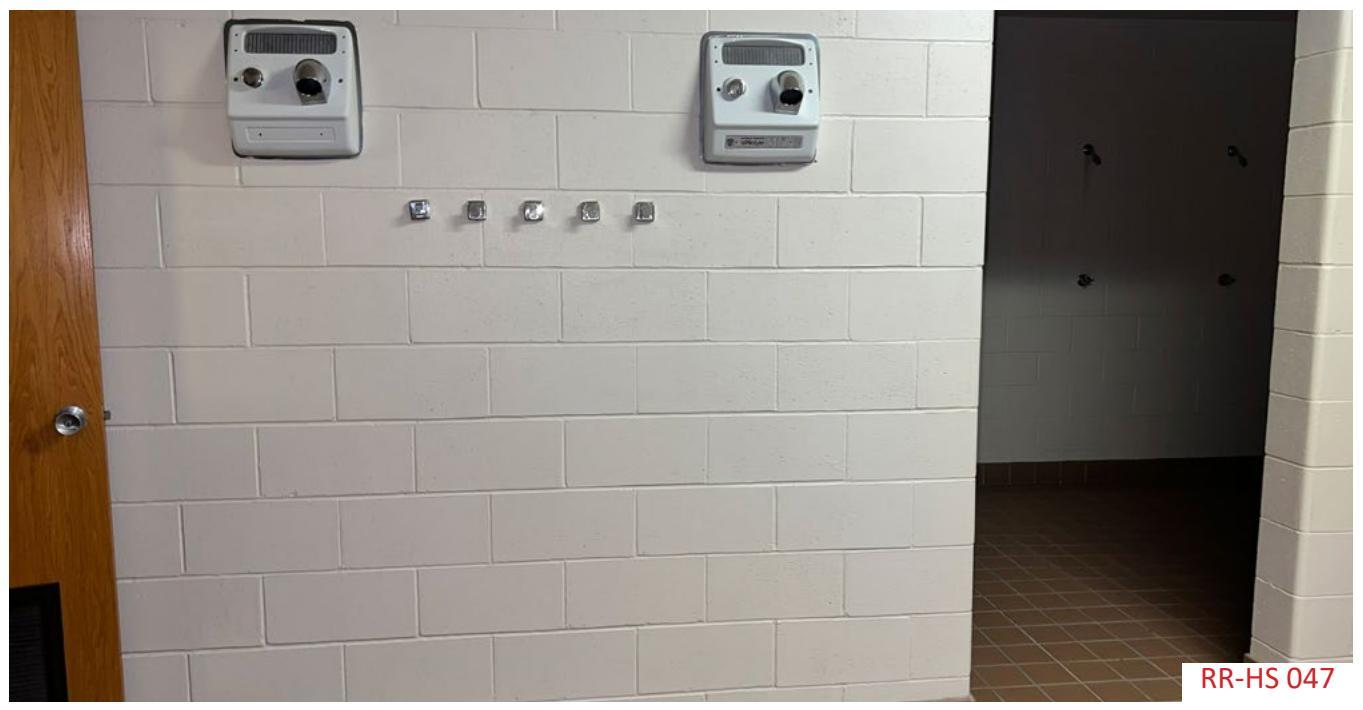
All men's and women's locker rooms have hand dryers that exceed height requirements.

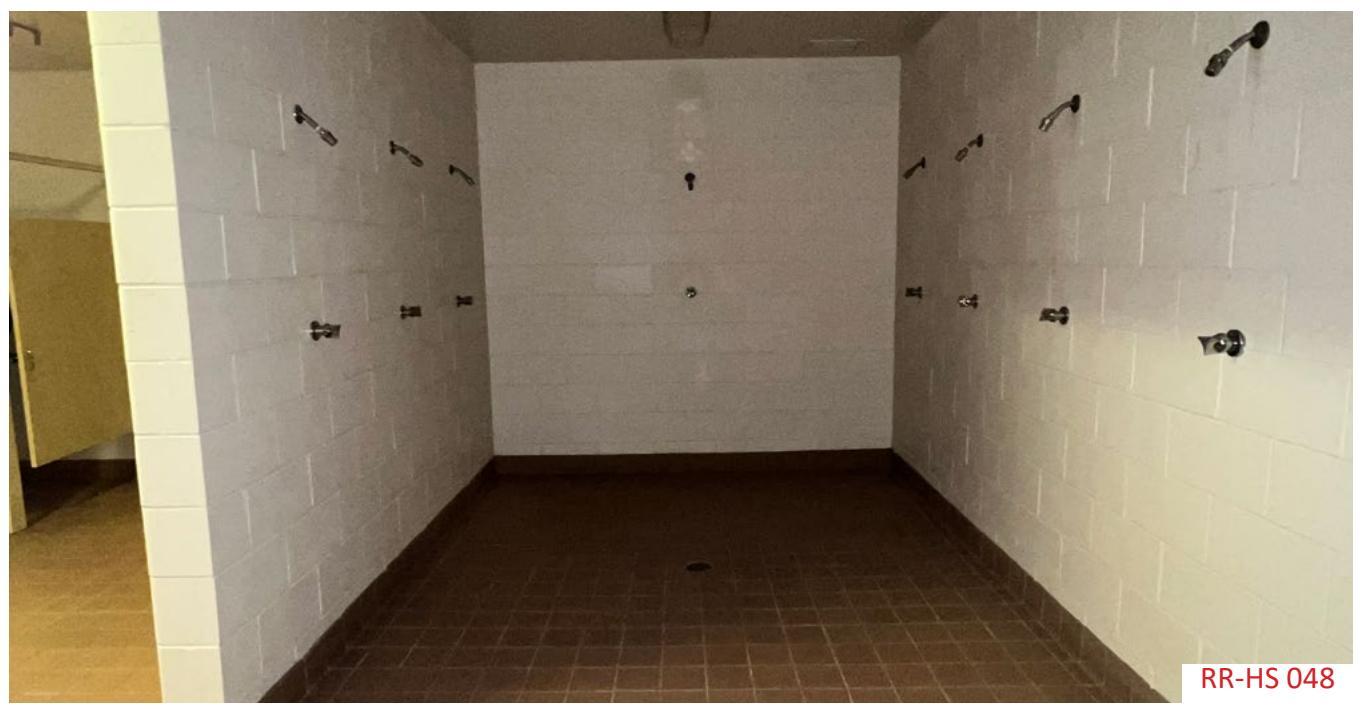
Locker rooms are provided with thermostatic mixing valves to temper the hot water to the showers to limit scald potential. Shower rooms are laid out with shower heads and controls along perimeter walls with a central drain in the middle of the room. This causes bath water to pass by other bathers to reach the drain. Recommend separate drains be provided for each shower stall to meet plumbing code requirements.

Showers in locker rooms do not have sufficient drains as required by code to prevent wastewater from one bather passing over areas occupied by other bathers.

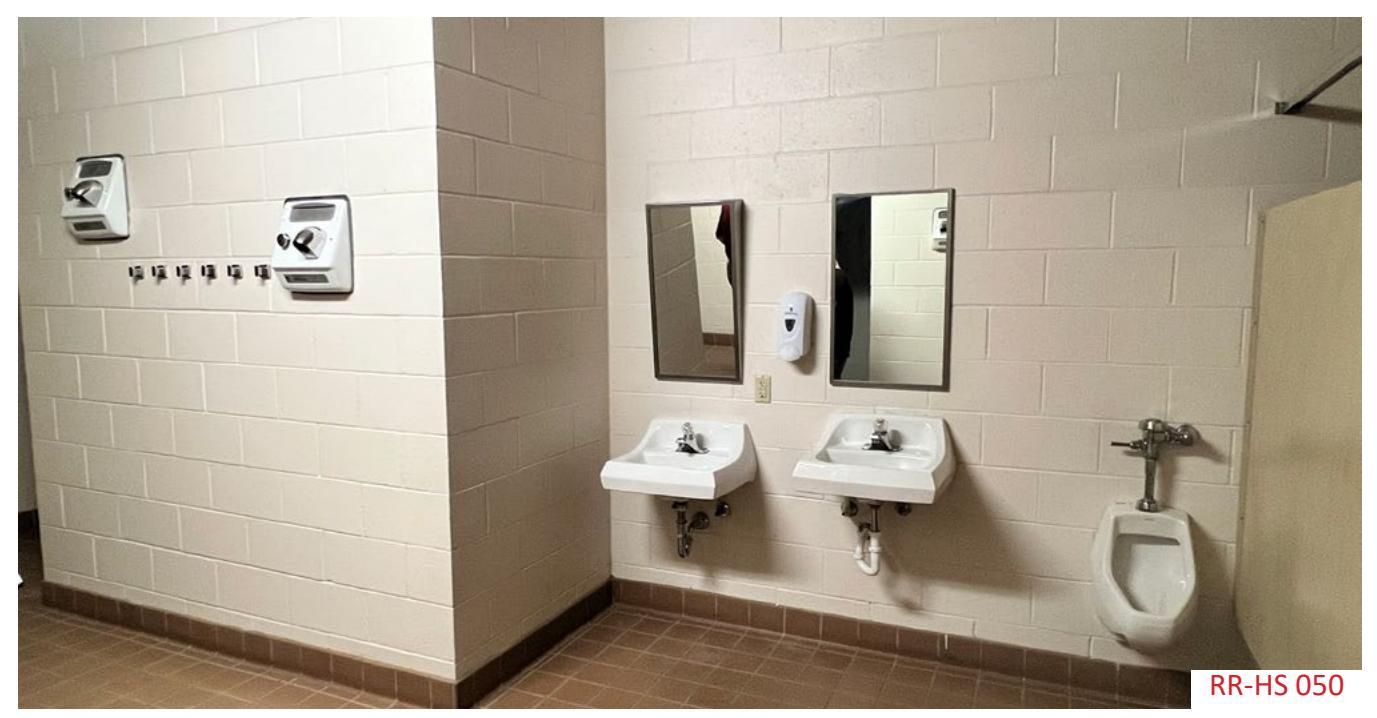
All three men's locker rooms are missing a lower urinal.

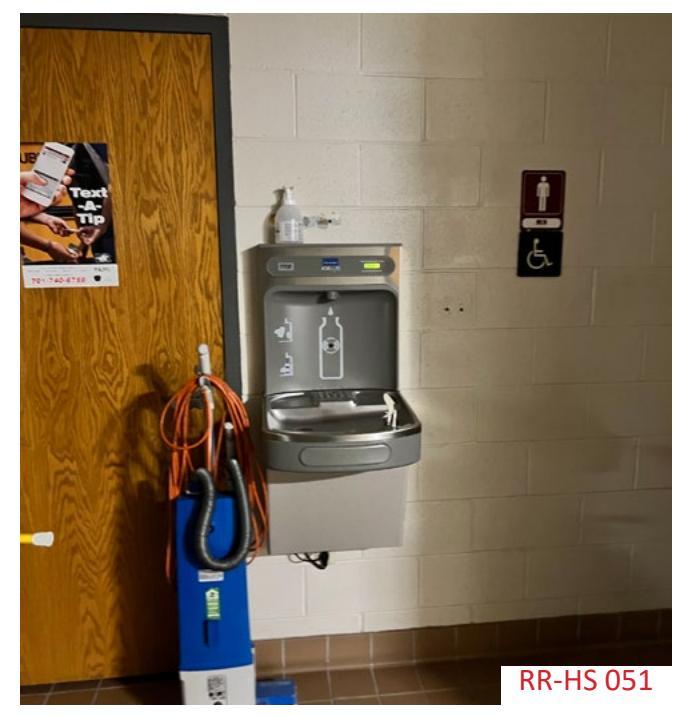
Drinking fountains throughout the building do not meet the required ratio of wheelchair accessible fountains to standing person accessible fountains

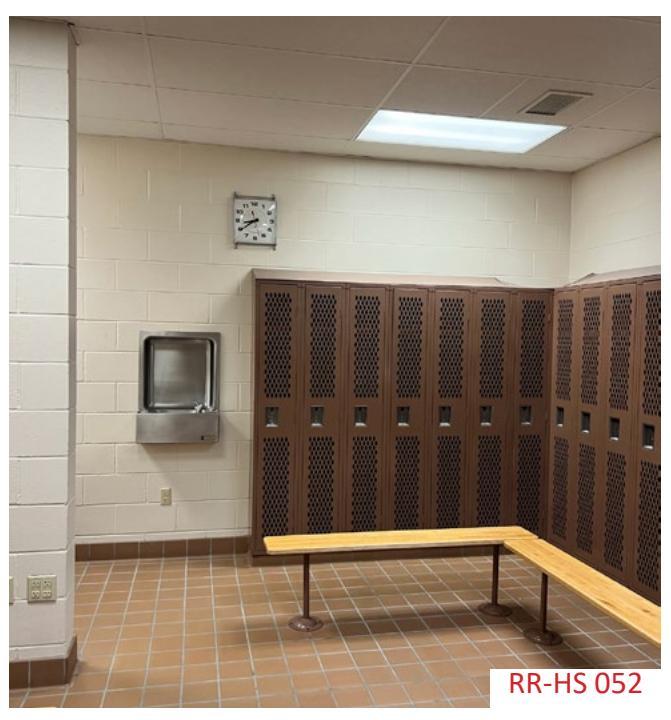
Drinking fountains throughout the building do not meet the required ratio of wheelchair accessible fountains to standing person accessible fountains

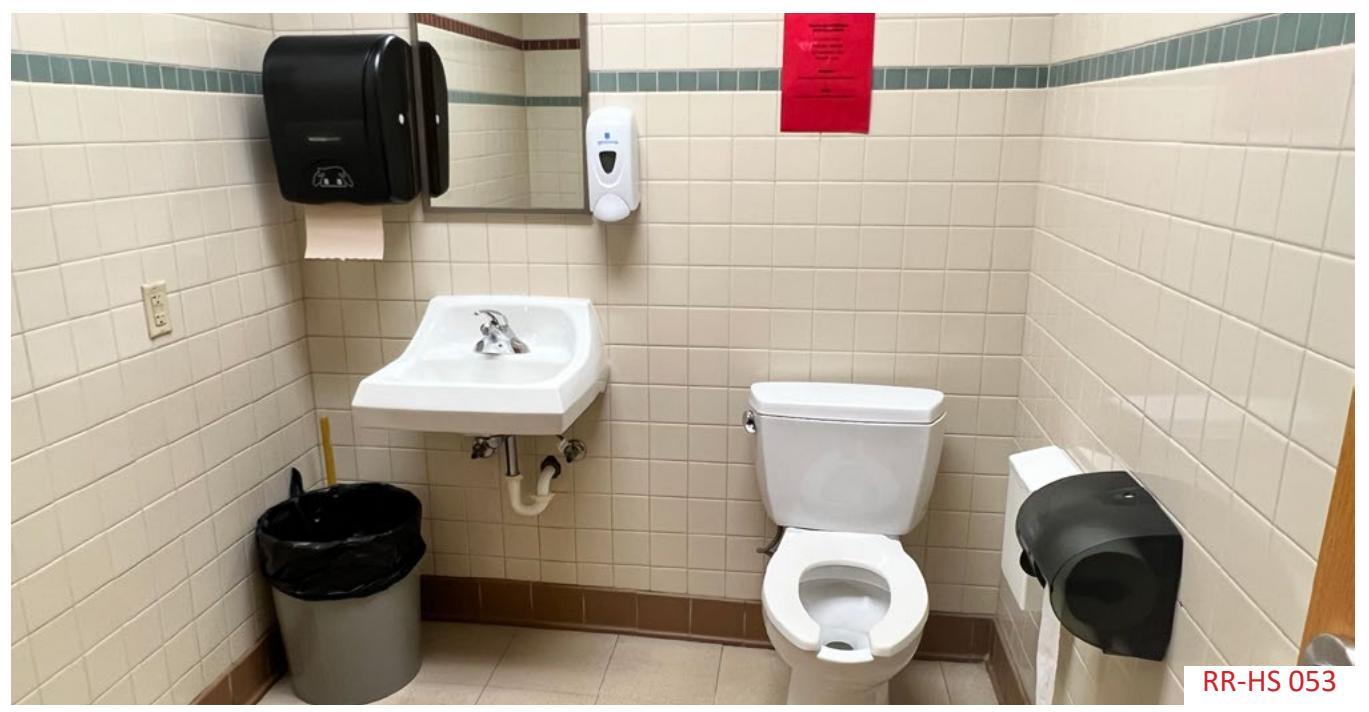
The restroom in the main office is not accessible.

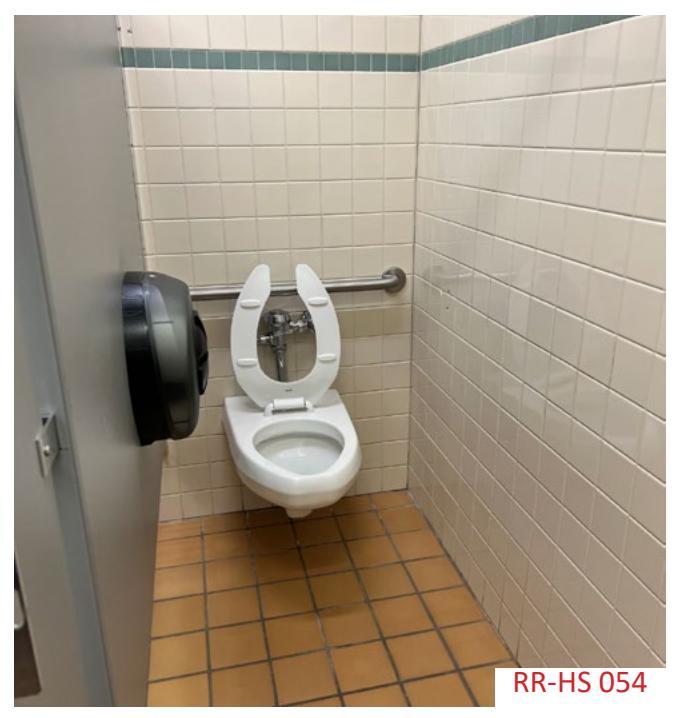
Many restrooms in the building are not accessible. Most restrooms where a larger stall is present do not meet clearance requirements for accessibility.

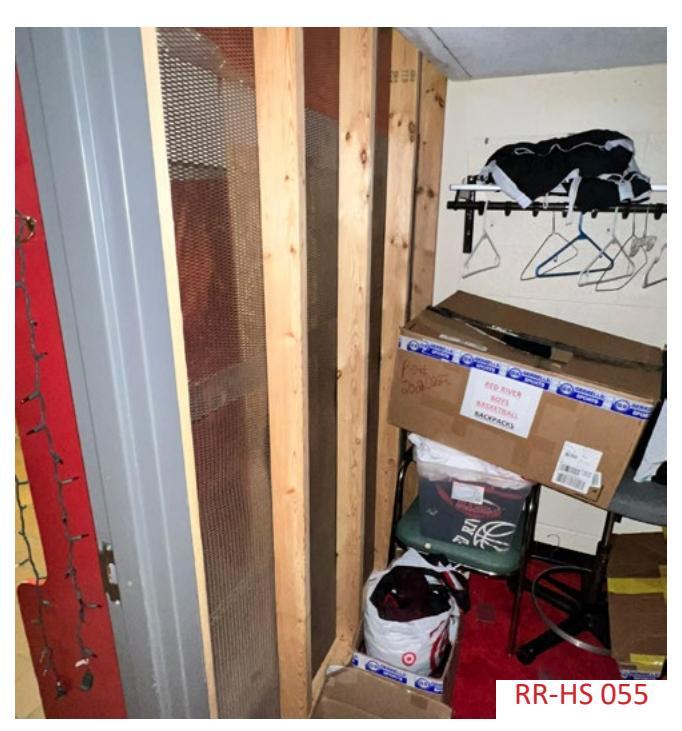
There is exposed wood structure in the storage area in the physical education office that is combustible and should be covered for fire safety.

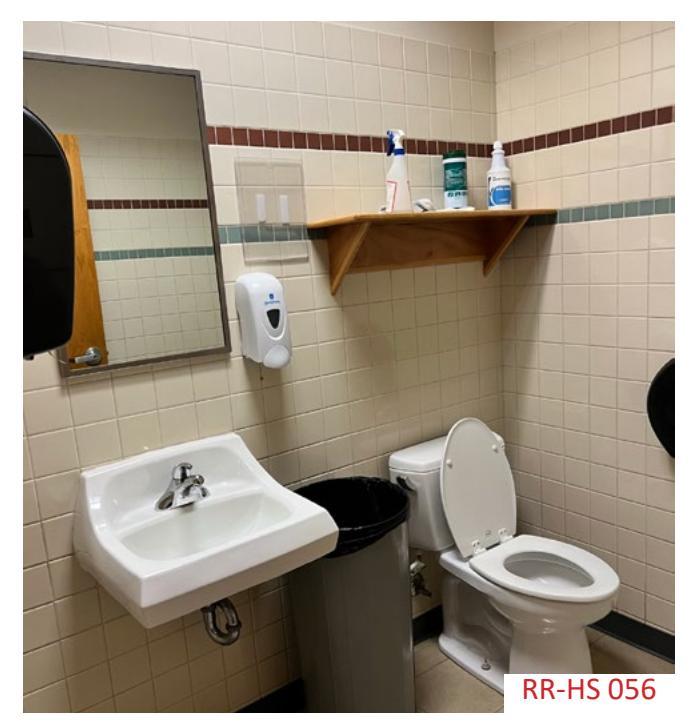
The staff lounge restroom is not accessible.

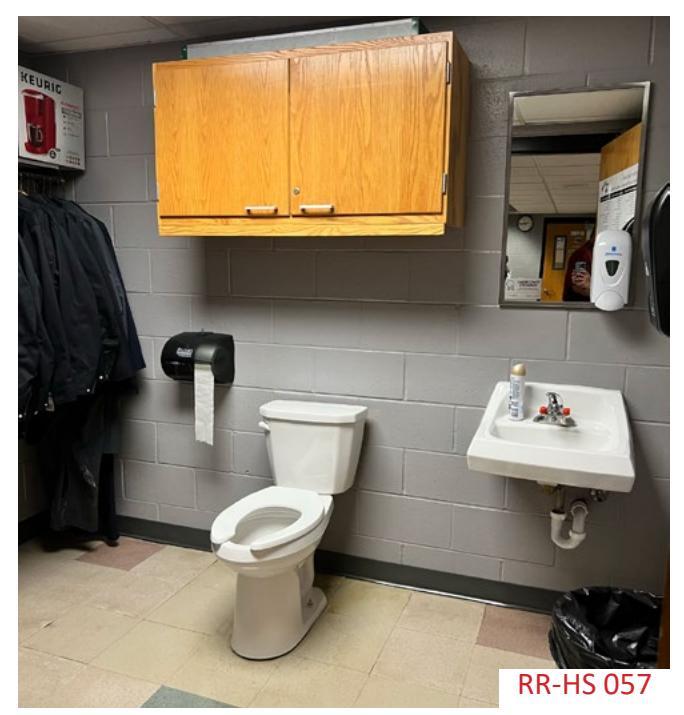
The restroom in the technological education office (Room 610) is not accessible.

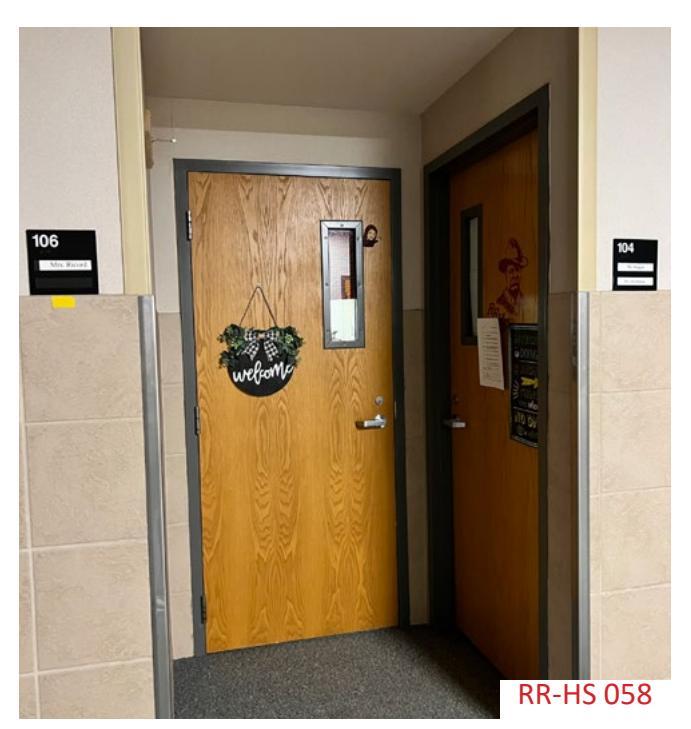
The doors into the I.D. classrooms (Rooms 102, 104 and 106) fail to meet required maneuvering clearances for accessibility.

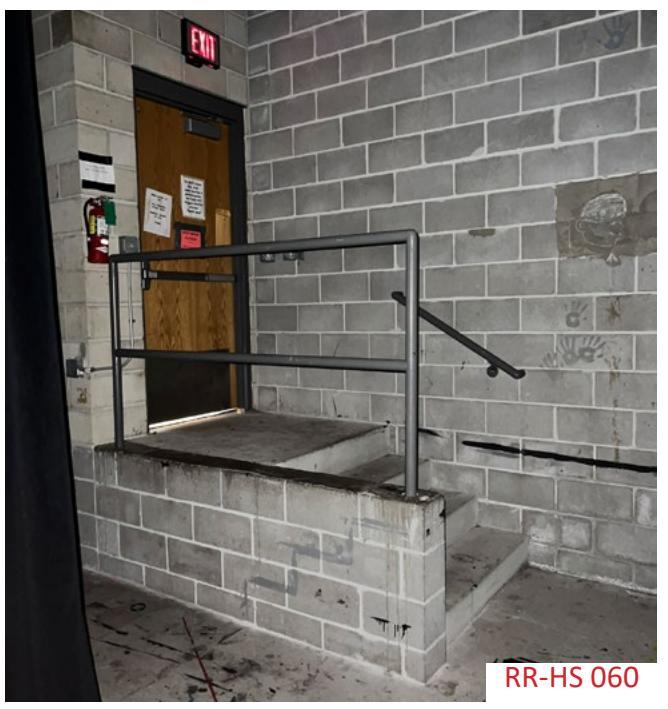
Handrails on the stairs from the original auditorium backstage to the commons do not provide the code required extensions at the top and bottom of the stairs.

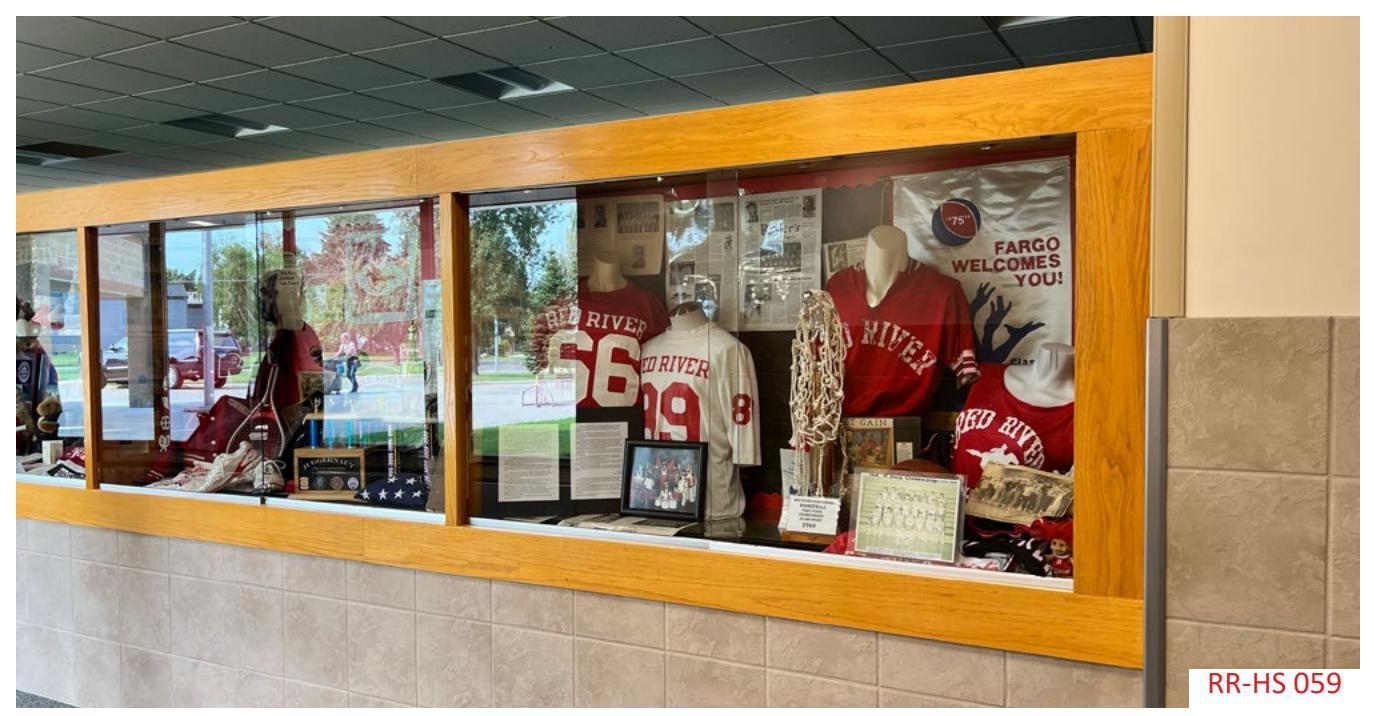
Display cases throughout do not have required safety glass.

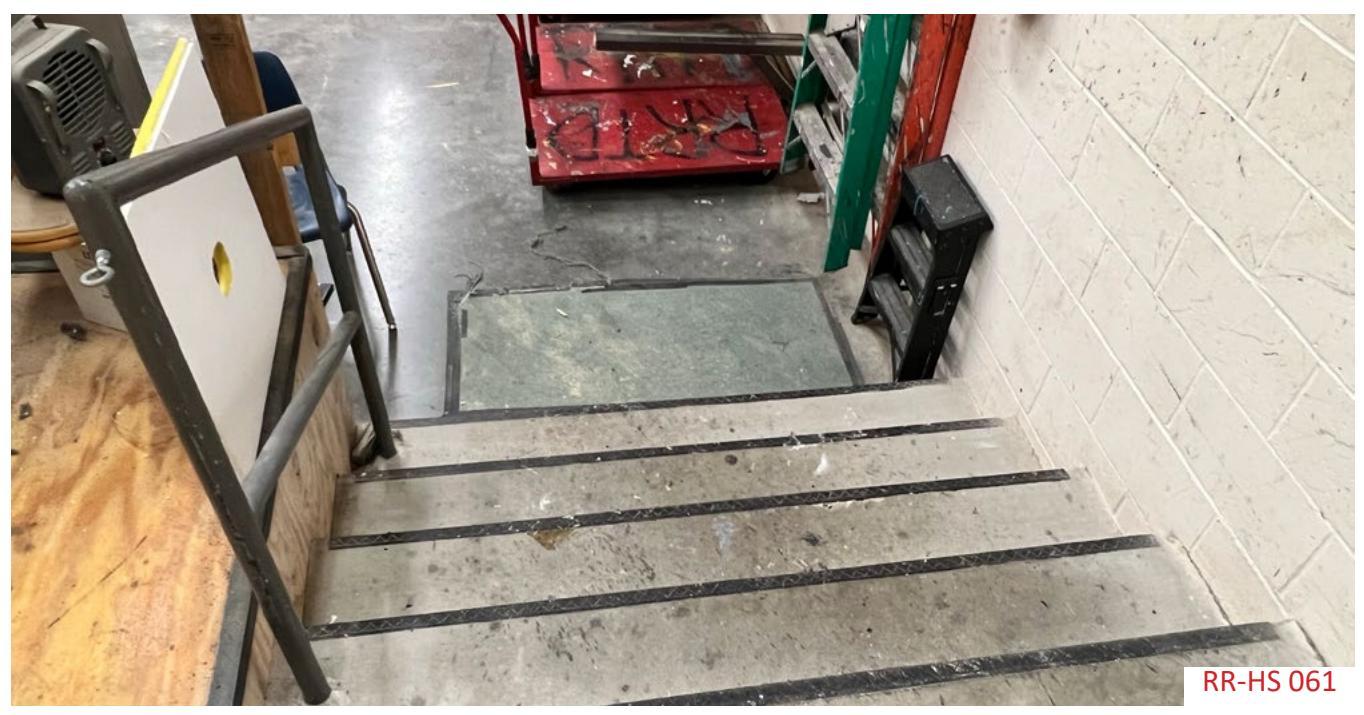
The stairs in the stage scene shop do not have handrails on both sides, as required by code.

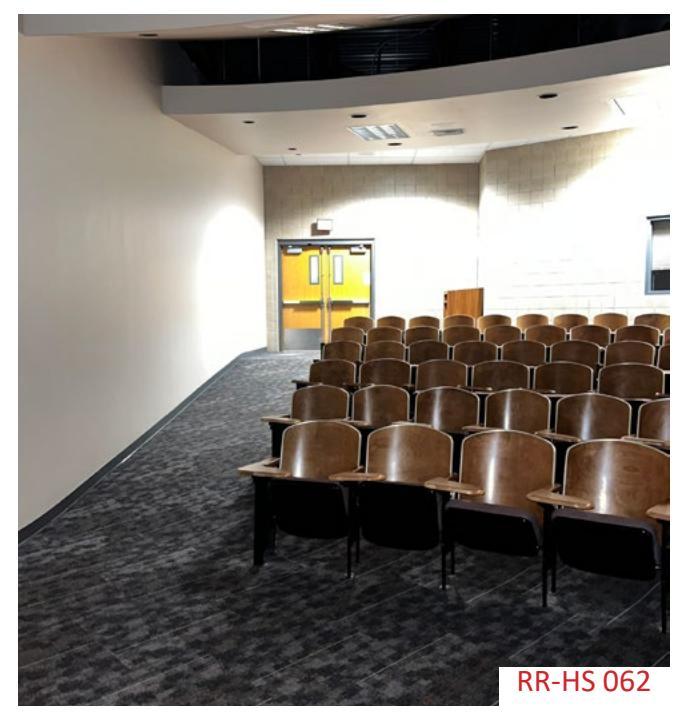
The Rider Room is missing handrails on the ramps.

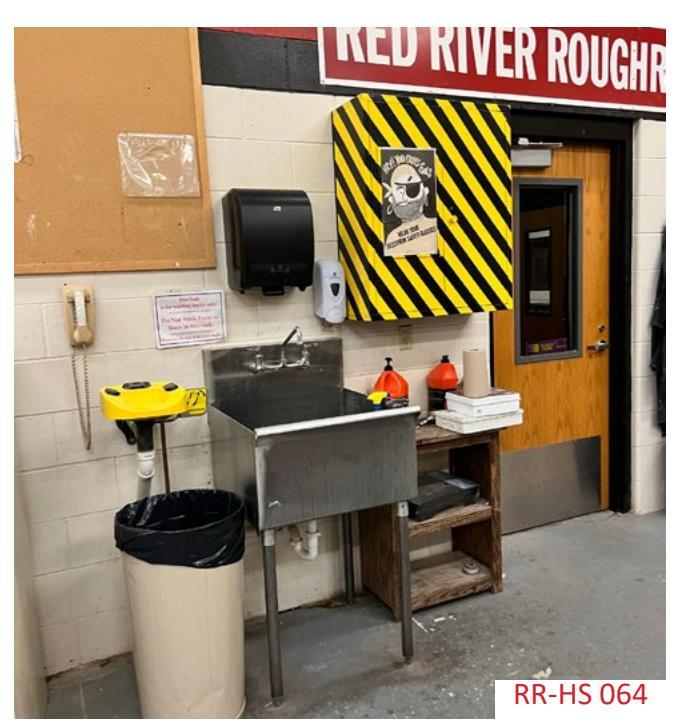
Eyewash stations in the automotive and manufacturing/ production classrooms (Rooms 608 and 612) are not accessible.

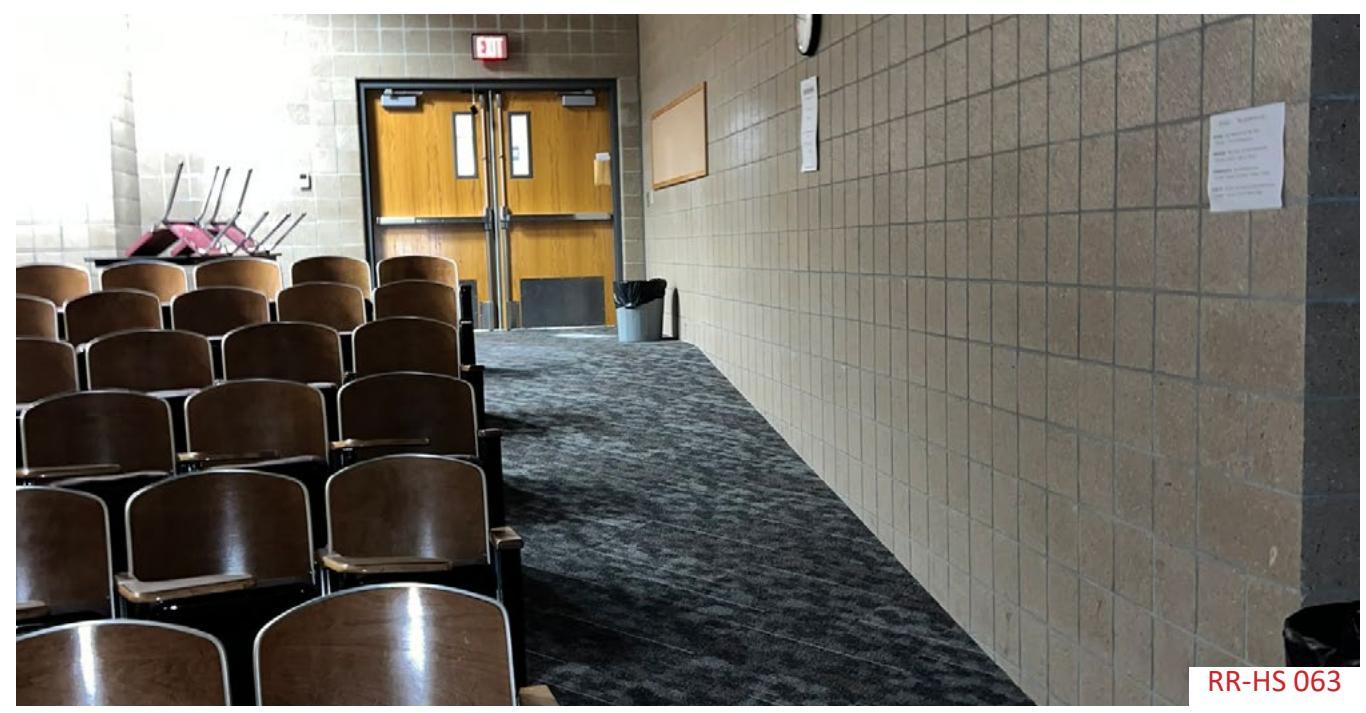
The Rider Room is missing handrails on the ramps.

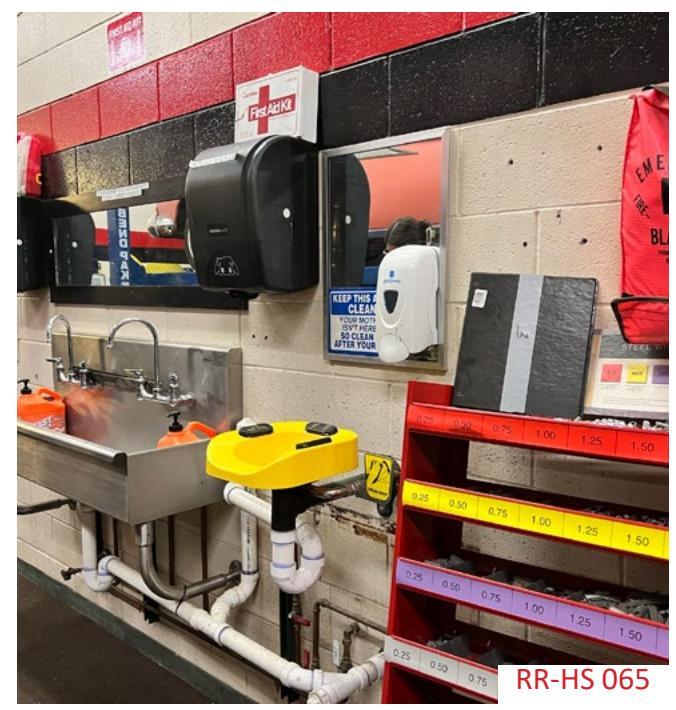
Eyewash stations in the automotive and manufacturing/ production classrooms are not accessible.

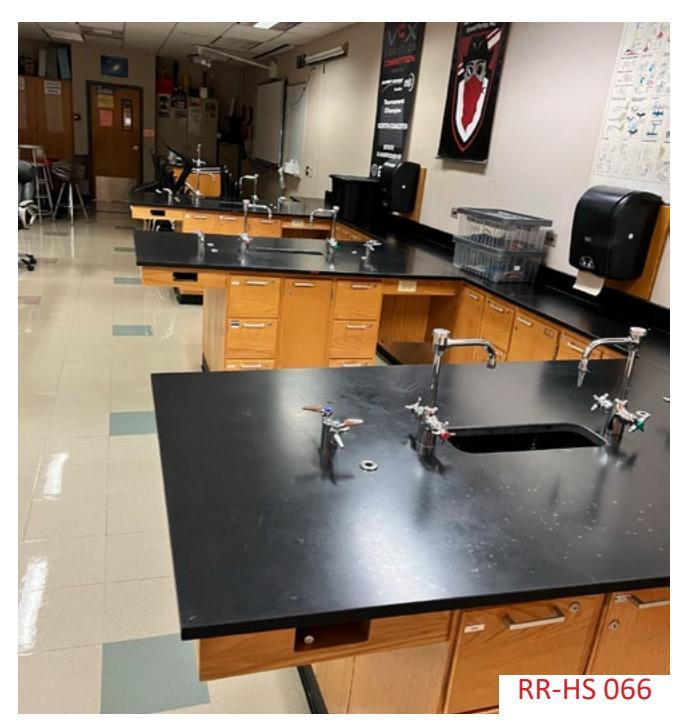
Science labs do not have accessible stations.

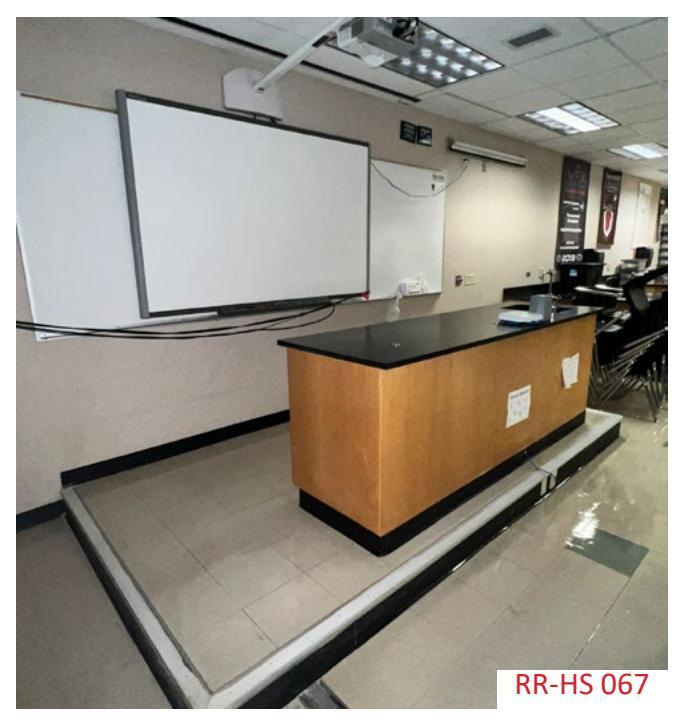
Platforms in the science classrooms are not accessible.

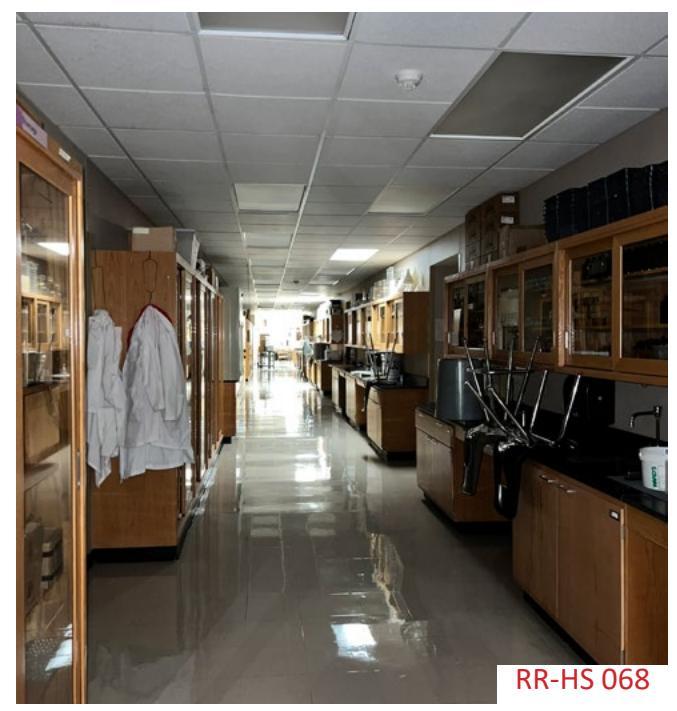
Glass within the science storage area is not safety glass, as required by code.
