VIKING ELEMENTARY SCHOOL

A. EXISTING BUILDING INVENTORY

B. ARCHITECTURAL FINISHES

D. EXISTING DEFICIENCIES

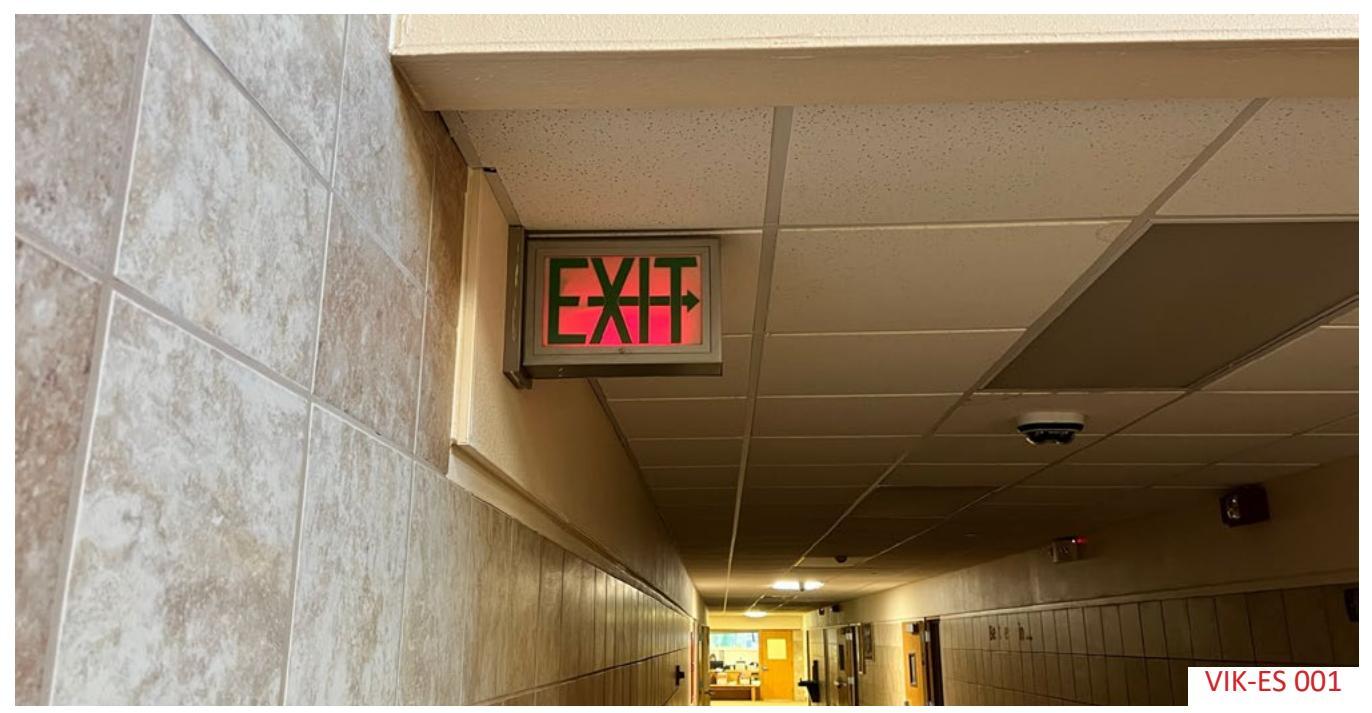
Exit signs are dim and should be replaced.

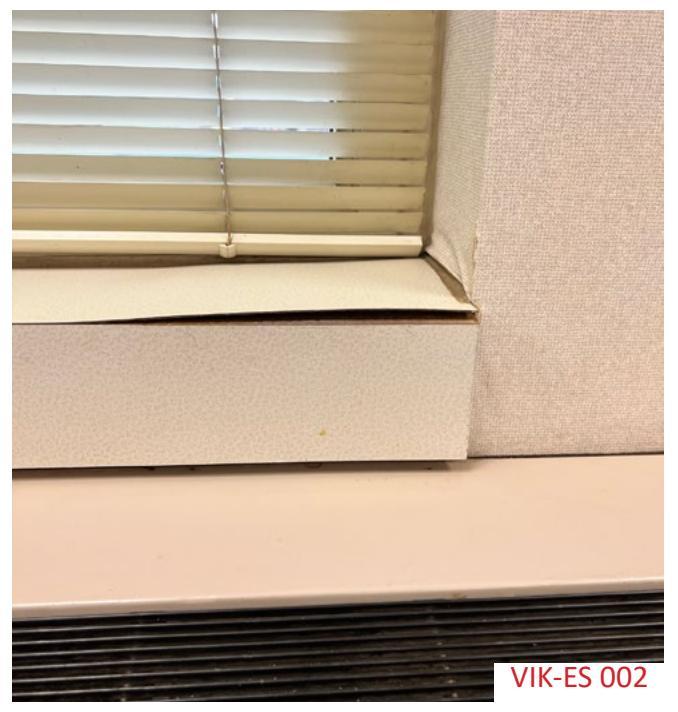
Some laminate under windows in the cafeteria is lifting.

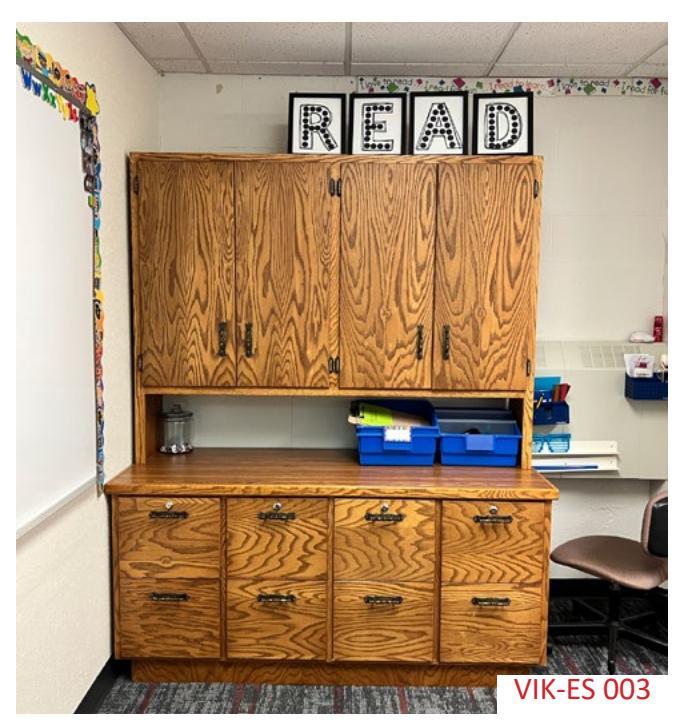
Casework in classrooms is dated, but functional.

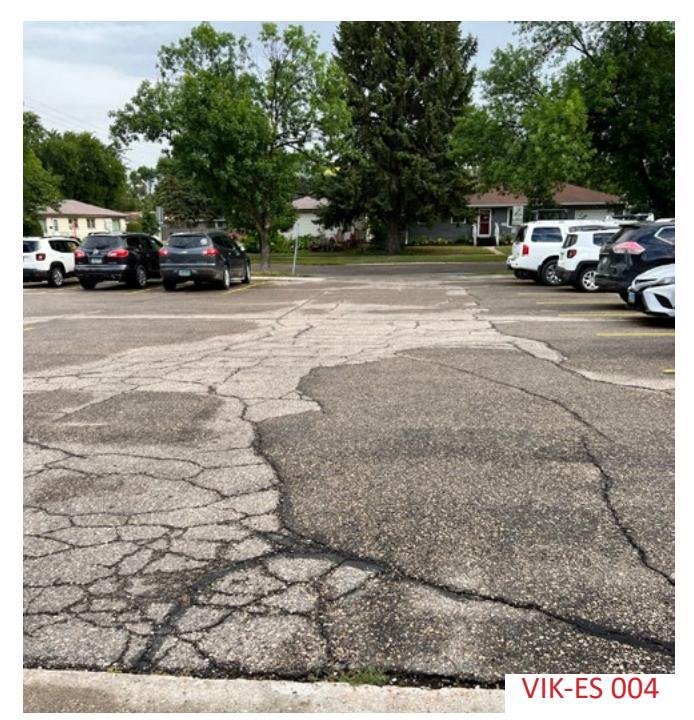
The asphalt on the site has some cracking (004). Several entrances to the school have uneven concrete which creates issues for accessibility. The school's parking lot is not large enough and could use more stalls. Two portable classrooms are located on the south side of the building (005).

The asphalt on the site has some cracking.

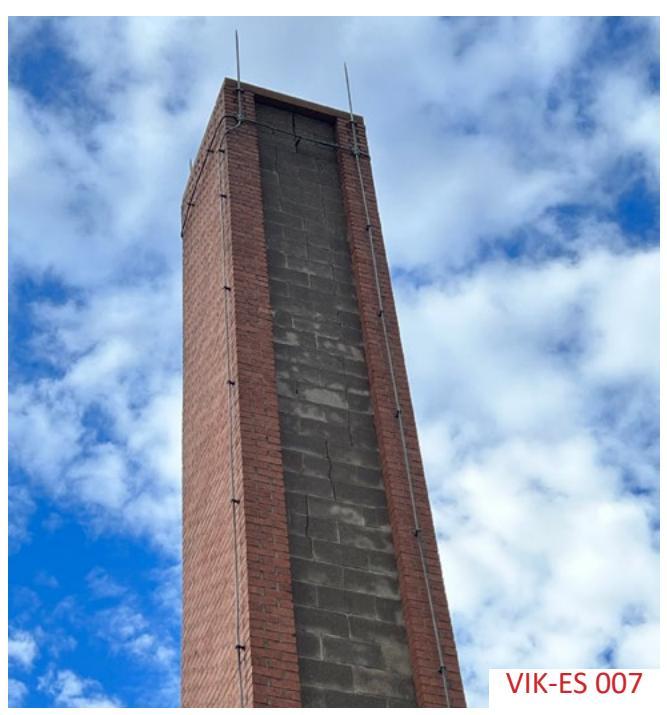
The exterior brick is in overall good condition. The brick mortar and caulking are in good condition. There is some cracking on exterior CMU brick (006), including up the chimney (007).

There is some cracking on exterior CMU brick, including up the chimney.

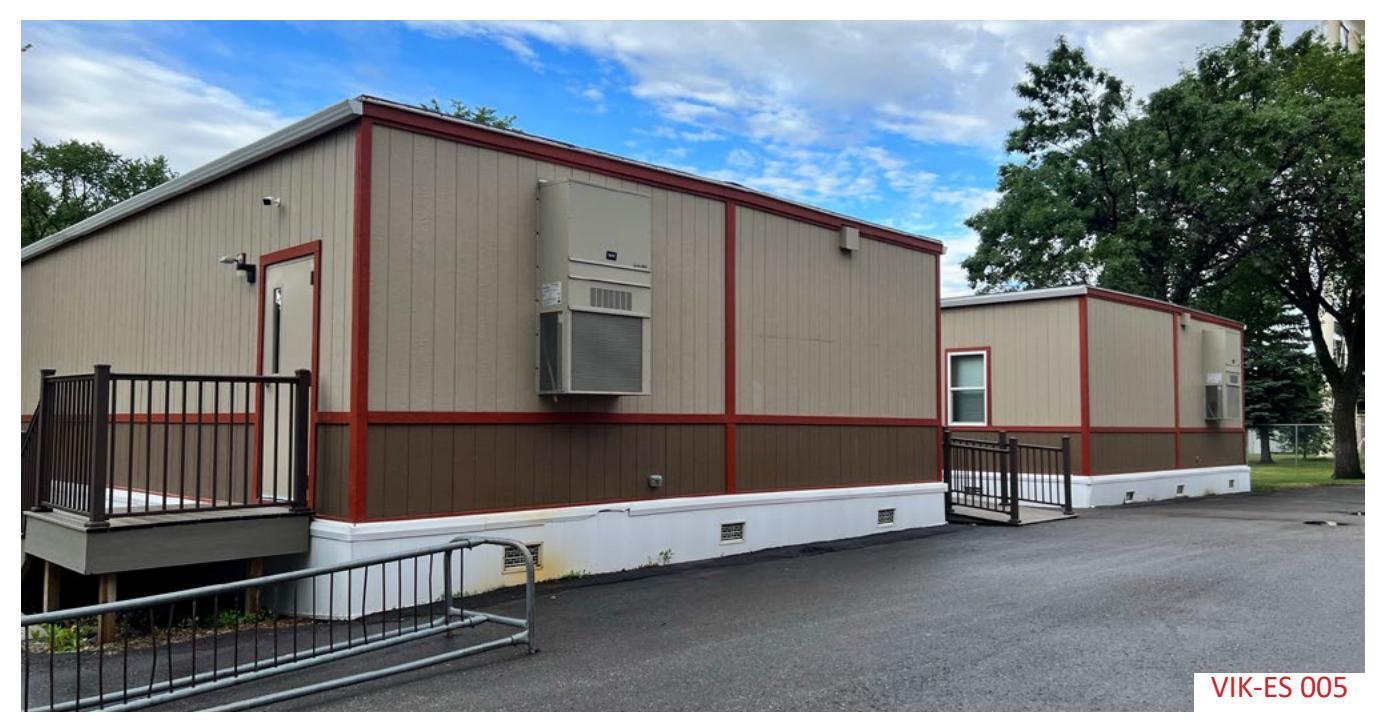
Two portable classrooms are located on the south side of the building.

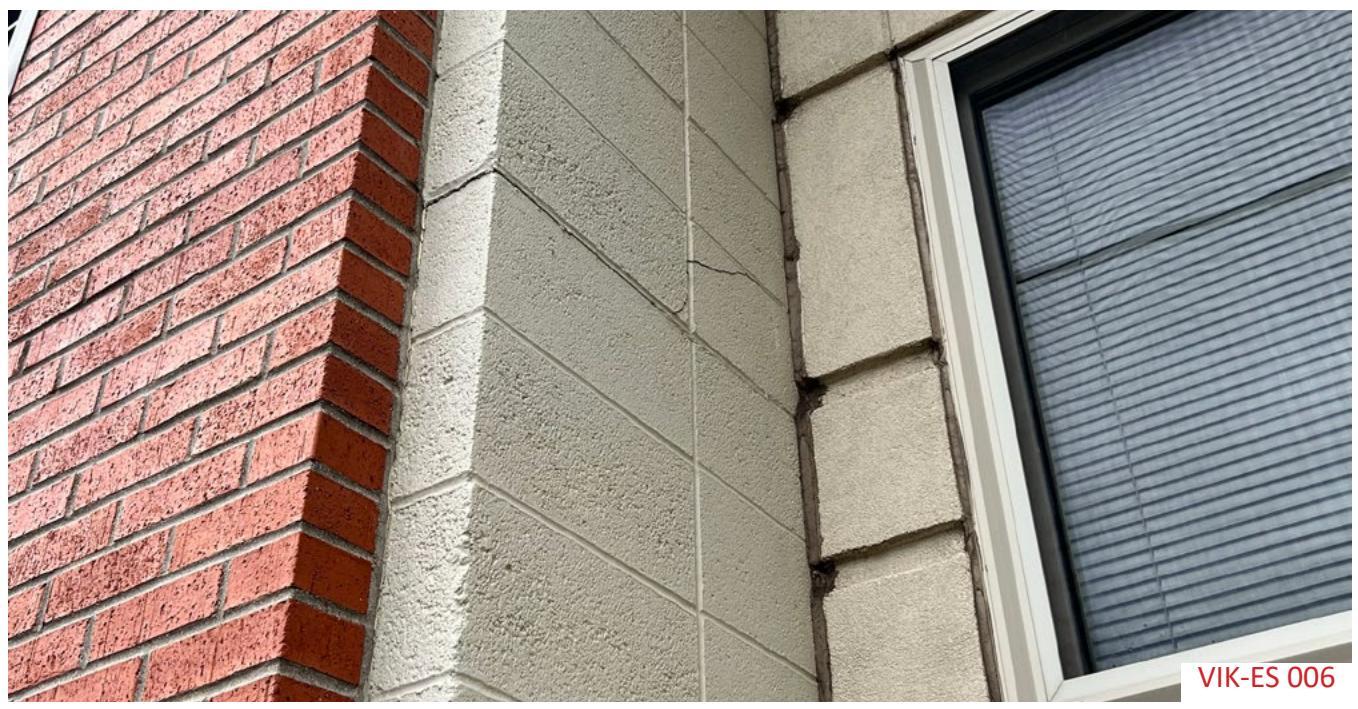
There is some cracking on exterior CMU brick.

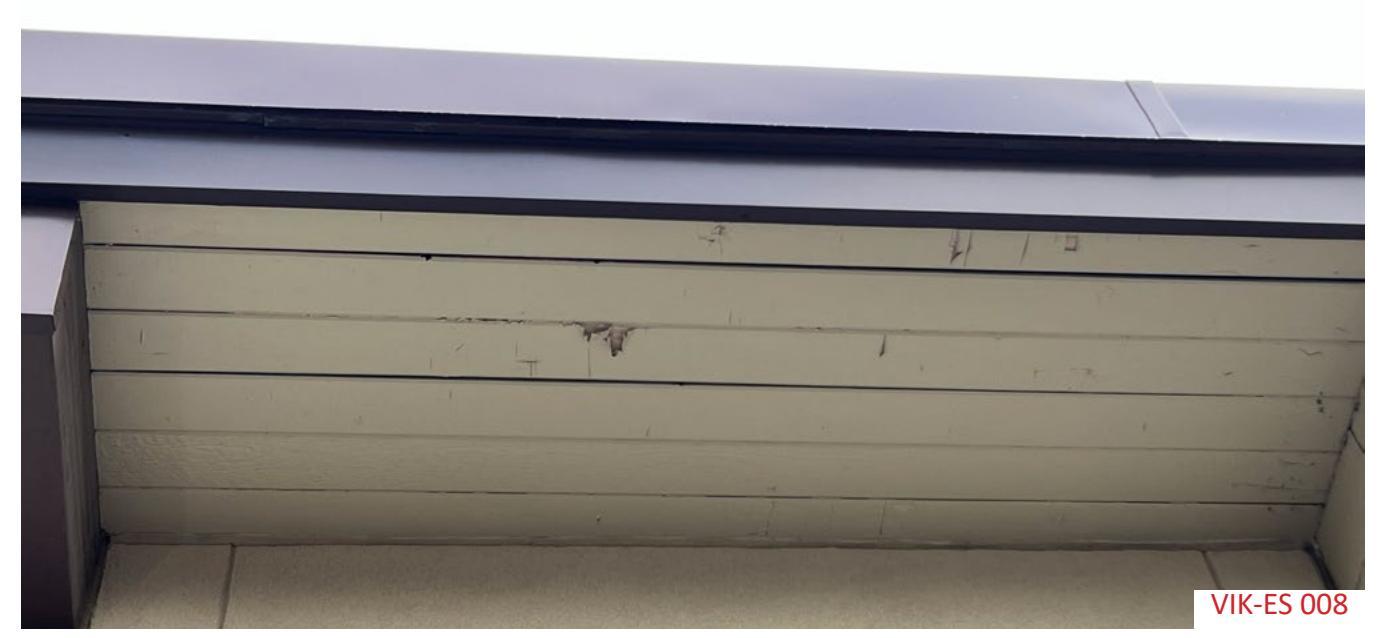
Plaster is cracking in some areas. Paint is peeling off the wood on the underside of overhangs around the building (008). Exterior overhangs consist of combustible material and may require sprinklers.

In areas of overhangs around the building, paint is peeling underneath the wood.

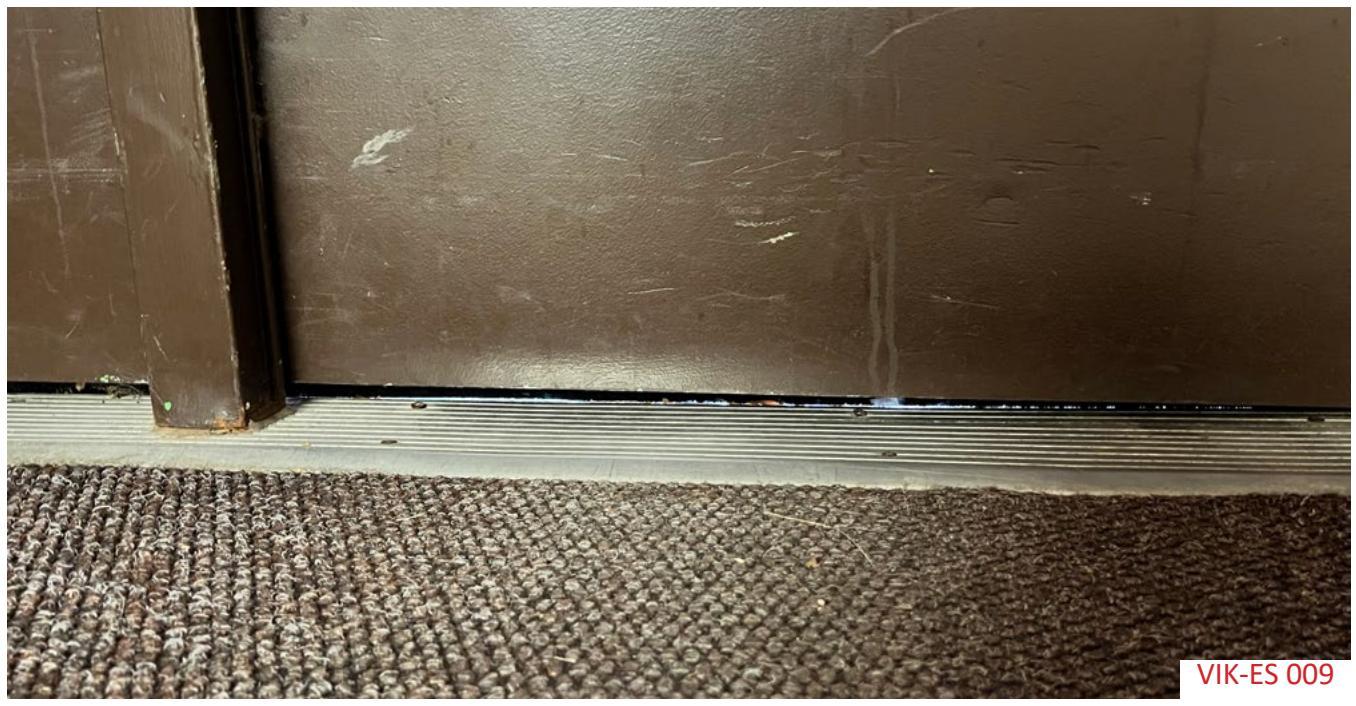
Weather stripping could be replaced.

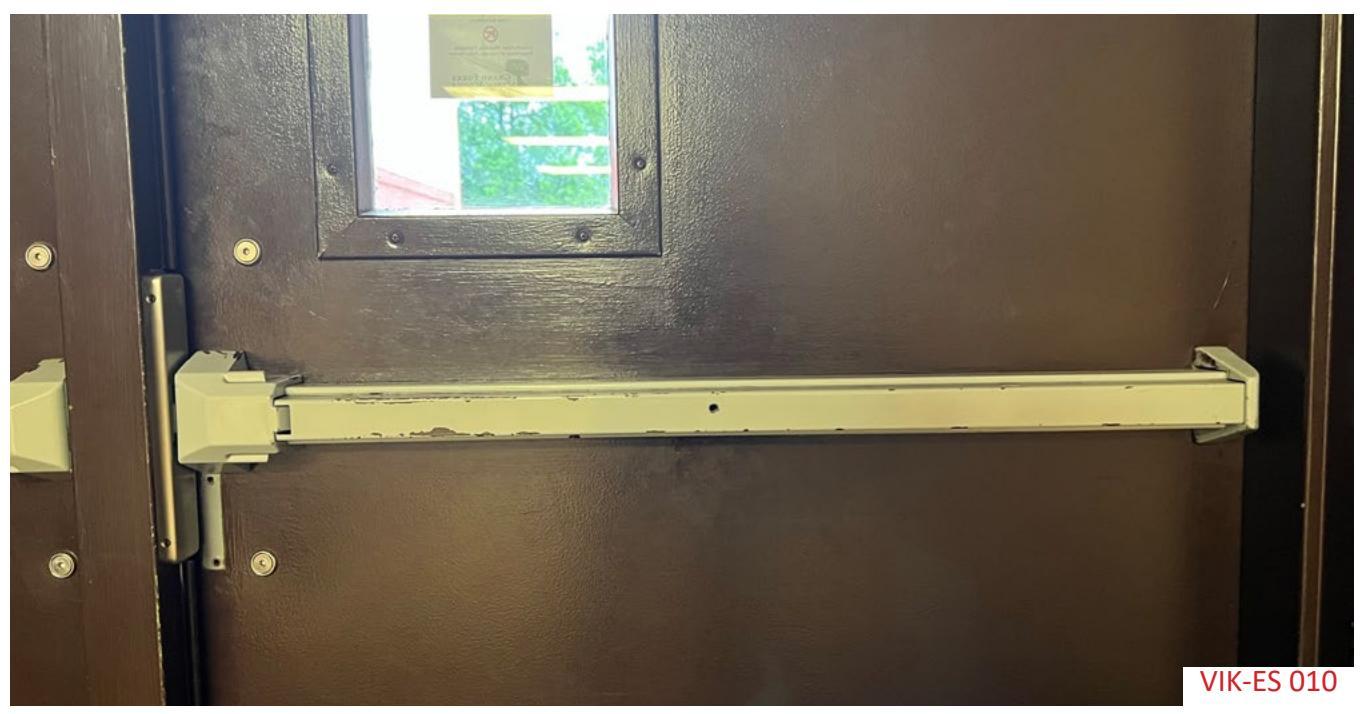
Weather stripping could be replaced and potentially door hardware.

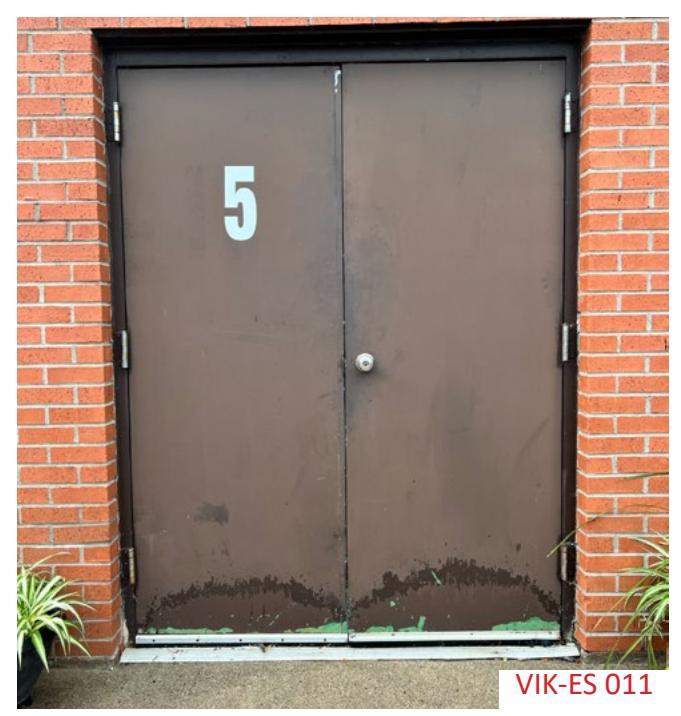
Paint on exterior doors is deteriorating and in poor condition.

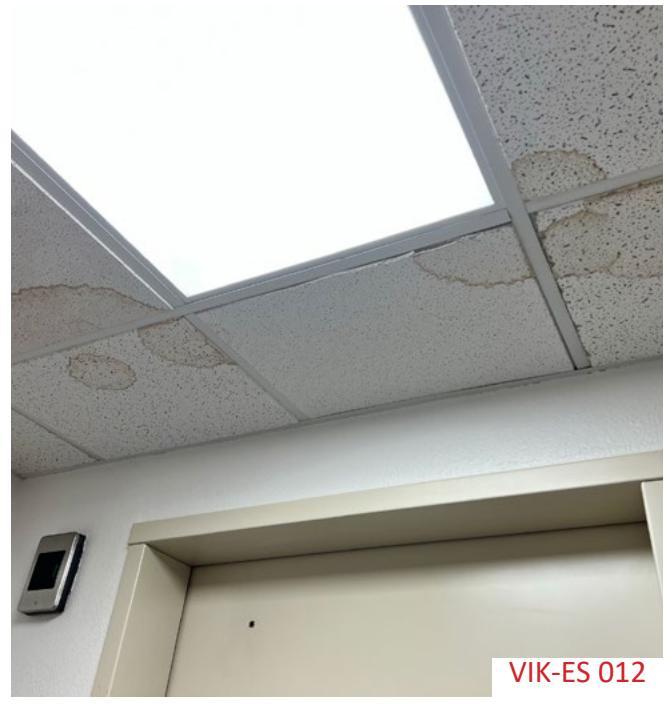
The ceilings within the school are mostly comprised of acoustical ceiling tiles (ACT). The ACT is generally in good condition, but there are some areas with water damage (012).

The ACT is generally in good condition, but there are some areas with water damage.

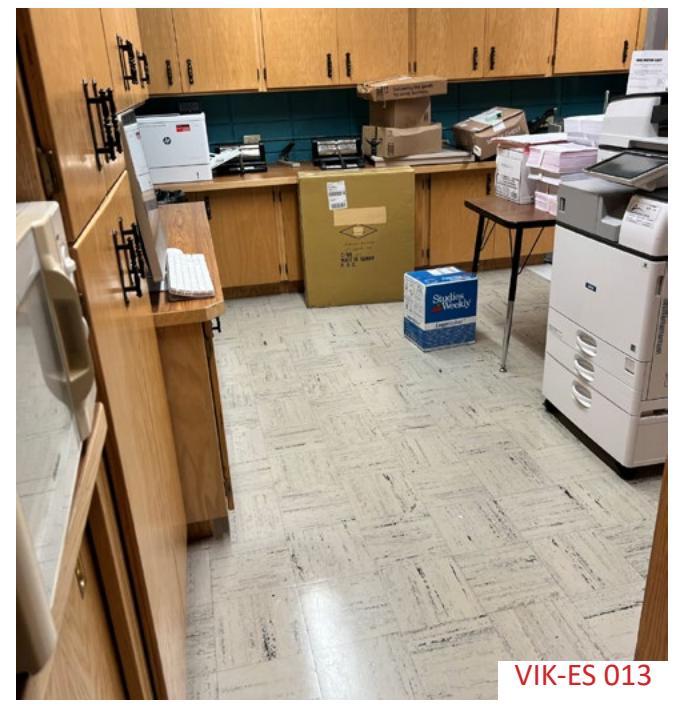
The floors in the school are either carpeting or various types of tiling. The carpet is 9-10 years old, but in overall good condition. Some portions of the original tile are dated, but still in good condition. There is potential asbestos in portions of older tile (013).

There is potential asbestos in portions of older tile.

Replace old VCT, assumed to be contaminated with asbestos, replace with new flooring	39	2,500 SF	\$24.78 /			\$61,950				\$61,95
Interior Upgrades Subtotal		36,729 SF	\$5.91 /	SF						\$217,19
Exterior Upgrades										
Regrade and landscape to prevent ground water from coming into the basement	40	1 Ea.	\$46,391.85 /	Ea. \$	46,392					\$46,39
Mill and overlay north parking lot asphalt	41	13,684 Ea.	\$5.08 <i> </i>	Ea.		\$69,515				\$69,51
Remove and replace uneven sidewalks	42	500 SF	\$17.56 /	SF	\$8,779					\$8,77
Add 42 additional parking stalls to the parking lot since it is not large enough	43	10,500 SF	\$14.84 <i> </i>	SF				\$155,820		\$155,82
Repair cracking on exterior brick and CMU including the chimney	44	36,729 SF	\$3.65 /	SF \$1	34,061					\$134,06
Paint the overhangs around the building	45	1 Ea.	\$13,645.36 /	Ea.		\$13,645				\$13,64
Exterior Upgrades Subtotal		36,729 SF	\$11.66 /	SF						\$428,21

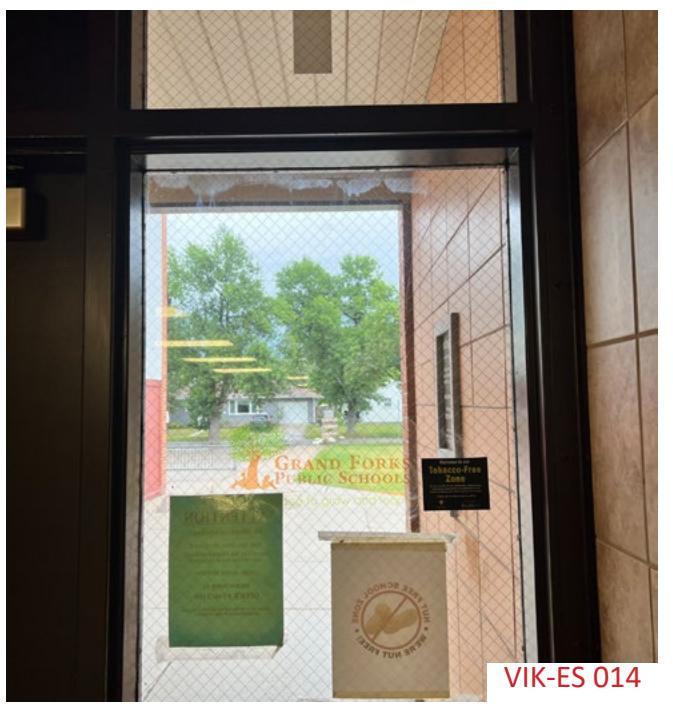
Traditional wire glass throughout the building is no longer to code as an acceptable type of safety glass.

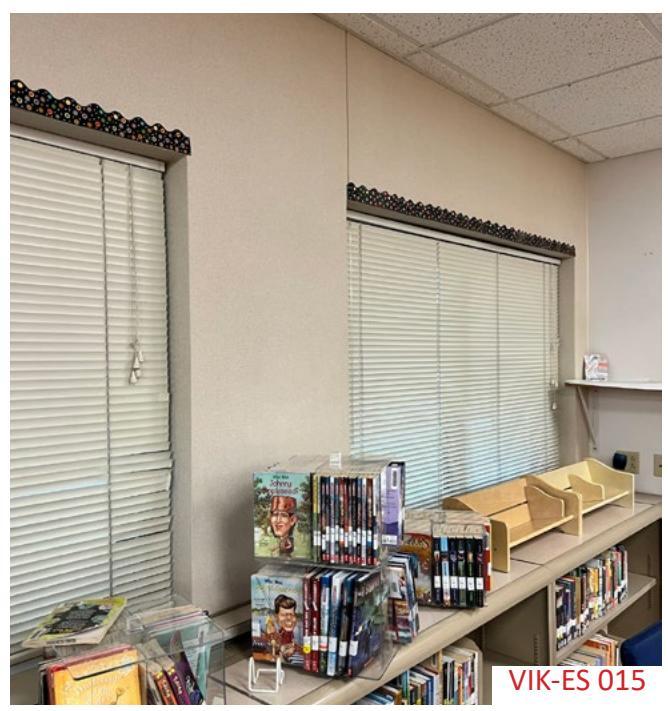
The interior walls are either painted masonry, painted gypsum board, have vinyl wall coverings, or have tiling. Large portions of exterior walls are covered with vinyl covering on the interior side. It is recommended the vinyl wall covering be removed from the interior surface of exterior walls, as this could potentially create a double vapor barrier and trap moisture within the walls. Current code does not permit the use of vinyl wall covering on outside walls for this reason.

Portions of exterior walls are covered with vinyl wall covering on the interior side, which is not to code.

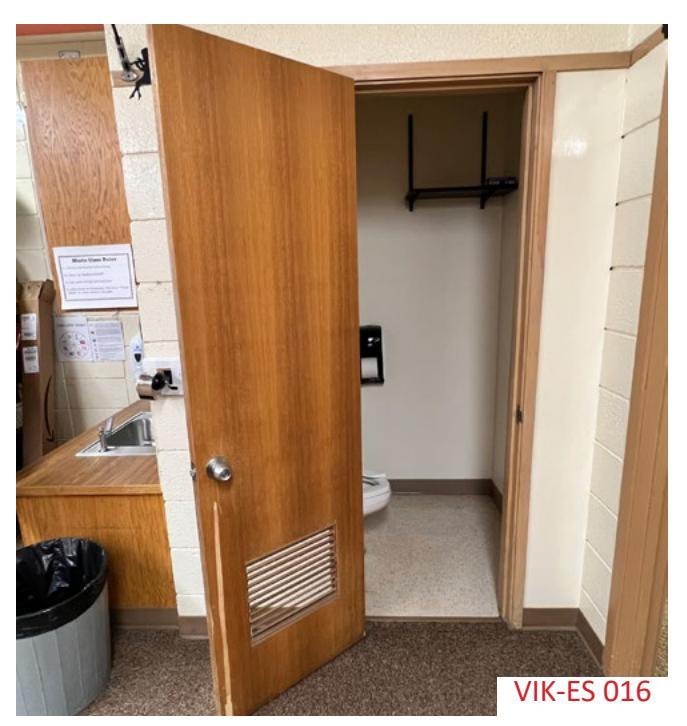
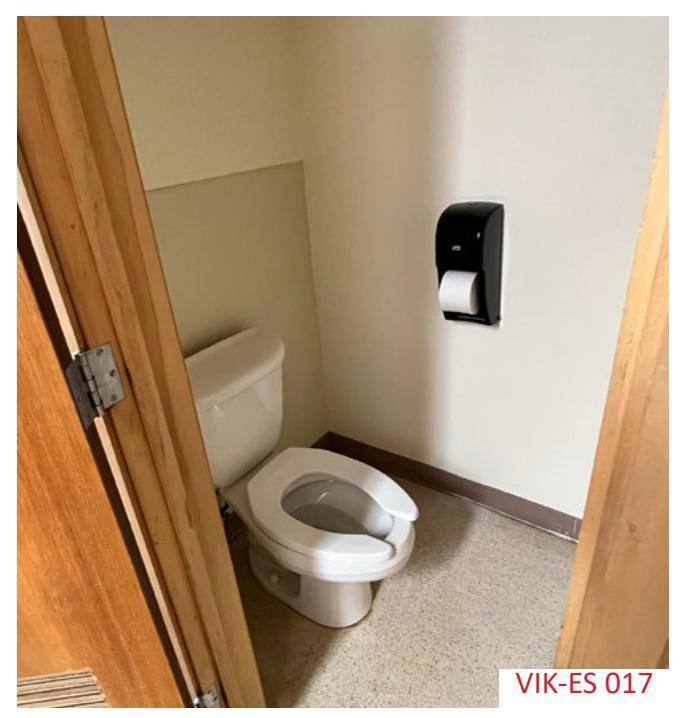
Multiple classrooms have restrooms that are not accessible.

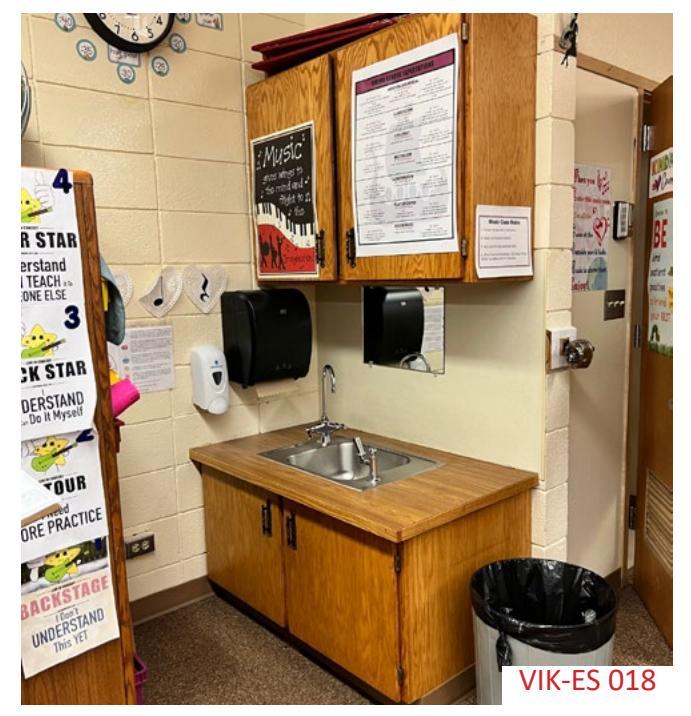
Sinks in classrooms are not accessible.

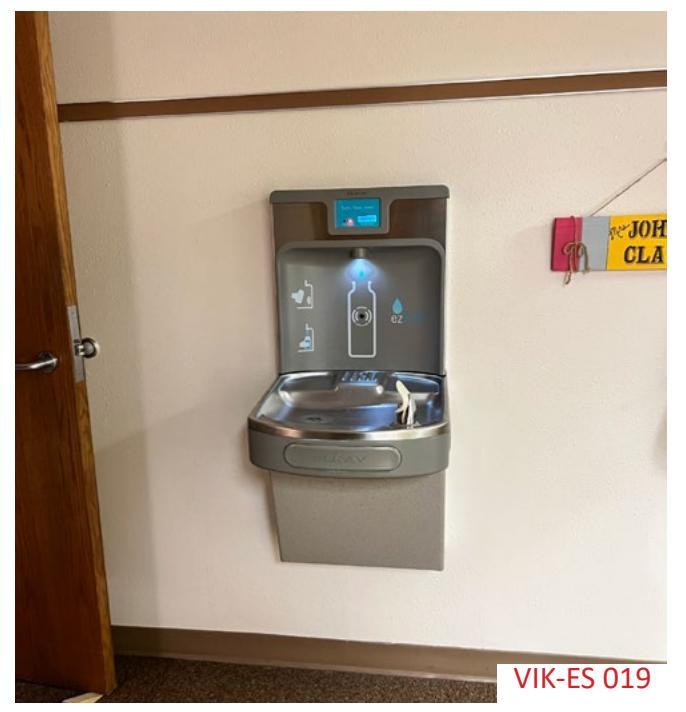
Drinking fountains throughout the building do not meet the required ratio of wheelchair accessible fountains to standing person accessible fountains.

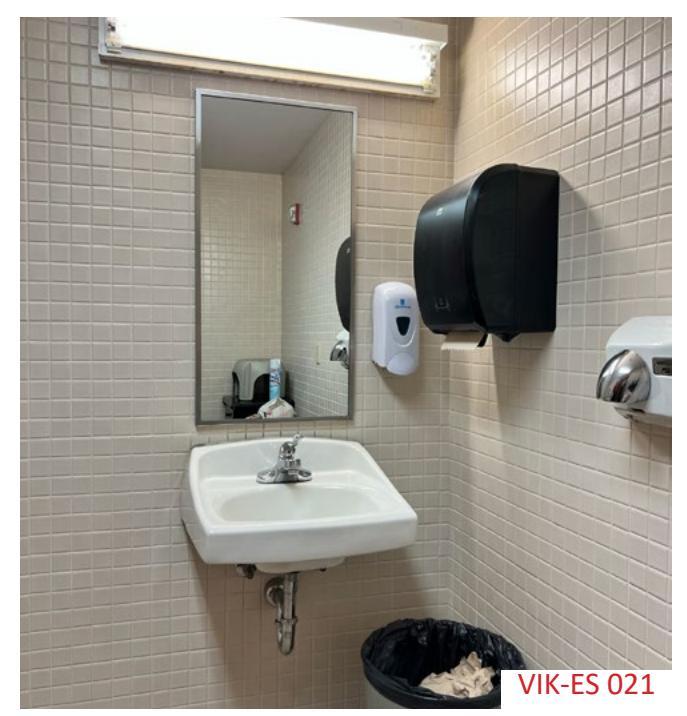
Pipes in restrooms are exposed and should be protected.

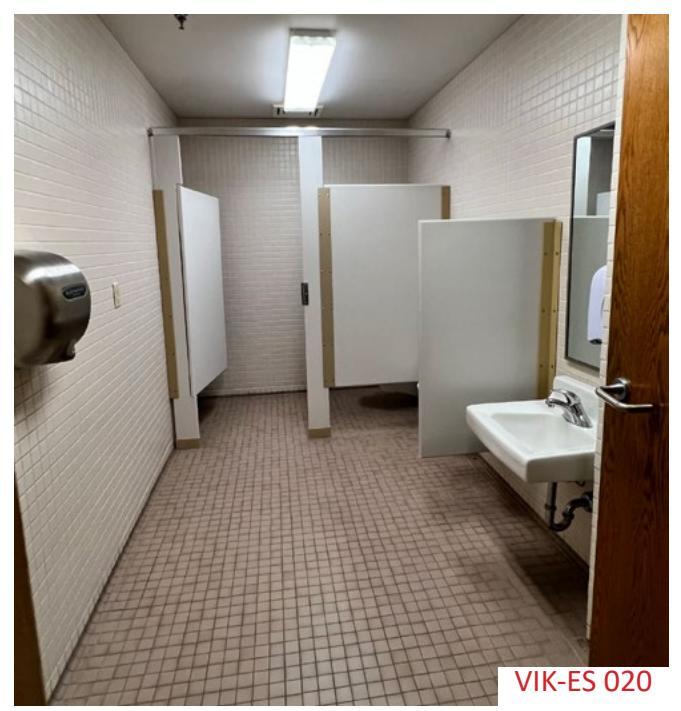
All boys' and girls' restrooms are not accessible.

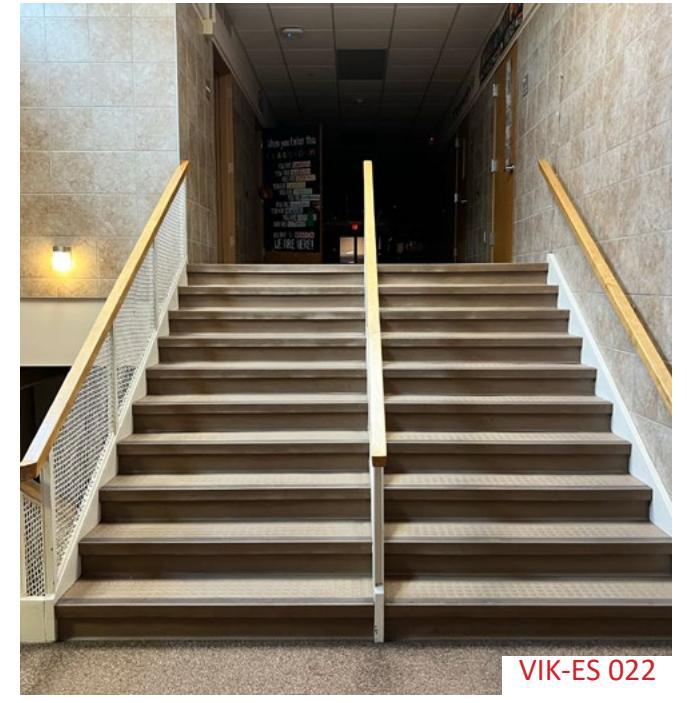
Guard rails for all stairwells do not meet height requirements.

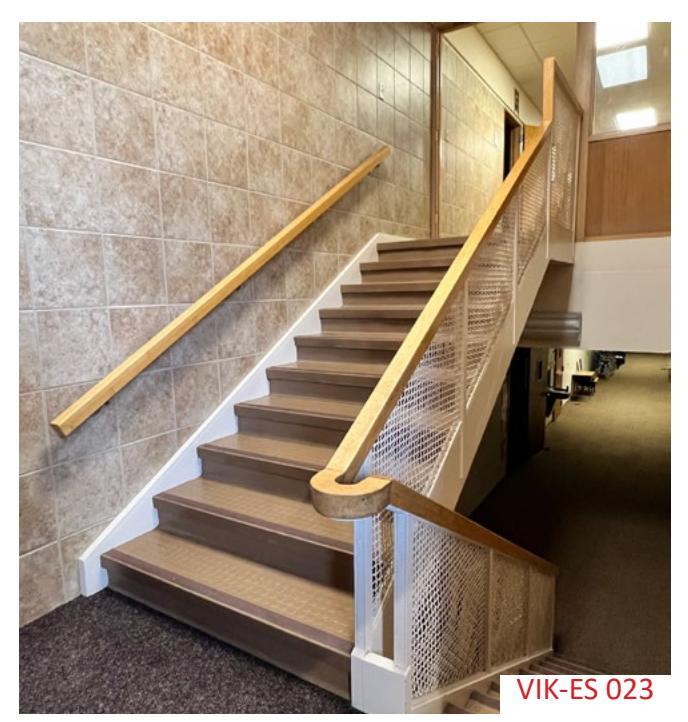
Handrail cross sections exceed size limitations per code.

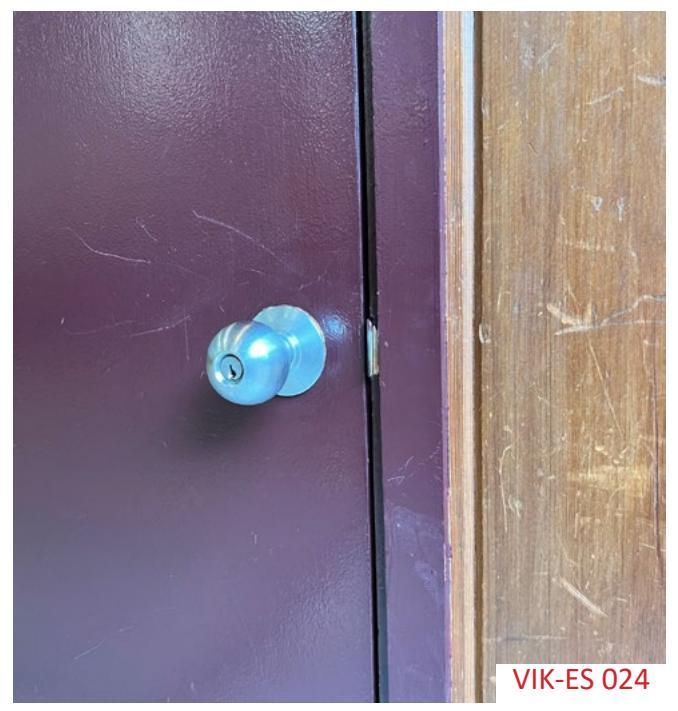
Doors in STAR rooms and storage rooms in the gym do not have accessible door hardware.

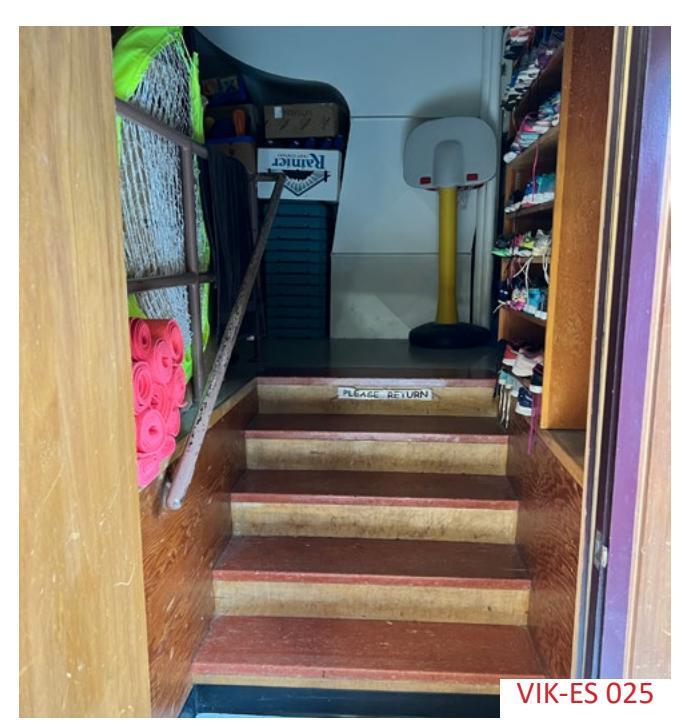
Stairwells leading up to the stage do not have handrails on both sides.

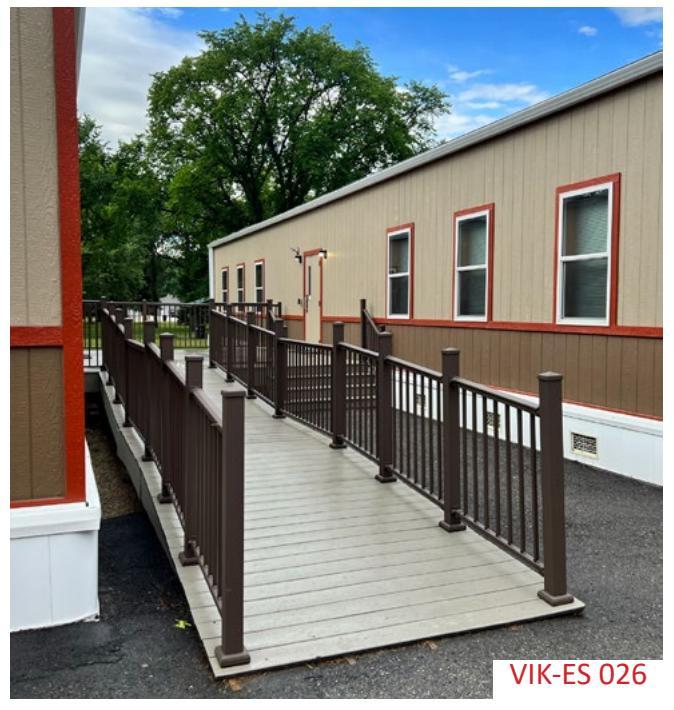
Handrails are not present in stairwells on ramps leading to portable classrooms.

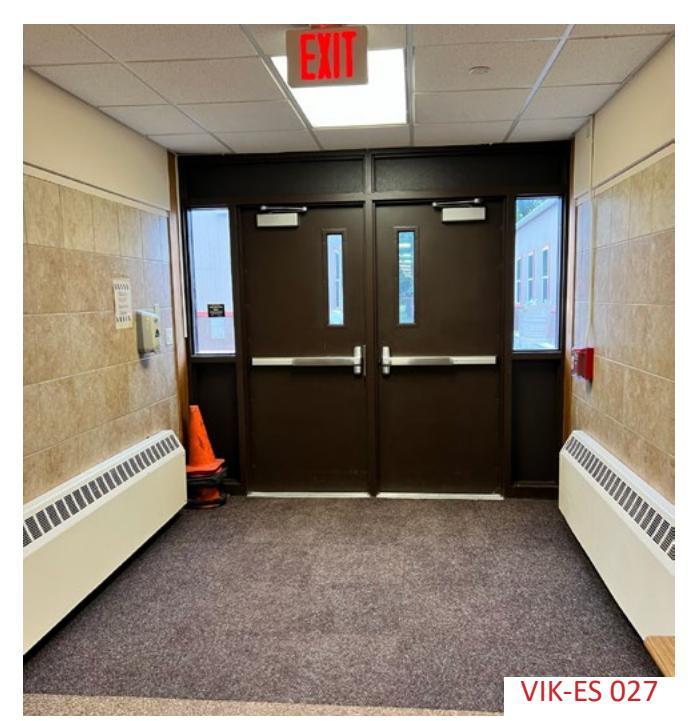
All public entrances should be protected with an enclosed vestibule, as required by energy code.
