# **A. EXISTING BUILDING INVENTORY**

Winship Elementary School is located at 1412 5th Avenue N in Grand Forks. The original building was built in 1973 and there was a remodel in 2001 to rework the hallways in the building to allow for more emergency exits.

Winship Elementary School Grand Forks, ND 11/2/2022

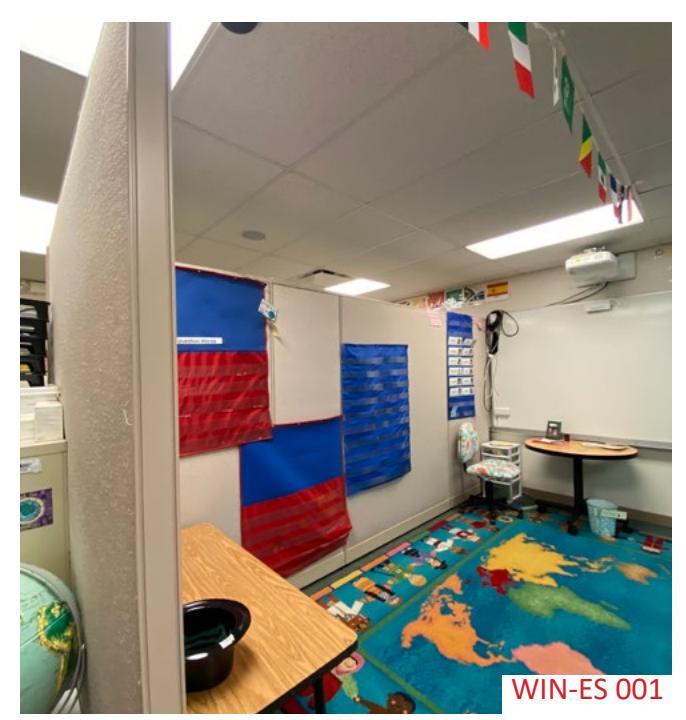
Many of the classrooms are split by shelves and partial walls to simulate smaller areas for individualized learning which is not ideal.

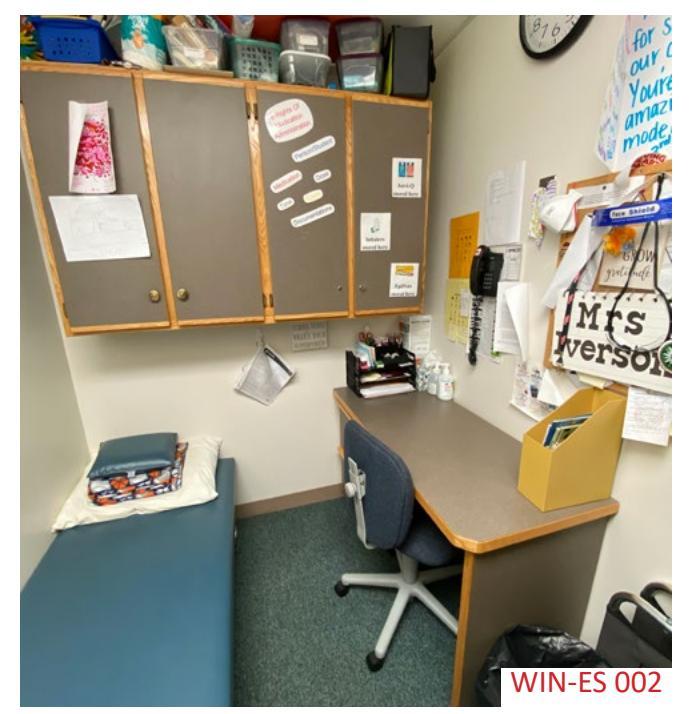
The nurse's office lacks space to accommodate both the nurse and a student. A larger room would allow for more than one student at a time to be there with the nurse.

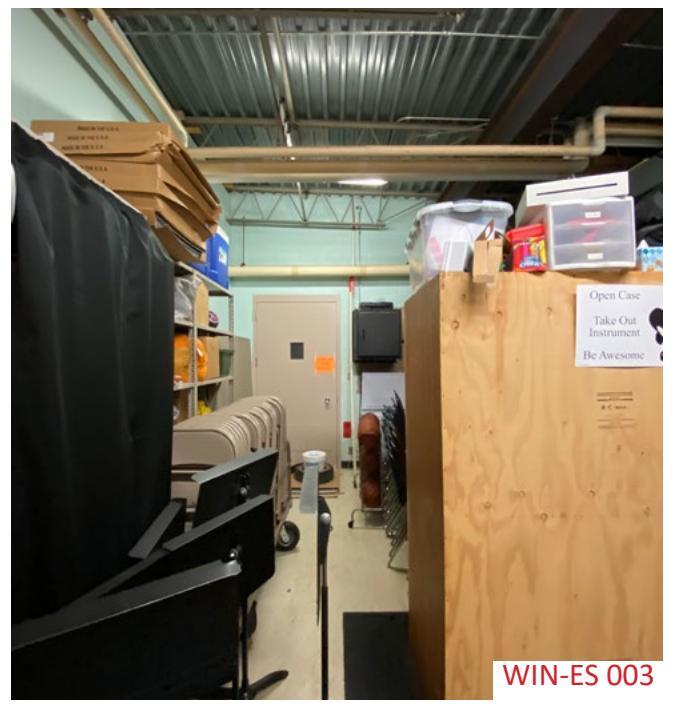
More storage space within the building is needed at the mechanical room is filled with objects.

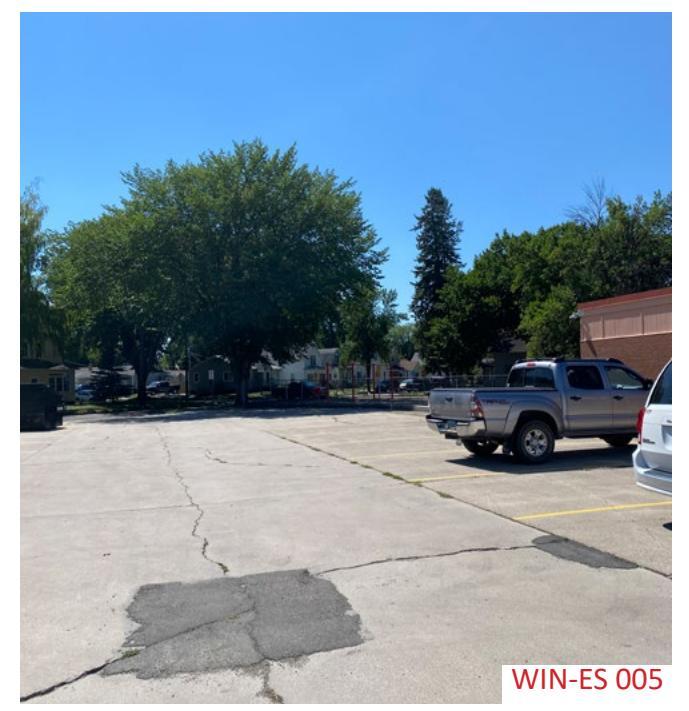
The asphalt on the site has a lot of cracking and is uneven near the entrances, which creates issues for accessibility (005). Numerous downspouts do not have concrete splash blocks underneath them to reduce water damage to the site (006). Downspouts near the main entry door wash rainwater from the roof drainage over the site paving causing for ice damming in winter months. This creates a hazard for students, staff, and parents entering the school from this door as this area becomes extremely slippery. Door 4 needs a concrete stoop on the exterior (007). Several emergency exit doors do not provide access to a public way (008). Neither of the playgrounds are accessible and both have sand bases which should be swapped with a safer alternative (009). There is a parking shortage causing staff and visitors to park on the street. The current drop-off area is not ideal as it takes place directly off the street. The residential streets are narrow creating congestion and potentially unsafe drop-off and pick-up conditions. Winter months only heighten these concerns.

The asphalt on the site had lots of cracking and was uneven near the entrances which creates issues for accessibility.

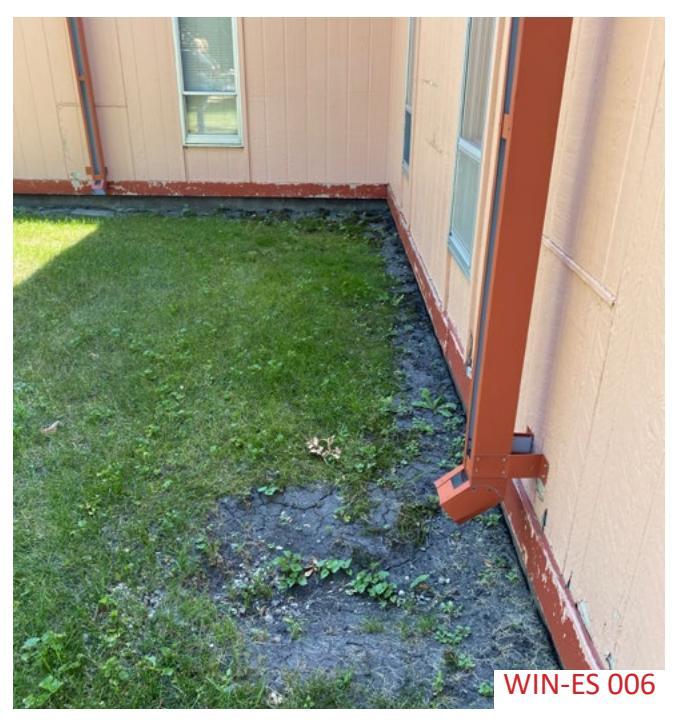
Numerous downspouts did not have concrete splash blocks underneath them to reduce water damage to the site.

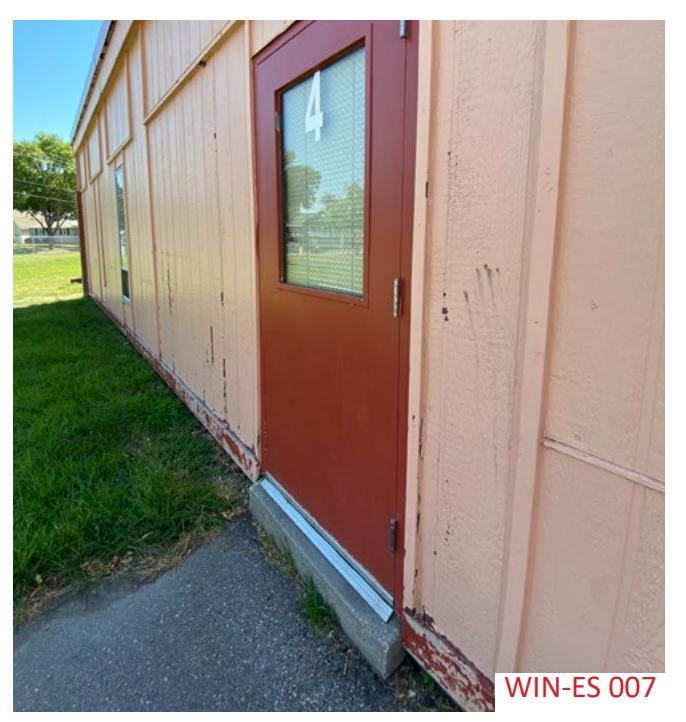
Door 4 needs a concrete stoop on the exterior.

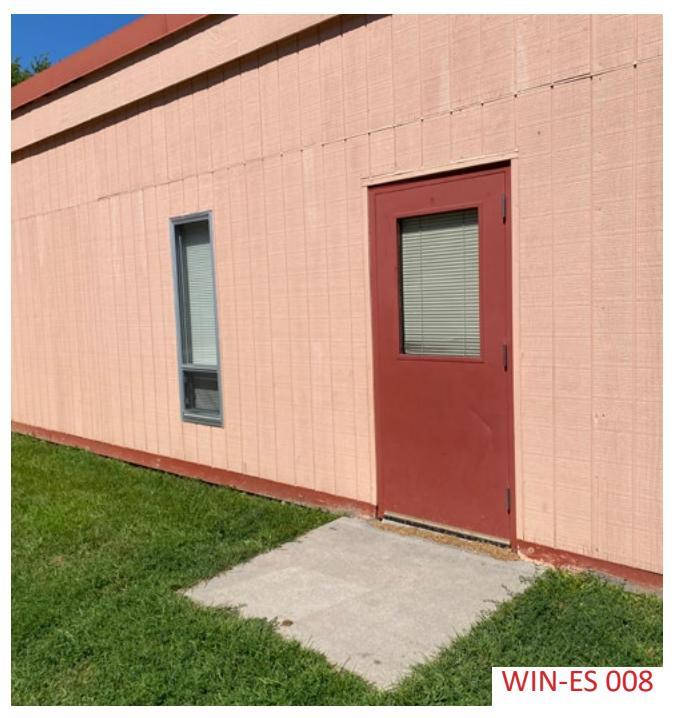
Several emergency exit doors do not provide access to a public way.

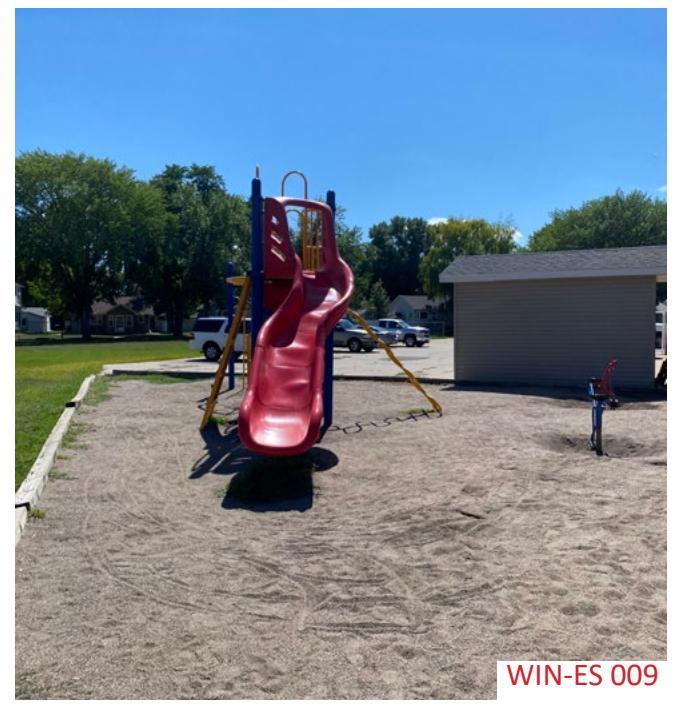
Neither of the playgrounds are accessible and both have sand bases which should be swapped with a safer alternative

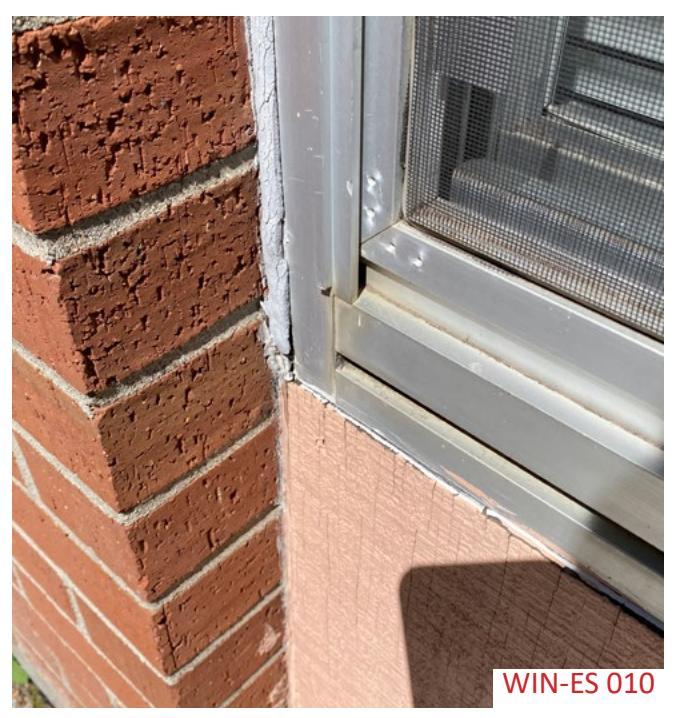
The exterior brick is overall in good condition. There is some cracking seen near the exterior doors of the mechanical room. Caulking around the windows could use some attention (010).

Caulking around the windows could use touching up.

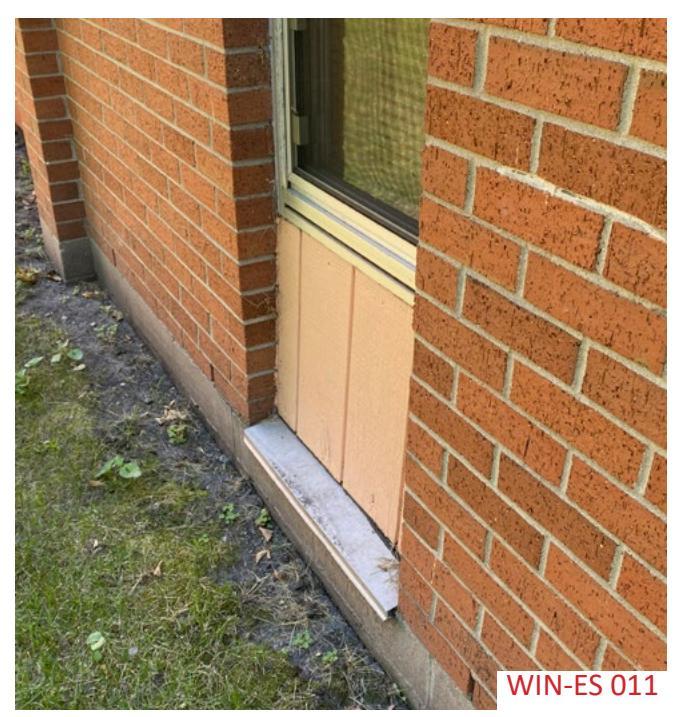
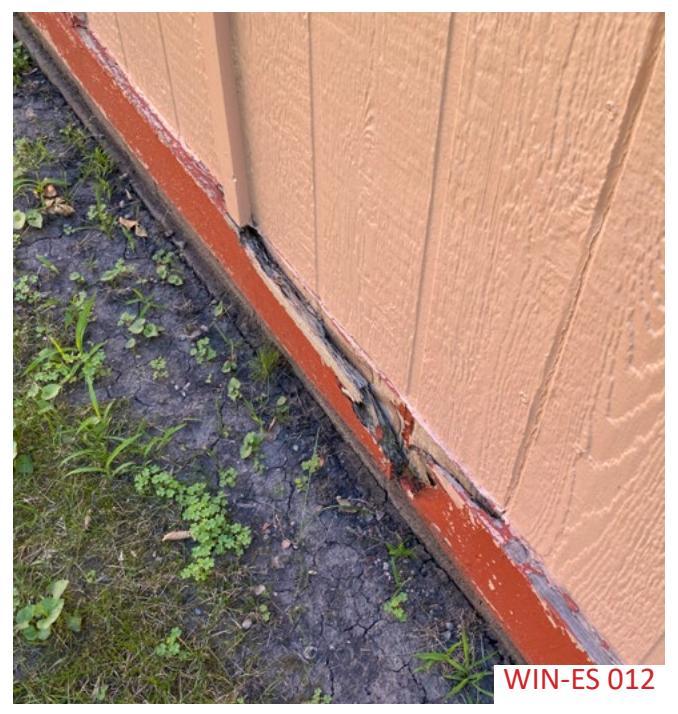
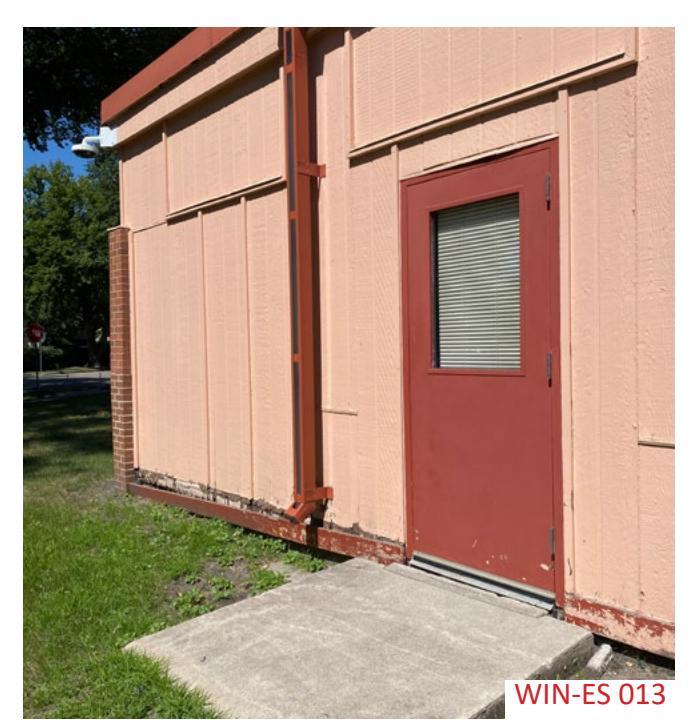
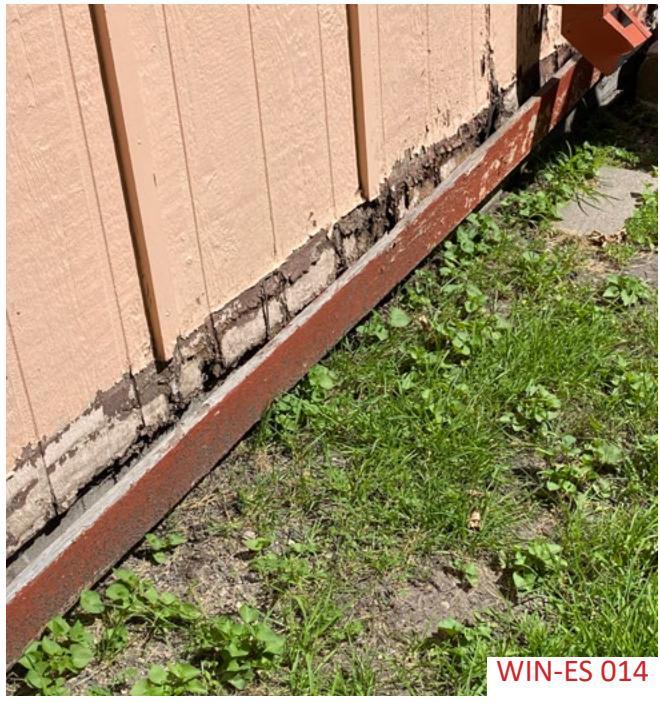
The wooden baseboard does not have the appropriate flashing for water protection

The wooden baseboard does not have the appropriate flashing for water protection, therefore the wood is rotting and falling off in a number of areas.

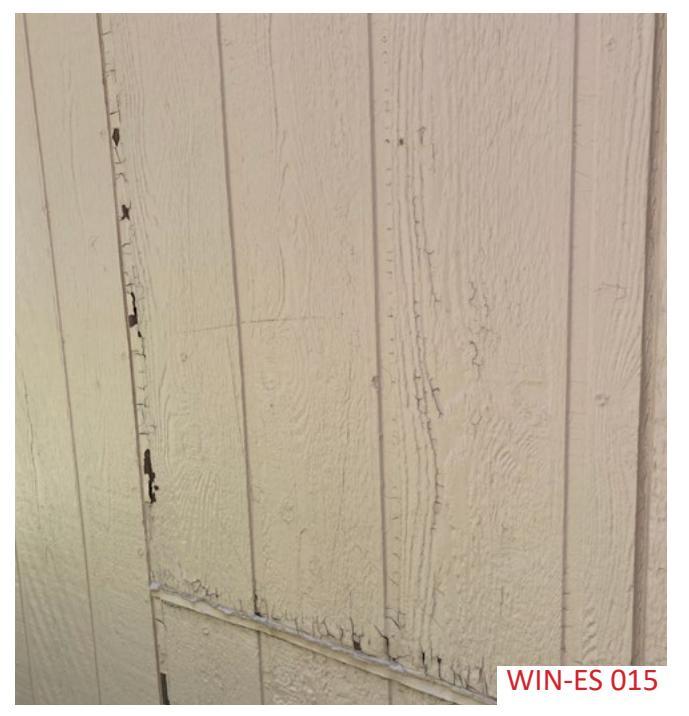
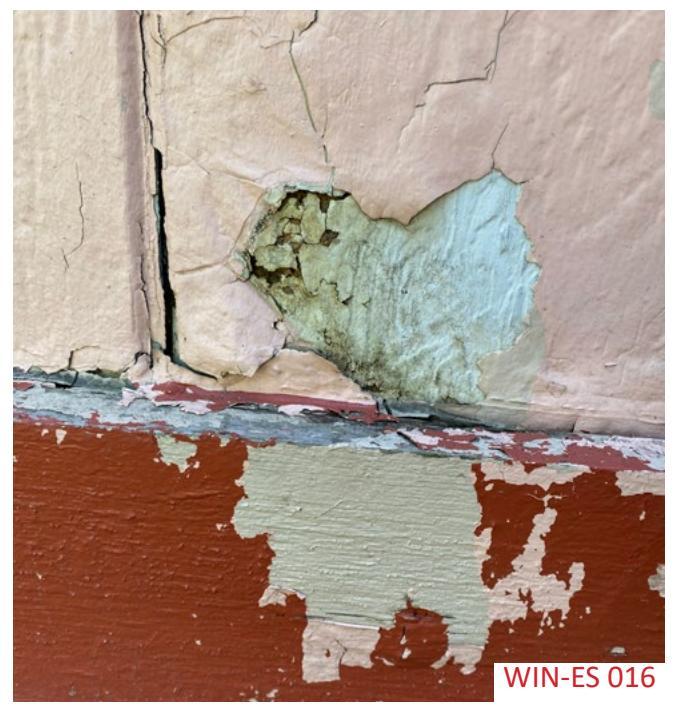
The paint is peeling off as well, further reducing the water protection of the exterior.

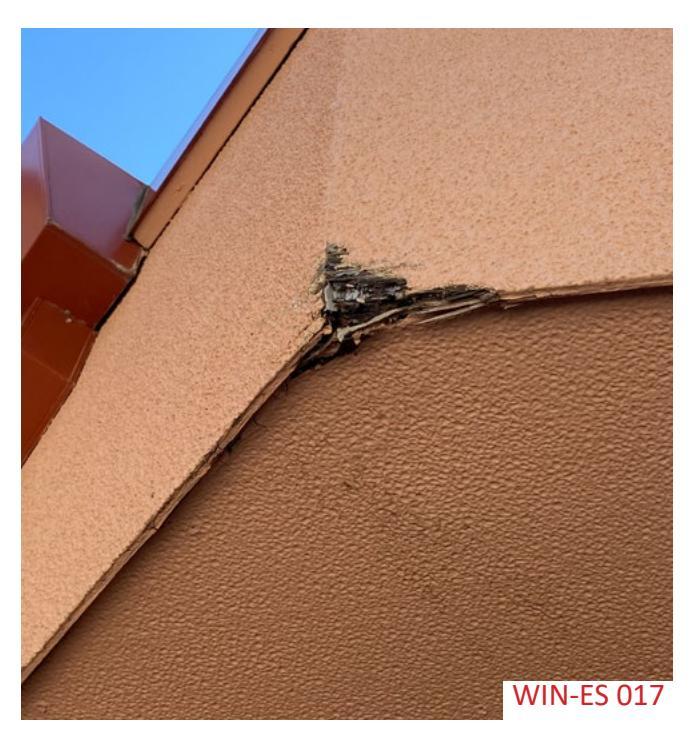
The plastered wood over the entrance is showing signs of age and is deteriorating.

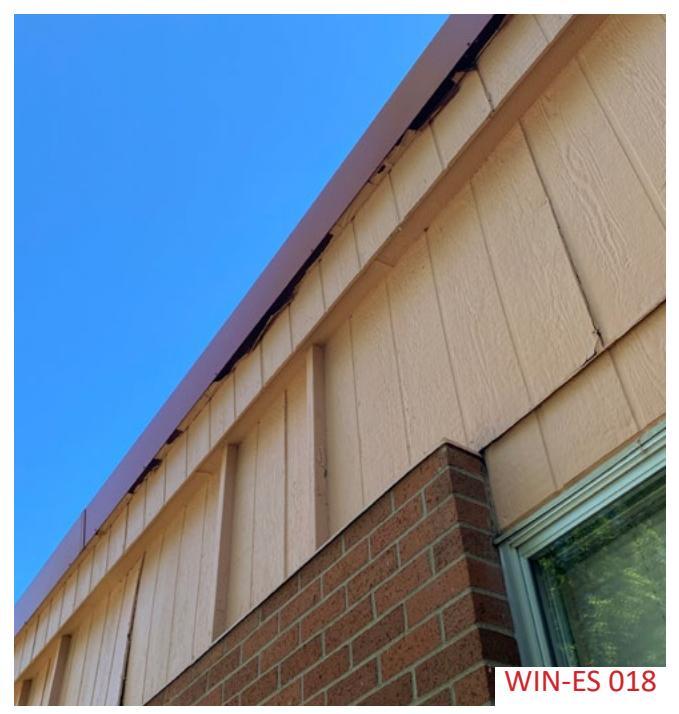
There is paint flaking off certain portions of the coping and flashing.

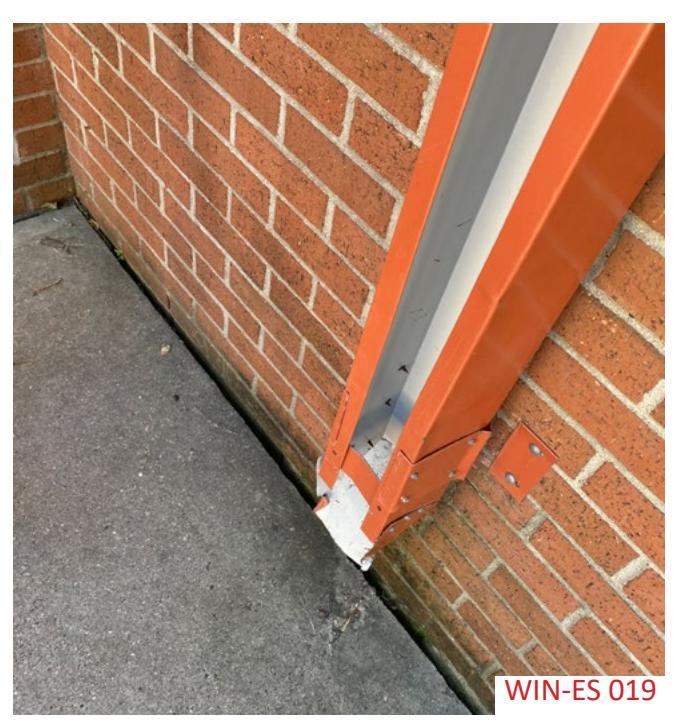
The roof is around 12 years old, but there haven't been any major issues. There is paint flaking off certain portions of the coping and flashing (018). The gutter adjacent to Door 3 is damaged (019).

The gutter adjacent to Door 3 is damaged.

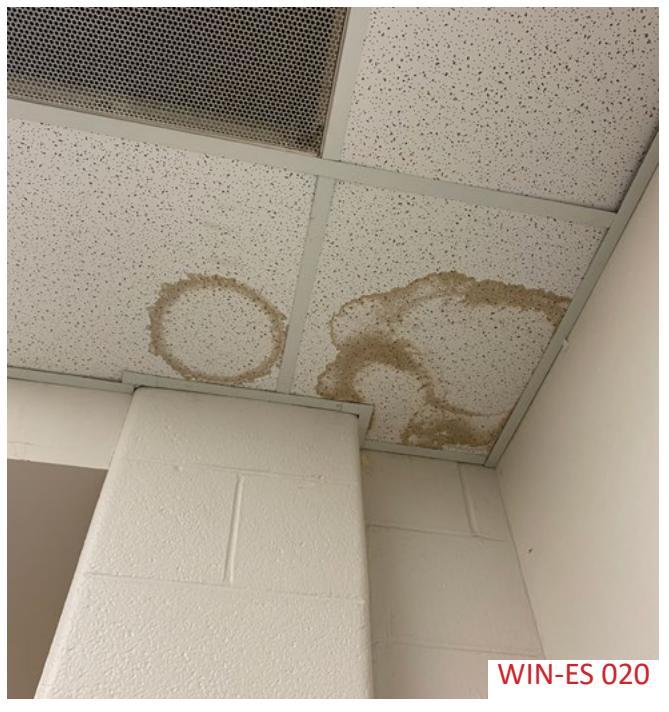
The majority of the ceilings are acoustical ceiling tile (ACT) and are in great condition. There are only a few water spots seen in the resource room (020).

There are only a few water spots seen in the resource room.

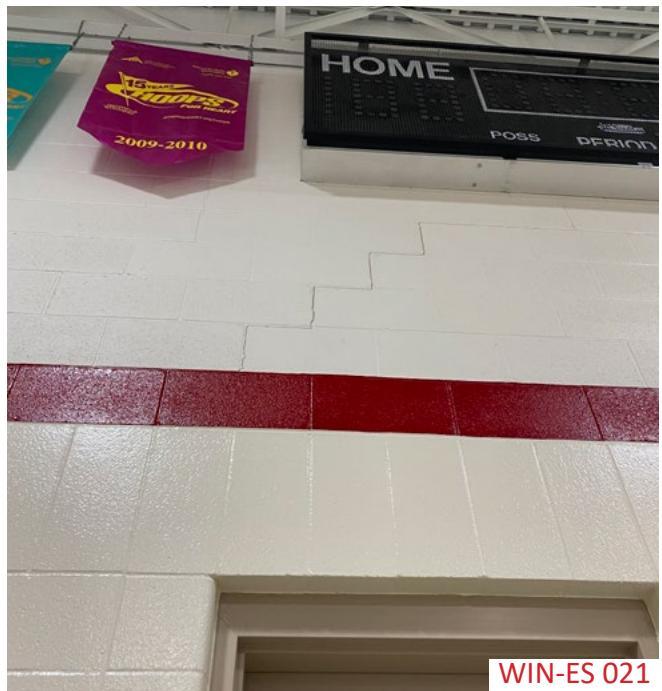
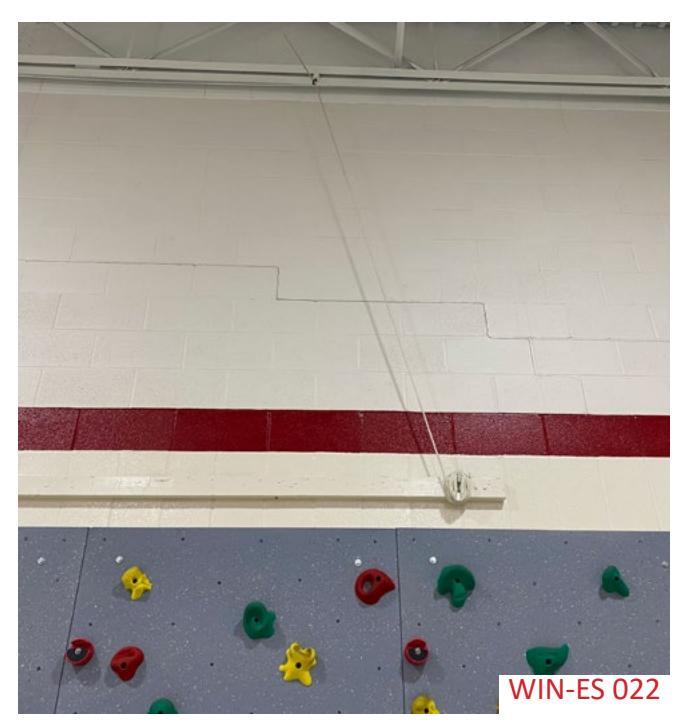
There is some cracking in the CMU seen within the gymnasium.

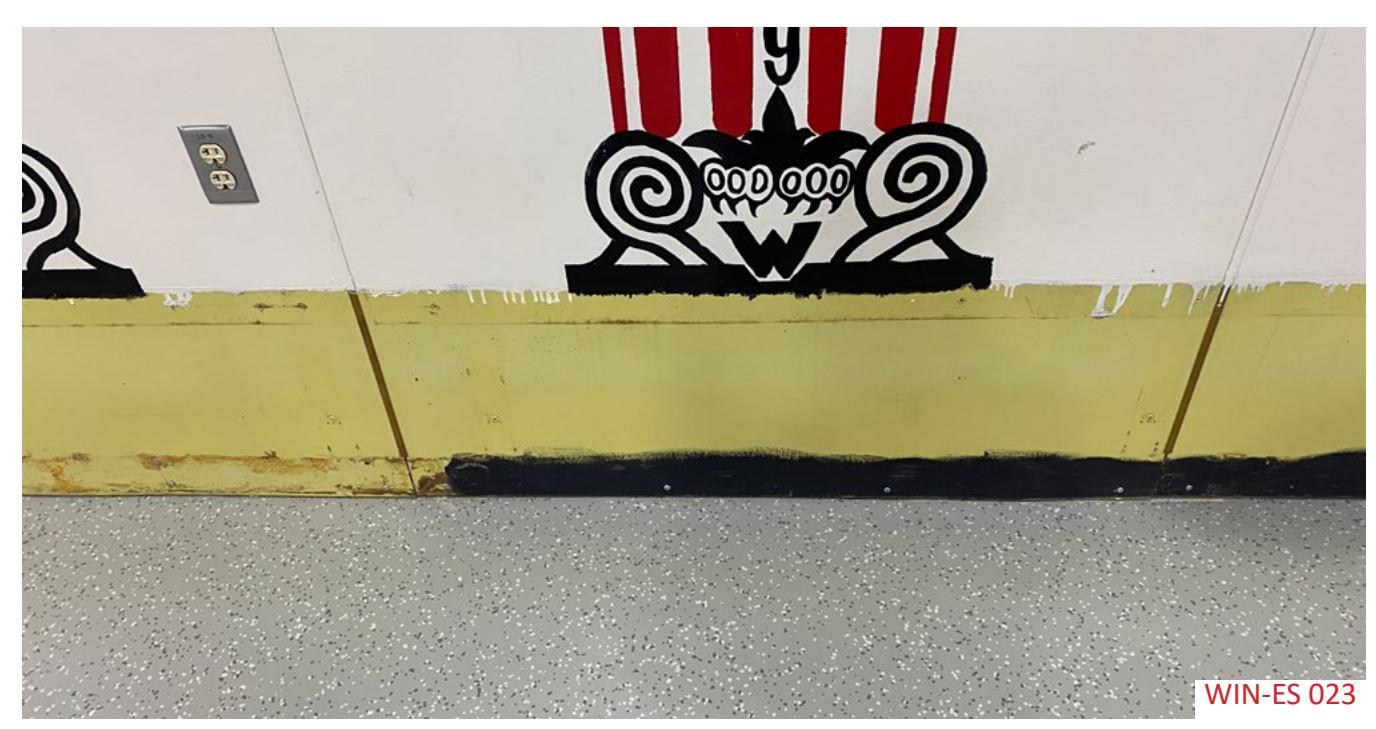
A gypsum board wall in the gymnasium needs painting after an attached bench was removed.

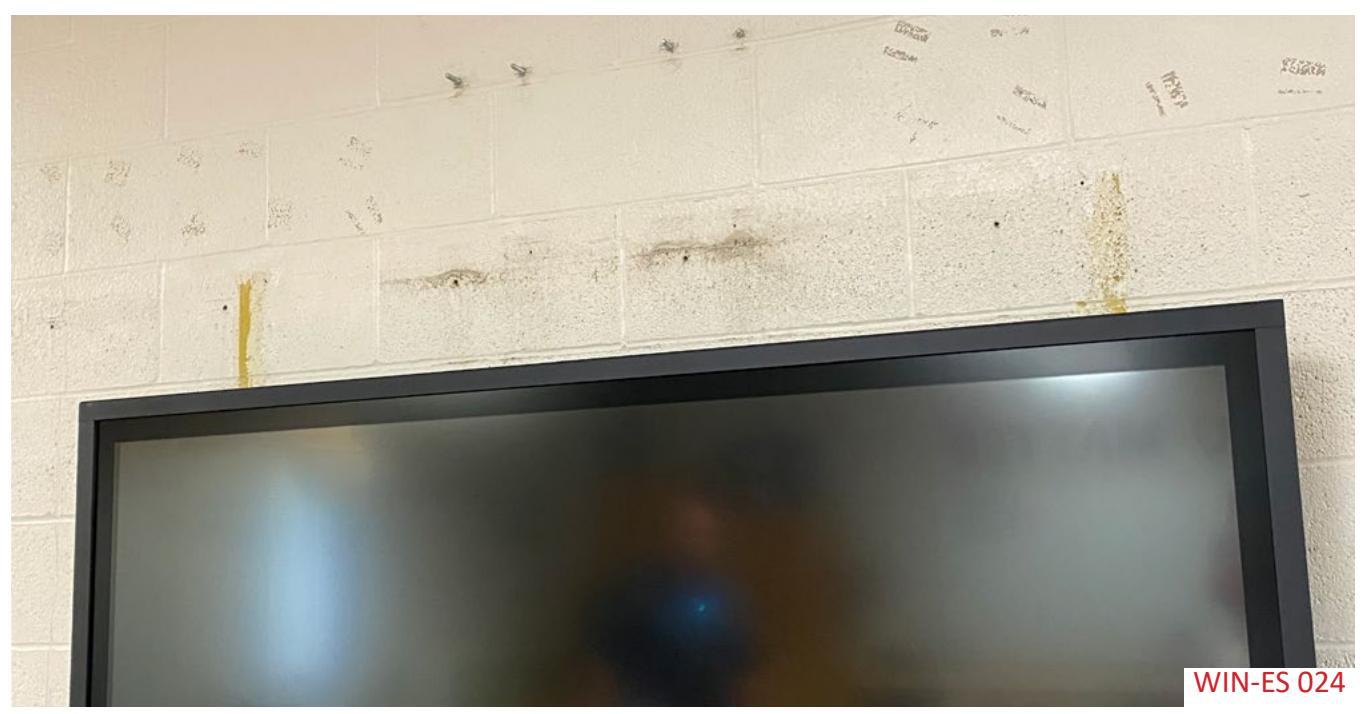
In Room 147C, the CMU paint has patches and could use some.

In Room 147C, patch and paint the CMU that could use some retouching	38	1 Ea.	\$6,269.65 /	Ea.	\$6,270					\$6,270
Replace dated carpet in the classrooms	39	15,000 SF	\$10.89 /	SF		\$163,350				\$163,350
Replace original tile in the bathrooms, offices and support spaces	40	2,350 SF	\$28.27 /	SF		\$66,435			×	\$66,435
Interior Upgrades Subtotal		28,295 SF	\$11.04 /	SF						<b>\$312,479</b>
Exterior Upgrades										
Mill and overlay the asphalt to improve accessibility	41	13,696 SF	\$5.32 <i> </i>	SF	\$72,863					\$72,863
Add concrete splash blocks to downspouts to reduce water damage to the site	42	20 Ea.	\$47.06 /	Ea.	\$941					\$941
Add a concrete stoop to Door 4	43	1 Ea.	\$18,808.95 /	Ea.	\$18,809					\$18,809
Connect exit doors to public sidewalks at locations where missing	44	1,000 SF	\$17.56 /	SF	\$17,560					\$17,560
Make an accessible entrance to both playgrounds and remove the sand bases, replace with	45	2 Ea.	\$24,145.50 /	Ea.	\$48,291					\$48,291

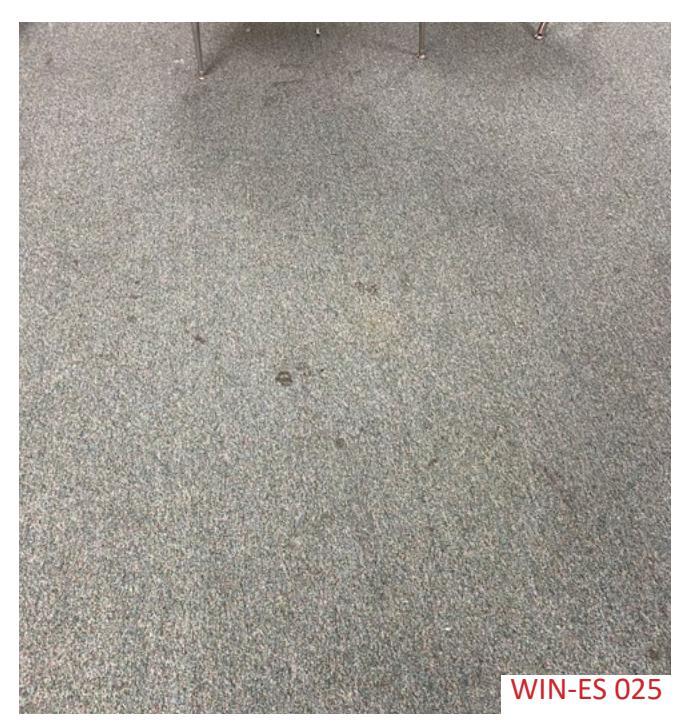
The carpet in the hallway was recently replaced, but the classrooms still have old carpet.

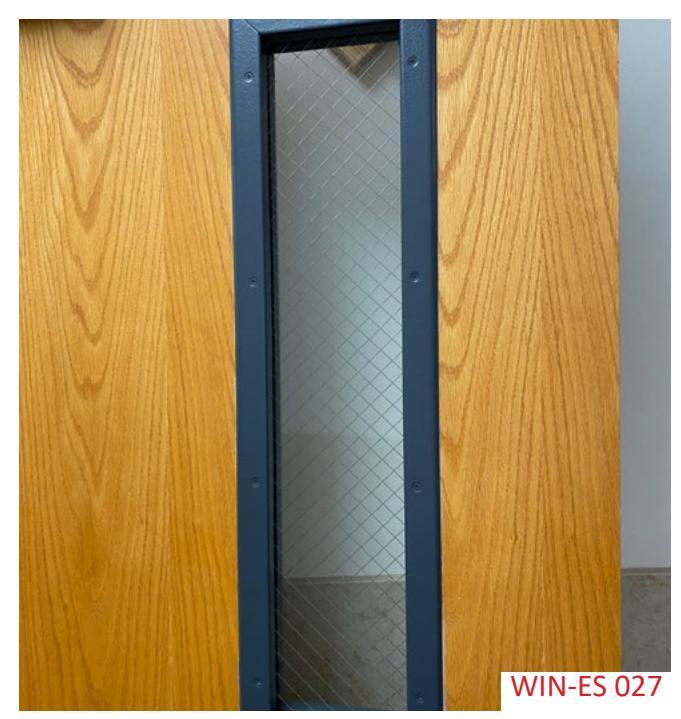
Traditional wire glass throughout the building is no longer to code as an acceptable type of safety glass.

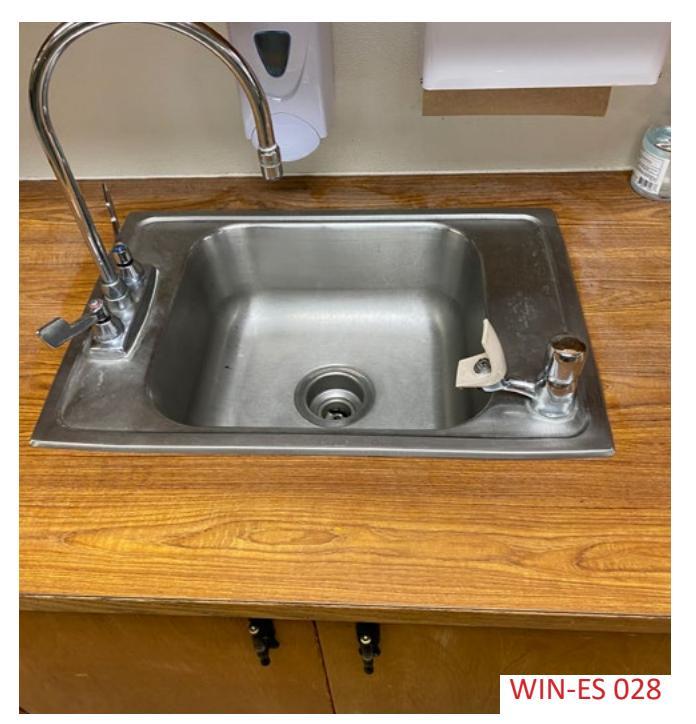
Sinks in classrooms and offices are not accessible.

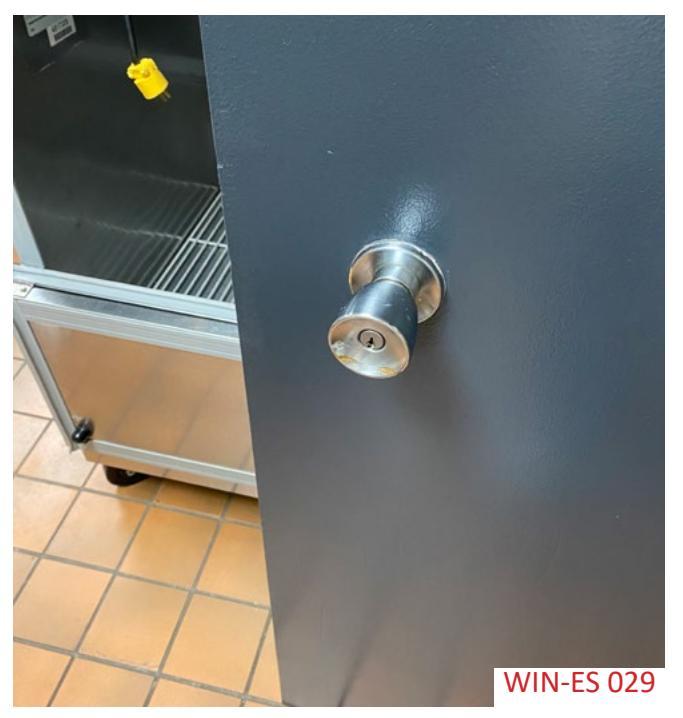
Many doors throughout the building have hardware that is not accessible.

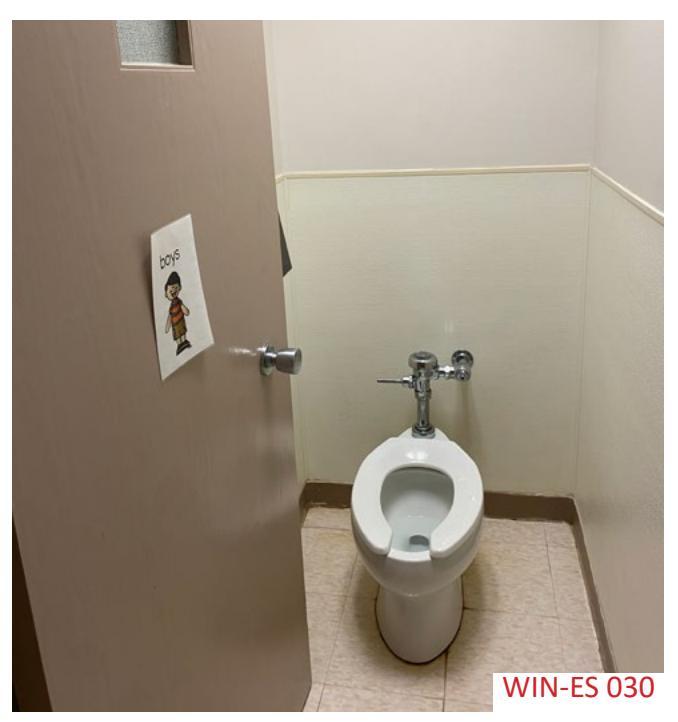
The bathrooms accessed through Room 102D are not accessible.

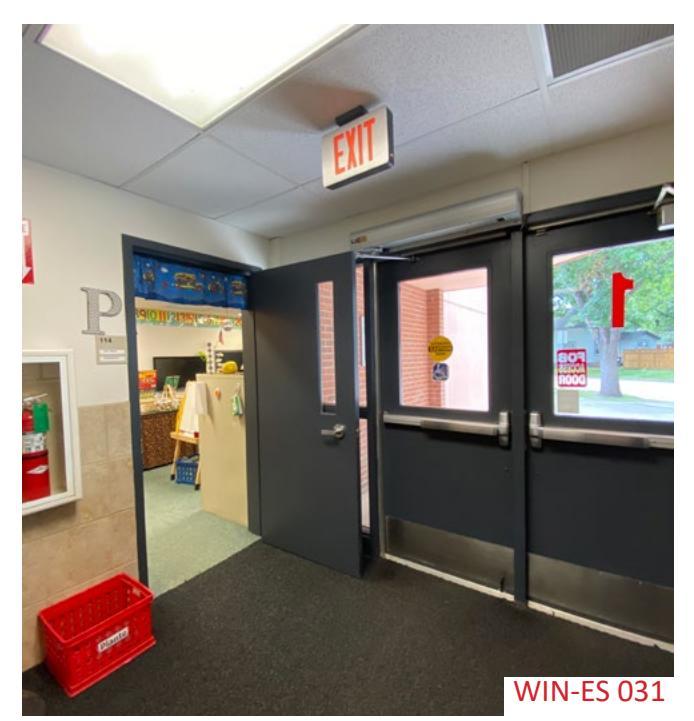
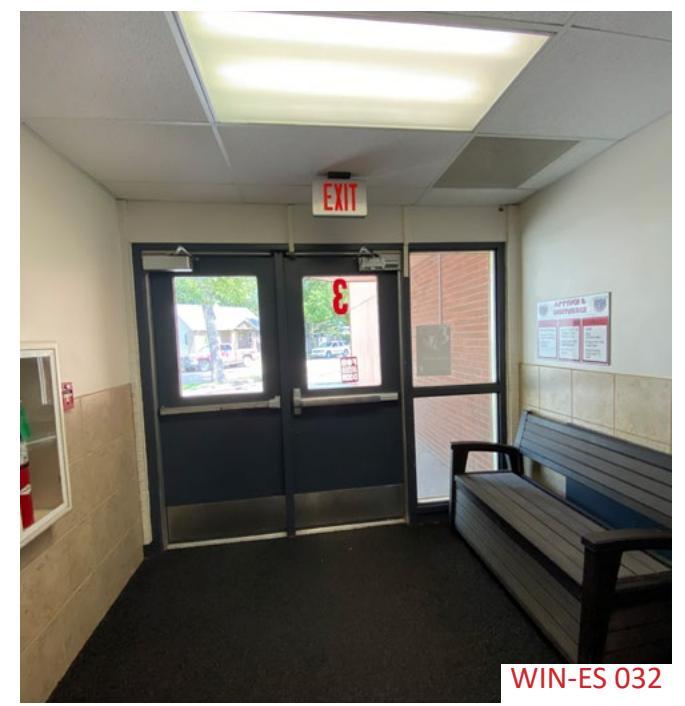
Doors 1, 3 and 7 are not protected with an enclosed vestibule, as required by energy code.

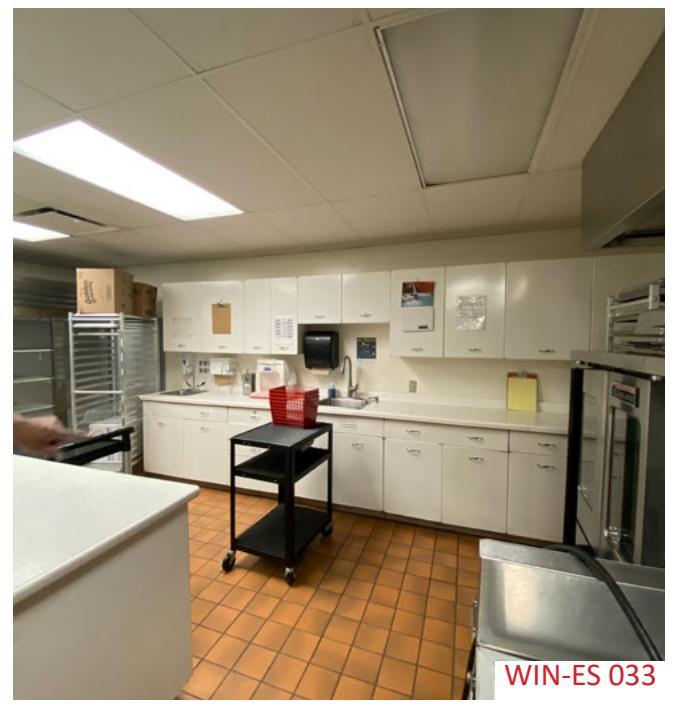
Prep surfaces in the kitchen need to be stainless steel for food safety.

Replace prep surfaces in the kitchen with stainless steel for food safety	9	1 Ea.	\$98,411.76 / E	a.	\$98,412					\$98,412
Remodel staff restroom to make them accessible	7	2 Ea.	\$39,915.61 / E	a.	\$79,831				×	\$79,831
Add a secondary exit to the library per occupancy load requirements	8	1 Ea.	\$3,508.60 / E	a.	\$3,509					\$3,509
Replace glazing in the interior windows in the library and main office with tempered glass for safety reasons.	6	96 SF	\$58.93 / SI	ш	\$5,657					\$5,657
Replace the door into the food safety office with fire rated door frame and hardware	10	1 Ea.	\$3,582.22 / E	e.	\$3,582					\$3,582
Replace glazing in some doors with tempered glass	11	10 Ea.	\$516.57 / Ea	a.	\$5,166					\$5,166
Replace sinks (4 sinks total in 2 locations) outside of the student restrooms with accessible sinks	12	2 Ea.	\$17,332.63 / E	a.	\$34,665				×	\$34,665
Remodel the center bathrooms to make them accessible	13	900 SF	\$292.03 / SI	ц	\$262,827				×	\$262,827

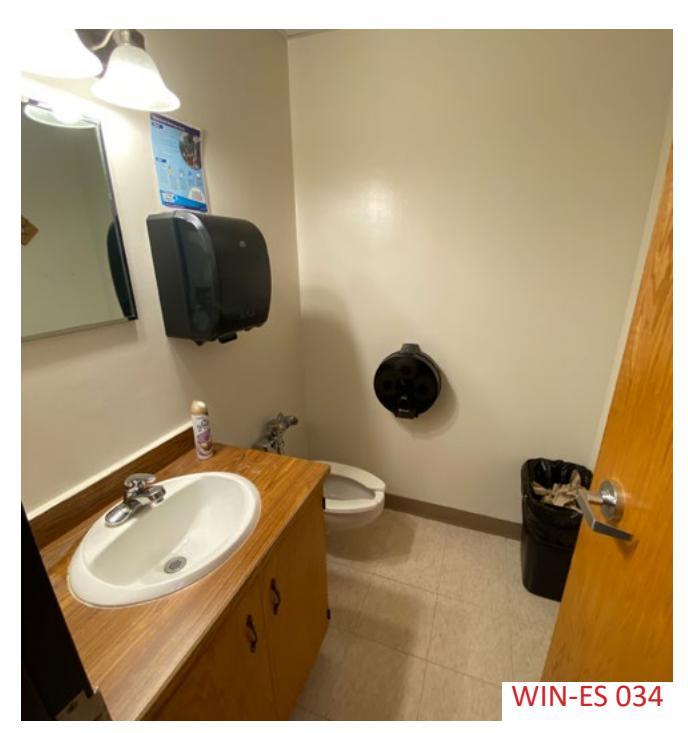
Staff restroom is not accessible.

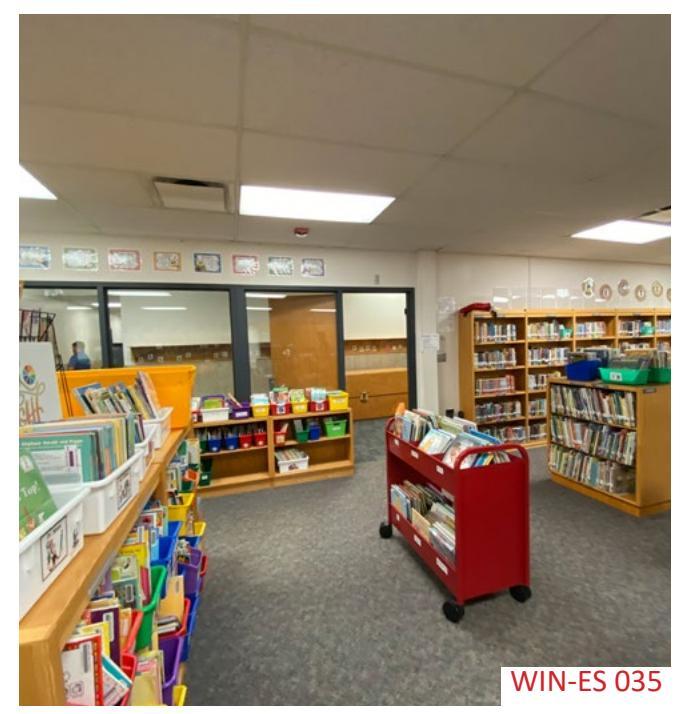
Interior windows in the library and main office do not have safety glass as required by code.

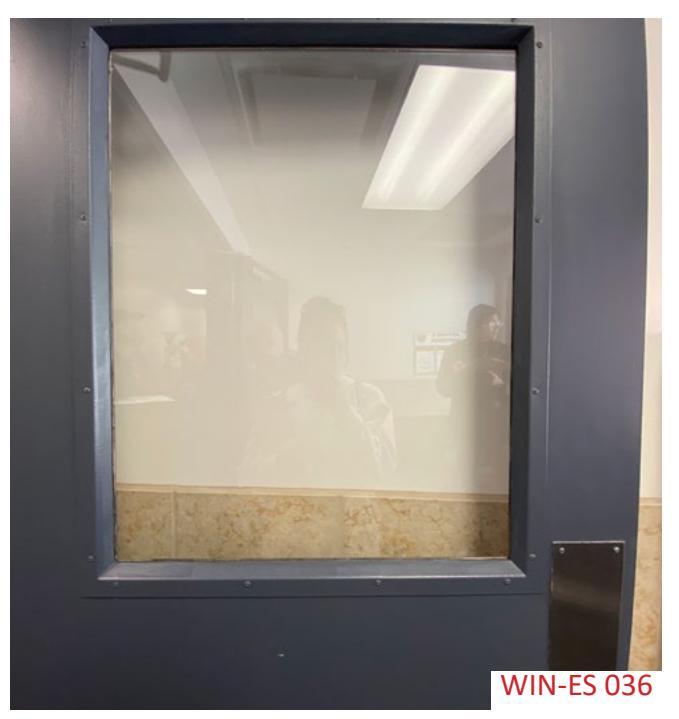
Numerous doors have glass windows that are not safety glass as required by code.

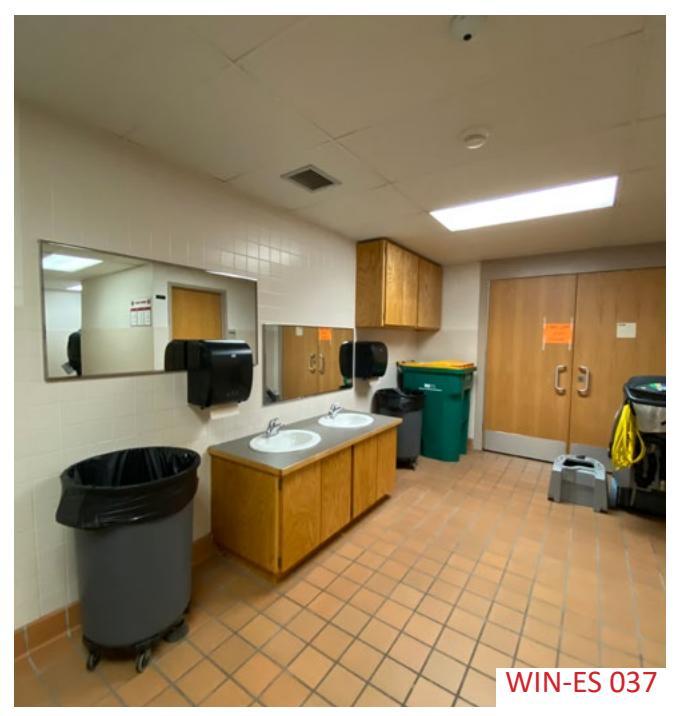
Sinks outside of the student restrooms are not accessible.

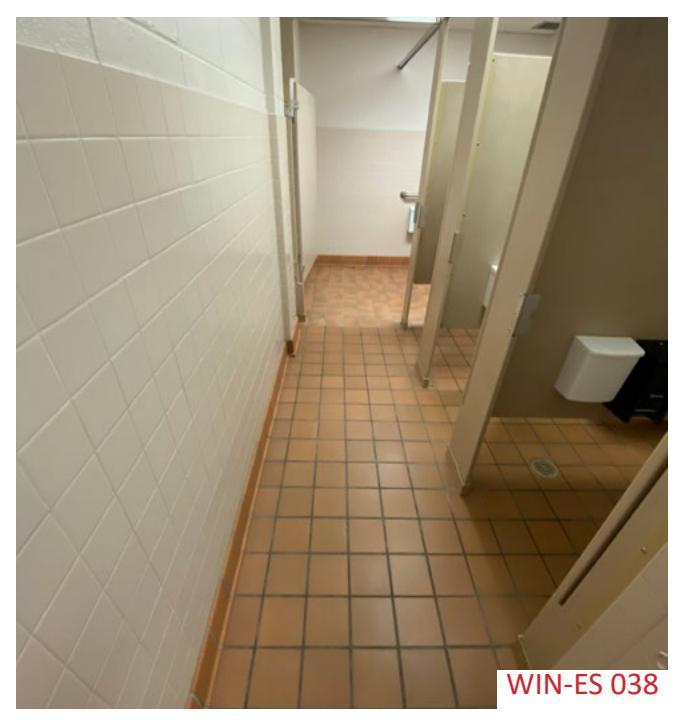
The pathway to the accessible stalls in the restrooms does not meet maneuverability requirements.
