Seismic Evaluation & Conceptual Retrofit Isbell Middle School - Building A

Dated: May 29, 2019

Prepared By: SSG Structural Engineers, LLP 811 El Capitan Way, Suite 240 San Luis Obispo, CA 93401

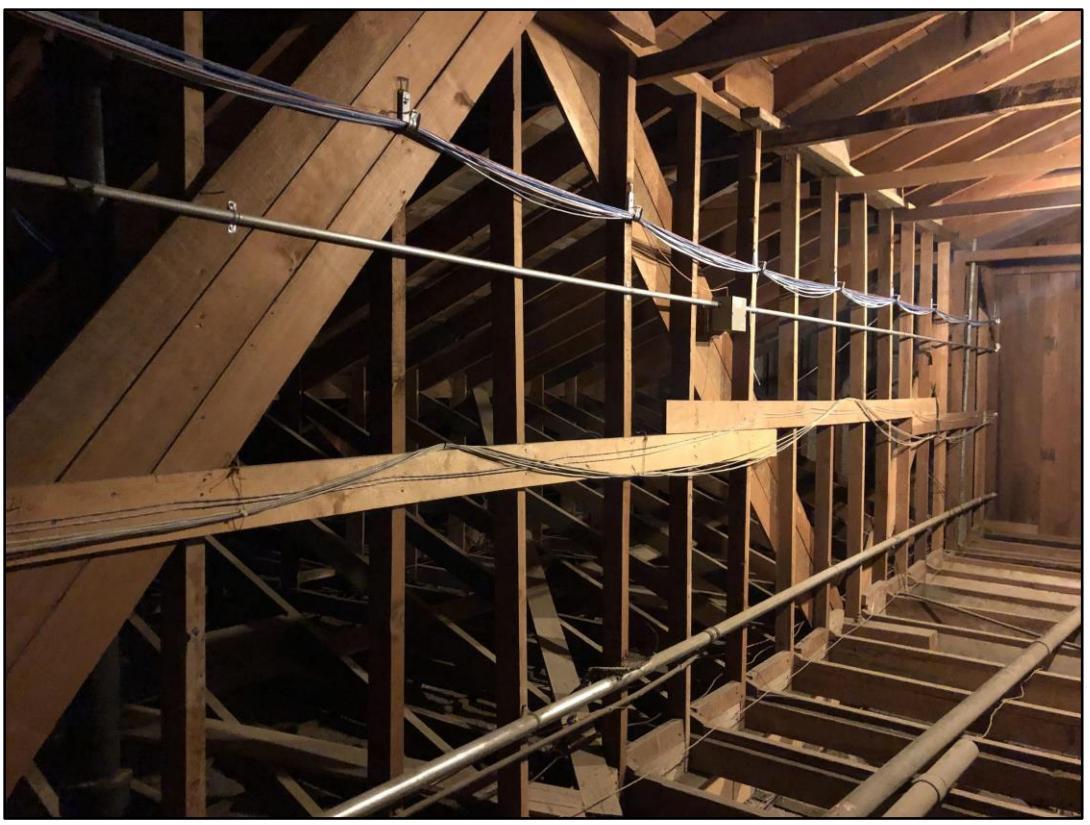
Figure 7 - Added 1x6 Braces Over Corridor Walls in Attic

The roof diaphragm system is 1x6 straight sheathing over the rafters and with wood struts to steel braces over the corridors. The strut and bracing system serves to transfer out-of-plane diaphragm loads to shear walls below. The main shear walls at the second level are reinforced gunite walls at the ends of corridors. The rehabilitation also included application of 1x6 diagonal bracing to wood corridor walls in the attic (Figure 7) and at the second floor.

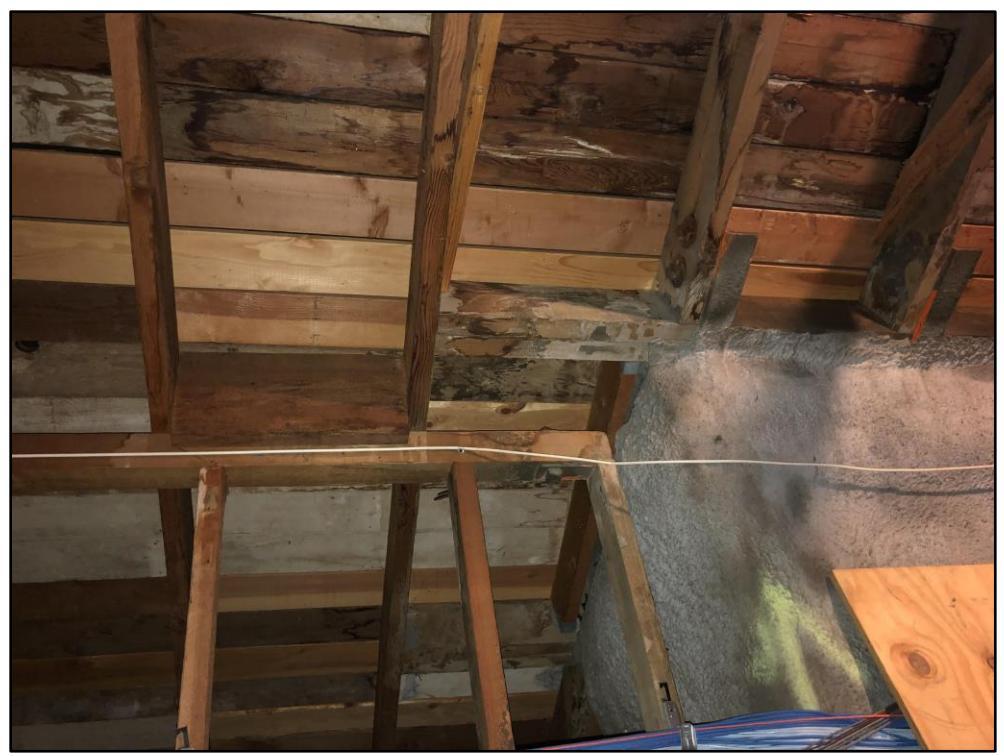
Figure 8 - Evidence of Water Intrusion in Attic

At the time of the site observation, the condition of the structure was considered good given its age, history and use. In general, it was observed to conform to a majority of the plans and details for the 1939 structural rehabilitation. The roof sheathing showed some signs of water intrusion and limited dryrot (Figure 8). Concrete in the basement level has several cracked locations. These are minorly displaced out of plane (Figure 9).

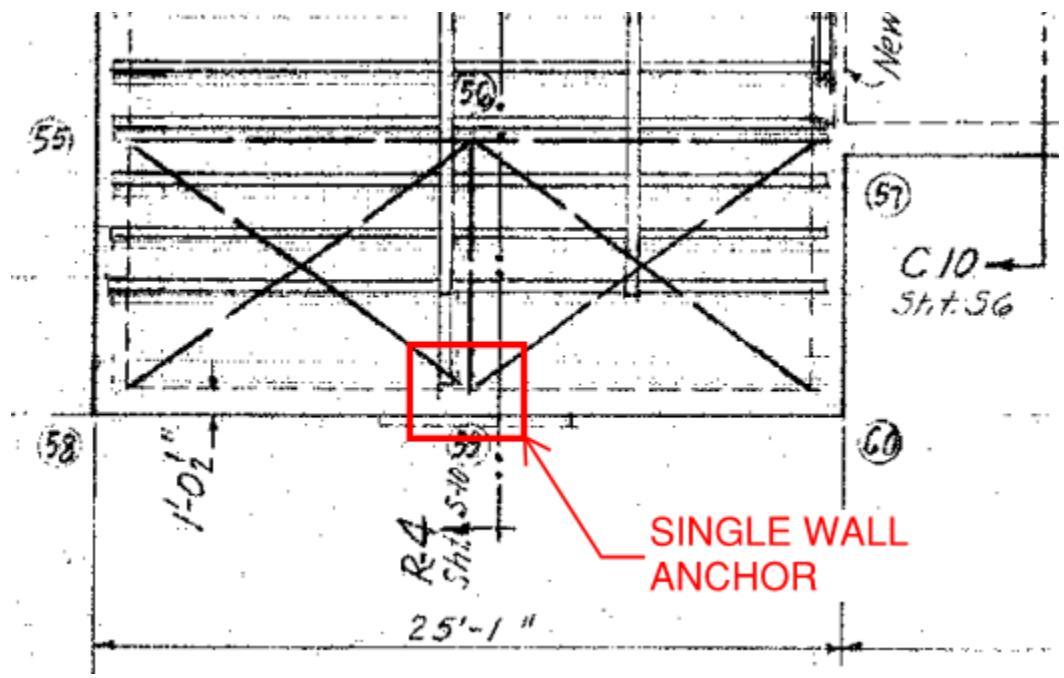
Figure 10 - Floor Framing in NW Corner of Structure

Wall anchors do exist at the roof and the second floor. Where framing is perpendicular to the concrete walls, it is generally anchored at every joist or every other rafter. Where framing is parallel to the concrete walls, anchor points are infrequent. For example, the NW and SW exterior walls are anchored in the middle of the wall length in one location. This anchor needs to resist 12.5-feet of out-of-plane forces, and does not have adequate strength to resist the ASCE 41-13 Quick Check forces. See Figure 10.

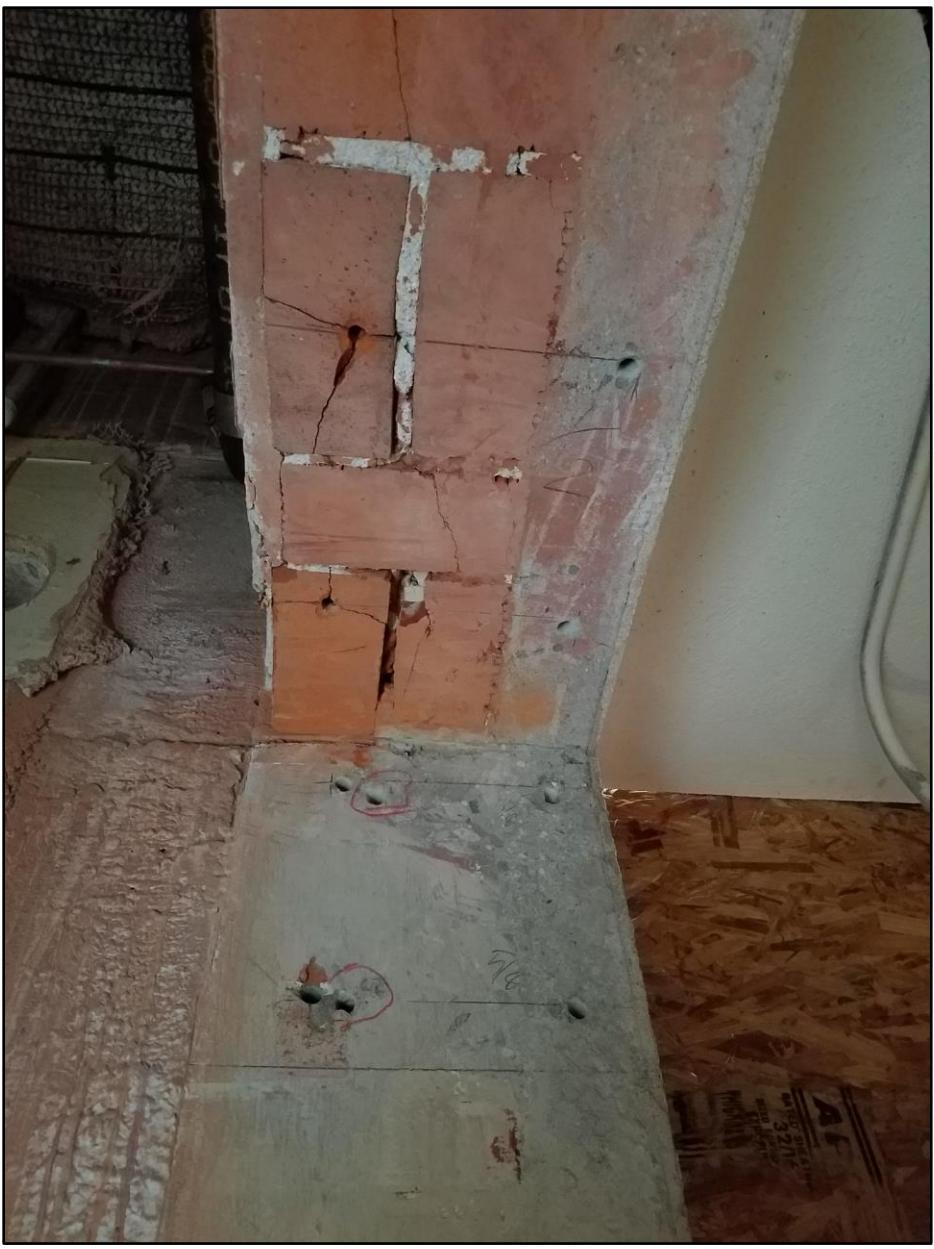
Figure 11 - Collar Joint at Door to Room 125

The quality of the original construction is such that voids can be seen in the collar joints, which makes this item non-compliant, see Figure 11.

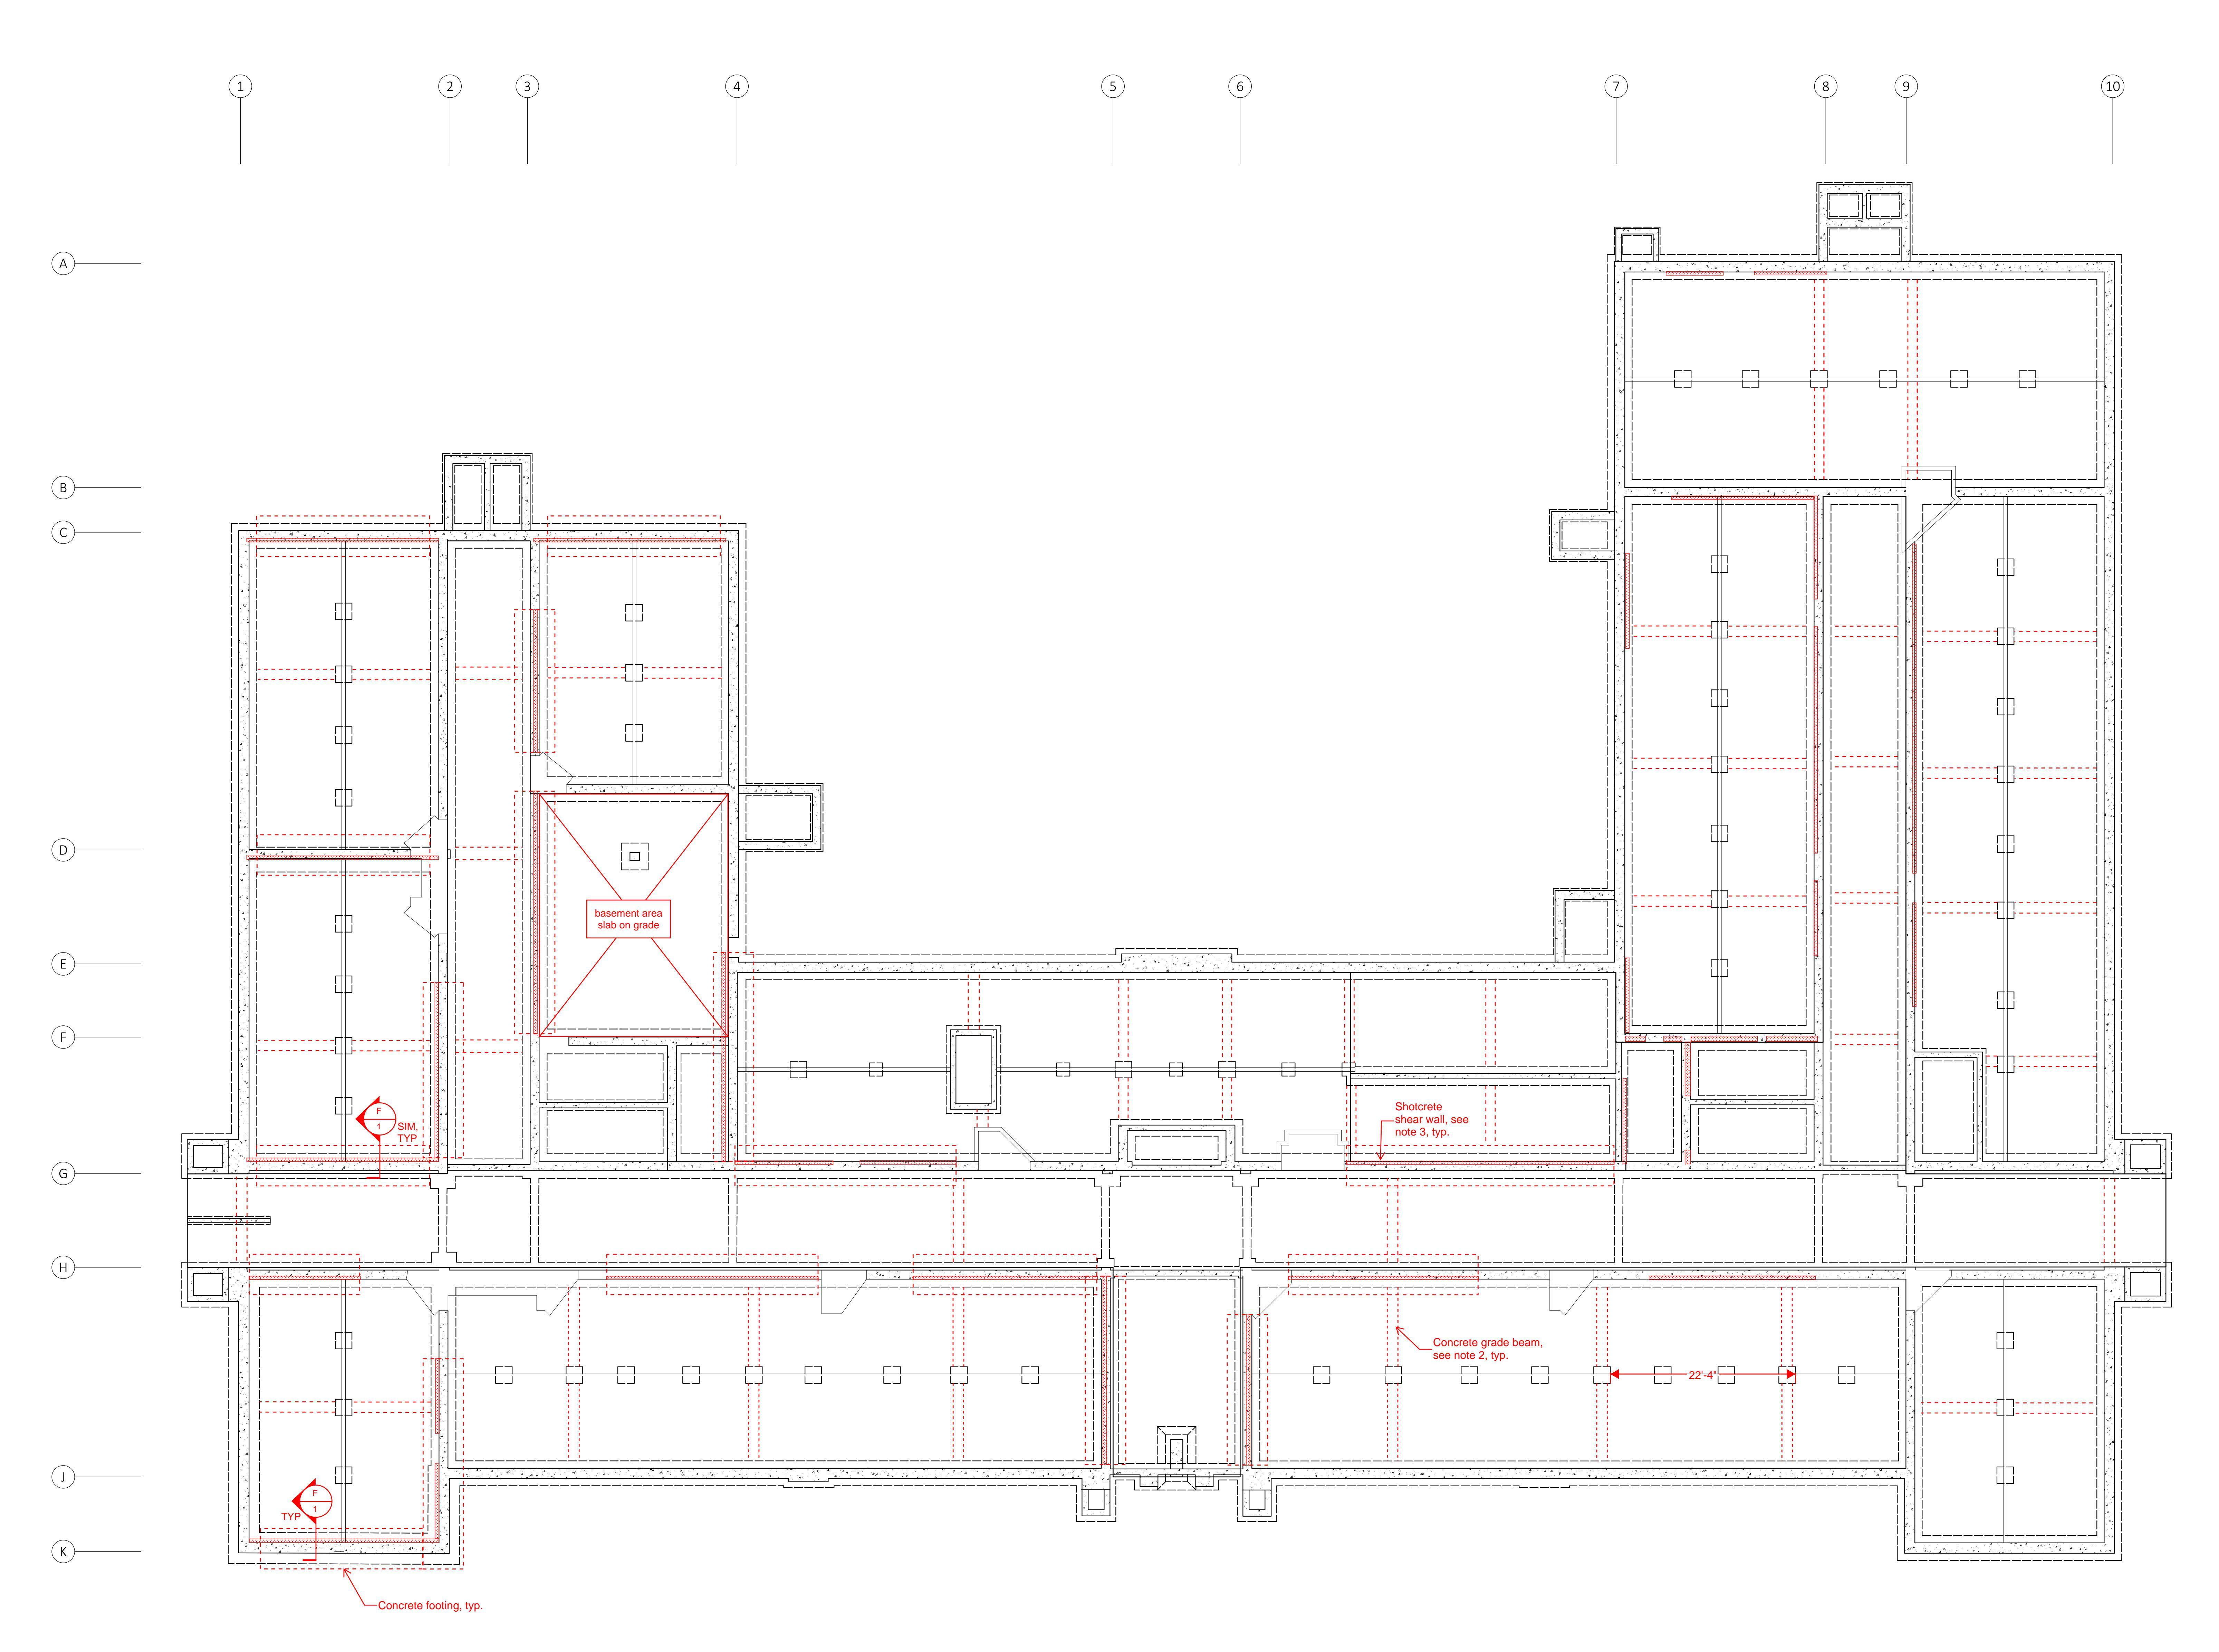
FOUNDATION PLAN SCALE: 1/8" = 1'-0"

need footings under shear walls on this sheet
