December 2021

Town of Vernon

Building Materials PCB Remediation Plan Daniel's Mill Building

DANIEL'S MILL BUILDING PCB RAP

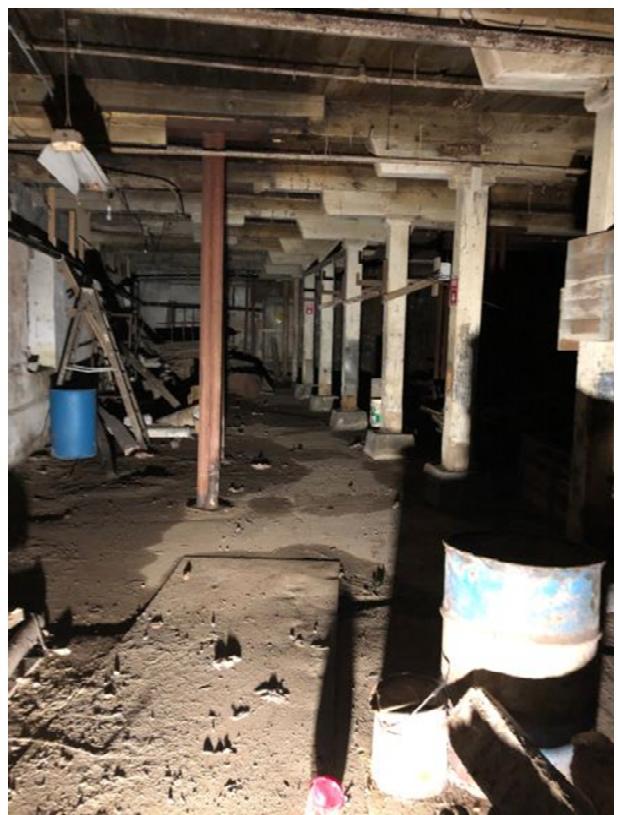
Photo B.1 – Basement Area with Concrete Floor Looking West

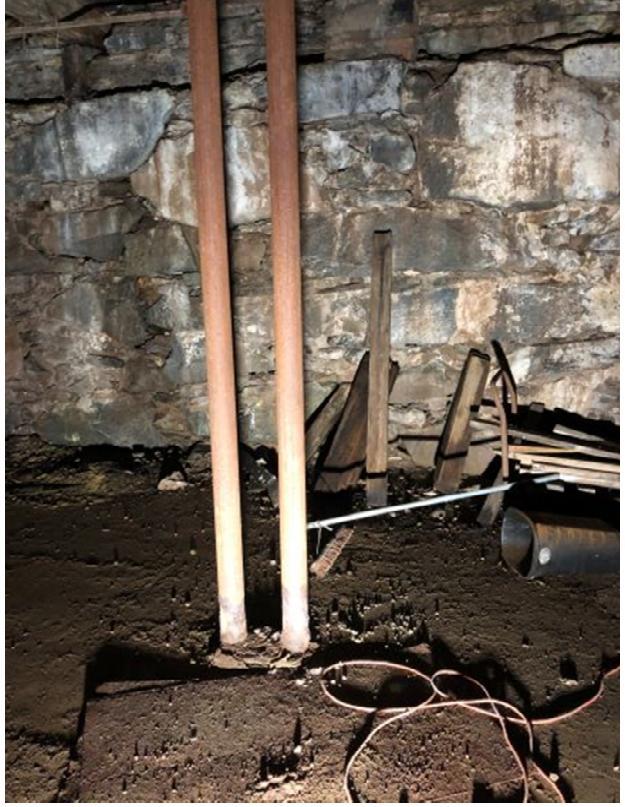
Photo B.2 – Rock Wall in Basement

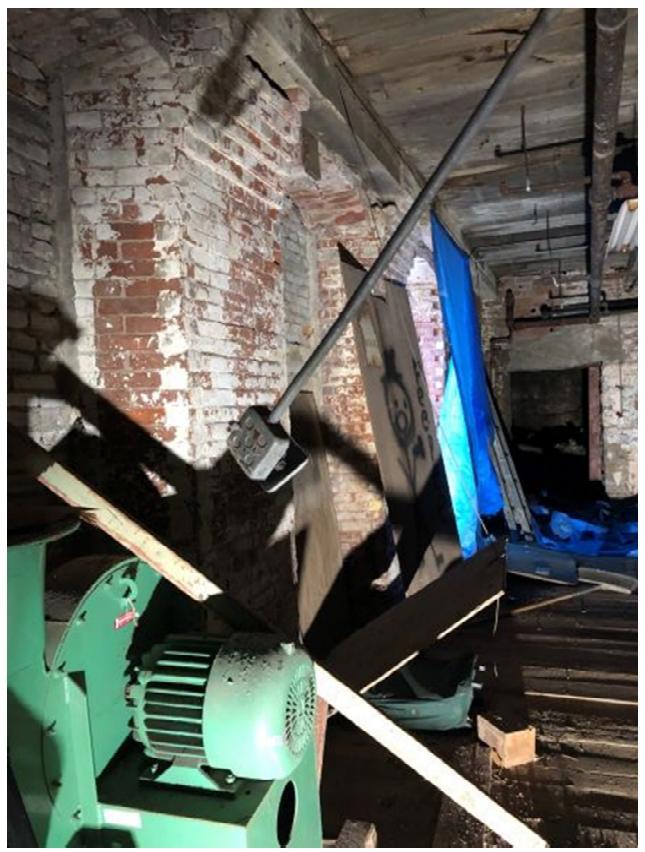
Photo B.3 – Painted Brick Wall and Debris, Southern Wing

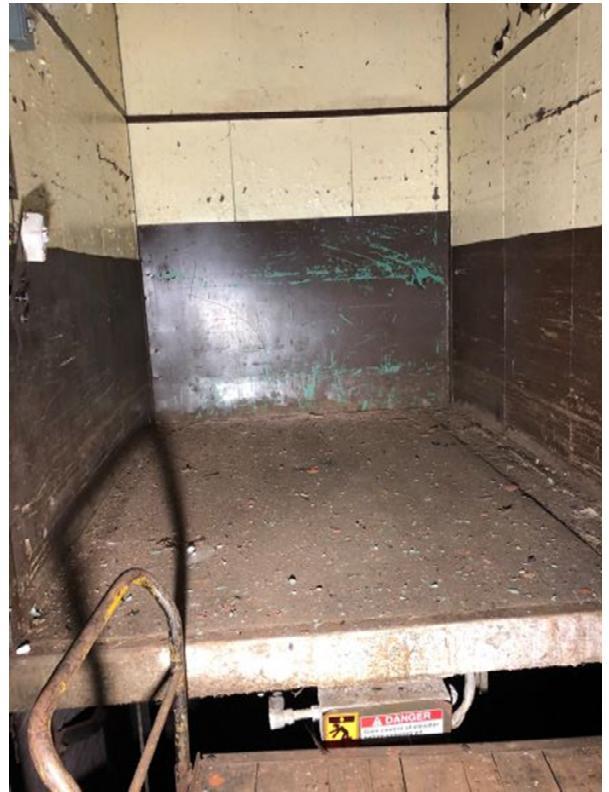
Photo B.4 – Painted Elevator Cab

- New doors and windows will be installed to replace existing.
- A new elevator cab and doors will be installed to replace the painted materials to be removed from the structure.

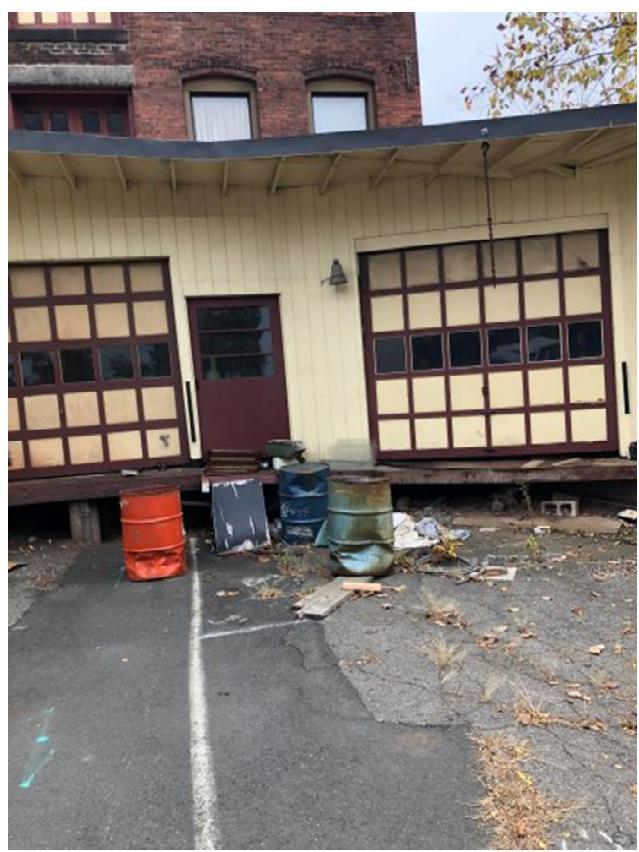
Photo E.1 – Loading Dock on West Side and PCB Soil Remediation Area

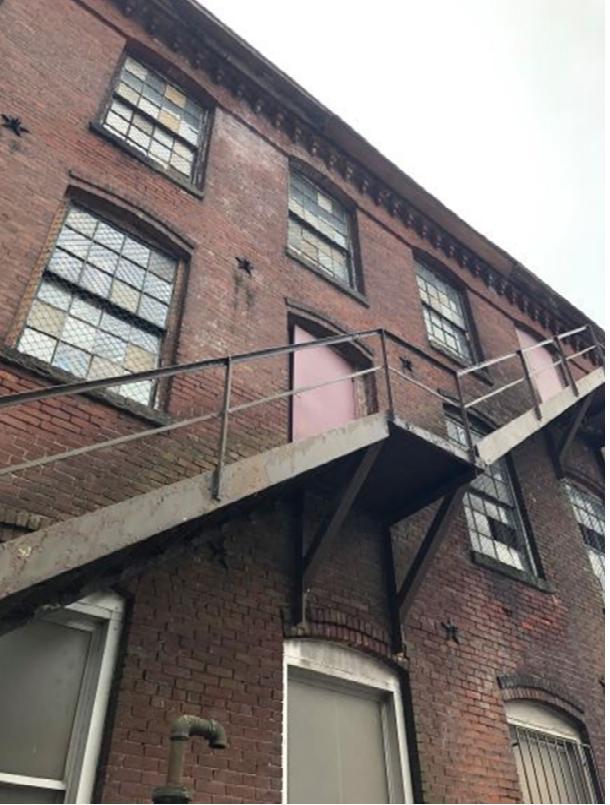
Photo E.2 – North Side of Building, Typical Windows and Fire Doors

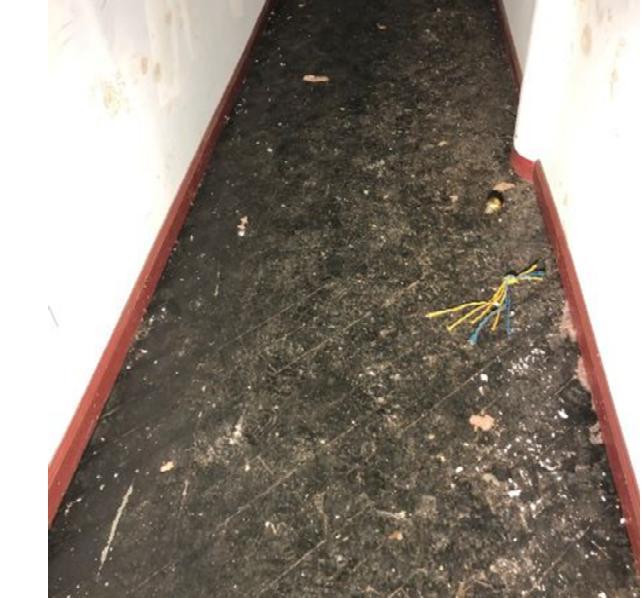
Photo 1.2 – Painted Wood Flooring and Temporary Walls in First Floor Office Area

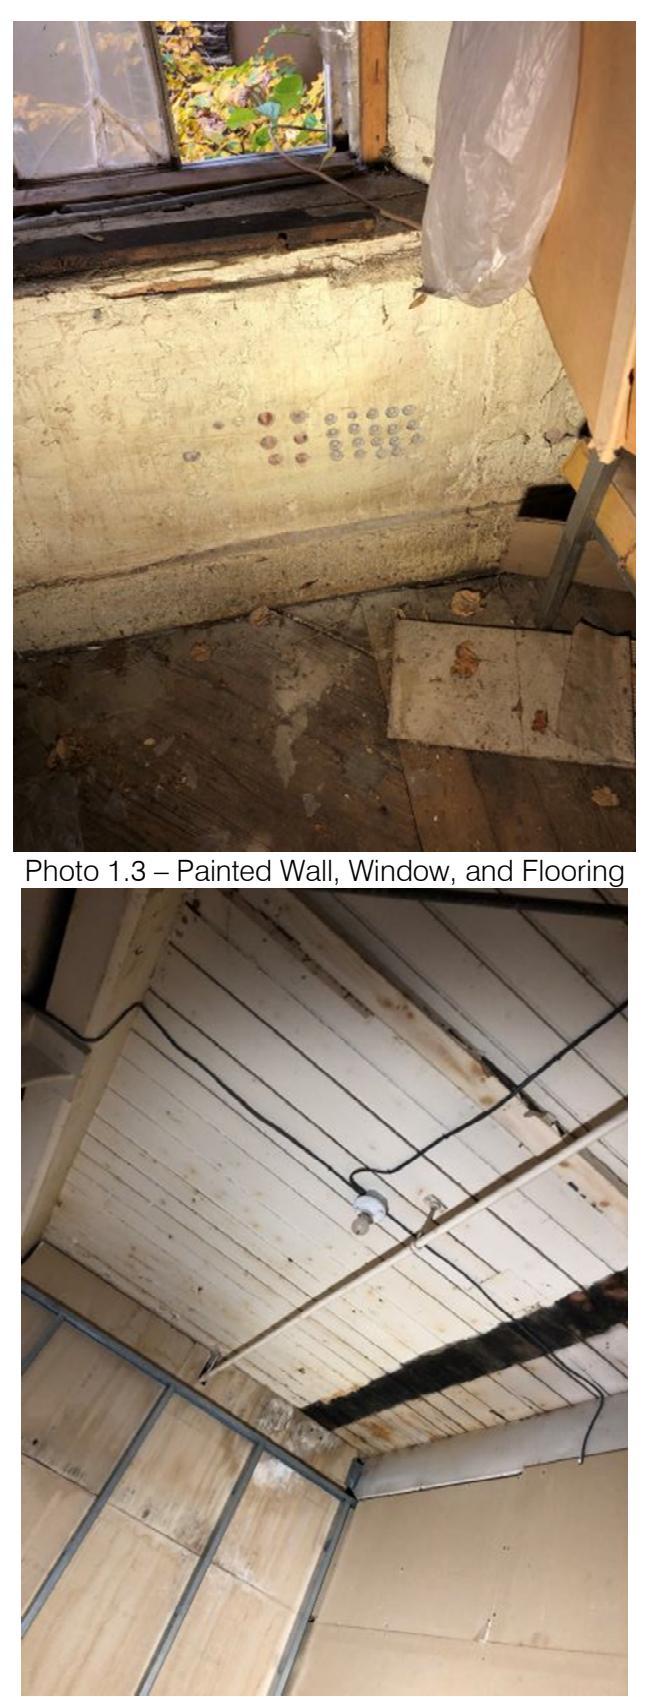
Photo 2.1 – Painted Ceiling and Temporary Walls for Self-Storage Units

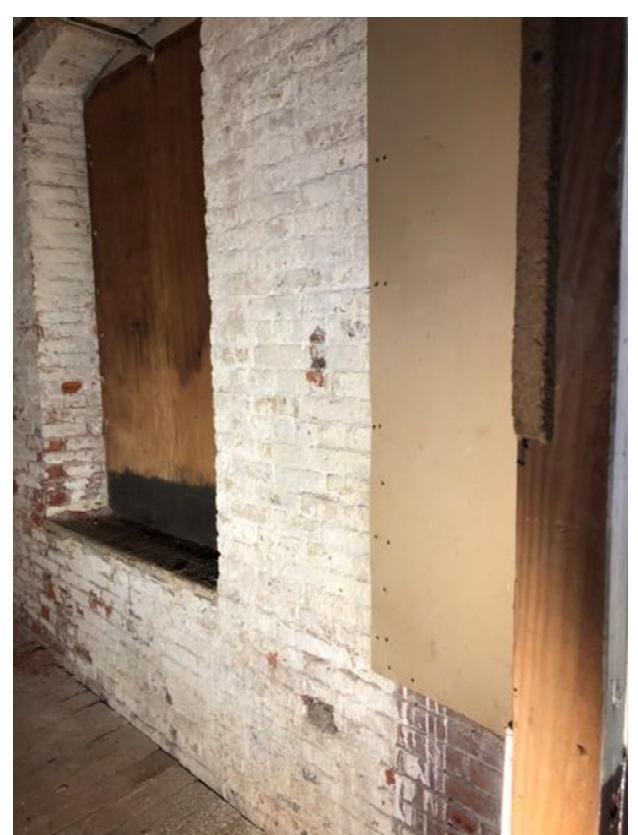
Photo 2.2 – Painted Wall, Boarded Up Window, Temporary Construction Wall

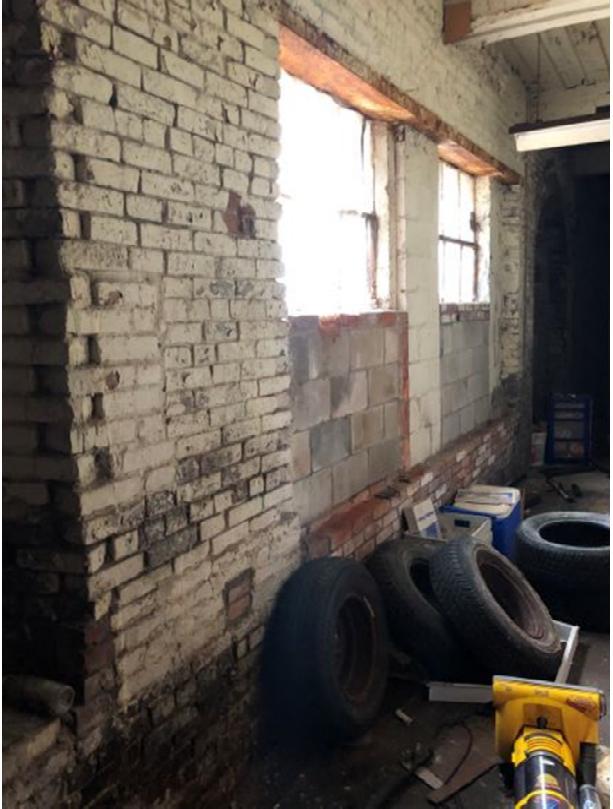
Photo 2.3 – Painted Brick Wall, Replacement Windows, Debris

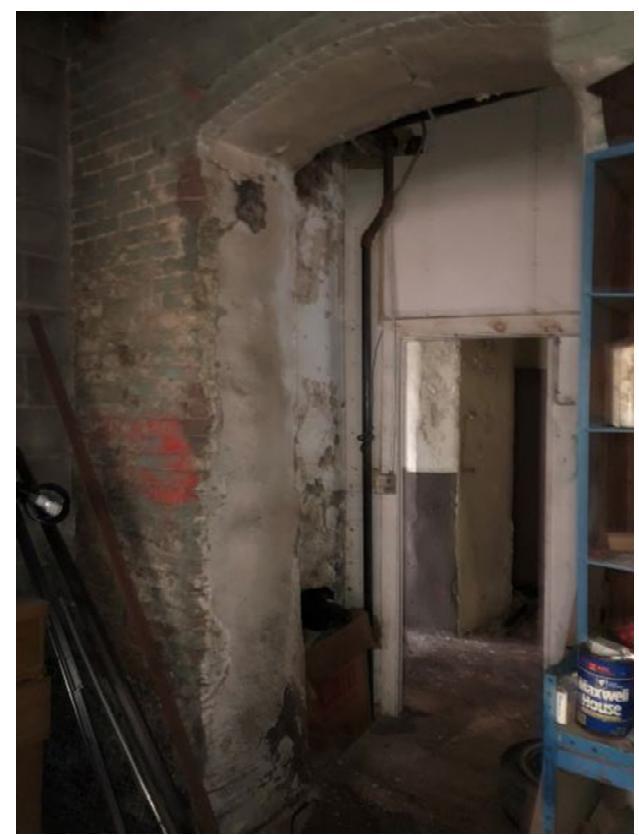
Photo 2.4 - Original Brick Framed Internal Doorway and Painted Walls

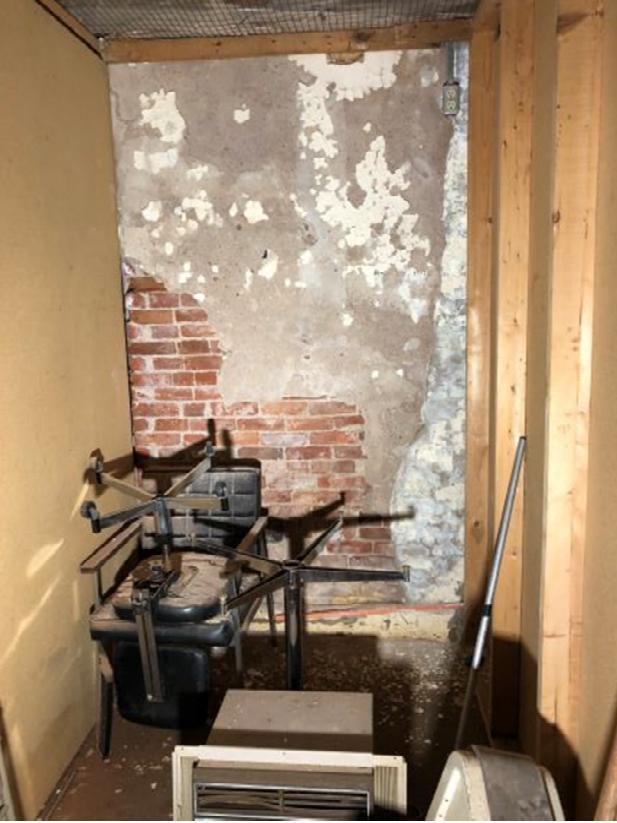
Photo 2.5 – Typical Self-Storage Locker Construction and Debris Within

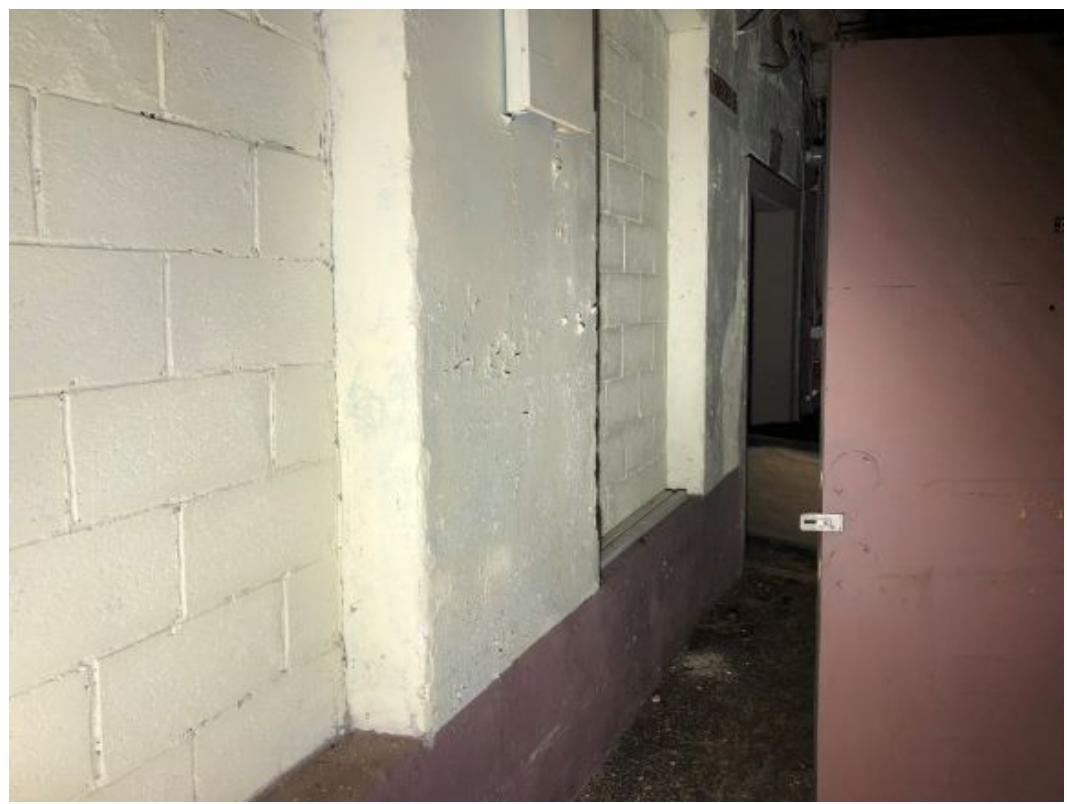
Photo 3.1 – Typical Cream and Maroon Painting Third Floor Self-Storage Area

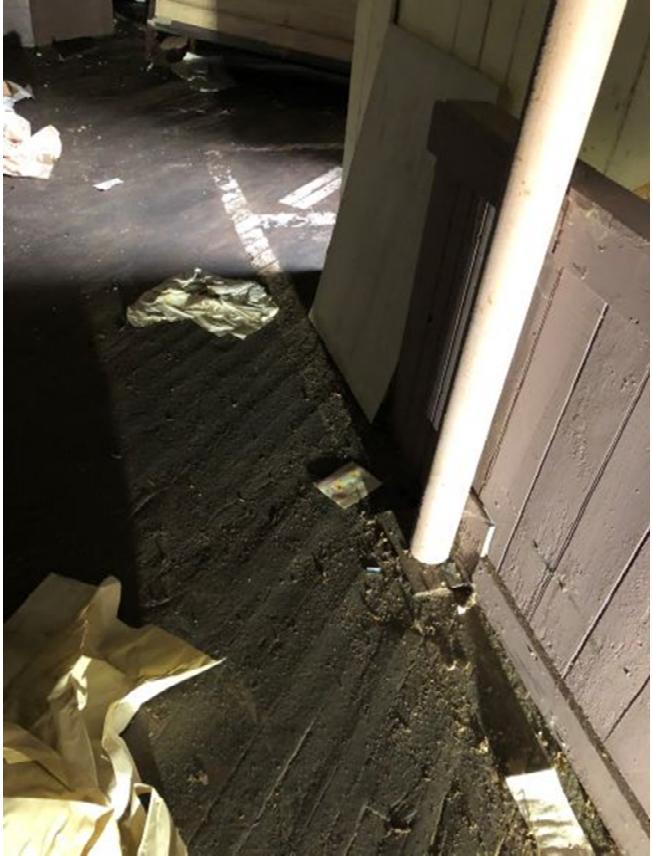
Photo 3.2 – Typical Flooring Condition

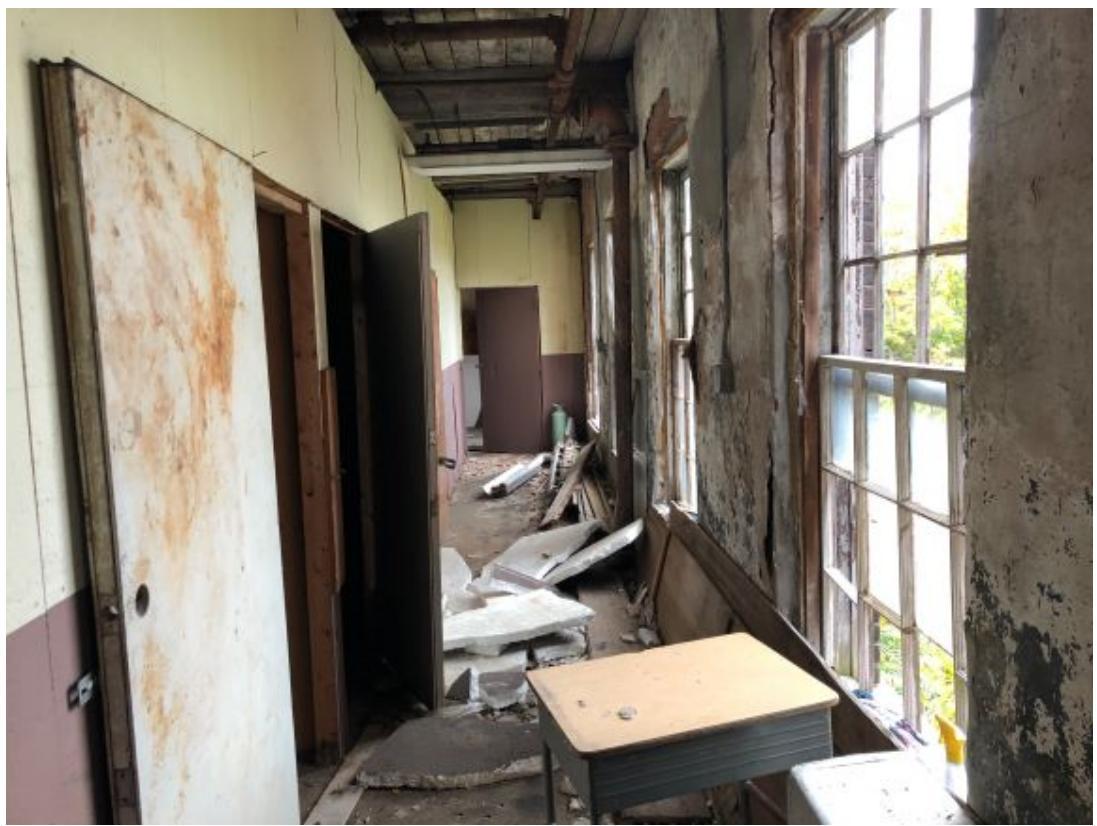
Photo 3.3 – Typical Storage Lockers, Windows (no caulk), and Debris

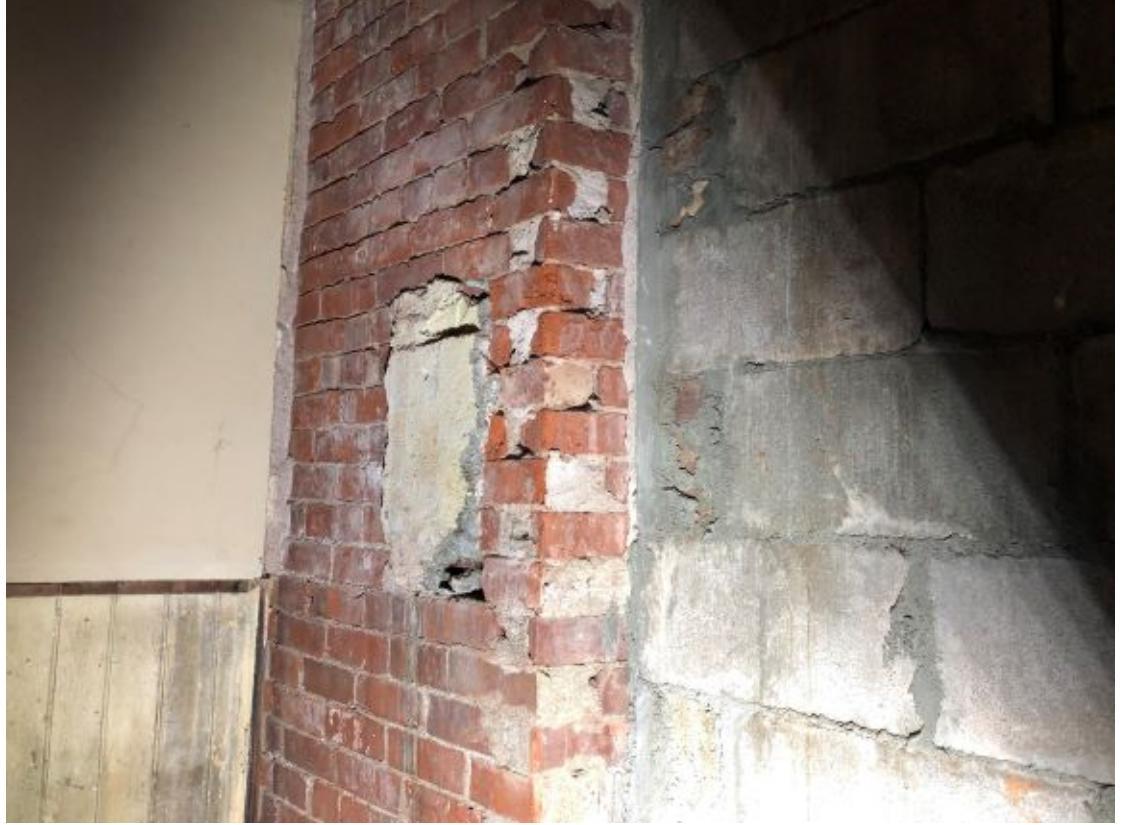
Photo 3.4 – Temporary Constructed Wall with Bricked Up Window

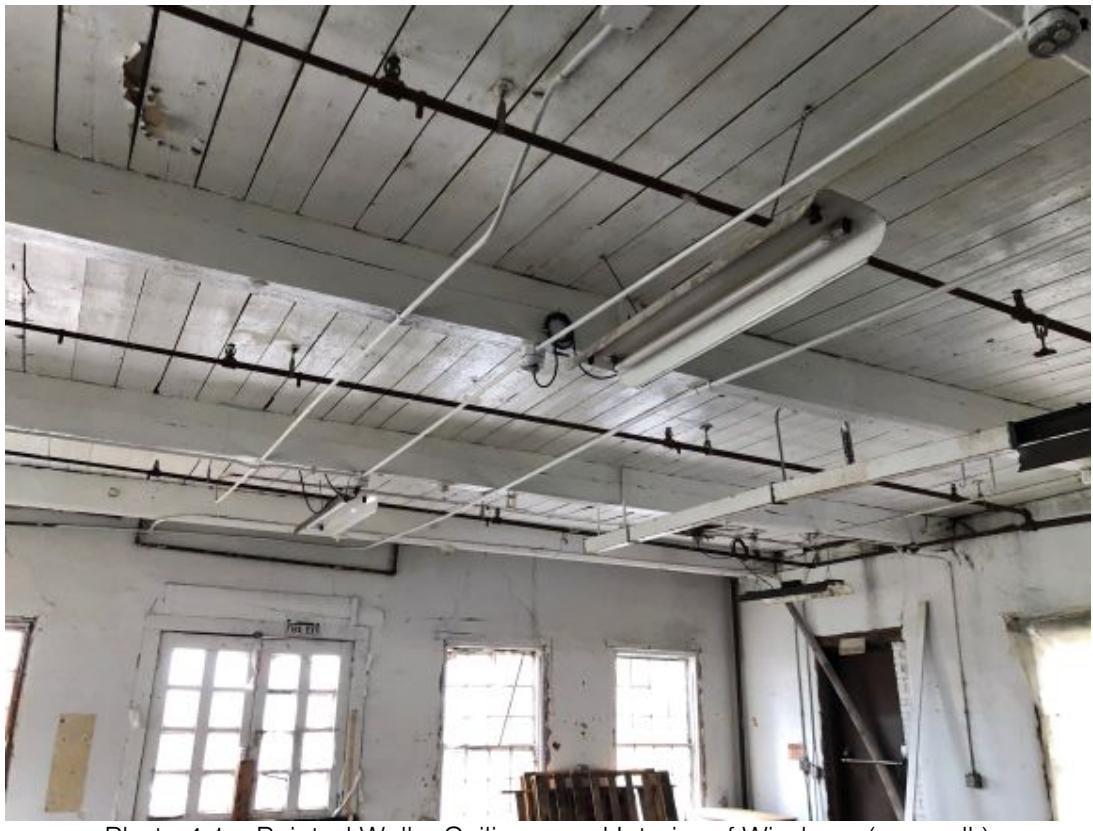
Photo 4.1 – Painted Walls, Ceilings, and Interior of Windows (no caulk)

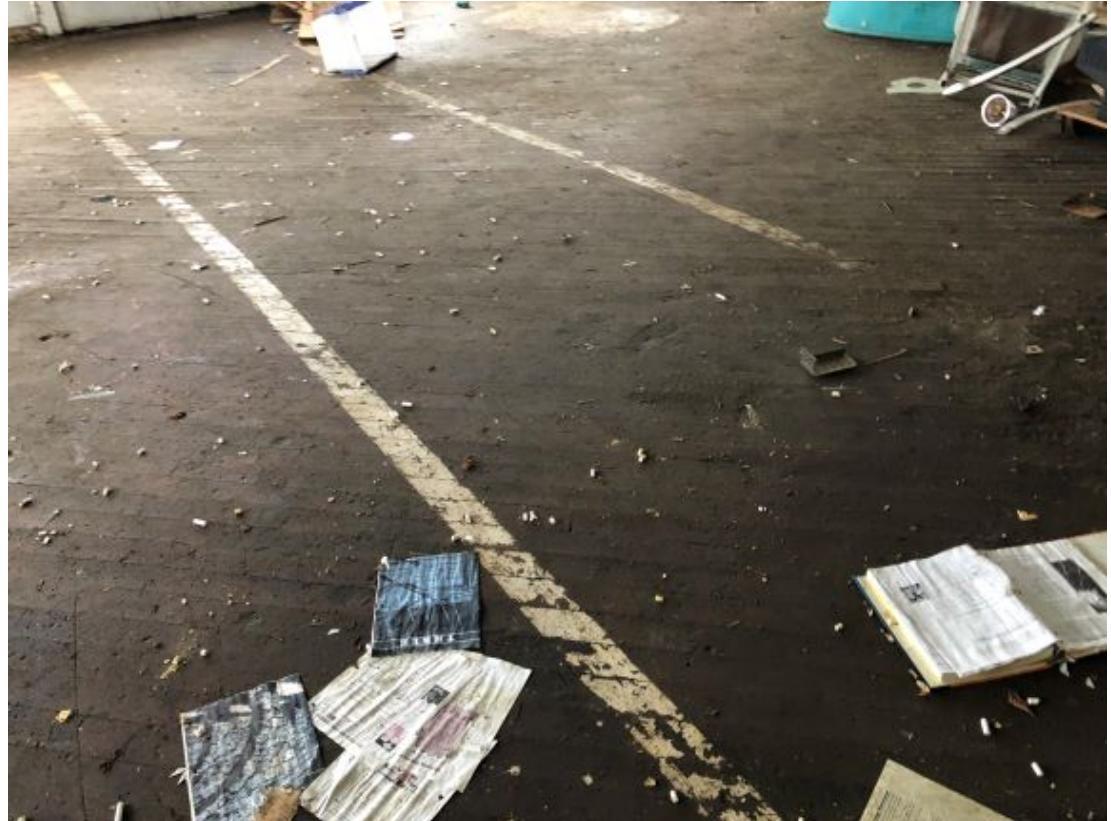
Photo 4.2 – Typical Flooring

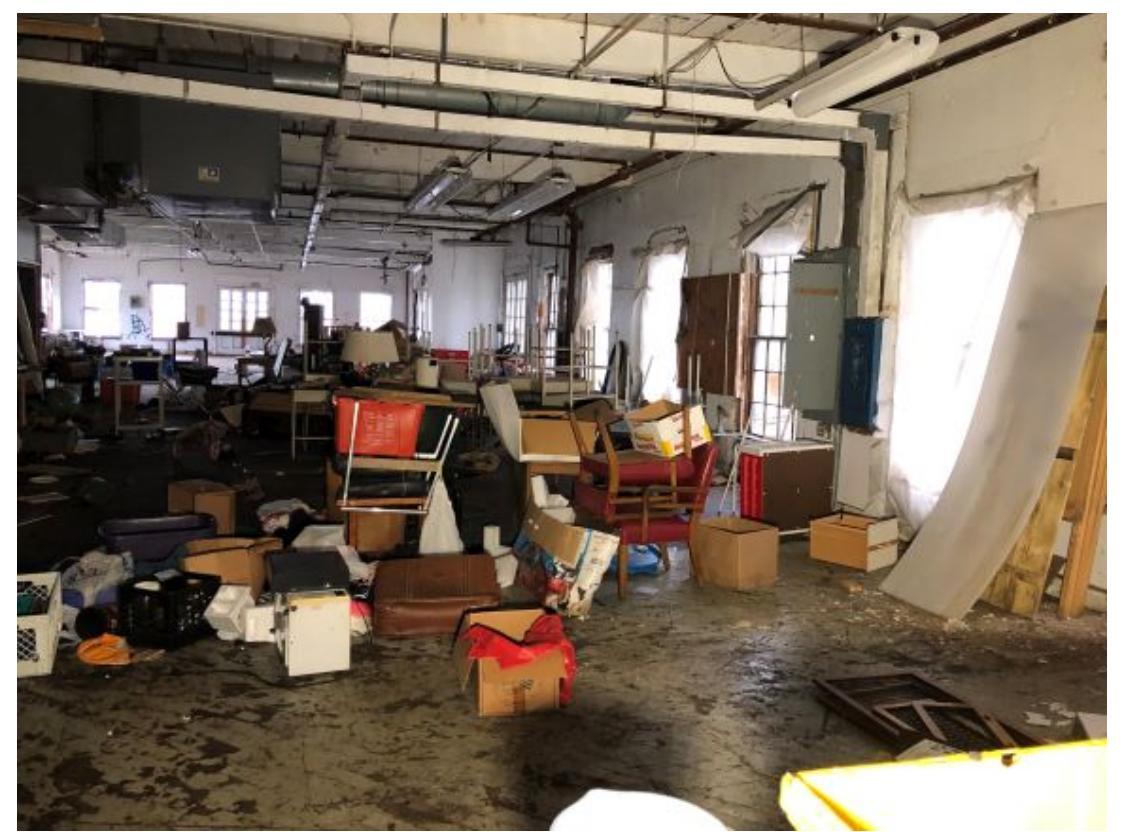
Photo 4.3 – Typical Debris

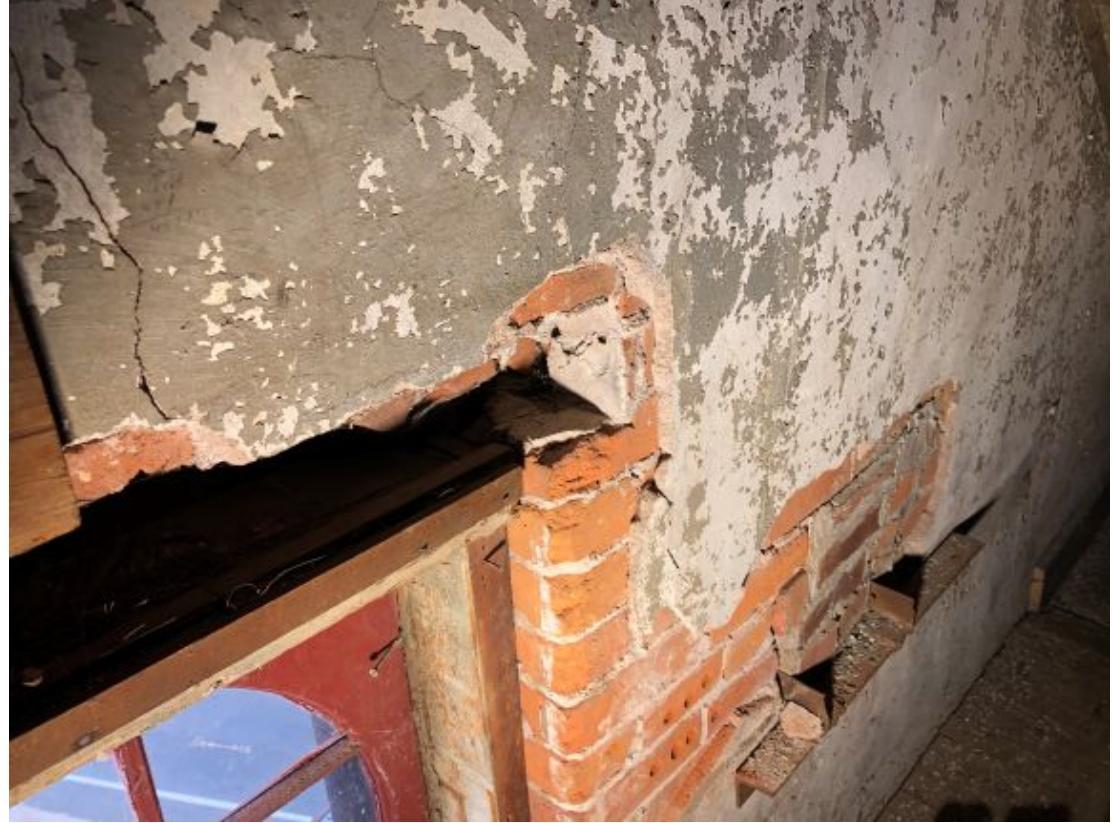
Photo A.1 – Typical Painted Plaster on Brick Wall and Window (no caulk)

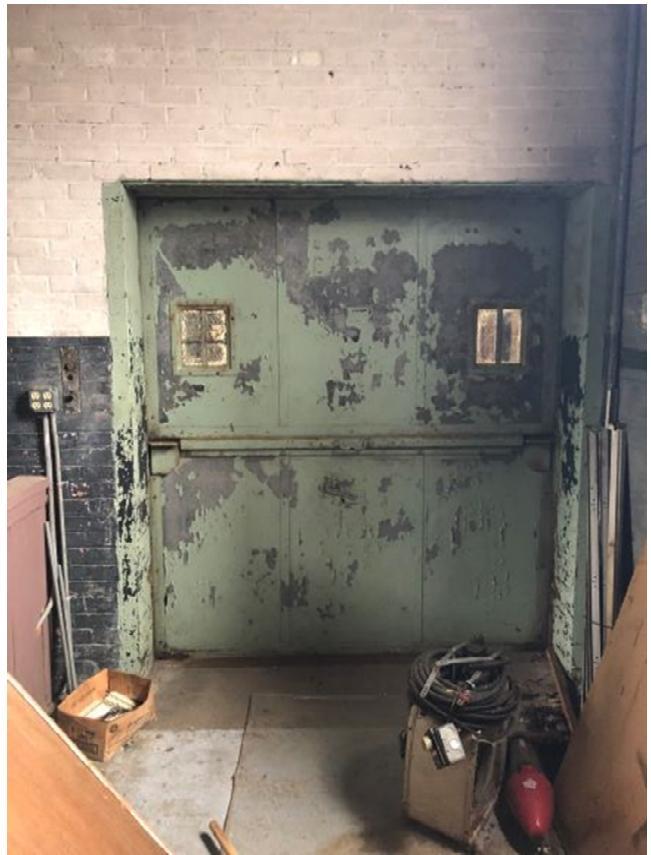
Photo A.2 – Painted Elevator Doors

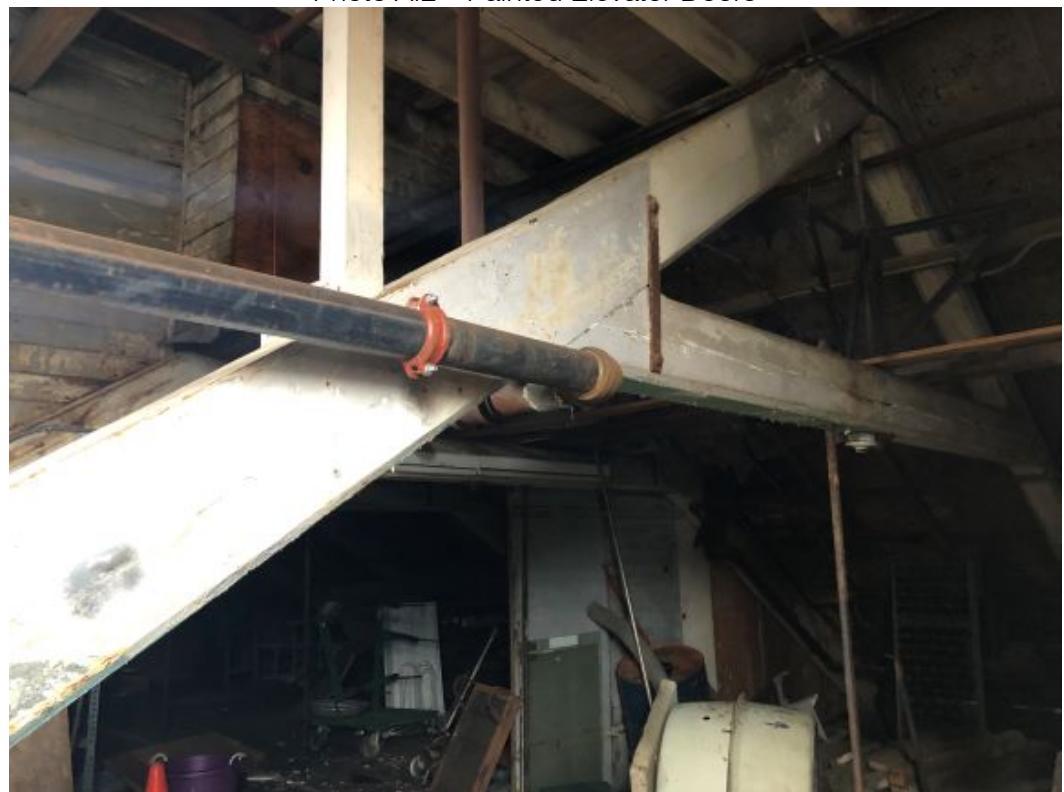
Photo A.3 – Painted Structural Roof Trusses

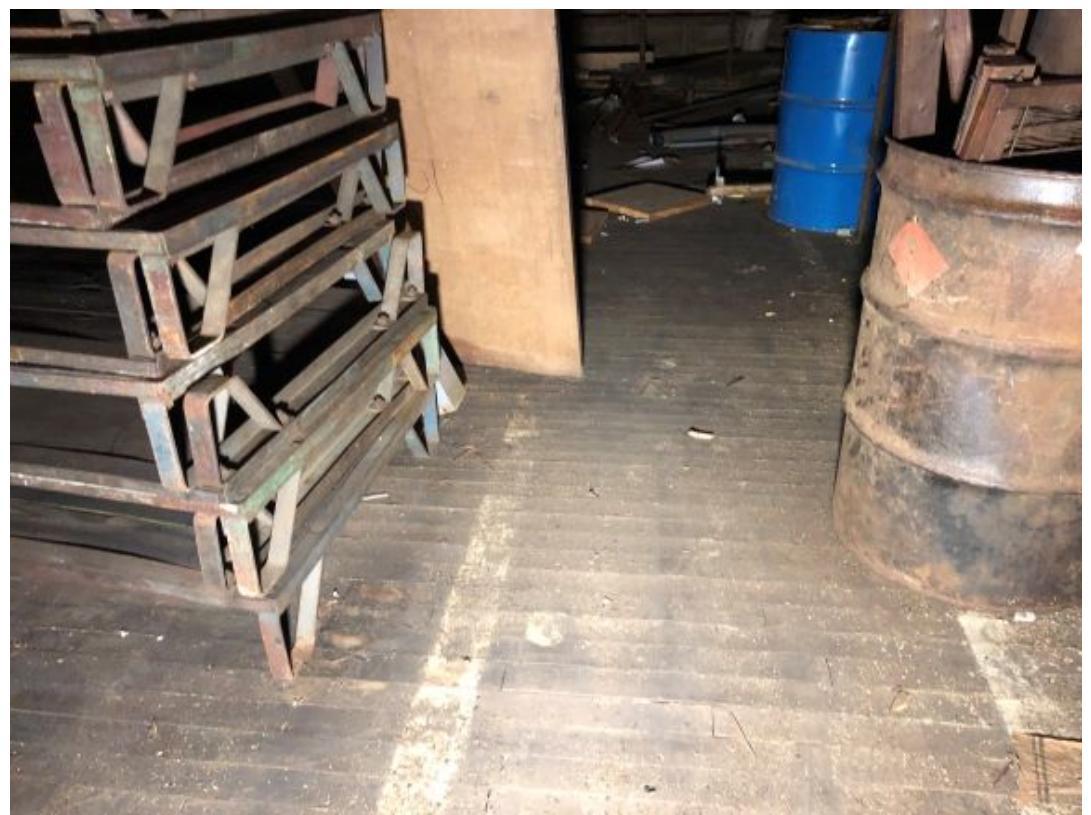
Photo A.4 – Typical Flooring

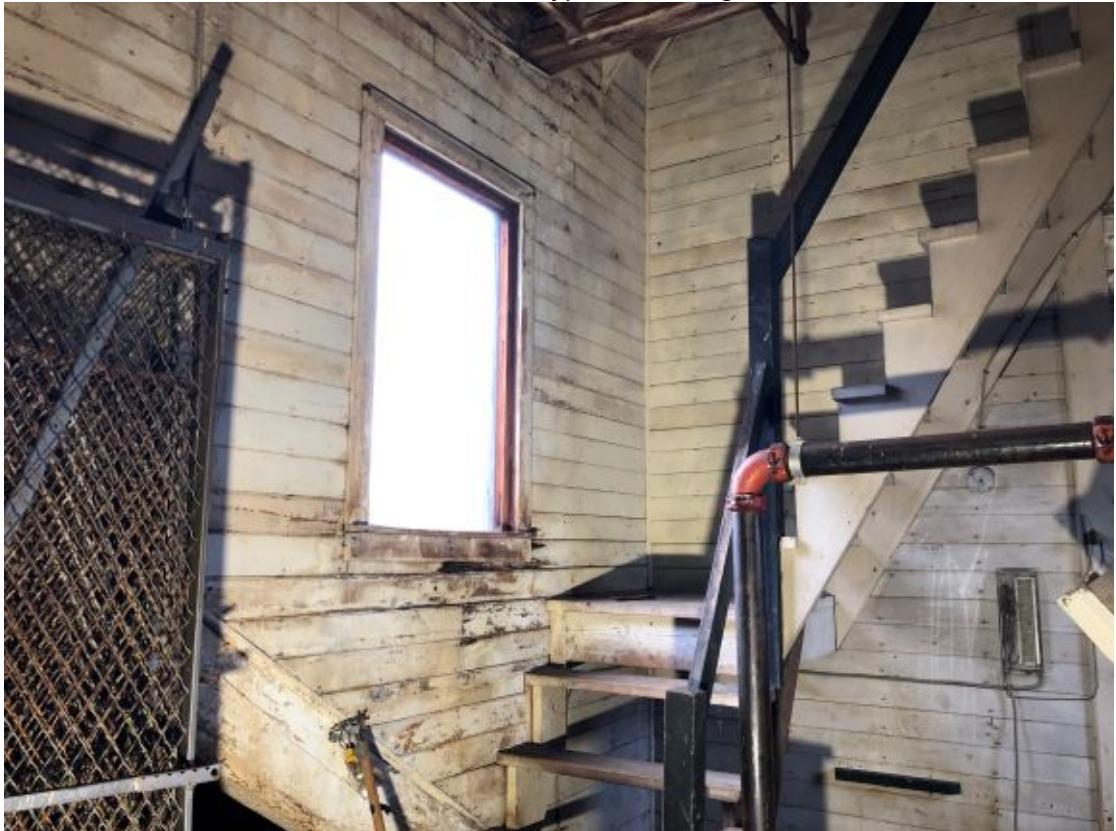
Photo A.5 – Typical Paint on Walls
