District-Wide Facilities Study May 3, 2019

## LOWER MORELAND TOWNSHIP SCHOOL DISTRICT DISTRICT-WIDE FACILITIES FEASIBILITY STUDY May 3, 2019

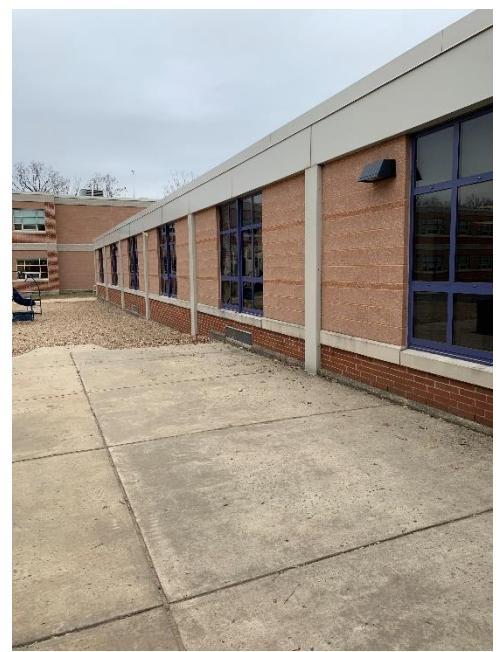
Exterior windows

The façade is masonry brick veneer with concrete accents at the floor line and columns. The original building's exterior was stripped and rebuilt in 2003; new windows were installed at this time. Some leaks occur by the window flashing, and these are repaired as needed.

Issues to consider: Continue to repair leaks as needed.

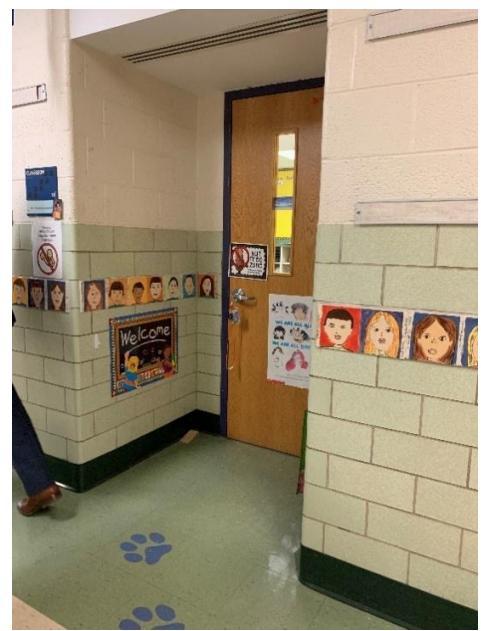
Non-compliant door clearances

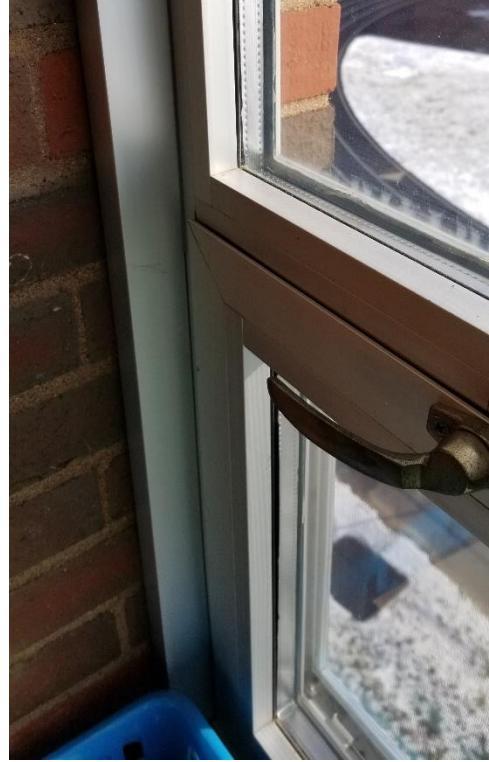
Portion of exterior classroom window

Re-caulk windows as part of regular maintenance.

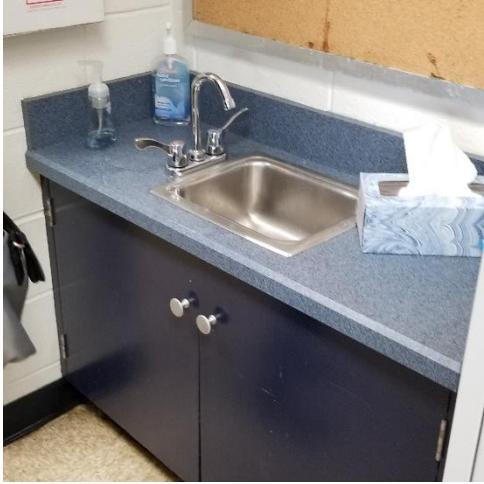
Not compliant classroom sink

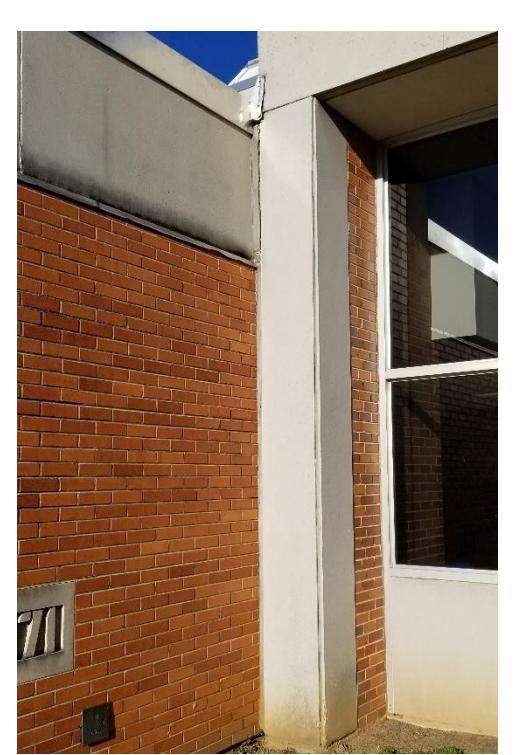
Portion of concrete structure at exterior

Issues to consider: Repoint brick in areas of heavy efflorescence and mortar disintegration.

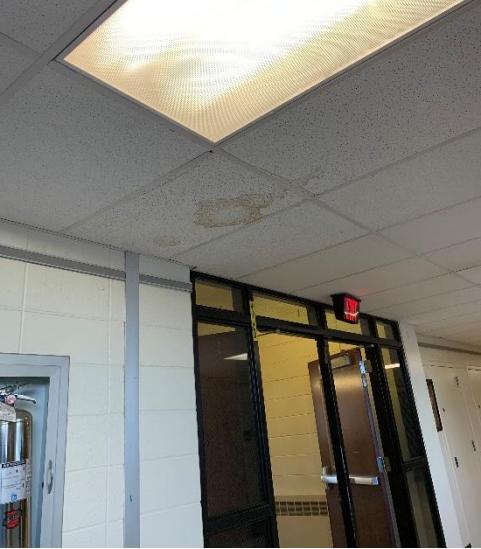
Leaks from roof on ceiling tile in corridor

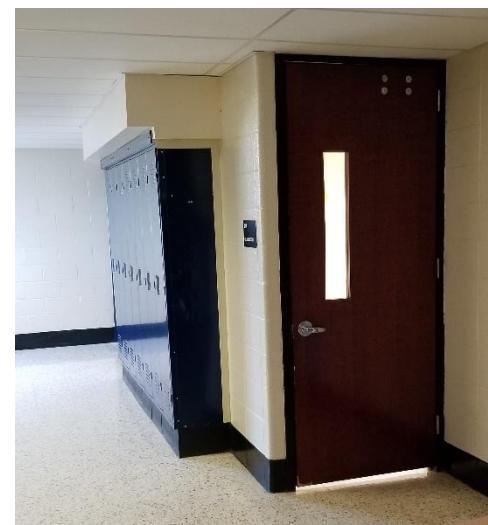
Non-compliant door clearances

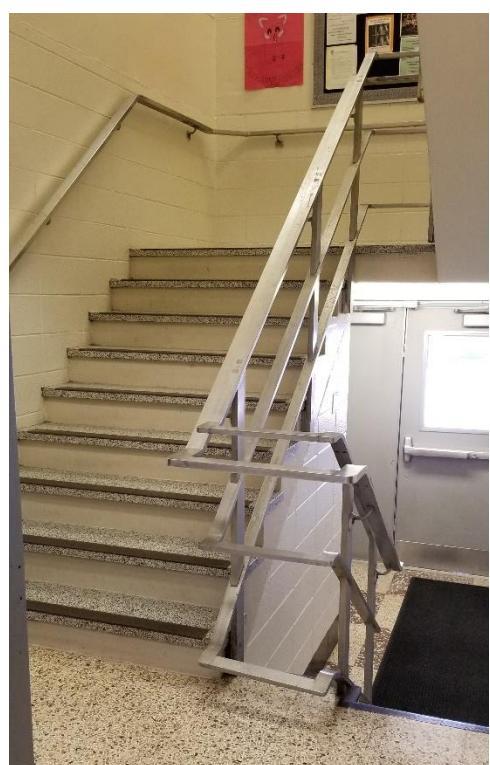
Non-compliant guards
