# School District of Onalaska 2018 Facilities Condition Assessment April 24, 2018 - Final

# FACILITIES CONDITION ASSESSMENT Onalaska School District Onalaska, WI 54650

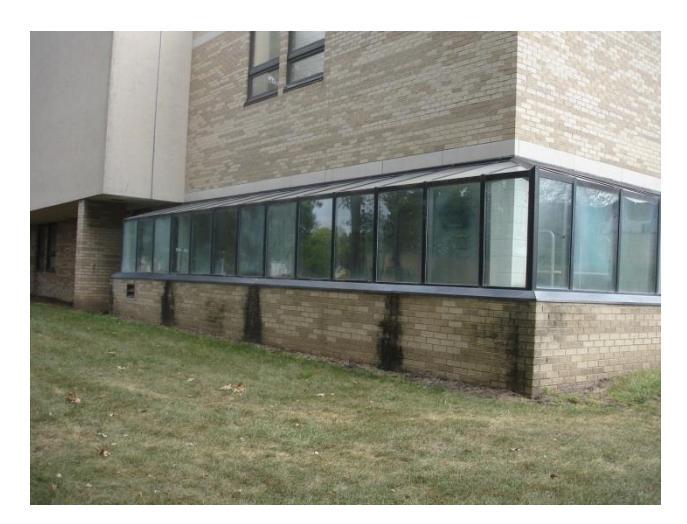
In general, the exterior face brick remains in very good condition with limited areas that should be cleaned of stains. Two locations on the west end of the building exhibit minor cracking that could easily be repaired. Mortar joints appear to be in satisfactory condition with various locations requiring re-pointing.

The stained brick walls below the greenhouse projection off the west end of the building were cleaned as part of the glass window replacement project.

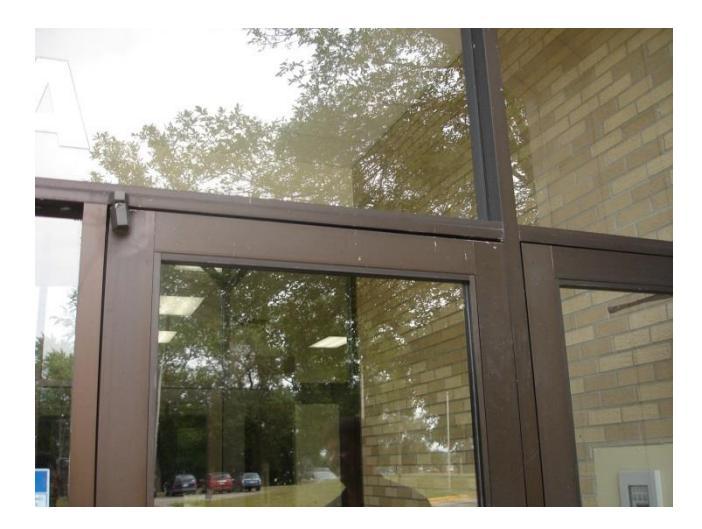
Hollow metal doors and frames are also showing signs of aging, with corrosion and general deterioration. Future maintanence related projects should be considered to include replacement of the exterior hollow metal doors and frames, which would also allow the restoration of any steel lintels above the door (and window openings).

All aluminum entrance doors, entry windows, hollow metal doors and framing are scheduled for replacement in 2018.

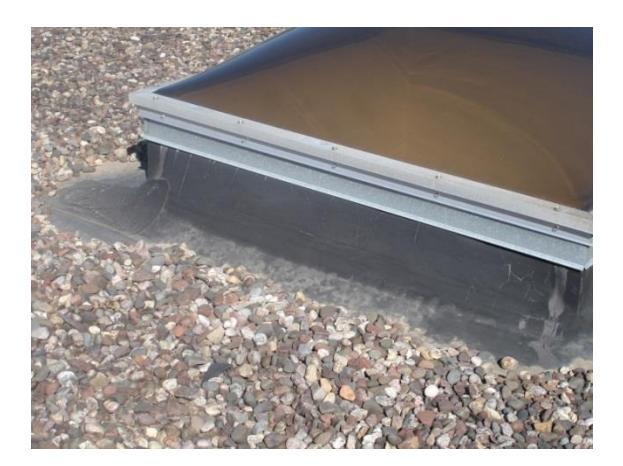
The typical shrinkage of the single-ply membrane roofing was noted to be expected for a roof approaching 24 years of age. The shrinkage primariliy shows up where the rubber membrane is pulling away ('tenting') from the vertically flashed face of the wall. It was recommended that the perimeter membrane be cut and reflashed with reinforced perimeter strip. Roof curbs for mechanical equipment and skylights should also be reflashed.

Properly maintained, the lifespan of the existing roofs could be extended indefinitely or at least added to the list of deferred maintanence projects. The decision to re-roof areas of the high school may be evaluated on a cost basis that compares the cost to repair the perimeter flashings and seams versus tear-off and replacement of the entire rubber membrane.

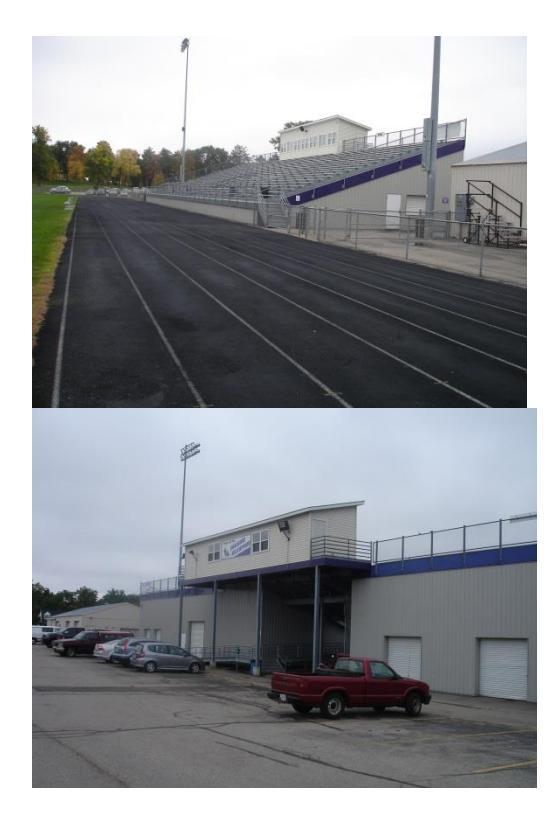
The main bleacher facility is located at the west edge of outside lane of the running track and was originally constructed without an underneath closure. The framing consists of steel substructure with aluminum bench seating and galvanized steel guardrails.

The underside was closed off with prefinished ribbed metal wall panels to provide secure storage for P.E. equipment and field maintenance equipment. The north end serves as concession sales. A wood framed press box was added in the 1990's and supported by wide flange steel columns. The west wall of the enclosed understructure includes three push-up coiling doors and three similar coiling counter doors at the concessions sales corner. With exception of the press box, the main structure and seating assemblies appear to be in satisfactory condition.

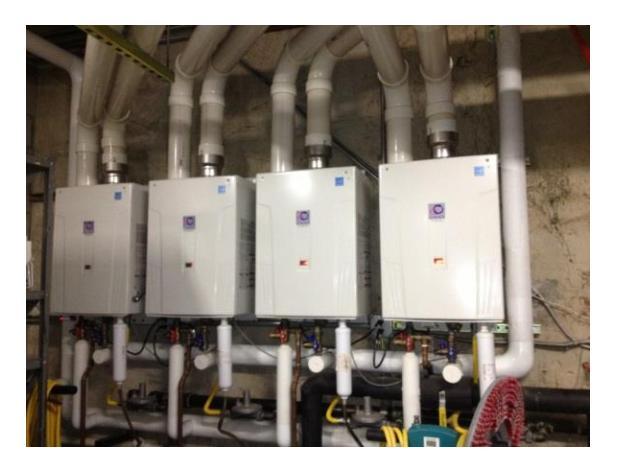
- Water heating equipment is gas fired instantaneous water heating equipment. Currently 4 units provide adequate hot water for the building. The units are in good condition and are operating well.
- 2. The building is served by a duplex water softener. The water softener is softening all domestic water and some cold water serving equipment.
- The Tech ED air compressor is an older model however it is operating well. The daily demand on the unit is relatively low. Would expect it to function properly for years to come.

1. Instantaneous water heating equipment is required to be maintained for scale on a regular basis. Annual maintenance shall be provided on equipment as required.

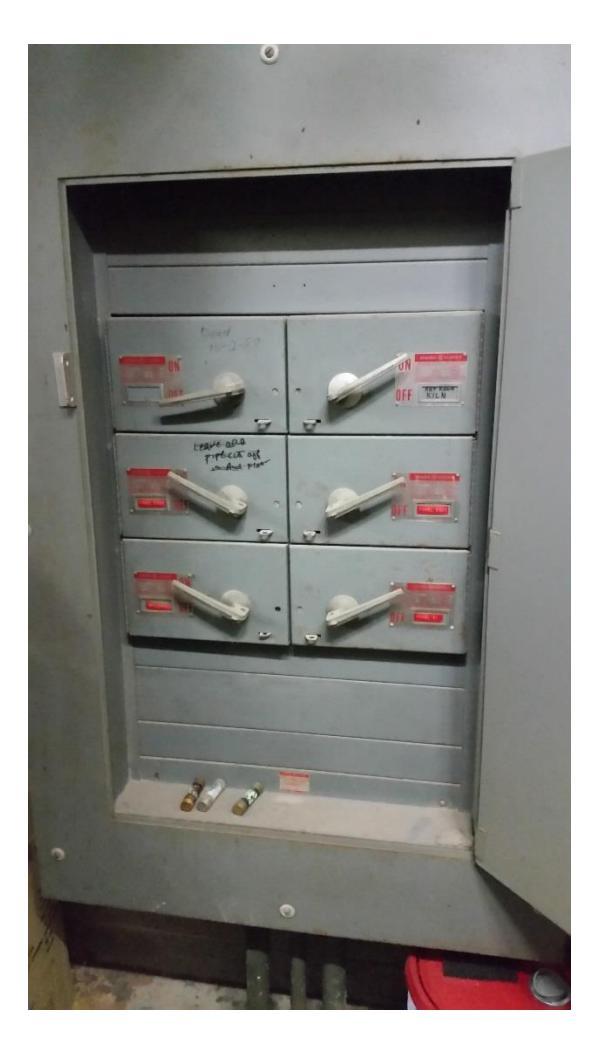
- A. The main service switchboard does not have a surge protection device.
- B. The existing 1960 Switchboard located in what is referred to as the 'Laundry Room #211C should be removed and replaced with new. This switchboard feeds an existing air handling unit, Woods and Metals Shop Panelboards, Panel LCF-2 and unknown Panels. Switchboard is fed from the 1968 Switchboard.

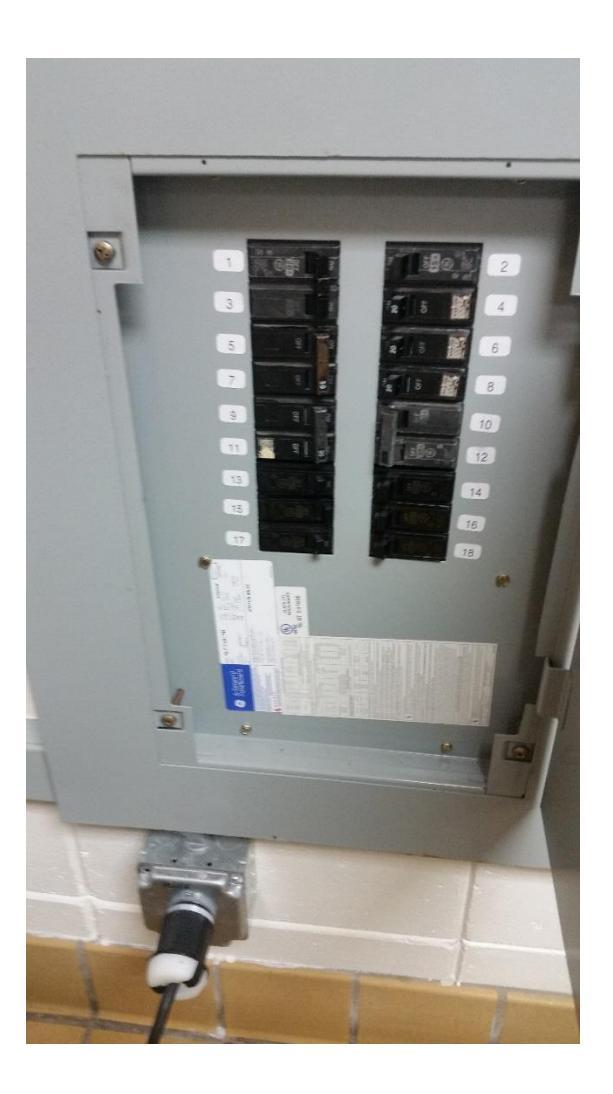
- A. The panelboards are generally full and do not have space for additional circuit breakers.
- B. The panelboards that were installed in 1968 are at the end of their useful life due to the operating lifespan of circuit breakers.
- C. The panelboards that were installed in 1988 are in good working order. However as noted above are full and have minimal space for additional circuit breakers.
- D. In the Kitchen by the Service Line, the panelboard is full and should be replaced with a new larger panelboard. It is also the opinion of this writer, the existing panelboard should be relocated to a better location. \$4,000.

- A. Replace the 1968 panelboards and feeder wire with new. New circuit breakers will allow for a safer and more expandable installation. \$7,000 EA for a Total of \$140,000.
- B. Provide one additional panelboard located adjacent to each 1988 panelboard. Observed a minimum of Seven (7) additional panelboards required. \$4,000 Each for a Total of \$28,000.
#### Generator

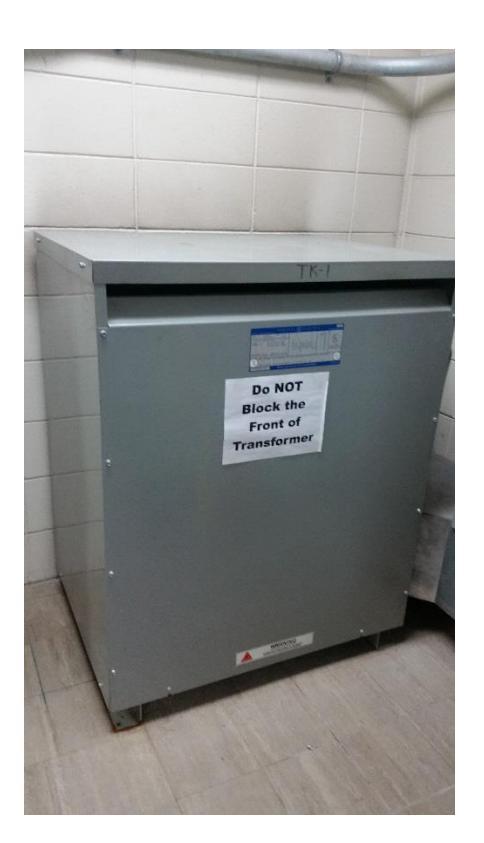
A. In the room referred to as 'Fire Alarm Control Panel" there is an existing 225 KVA, 480 VAC, Delta primary, 120/208 VAC Y Secondary transformer which is excessively noisy and distracting to personnel and students in the adjacent offices and classrooms. It is recommended that this transformer shall be replaced with a less noisy and more energy efficient transformer. \$8,000.

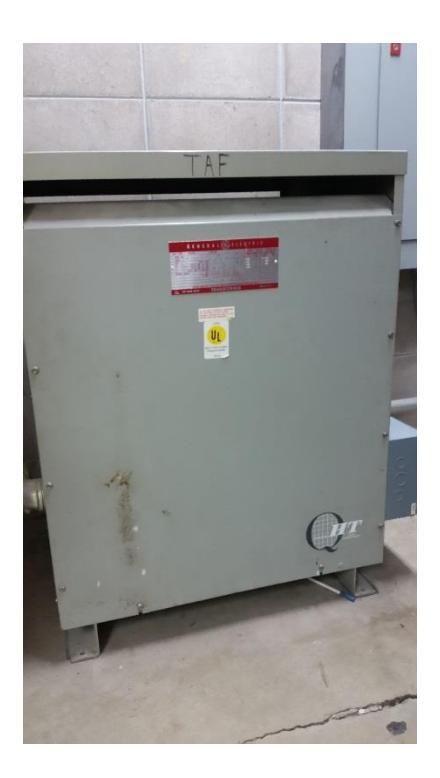
B. In the room referred to as 'LMC Transformer Room" there is an existing 112.5 KVA, 480 VAC, Delta primary, 120/208 VAC Y Secondary transformer which is excessively noisy and distracting to students in the adjacent classrooms. It is recommended that this transformer shall be replaced with a less noisy and more energy efficient transformer. \$6,000.

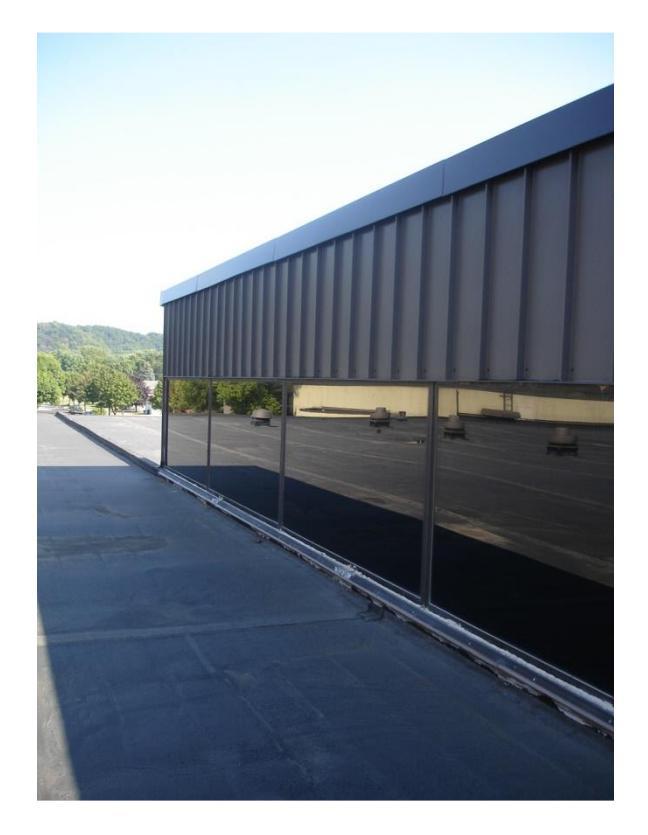
The 2006 re-roofing appears in satisfactory condition. The ballasted roof system above the 1999 Central Kitchen addition also appears in satisfactory condition with no significant signs of deterioration.

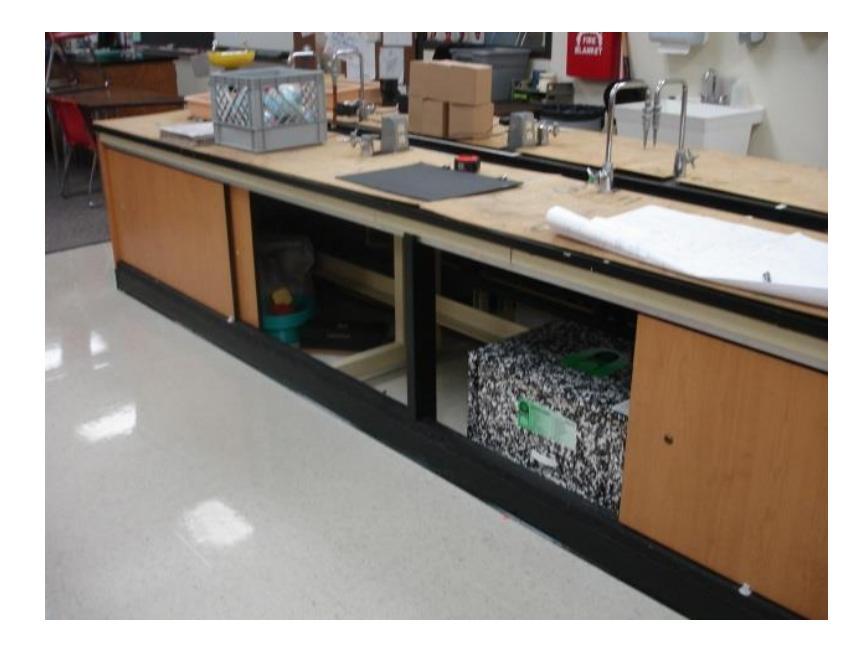
The original lab work counters are still in place and consists of epoxy resin countertops on a steel framed support system. The work surfaces are worn and shows the signs of 30+ years of use. Sliding wood panel fronts were added as a means to close off the undercounter space and to conceal storage of boxed science kits.

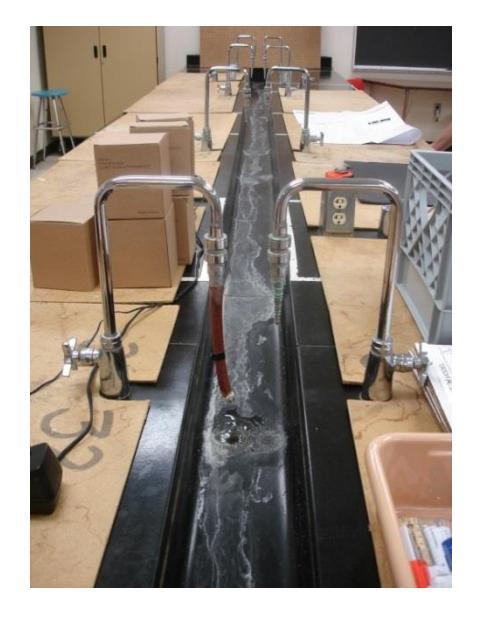
The epoxy resin counters include a continuous shallow depth drainage trough that slopes to a single drain at the end of the sections of countertops. Gooseneck water faucets are positioned above the drainage trough but splashes water on countertop surfaces outside of the trough (poor design).

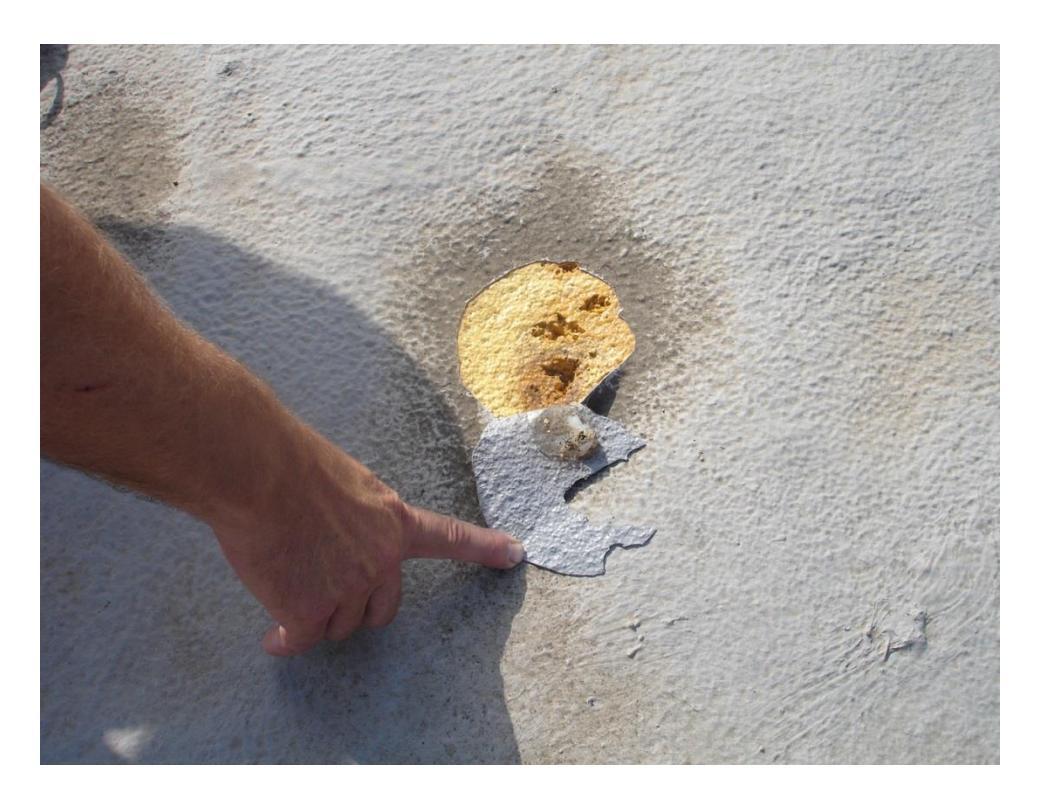
The foam roofs above the 1966 classroom/gymnasium wing will continue to require frequent inspections for holes thru the foam that will contribute to leakage into the interior. The foamed roof surface is irregular and allows water to pond before finding its way to the roof drains and scuppers. Damage from birds are often the source of creating holes in the foam which can expand over time.

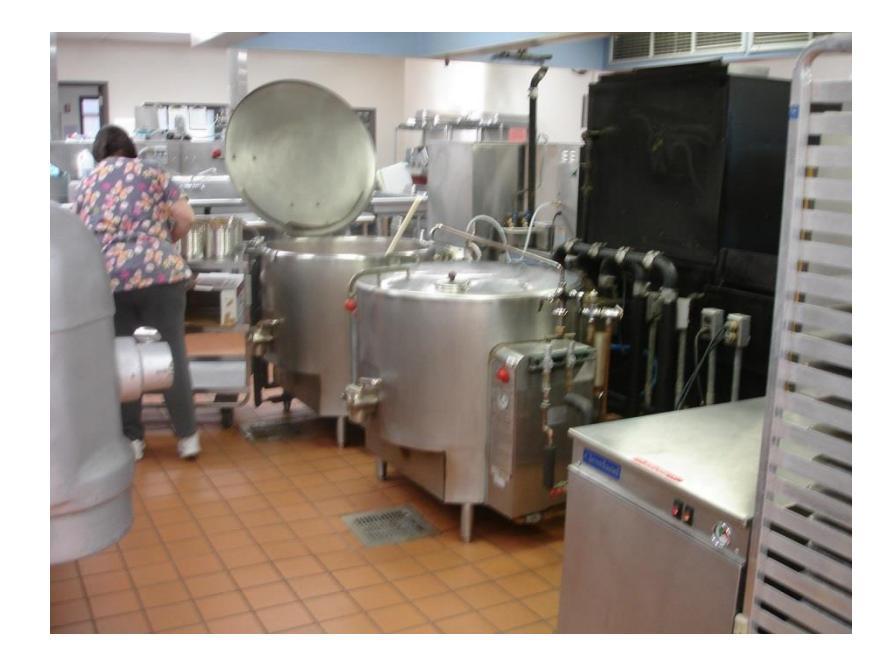
Equipment in the steam production area is still the original equipment. One of the two 60 gallon jacketed steam kettles was written up by the State inspector will need to be replaced. The steam kettles are approaching 40-years old and both will ultimately need to be replaced. Other old equipment that will need to be considered for replacement includes the 5-door steamer, two ovens, 2-burner stove, mixer and bread slicer.
