School District of Onalaska 2013 Facilities Condition Assessment October 10, 2013

2013 Facilities Condition Assessment School District of Onalaska

FACILITIES CONDITION ASSESSMENT Onalaska School District Onalaska, WI 54650

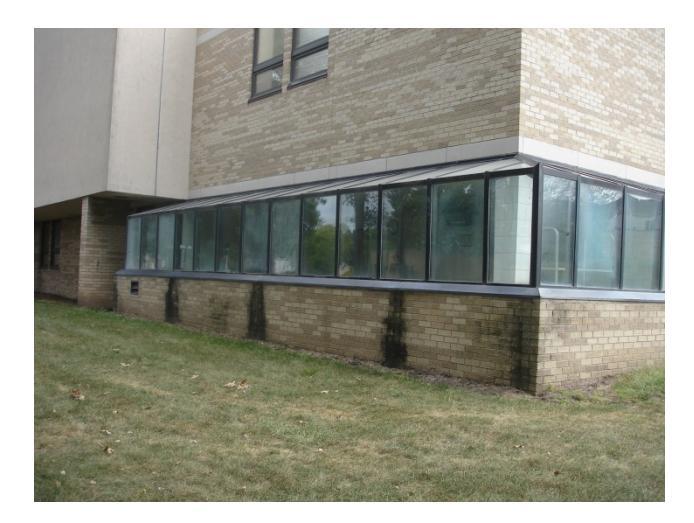
In general, the exterior face brick remains in very good condition with limited areas that should be cleaned of stains. Two locations on the west end of the building exhibit minor cracking that could easily be repaired. Mortar joints also appear to be in good condition and there should not be any immediate need for any re-pointing of the mortar joints. The brick walls below the greenhouse projection off the west end of the building exhibit the most visible staining of face brick. The stain appears to coincide with the greenhouse glazing sill flashing and may warrant inclusion into a maintanence project with higher priority.

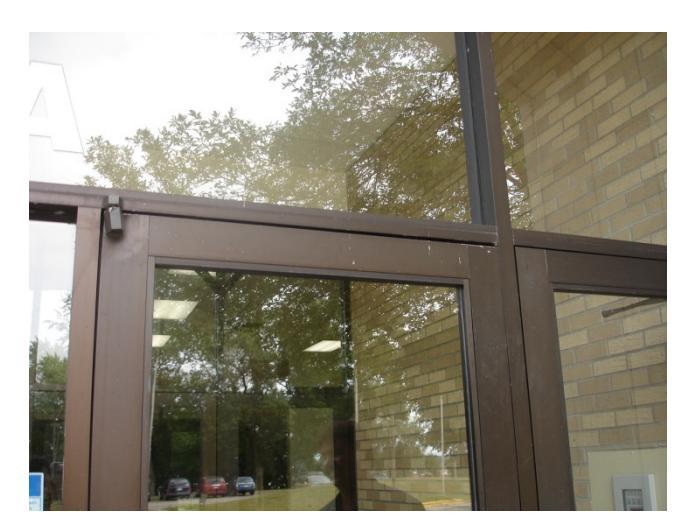
Aluminum entrance doors at the main south side entrance (Entrance 'A') exhibit signicant signs of wear and tear from the heavy usage.

Hollow metal doors and frames are also showing signs of aging, with corrosion and general deterioration. Future maintanence related projects should be considered to include replacement of the exterior hollow metal doors and frames, which would also allow the restoration of any steel lintels above the door (and window openings).

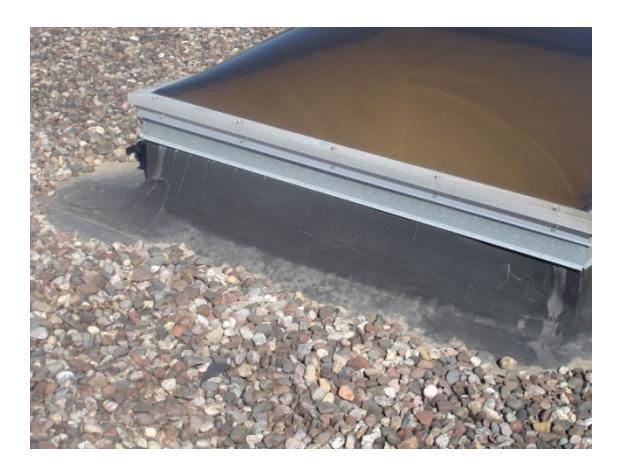
The typical shrinkage of the single-ply membrane roofing was noted to be expected for a roof approaching 24 years of age. The shrinkage primariliy shows up where the rubber membrane is pulling away ('tenting') from the vertically flashed face of the wall. It was recommended that the perimeter membrane be cut and reflashed with reinforced perimeter strip. Roof curbs for mechanical equipment and skylights should also be reflashed.

Properly maintained, the lifespan of the existing roofs could be extended indefinitely or at least added to the list of deferred maintanence projects. The decision to re-roof areas of the high school may be evaluated on a cost basis that compares the cost to repair the perimeter flashings and seams versus tear-off and replacement of the entire rubber membrane.

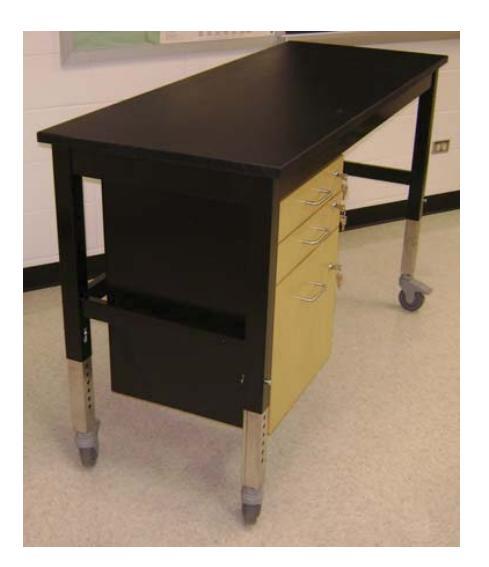
The perimeter countertop worksurfaces and student tables in the three biology and physics lab also appear to be in satisfactory condition given their age of 24 years. The student tables were originally movable and positioned in conjunction with floor pedestal type electrical receptacles. The tables were then anchored to the floor and conduit routed to the table aprons with receptacles.

- 1. An annual budgeted allowance should be established for the replacement of any of the original faucets or gas turrets that may begin to wear beyong the ability to make cost effective repairs.
- 2. None of the six science labs offer provisions for handicap accessibility. It is suggested that the District replace the instructor's demonstration tables with new ADA compliant tables and also purchase a movable and adjustable height table and worksurface that could easily be shared and utilized should it be necessary to provide for wheelchair access to the student workstations.

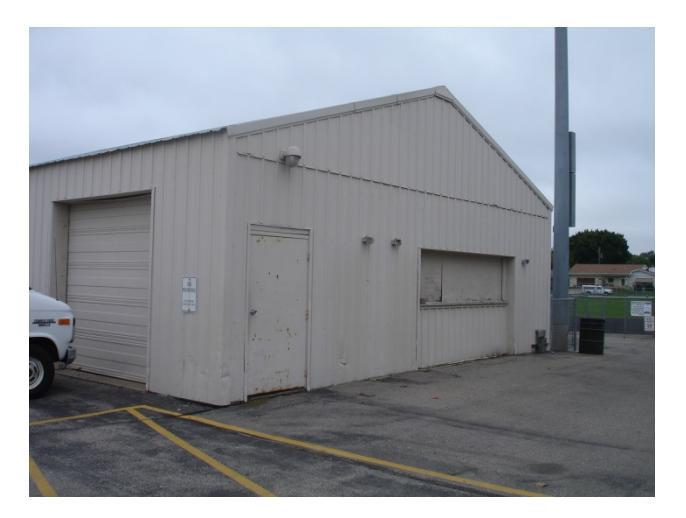
The vehicle garage building located just north of the grandstands was constructed as a simple pole barn structure, wood framed with corrugated metal siding and roofing.

The garage structure shows signs of wear and corrosion but can likely be used indefinitely. Overhead doors and swinging doors can be replaced, however the building in general appears to have deteriorated to the point of total replacement.

Continue usage of the building but schedule future building replacement when funds are Available.

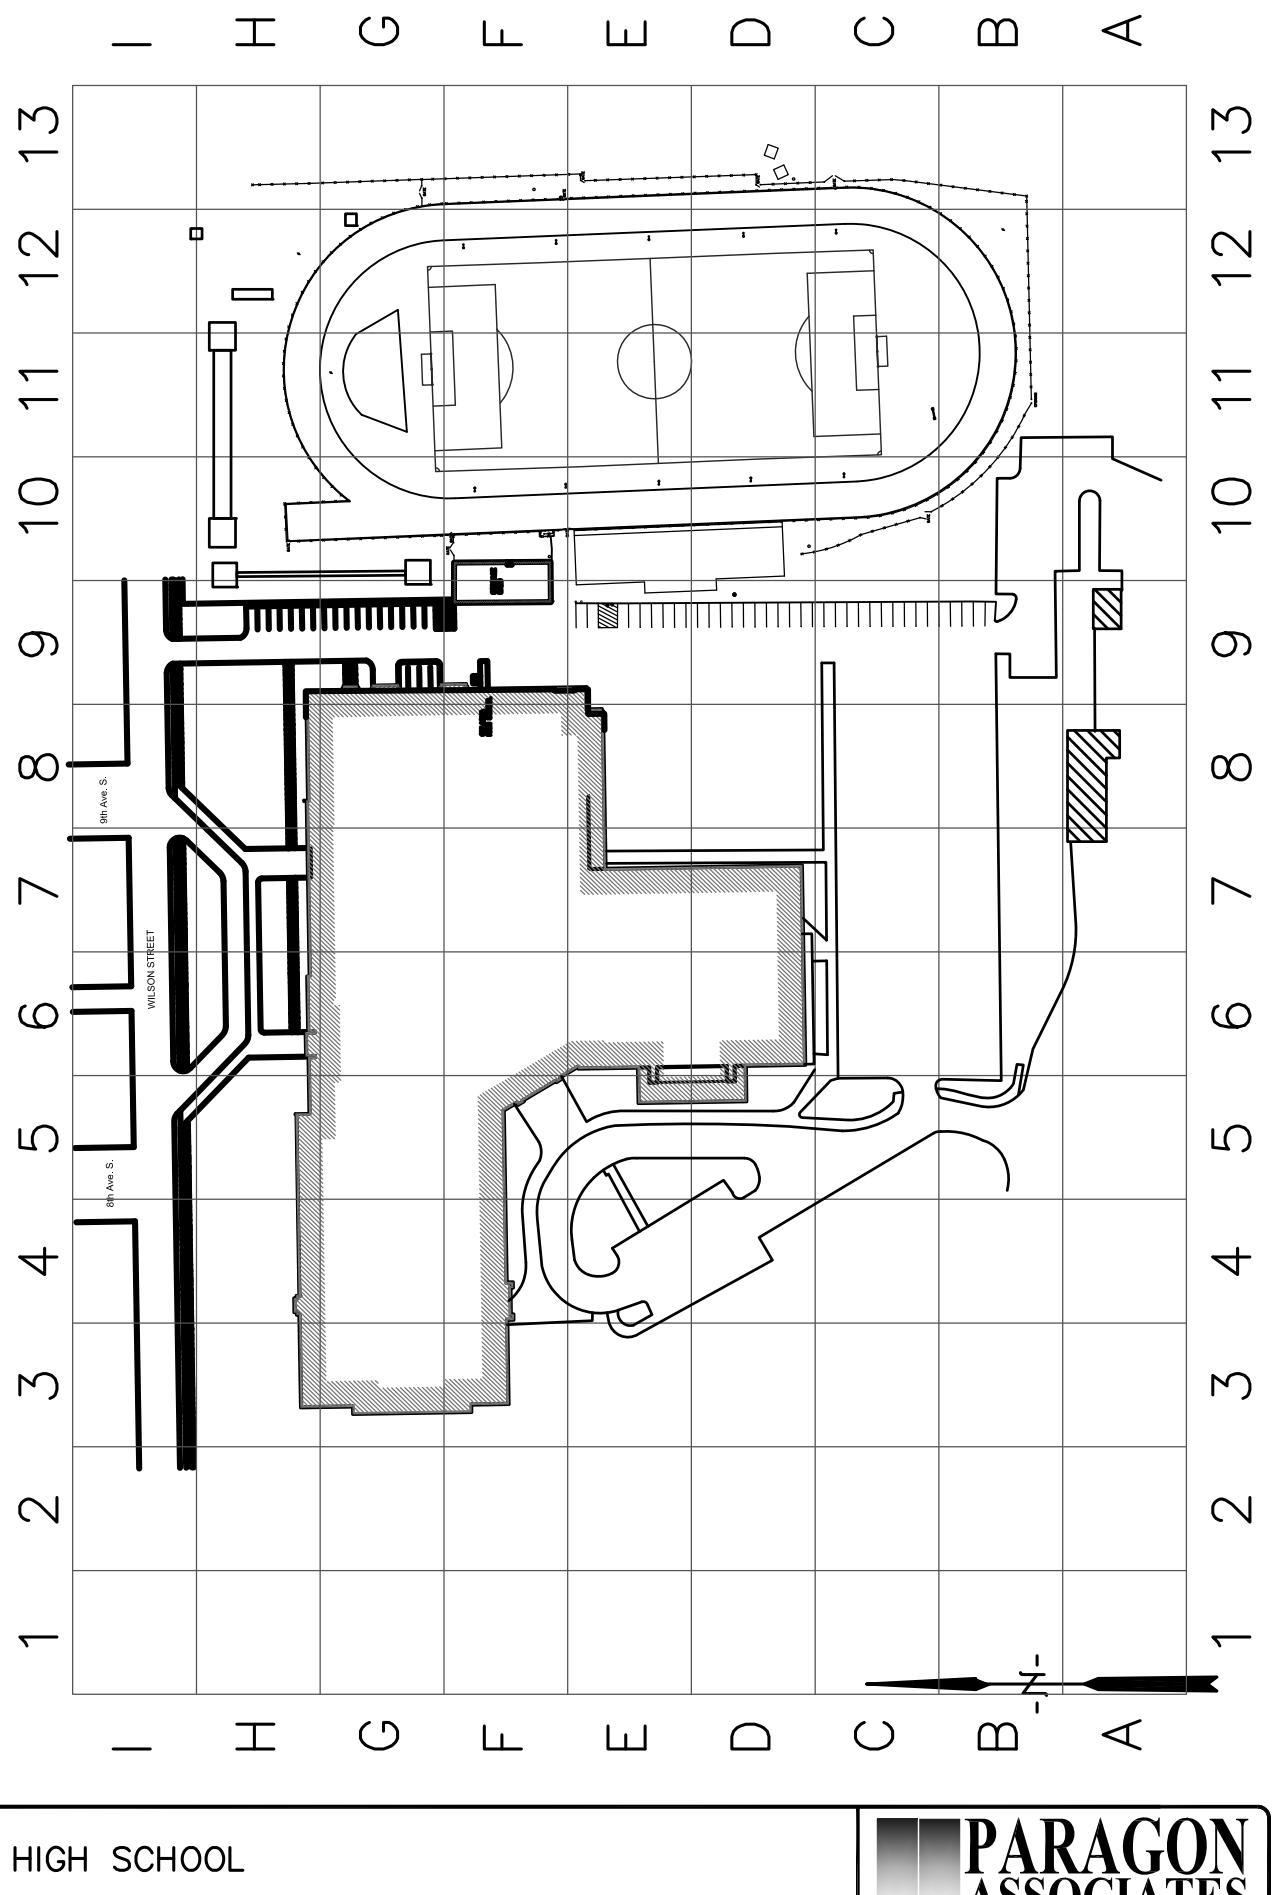
The Onalaska High School is a mature facility with much of the site infrastructure approaching the end of its useful life. In general, most of the asphalt pavement should be scheduled for replacement within the next 5 to 8 years. General weathering/disintegration of the pavement and rutting/ridging are the primary concerns. An area in sections C-7&8 is in particularly poor condition and should be reconstructed as soon as possible. Along the south edge of the building in sections C-6&7, sidewalk that is generally in good condition has sagged or heaved out of alignment with the curb and constitutes a critical tripping hazard that should be corrected as soon as possible. Much of the sidewalk could be salvaged by mud jacking into alignment. A similar situation exists at the drop off loop on the west side of the school. However, this appears to be the result of unusual freeze/thaw activity and some general differential settlement that could possibly be the result of a poor subgrade. The solution to this problem is more complex and is likely to involve a broad reconstruct of the entire area to provide a stable subgrade. This area of sidewalk is also in generally in good condition but the misalignment is also a critical tripping hazard that should be corrected as soon as possible. This will also provide an opportunity to correct some drainage issues in this area. Also, the parking area in the general area of section D-8 would be an excellent candidate for porous pavement and this would ameliorate the drainage issues by the stadium bleachers.

The running track surface is also showing signs of significant failure. There are a considerable number of patches already. The basic problem is that the rubberized surface is delaminating from the asphalt base. This allows the surface to move independently resulting in rips in the surface. Small patches of delaminated surface may be serviceable but large areas are not safe. We observed in the area of the west side up to 100 feet of continuously delaminated surface. Although we do not have specific survey data to know for sure what is causing the problem, delamination can be caused by inadequate surface drainage which allows ice to form under the rubber area that ultimately separates the rubber surface from the asphalt base.

Lastly, the site is not in compliance with ADA code for parking. As an older facility, improvements to surfaces such as slope changes are not required however, signing and striping are not "grandfathered" and where signing and striping can be implemented to create current code compliant parking it is required to be done at the time of ANY sealcoat and restripe operation.

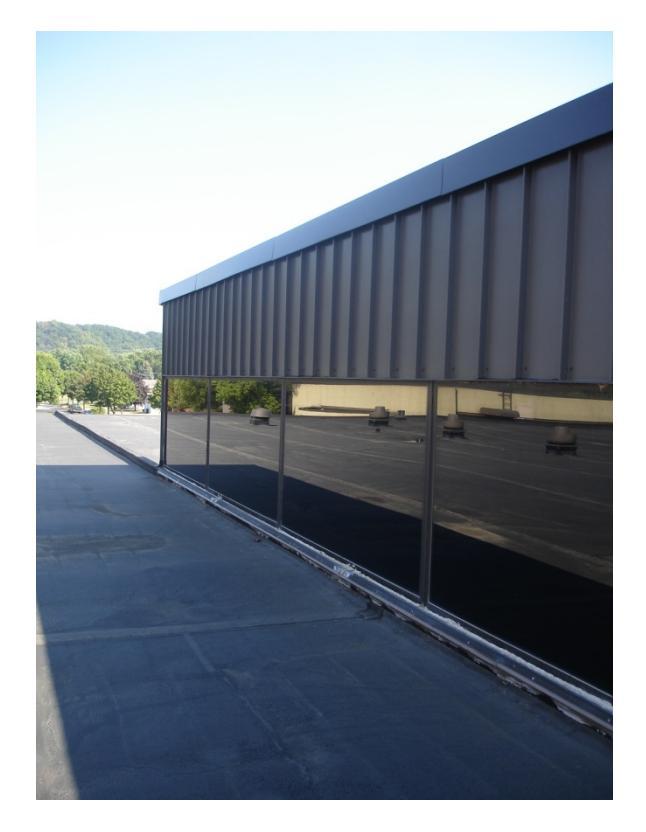
No current leaks were reported by maintenance staff. The 2006 re-roofing appears in good condition. The ballasted roof system above the 1999 Central Kitchen addition also appears in satisfactory condition with no significant signs of deterioration. Roof flashings and counterflashings at the clerestory windows could be improved as part of any replacement of the clerestory window frames.

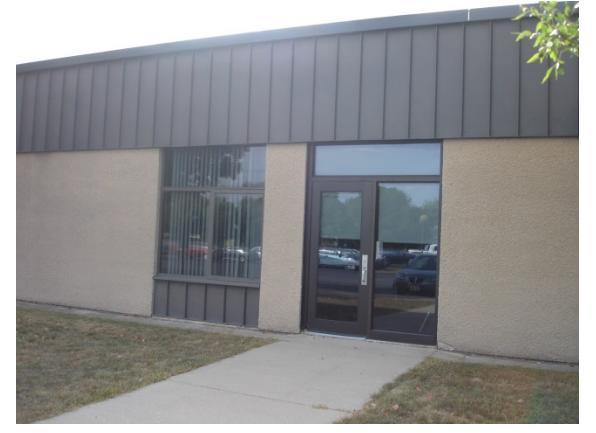
The existing aluminum windows are framed within the metal stud exterior walls. The wall area below the windows are clad with the same ribbed metal fascia panels.

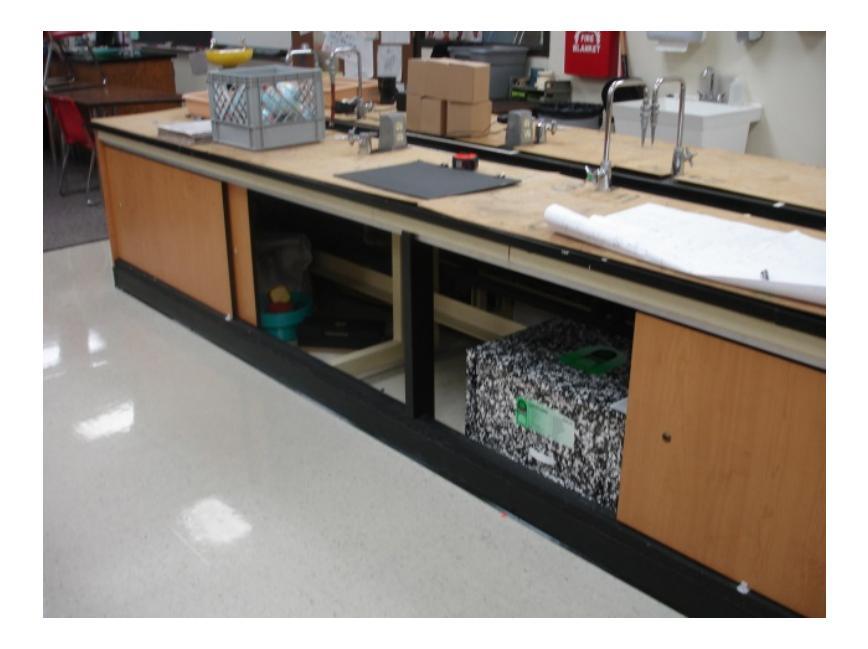
The original lab work counters are still in place and consists of epoxy resin countertops on a steel framed support system. The work surfaces are worn and shows the signs of 30+ years of use. Sliding wood panel fronts were added as a means to close off the undercounter space and to conceal storage of boxed science kits.

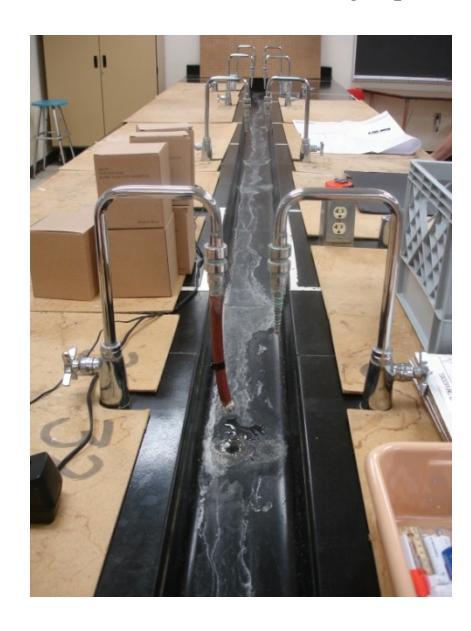
The epoxy resin counters include a continuous shallow depth drainage trough that slopes to a single drain at the end of the sections of countertops. Gooseneck water faucets are positioned above the drainage trough but splashes water on countertop surfaces outside of the trough (poor design).

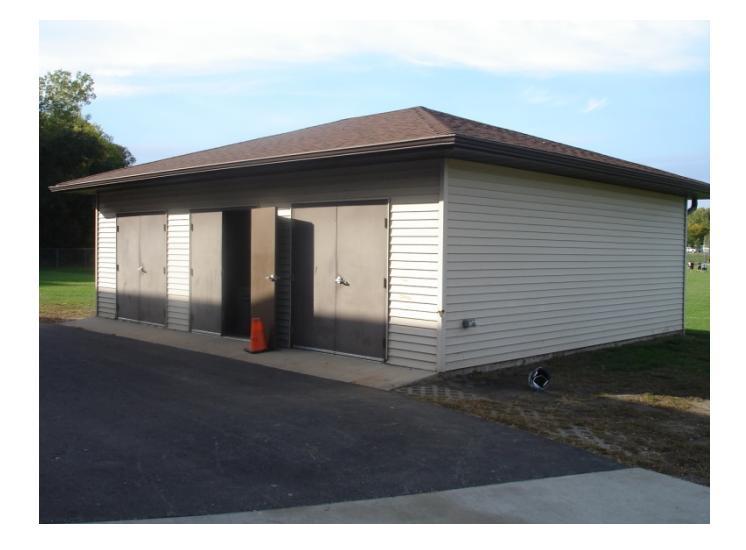
2.1 A 30' x 24' wood framed storage garage is located on the north side of the school and utilized for miscellaneous equipment. The structure consists of a wood stud frames walls on a concrete floor slab, prefabricated wood trusses, vinyl lap siding and asphalt shingled roof. There are three pairs of hollow metal doors on the south side and a single pair on the north wall.

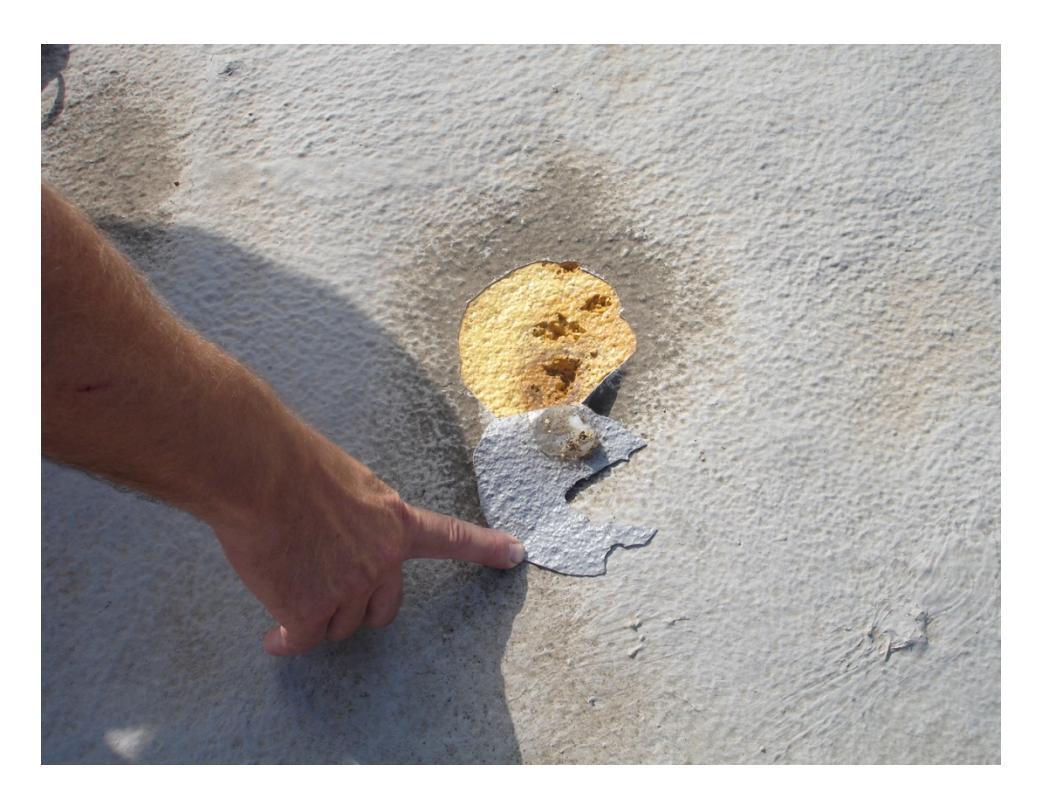
The foam roofs above the 1966 classroom/gymnasium wing continue to require frequent inspections for holes thru the foam that will contribute to leakage into the interior. The foamed roof surface is irregular and allows water to pond before finding it's way to the roof drains and scuppers. It was reported by the building maintenance that birds are often the source of creating holes in the foam which can expand over time.

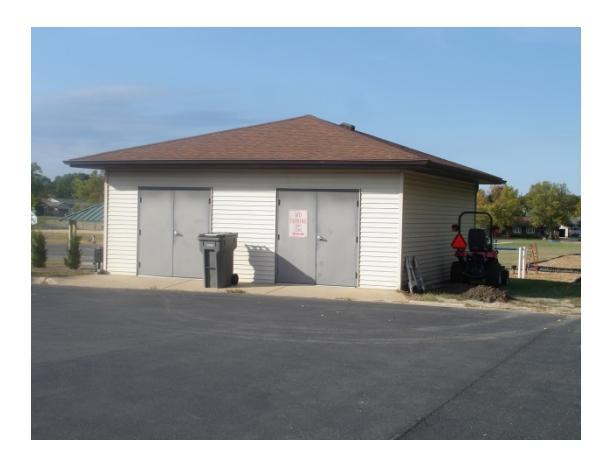
2.5 A 24' x 24' wood framed storage garage is located of the northeast corner of the school and utilized for miscellaneous equipment. The structure consists of a wood stud frames walls on a concrete floor slab, prefabricated wood trusses, vinyl lap siding and asphalt shingled roof. There are two pairs of hollow metal doors on the south side.

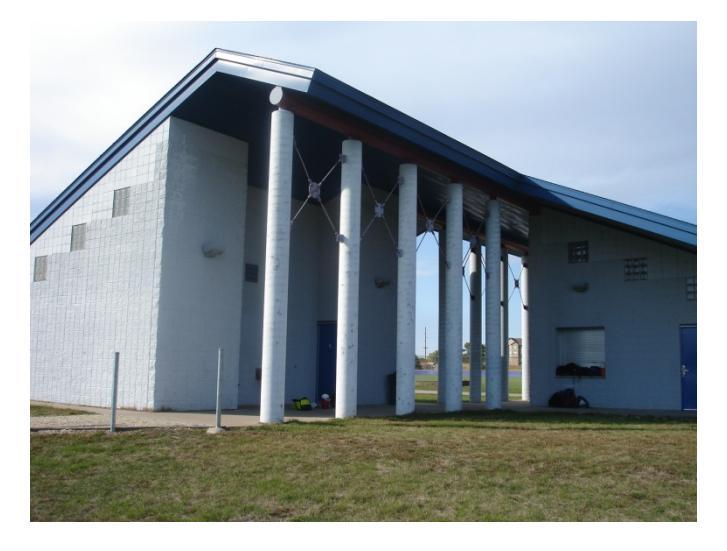
The masonry surfaces appear to be in satisfactory condition. The split-faced concrete block is generally in good condition, however, the smooth faced block could be re-coated with an elastomeric coating. The steel X-bracing assemblies between the concrete columns are showing signs of corrosion. The painted concrete columns should be recoated with a high-quality coating.

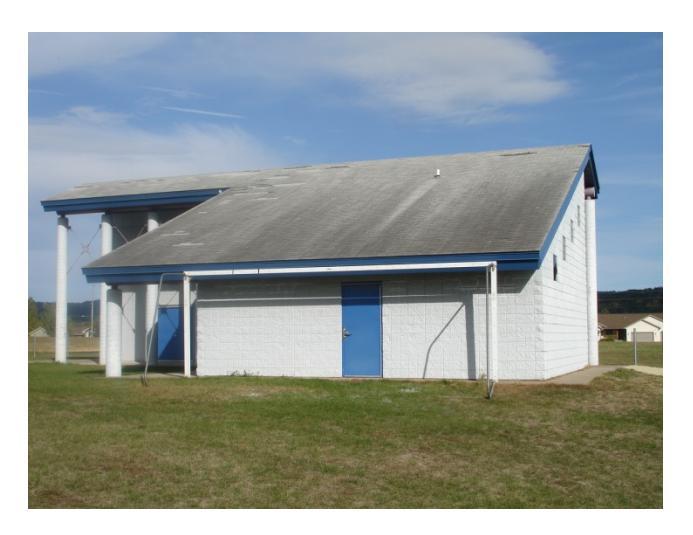
The roof system consists of asphalt shingles over engineered wood joists with plywood sheathing.

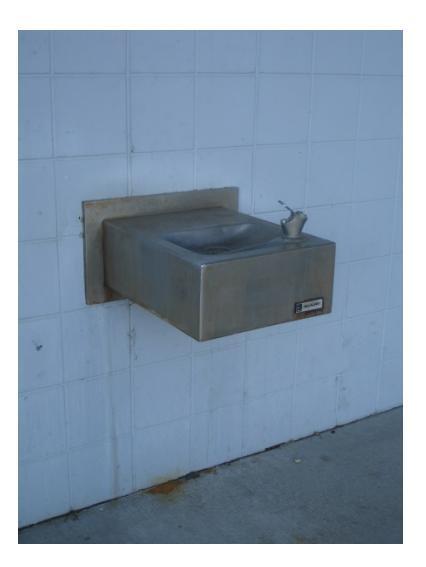
The existing toilets, urinals and wall hung lavatories all appear to be in satisfactory condition. The exterior wall hung drinking fountain is showing signs of corrosion but remains functional.

Recommendations No work required. The exterior drinking fountain can continue to be utilized until damaged or worn out.
3.0 HANDICAP ACCESSIBILITY

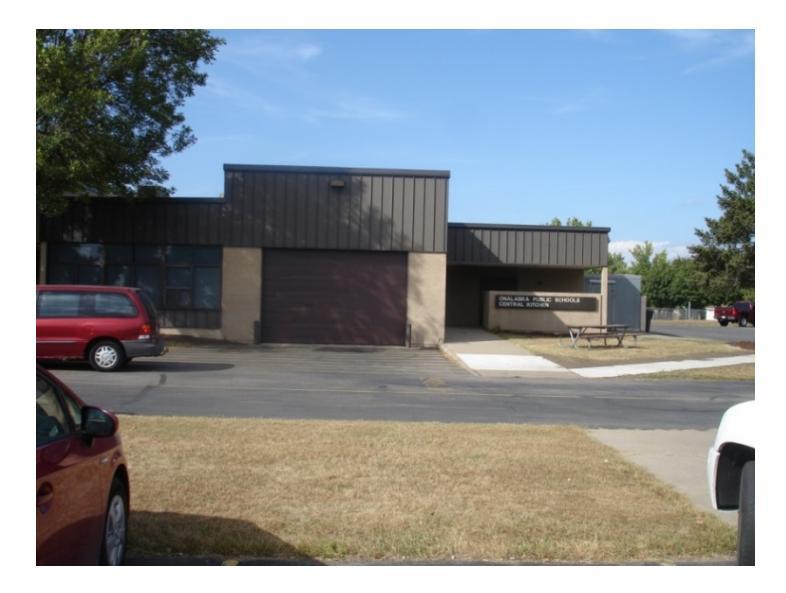
The 1999 addition to the Central Kitchen was constructed as a steel framed structure of steel columns, wide flanged beams and open web steel bar joists and steel decking. The exterior walls were constructed of light-gauge steel studs clad with exterior gypsum sheathing and a textured stucco. The interior side of the walls are painted gypsum board. The exterior metal stud walls were insulated with 5-1/2 inch R-19 batt insulation. A continuous fascia band of ribbed metal panels was applied to the wall area above the stucco surface to match the adjoining Middle School.

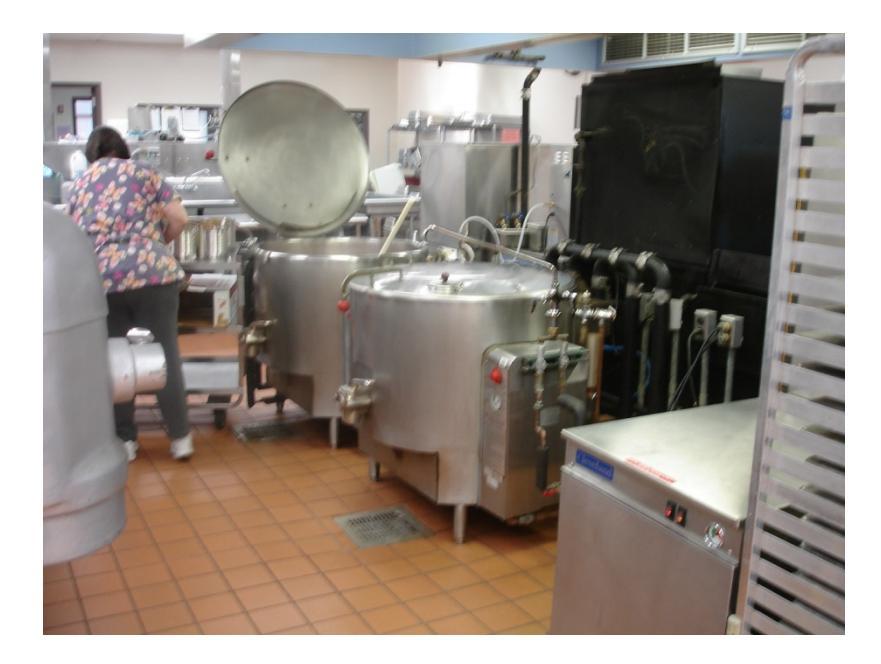
Equipment in the steam production area is still the original equipment. One of the two 60 gallon jacketed steam kettles was written up by the State inspector will need to be replaced. The steam kettles are approaching 40-years old and both will ultimately need to be replaced. Other old equipment that will need to be considered for replacement includes the 5-door steamer, two ovens, 2-burner stove, mixer and bread slicer.

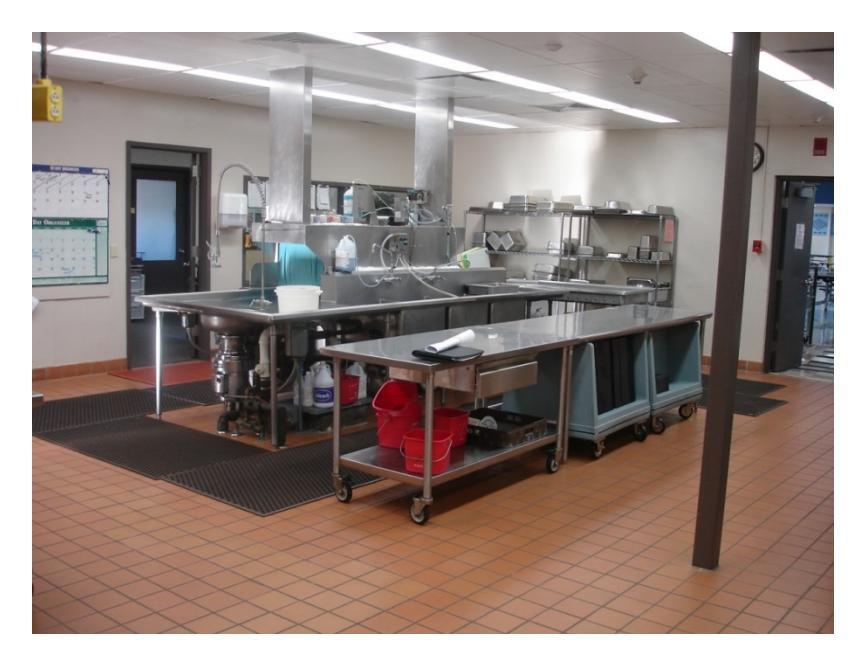
The Hobart dishwasher (1974) is also beyond the typical lifespan. Parts are very difficult to obtain and maintenance continues to increase.
