Facility Study and Master Plan

Rockville High School

SUMMER 2023

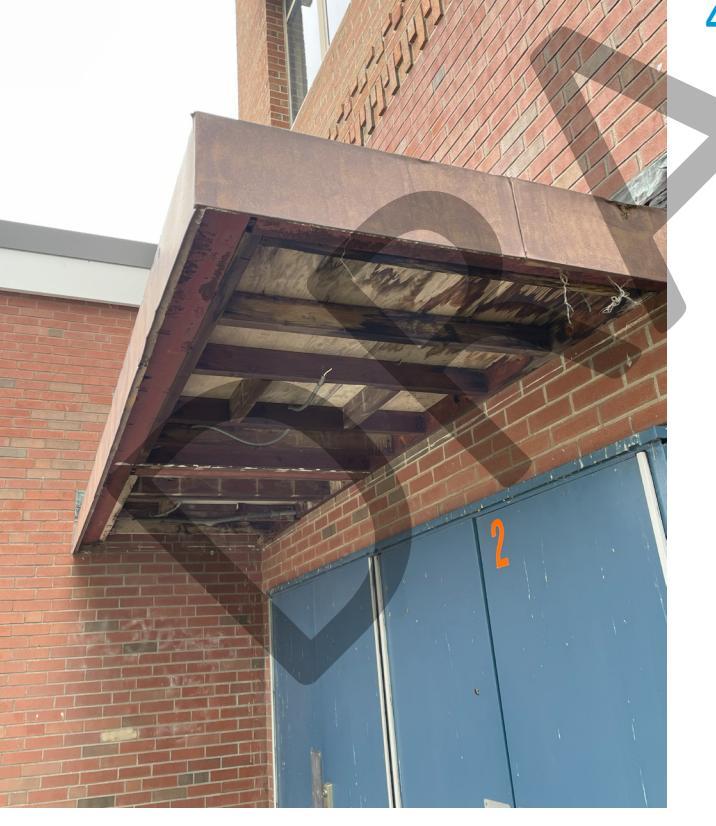
4. Location:

Wood canopy needs to be replaced.

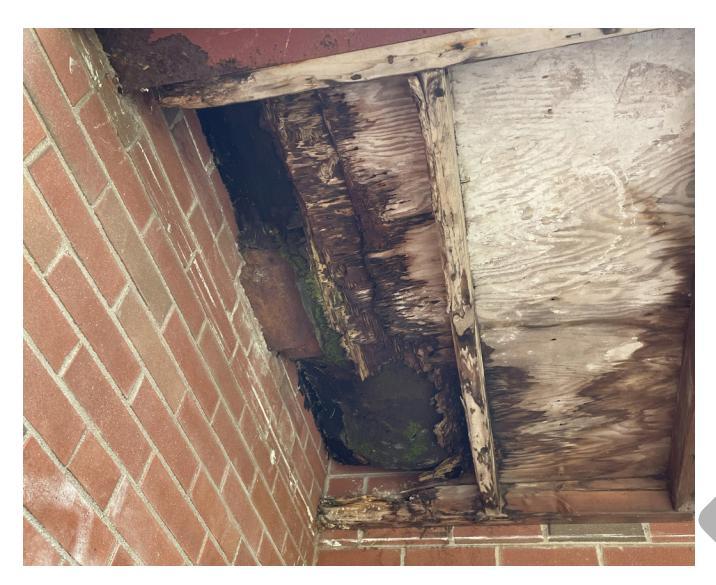
5. Location:

View of deterioration of wood canopy.

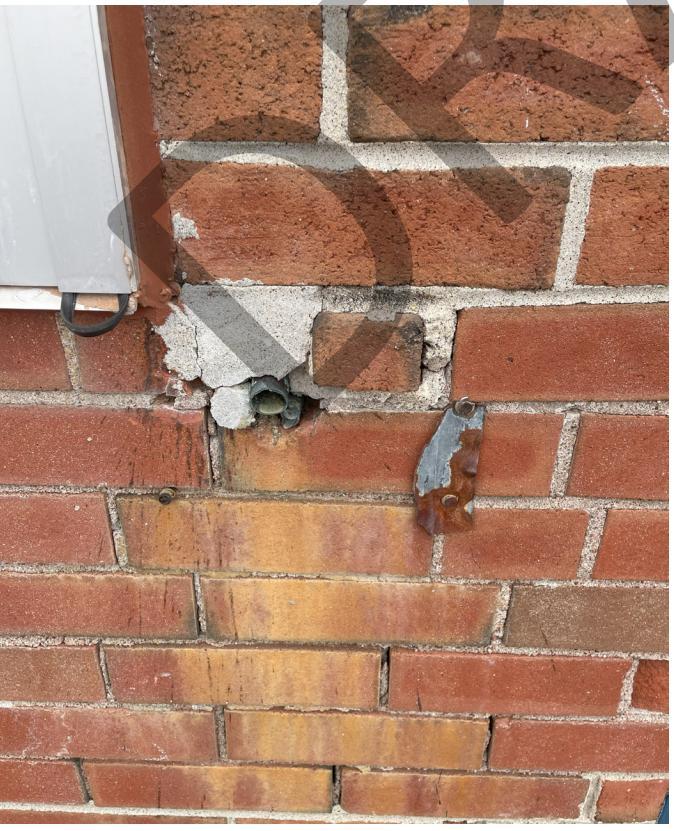
11. Location:

Patched area of brick needs to is beginning to crumble. Brick needs repointing due what appears to be consistent water flow in the area. Water should be directed away from the brick to prevent further deterioration.

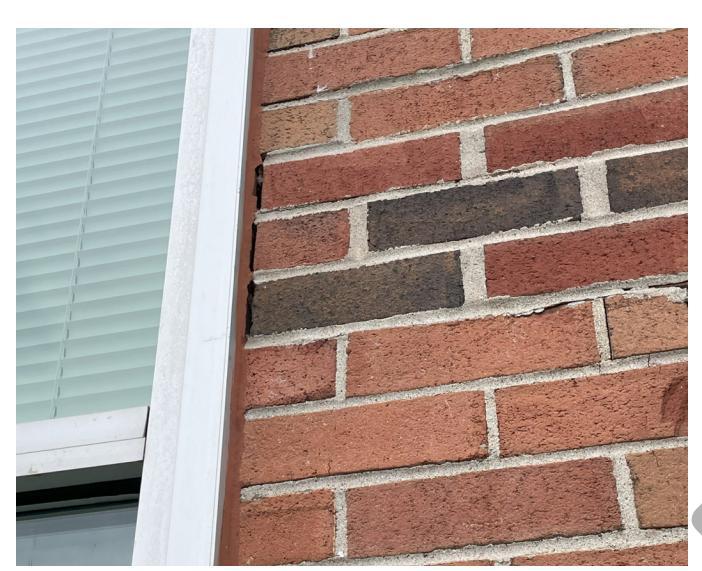
12. Location:

Area of missing sealant at window

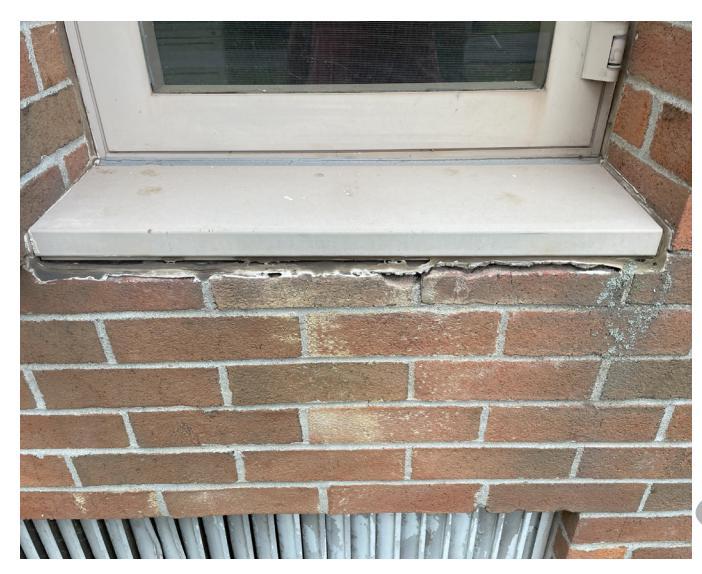
32. Location:

Window sill and frame finish is peeling away and rust is beginning to form.

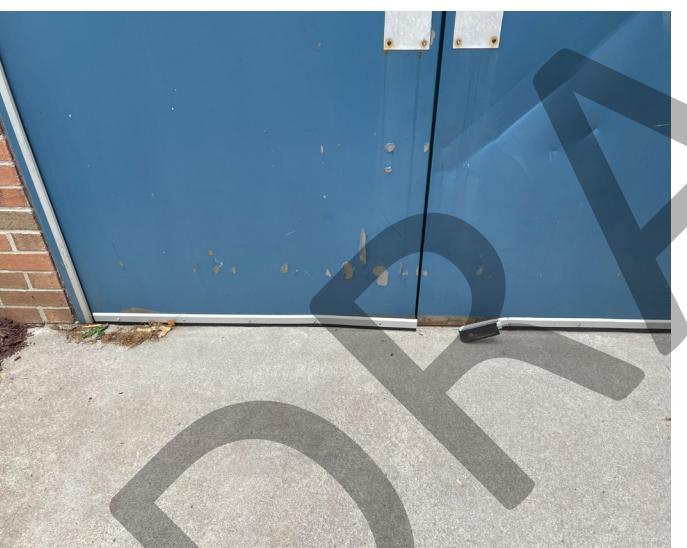
35. Location:

Damaged weather stripping at hollow metal door

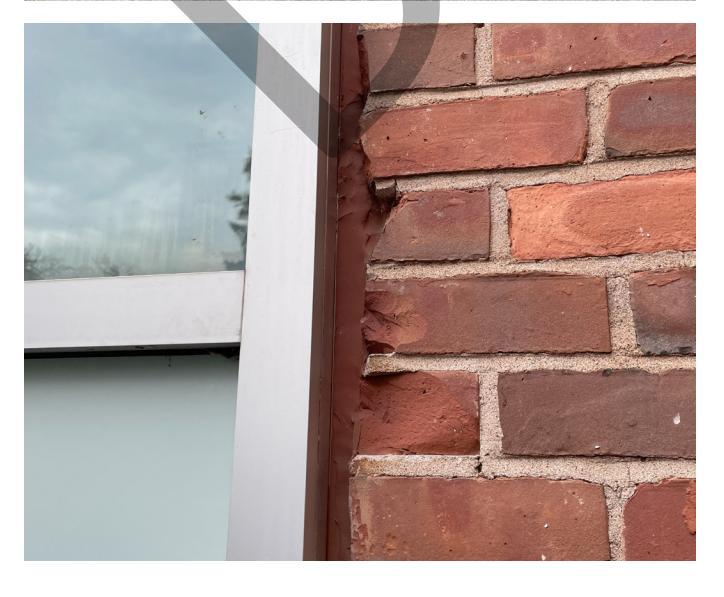
36. Location:

Damaged brick at window jamb

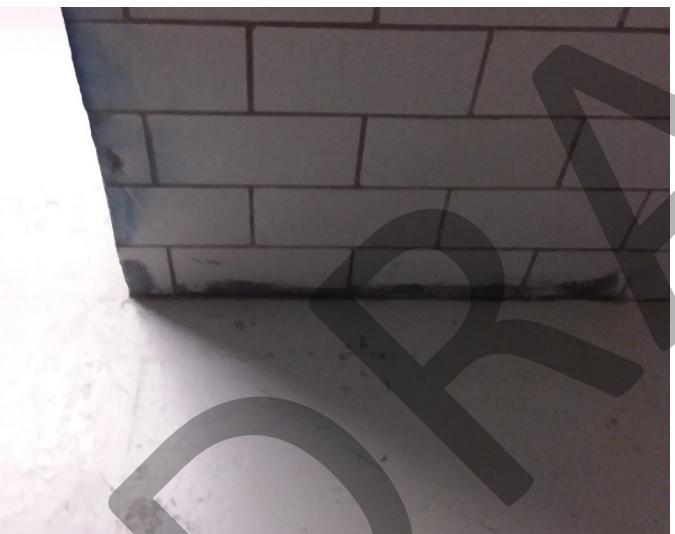
49. Location:

CMU block is crumbling apart and damaged.

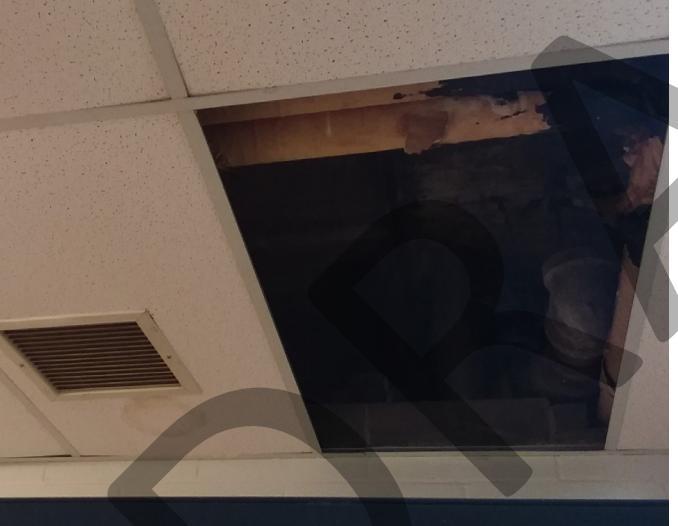
54. Location:

Several ceiling tiles are damaged and need to be fixed.

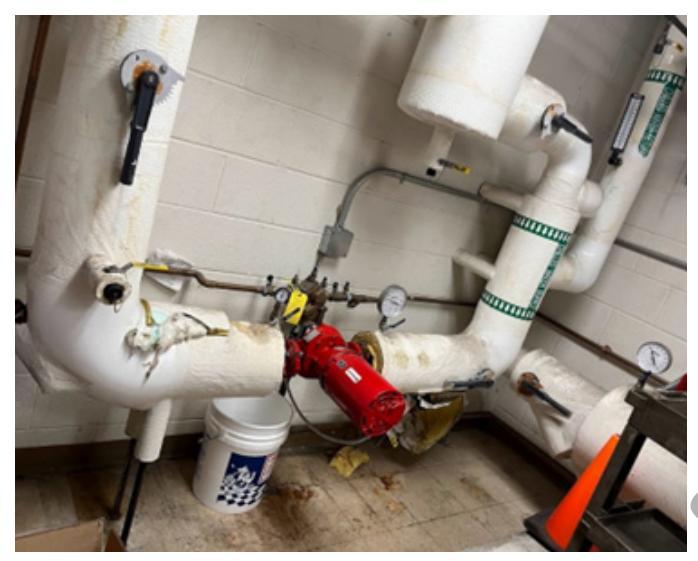
7. Location: Storage Room Description:

Leaking chilled water pump

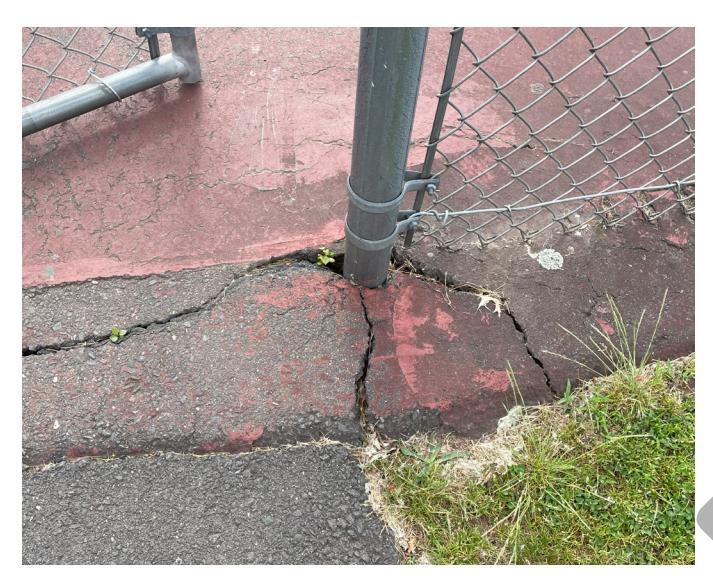
16. Location:

Cracked concrete around pole of fence

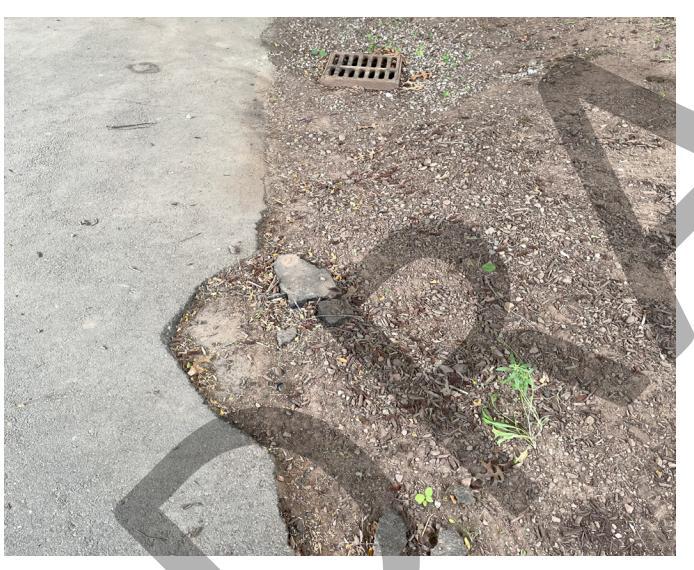
20. Location:

Cracks visible and weeds growing in cracks. Sloped area but no indication of accessibility.
