Facility Study and Master Plan

Center Road School

20 Center Rd, Vernon, CT 06066

SUMMER 2023

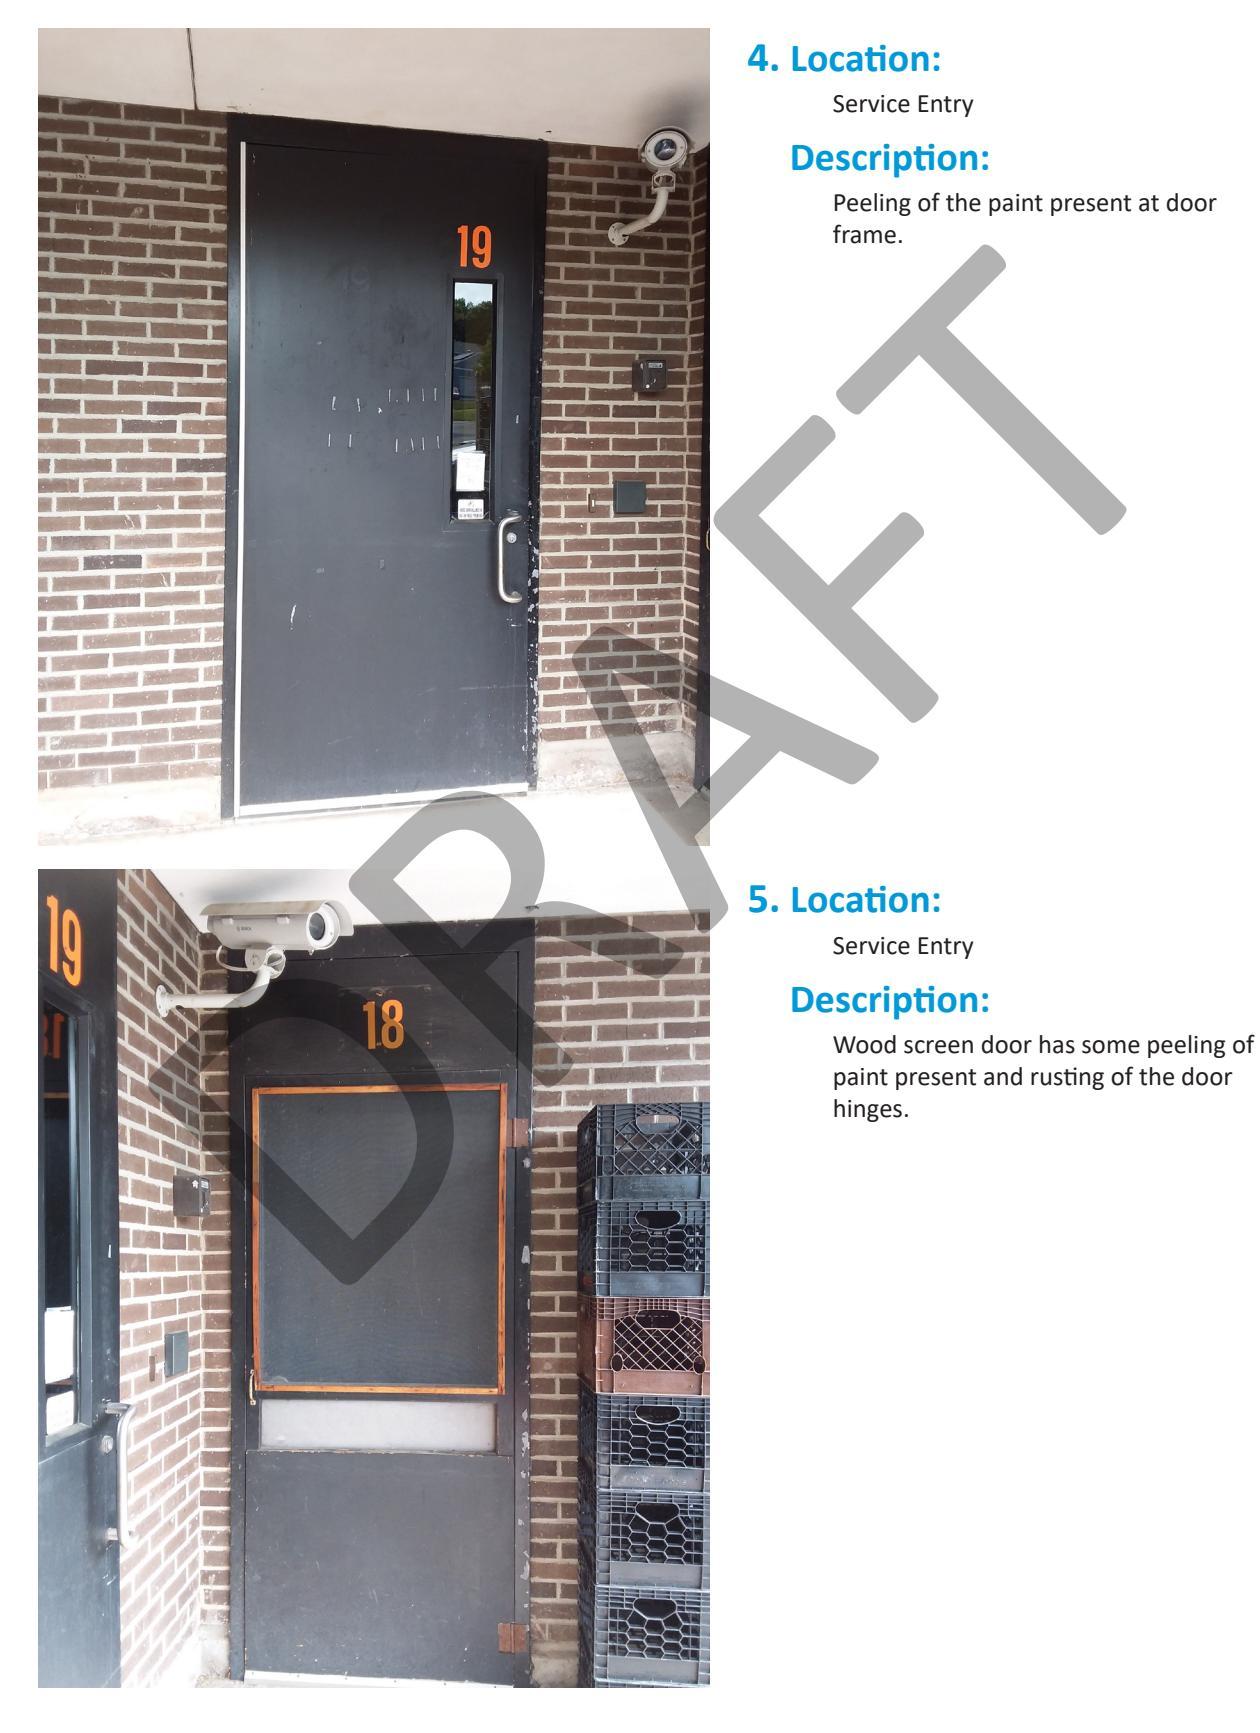
Door and frame show signs of wear and tear - appear to be stable but may need to be replaced in the next 5-10 years.
Architectural & Structural Survey Photographs

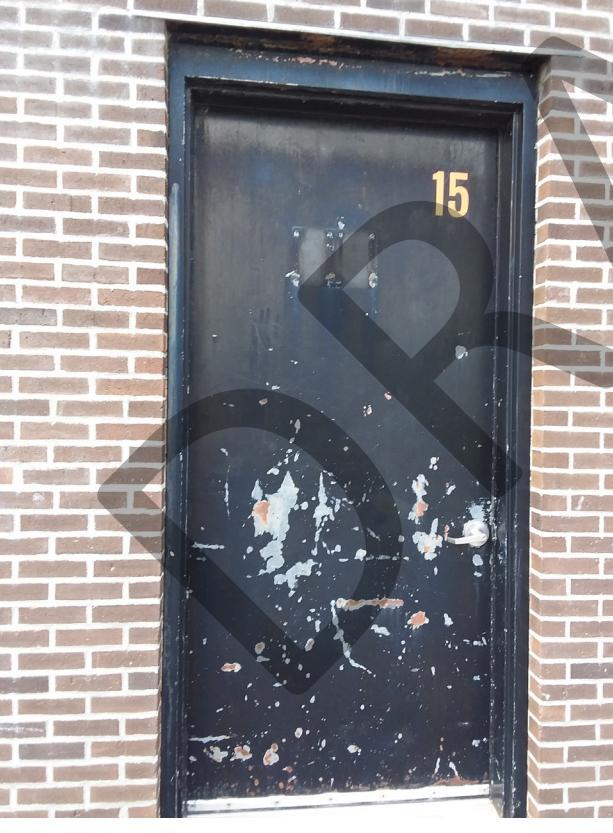
Door needs to be replaced due to damage and wear and tear.

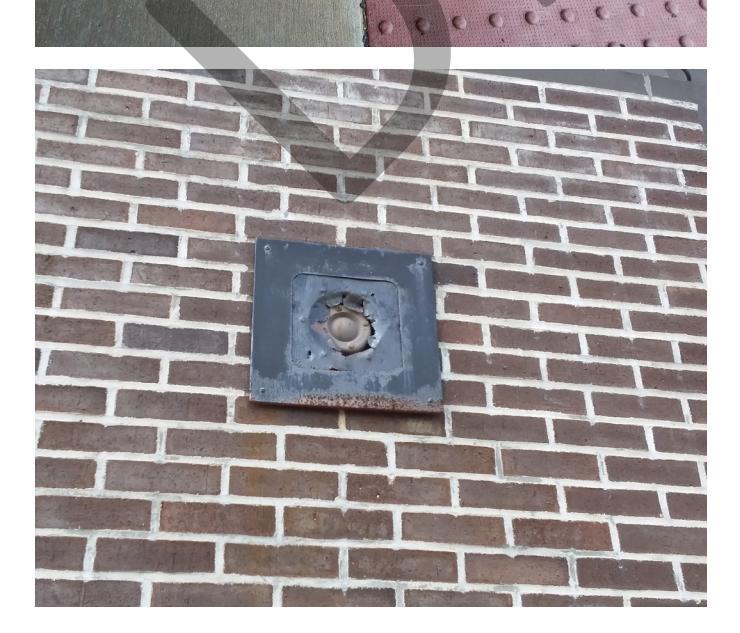
Damaged / abandoned fixture

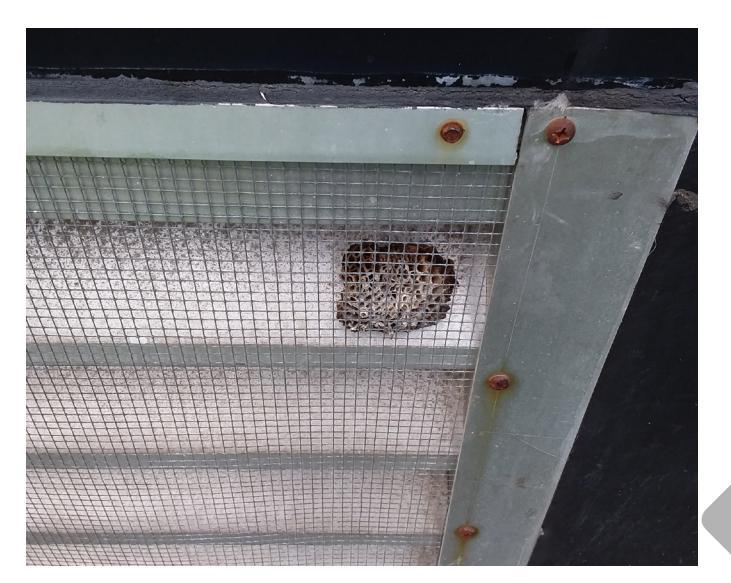
17. Location:

Sealants at vents should be refinished. Remove any insect infiltrations.

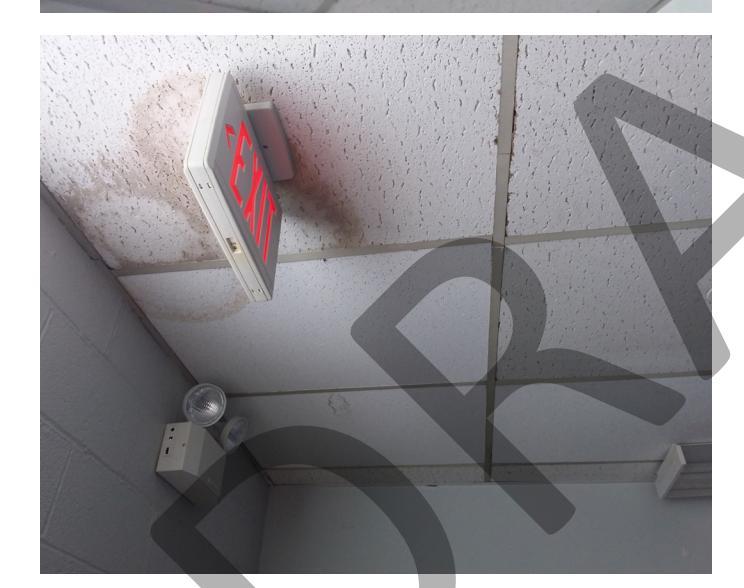
Ceiling Tile loose and falling out.

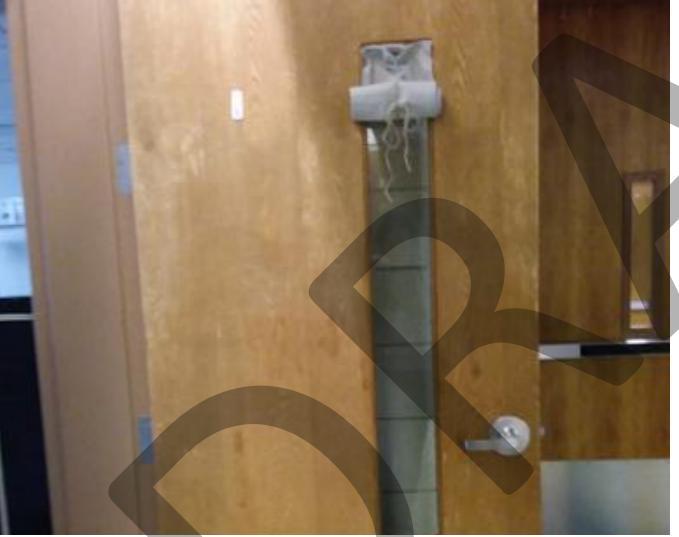
Blinds are damaged and bent.

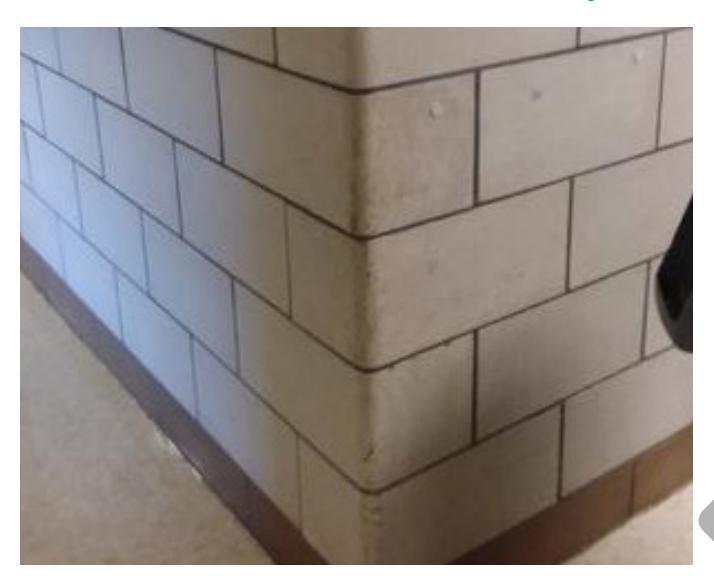
28. Location:

CMU has scratches and wear at corners.

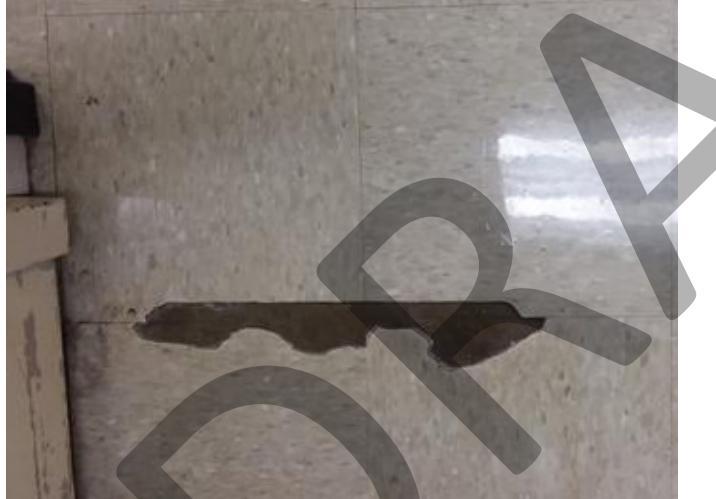
Vinyl composite tile (VCT) finish is worn and stained.

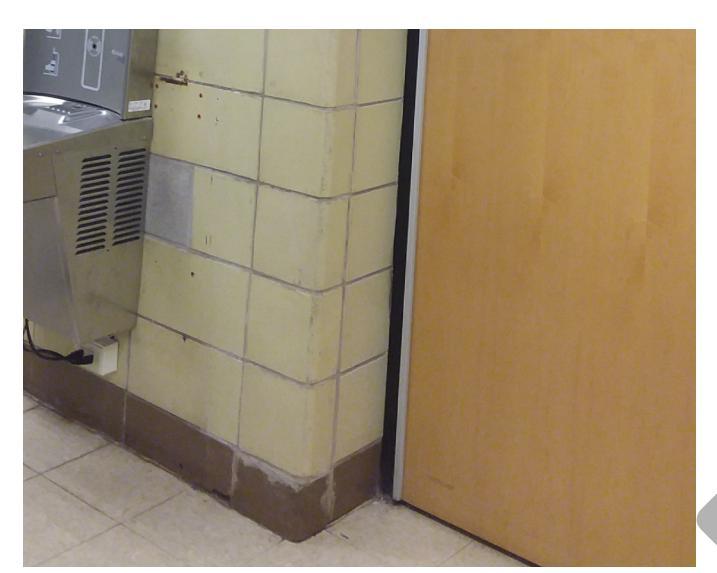
34. Location:

Enameled/polished CMU has cracks and gouges.

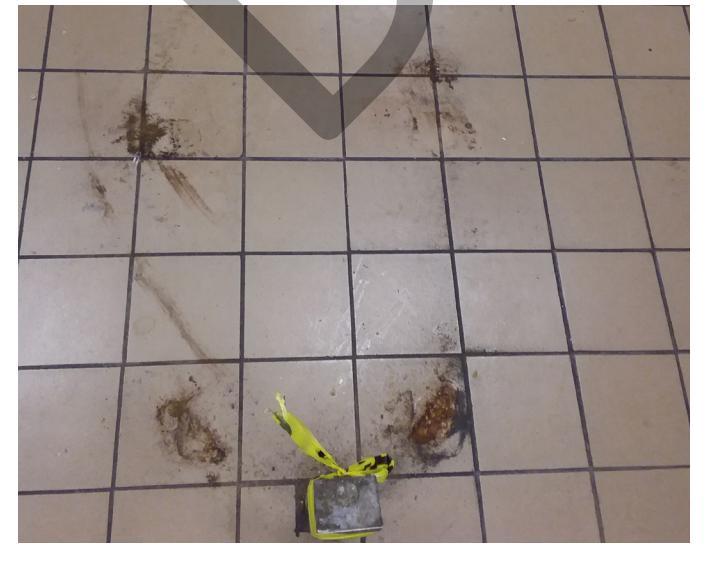
Quarry tile is damaged and has rust. The finish is worn in areas. Tile in good shape should be thoroughly cleaned and damaged tiles should replaced.

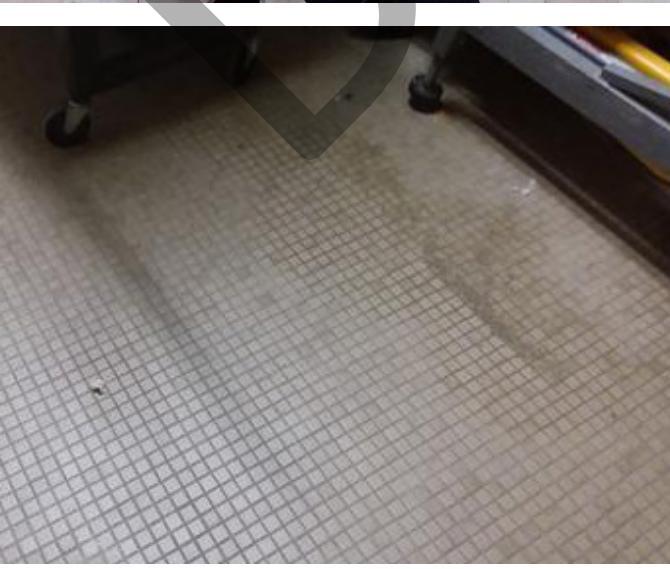
Tile finish is stained and fading. Several tiles have chips/cracks.

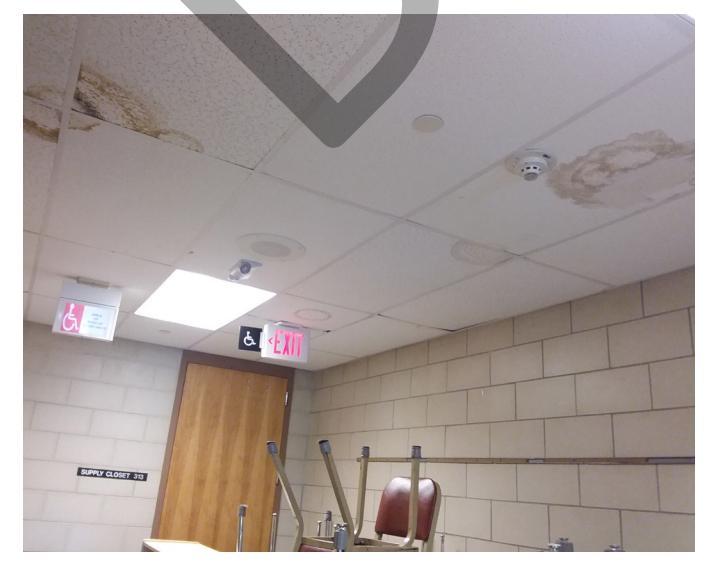
Panels show water damage and some cracking.

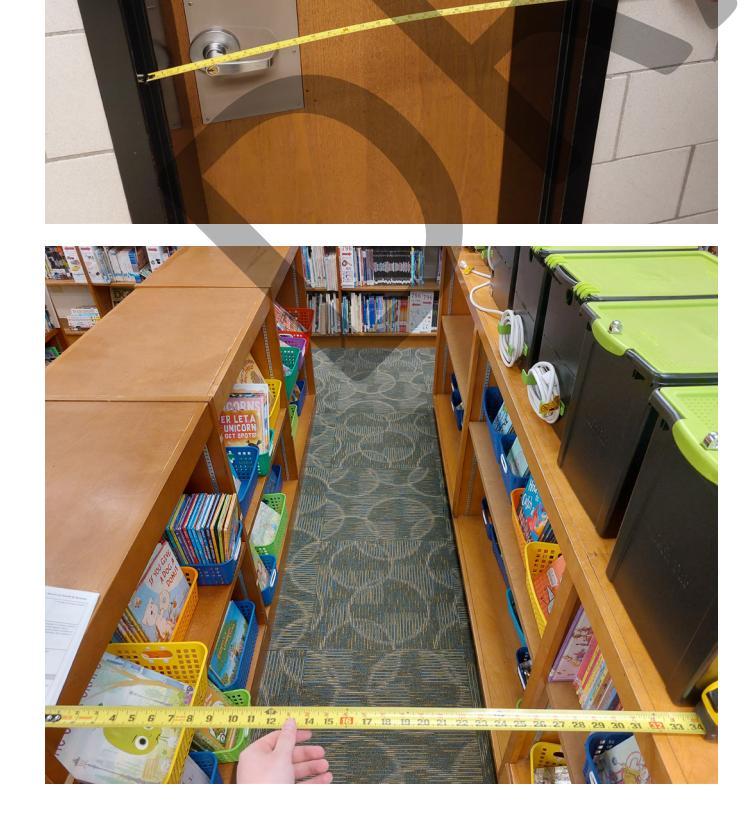
Clear width between aisles is less than the required 36" minimum.

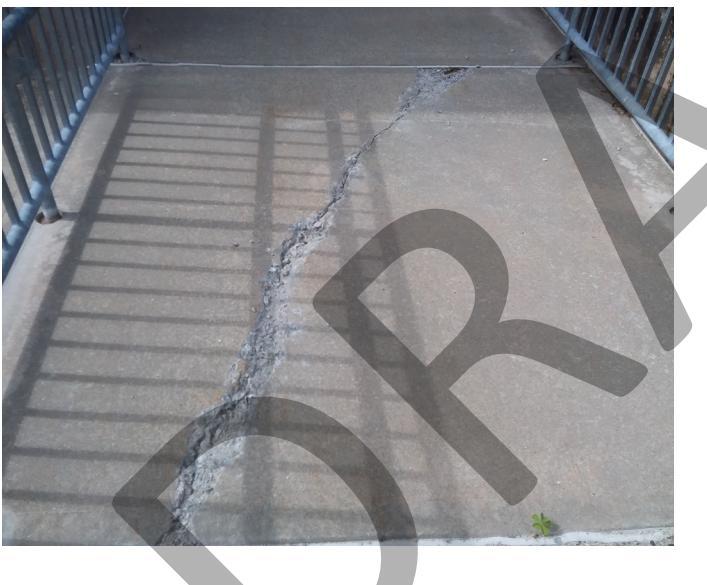
Concrete ramp in poor condition

- Provide signage for Service Area and designate with striping any areas reserved for loading/unloading.
- Repair damaged concrete ramp
