Facility Study and Master Plan

# 166 Union Street

166 Union Street, Vernon, CT 06066

**SUMMER 2023**

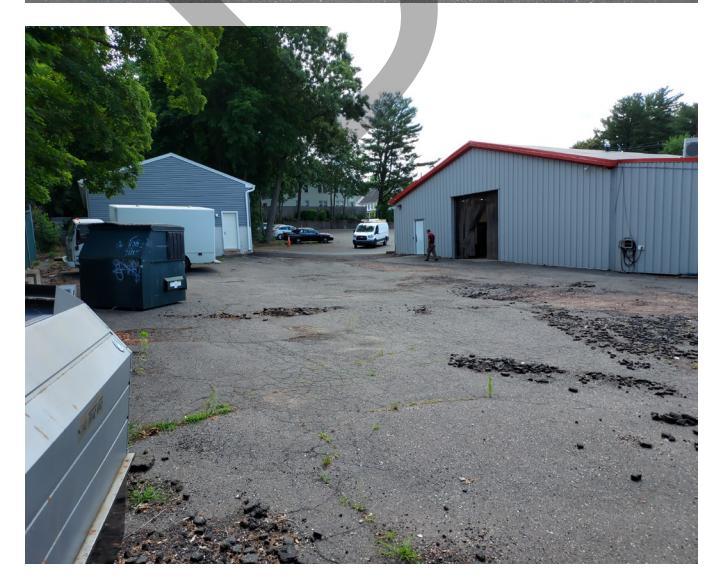
#### **12.** Location:

The gated parking area is too steep for accessible parking. This area or the side parking area would need to provide accessible parking in proximity to the front entrance.

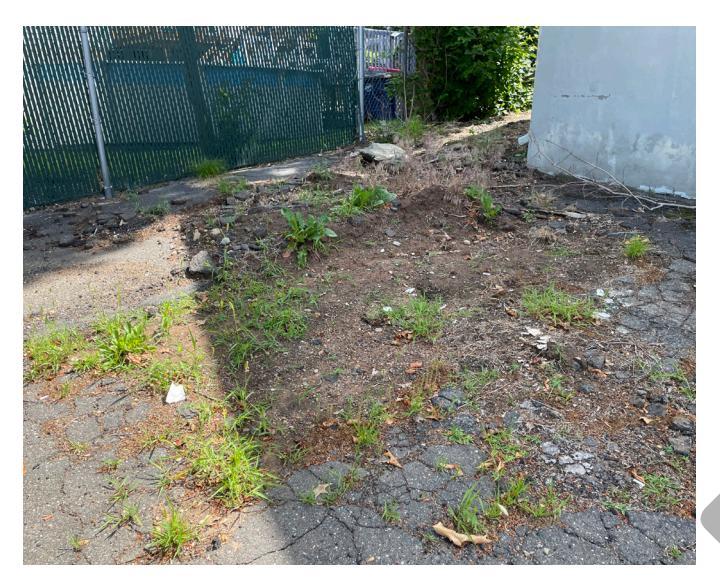
## 4. Location:

Significant deterioration of bituminous pavement.

- Remove and replace bituminous pavement at north end of site
- Repair damaged bituminous curbing
- Remove and replace damage concrete walkway
