MOLD AND MOISTURE ASSESSMENT REPORT

OVERBY-SHEPHARD ELEMENTARY SCHOOL

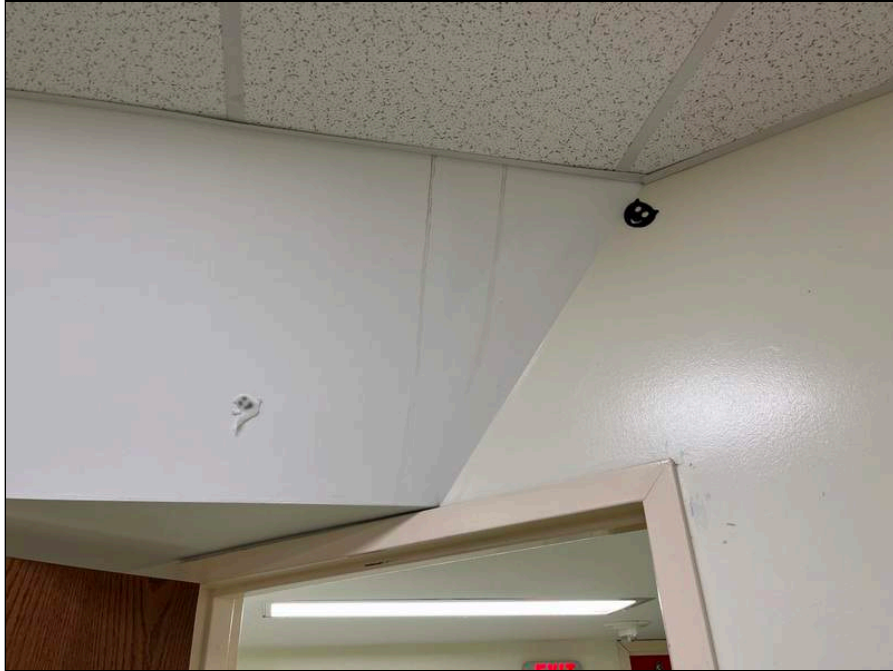
1 - View of water stain on the gypsum board located within room 110.

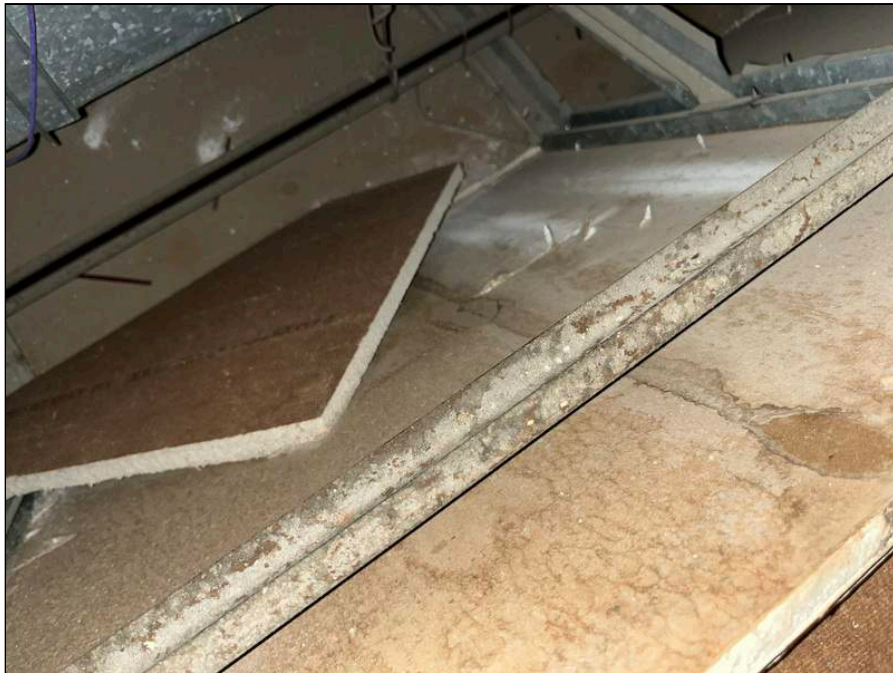
2 - View of rear side of the gypsum board which had water staining in room 110

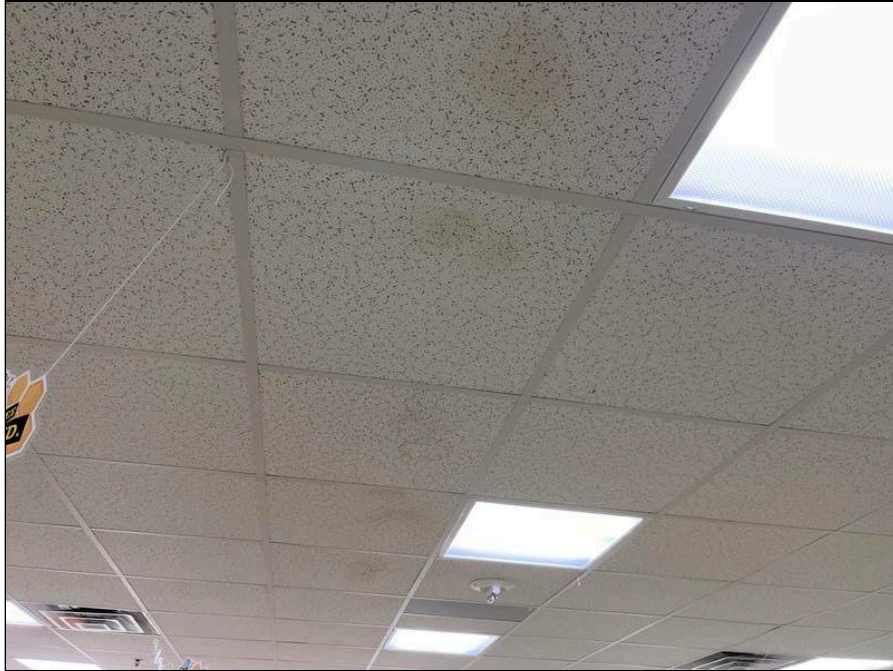
3 - General view of stained ceiling tile which were observed sporadically throughout the school

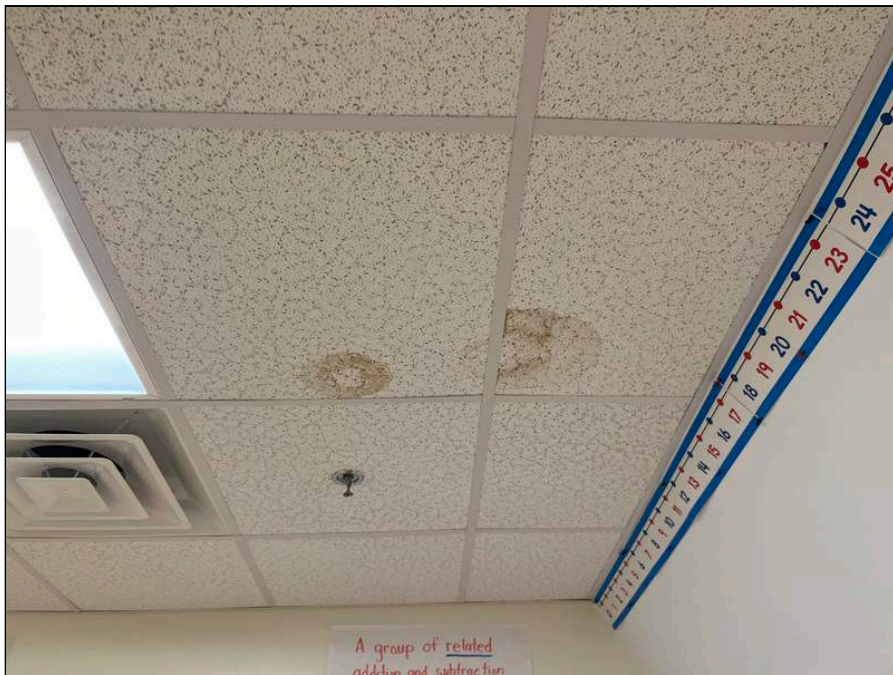
4 - General view of stained ceiling tile which were observed sporadically throughout the school

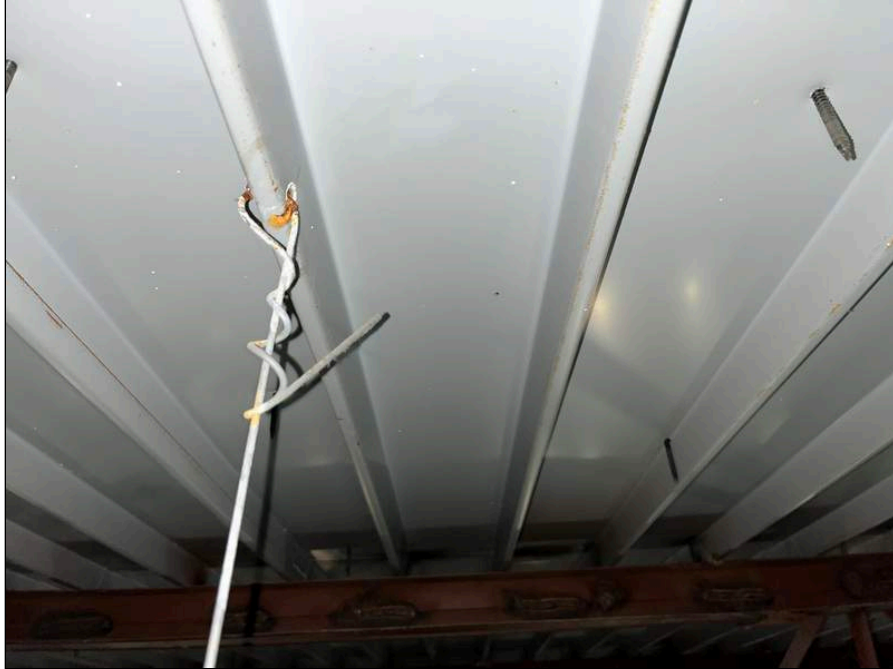
5 - View of ceiling tile wire hanger with moisture and rust observed where it goes through the ceiling deck.

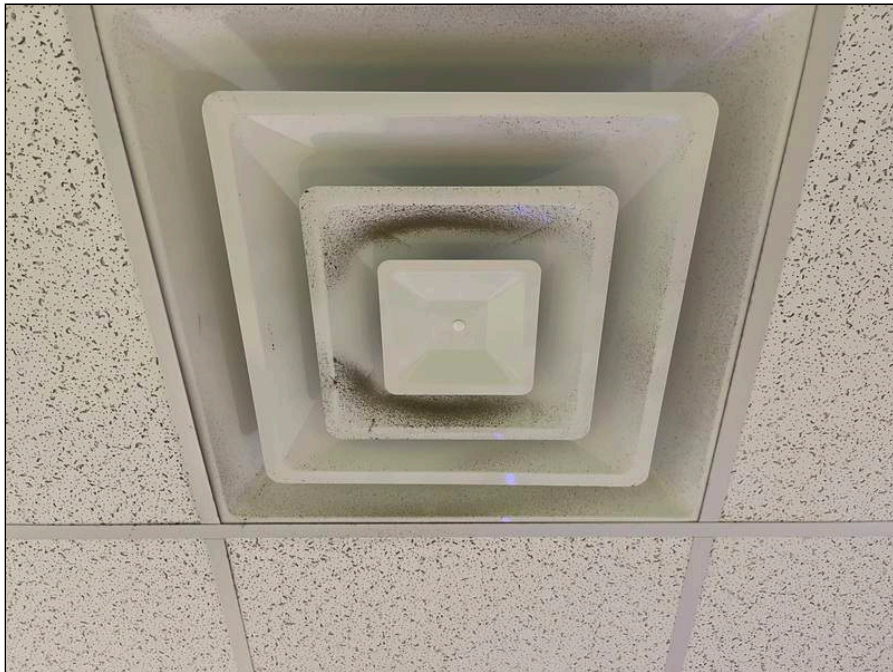
6 - View of supply vent with heavy debris observed.

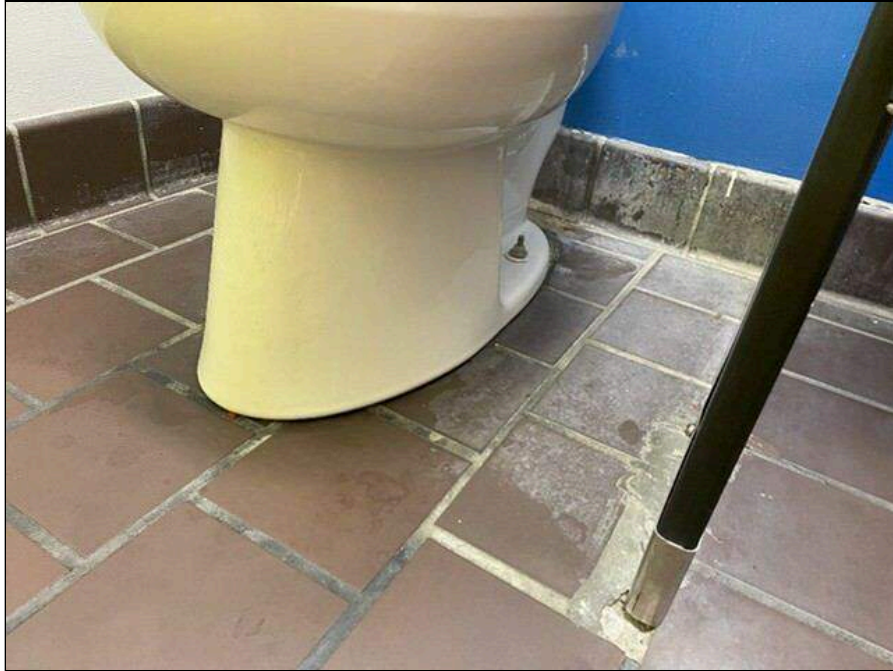
7 - View of bathroom with water staining observed.

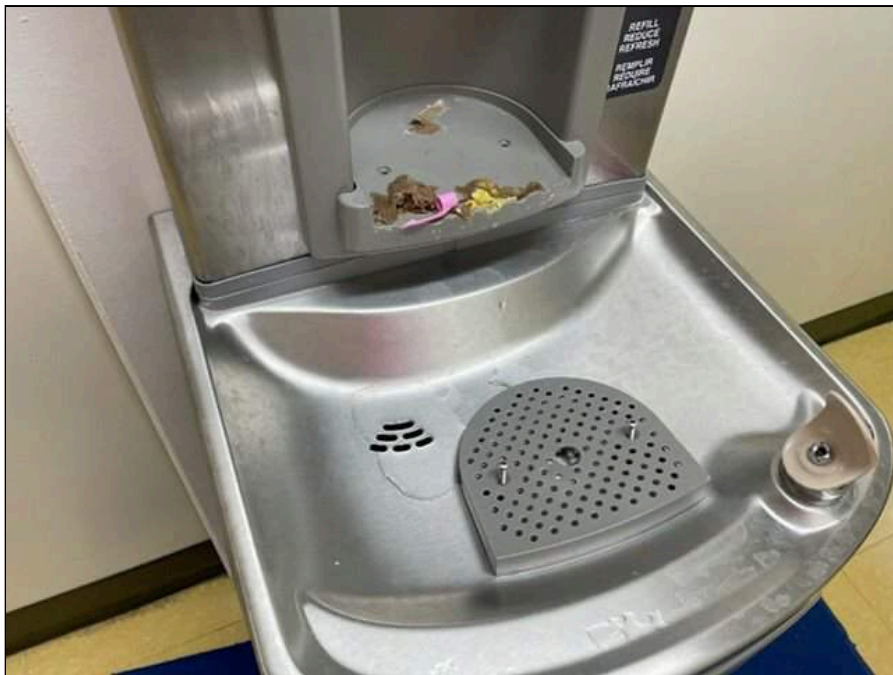
8 - View of bottle filler with debris and staining from overflow.

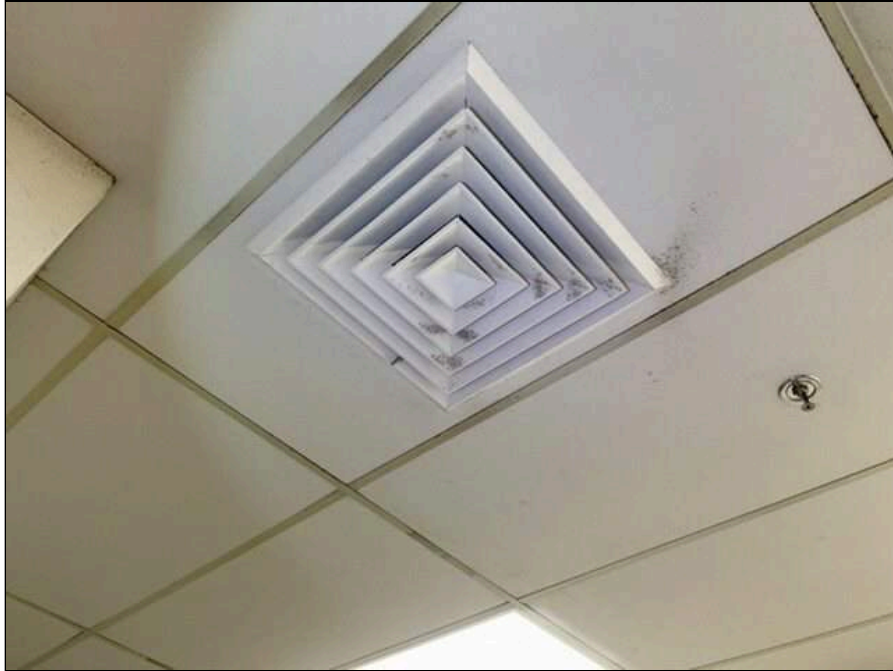
9 - View of Kitchen vent with heavy dust observed.

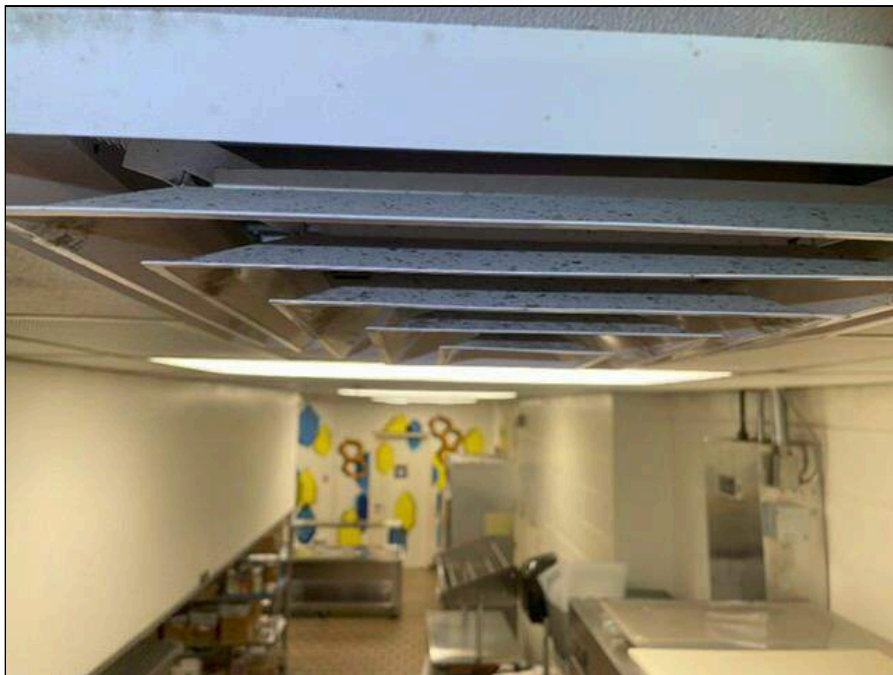
10 - Close view of of kitchen vent with suspect mold observed.
