MOLD AND MOISTURE ASSESSMENT REPORT

HUGUENOT HIGH SCHOOL JROTC ROOMS

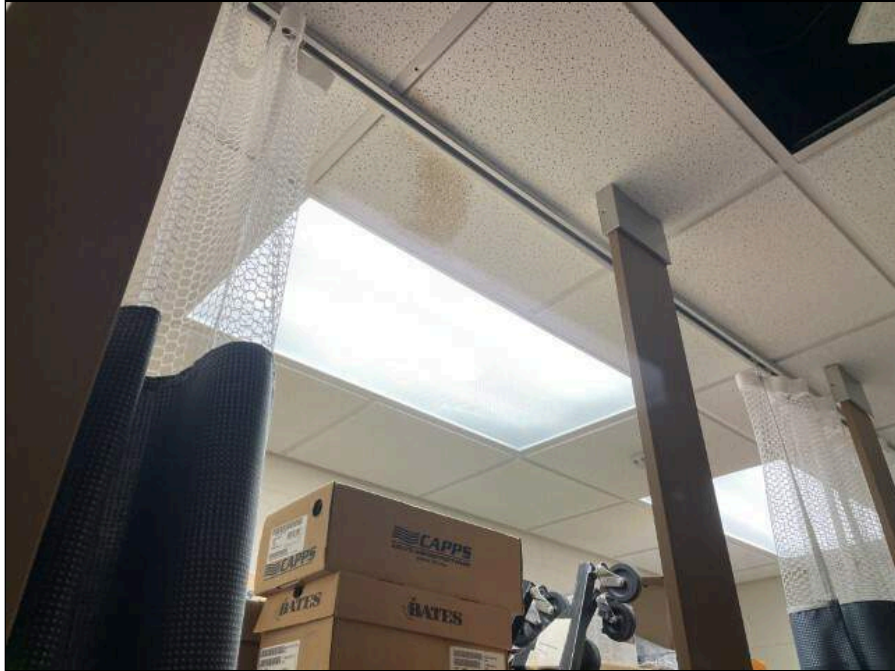
1 - Stained ceiling tile in dressing area of G-008B

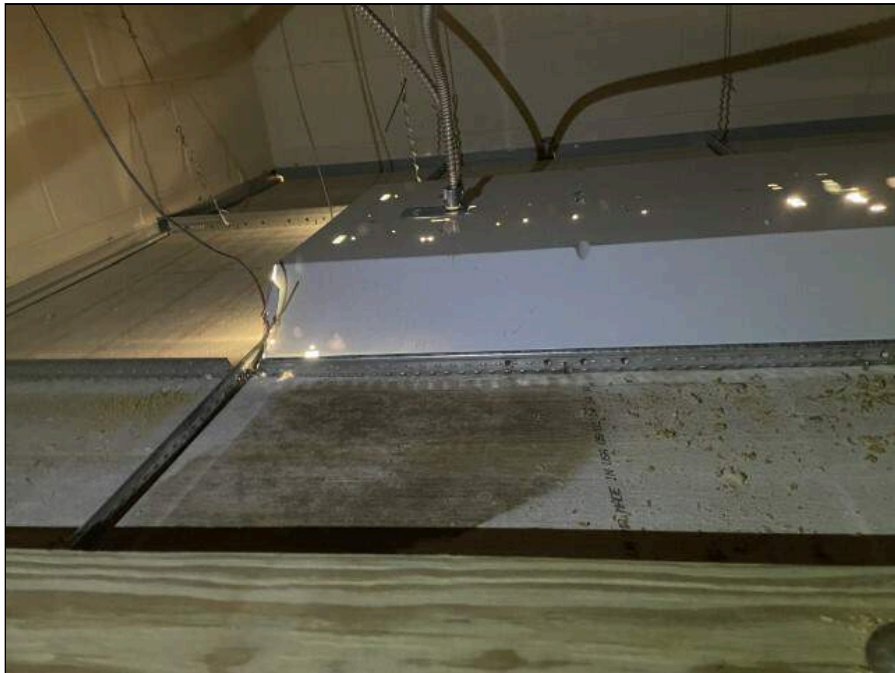
2 - Top of stained ceiling tile in G-008B

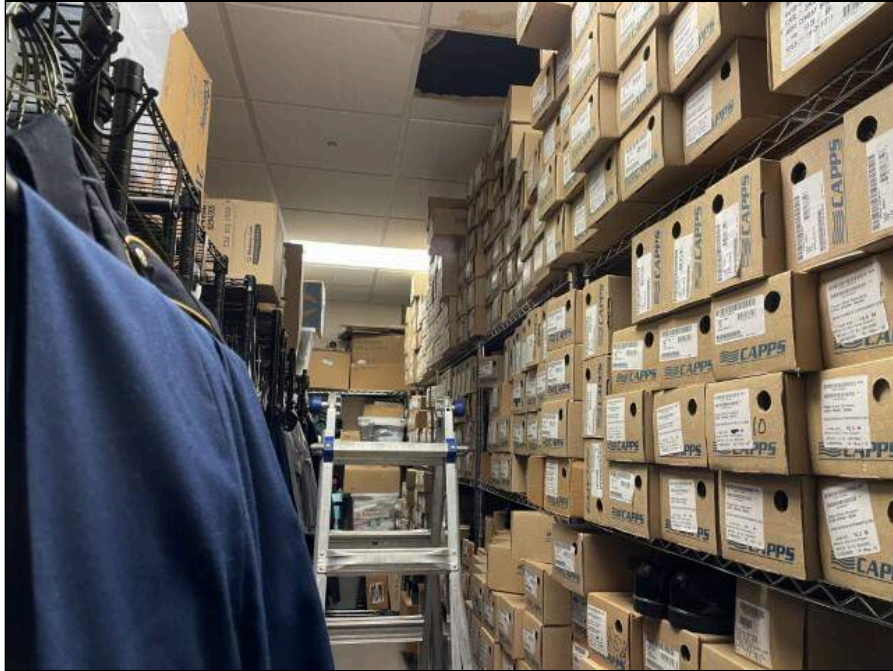
3 - Damaged and stained ceiling tiles in G-008B

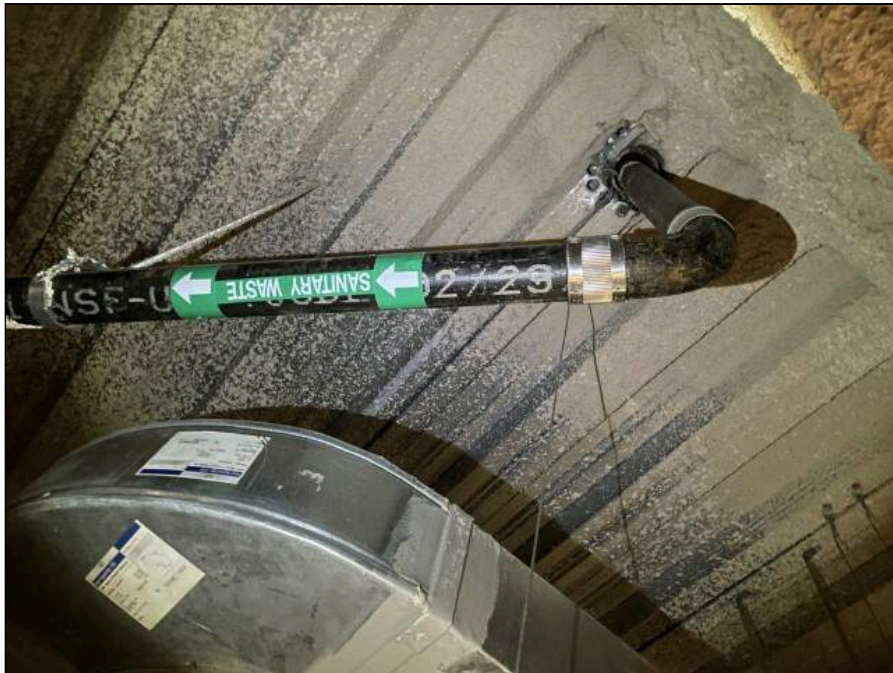
4 - Sanitary water line above damaged ceiling tile in G-008B

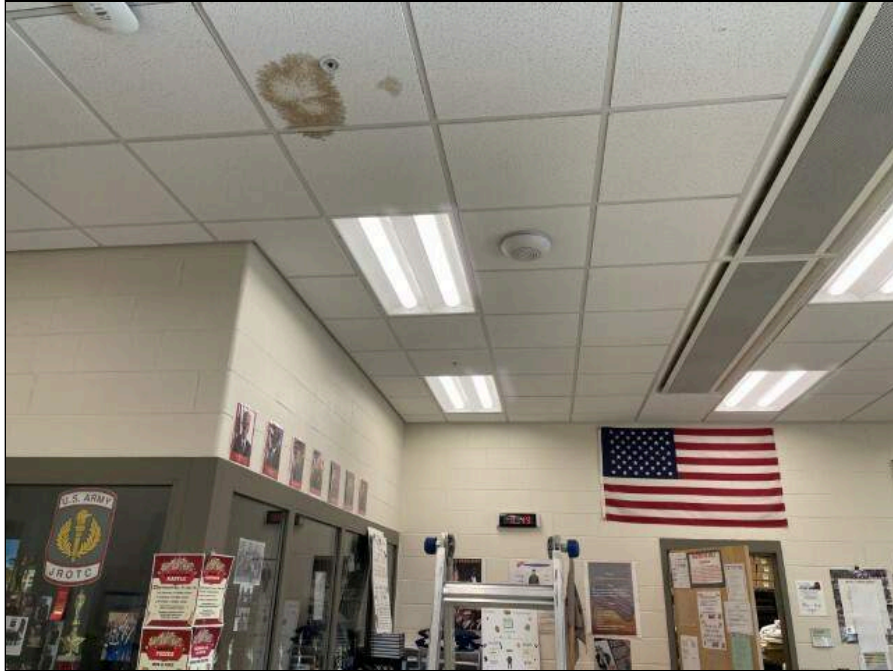
5 - Stained ceiling tiles in room G-007

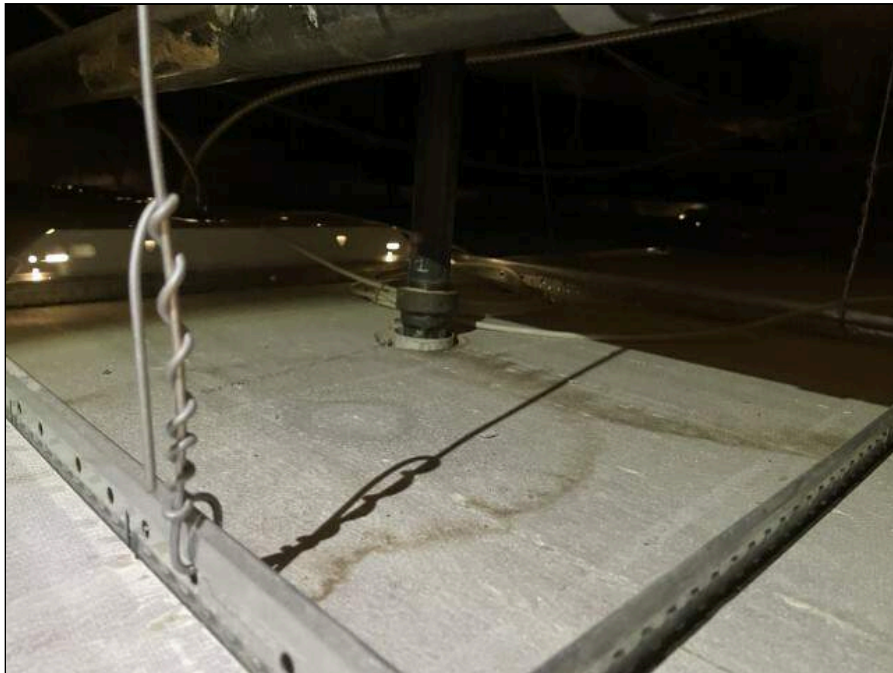
6 - Top of stained ceiling tile in G-007

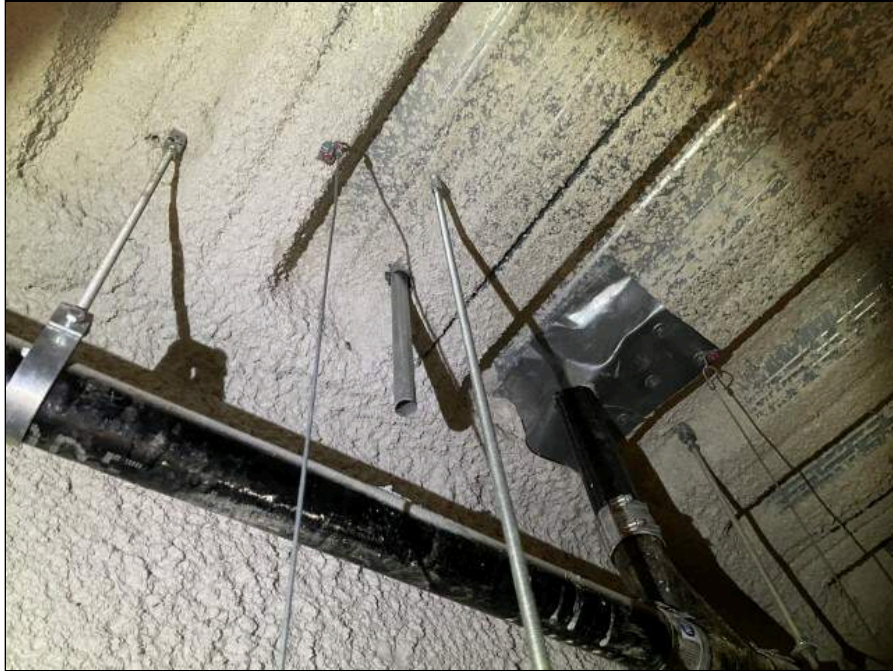
7 - Pipe affixed in roof, suspected source of moisture intrusion above ceiling tile in G-007

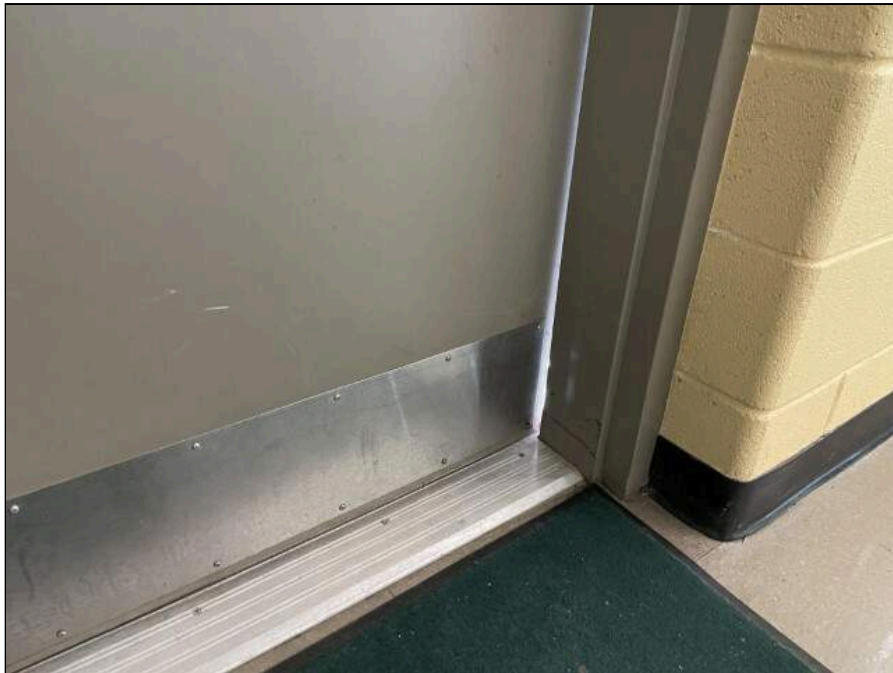
8 - Exterior door in G-007, poorly sealed

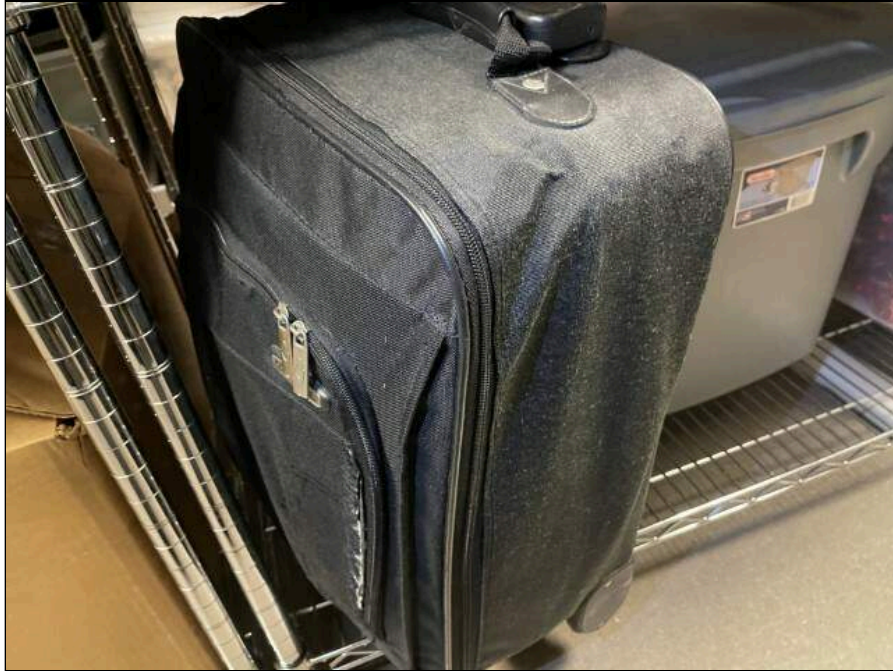
9 - Suspect staining found on black travel bag located in G-008B

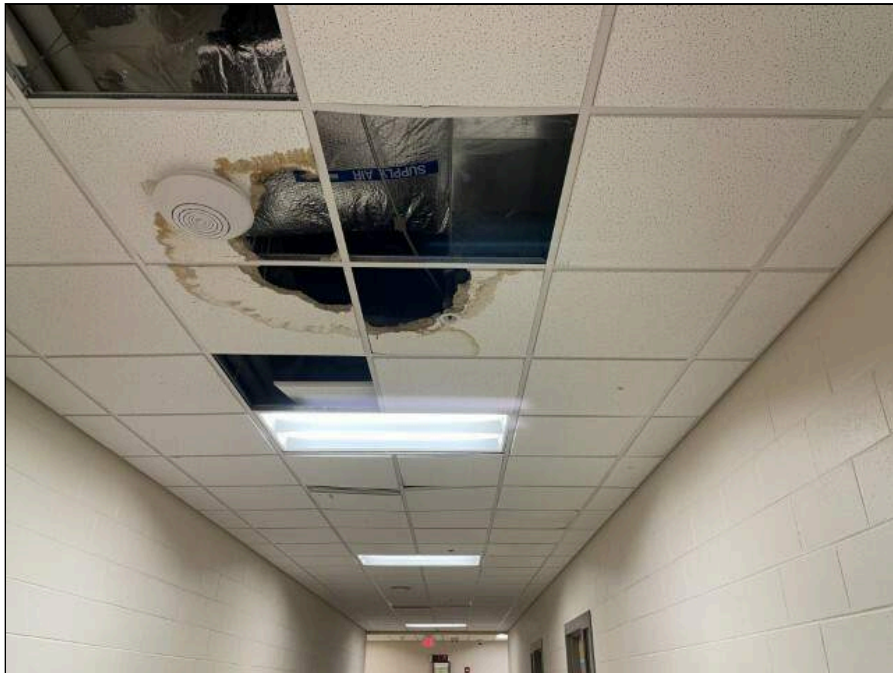
10 - Damaged and stained ceiling tiles in the hall outside G-008
