| FIVE-YEAR CAPITAL FACILITIES PLAN | | | | | | | | | | | | | | |
| Facility Name: | Woodstock Elem. School | | | | | | | | | | | | | |

**2021 BUILDING CONDITION SURVEY - 2021 Building Condition Survey - WOODSTOCK ES**Building Information

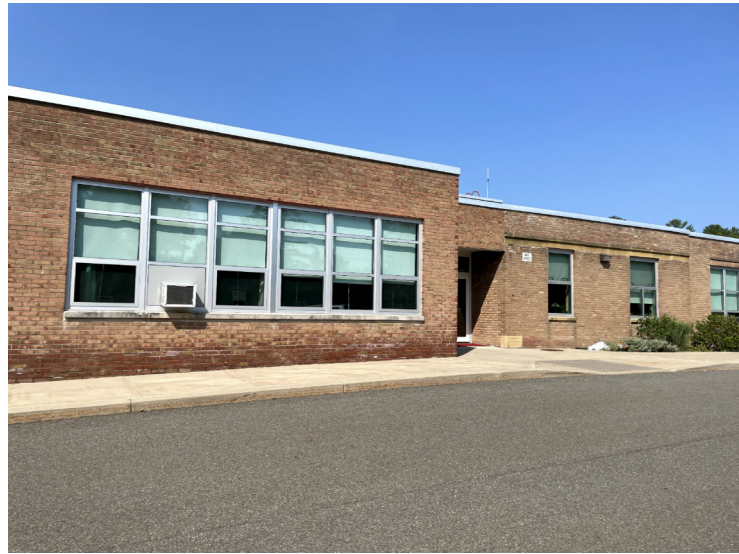
(A1) TYPICAL

| FIVE-YEAR CAPITAL FACILITIES PLAN | | | | | | | | | | | | | | |
|---|---|---|---|---|---|---|---|---|---|---|---|---|---|---|
| WES-066-01-21 | 1 | ST | U | Repointing | Repointing, potential re-flashing, above and below windows in older sections and select areas of building. | A1 | REP | Y | | \$ 86,250 | \$ 8,625 | \$ 17,250 | \$ 8,625 | \$ 120,750 |

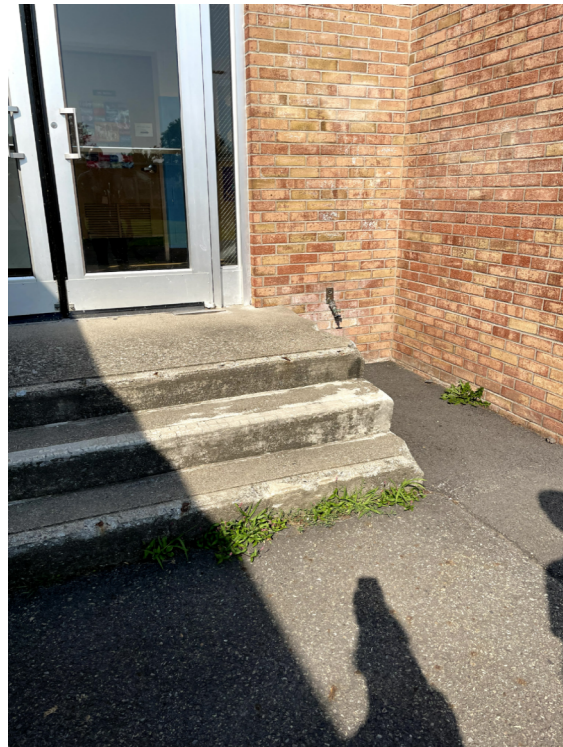
(A2)

| FIVE-YEAR CAPITAL FACILITIES PLAN | | | | | | | | | | | | | | |
|---|---|---|---|---|---|---|---|---|---|---|---|---|---|---|
| WES-070-01-21 | 1 | HS | U | Concrete Gym Stairs | Replace concrete gym stairs and add hand railing. | A2 | REP | Y* | | \$ 69,000 | \$ 6,900 | \$ 13,800 | \$ 6,900 | \$ 96,600 |

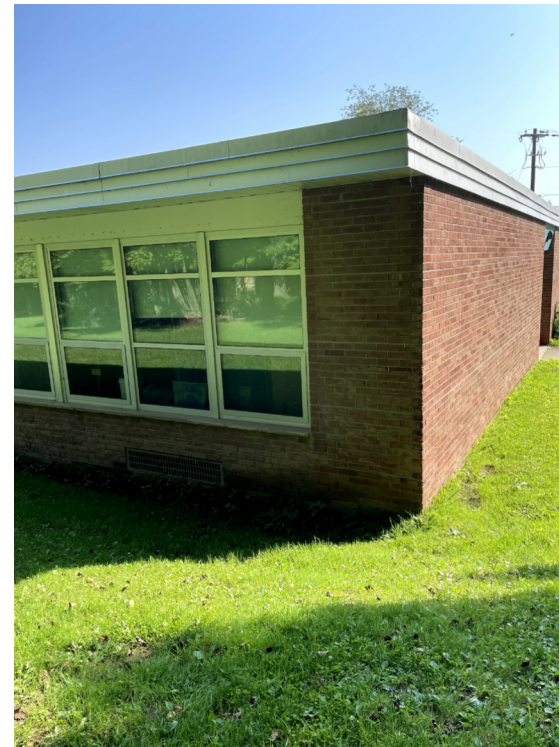
(A3)

| FIVE-YEAR CAPITAL FACILITIES PLAN | | | | | | | | | | | | | | |
|---|---|---|---|---|---|---|---|---|---|---|---|---|---|---|
| WES-073-01-21 | 1 | ST | S | Restore roofing and roof pitch | Perform infrared roof moisture scans and restore all roof levels. Area of roofing at back of building is improperly pitched. Repair/replace (increase thickness of restoration coating (if restoration is possible) at subject areas to provide pitch to drains) | A3 | REP | Y | | \$ 650,000 | \$ 65,000 | \$ 130,000 | \$ 65,000 | \$ 910,000 |

Area of roof at back of building is improperly pitched. Requires change in insulation pitch.

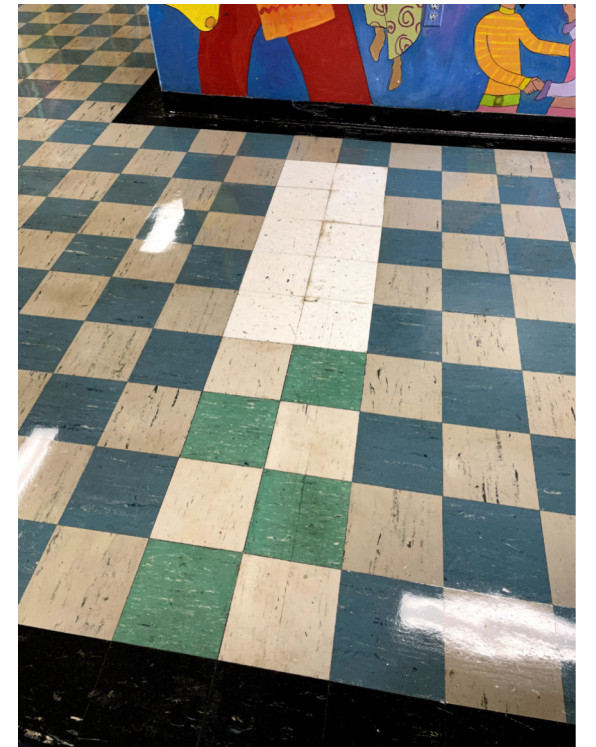
(A4)

| FIVE-YEAR CAPITAL FACILITIES PLAN | | | | | | | | | | | | | | |
|---|---|---|---|---|---|---|---|---|---|---|---|---|---|---|
| WES-077-01-21 | 1 | AP/HS | S | VAT | Replace VAT @ end of useful life, some damaged tile, abate VAT in older sections. | A4 | MSR | Y | | \$ 201,250 | \$ 20,125 | \$ 40,250 | \$ 20,125 | \$ 281,750 |

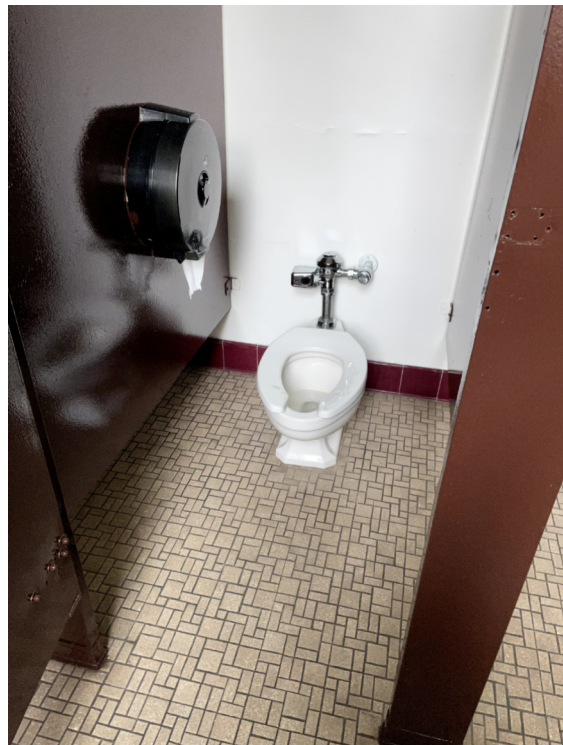
(A5)

| FIVE-YEAR CAPITAL FACILITIES PLAN | | | | | | | | | | | | | | |
|---|---|---|---|---|---|---|---|---|---|---|---|---|---|---|
| WES-115-01-21 | 1 | AP | S | Restroom Facilities | Update bathrooms to be ADA compliant. Replace plumbing fixtures and upgrade Toilet Rooms to comply with ADA requirements | A5 | ALT | Y | | \$ 300,000 | \$ 30,000 | \$ 60,000 | \$ 30,000 | \$ 420,000 |

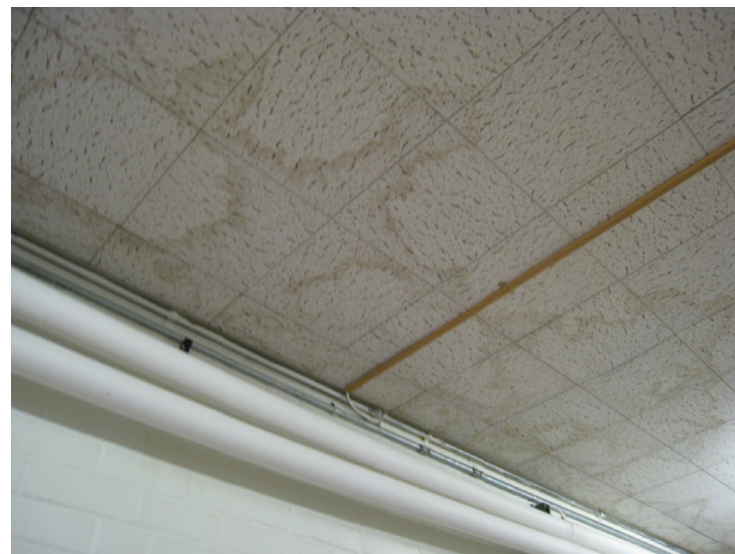
(A6) TYPICAL

| FIVE-YEAR CAPITAL FACILITIES PLAN | | | | | | | | | | | | | | |
|---|---|---|---|---|---|---|---|---|---|---|---|---|---|---|
| WES-080-01-21 | 1 | HS | U | Spline ceilings. | Replace spline, and damaged older 2 x 4, ceilings. | A6 | MSR | Y | | \$ 177,100 | \$ 17,710 | \$ 35,420 | \$ 17,710 | \$ 247,940 |

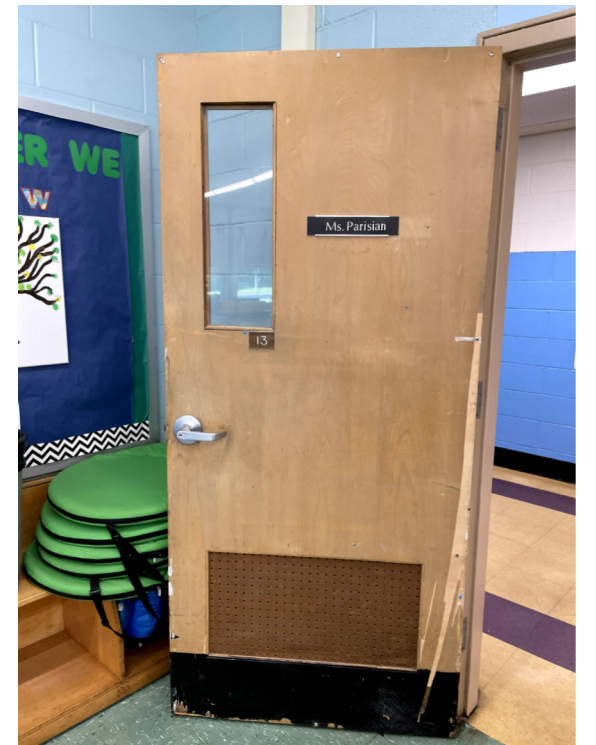
(A8) TYPICAL

| FIVE-YEAR CAPITAL FACILITIES PLAN | | | | | | | | | | | | | | |
|---|---|---|---|---|---|---|---|---|---|---|---|---|---|---|
| WES-082-01-21 | 1 | AP | U | Doors | Doors are original to building and have reached end of useful life. However several doors are in need of immediate replacement (Approx. 50 Hallway Doors) | A8 | MSR | Y | | \$ 150,000 | \$ 15,000 | \$ 30,000 | \$ 15,000 | \$ 210,000 |

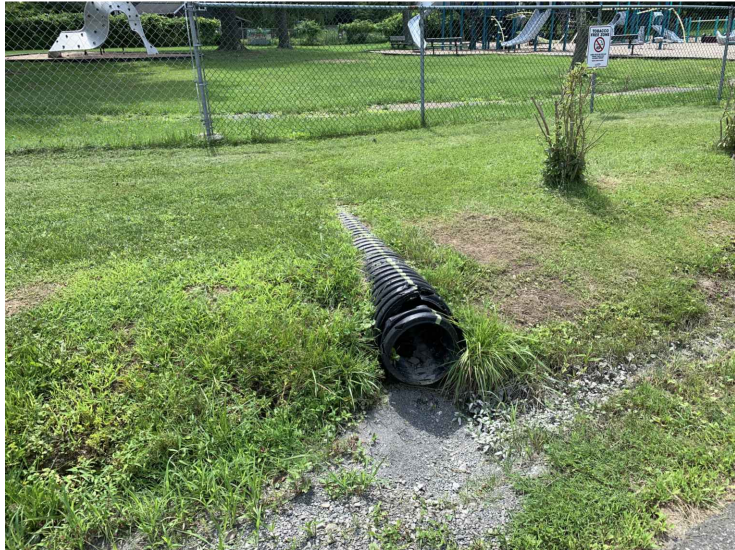
| FIVE-YEAR CAPITAL FACILITIES PLAN | | | | | | | | | | | | | | |
|---|---|---|---|---|---|---|---|---|---|---|---|---|---|---|
| WES-045-01-21 | 1 | AP | S | Fill in exposed drainage pipe | Exposed pvc drainage pipe needs to be filled in | C1 | MNT | Y* | | \$ 1,500 | \$ 150 | \$ 300 | \$ 150 | \$ 2,100 |

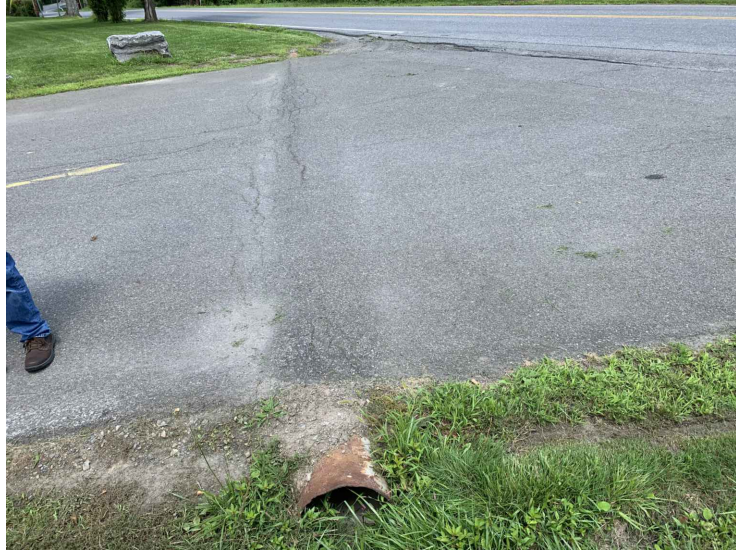
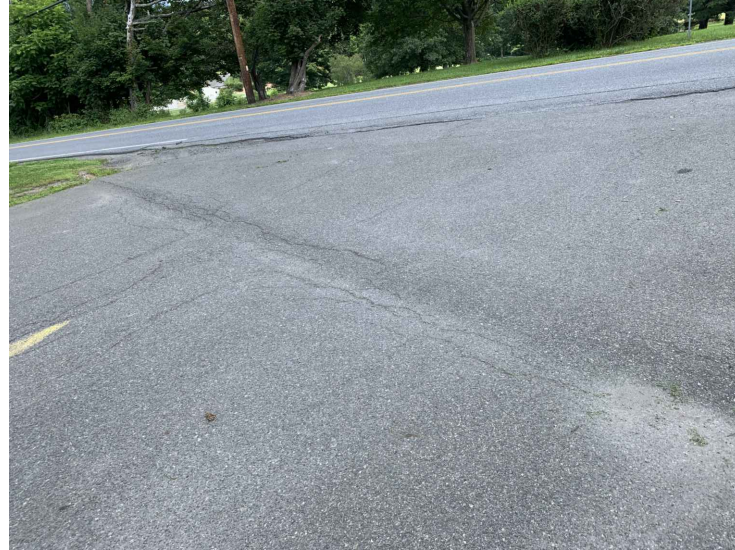
| FIVE-YEAR CAPITAL FACILITIES PLAN | | | | | | | | | | | | | | |
|---|---|---|---|---|---|---|---|---|---|---|---|---|---|---|
| WES-045-01-21 | 1 | AP | S | Re-grade Road Shoulder | Culvert pipe exposed, re-grade road shoulder. | C2&C3 | REP | Y* | | \$ 7,875 | \$ 788 | \$ 1,575 | \$ 788 | \$ 11,025 |

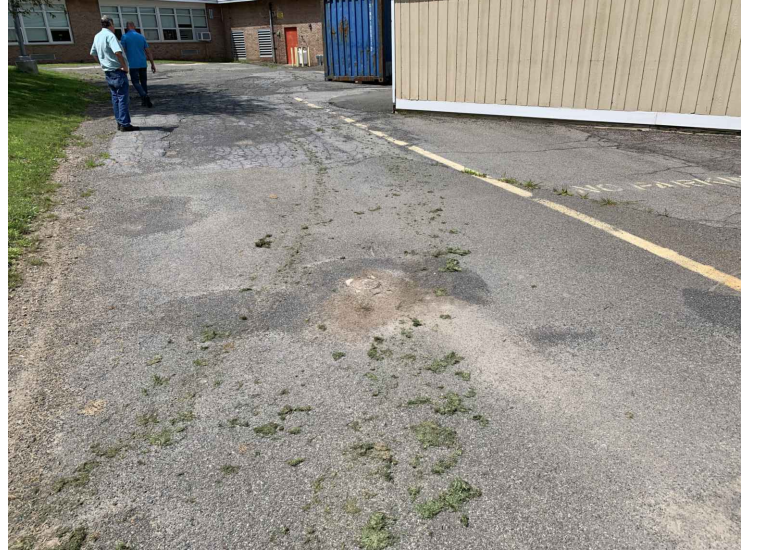
| FIVE-YEAR CAPITAL FACILITIES PLAN | | | | | | | | | | | | | | |
|---|---|---|---|---|---|---|---|---|---|---|---|---|---|---|
| WES-055-01-21 | 1 | AP | S | Asphalt paving - Boiler/kitchen area. - Install new sewer main and storm drain | Replace paving at Boiler/Kitchen area. Add catch basins, replace clay drainage line; replace sewer main. | C4 | ALT | Y* | | \$ 200,000 | \$ 20,000 | \$ 40,000 | \$ 20,000 | \$ 286,000 |

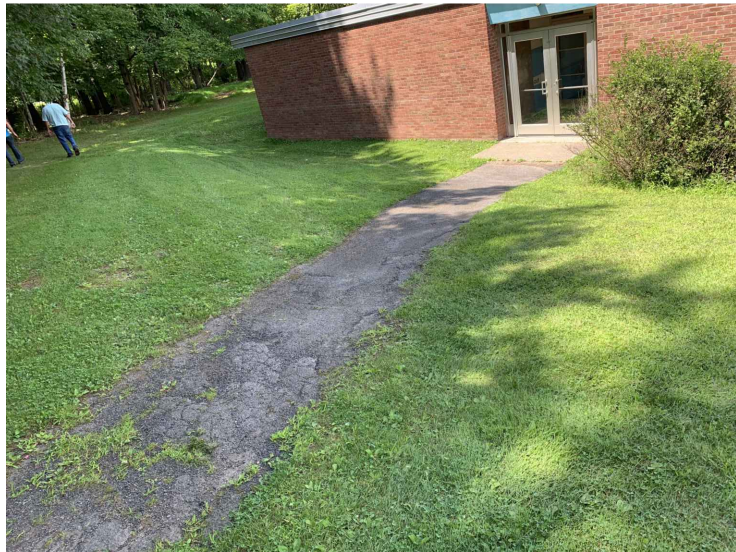
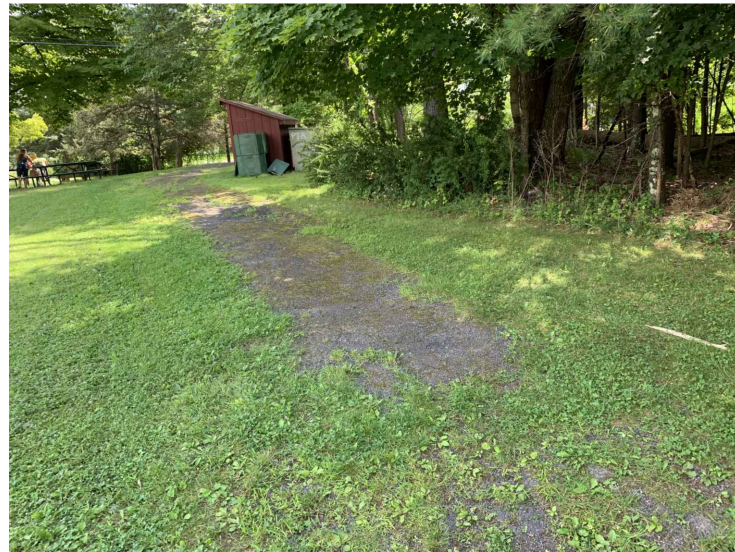
| WES-056-01-21 | 5 | AP | S | Asphalt sidewalk to Riseley Lane | Replace (full depth) Asphalt sidewalks from school to Riseley Lane. | C6&C7 | REP | Y* | | \$29,120.00 | \$2,912.00 | \$5,824.00 | \$2,912.00 | \$40,768.00 | | | | | | | | | |

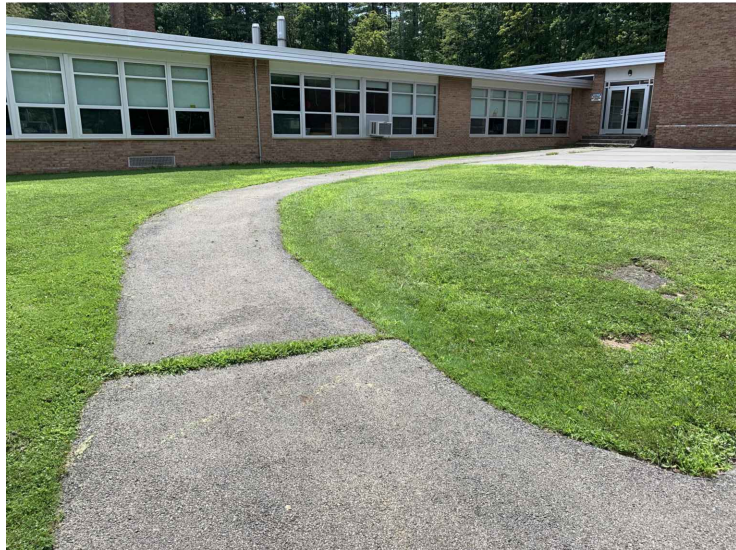
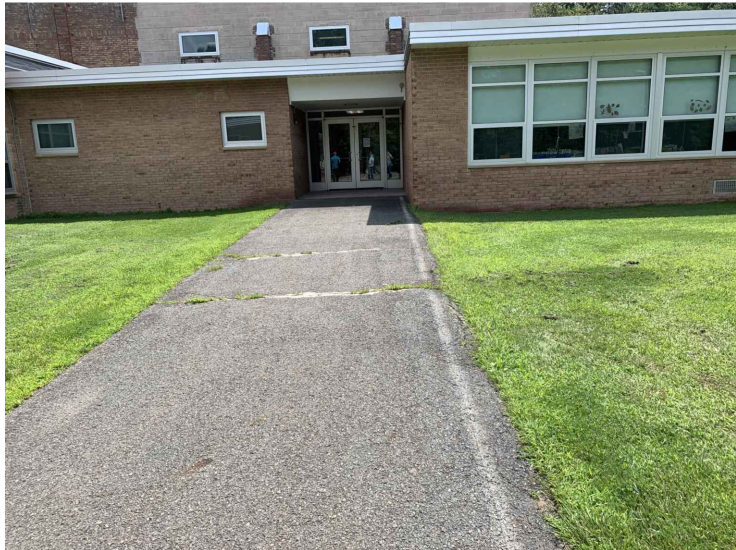
| WES-056-04-21 | 5 | AP | S | Asphalt walk front North Parking Lot | Replace asphalt sidewalk with concrete from North Parking lot to both entrances of building. | C14&15 | REP | Y* | | \$18,400.00 | \$1,840.00 | \$3,680.00 | \$1,840.00 | \$25,760.00 | | | | | | | | | |

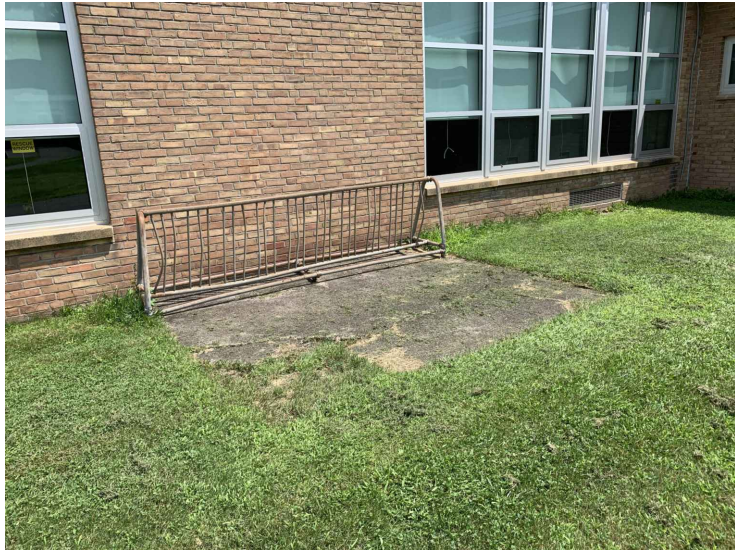
| WES-056-01-21 | 5 | AP | S | Bike rack and concrete pad | Install new bike rack and remove and replace concrete pad on northern part of the building | C16 | REP | Y* | | \$3,850.00 | \$385.00 | \$770.00 | \$385.00 | \$5,390.00 | | | | | | | | | |

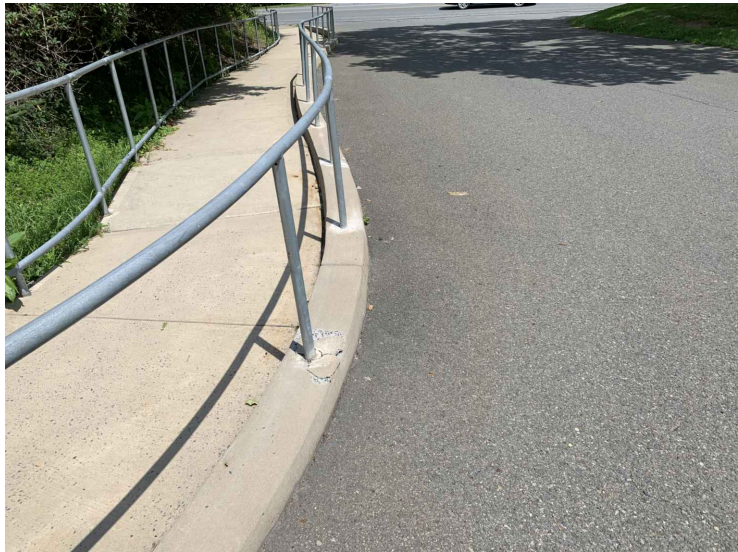
| WES-056-01-21 | 5 | AP | S | Concrete sidewalk along northern entrance | Repair as needed; caulk sidewalk joints and repair concrete curbing around railing posts | C17 | REP | Y* | | \$1,500.00 | \$150.00 | \$300.00 | \$150.00 | \$2,100.00 | | | | | | | | | |
