## FIVE-YEAR CAPITAL FACILITIES PLAN

| Facility Name: | | Bus Garage | | | | | | | | | | | | | |

**2021 BUILDING CONDITION SURVEY - 2021 Building Condition Survey - Bus Garage-BCS**Building Information

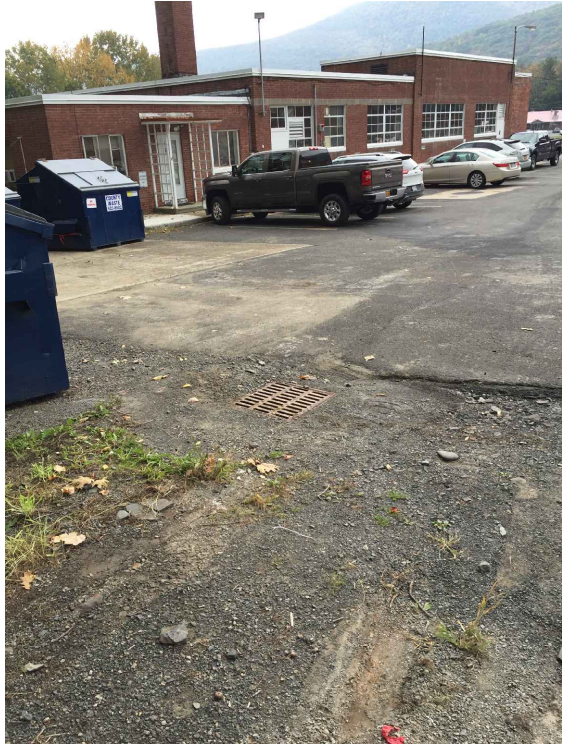
| BG-055-01-21 | 5 | AP | S | Concrete slab | Remove concrete slab in dumpster area and replace with asphalt drive | C1 | ALT | Y* | | \$ 17,000 | \$ 1,700 | \$ 3,400 | \$ 1,700 | \$ 23,800 | |

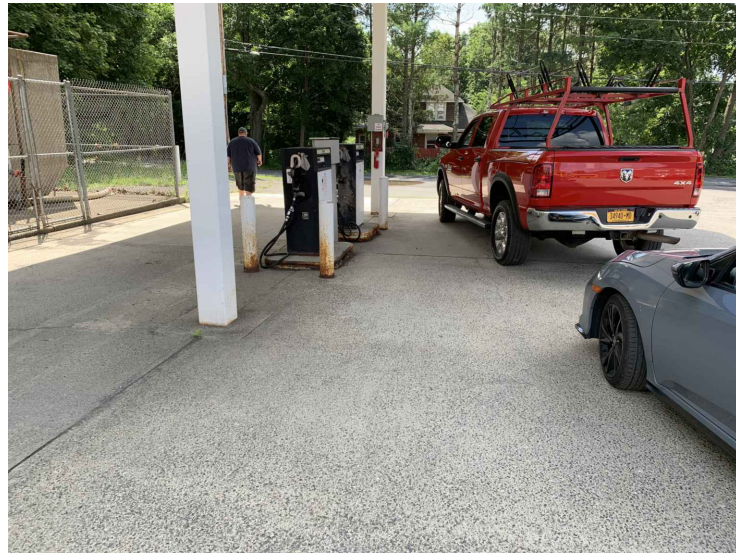
| BG-042-01-21 | 4 | HS | S | Fuel station | Remove and install new fuel station with new tanks, pumps, canopy, and slabs | C3 | REP | Y | | \$ 472,900 | \$ 47,290 | \$ 94,580 | \$ 47,290 | \$ 662,060 | |

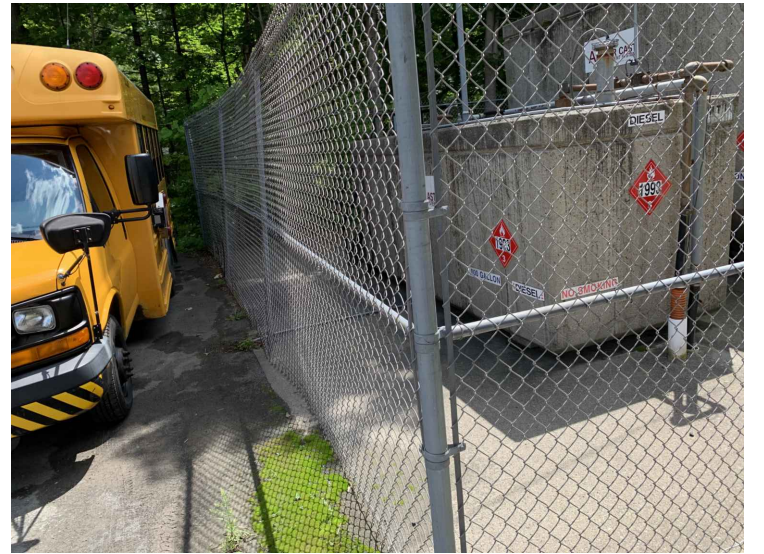
| BG-042-01-21 | 5 | AP | S | Fence | Remove and install new fence line as needed | C4 | REP | Y* | | \$ 4,000 | \$ 400 | \$ 800 | \$ 400 | \$ 5,600 | |
