| FIVE-YEAR CAPITAL FACILITIES PLAN | | | | | | | | | | | | | | |
| District Name: | Onteora CSD | | | <div>ITEM NUMBER LEGEND</div> <div>BLDG BCS# ITEM BCS YR.</div> <div>FES - 067 - 01 - 21 [00 is no BCS #]</div> <div>SYSTEM TYPE</div> <div>HS - Health &amp; Safety</div> <div>ST - Structure</div> <div>EE - Energy Efficiency</div> <div>AP - Asset Preservation</div> <div>SYSTEM RATING</div> <div>E - Excellent</div> <div>S - Satisfactory</div> <div>U - Unsatisfactory</div> <div>NF - Non-Functioning</div> <div>CF - Critical Failure</div> <div>COST TYPE</div> <div>NEW - New Construction</div> <div>ADD - Addition</div> <div>ALT - Alterations</div> <div>MSR - Major System Replacement</div> <div>REP - Repair</div> <div>ENG - Energy</div> <div>MNT - Maintenance</div> <div>Y* - Must be part of larger building project</div> <div>Clark Patterson Lee</div> <div>ARCHITECTURE ENGINEERING PLANNING</div> | | | | | | | | | | |
| Facility Name: | Phoenicia Elem. School | | | | | | | | | | | | | |

**2021 BUILDING CONDITION SURVEY - 2021 Building Condition Survey - PHOENECIA ES**Building Information

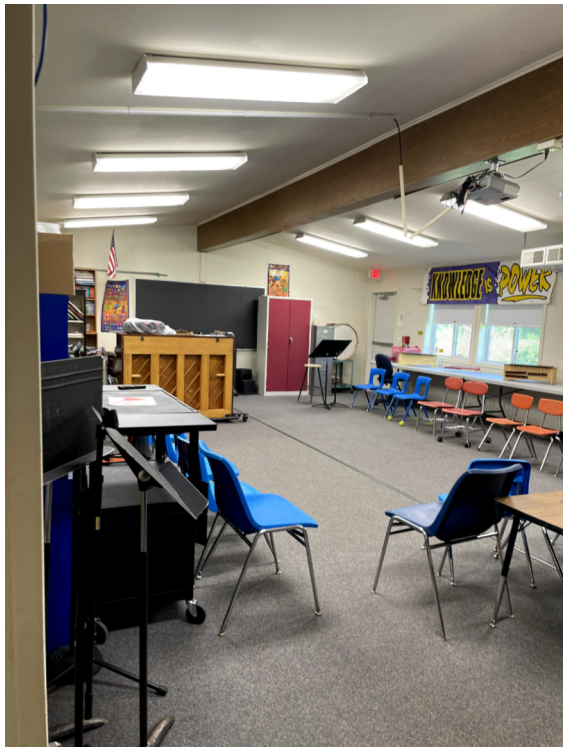
(A1)

| FIVE-YEAR CAPITAL FACILITIES PLAN | | | | | | | | | | | | | | |
|---|---|---|---|---|---|---|---|---|---|---|---|---|---|---|
| PES-066-01-21 | 1 | ST | S | Demo Music Classroom Modular Wing | Demo modular wing that includes music classrooms, remove ramp, restore building exterior at connector. | A1 | ALT | | N | \$ 150,000 | \$ 15,000 | \$ 30,000 | \$ 15,000 | \$ 210,000 |

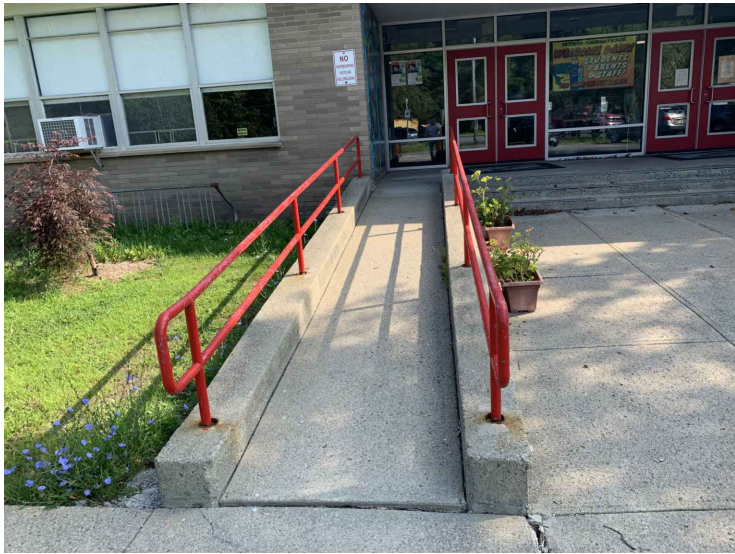
| FIVE-YEAR CAPITAL FACILITIES PLAN | | | | | | | | | | | | | | |
|---|---|---|---|---|---|---|---|---|---|---|---|---|---|---|
| PES-056-02-21 | 1 | AP | S | Northwestern Entrance Repairs | Remove and replace concrete panels at school entrance; Install new crosswalk from entrance to flag pole area; Remove and install new ramp railing on northwestern entrance | C1, C2, & C3 | REP | Y* | | \$ 30,000 | \$ 3,000 | \$ 6,000 | \$ 3,000 | \$ 42,000 |
