WOODSTOCK ACADEMY FACILITY ASSESSMENT October 15, 2019

Juster Pope Frazier LLC Architects

EXECUTIVE SUMMARY

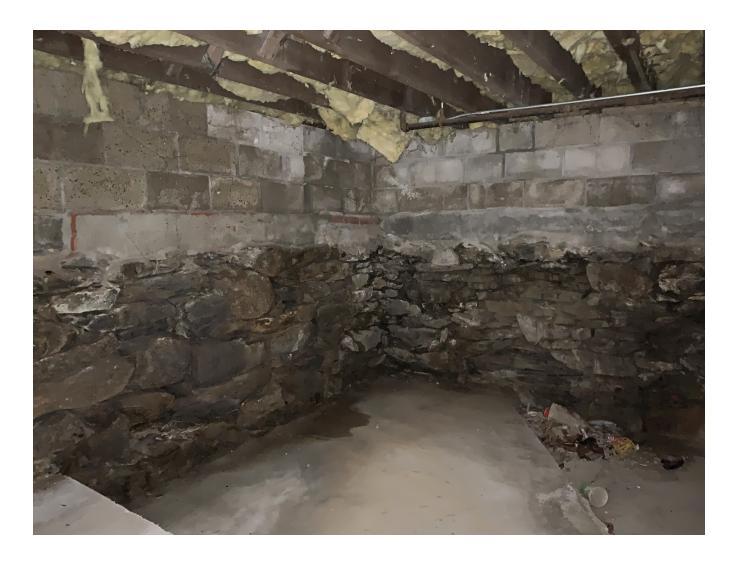
Perimeter foundation rubble and CMU walls show moisture penetration, decay.

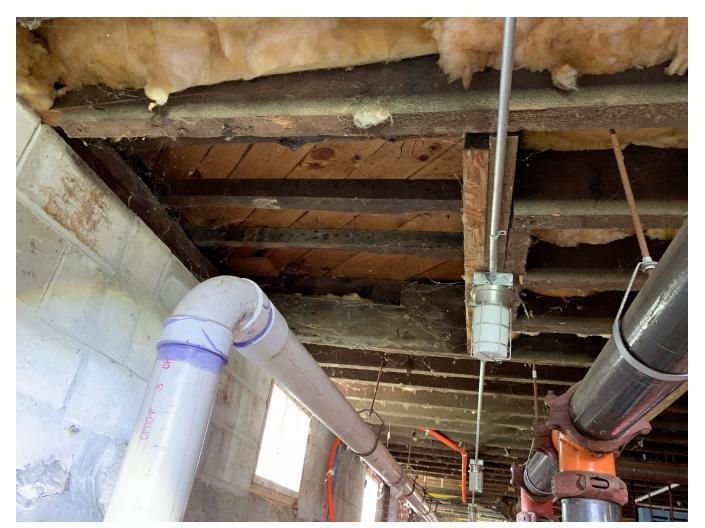
Insulation between basement and first floor is inconsistent. Perimeter foundation is uninsulated resulting in significant heat loss

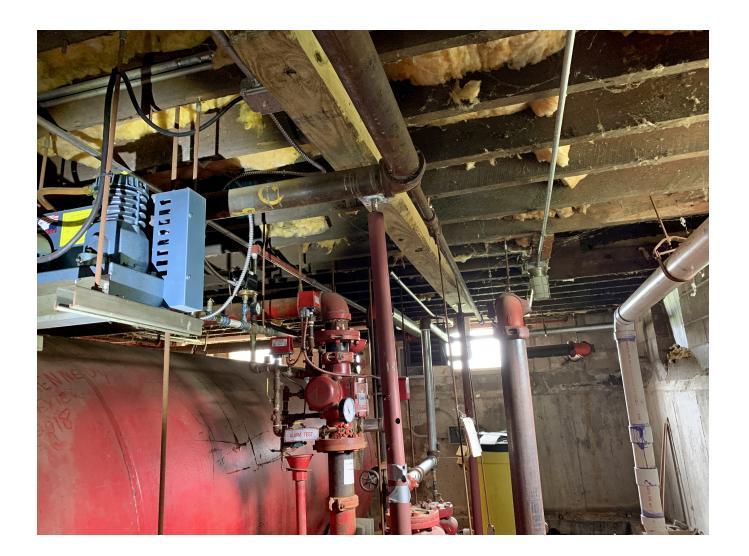
Significant gaps in floor insulation throughout the first floor framing. Floor framing undersized for current code required loads.

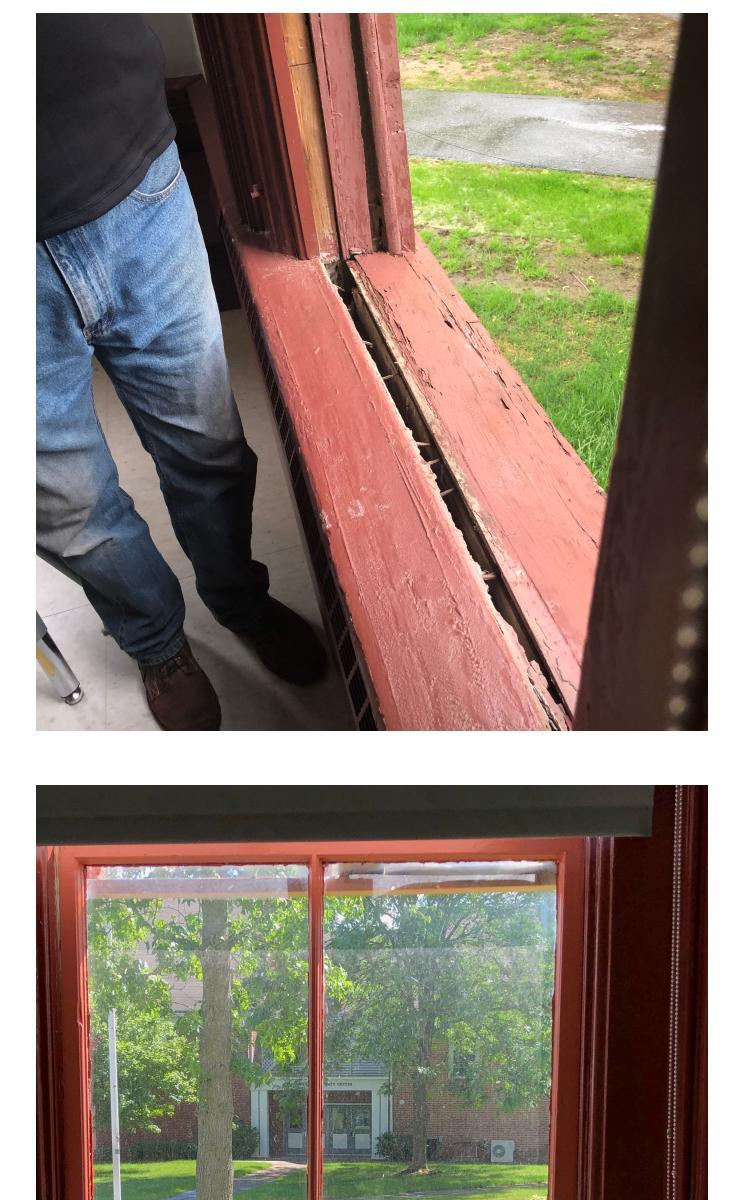
Windows, window frames and trim need to be replaced. They are out of square and cannot be locked. Many cannot open or have broken counterweight. Windows are single pane. This In concert with the gaps and framing voids is creating significant heat loss.

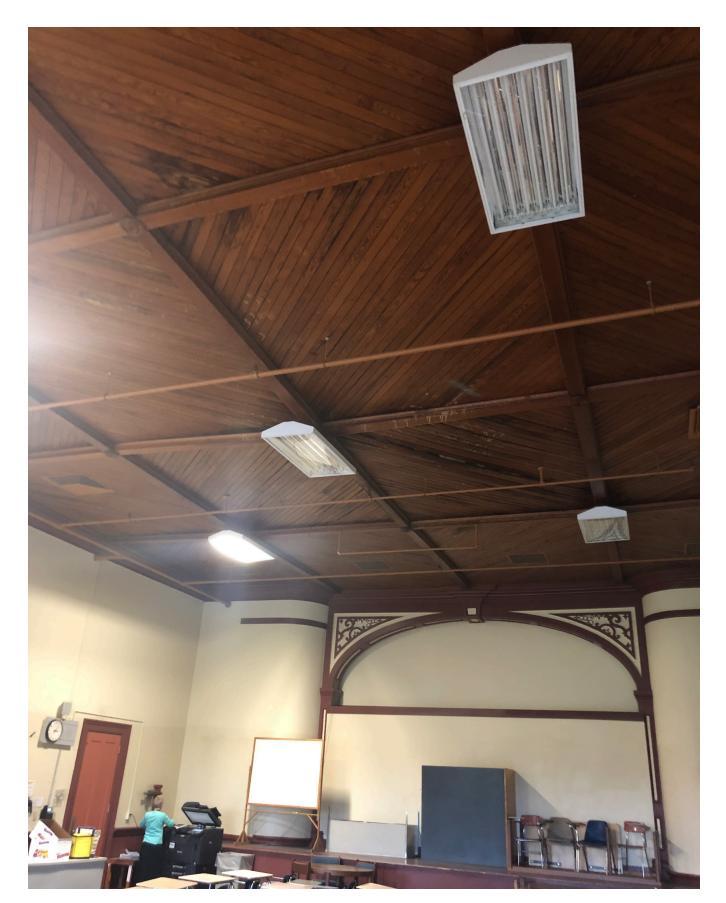
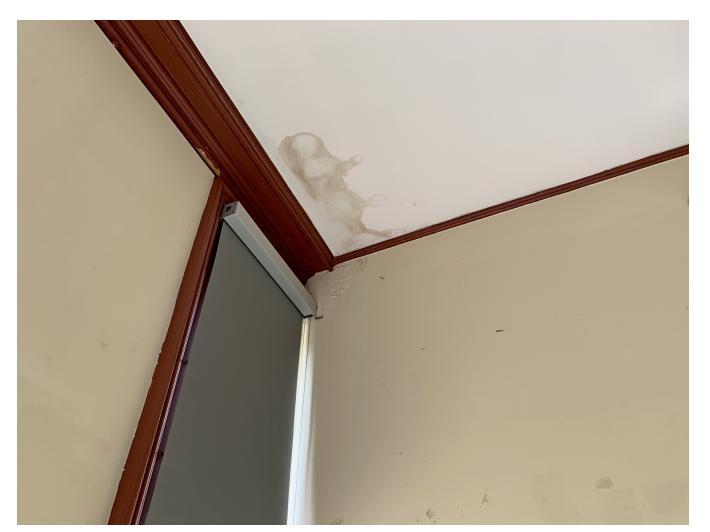
The wood ceiling in the auditorium has water damage from leaks through the belfry above. Light fixtures are inappropriate and the former stage has been infilled in past renovations.

Ceiling in classrooms are showing signs of water damage from leaking roof and gutter assemblies.

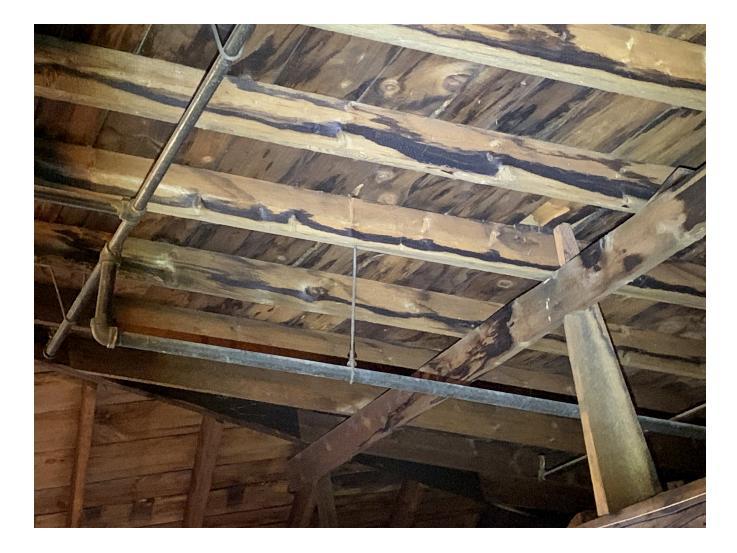
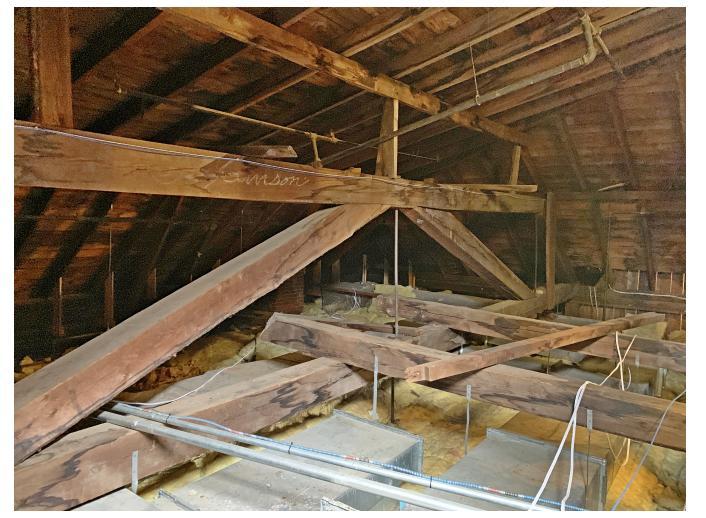
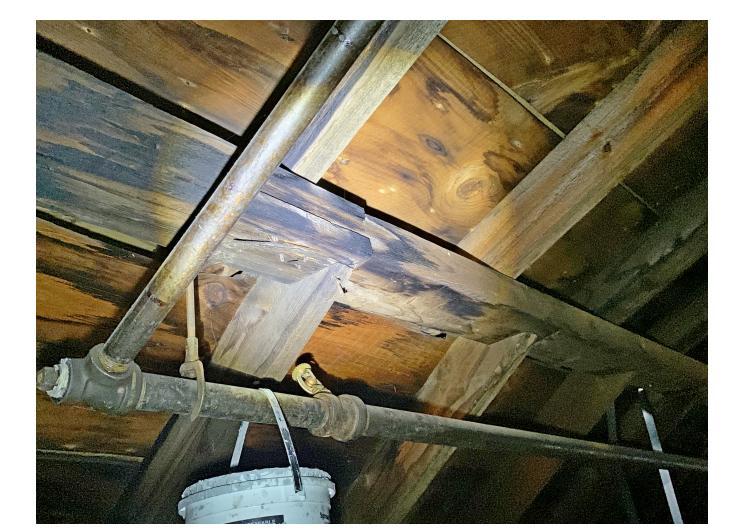
Attic roof framing and sheathing are showing signs of water damage from roof leaks in the main roof and belfry. Water is also leaking from located mechanical equipment and fire protection piping located within the attic.

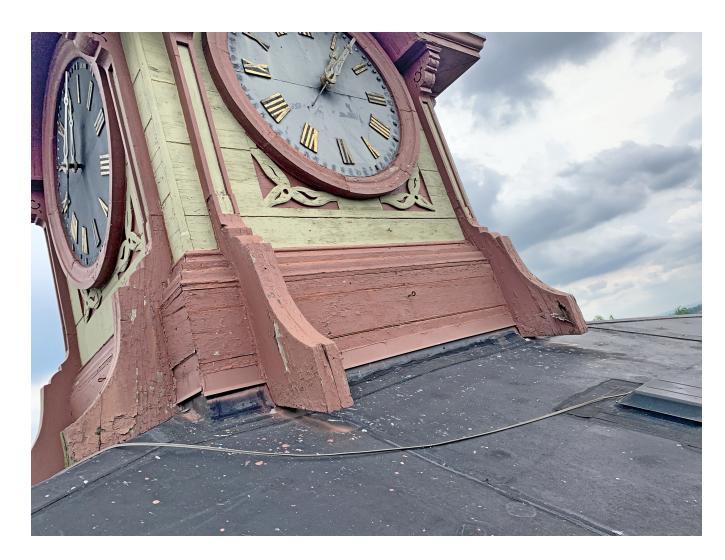
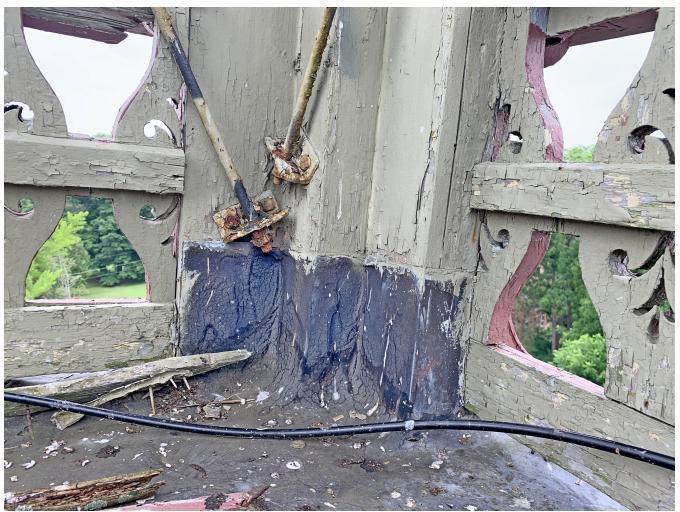
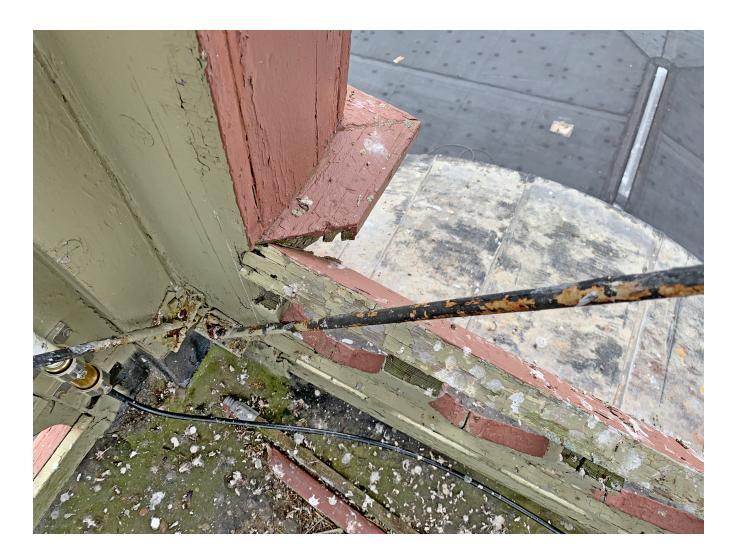
The belfry and clocktower have poor flashing and roof leaks resulting in significant damage to the original wood trim and leaks into the attic below.

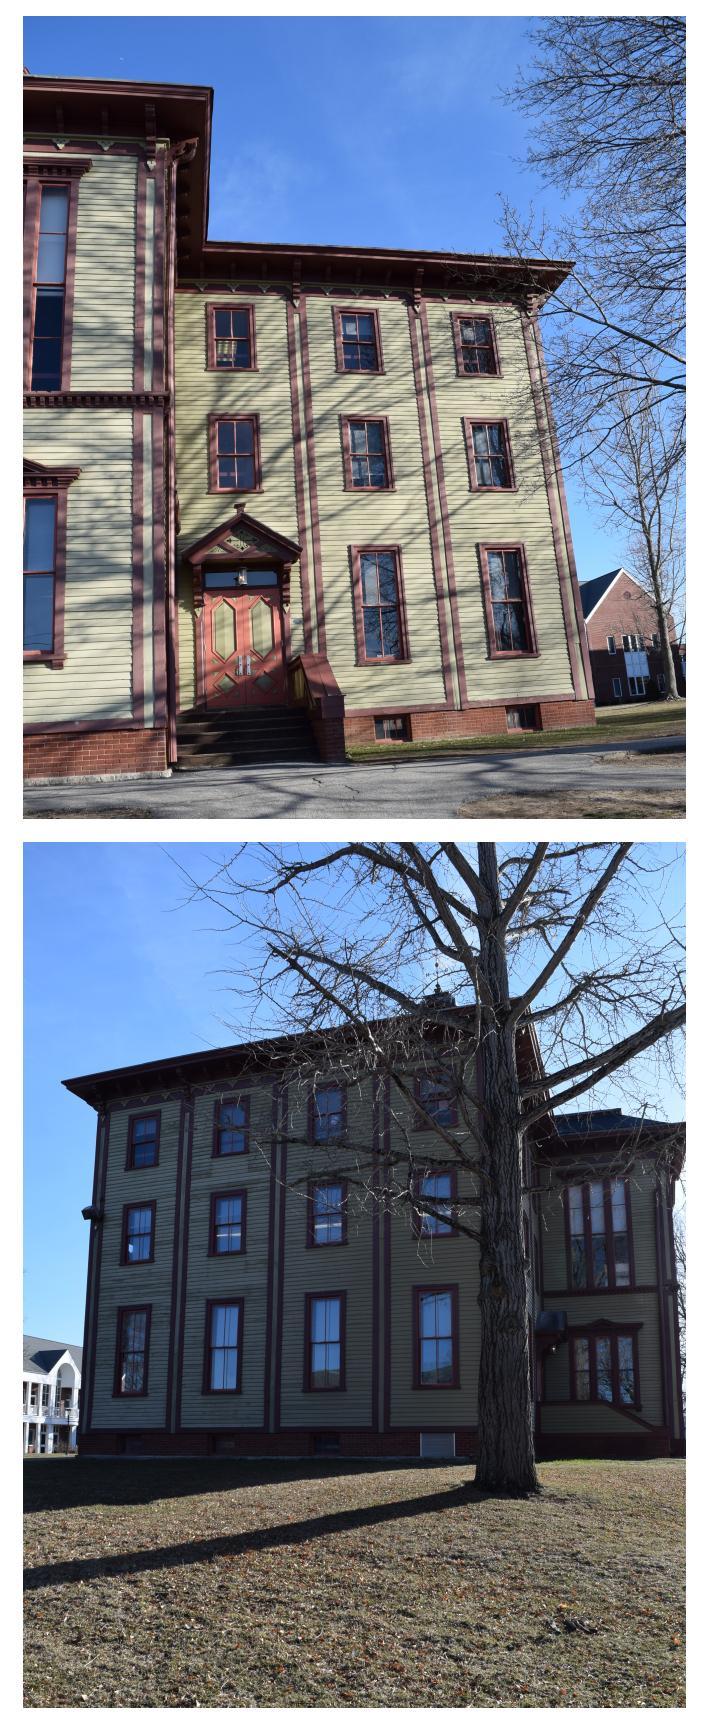
Exterior siding shows signs of staining and cupping, trim is rotting and gutter / downspouts are no longer connected. These all indicate potential concealed framing damage from moistur infiltration at the roof, windows and roof eaves.
