Fairfield Woods Middle School

Fairfield Public Schools Recommissioning (RCx) and Testing, Adjusting, & Balancing (TAB) Study van Zelm Project # 2020102.00 (05-FWMS) August 01, 2022

FAIRFIELD PUBLIC SCHOOLS RECOMMISSIONING (RCX) AND TESTING, ADJUSTING, & BALANCING (TAB) STUDY

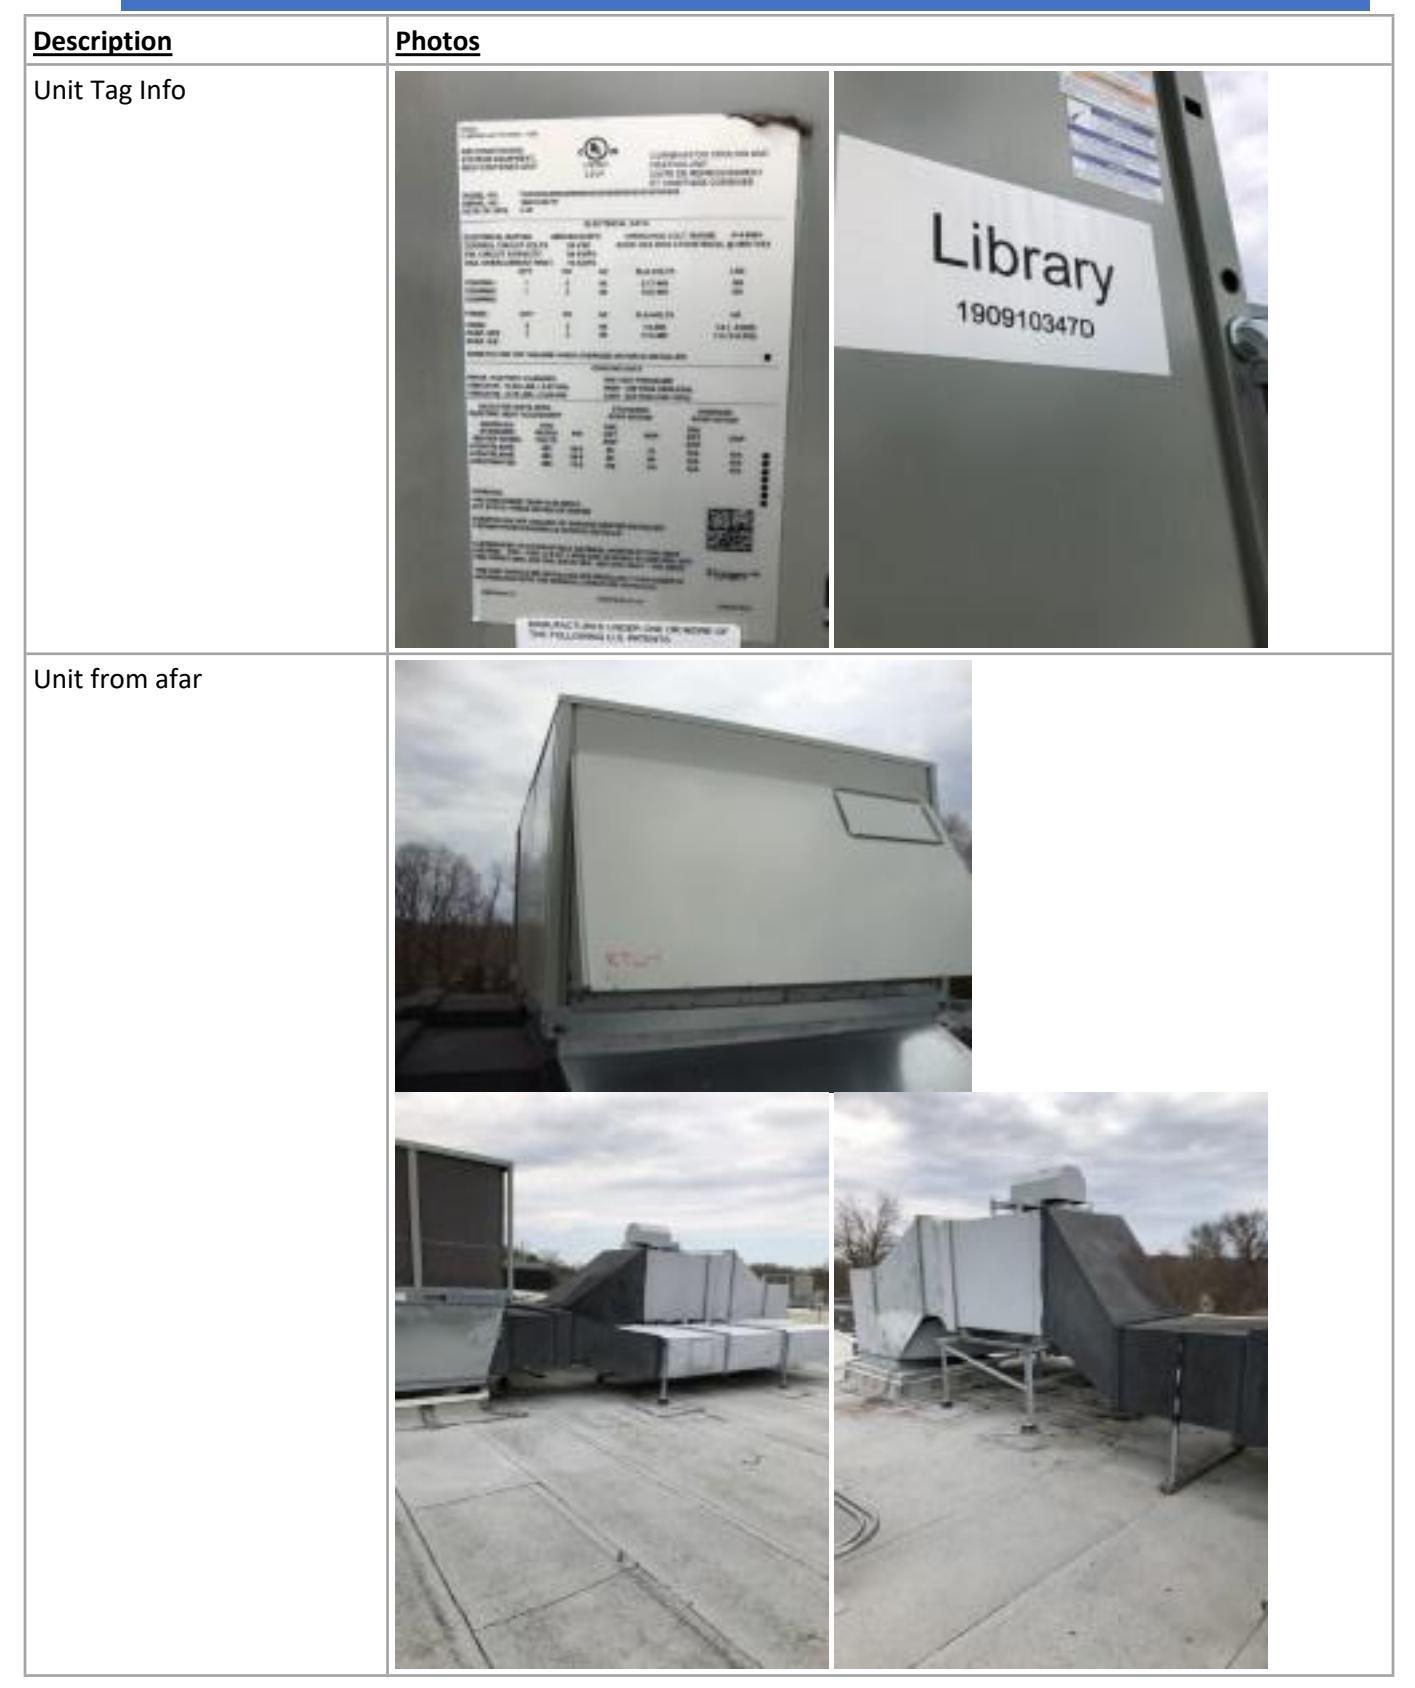
<u>Unit Tag</u>	<u>RTU-1</u>	Addition comments descriptions
Location	East Roof	
Serving	Library/Media Center	
Config/Style	CV Cooling only	Downdraft to existing Horizontal exposed ductwork on roof
Mfr.	Trane	
Model #	TSD300G4R0A0R	
Serial #	190910347D	
Age (years)	2019	
System CFM	10000	
Max OA CFM		
V/Hz/Ph	460. 3_Phase	
SF Qty/HP	7.5 ECM motor	
SF VFD Data		
RF Qty/HP		Existing Ductwork and inline fan not operational
RF VFD Data		
Filter Data (Size Quantity)	(6) 20 x 25 x 2	Changed last 10-5-21
Filter Status	Moderate	
Controls Type	DDC Electronic	
Controls Mfr.	Trane Factory/Alerton	
Economizer	Packaged	
CO ₂ DCV		
Damper Styles	Flapper Blade	
Damper Status		
Heating Type	NA	
Heating Coil Condition		
Cooling Type	DX 3-stage	
Cooling Coil Condition	ОК	
CU Serial		
Drain Pan Status	Some dried scale and debris	
Notes:

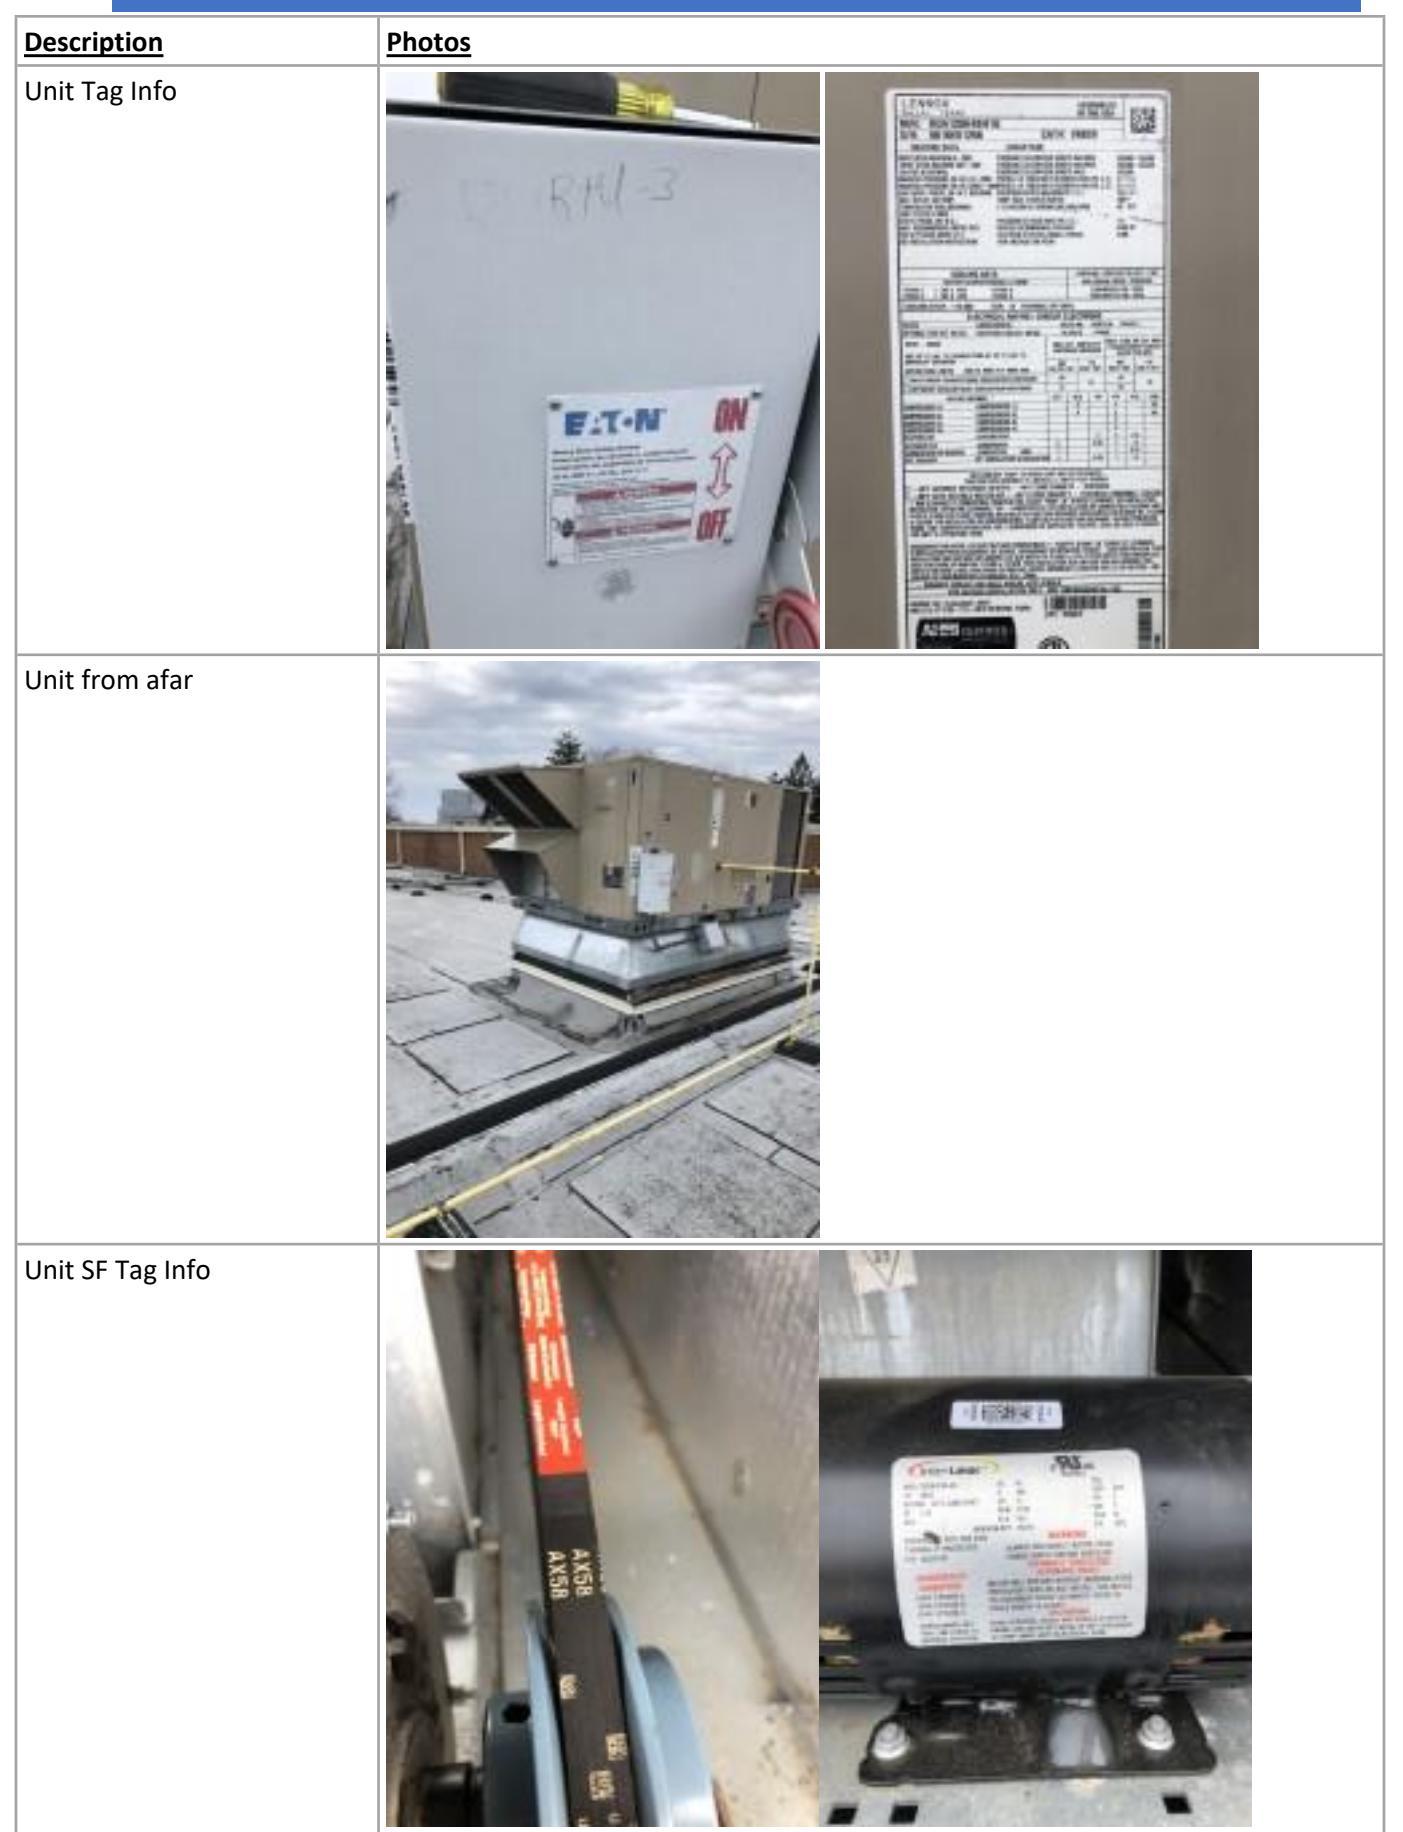
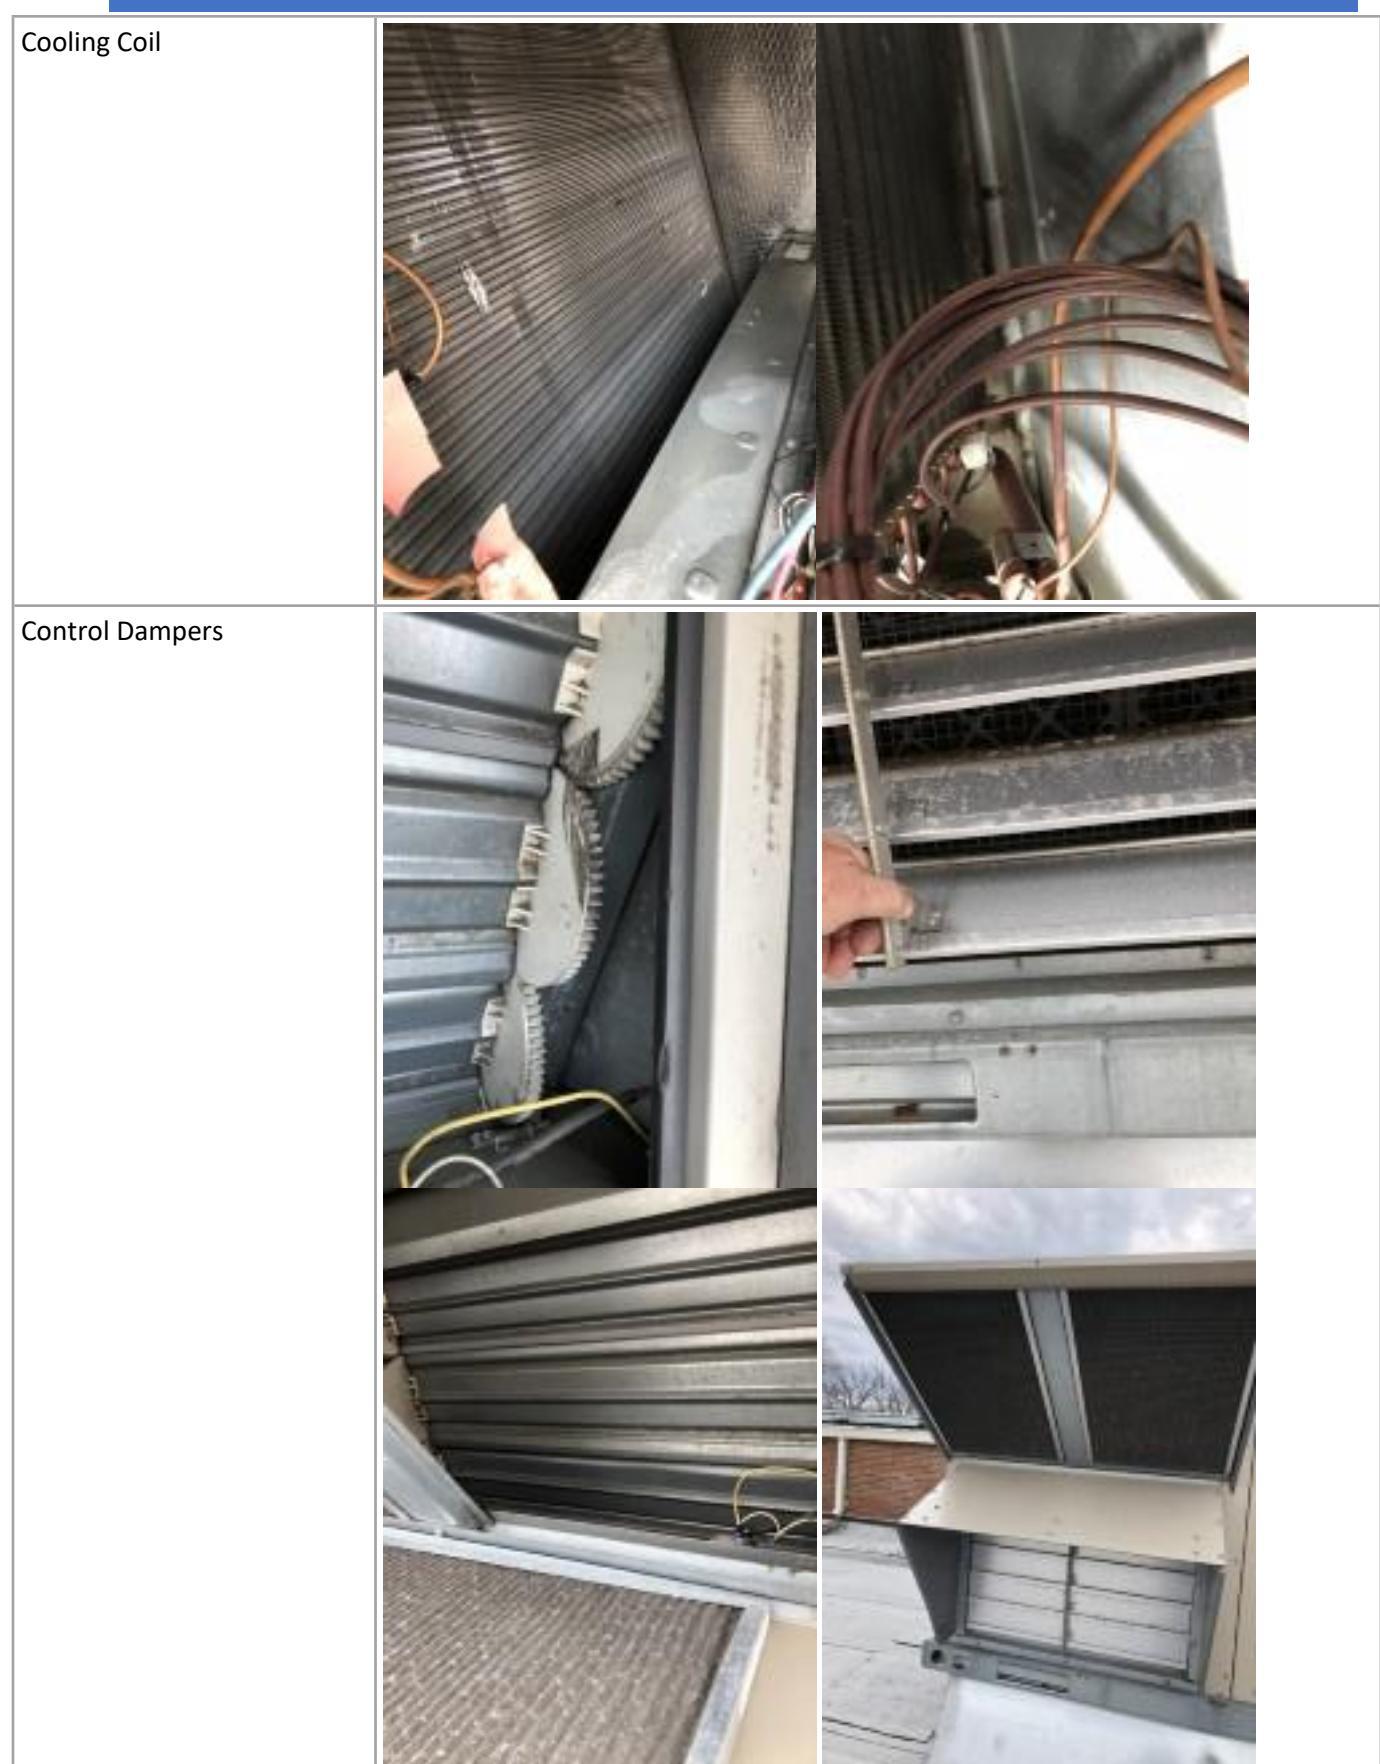
Unit Tag	RTU-3	Addition comments descriptions
Location	Northeast Roof	
Serving	Computer	
Config/Style	CV Cooling with Gas Heat	
Mfr.	Lennox	
Model #	KGA120H4BH1G	
Serial #	5616E01266	
Age (years)	10-28	Original project 1994
System CFM	3400	
Max OA CFM		
V/Hz/Ph	460, 3-Phase	
SF Qty/HP	3HP InterLink	
SF VFD Data		
RF Qty/HP	Power Exhaust .33 HP	1 AX58 Belt in good condition
RF VFD Data		
Filter Data (Size Quantity)	OA Metal mesh (2) 16 x 25 x1 (4) 20 x 25 x 2	
Filter Status	Moderately dirty	
Controls Type		
Controls Mfr.		
Economizer	Packaged Honeywell Enthalpy controller	Gravity Exhaust damper should be lubricated
CO ₂ DCV		
Damper Styles	Opposed Gear sectional Packaged controlled	
Damper Status	Should be cleaned and lubricated	
Heating Type	Natural Gas 192 MBH	
Heating Coil Condition		
Cooling Type	DX 2-Stage	
Cooling Coil Condition		
CU Mfr.		
CU Model		
CU Serial		
Drain Pan Status		
Notes:

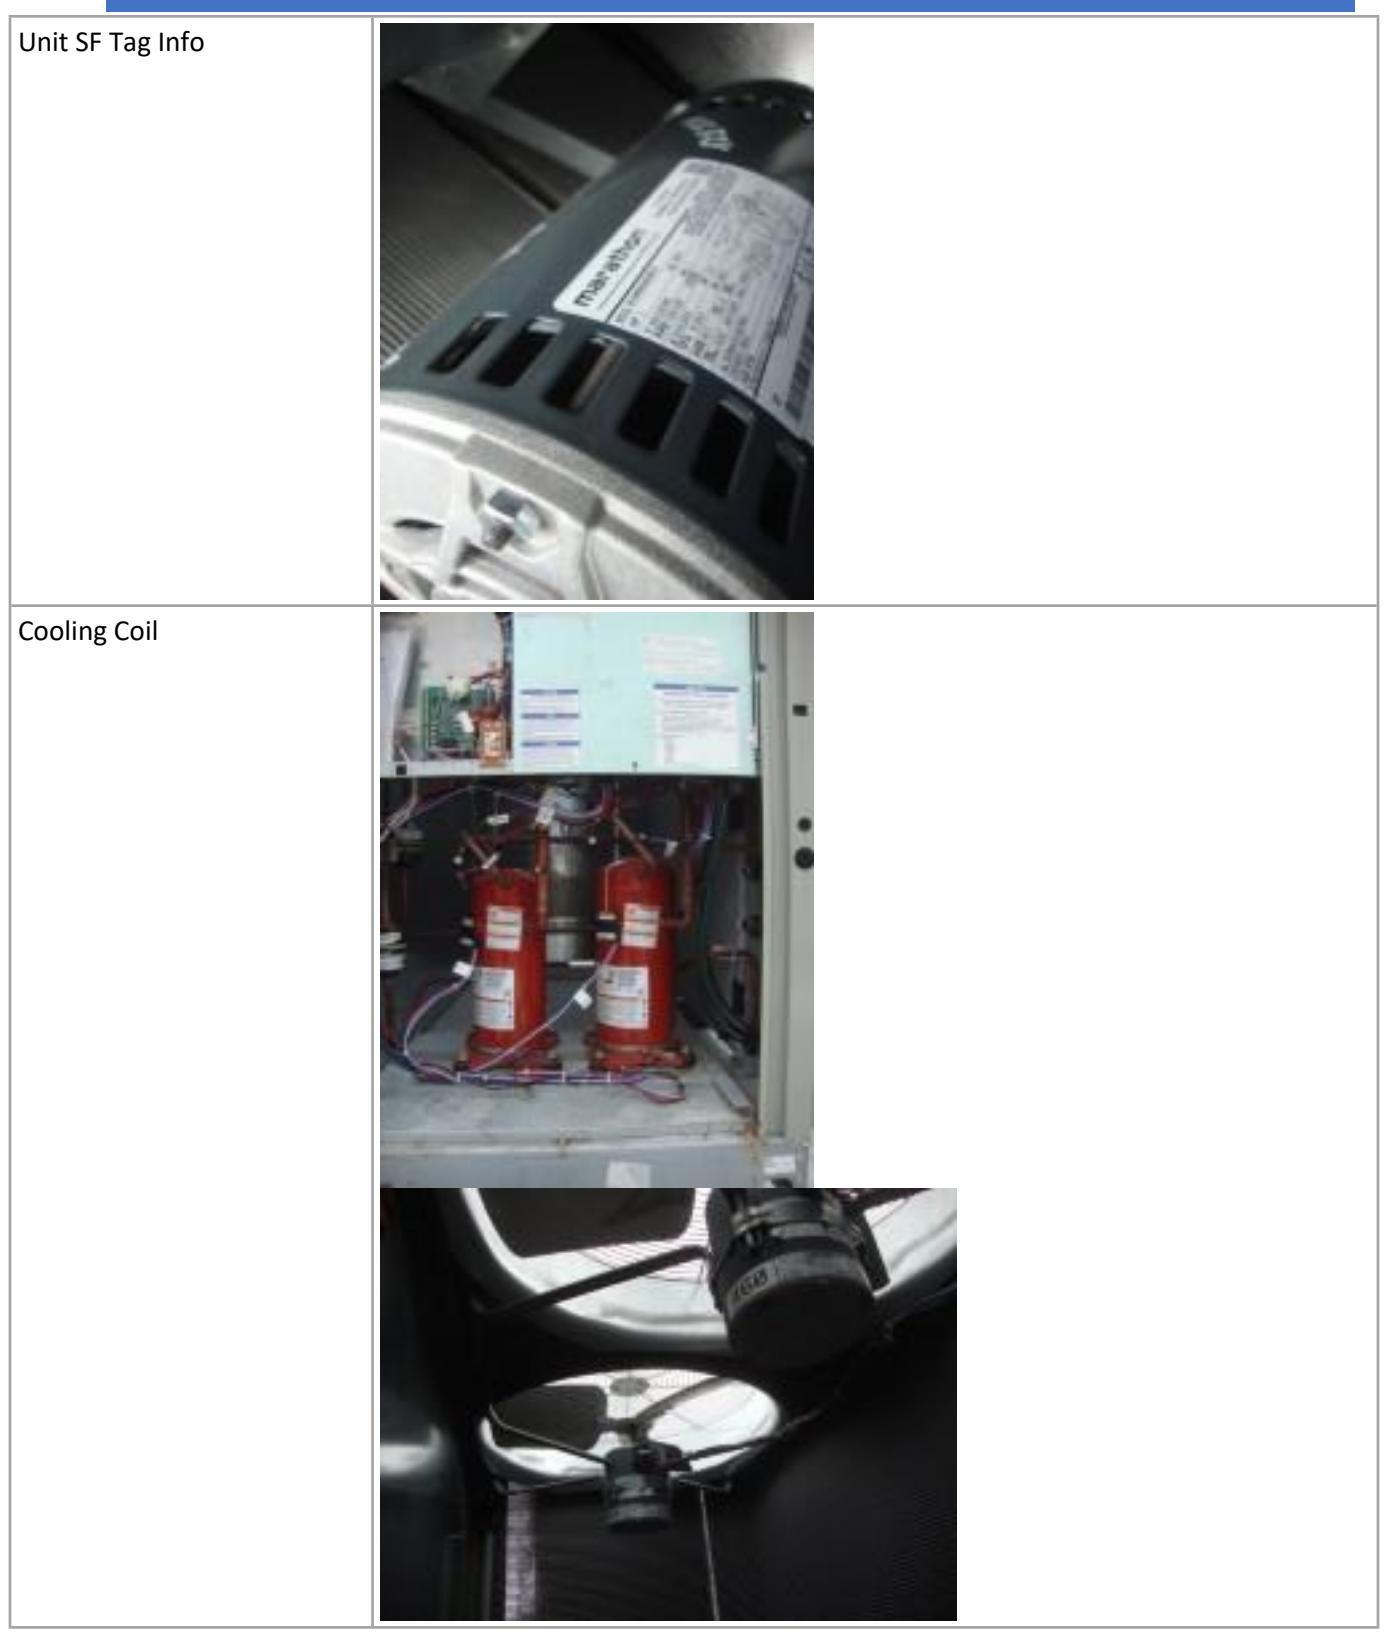
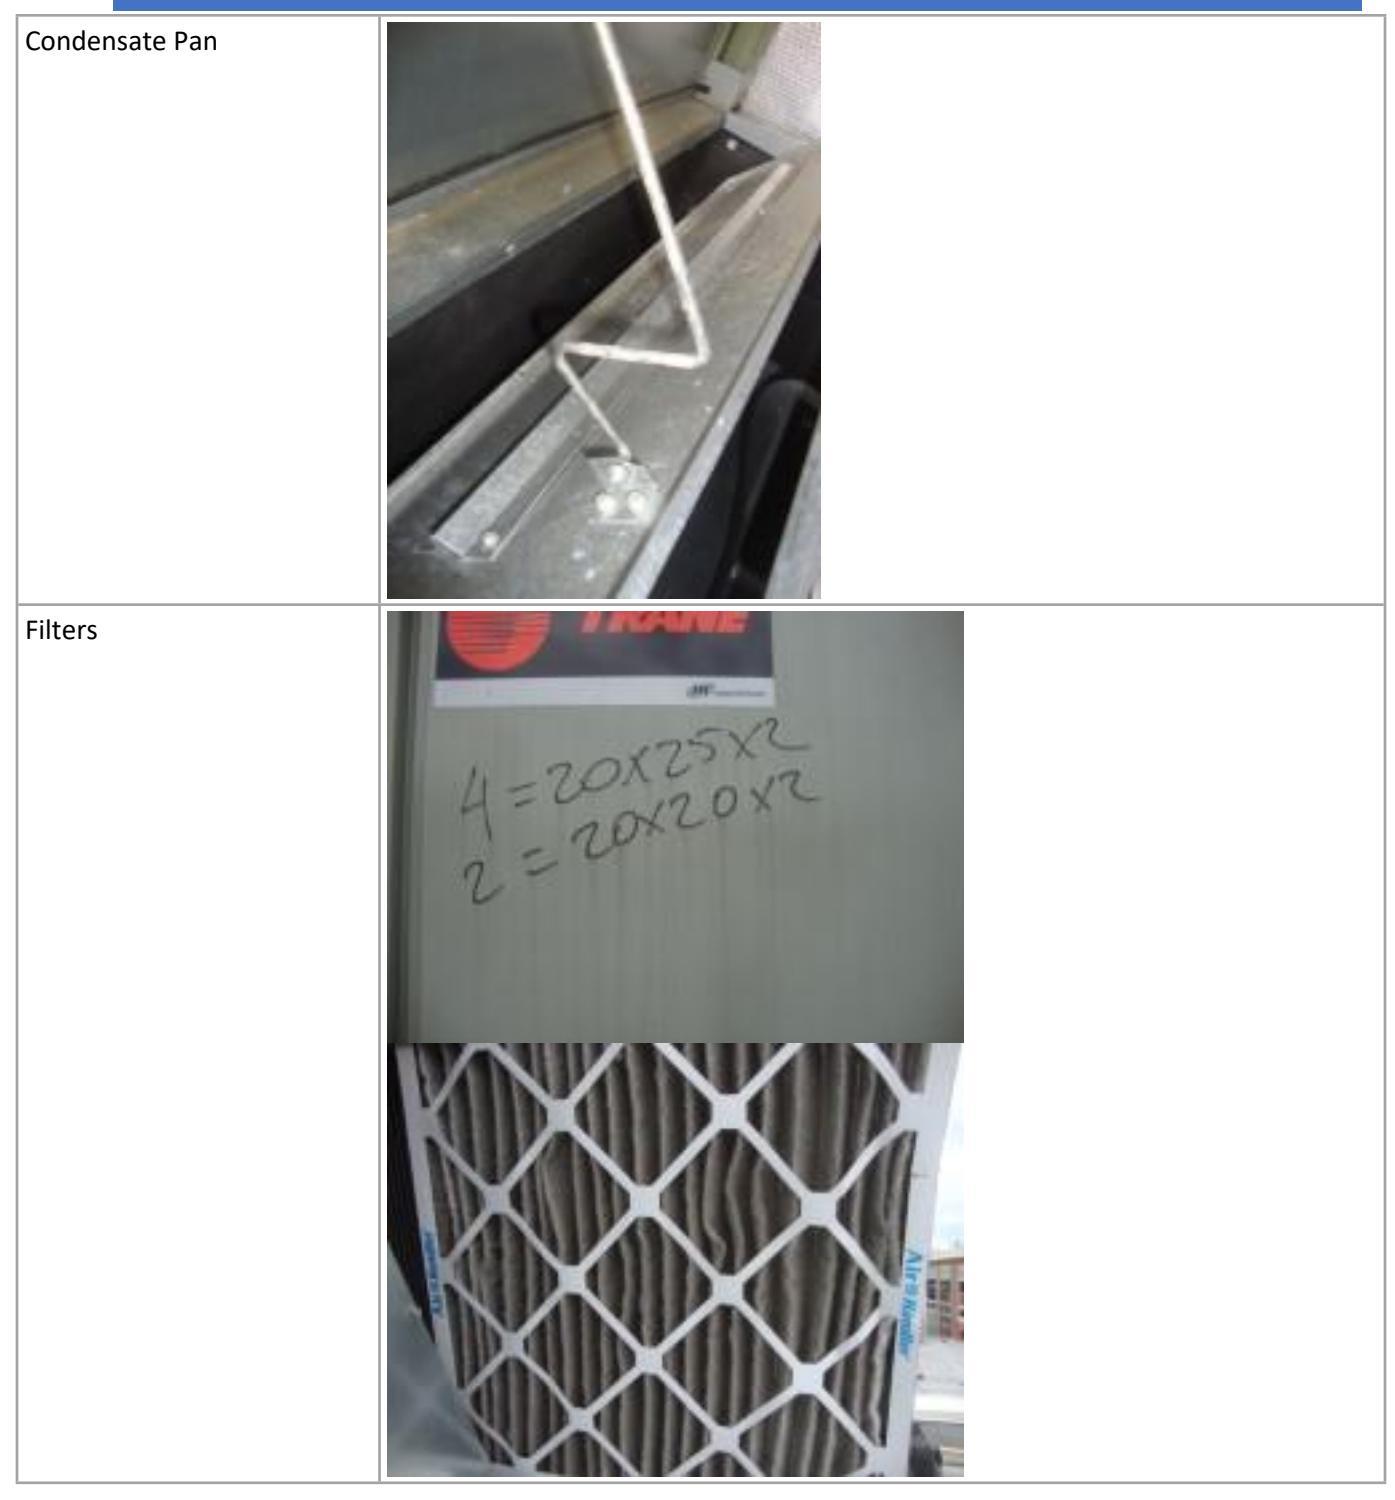
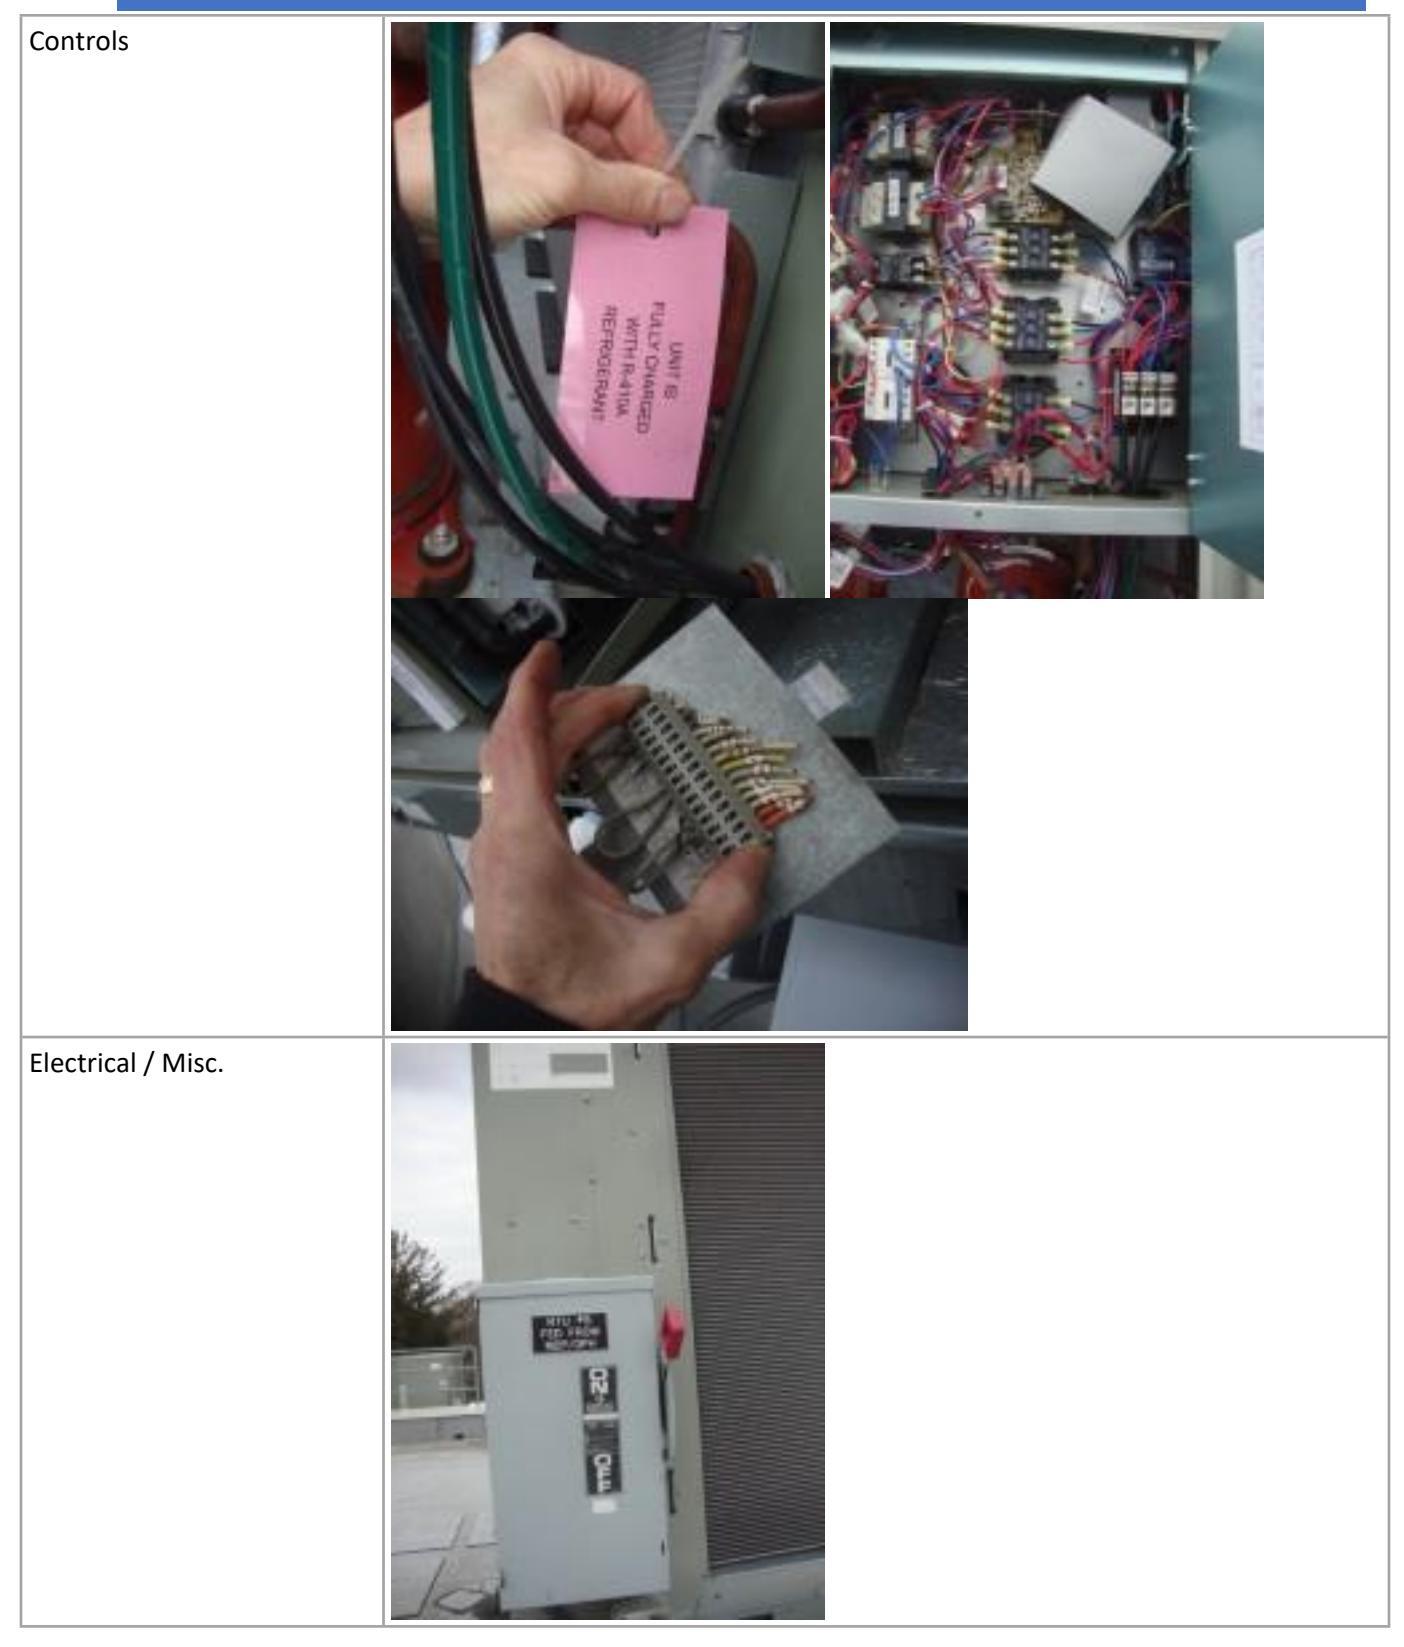
<u>Unit Tag</u>	RTU-5	Addition comments descriptions
Location	Northeast Roof	
Serving	Culinary	
Config/Style	Packaged Gas/DX	
Mfr.	Trane	
Model #	YSD150GR4RHAOVD	
Serial #	192910924D	
Age (years)	7/2019	
System CFM	6000	
Max OA CFM		
V/Hz/Ph	460/60/3	
SF Qty/HP	(1) 3.0	
SF VFD Data	N/A	
RF Qty/HP	N/A	
RF VFD Data	N/A	
Filter Data (Size Quantity)	(4) 20"x25"x2" (2) 20"x20"x2"	
Filter Status	Dirty	10/4/21
Controls Type	DDC Electronic Packaged Controls	
Controls Mfr.	Packaged Controls Allerton	
Economizer	Yes	
CO ₂ DCV		
Damper Styles	Trane Packaged Configuration	
Damper Status	ОК	
Heating Type	Gas Burner	
Heating Coil Condition	ОК	
Cooling Type	DX (2) compressors	
Cooling Coil Condition	ОК	
CU Mfr.	Twin Condenser fans	
CU Model		
CU Serial		
Drain Pan Status	Clean	
Notes:		
Description	Photos	
--------------------	--------	
Unit Tag Info		
Unit from afar

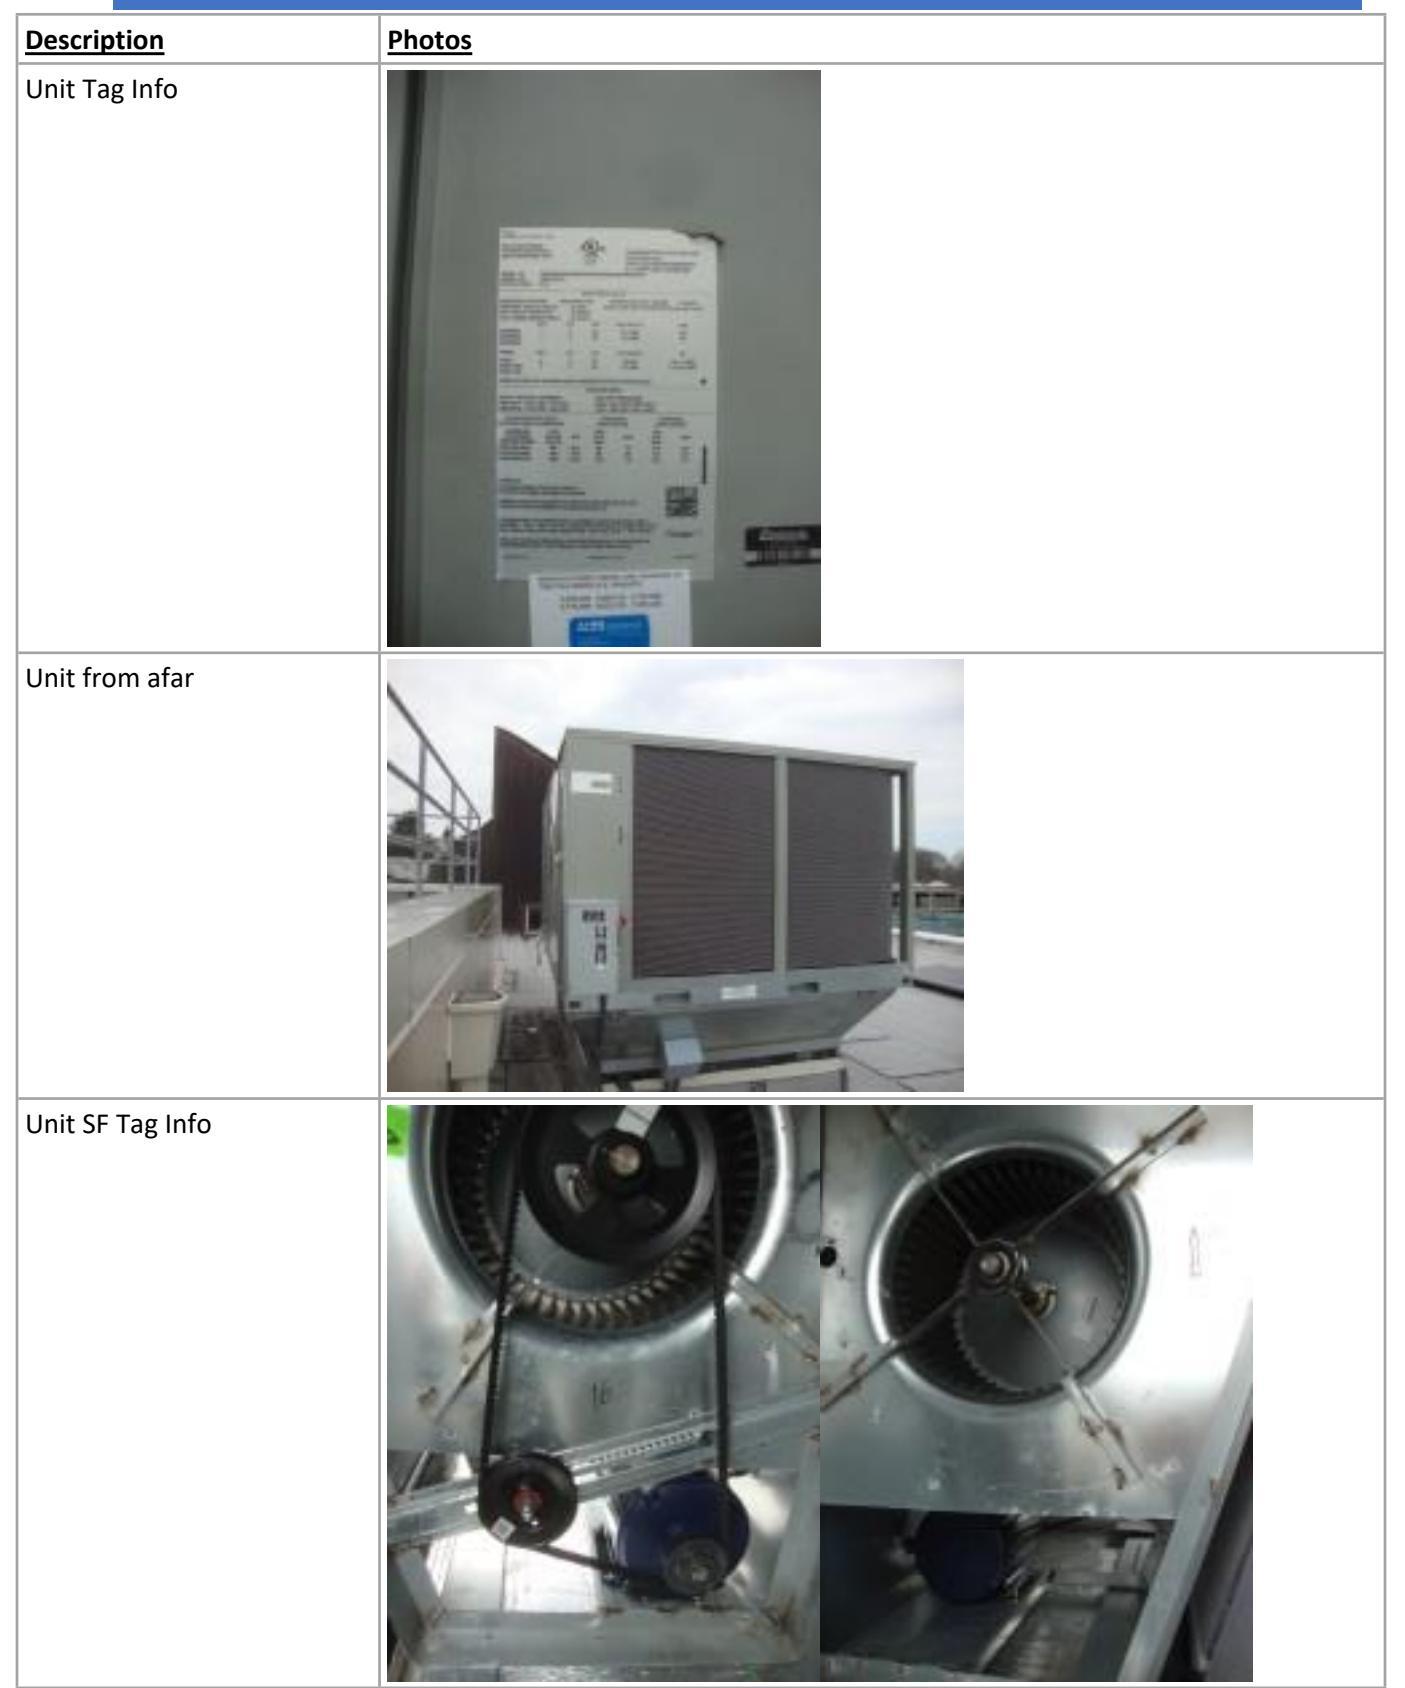
<u>Unit Tag</u>	RTU-6 Addition comments descriptions	
Location	Northeast Roof	
Serving	Administration	
Config/Style	Packaged Gas/Dx	
Mfr.	Trane	
Model #	YSD180G4RHAORD	
Serial #	191111094D	
Age (years)	3/2019	
System CFM	5000	
Max OA CFM		
V/Hz/Ph	460/60/3	
SF Qty/HP	(1) 7-1/2	
SF VFD Data	N/A	
RF Qty/HP	N/A	
RF VFD Data	N/A	
Filter Data (Size Quantity)	(4) 20"x20"x2" (4) 20"x25"x2"	
Filter Status	Dirty	8/10/21
Controls Type	DDC Electronic Packaged Controls	
Controls Mfr.	Package Controls Allerton	
Economizer	Yes	
CO ₂ DCV		
Damper Styles	Trane Packaged Configuration	
Damper Status	ОК	
Heating Type	Gas Burner	
Heating Coil Condition	ОК	
Cooling Type	DX R-410A	
Cooling Coil Condition	ОК	
CU Mfr.		
CU Model		
CU Serial		
Drain Pan Status	Clean	Part of trap of, replaced REA
Notes:
