Fairfield Woods Middle School

Fairfield Public Schools Recommissioning (RCx) and Testing, Adjusting, & Balancing (TAB) Study van Zelm Project # 2020102.00 (05-FWMS) August 01, 2022

FAIRFIELD PUBLIC SCHOOLS RECOMMISSIONING (RCX) AND TESTING, ADJUSTING, & BALANCING (TAB) STUDY

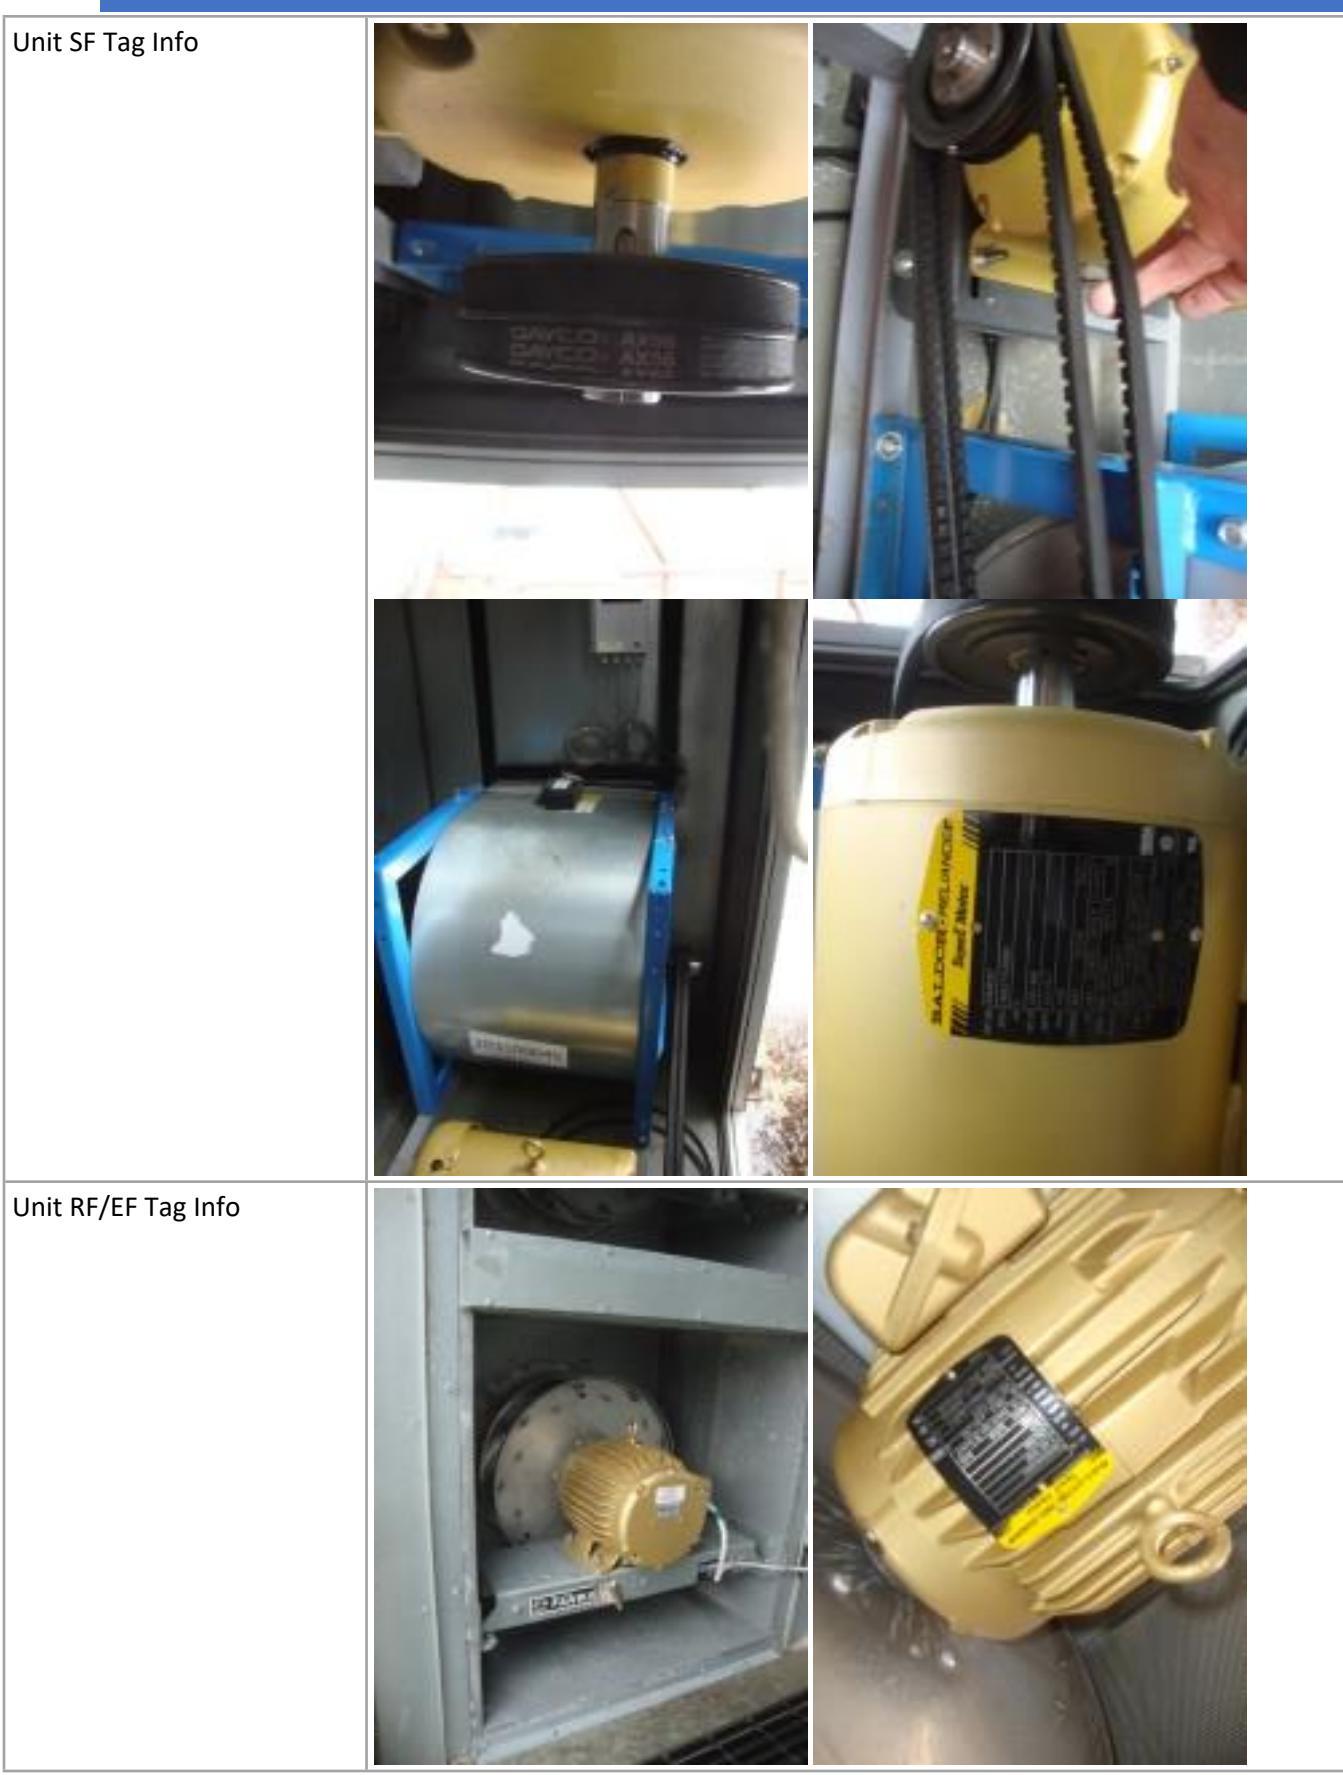
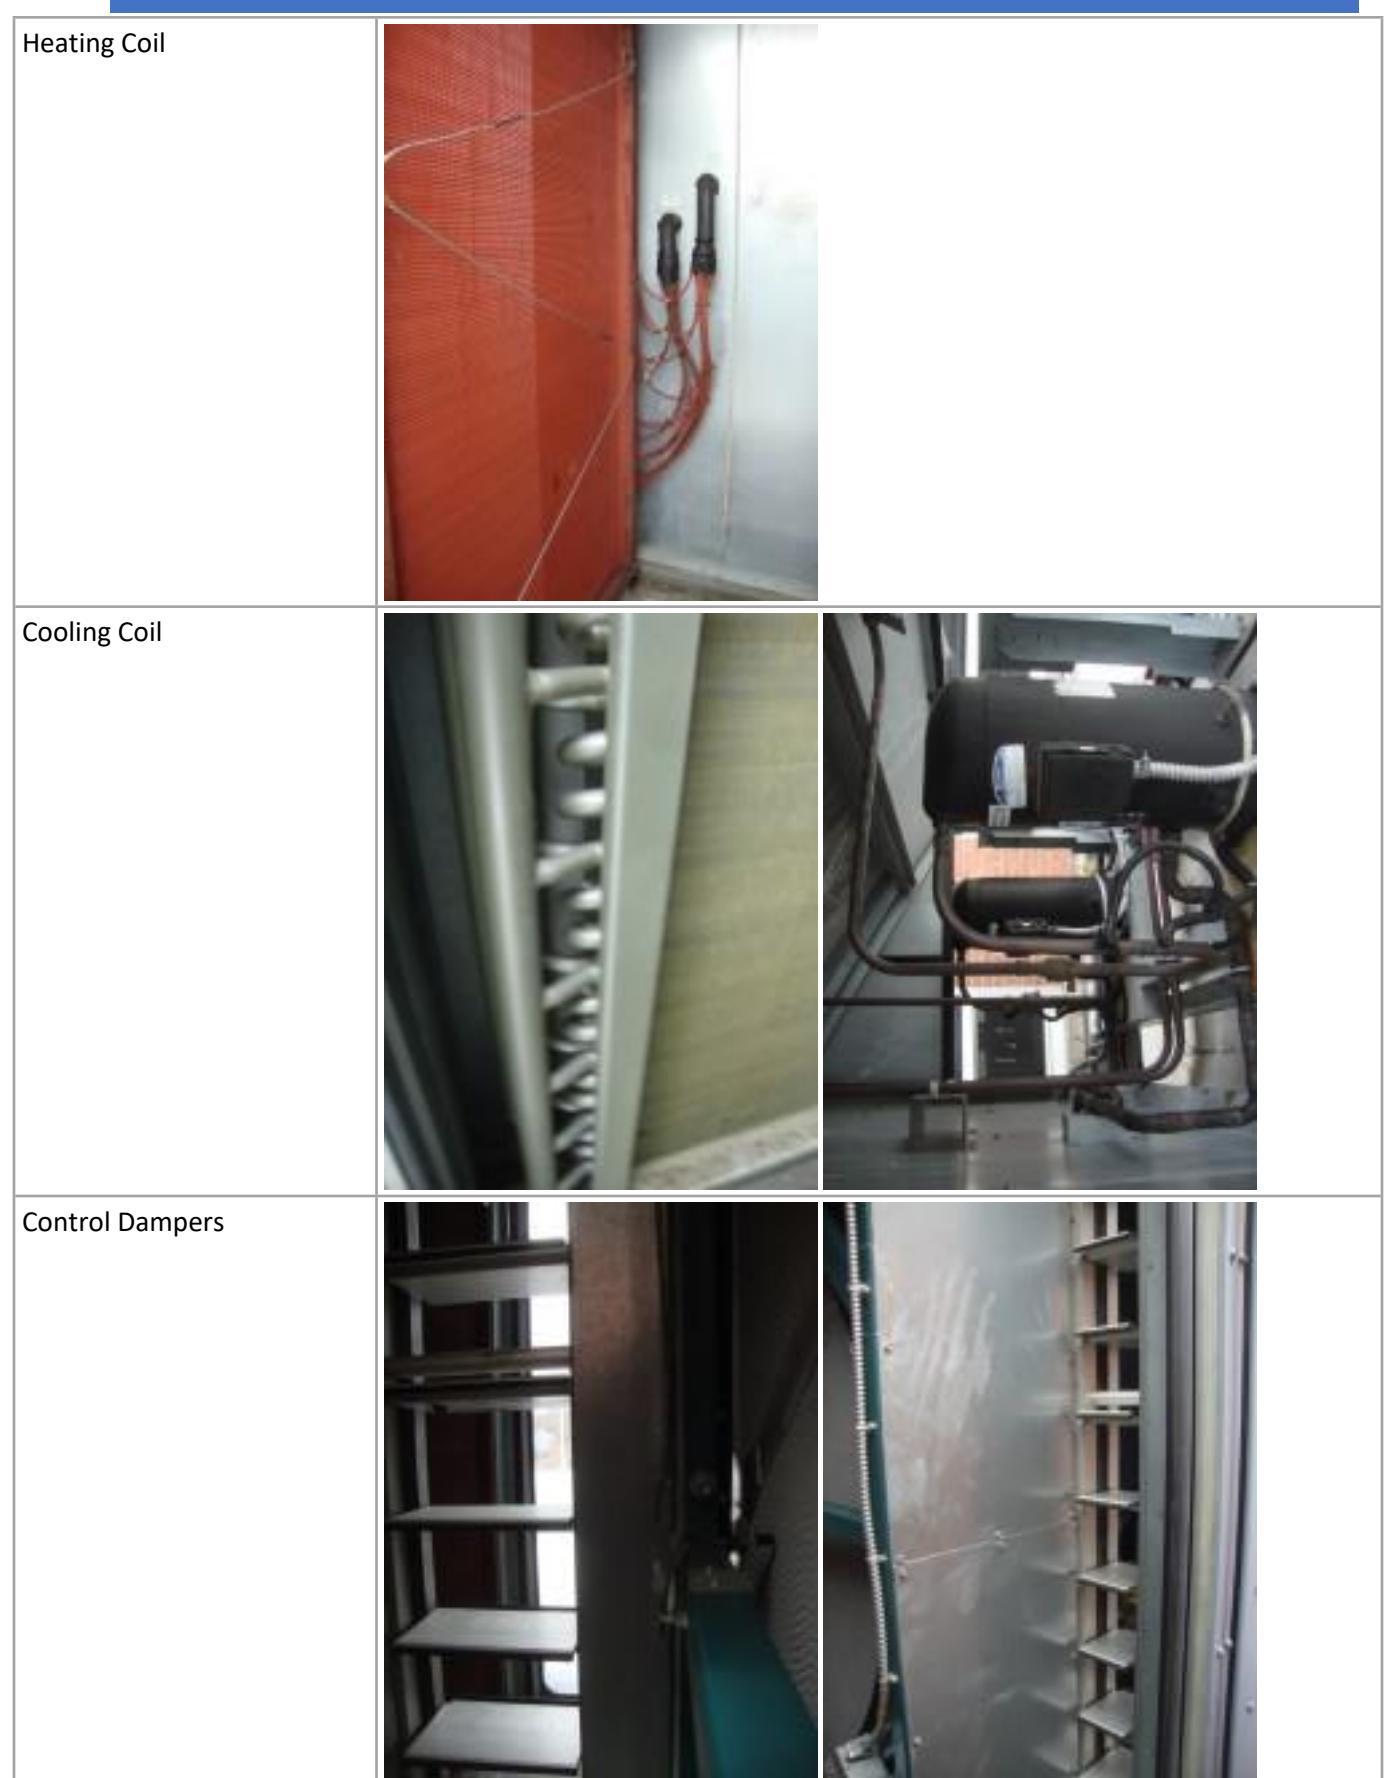
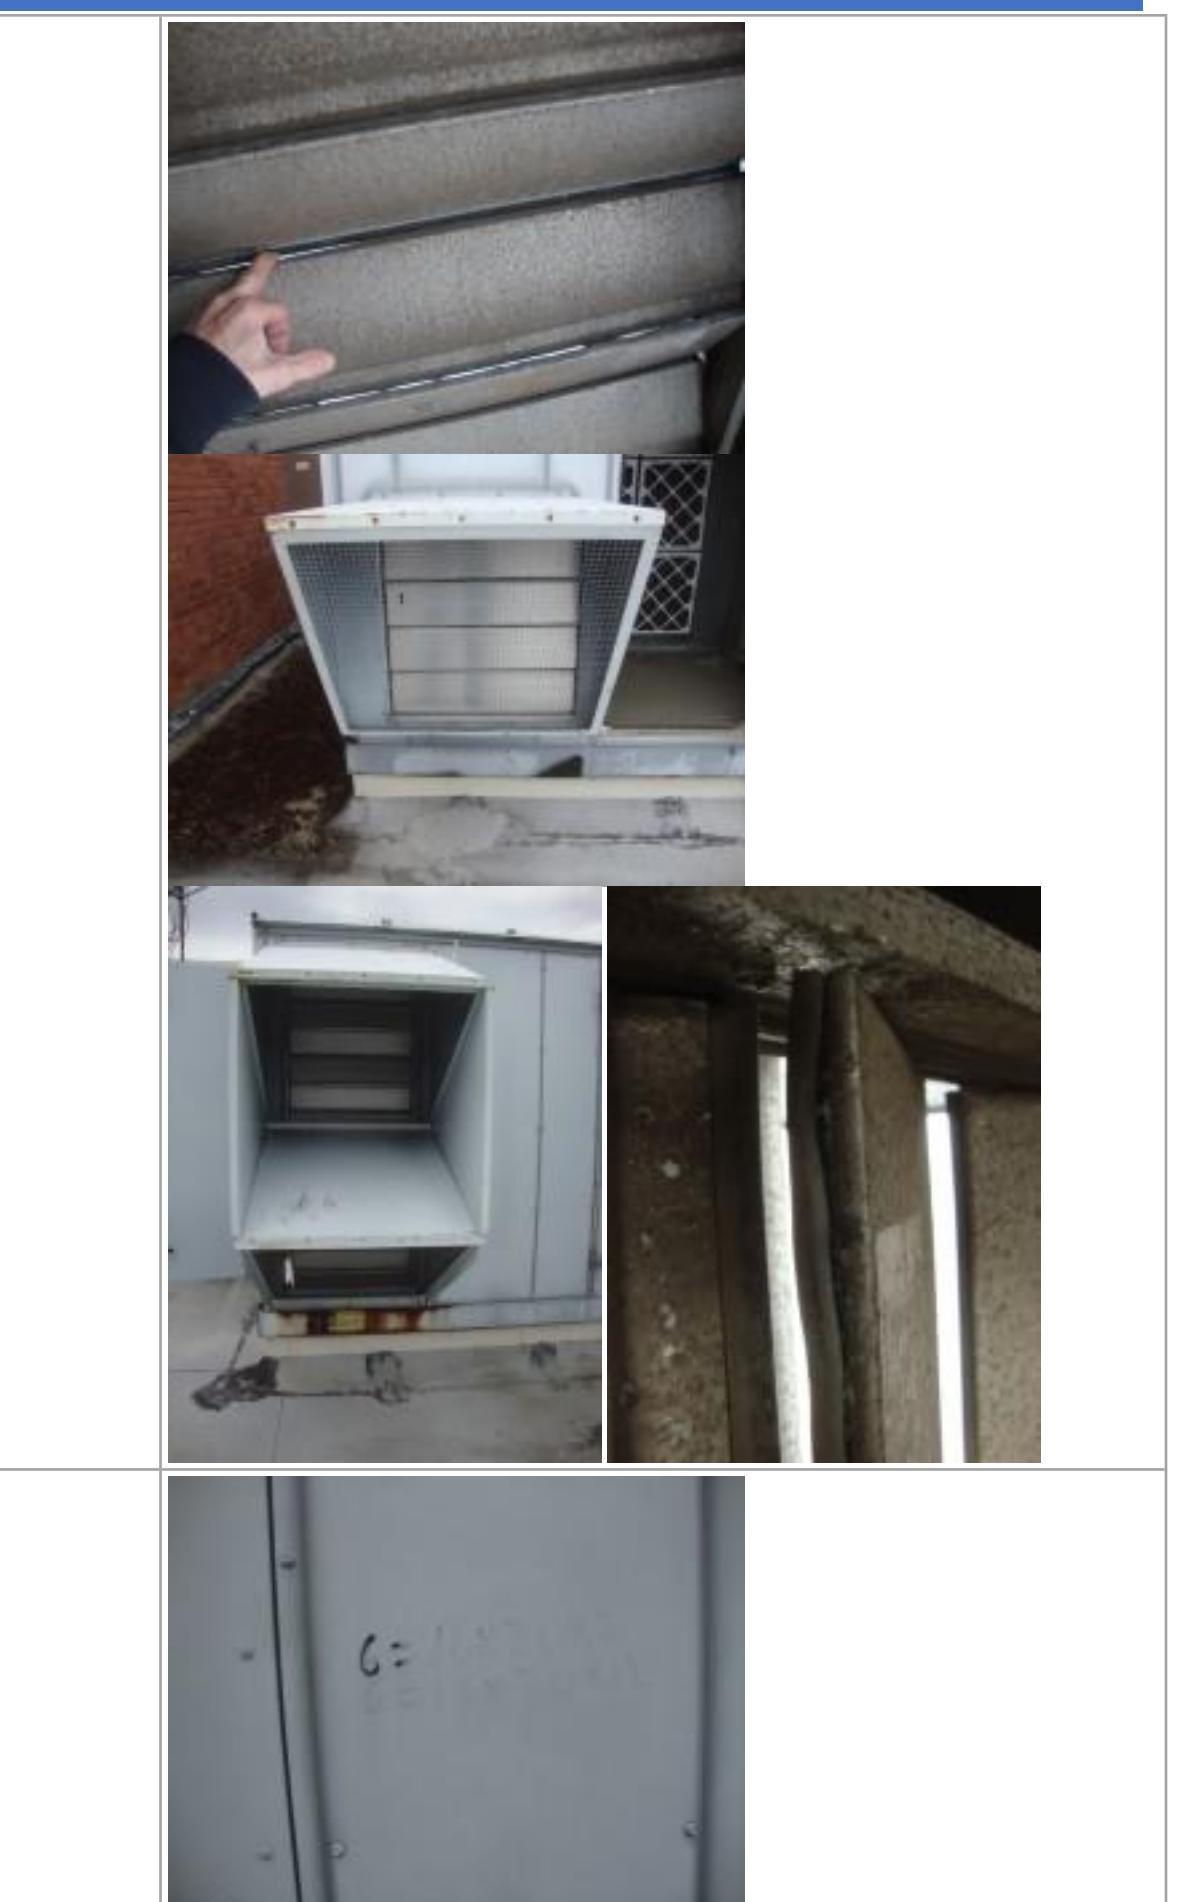
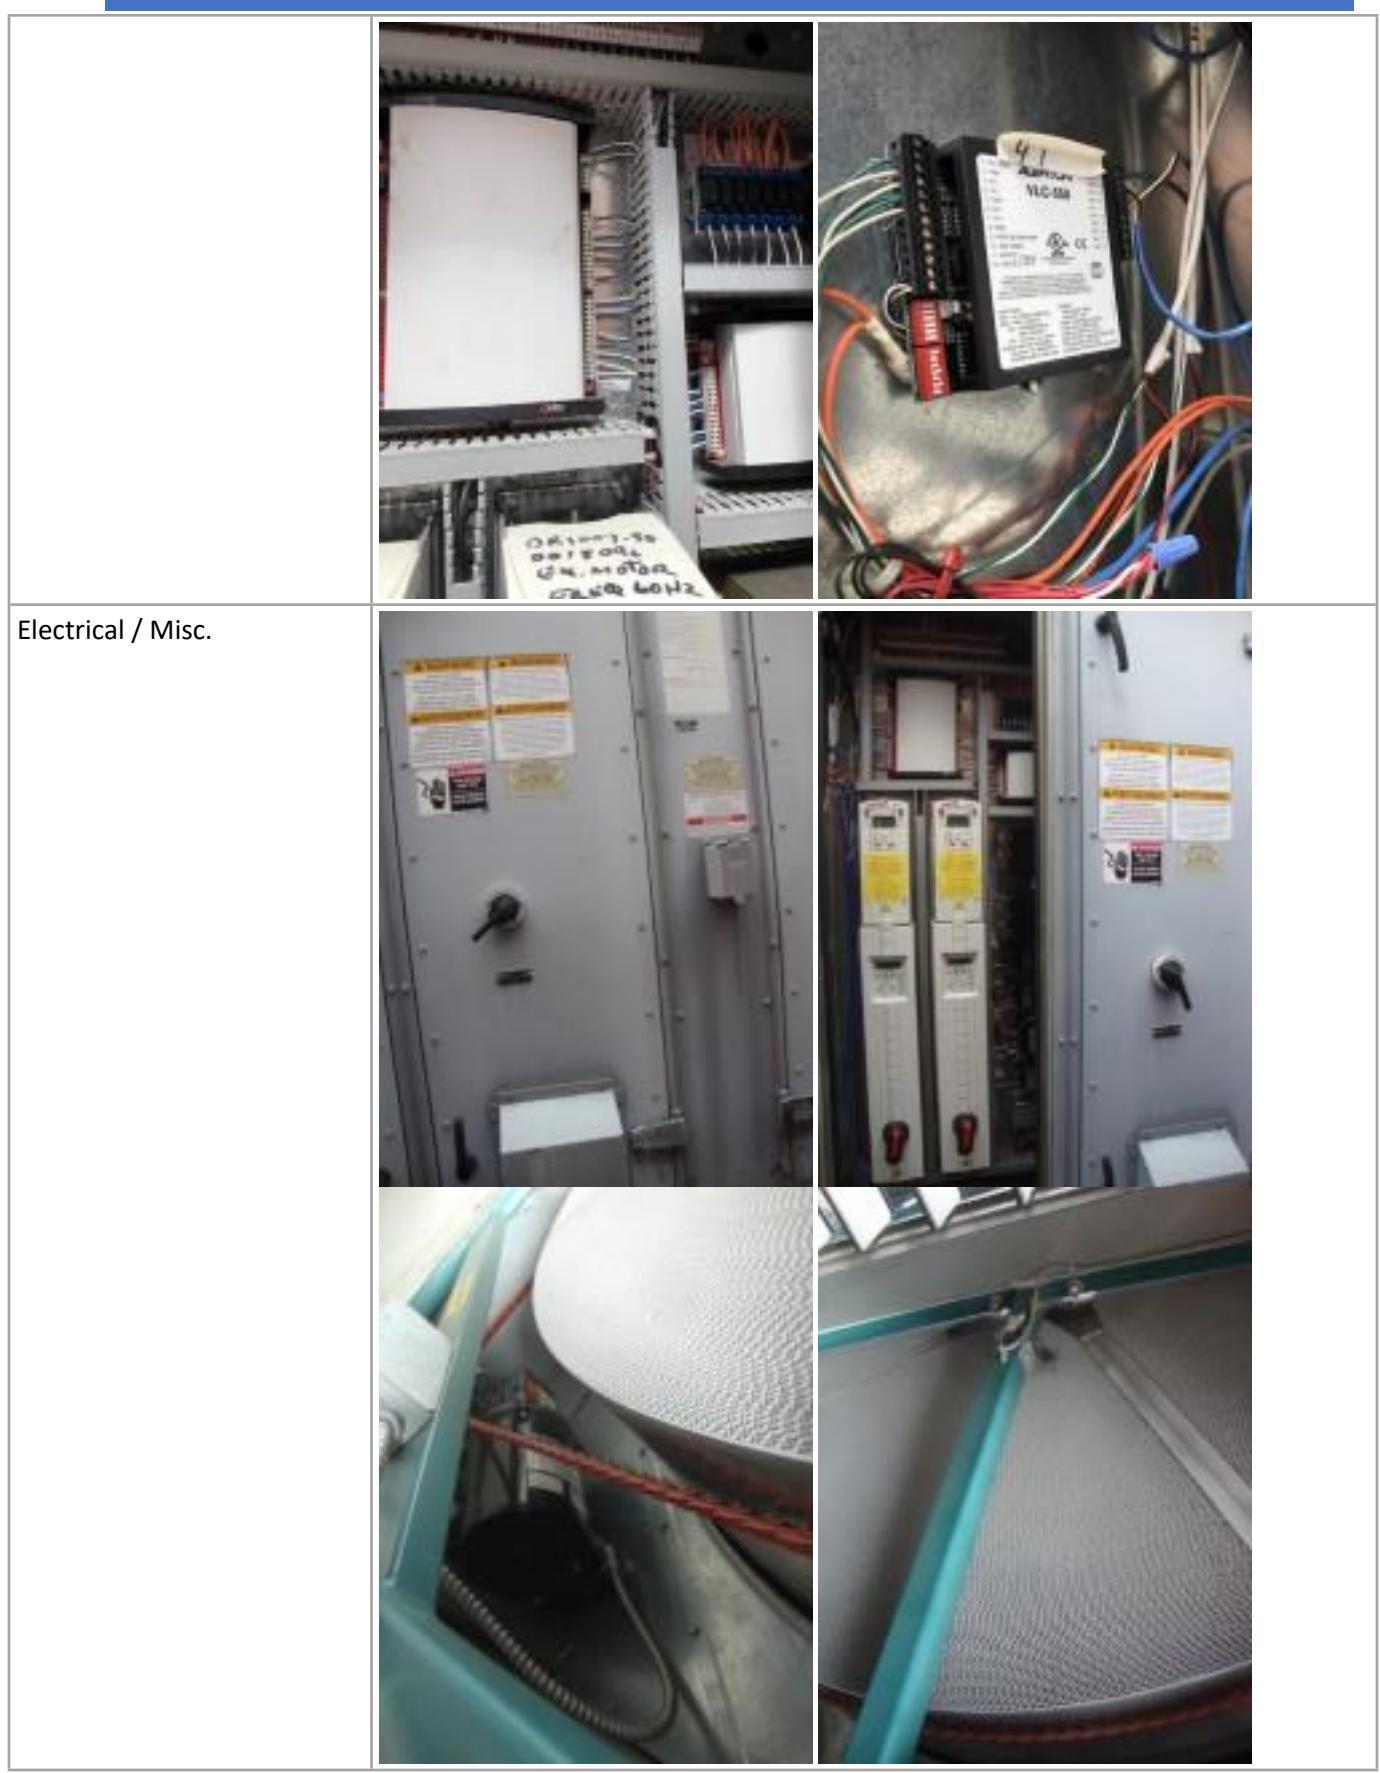
<u>Unit Tag</u>	RTU-8	Addition comments descriptions
Location	North Roof	
Serving	Cafeteria	
Config/Style	VAV AHU, SF/EF, HW, DX Cooling, ERW	
Mfr.	Venmar CES	
Model #	5WC-6-48x30x2-8AL	
Serial #	00547980-C04249	
Age (years)	80/2011	
System CFM	5600	1994 drawings indicate 8000 cfm max
Max OA CFM	5600	
V/Hz/Ph	460/60/3	
SF Qty/HP	(2) 3.0 Fan wall direct drive	
SF VFD Data	VFD ABB	
EF Qty/HP	(1) 5.0 Belt driven, mismatched (2) AX-56	
EF VFD Data	VFD ABB	
Filter Data (Size Quantity)	Outdoor intake: (6) 16"x20"x2" Pre (6) 16"x20"x11.5" Final	Return Air: (6) 24"x24"x2"
Filter Status	Dirty changed on (10-4-21)	Dirty changed on (10-4-21)
Controls Type	Packaged	
Controls Mfr.	Delta/Allerton	
Economizer	Yes 100% O.A. capable	
CO ₂ DCV		
Damper Styles	Tamco parallel	
Damper Status	Dirty, seals need to be cleaned, lubricated, and adjusted (All)	
Heating Type	Hot water	
Heating Coil Condition	Coil should be professionally cleaned (Coated)

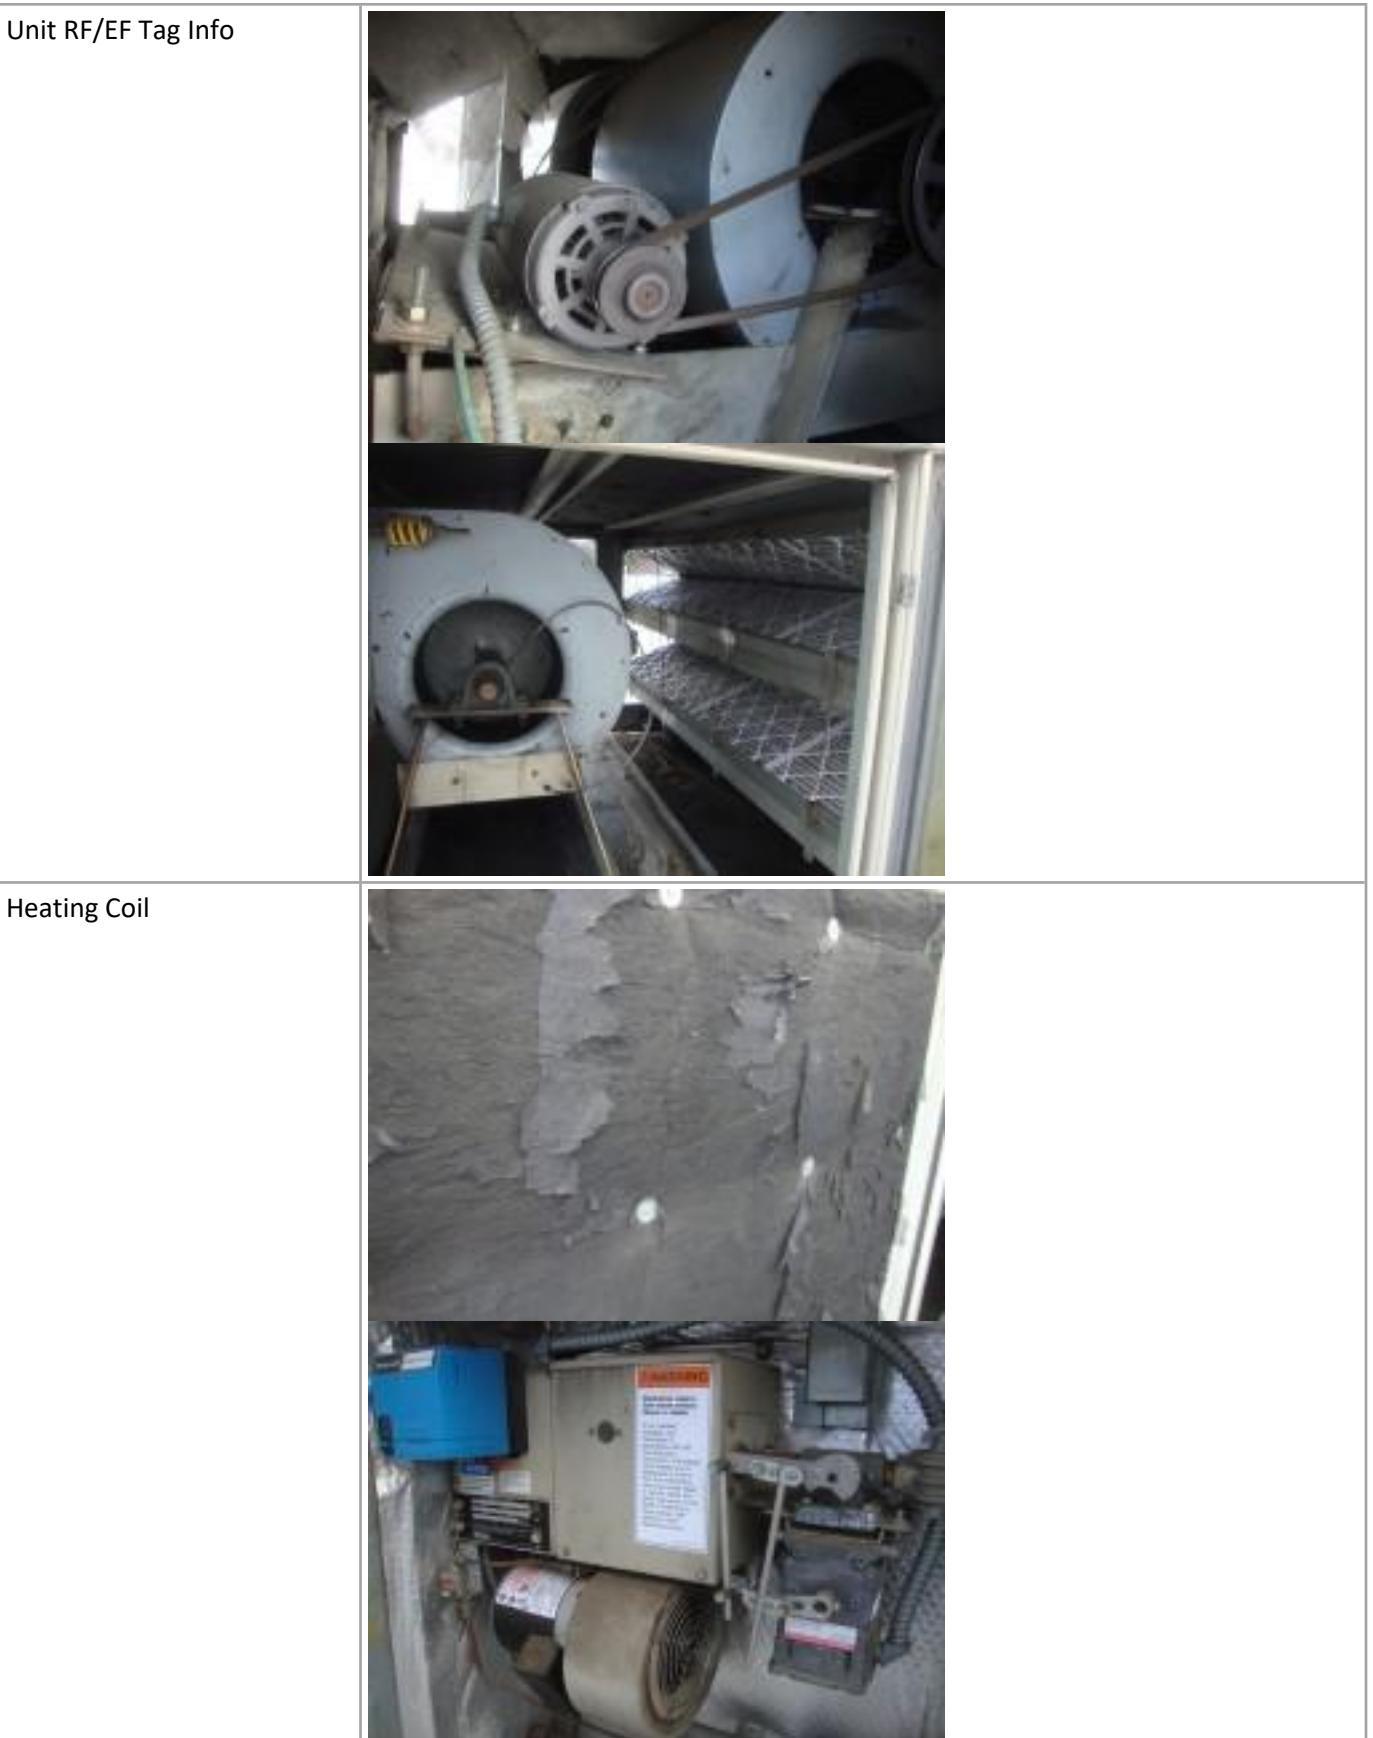
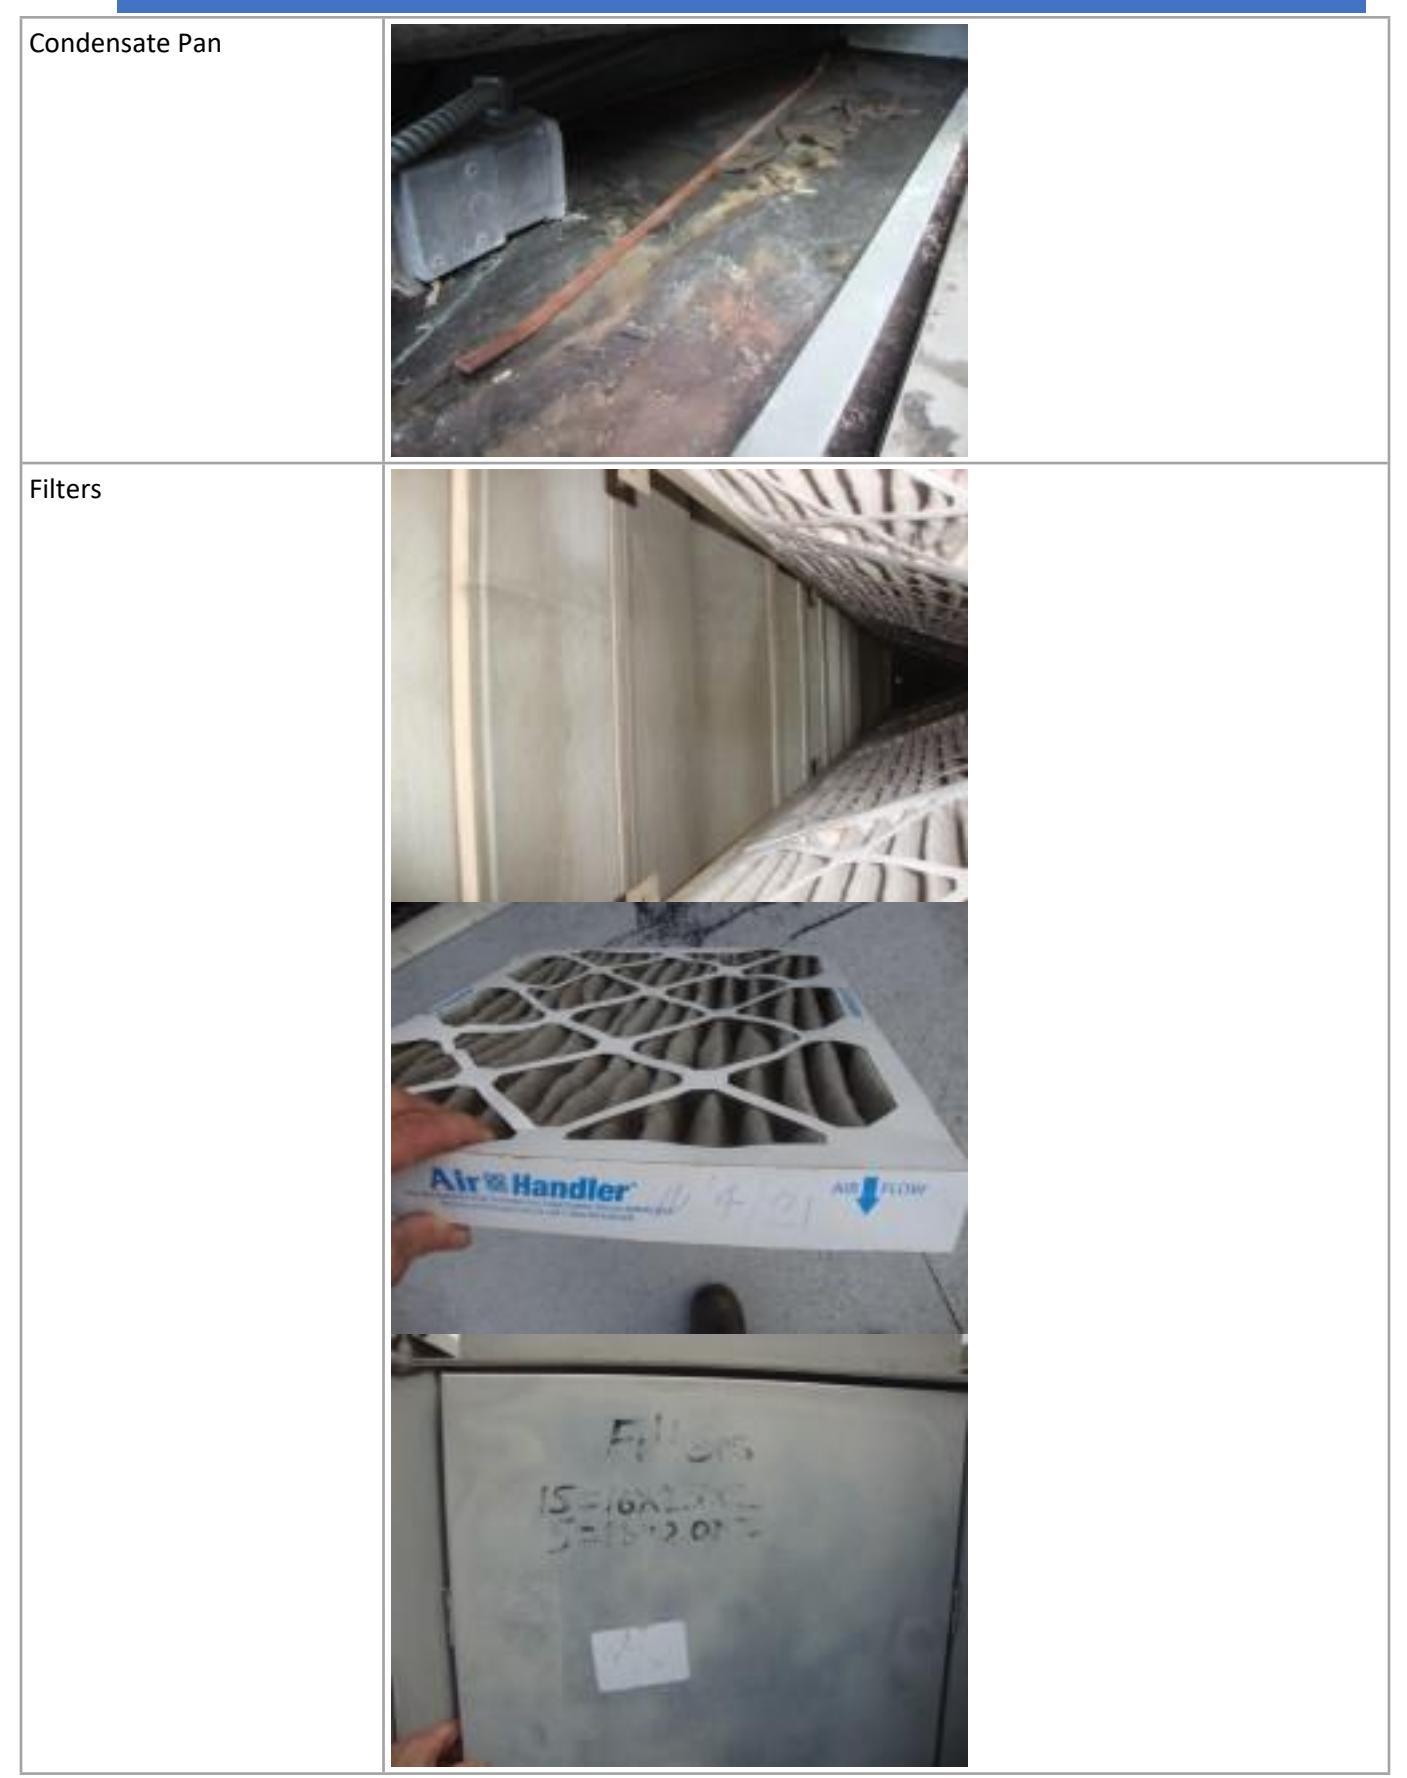
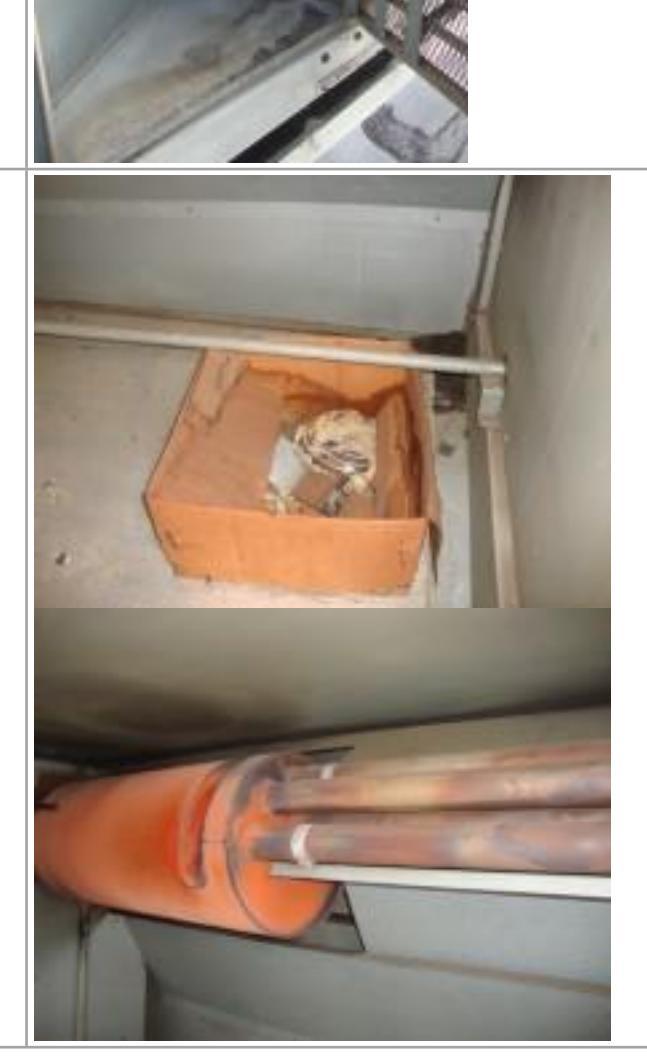
<u>Unit Tag</u>	RTU-9	Addition comments descriptions
Location	Center West Roof	
Serving	Project Adventure/Weight Room	
Config/Style	Packaged Gas Fired	
Mfr.	McQuay	
Model #	RWS800BA	
Serial #	35G01783 17	
Age (years)	Unknown, 10-28	Original project 1994, Unit is in poor condition, no cooling
System CFM	8000	
Max OA CFM		
V/Hz/Ph	460/60/3	
SF Qty/HP	(1) 5.0 Belt (1) BP-62	
SF VFD Data	N/A	
RF Qty/HP	(1) 1-1/2 Single belt, cracked	
RF VFD Data	N/A	
Filter Data (Size Quantity)	(15) 16"x25"x2" (5) 16"x20"X2"	Angled Racks
Filter Status	Dirty	Changed 10/4/21
Controls Type	Panel was not opened, no external disconnects	
Controls Mfr.	Panel was not opened, no external disconnects	
Economizer	Yes	
CO ₂ DCV		
Damper Styles	Parallel Factory	
Damper Status	Fair, did not modulate upon shut down, operation unknown.	
Heating Type	Gas Burner	
Heating Coil Condition	Dirty	
Cooling Type	N/A	
Cooling Coil Condition	N/A	
CU Mfr.		
CU Model
