Fairfield Woods Middle School

Fairfield Public Schools Recommissioning (RCx) and Testing, Adjusting, & Balancing (TAB) Study van Zelm Project # 2020102.00 (05-FWMS) August 01, 2022

FAIRFIELD PUBLIC SCHOOLS RECOMMISSIONING (RCX) AND TESTING, ADJUSTING, & BALANCING (TAB) STUDY

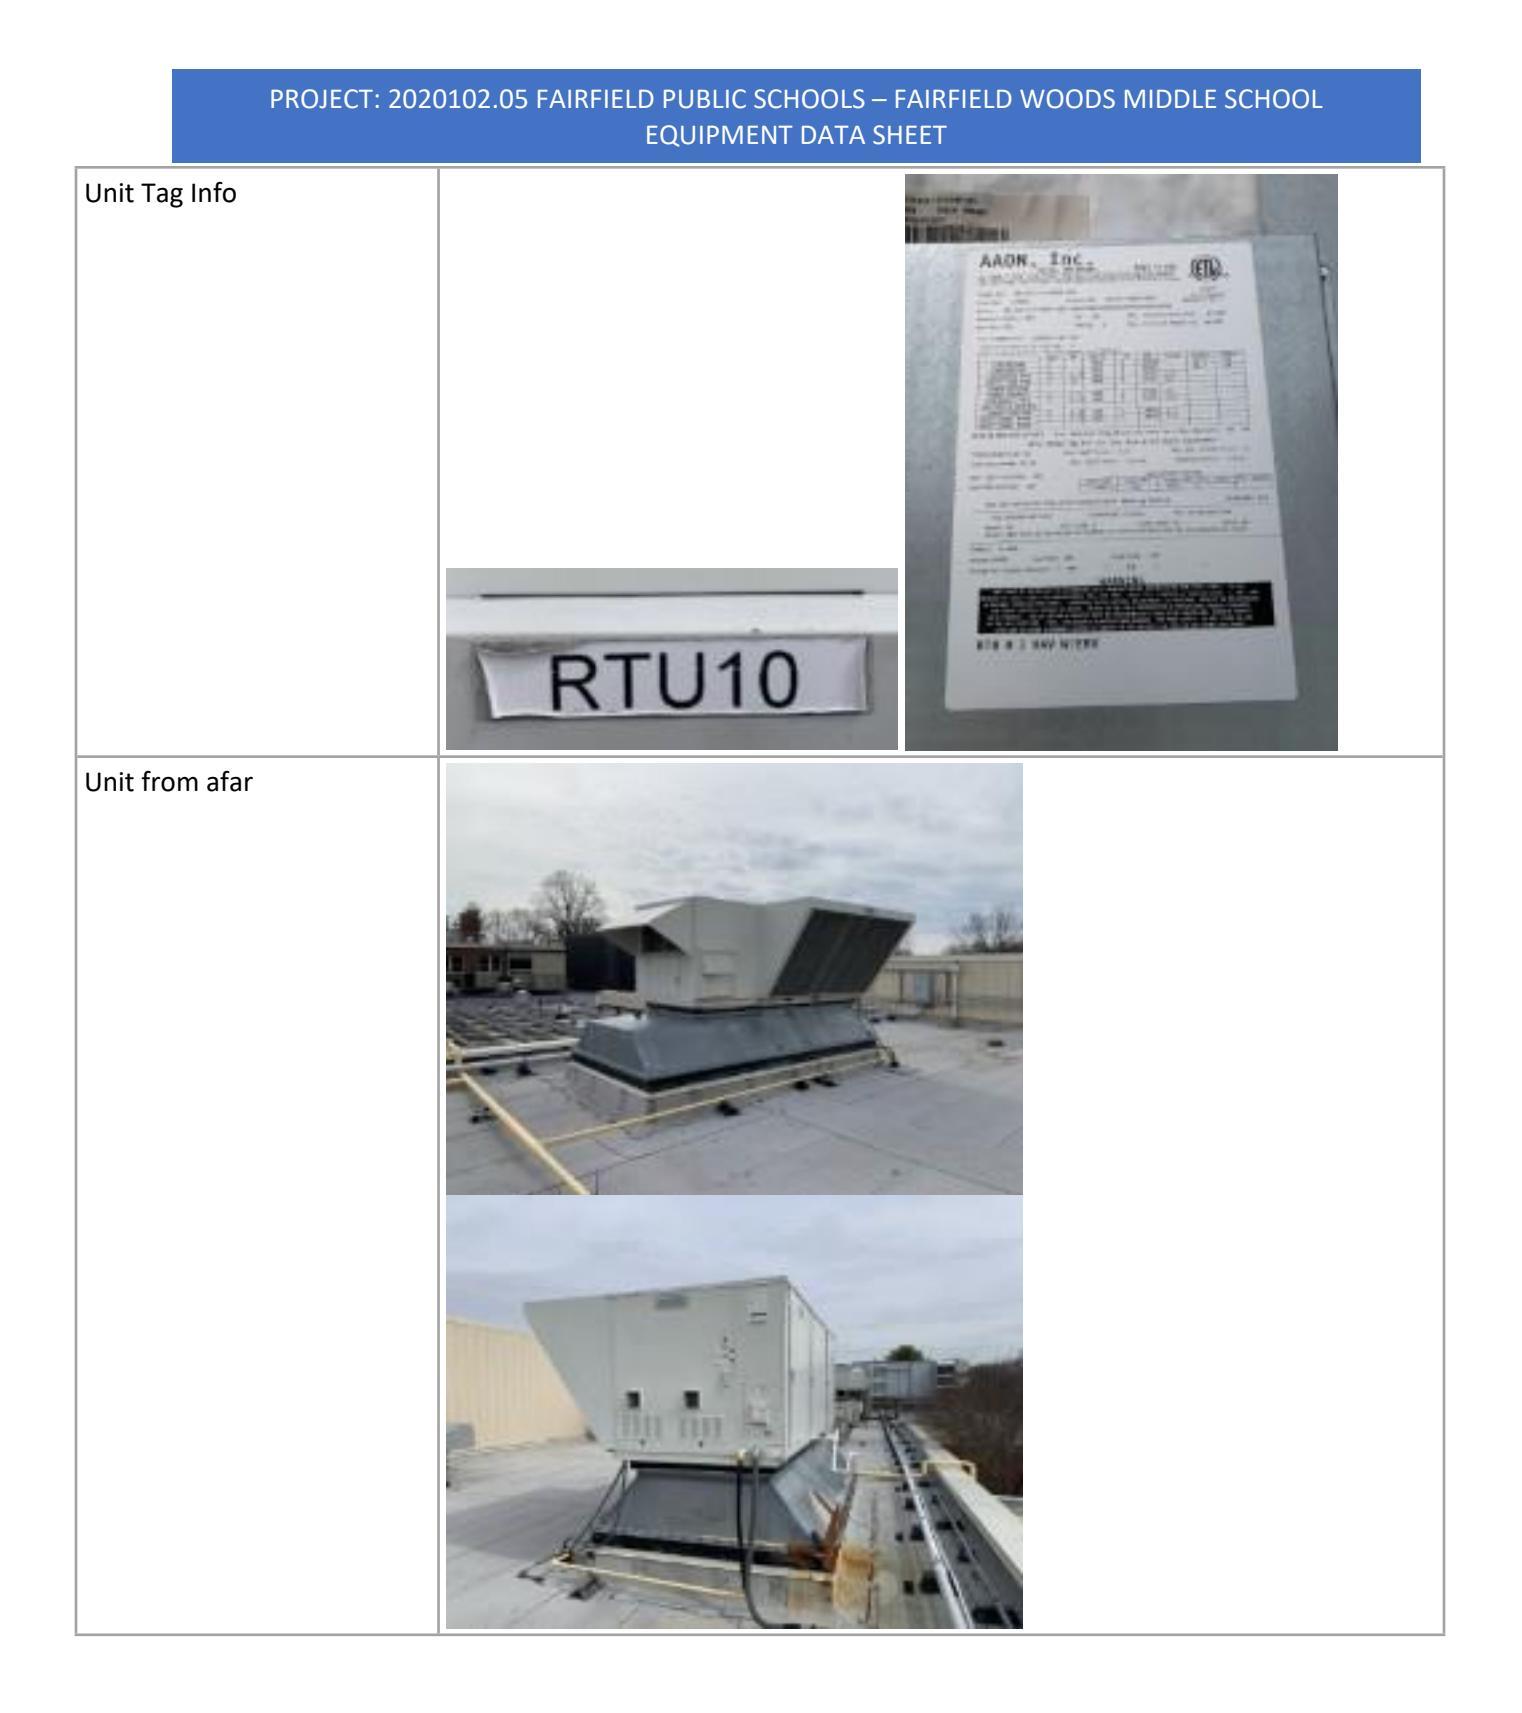
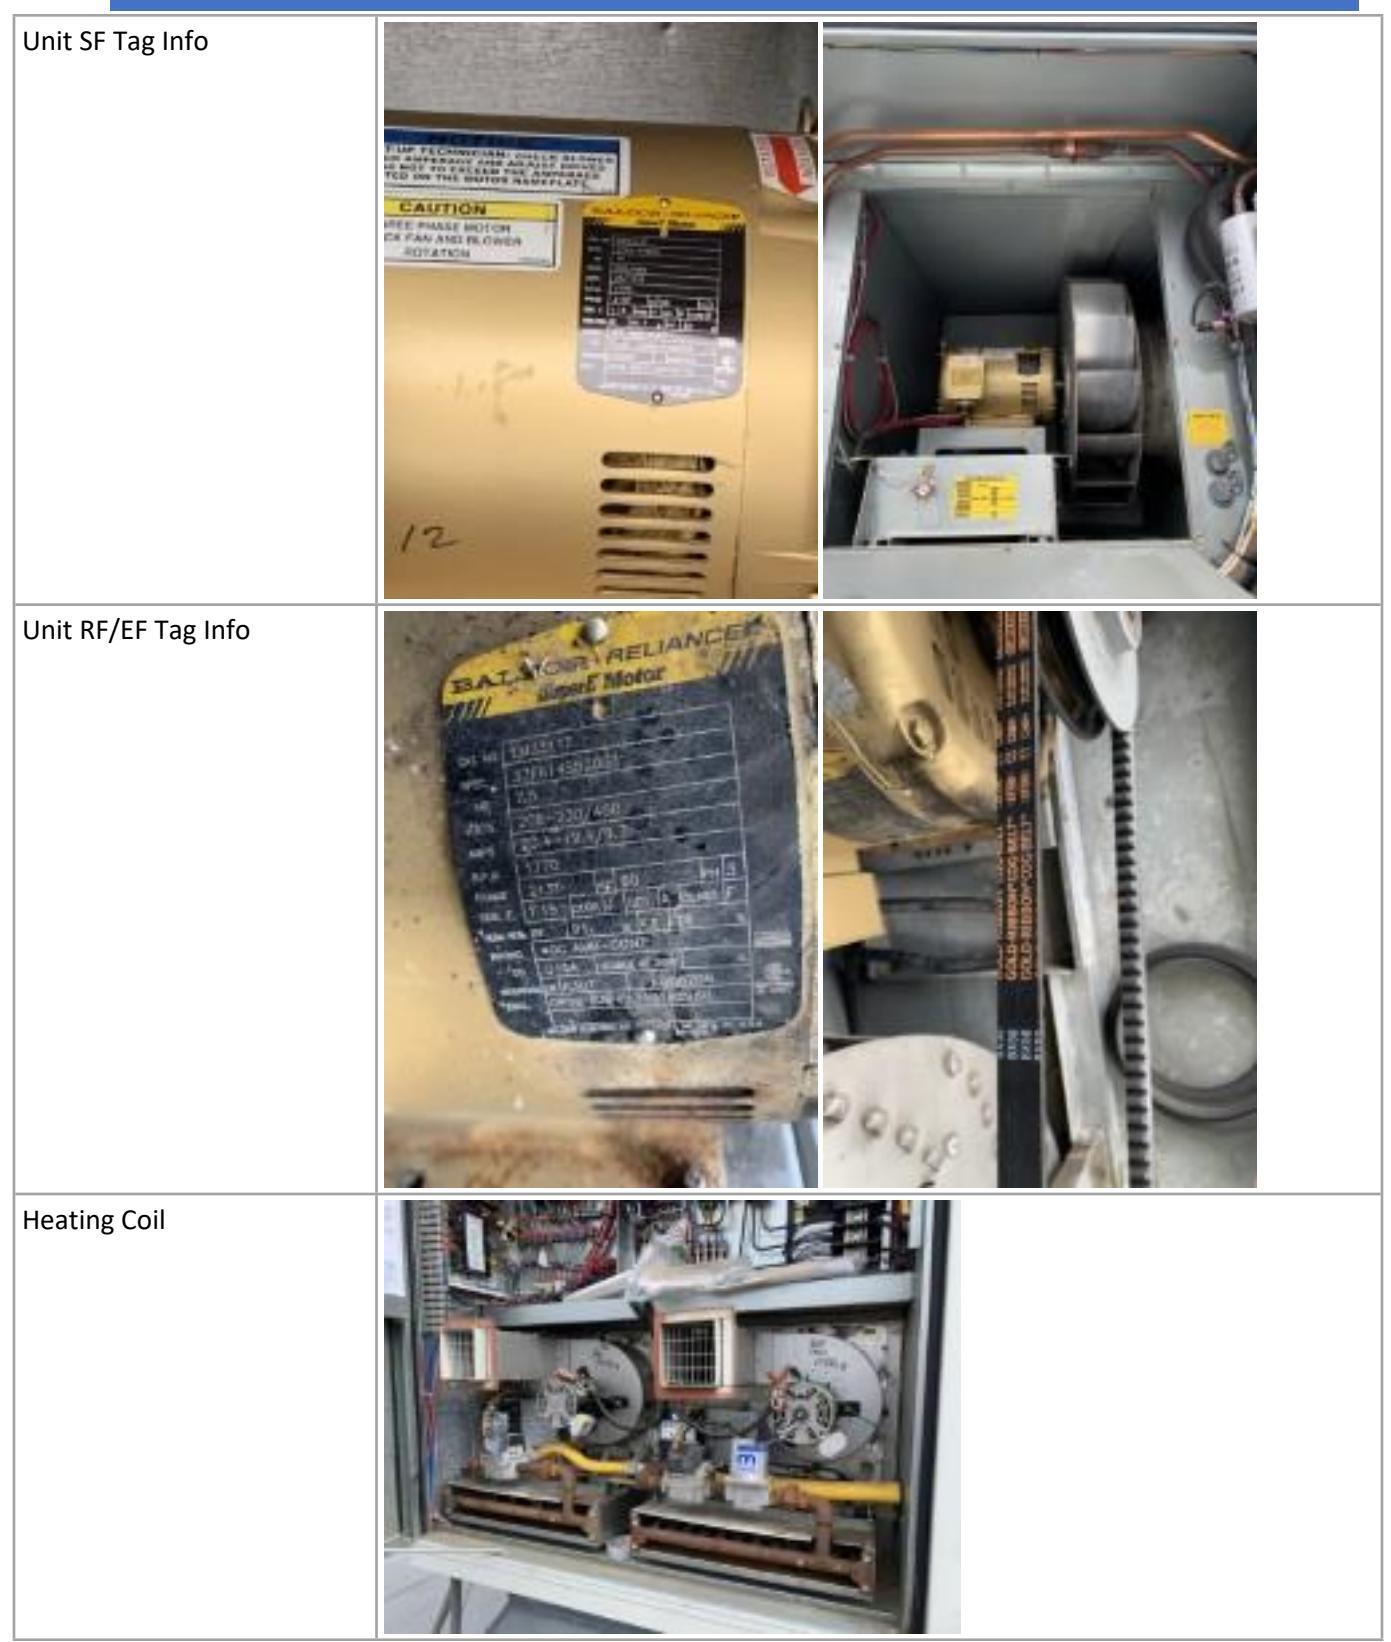
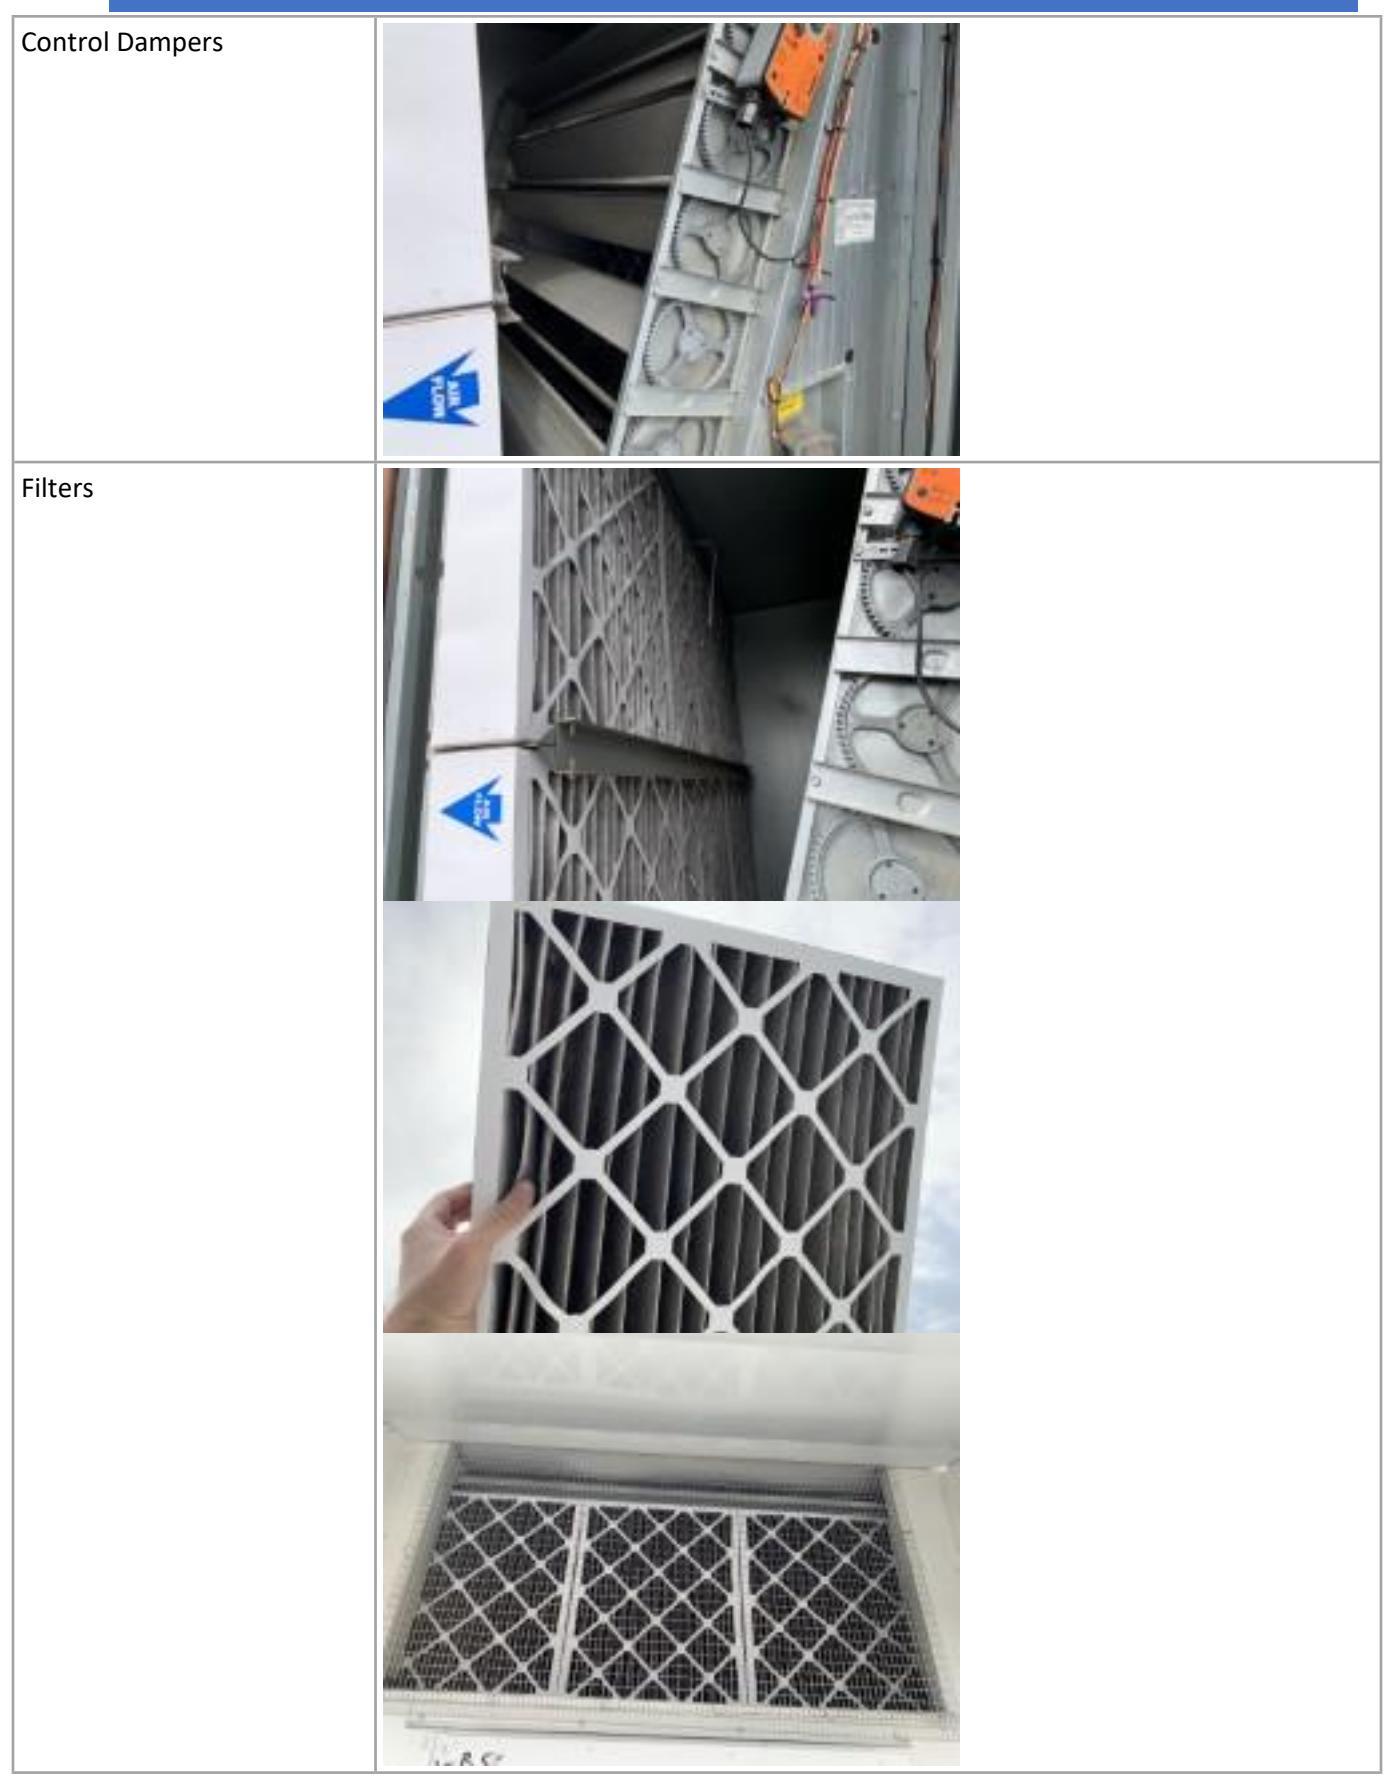
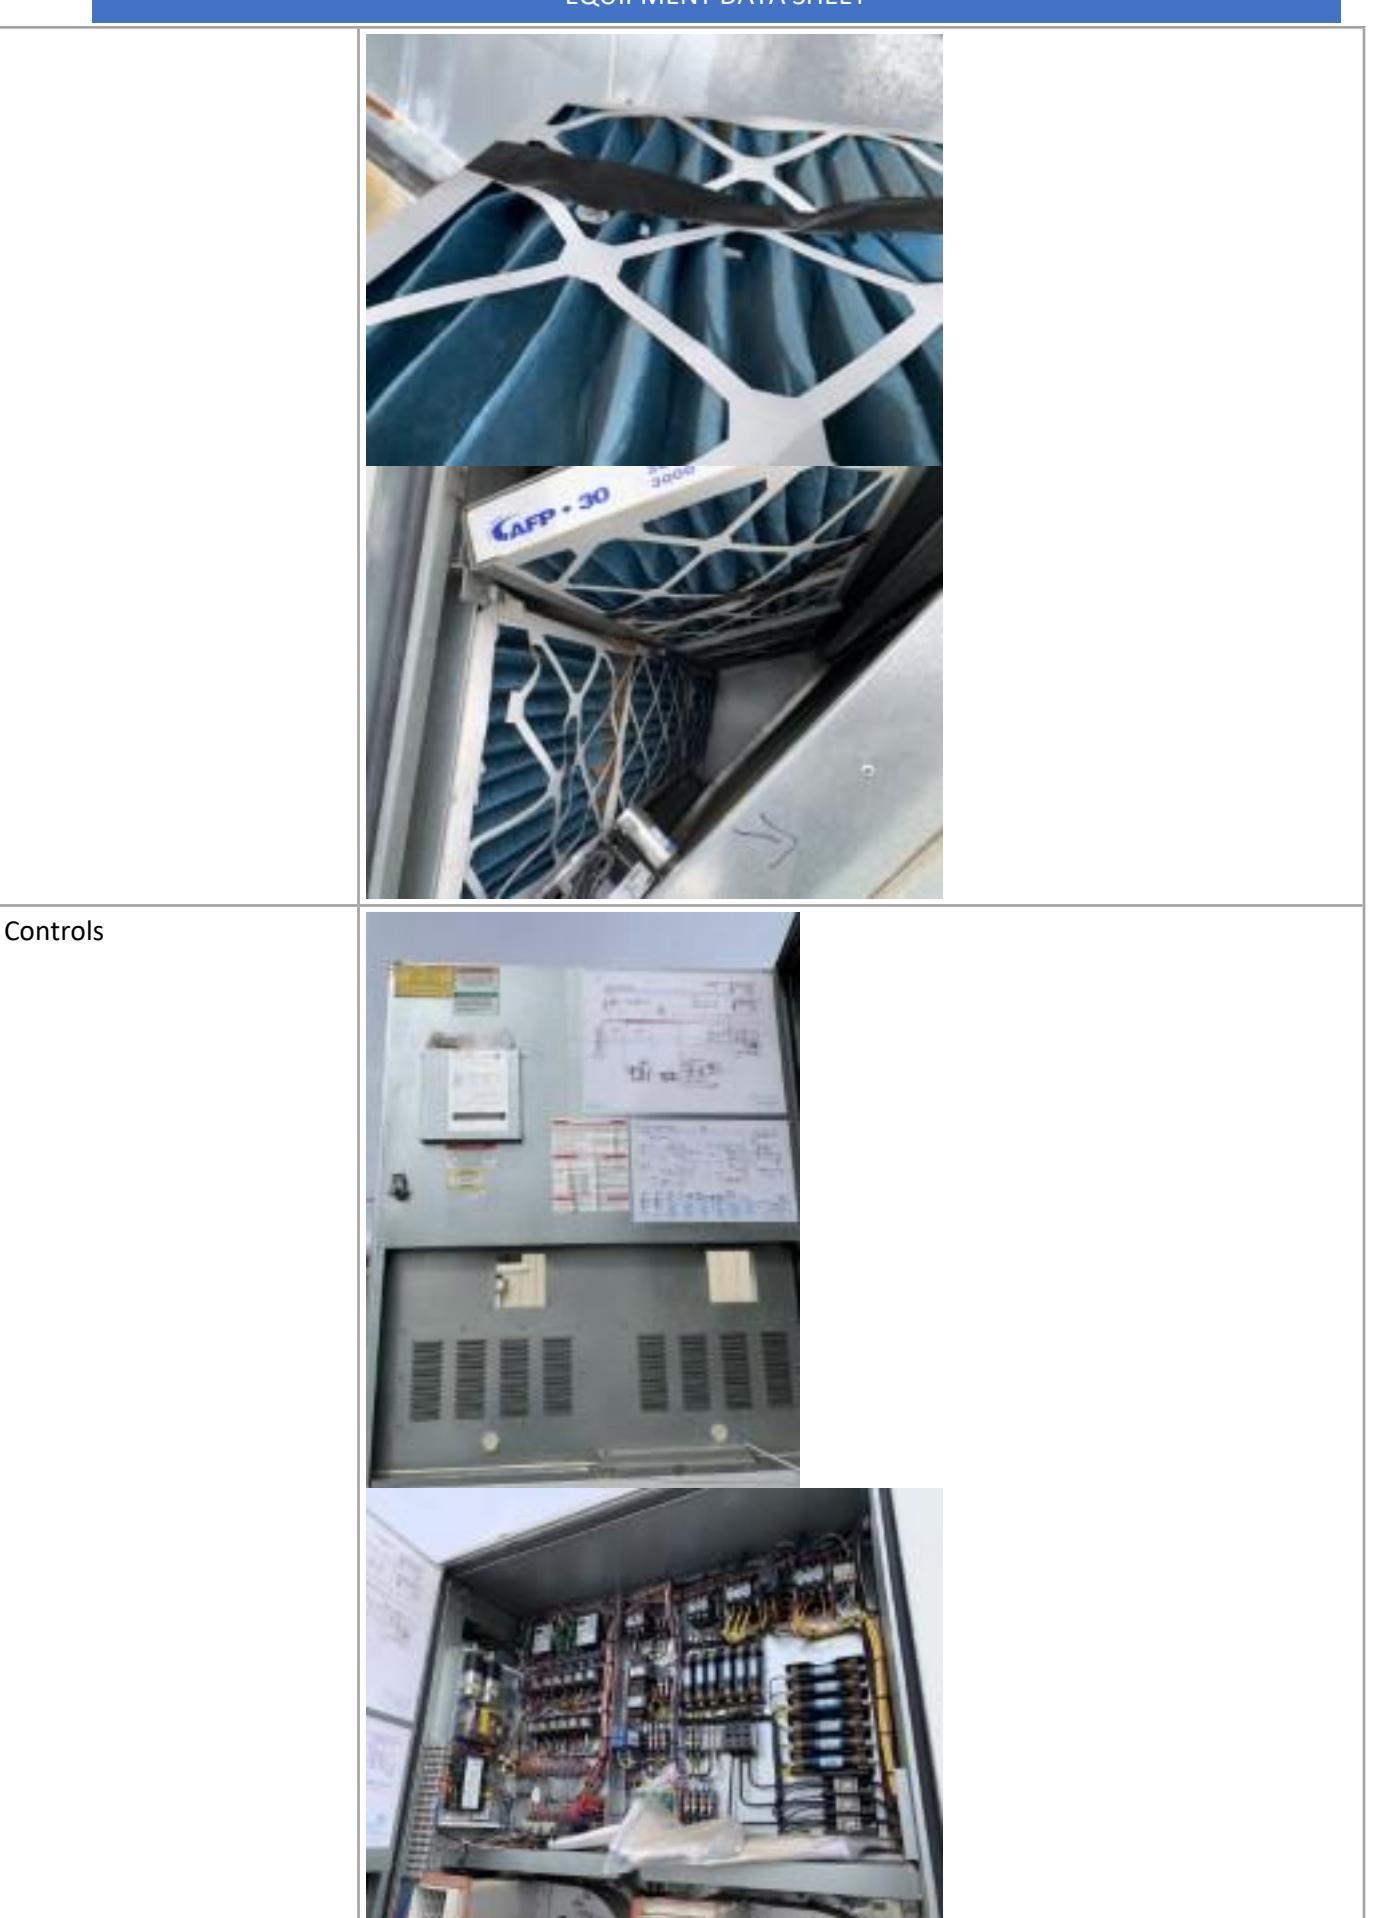
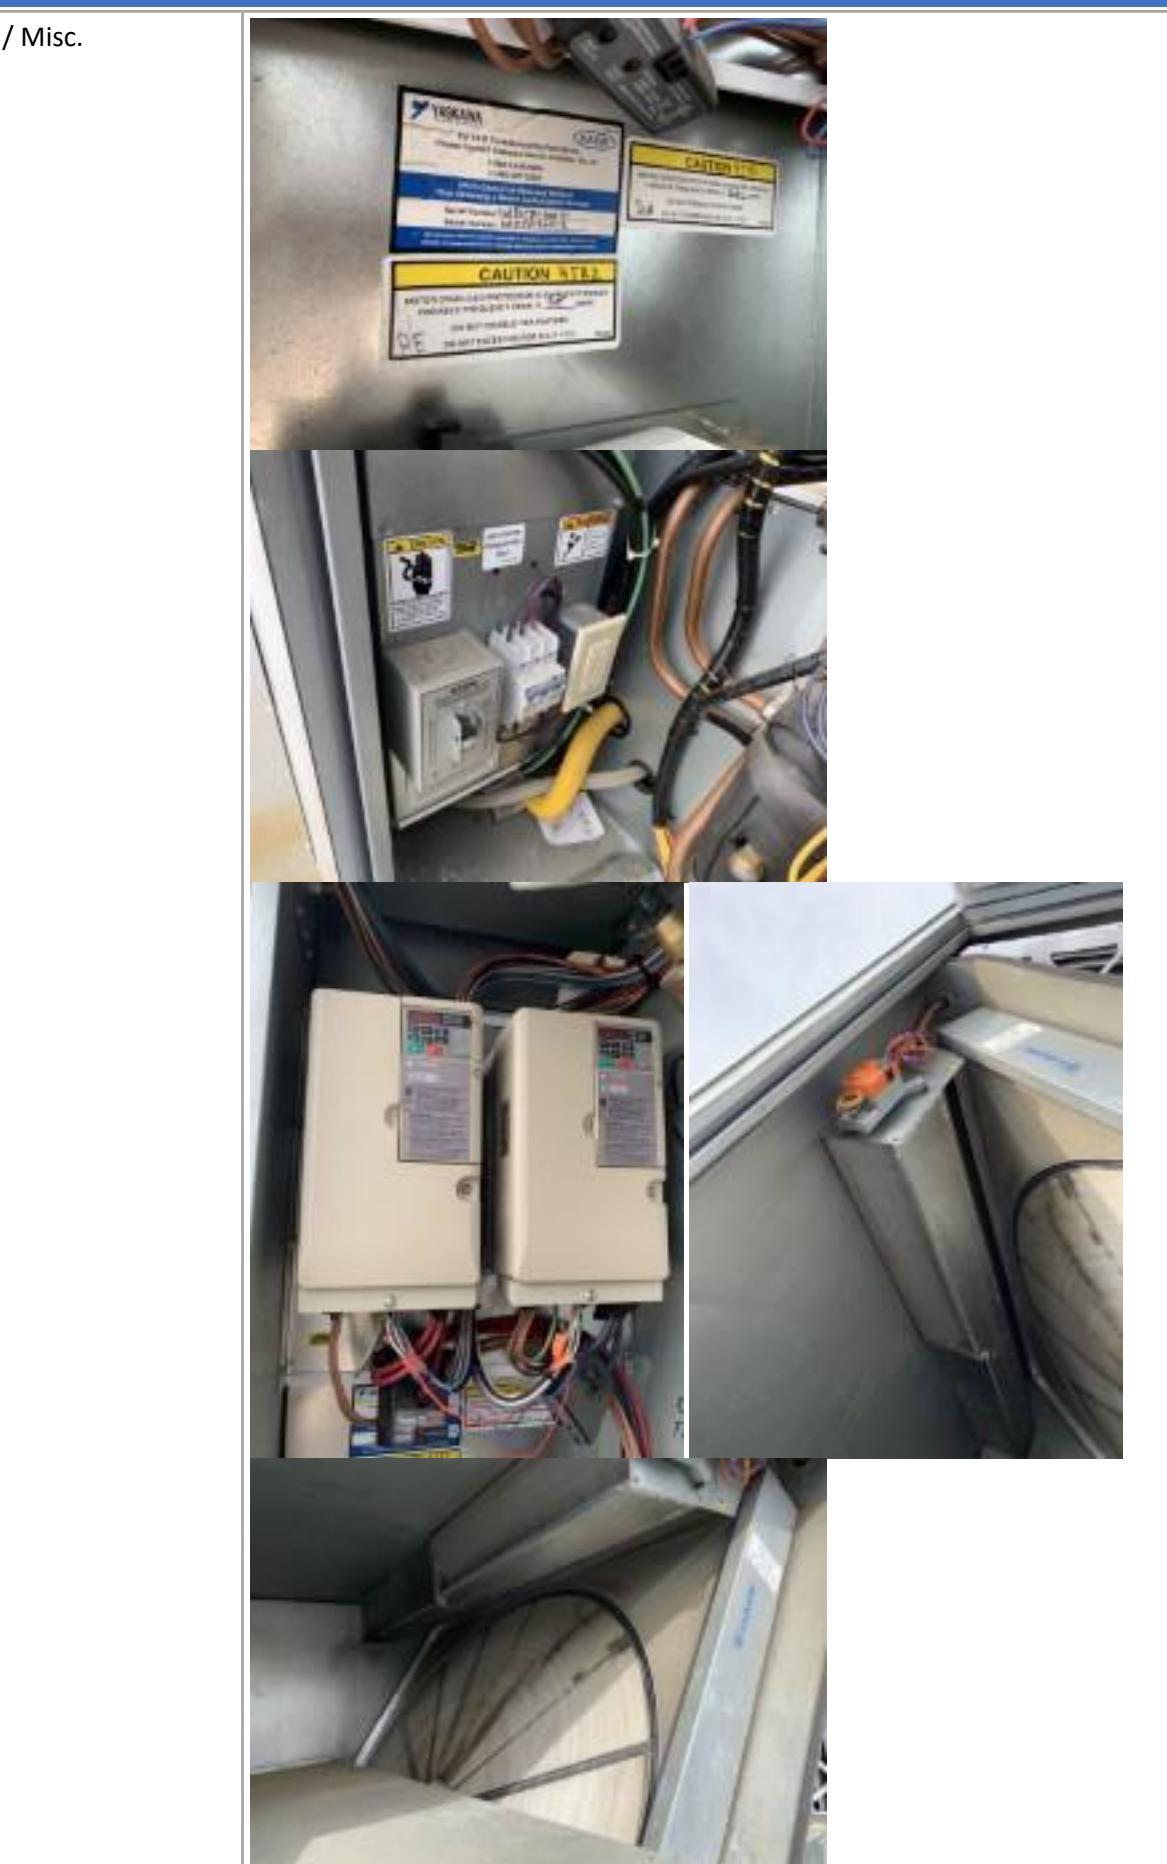
Unit Tag	RTU-10		Addition comments descriptions
Location	West Roof		
Serving	Music		
Config/Style	Roofto	p ERV w/ DX Cooling and Gas Heat	
Mfr.	Aaon		
Model #	RN-020	-3-0-EA09-389	
Serial #	20131 ⁻	I-BNGP33327	
Age (years)	10-28		Original named unit install in 1994, might have been replaced since then
System CFM	10000		
Max OA CFM			
V/Hz/Ph	460/60)/3	
SF Qty/HP	1, 10		
SF VFD Data	460V /	14A / 3ph / 60Hz	
RF Qty/HP	1, 7.5		
RF VFD Data	208-23	0/460V / 20.4-19.4/9.7A / 60Hz	
Filter Data (Size Quantity)	6x 20x 3x 20x 6x 14x	25x4 MERV 13 Final Filters 25x2 MERV 8? OA 25x2 MERV 8? EA	Wheel exhaust filters falling out of the frame and some have the filter box frame cut and taped to have the filter fit, rather than using properly sized filters/blank off plates
Filter Status	Dirty		Some major damage particularly to EA
Controls Type	VLC-1	188 DDC	
Controls Mfr.	Alertor	1	
Economizer			
CO ₂ DCV			
Damper Styles	Revers	e blade

Damper Status	Most c	lo not close fully	
Heating Type	Gas		
Heating Coil Condition	Okay		
Cooling Type	DX		
Cooling Coil Condition	Dirty		
CU Mfr.	Copeland Scroll		
CU Model	#1 ZP103KCE-TFD-250, #2 ZPD103KCE-TFD-155		
CU Serial	#1 13JC0139D, #2 13IA8787D		
Drain Pan Status	Okay		
Notes:			
Description Photos

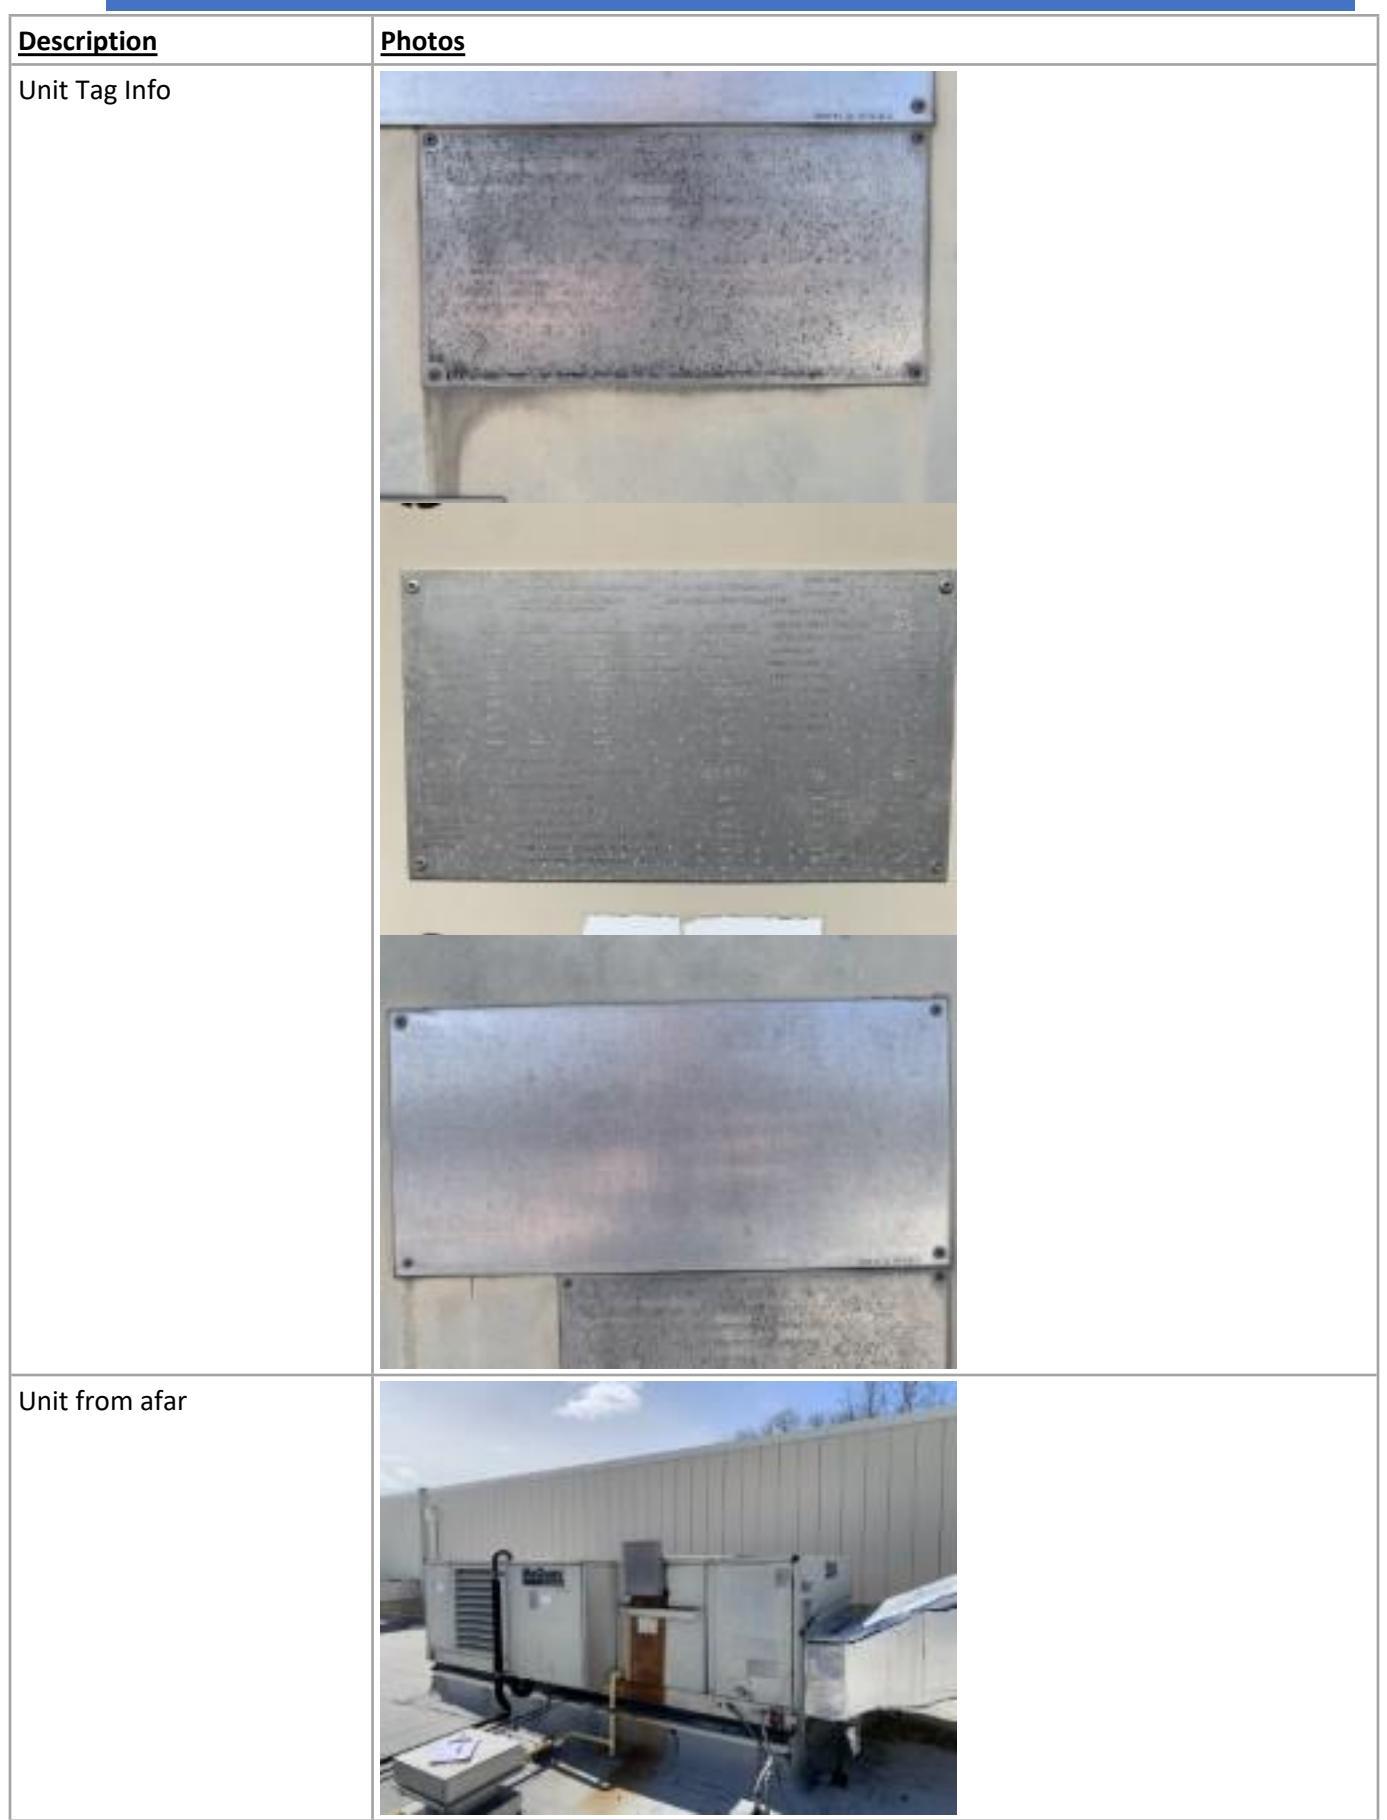
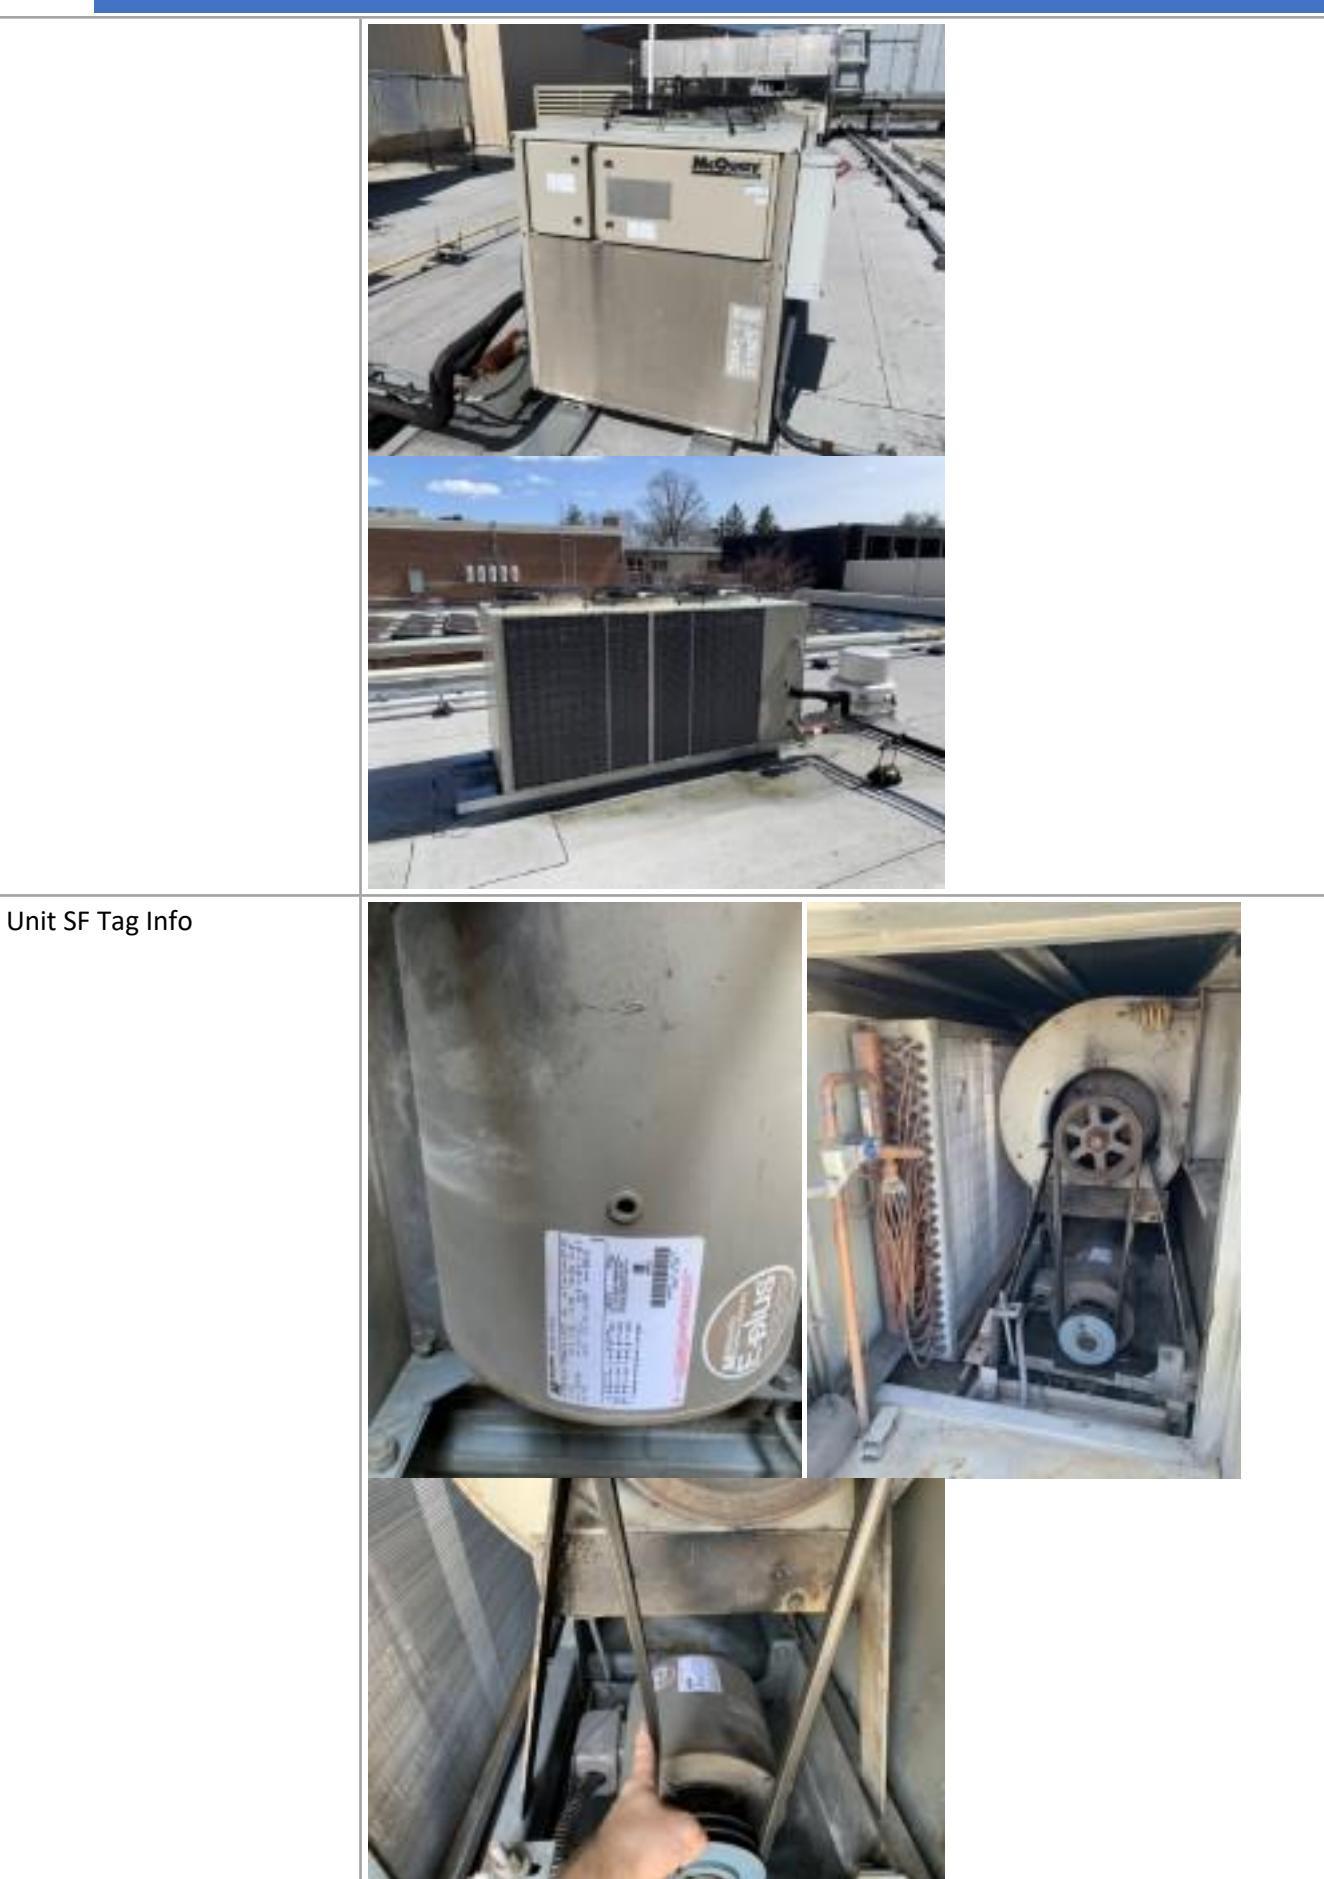
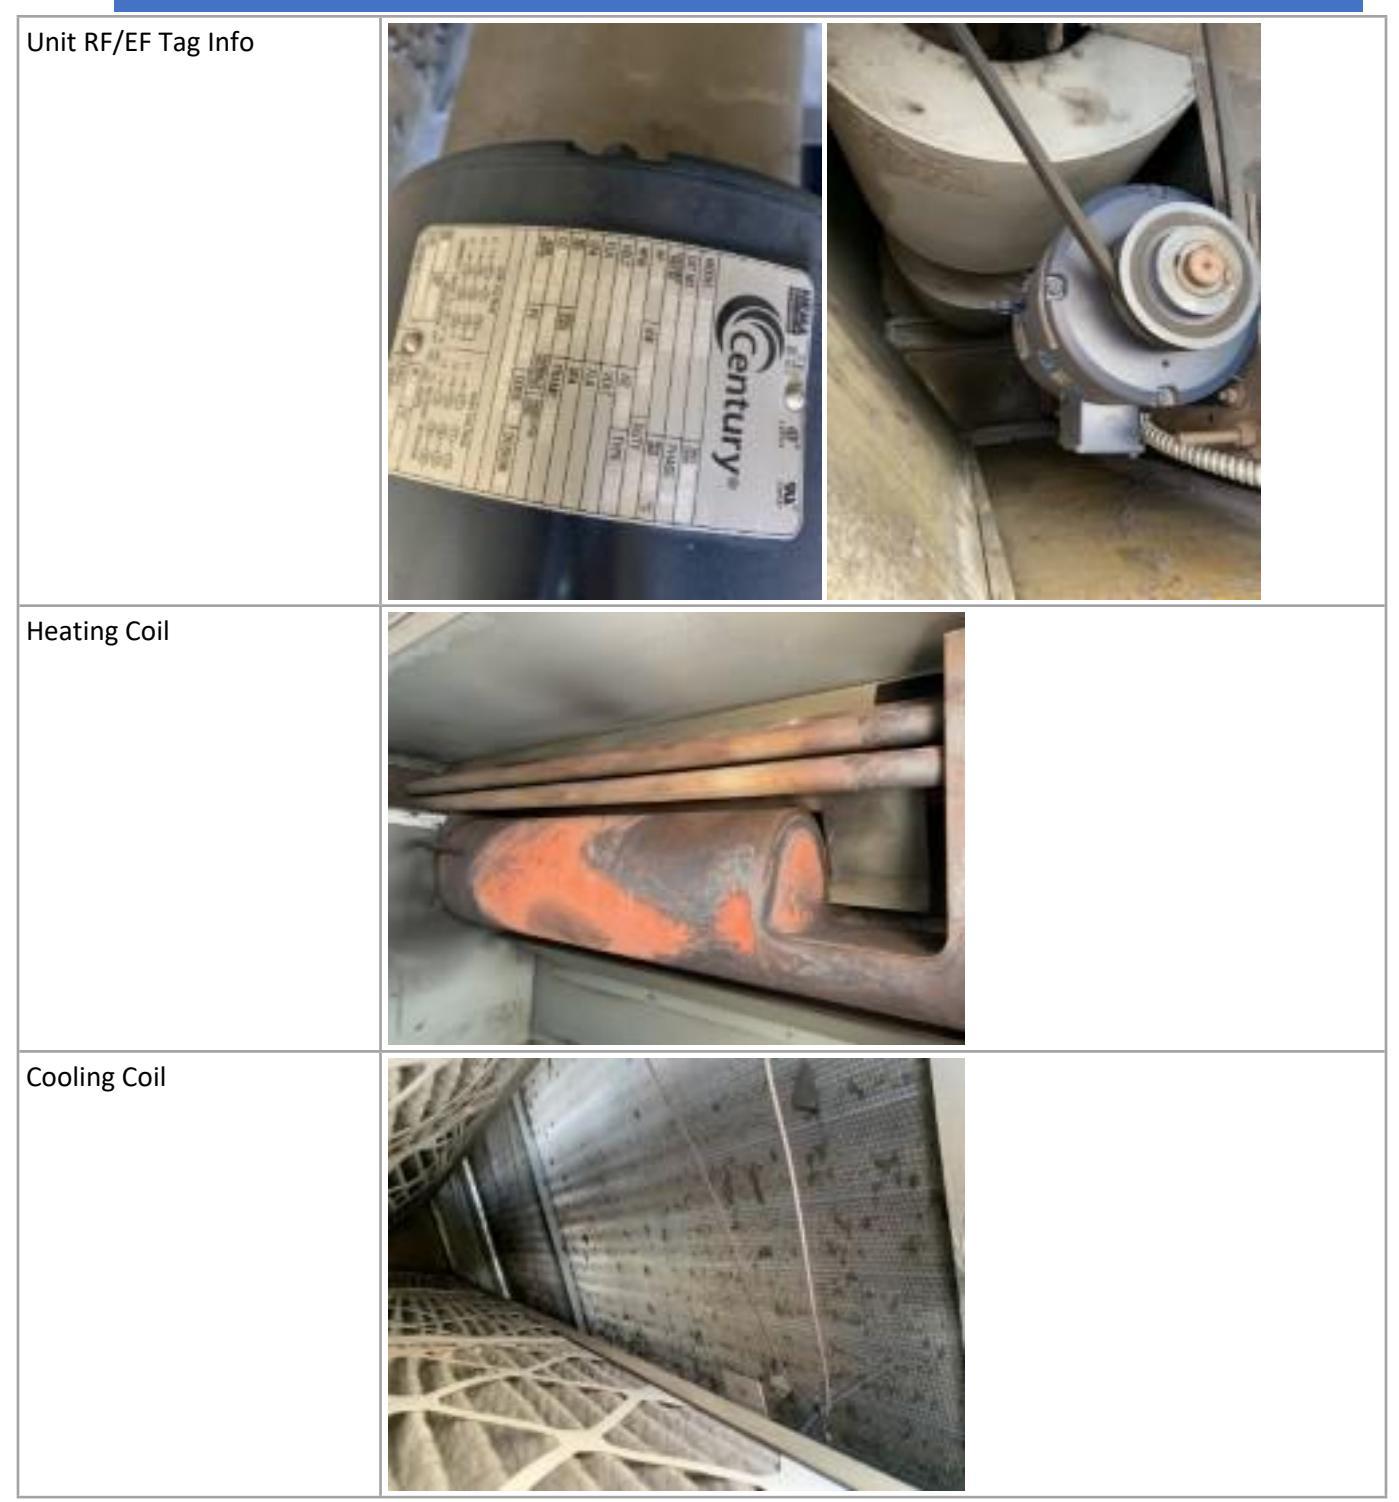
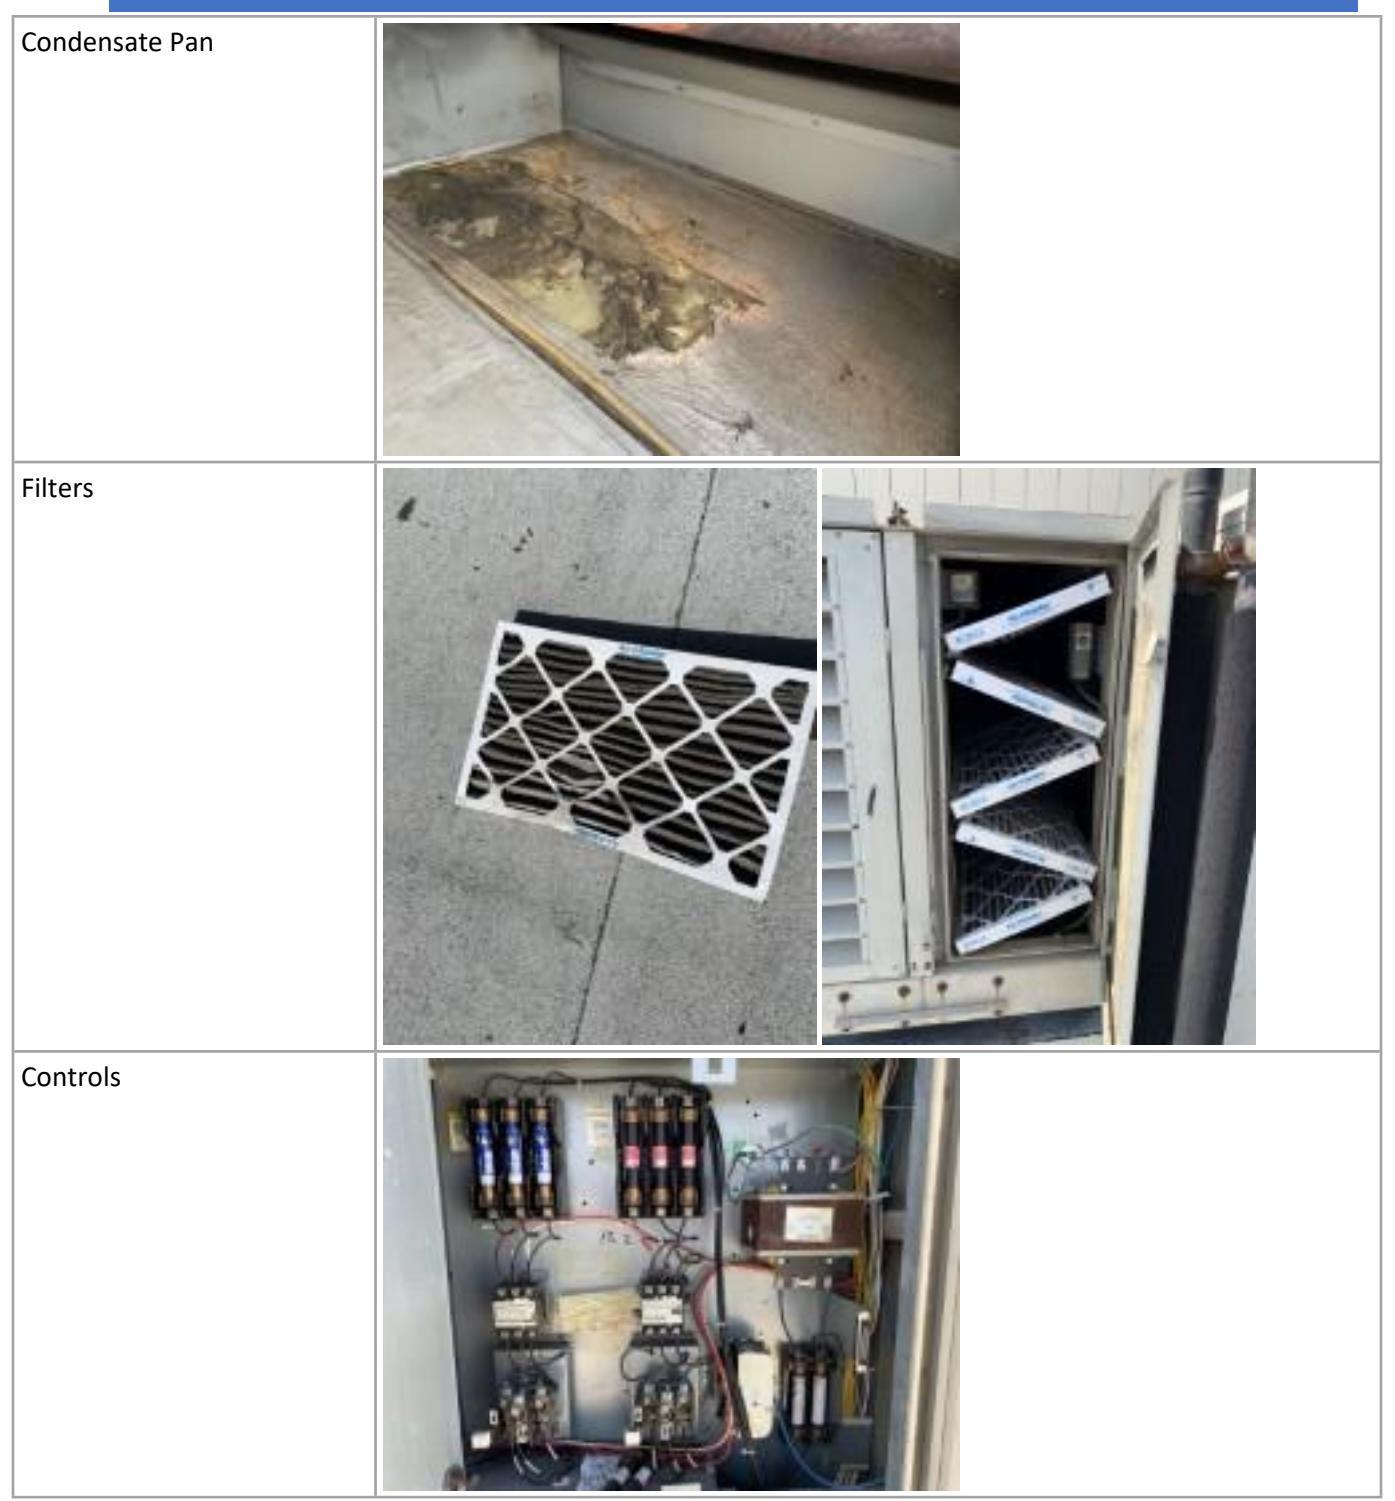
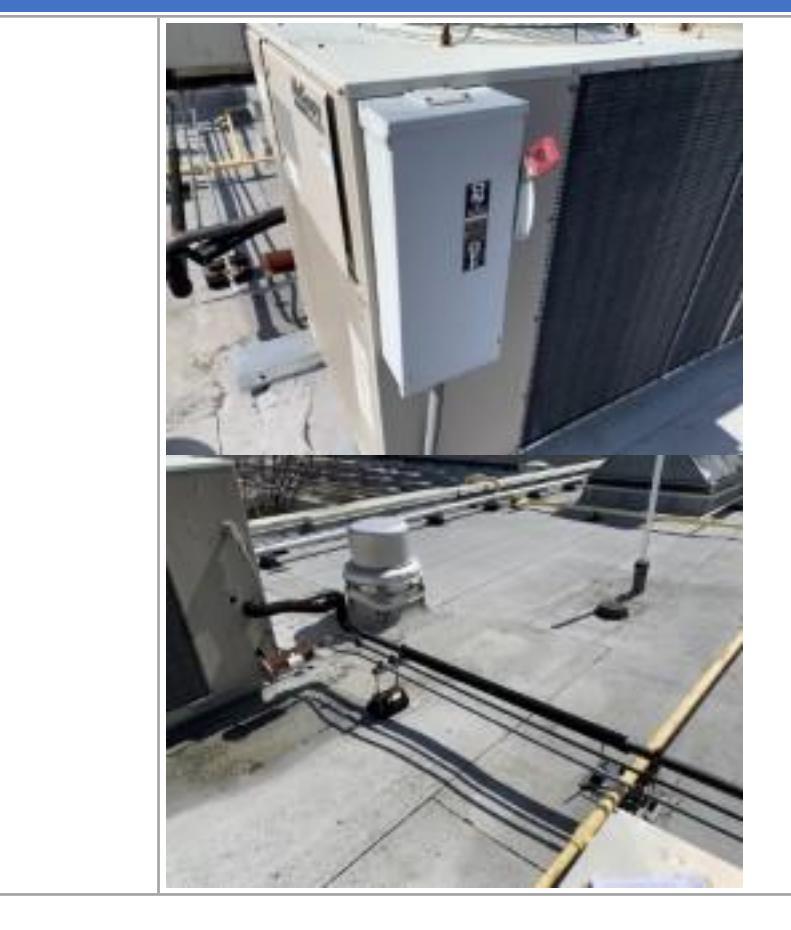
<u>Unit Tag</u>	RTU-11	Addition comments descriptions
Location	West Roof	
Serving	Gym (South)	
Config/Style	Rooftop SF/RF, DX cooling, gas heat, OA w/ Relief damper	
Mfr.	McQuay	
Model #	RWS800 BA	Burner: FB400AAE
Serial #	35E01205 17	P/N: X9 599113040
Age (years)	10-28	Original project 1994
System CFM	10000	
Max OA CFM		
V/Hz/Ph	460V / 60Hz / 3ph	
SF Qty/HP	2 fans, 1 motor, 10Hp	
SF VFD Data	230/460V / 24.4/12.2A / 60Hz	
EF Qty/HP	2 fans, 1 motor, 3Hp	Uncontrolled associated relief damper
EF VFD Data	208-230/460V / 8.4-8.0/4A / 60Hz	
Filter Data (Size Quantity)	15x 16x25x2 MERV 13 5x 16x20x2 MERV 13	
Filter Status	Dirty	
Controls Type	DDC	
Controls Mfr.	Alerton/JCI	
Economizer	Partial, analog enthalpy control (dial in OA intake)	
CO ₂ DCV		
Damper Styles	Parallel blade	
Damper Status	Okay seal but dirty	
Heating Type	Gas	
Heating Coil Condition	Rusty HX	
Cooling Type	DX	Refrigerant insulation is completely destroyed, requires new insulation with UV protection

Cooling Coil Condition	Dirty	
CU Mfr.	McQuay	Near the unit on the roof
CU Model	ACZ033AC527-ER11	
CU Serial	STNU061100104	
Drain Pan Status	Okay	
Notes:
