Fairfield Woods Middle School

Fairfield Public Schools Recommissioning (RCx) and Testing, Adjusting, & Balancing (TAB) Study van Zelm Project # 2020102.00 (05-FWMS) August 01, 2022

FAIRFIELD PUBLIC SCHOOLS RECOMMISSIONING (RCX) AND TESTING, ADJUSTING, & BALANCING (TAB) STUDY

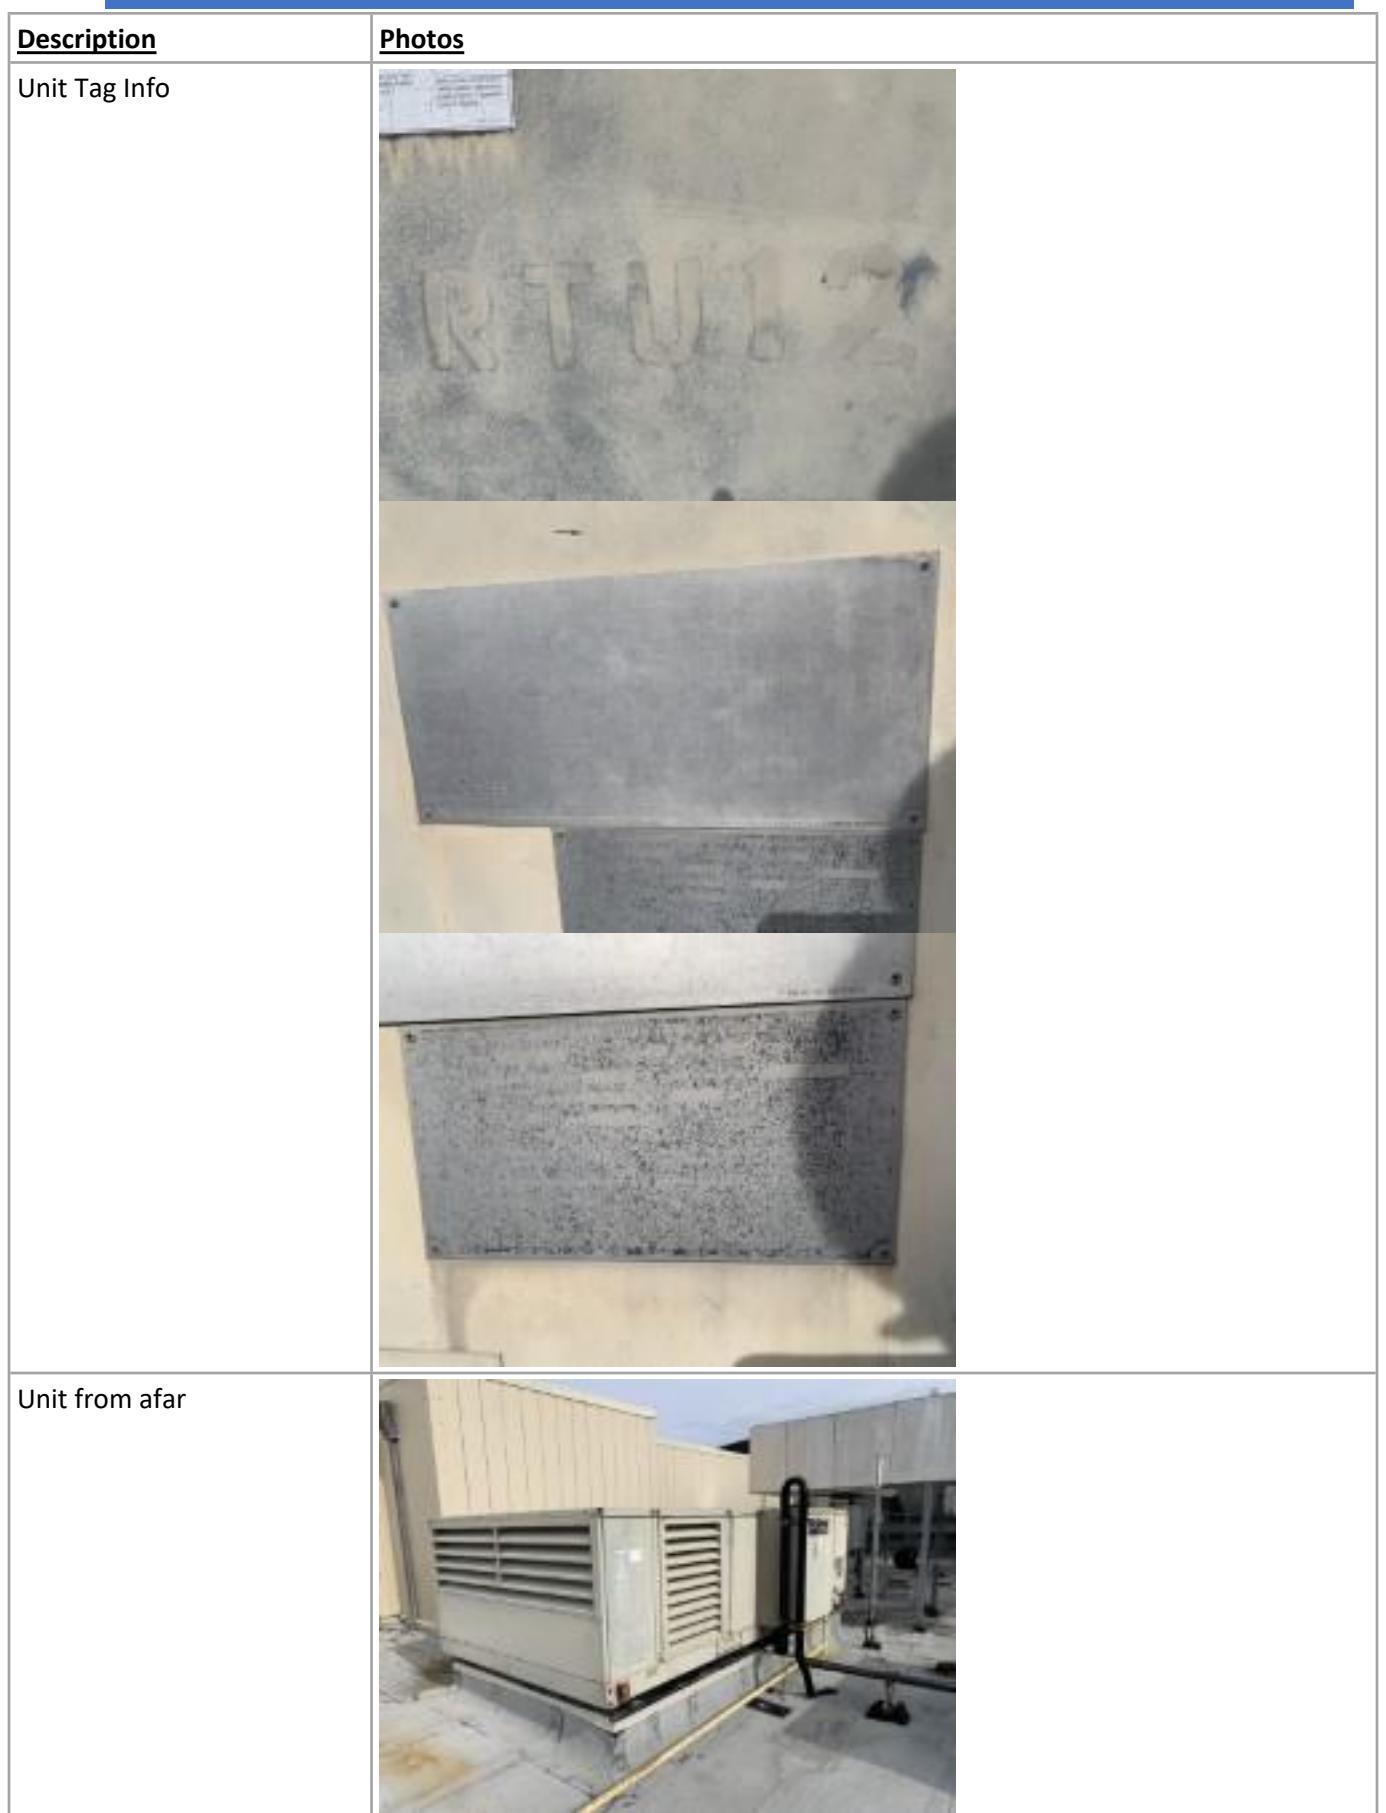
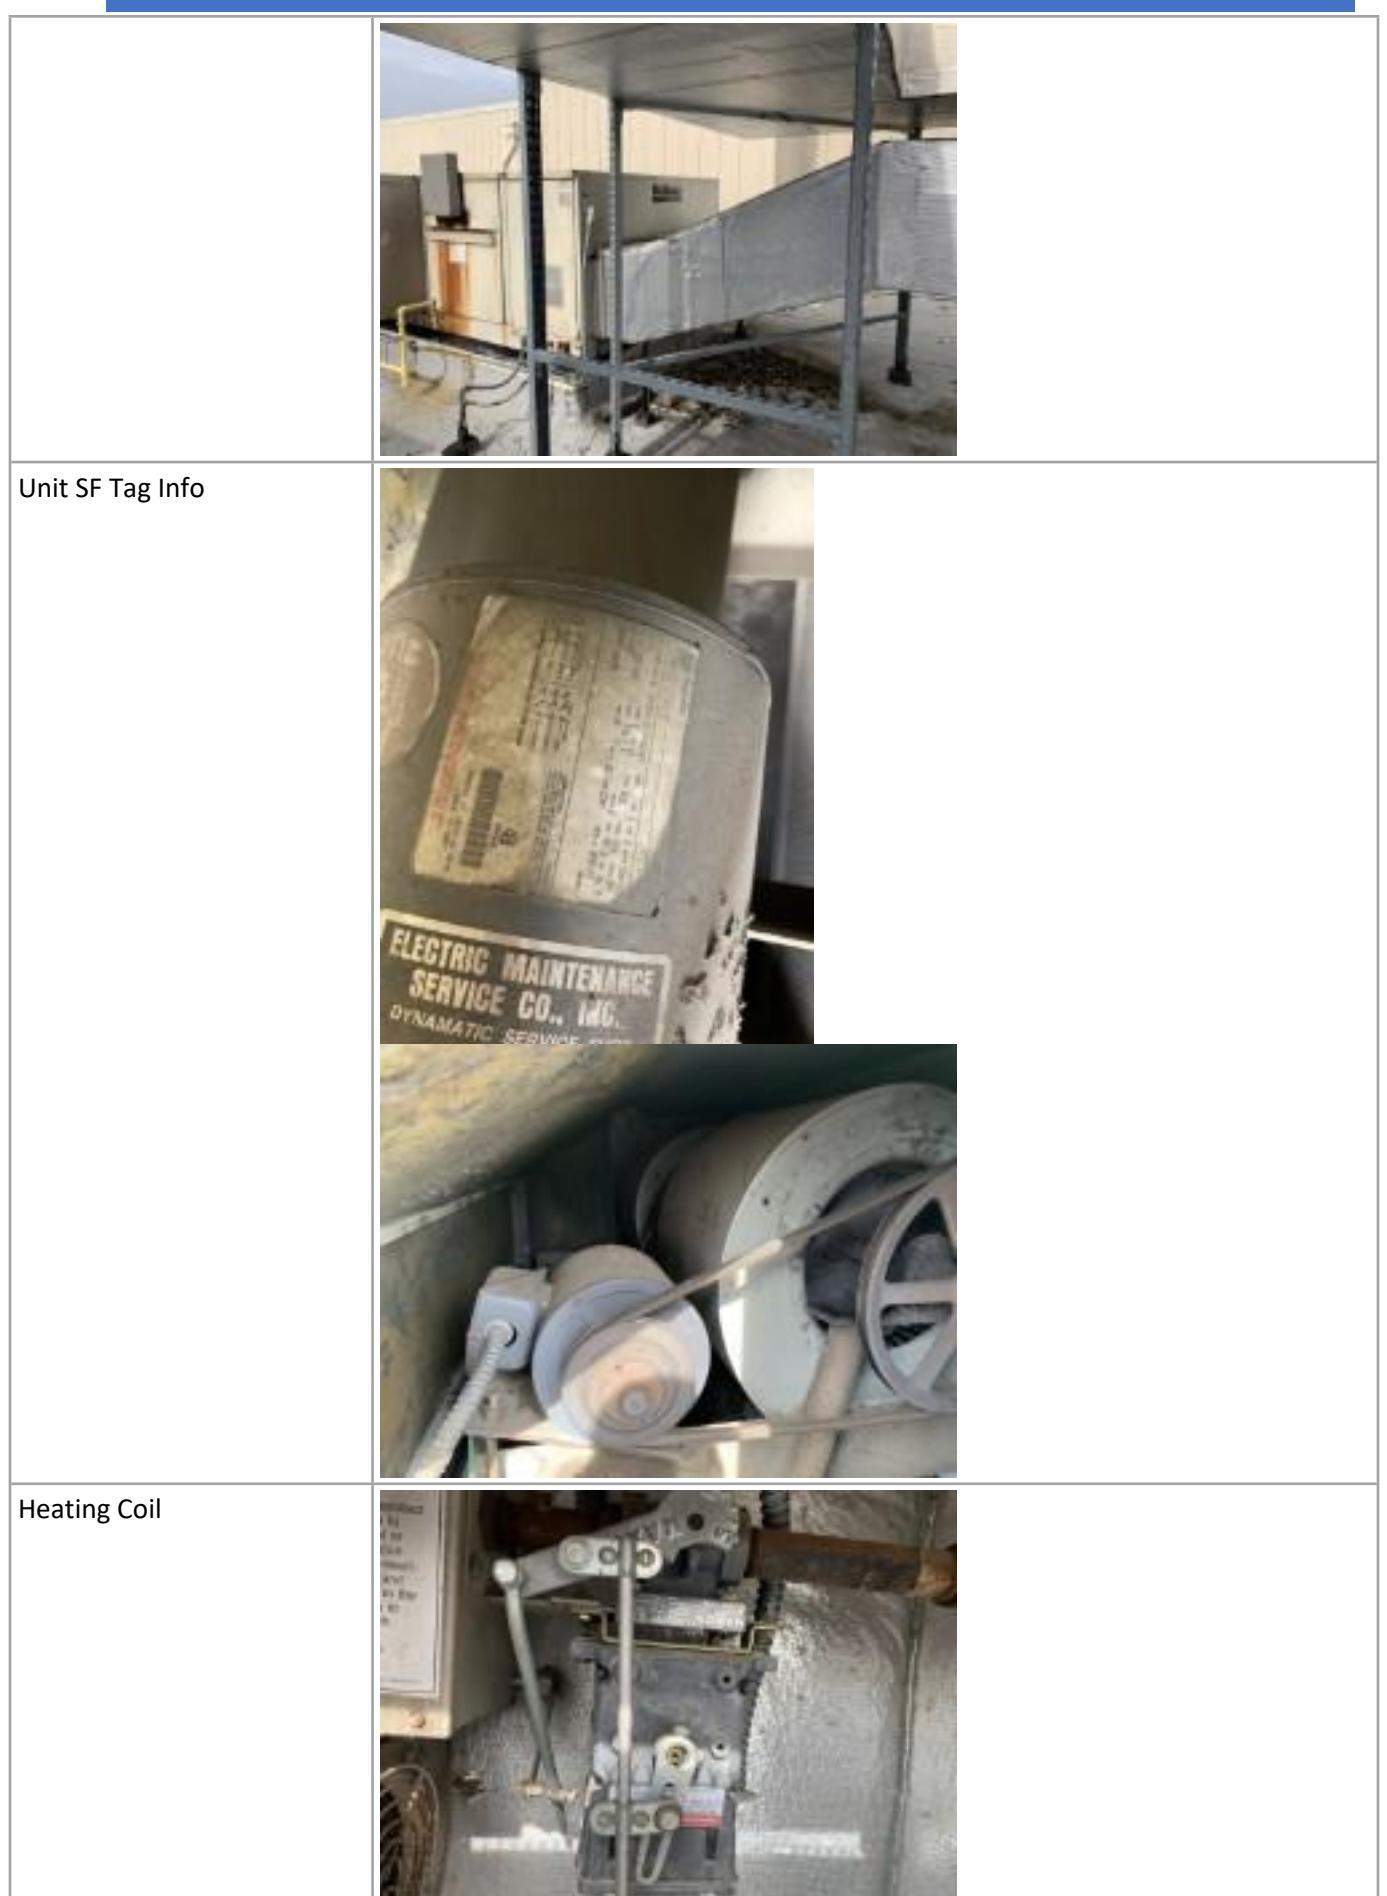
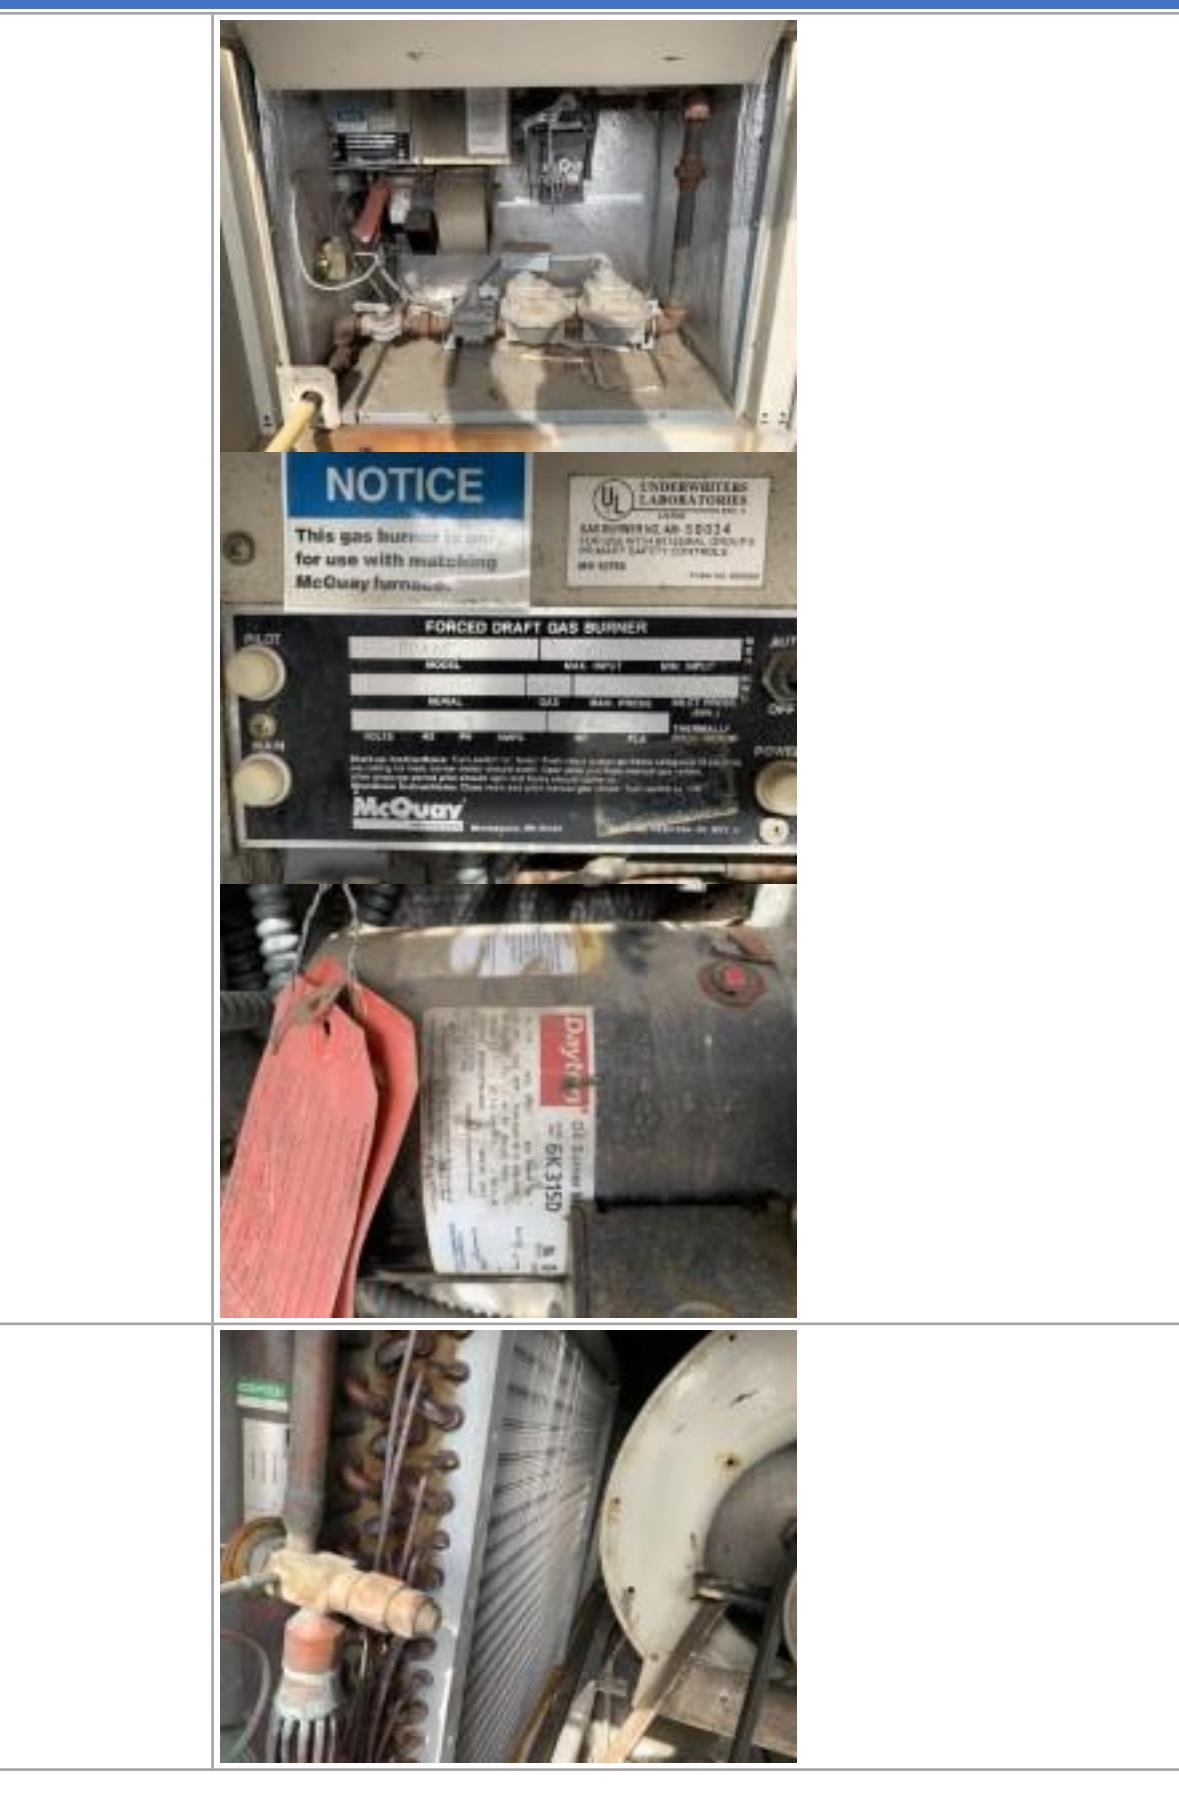
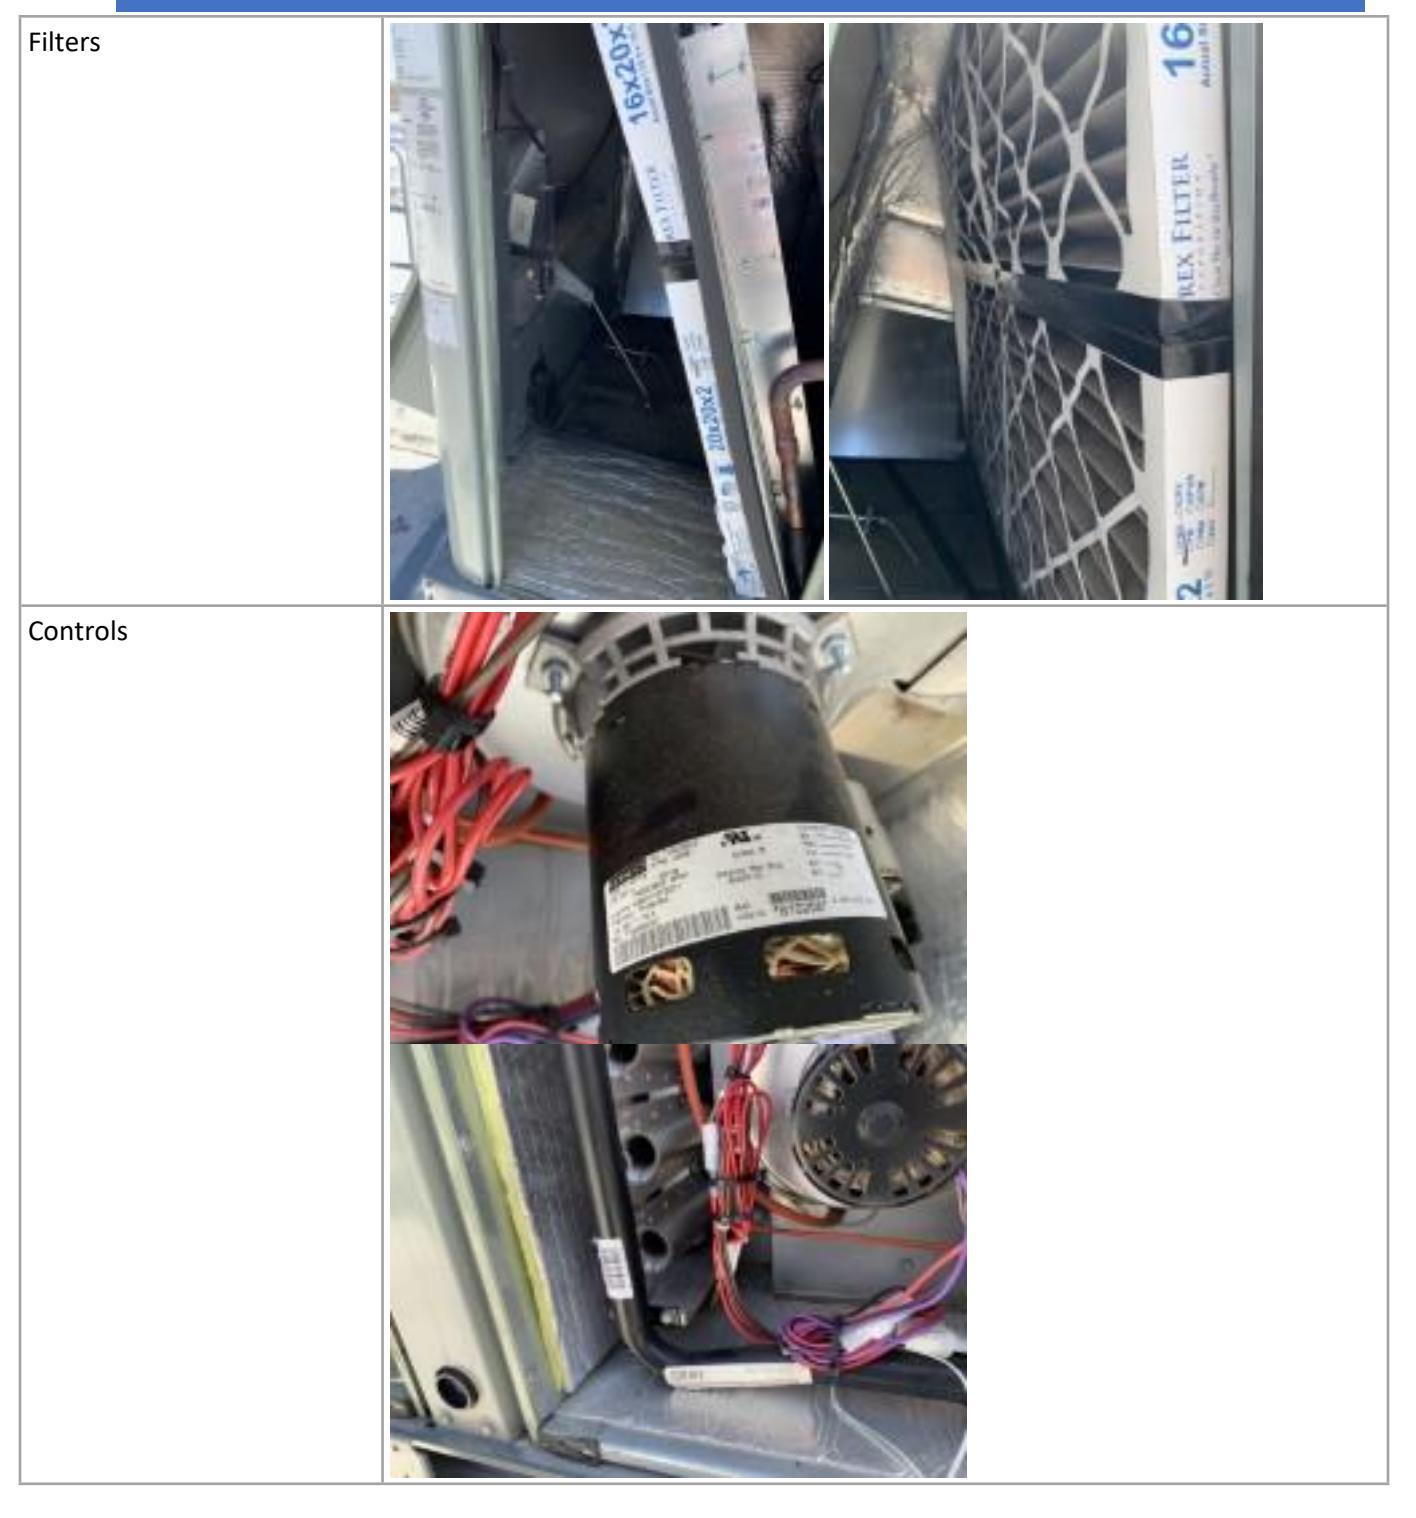
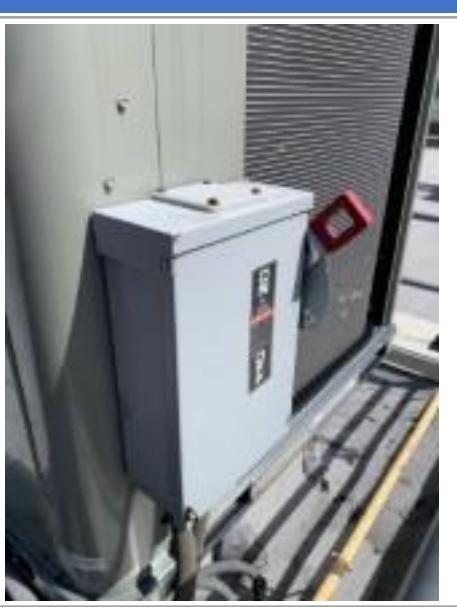
<u>Unit Tag</u>	RTU-12	Addition comments descriptions
Location	West Roof	
Serving	Gym (North)	
Config/Style	Rooftop SF/RF, DX cooling, gas heat, OA w/ Relief damper	
Mfr.	McQuay	
Model #	RWS800 BA	Burner: C40SE 0
Serial #	35E01206 17	
Age (years)	10-28	Original project 1994
System CFM	10000	
Max OA CFM		
V/Hz/Ph	460V / 60Hz / 3ph	
SF Qty/HP	2 fans, 1 motor, 10Hp	
SF VFD Data	230/460V / 24.4/12.2A / 60Hz	
EF Qty/HP	2 fans, 1 motor, 3Hp	Uncontrolled associated relief damper
EF VFD Data	230/460V / 7.8/3.9A / 60Hz	
Filter Data (Size Quantity)	15x 16x25x2 MERV 13 5x 16x20x2 MERV 13	
Filter Status	Dirty	
Controls Type	DDC	
Controls Mfr.	Alerton/JCI	
Economizer	Partial, analog enthalpy control (dial in OA intake)	
CO ₂ DCV		
Damper Styles	Parallel blade	
Damper Status	Seals are not tight, dirty	
Heating Type	Gas	
Heating Coil Condition	Rusty HX	
Cooling Type	DX	Refrigerant insulation is completely destroyed, requires new insulation with UV protection

Cooling Coil Condition	Okay	
CU Mfr.	McQuay	Near the unit on the roof
CU Model	ACZ033AC527-ER11	
CU Serial	STNU061100104	
Drain Pan Status	Okay, some debris	Condensate splash pad is severely deteriorated between the unit and the wall
Notes:

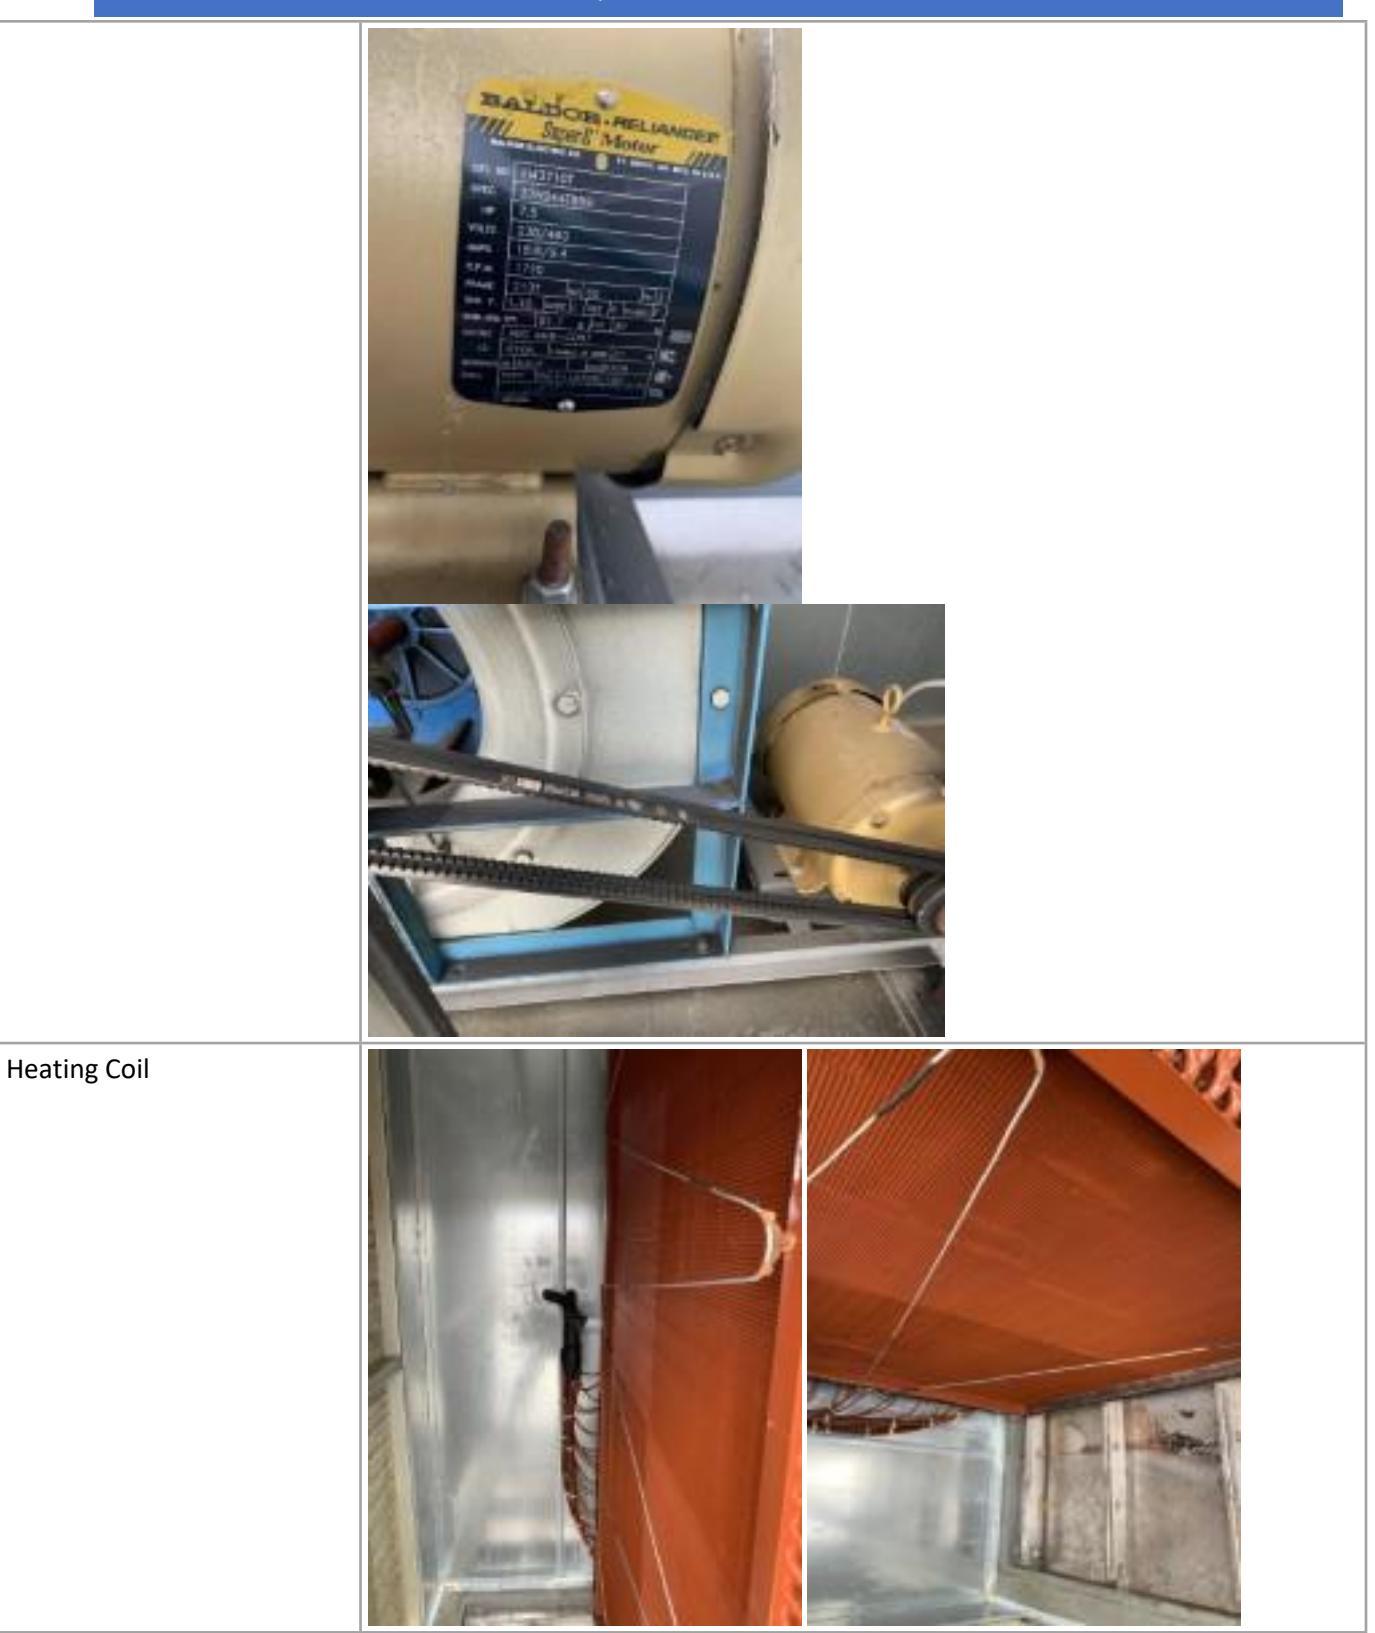
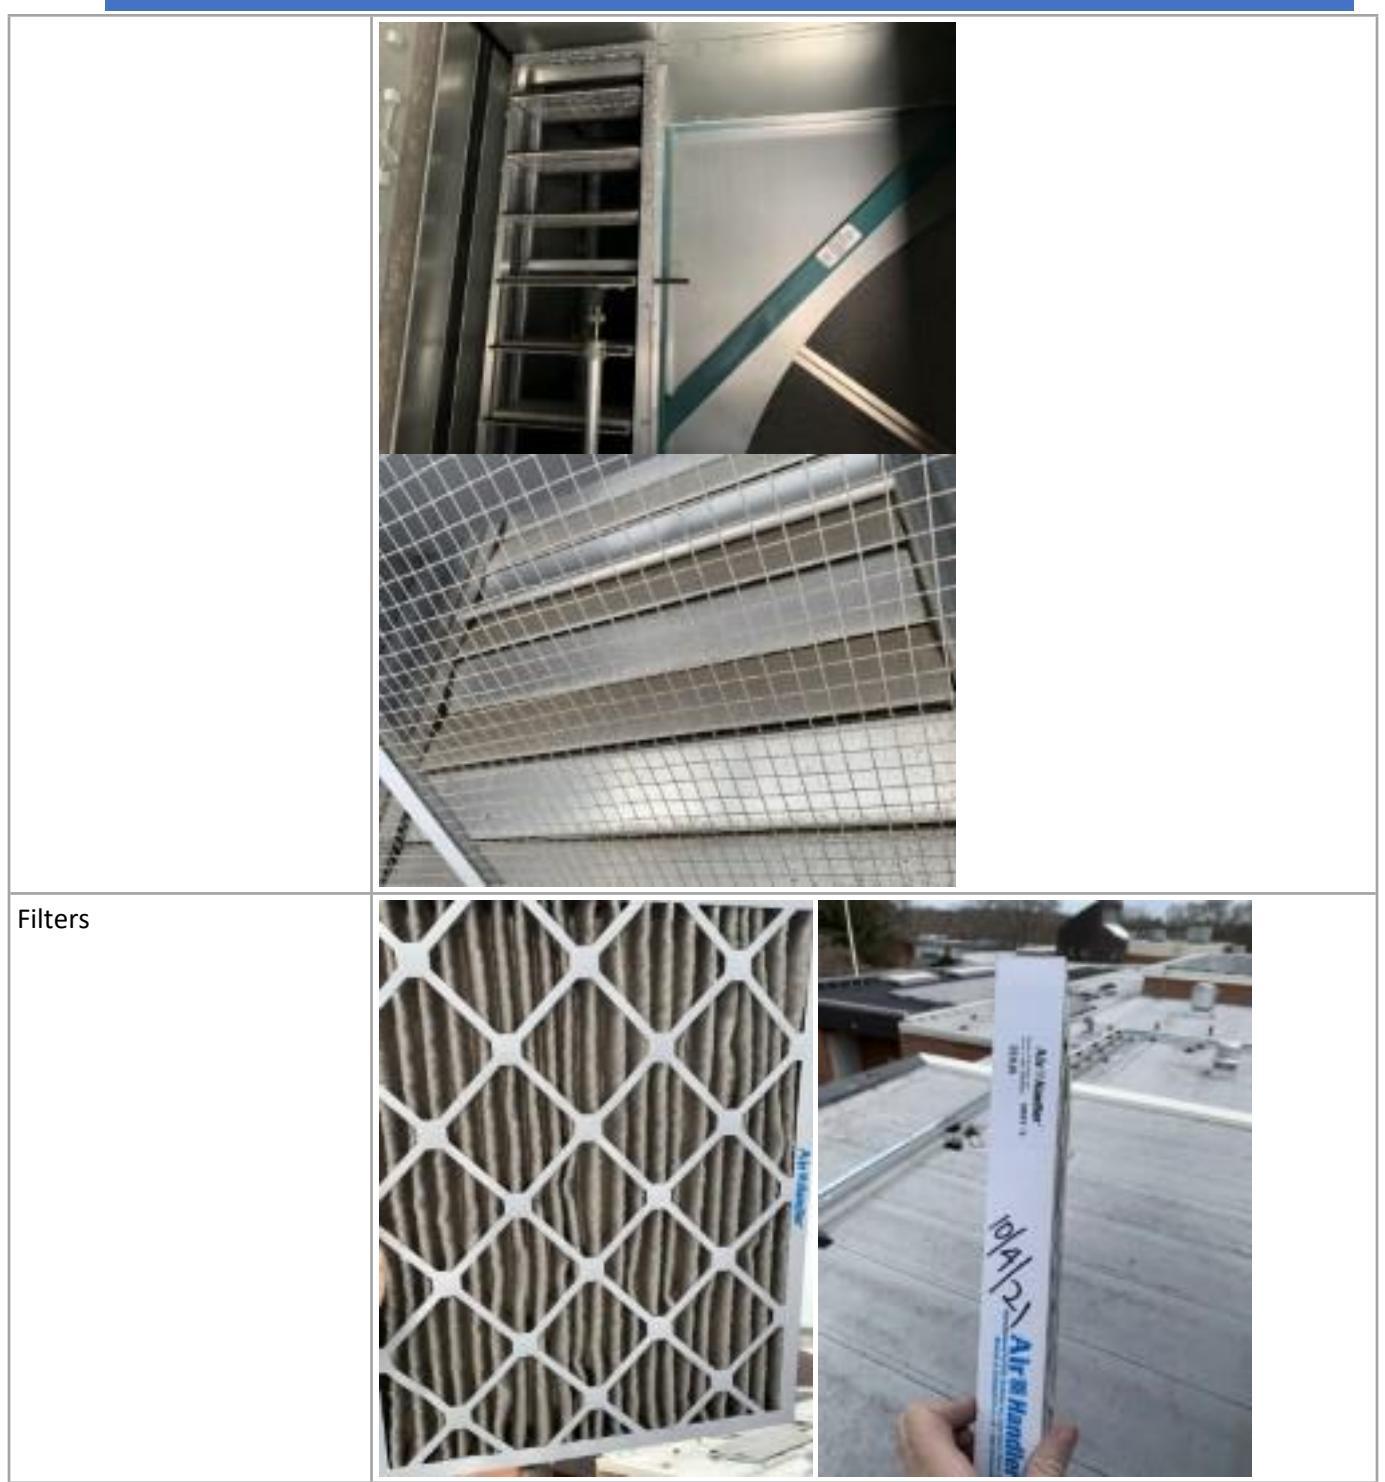
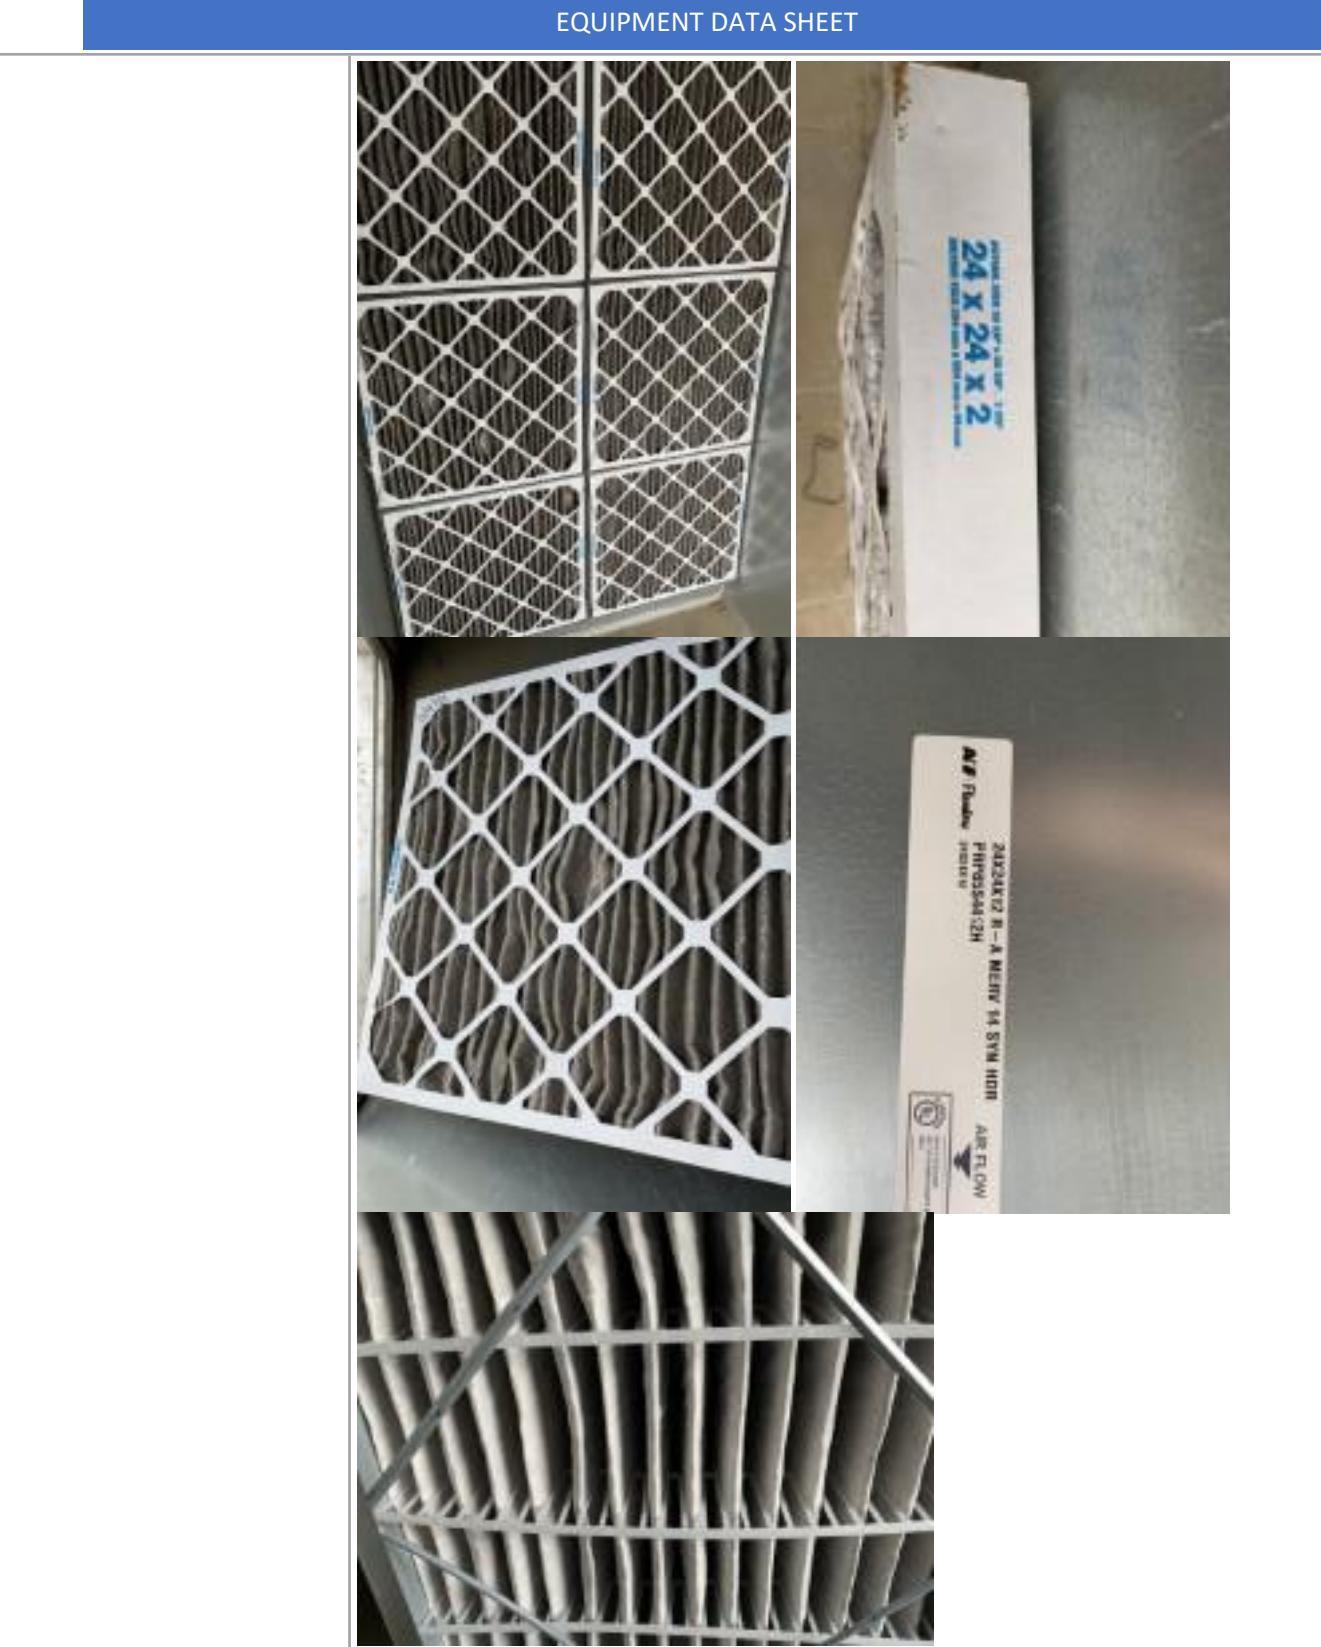
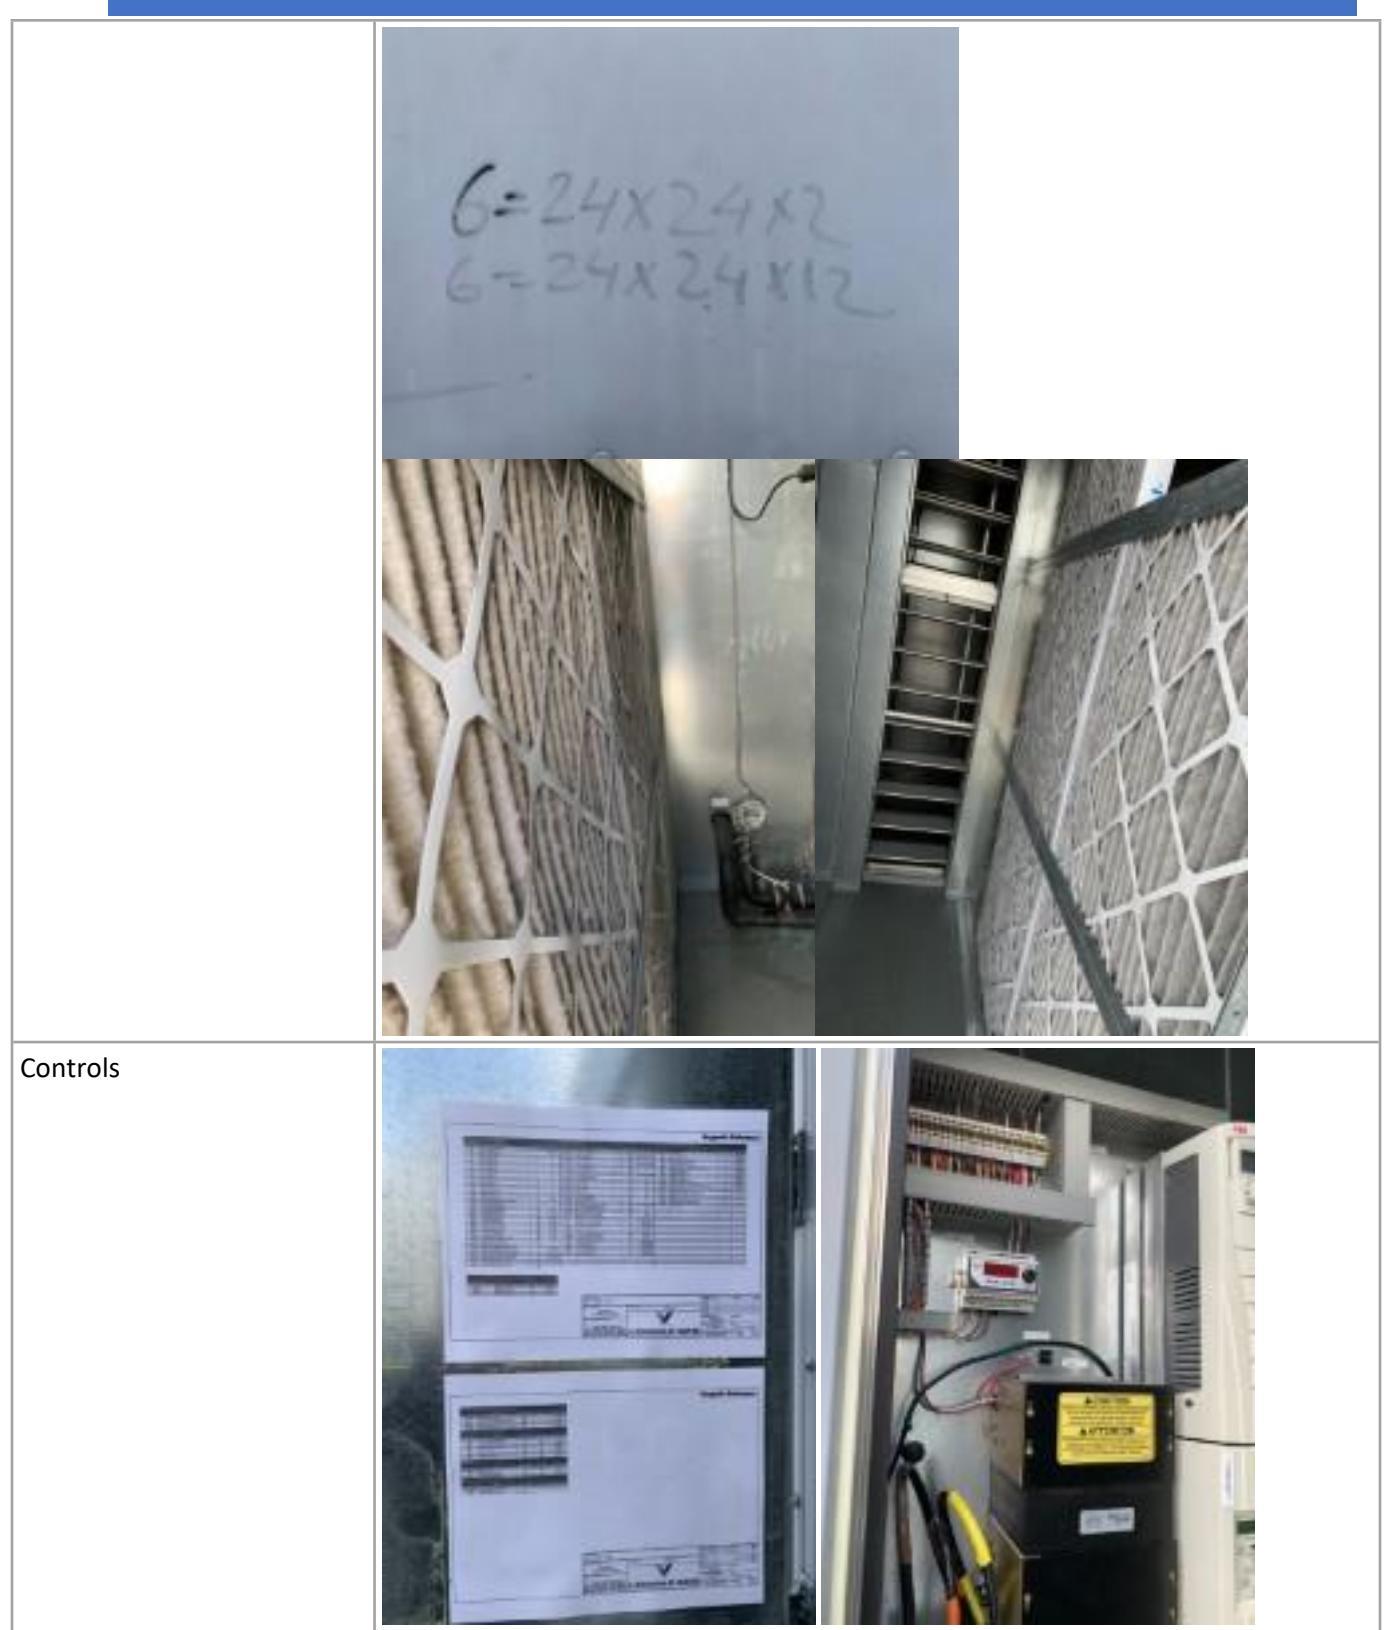
<u>Unit Tag</u>	RTU-14	Addition comments descriptions
Location	Northwest Roof	
Serving	Auditorium	
Config/Style	VAV AHU, SF/RF, HW, DX Cooling, ERW	
Mfr.	Venmar CES	
Model #	5WC-4-60x46x2-8AL	EnergyPack-W-2-12e-WB-HW-CT404-X- P
Serial #	00551108-C04273	
Age (years)	11 (02/2011	
System CFM	11500	
Max OA CFM	9900	
V/Hz/Ph	460V / 60Hz / 3ph	
SF Qty/HP	2, 7.5 (15hp total)	Direct drive
SF VFD Data	480V / 23A / 15Hp	
RF Qty/HP	1, 7.5	Belt drive
RF VFD Data	480V / 11.5A / 7.5Hp	
Filter Data (Size Quantity)	EA 6x 20x24x2 MERV 13 OA Pre- 6x 24x24x2 MERV 13 OA Final- 6x 24x24x12 MERV 14 Box Filters	
Filter Status	OA 2" filters are dirty, the rest are okay	
Controls Type	DDC	
Controls Mfr.	Alerton	
Economizer	No, ERW	
CO ₂ DCV		
Damper Styles	Reverse blade for OA/EA, parallel blade on bypass/internal/MA	
Damper Status	OA damper does not seal fully	
Heating Type	Hot Water	
Heating Coil Condition	Good	
Cooling Type	DX	
Cooling Coil Condition	Good
