Fairfield Woods Middle School

Fairfield Public Schools Recommissioning (RCx) and Testing, Adjusting, & Balancing (TAB) Study van Zelm Project # 2020102.00 (05-FWMS) August 01, 2022

FAIRFIELD PUBLIC SCHOOLS RECOMMISSIONING (RCX) AND TESTING, ADJUSTING, & BALANCING (TAB) STUDY

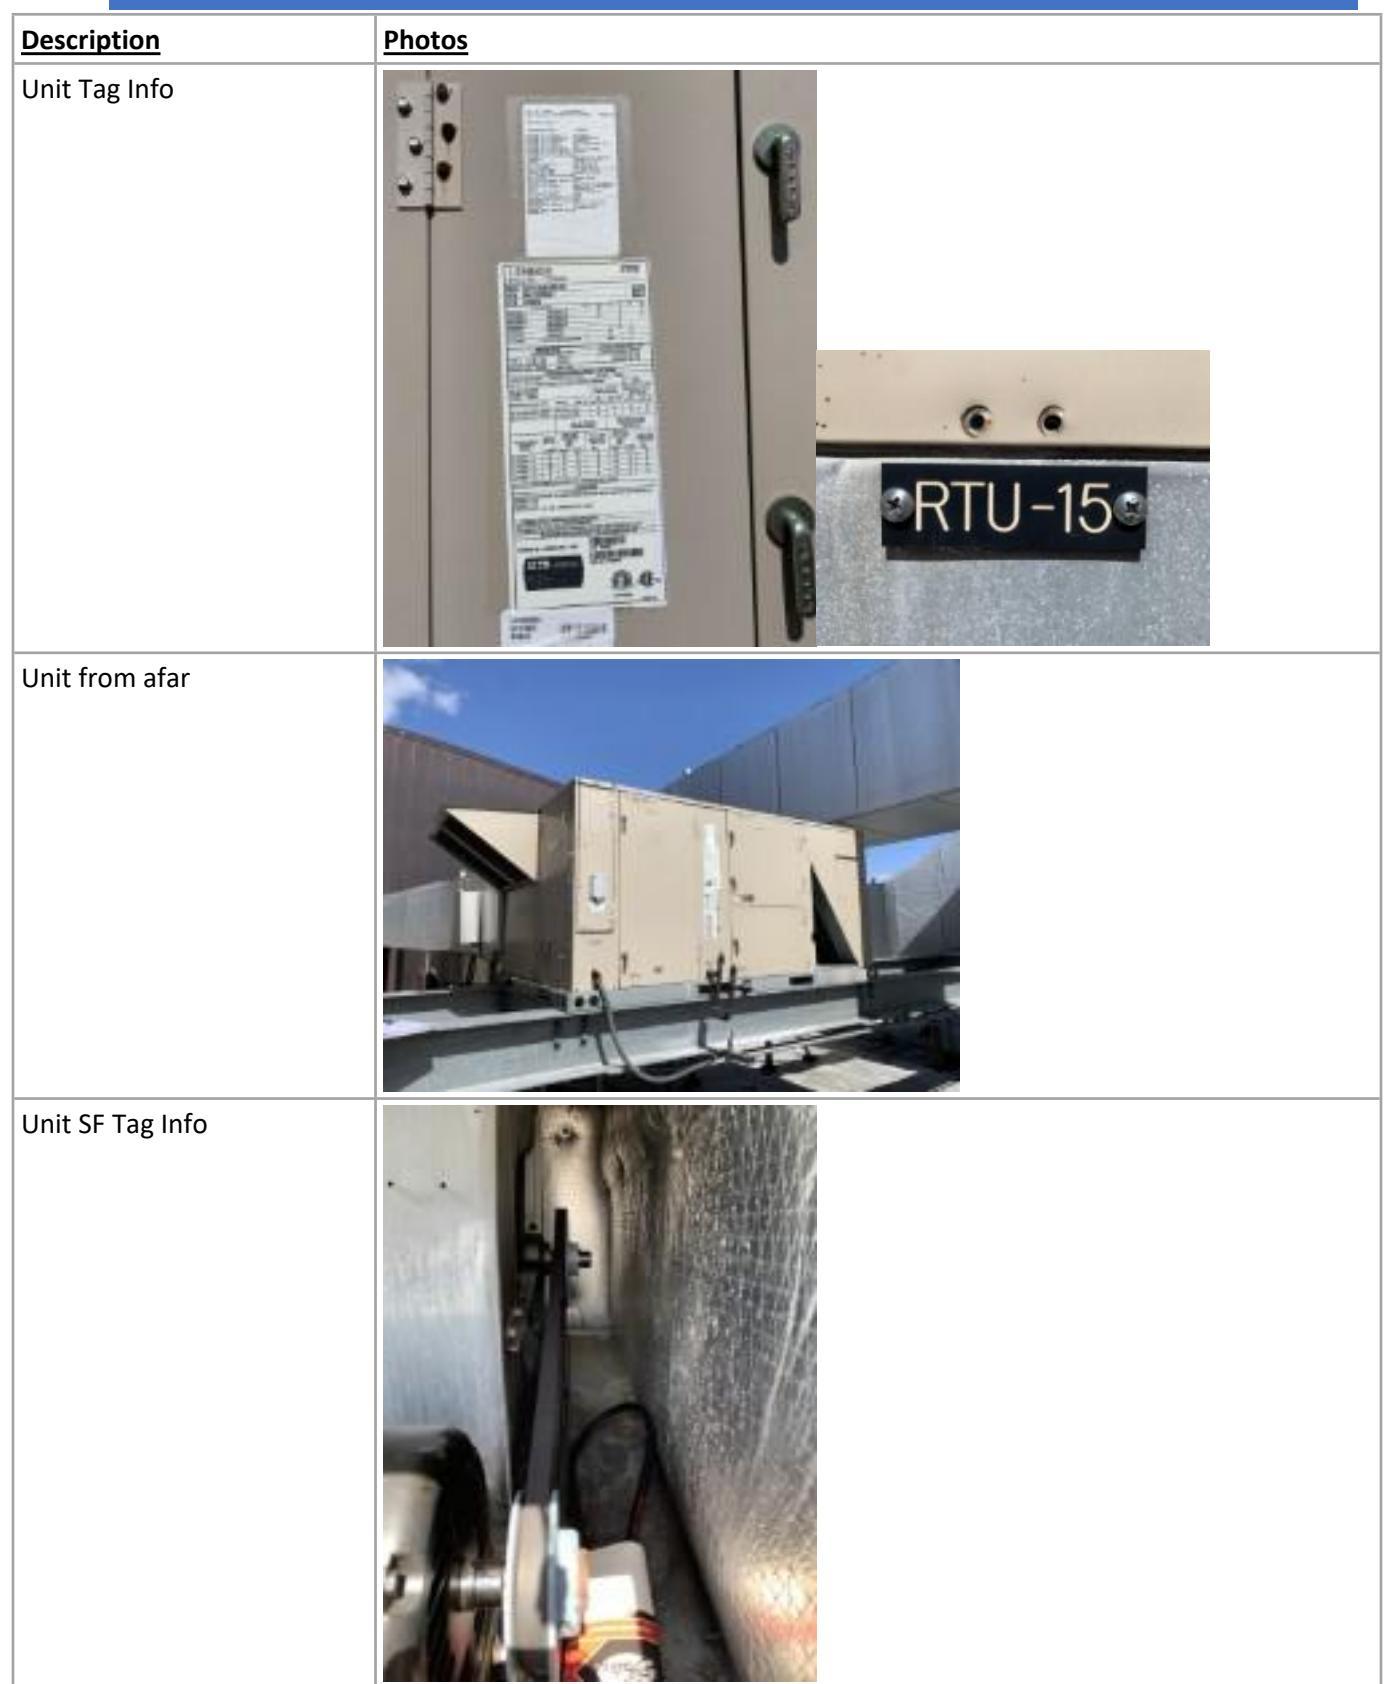
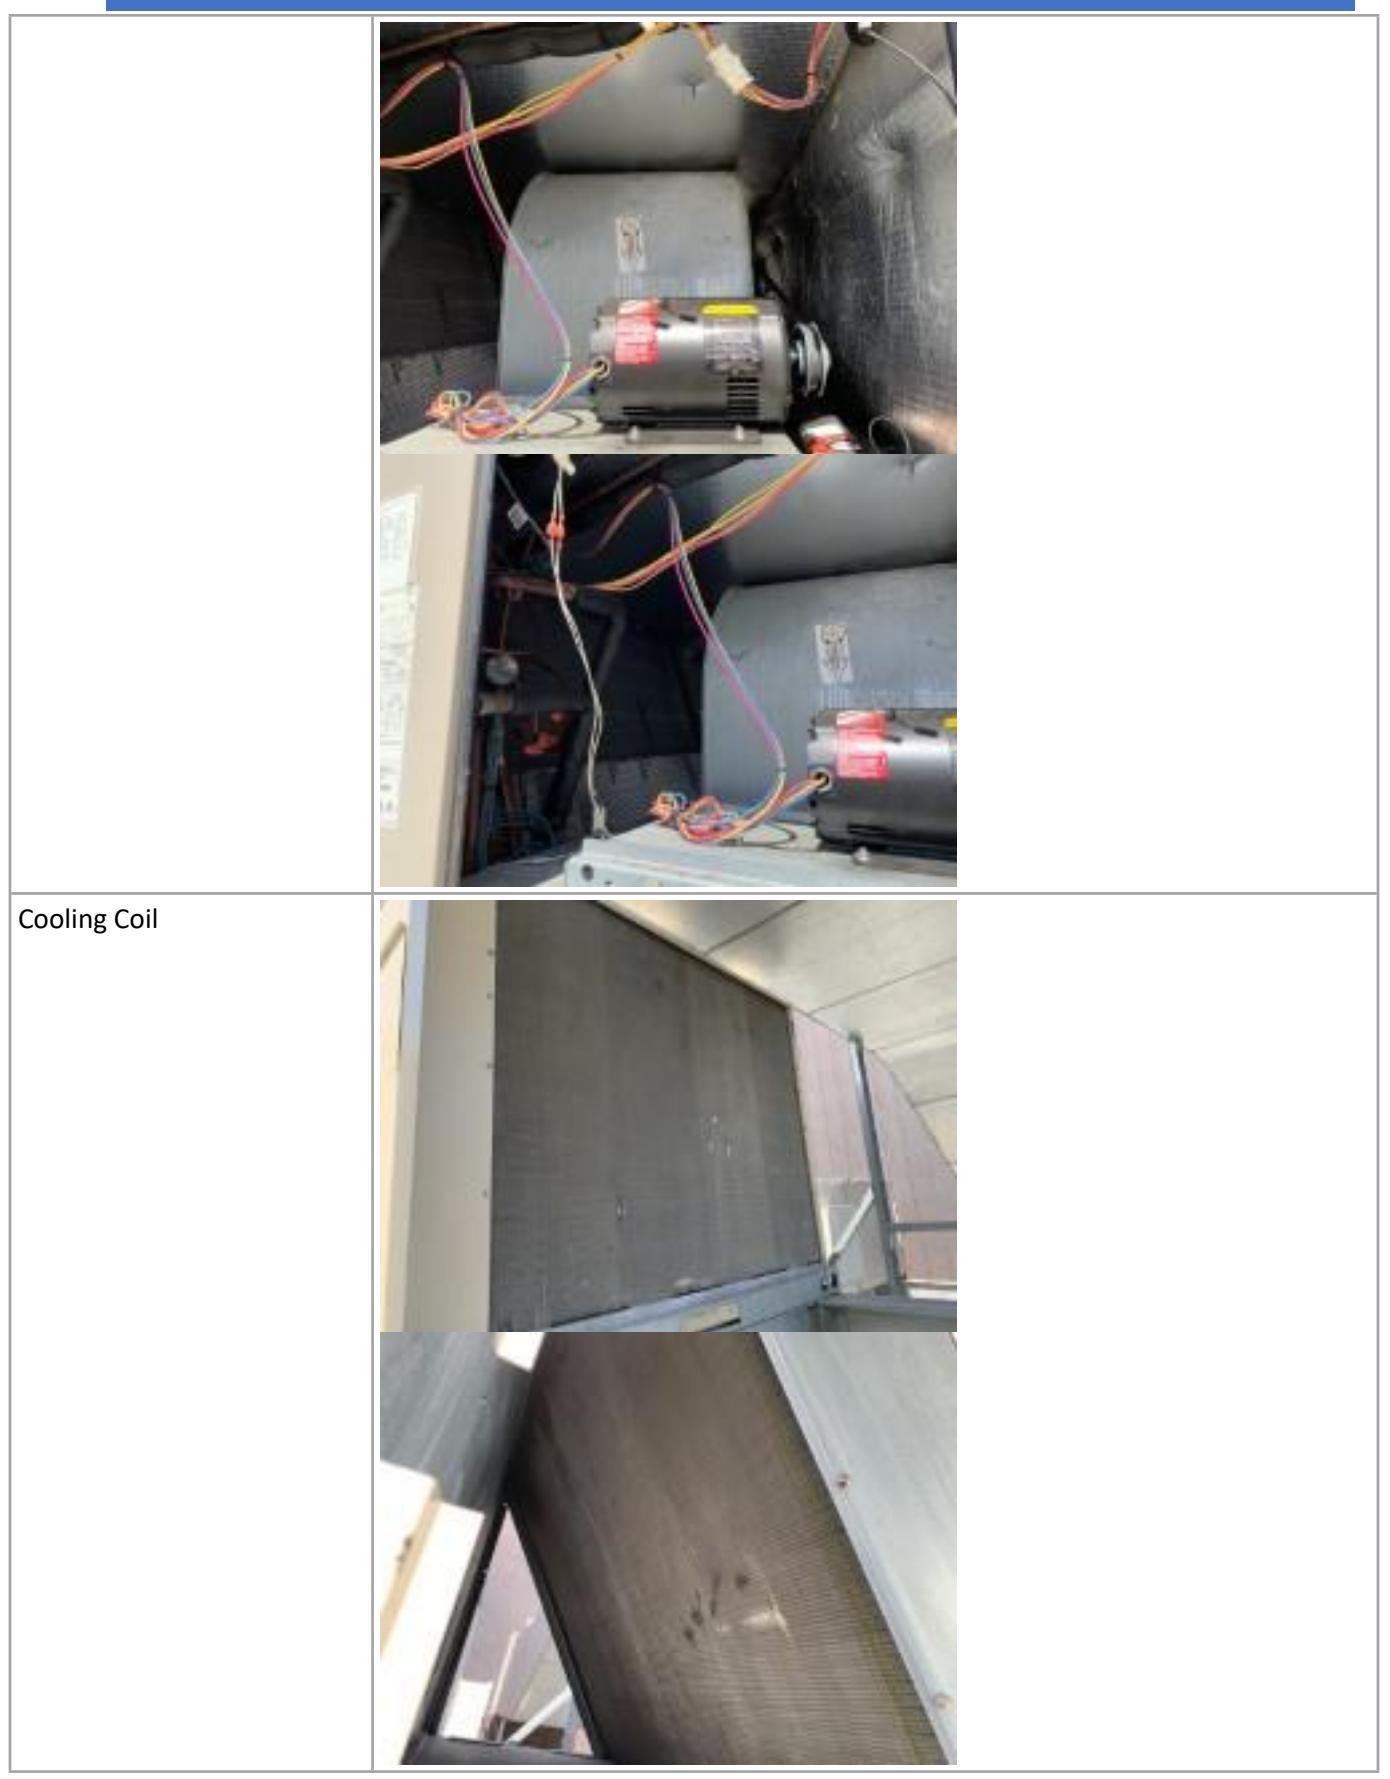
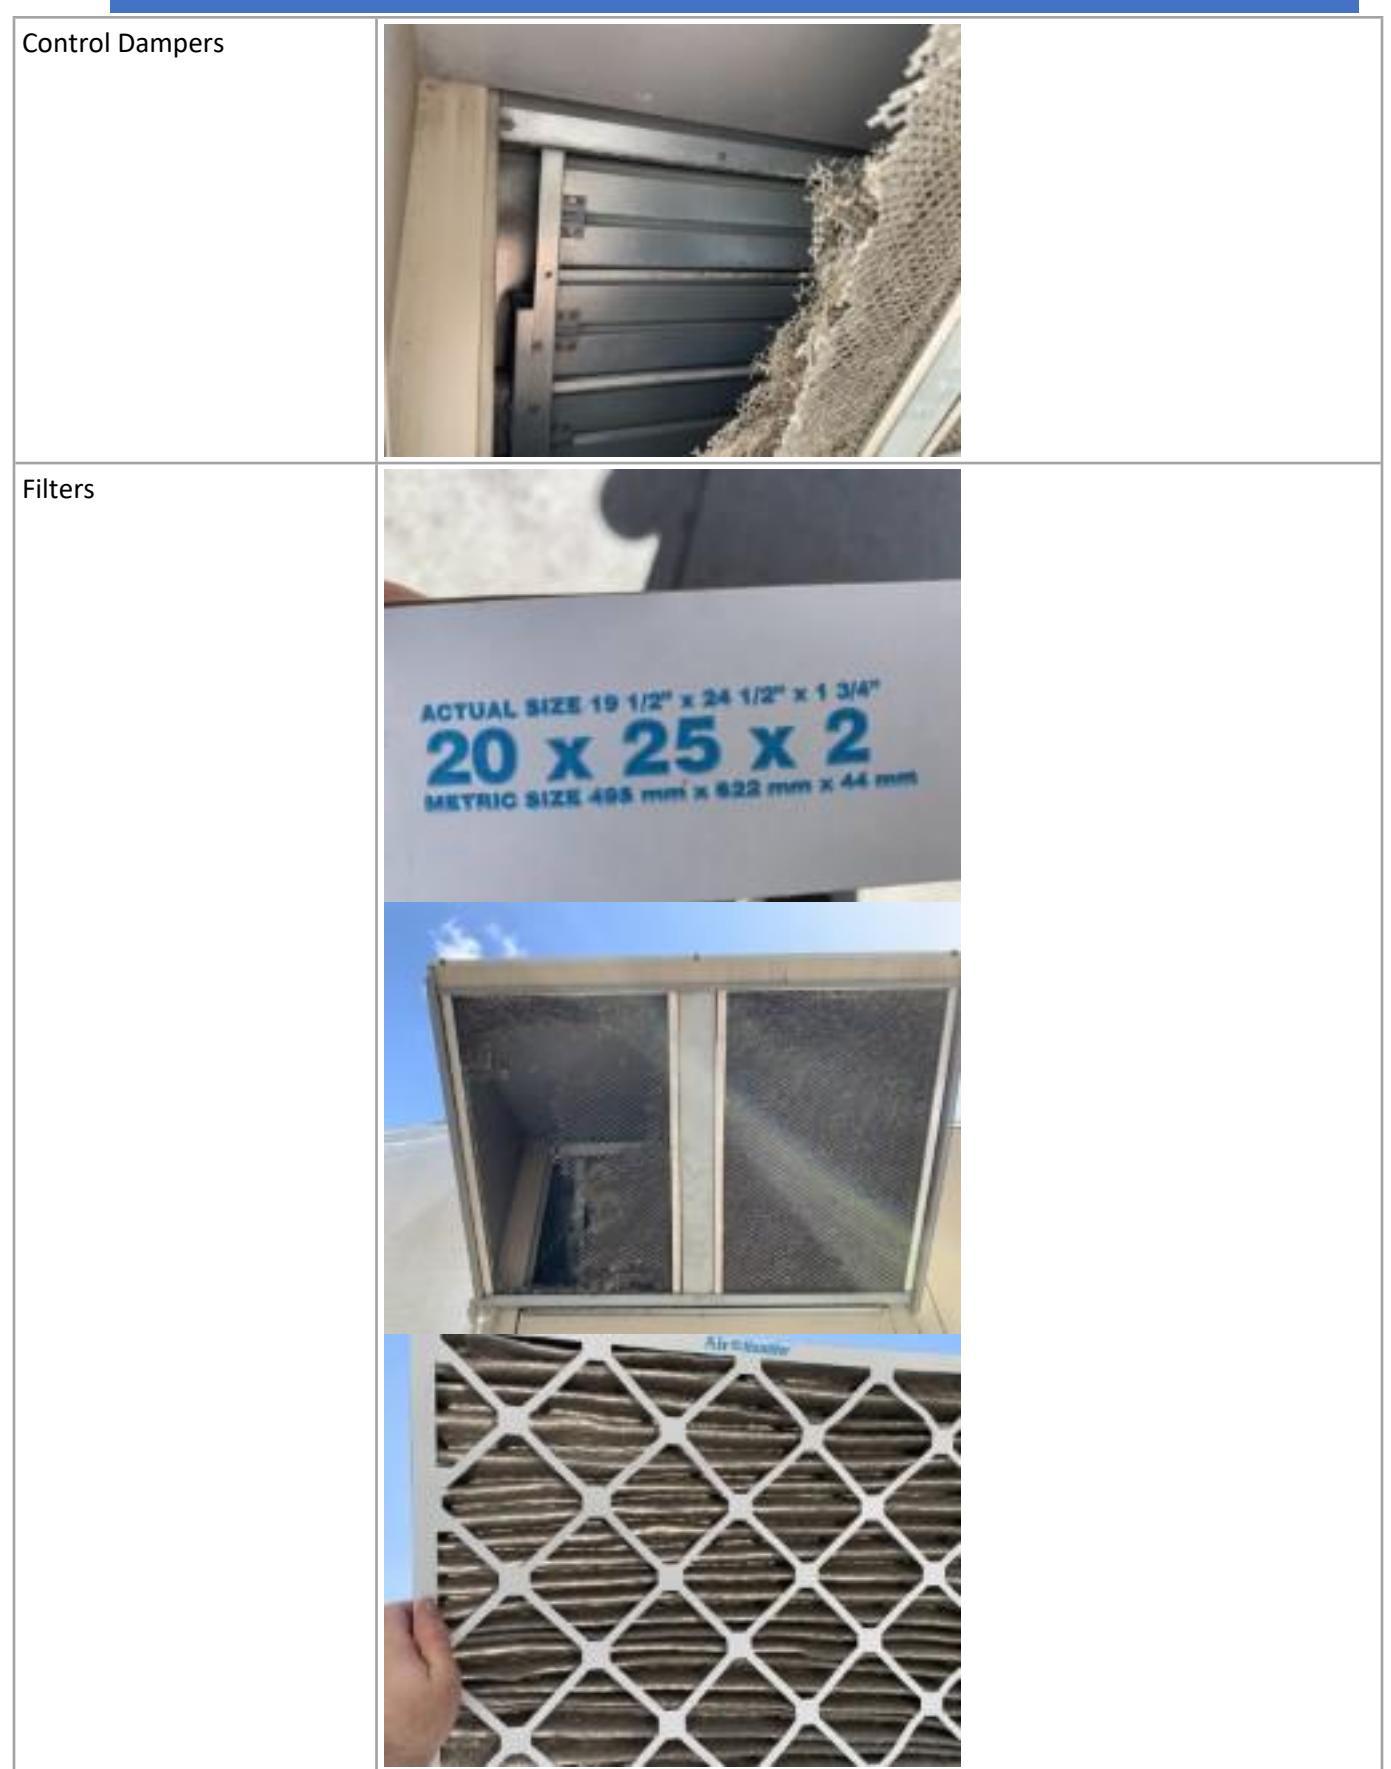
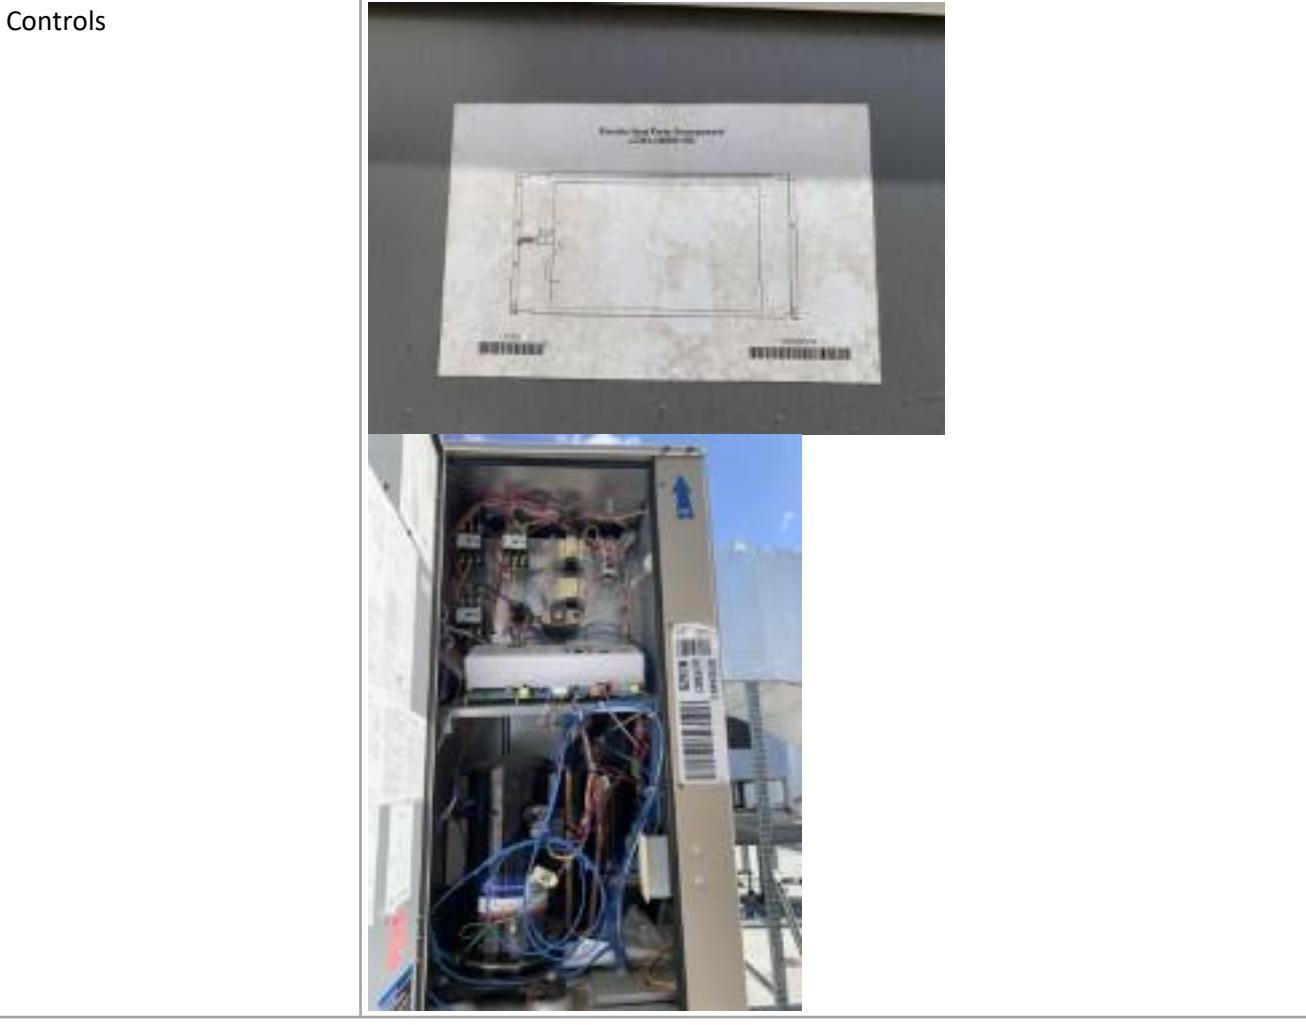
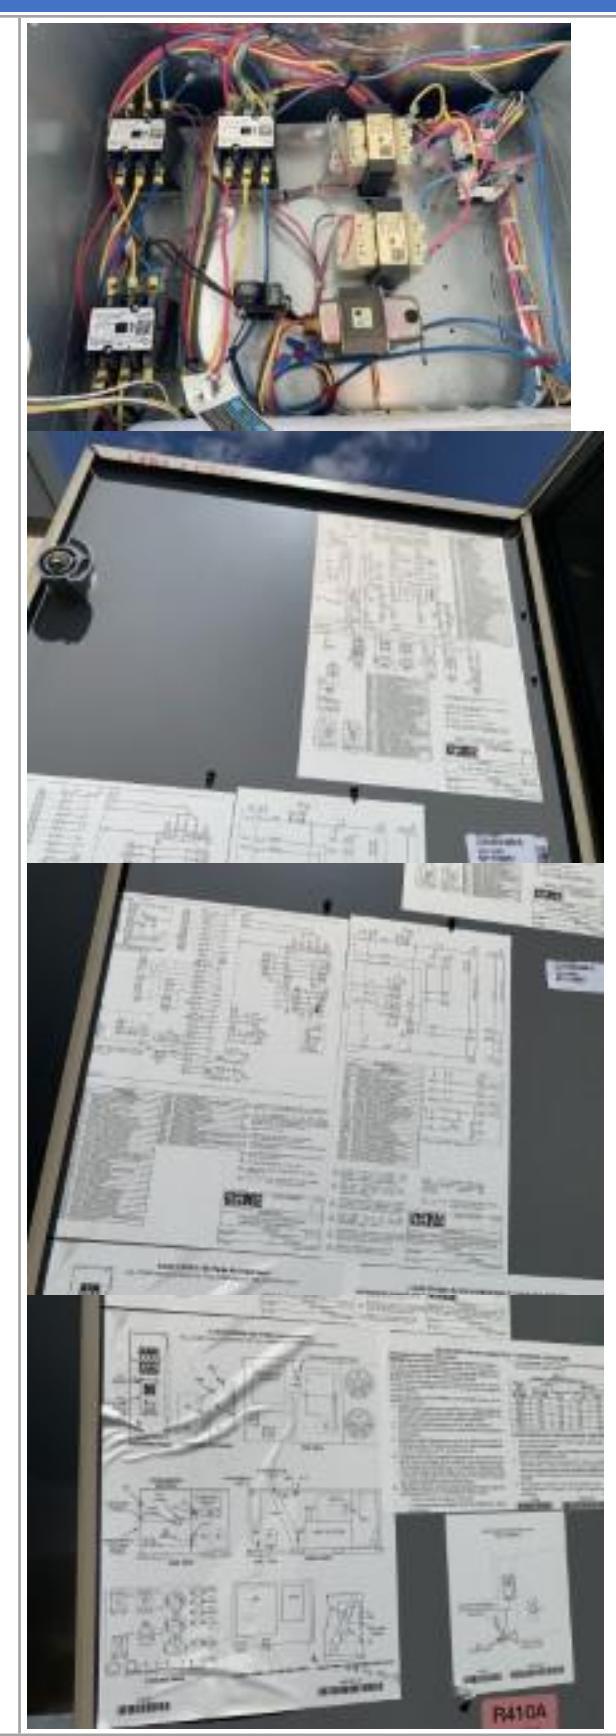
<u>Unit Tag</u>	RTU-15	Addition comments descriptions
Location	Northwest Roof	
Serving	Auditorium Lobby	
Config/Style	VAV AHU, SF, DX Cooling	
Mfr.	Lennox	
Model #	LCH102H4BN1G	
Serial #	5611F00657	
Age (years)	13 (10/2009)	
System CFM	2700	
Max OA CFM	800	
V/Hz/Ph	460V / 22A / 3ph	
SF Qty/HP	1, 2	
SF VFD Data	460V / 2.8A / 60Hz	
RF Qty/HP	N/A	
RF VFD Data	N/A	
Filter Data (Size Quantity)	4x 20x25x2 MERV 13	
Filter Status	dirty	OA intake bird screen is destroyed
Controls Type	Lennox packaged	
Controls Mfr.	Lennox Commercial	
Economizer	No	
CO ₂ DCV		
Damper Styles	Parallel blade	
Damper Status	Okay	
Heating Type	None, electric heat compatible	
Heating Coil Condition	N/A	
Cooling Type	DX	
Cooling Coil Condition	Okay	
CU Mfr.	Copeland Scroll	
CU Model	2x ZP42KSE-TFD-130	R-410A
CU Serial	11E7698CN, 11E7703CN	
Drain Pan Status	Okay	
Notes:

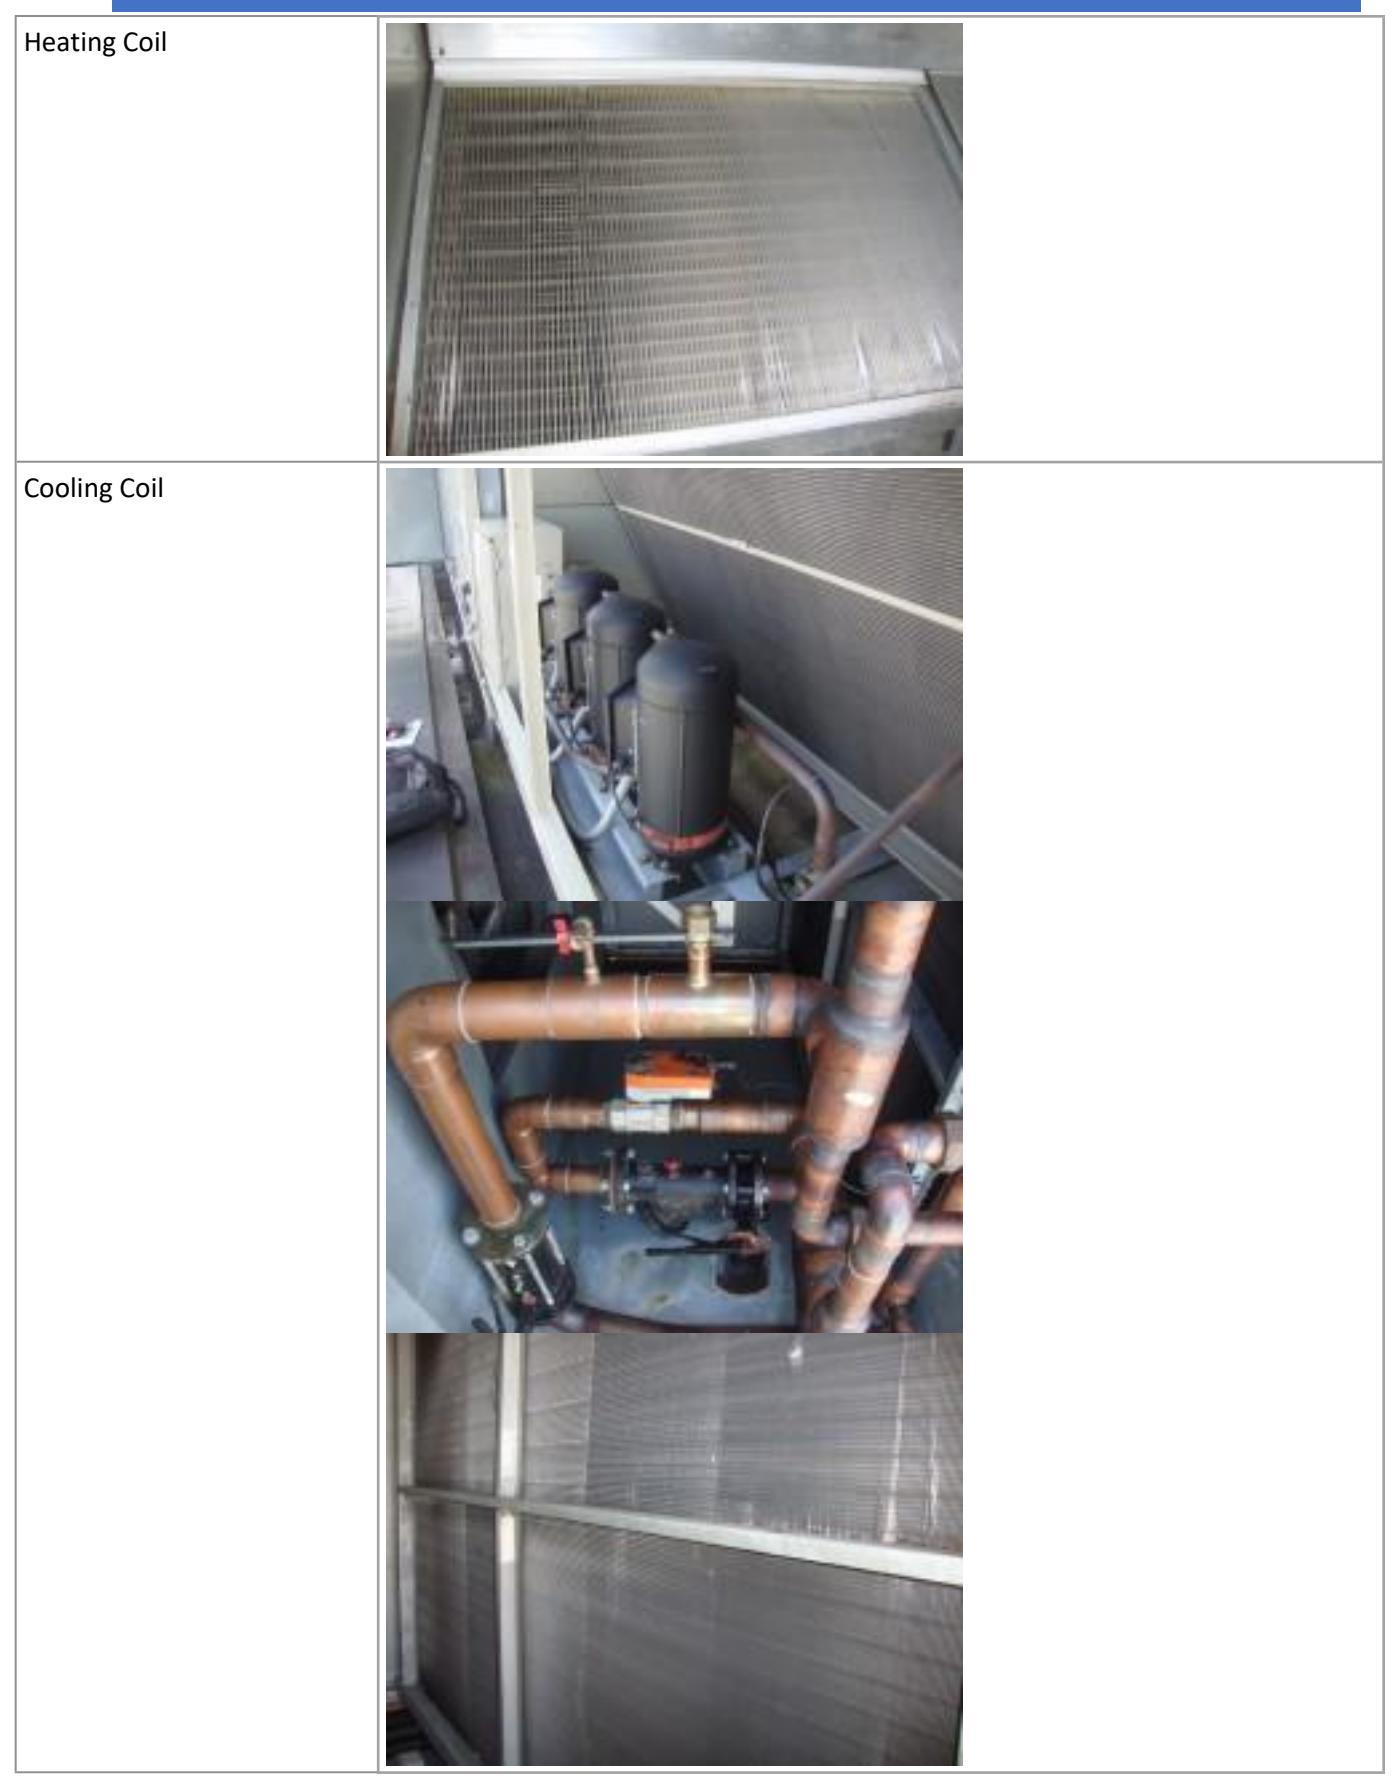
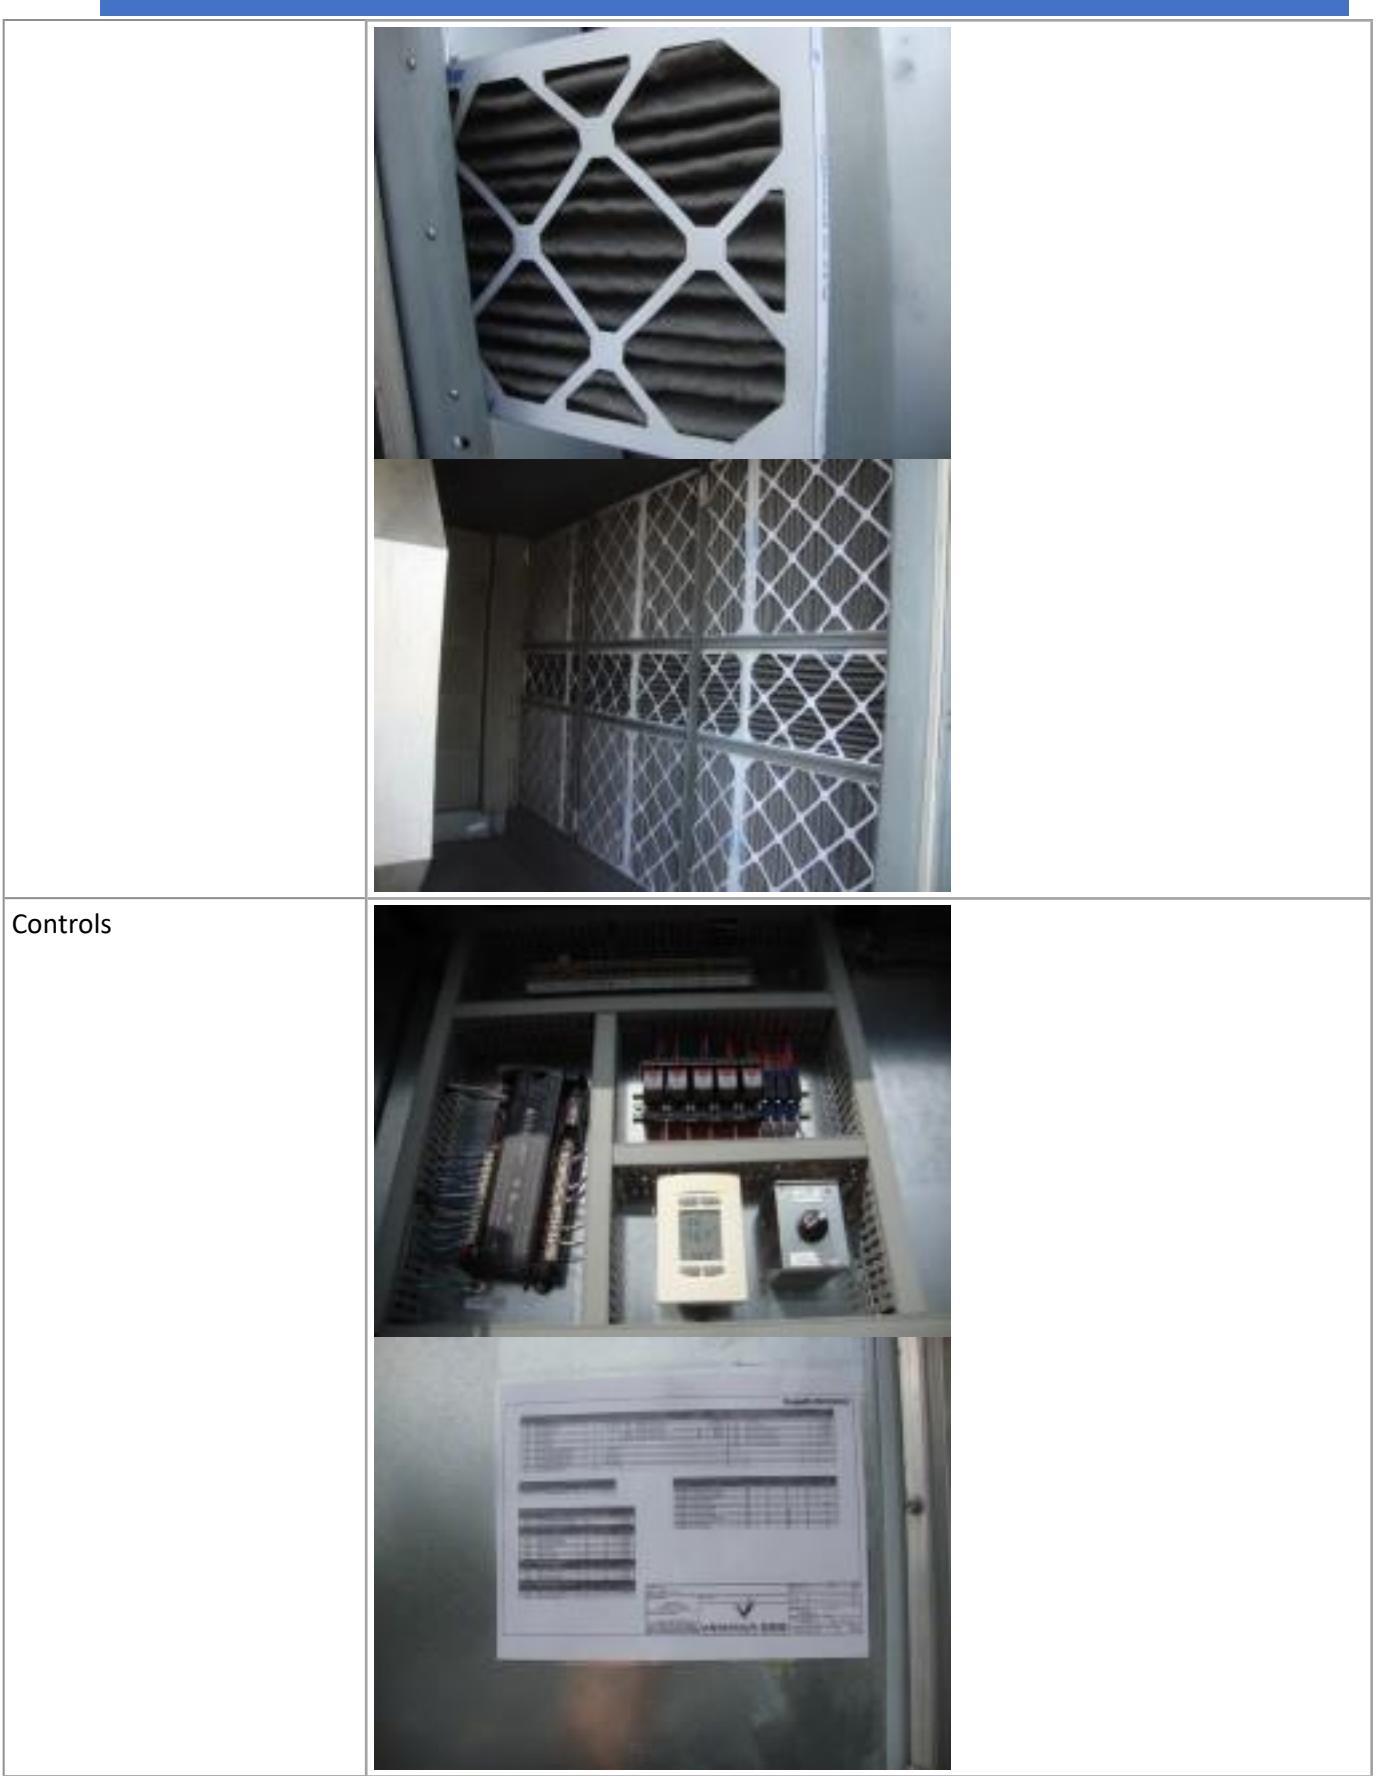
<u>Unit Tag</u>	RTU-16	Addition comments descriptions
Location	South Roof	
Serving	Classroom Addition	
Config/Style	VAV AHU, SF/RF, HW, DX Cooling, Cross-flow ERU-1	
Mfr.	McQuay	
Model #	RPS079DLW	
Serial #	FBOU110601707 00	
Age (years)		
System CFM	21000	
Max OA CFM	11655	
V/Hz/Ph	460/60/3	
SF Qty/HP	1x 30.0 3x Belts	Replaced 11-30-17
SF VFD Data	VFD	
RF Qty/HP	5(1) 5.0 Belt (2) BX-75	Horizontal, grease fitting missing
RF VFD Data	VFD	
Filter Data (Size Quantity)	(8) 24"x24"x2" (4) 12"X24"x2" Pre-Filters	(8) 24"x24"x11.5" (4) 12"X24"x11.5" Final Filters
Filter Status	Pre-Dirty	Last changed 10/5/21
Controls Type	DDC Electronic Packaged Controls	
Controls Mfr.	Packaged Controls / Allerton	Ebtron Flow Measuring
Economizer	Yes	
CO ₂ DCV		
Damper Styles	Parallel (O.A. insulated Tamco dampers)	
Damper Status	OK dampers should be cleaned lubricated and adjusted, operation unknown	
Heating Type	Hot Water	
Heating Coil Condition	Dirty

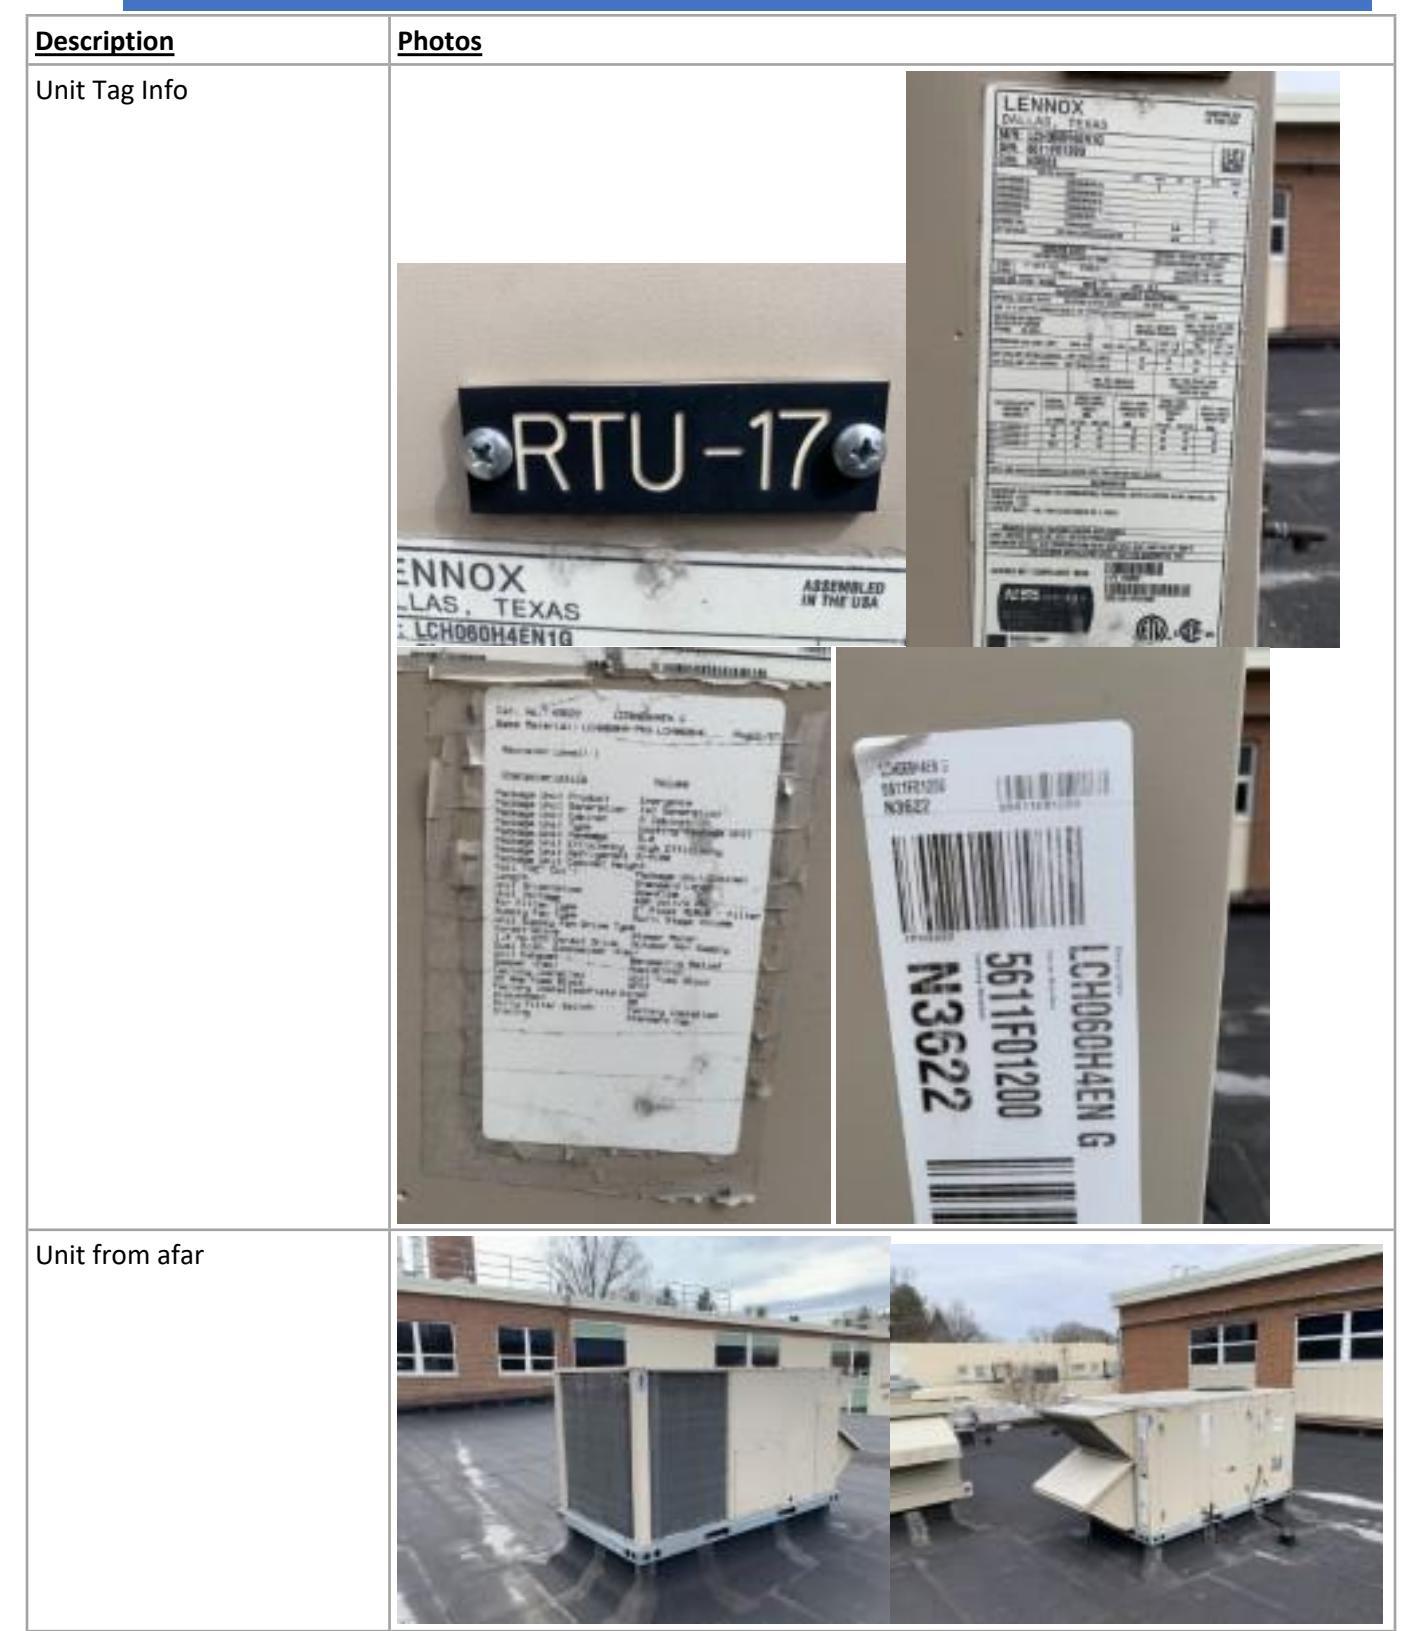
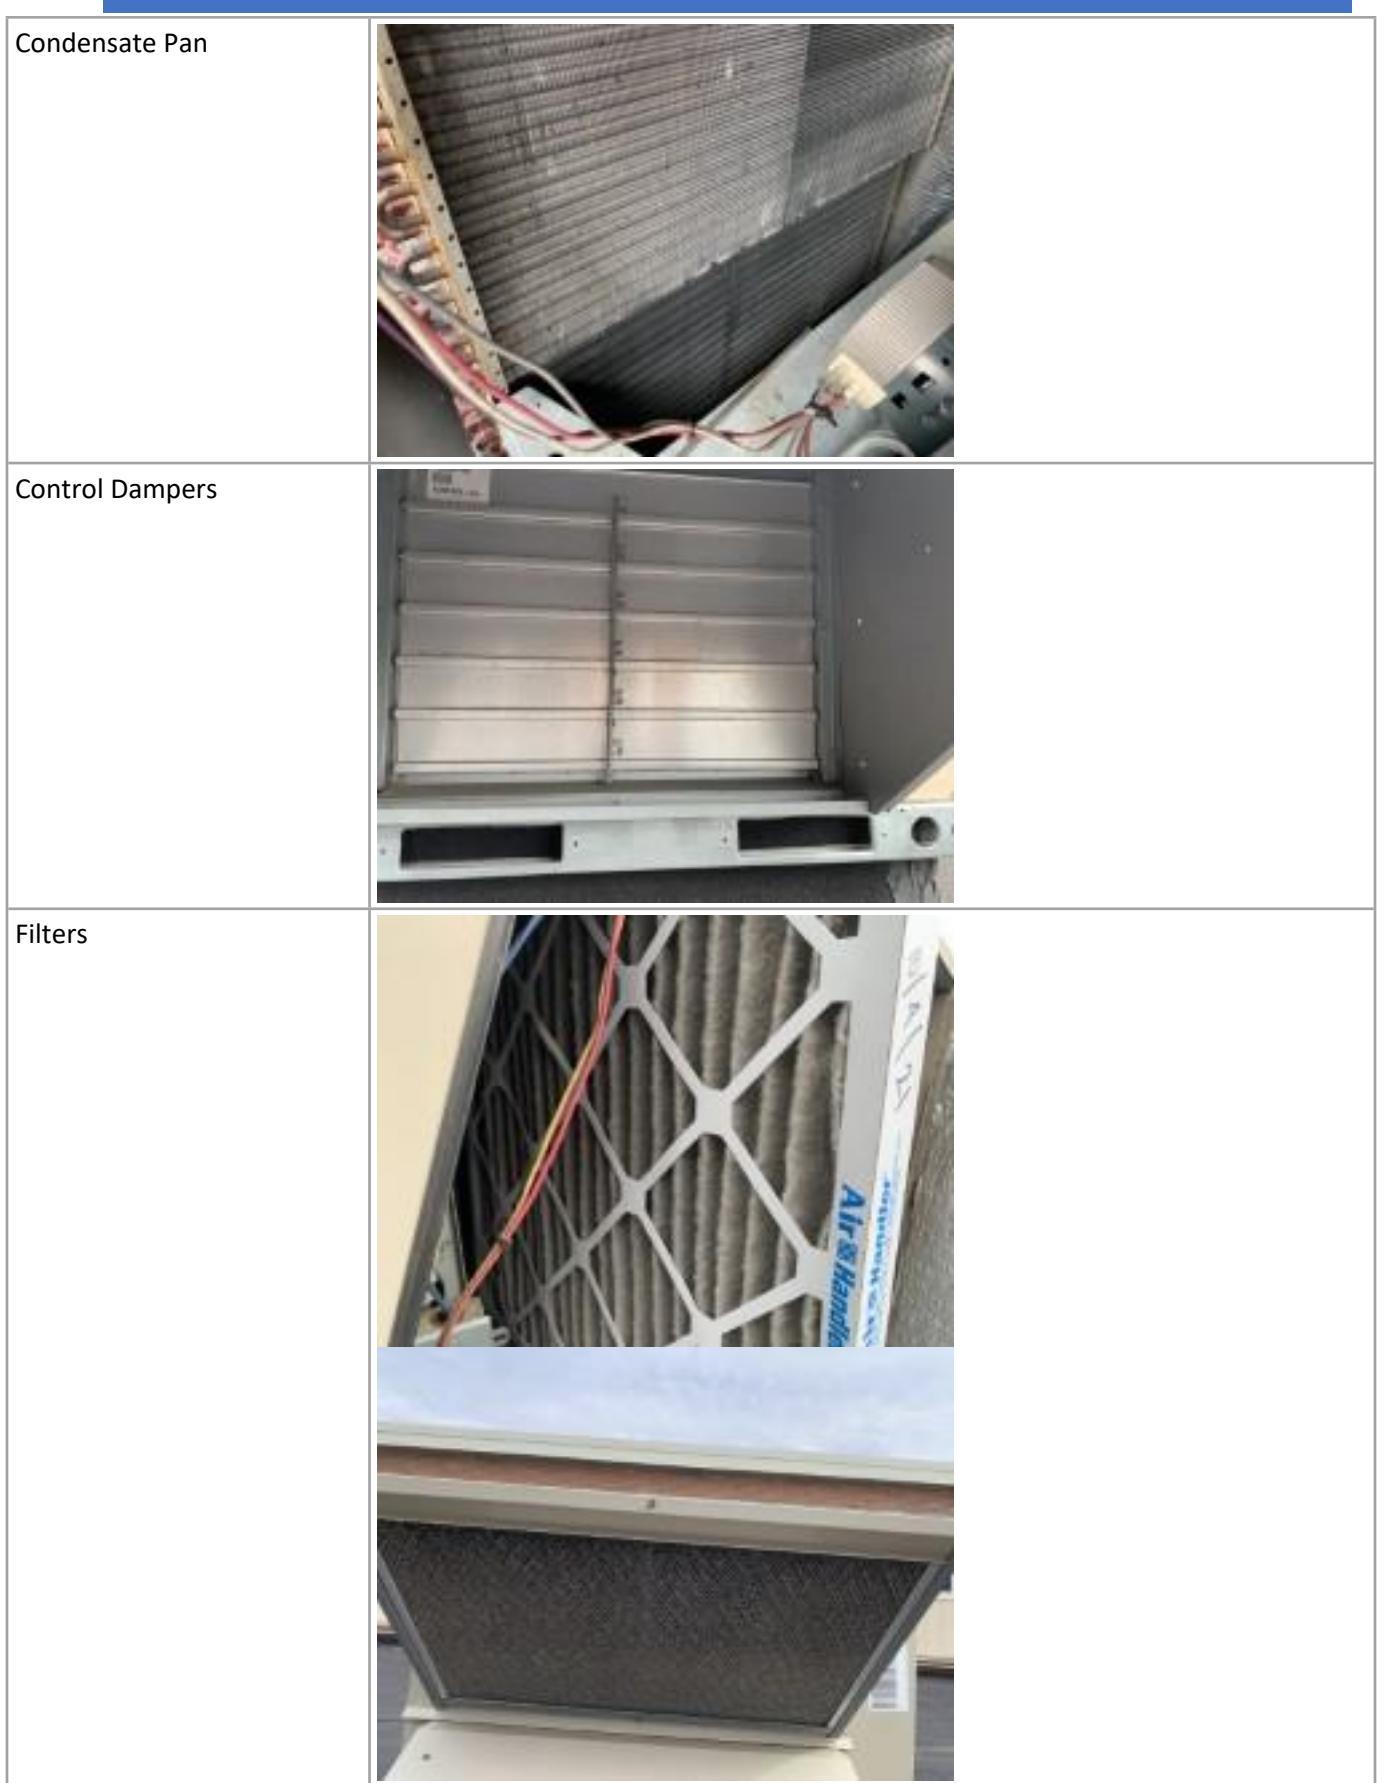
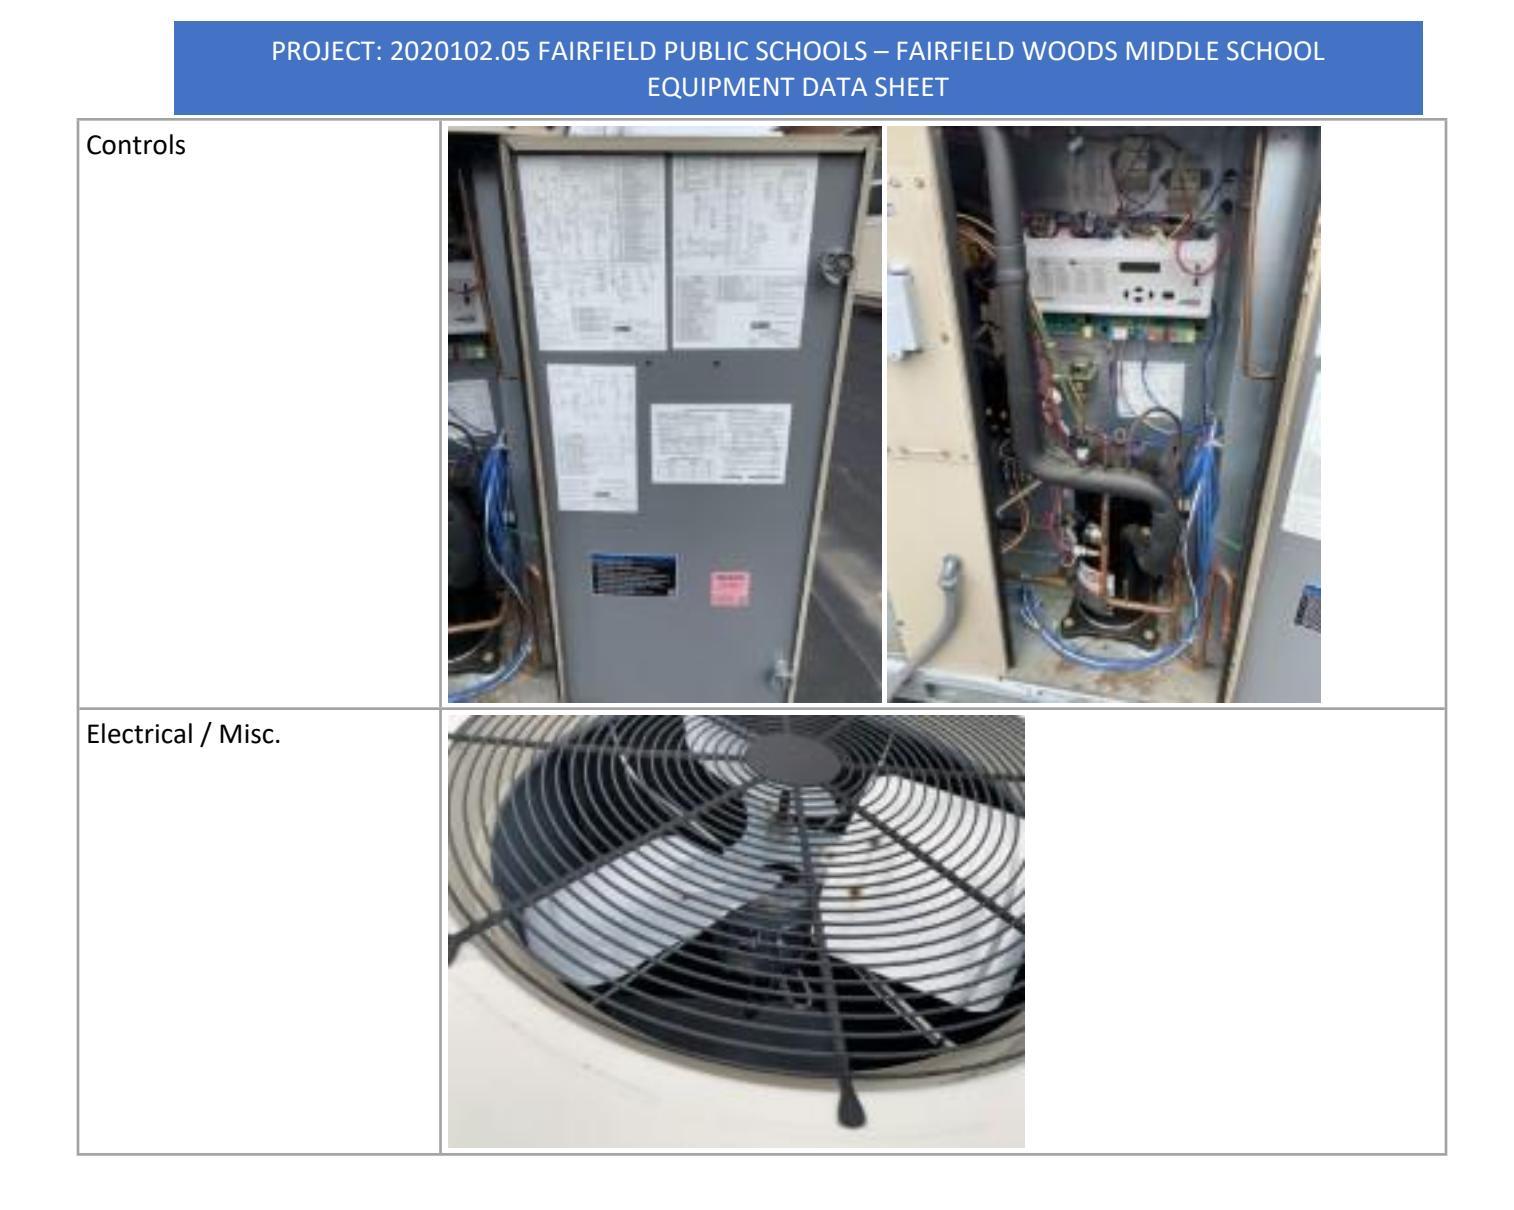
<u>Unit Tag</u>	RTU-17	Addition comments descriptions
Location	Center South Roof	
Serving	ОТ/РТ	
Config/Style	CV AHU w/ Economizer, HW, DX Cooling	
Mfr.	Lennox	
Model #	LCH060H4EN1G	
Serial #	5611F01200	C/N: N3622
Age (years)	13?	
System CFM	1420	
Max OA CFM	550	
V/Hz/Ph	460V / 60Hz / 3ph	
SF Qty/HP	1, 1.0	
SF VFD Data	120/240V / 3.7A / 60Hz	Direct Drive fan
RF Qty/HP	N/A	
RF VFD Data	N/A	
Filter Data (Size Quantity)	4x 20x20x2 MERV13?	
Filter Status	Dirty	
Controls Type	Lennox Packaged	
Controls Mfr.	Lennox Commercial	
Economizer	No	
CO ₂ DCV		
Damper Styles	Parallel blade	
Damper Status	OA does not close fully	
Heating Type	None, electric coil compatible	Hot gas reheat
Heating Coil Condition	N/A	
Cooling Type	DX	
Cooling Coil Condition	Some rust/chipping of the fins, particularly on the lower part of the hot gas reheat	
CU Mfr.	Copeland Scroll	
CU Model	ZPS51K4E-TFD-130	R-410A
CU Serial	11EA6480N	
Drain Pan Status	Okay
