Fairfield Woods Middle School

Fairfield Public Schools Recommissioning (RCx) and Testing, Adjusting, & Balancing (TAB) Study van Zelm Project # 2020102.00 (05-FWMS) August 01, 2022

FAIRFIELD PUBLIC SCHOOLS RECOMMISSIONING (RCX) AND TESTING, ADJUSTING, & BALANCING (TAB) STUDY

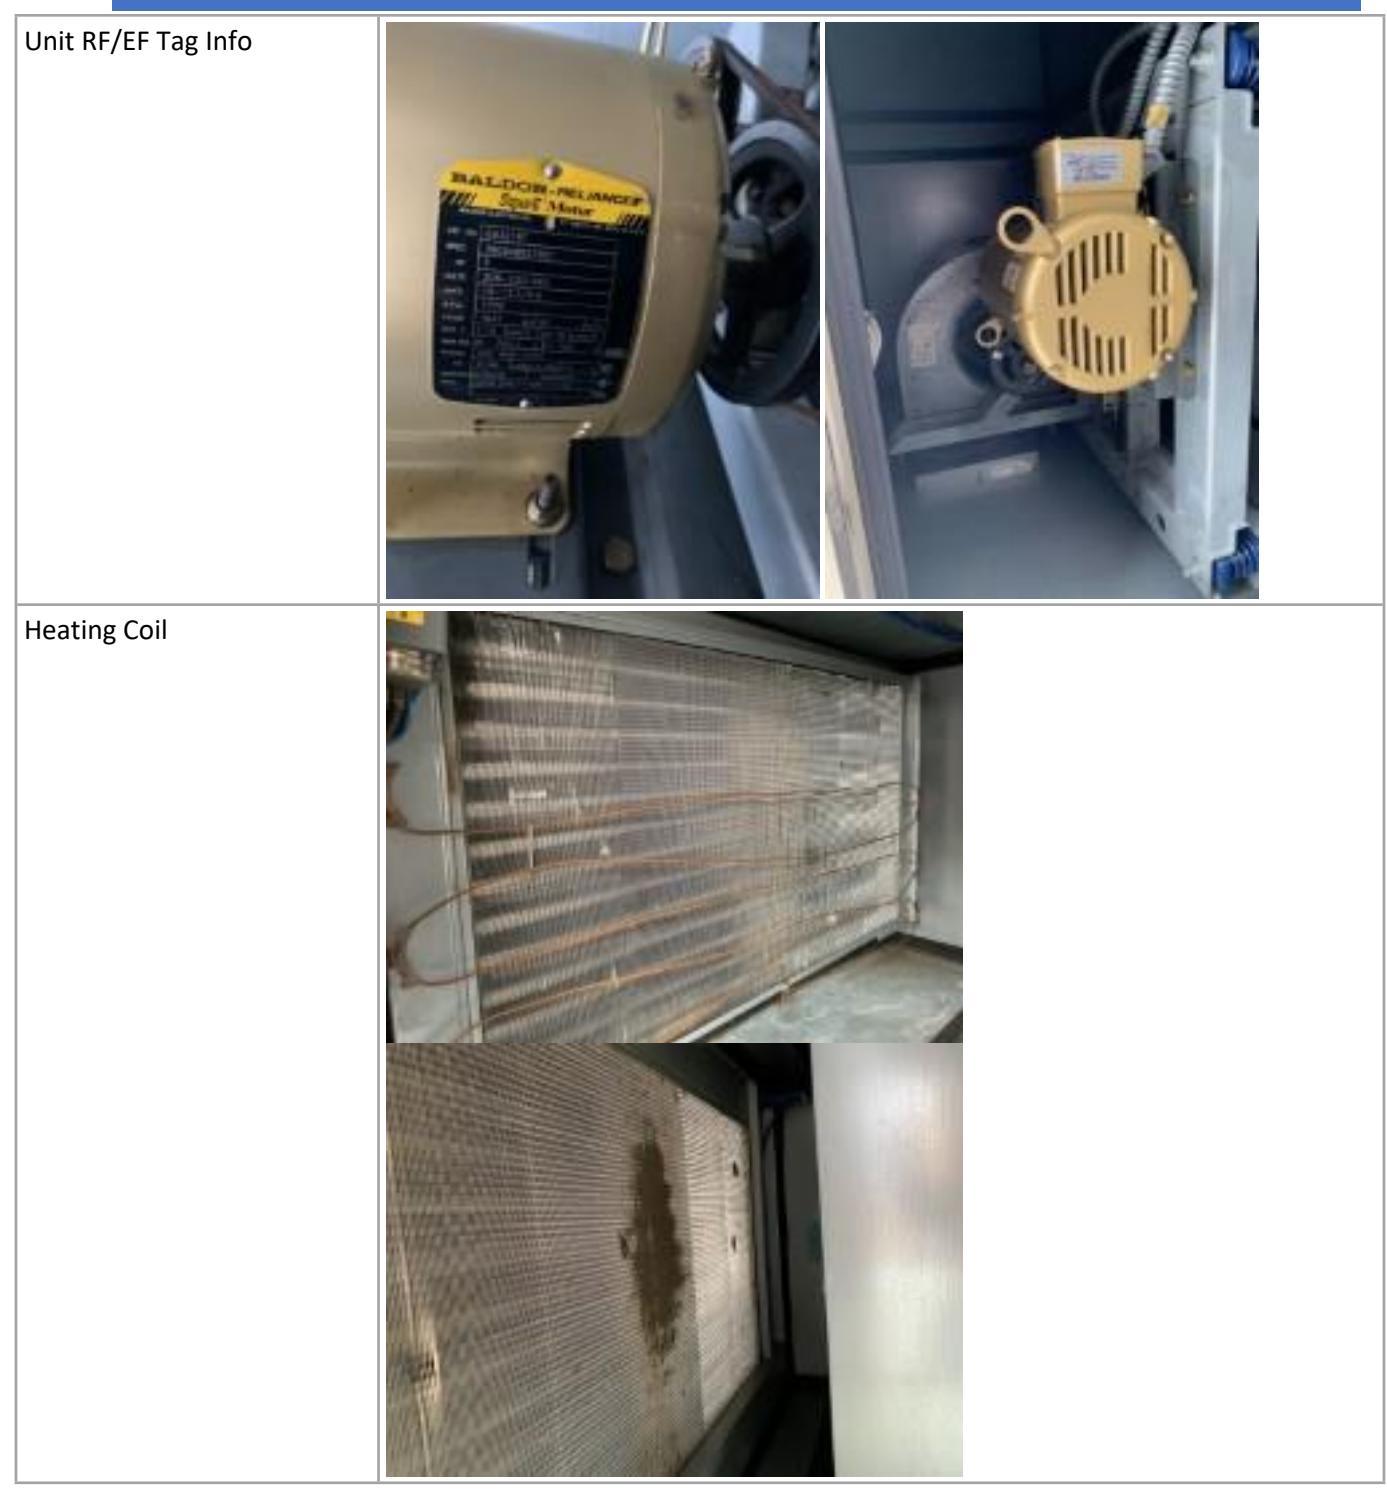
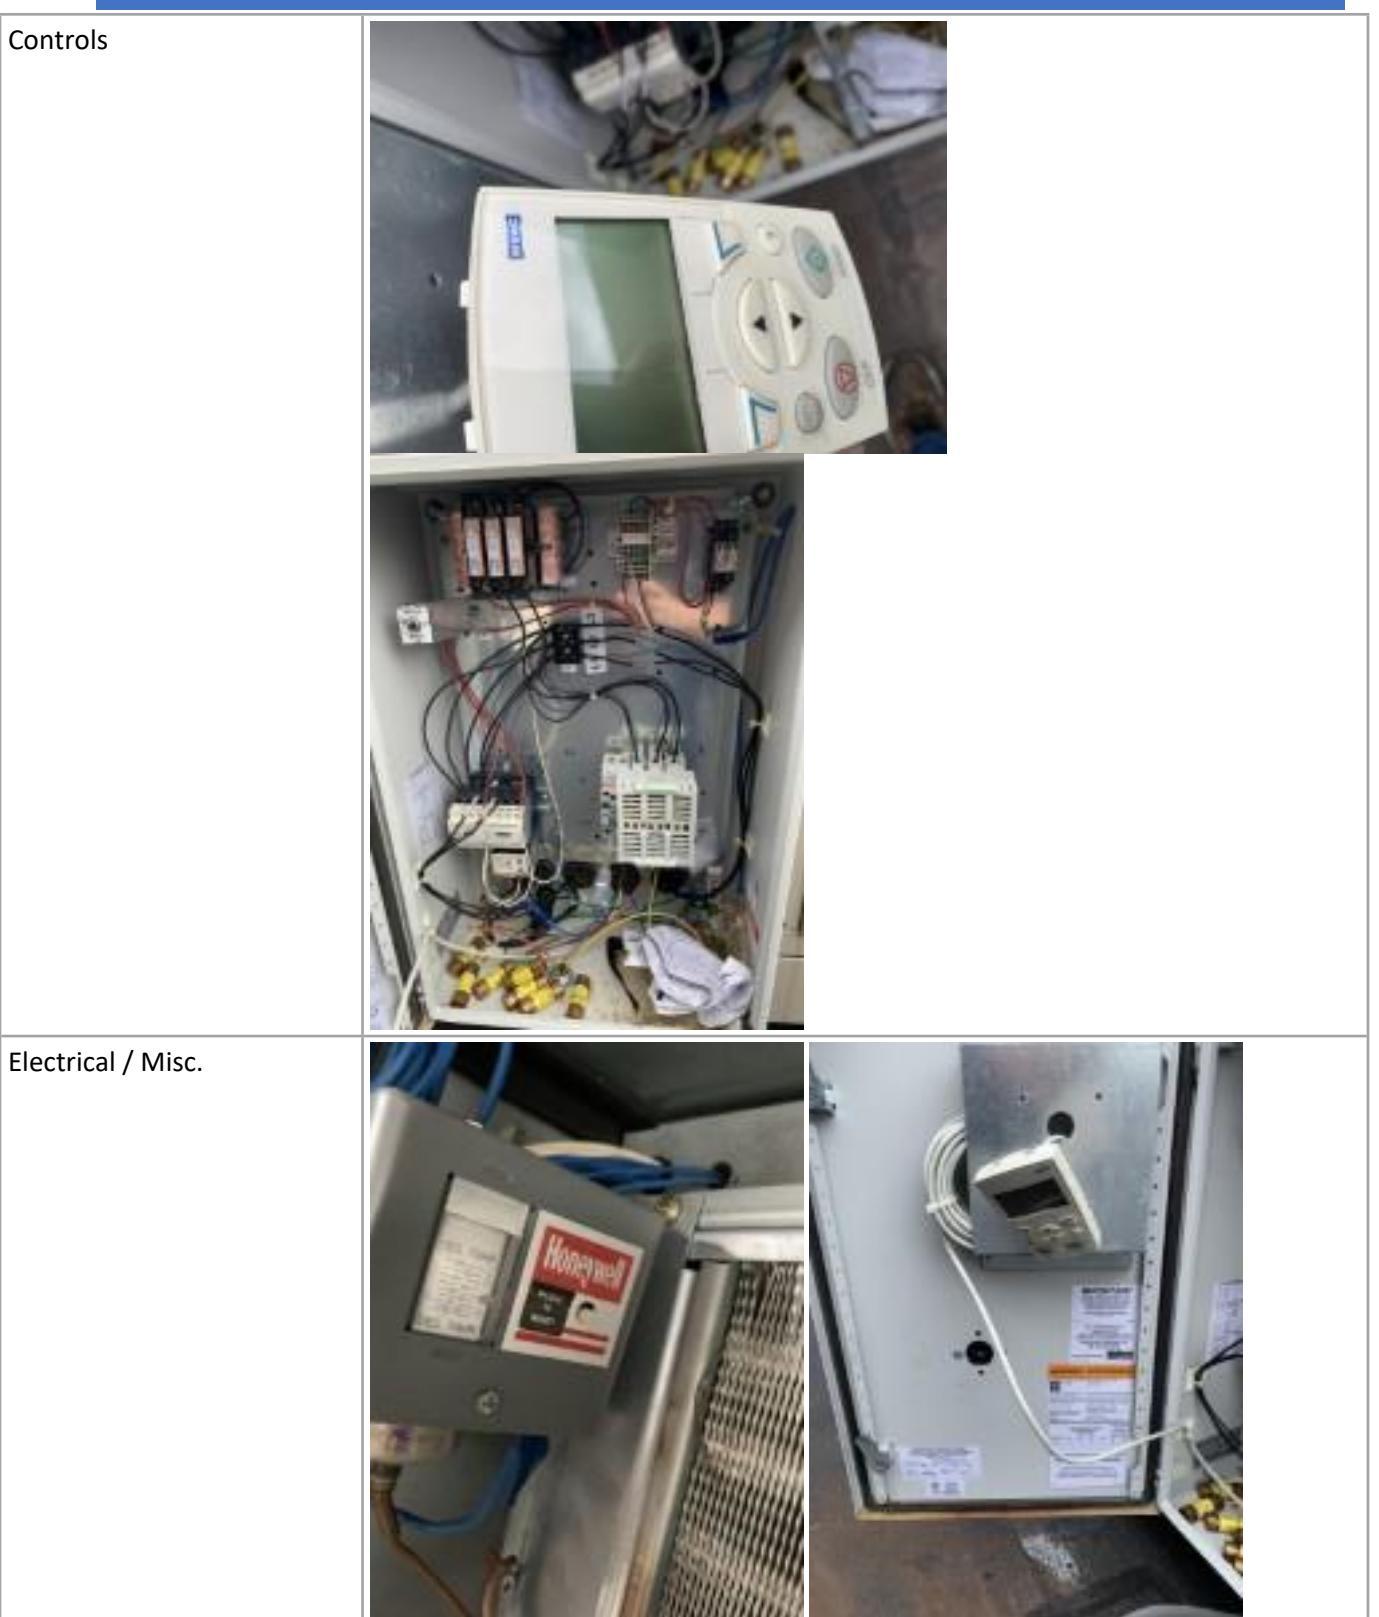
Unit Tag	RTU-18	Addition comments descriptions
Location	Center South Roof	
Serving	Auxiliary Gym	
Config/Style	H&V, SF/EF, HW, no cooling	Unit lights do not function
Mfr.	Skyline	McQuay
Model #	OAH006GHAC	
Serial #	FBOU110601357	P/N: E878156080 FB0
Age (years)		
System CFM	2500	
Max OA CFM	1200	
V/Hz/Ph	480V / 60Hz / 3ph	
SF Qty/HP	1, 5	
SF VFD Data	480V / 8.8A / 5Hp	Remote VFD unit screen located in electrical cabinet
EF Qty/HP	1, 1.5	Found turned OFF
EF VFD Data	480V / 3.3A / 1.5Hp, ACH550	The fan runs, however the VFD LCD screen in the remote control cabinet is broken and does not display anything. The remote unit does still seem to control the fan (auto/hand, etc.).
Filter Data (Size Quantity)	2x 24x24x2 MERV 13 2x 24x24x12 MERV 14 box filters	
Filter Status	2" are dirty, 12" are clean	
Controls Type	DDC packaged	
Controls Mfr.	McQuay packaged/Schneider	
Economizer		AFMS in this unit
CO ₂ DCV		
Damper Styles	Parallel blade

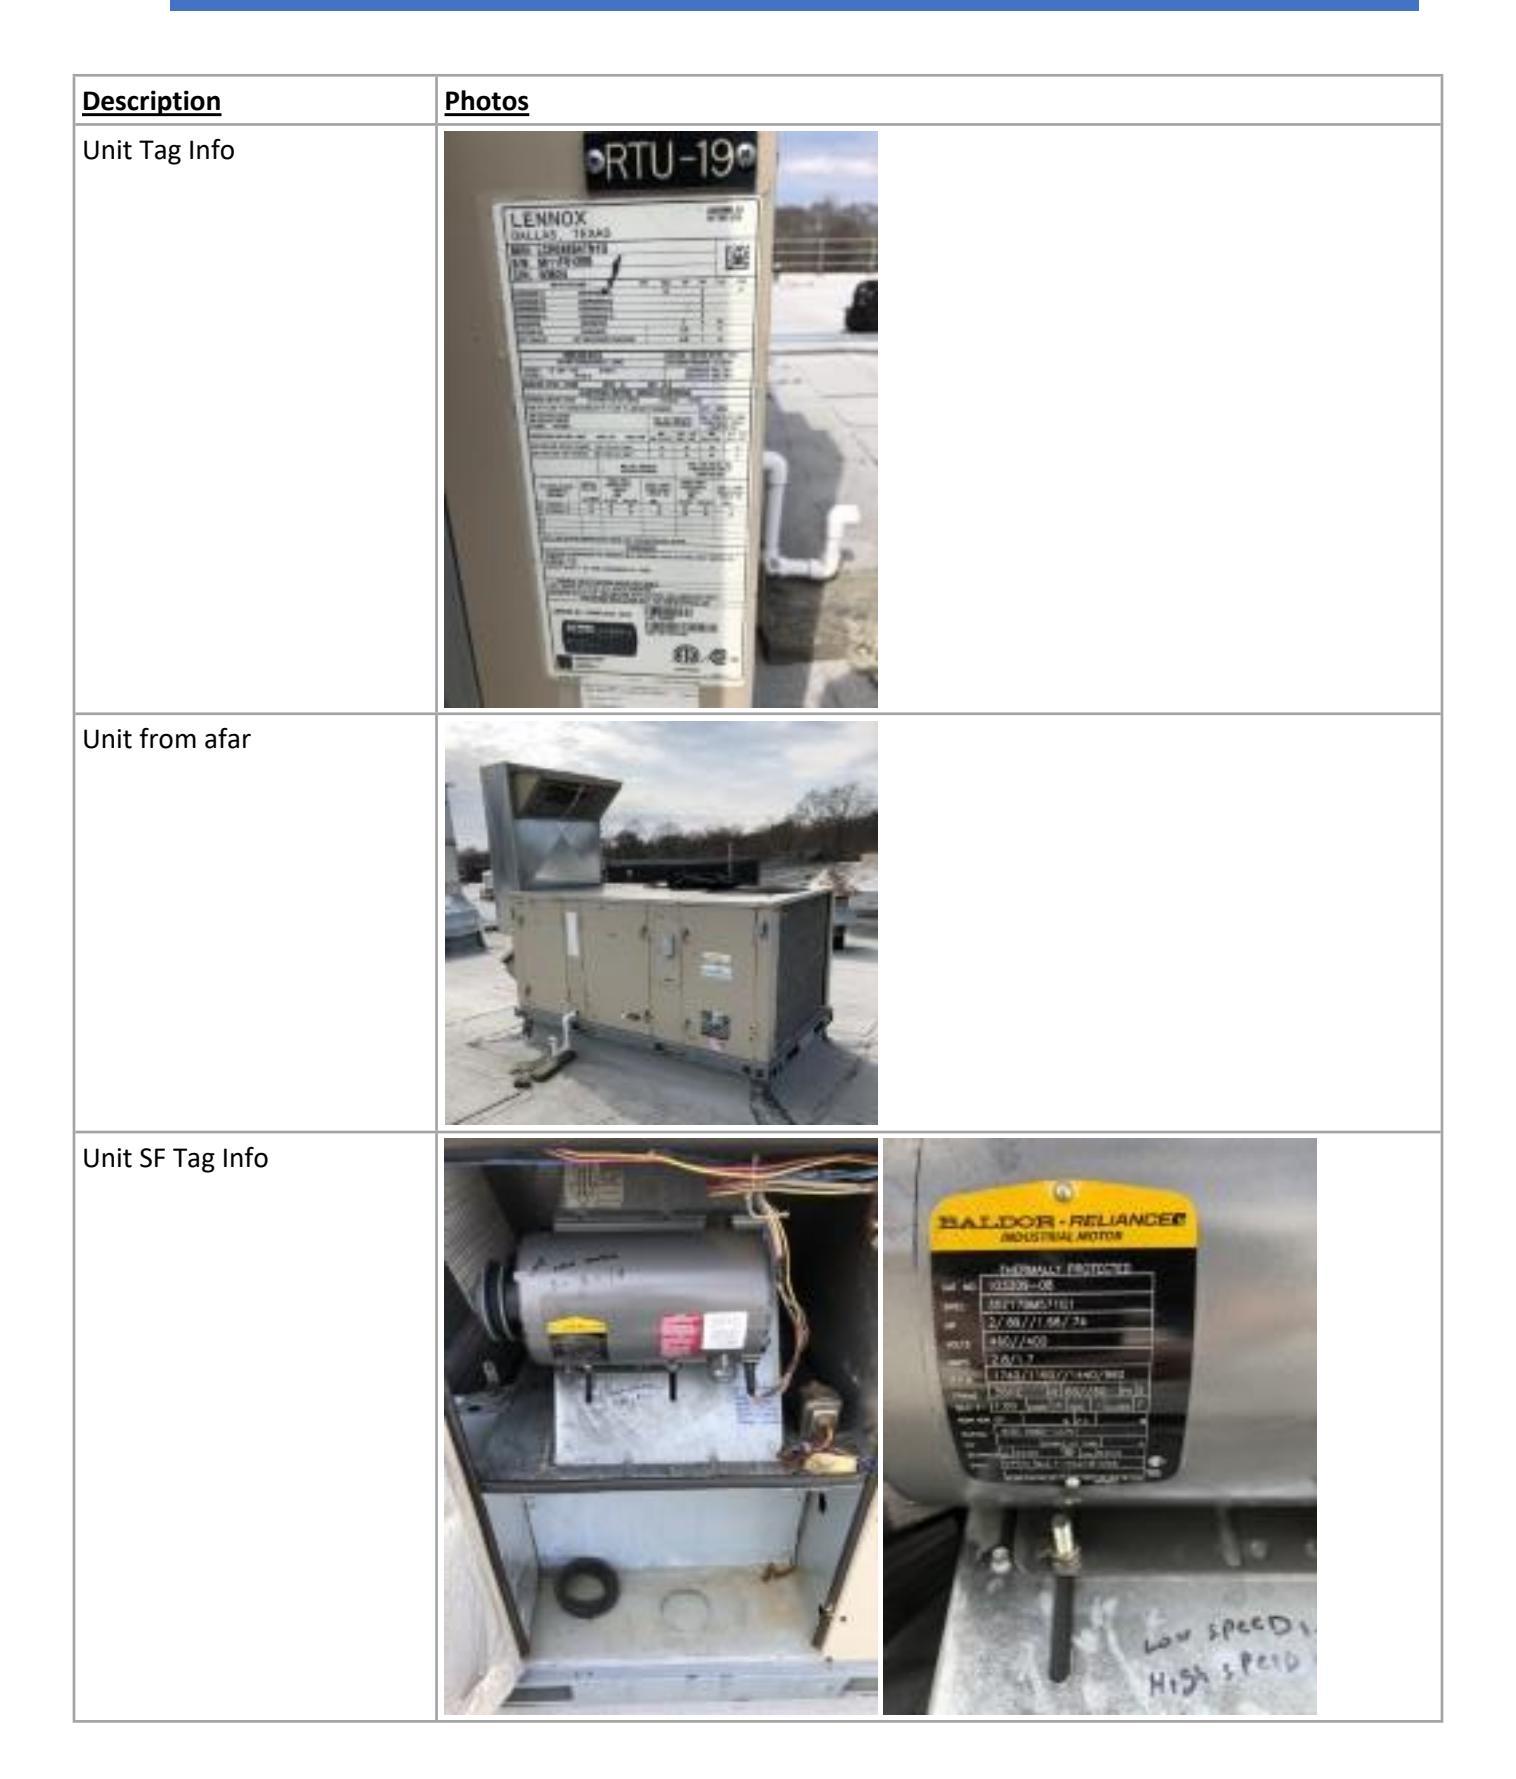
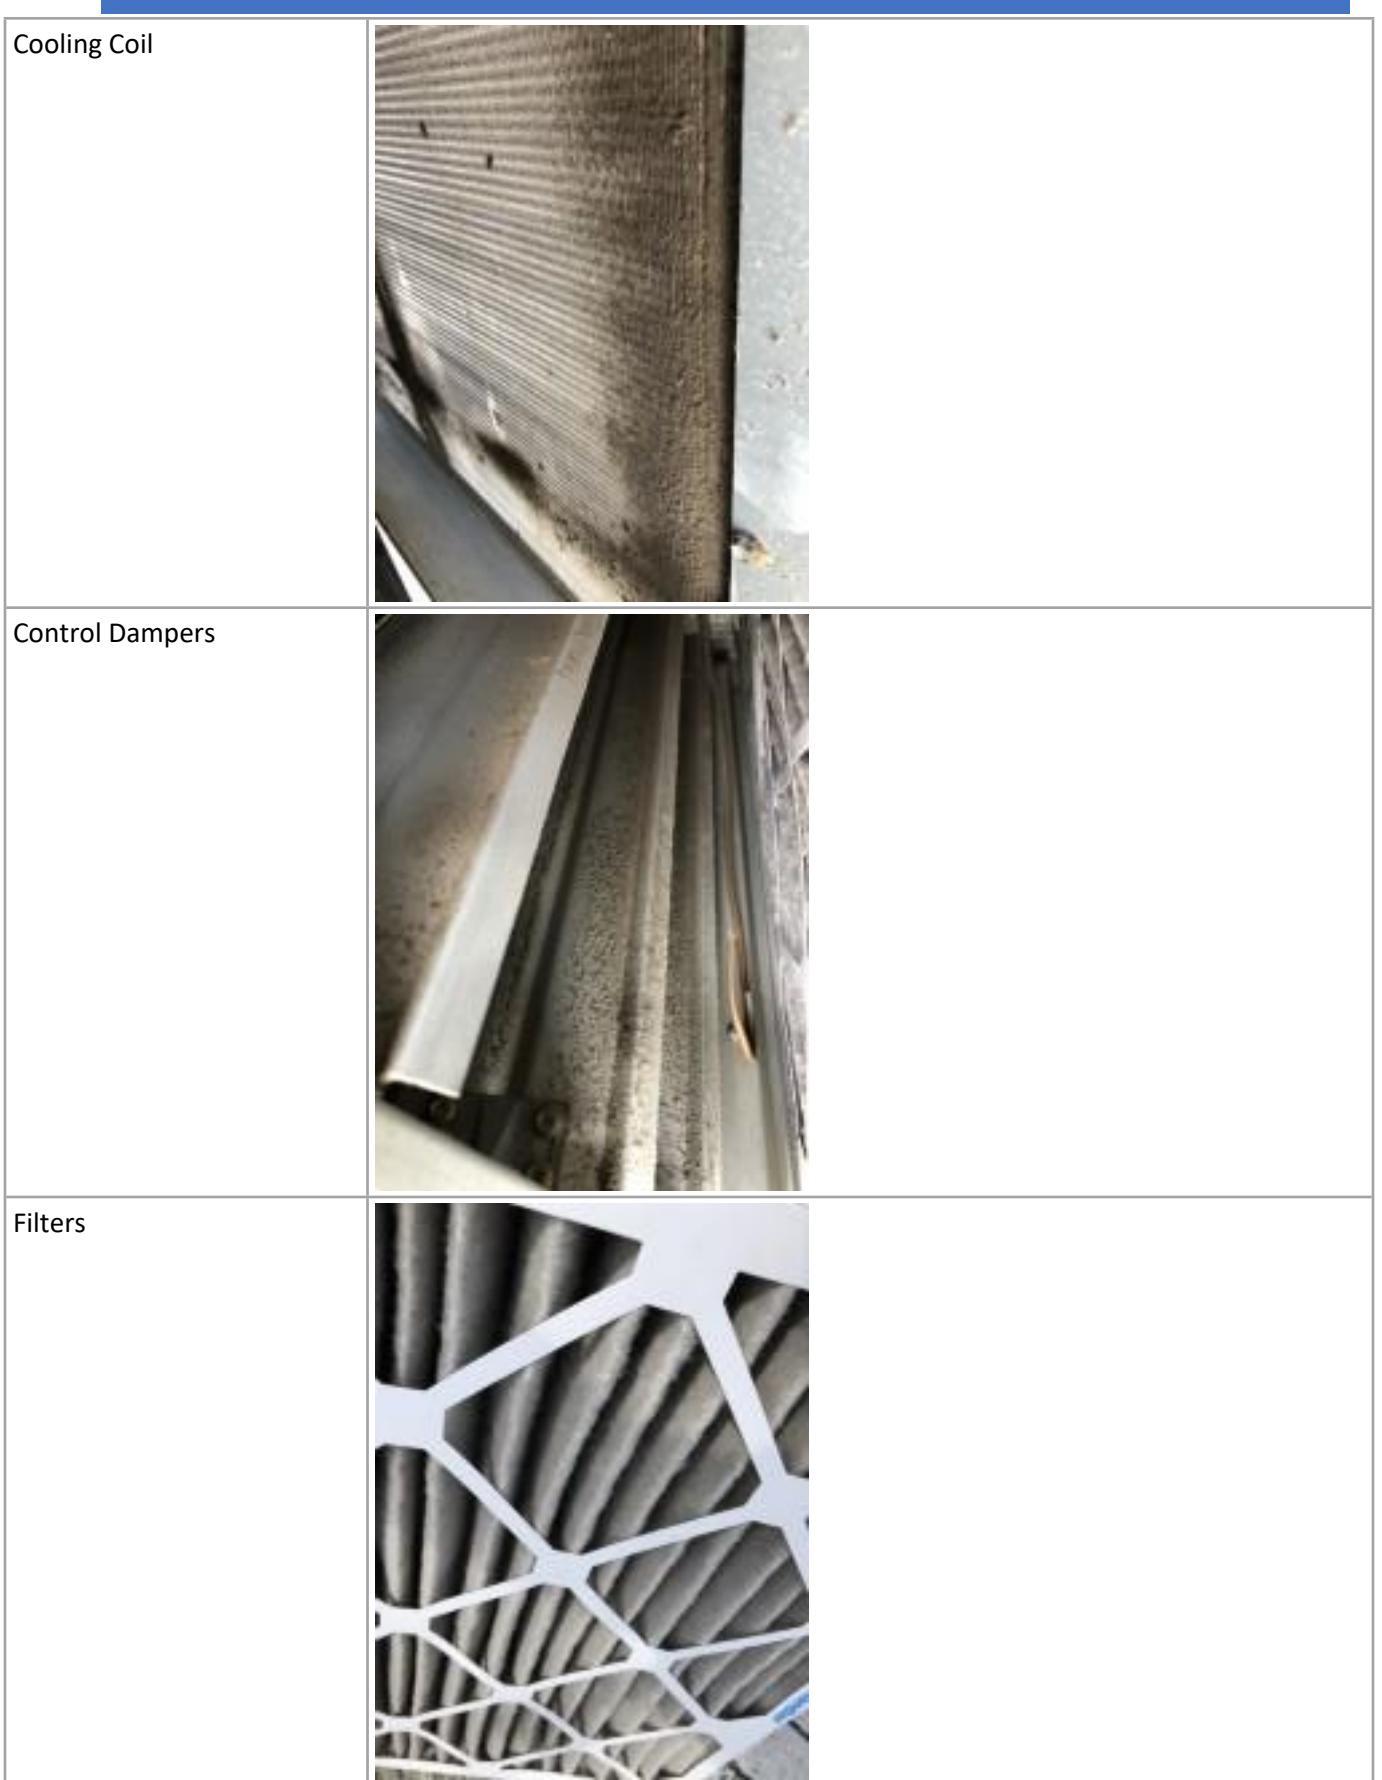
<u>Unit Tag</u>	RTU-19	Addition comments descriptions
Location	Center East Roof	
Serving	Classrooms	
Config/Style	CV AHU, SF, w/ Economizer, HW, DX Cooling	
Mfr.	Lennox	
Model #	LCH048S4TN1G	
Serial #	5611F01205	
Age (years)		
System CFM	1120	
Max OA CFM	390	
V/Hz/Ph	460/480 3-Phase	
SF Qty/HP	2 HP Baldor Reliance 2-speed	AP41 Belt
SF VFD Data		
RF Qty/HP		
RF VFD Data		
Filter Data (Size Quantity)	(4) 16 x 20 x 2	10-5-21
Filter Status	Dirty	
Controls Type	DDC Electronic	
Controls Mfr.	Packaged /	No Alerton controller in cabinet
Economizer		
CO ₂ DCV		
Damper Styles	Opposed	
Damper Status	In need of cleaning, adjusting and lubrication	
Heating Type	NA	
Heating Coil Condition		
Cooling Type	DX 2-stage	
Cooling Coil Condition	Very dirty	
CU Mfr.		
CU Model		
CU Serial		
Drain Pan Status	Needs cleaning	
Notes:

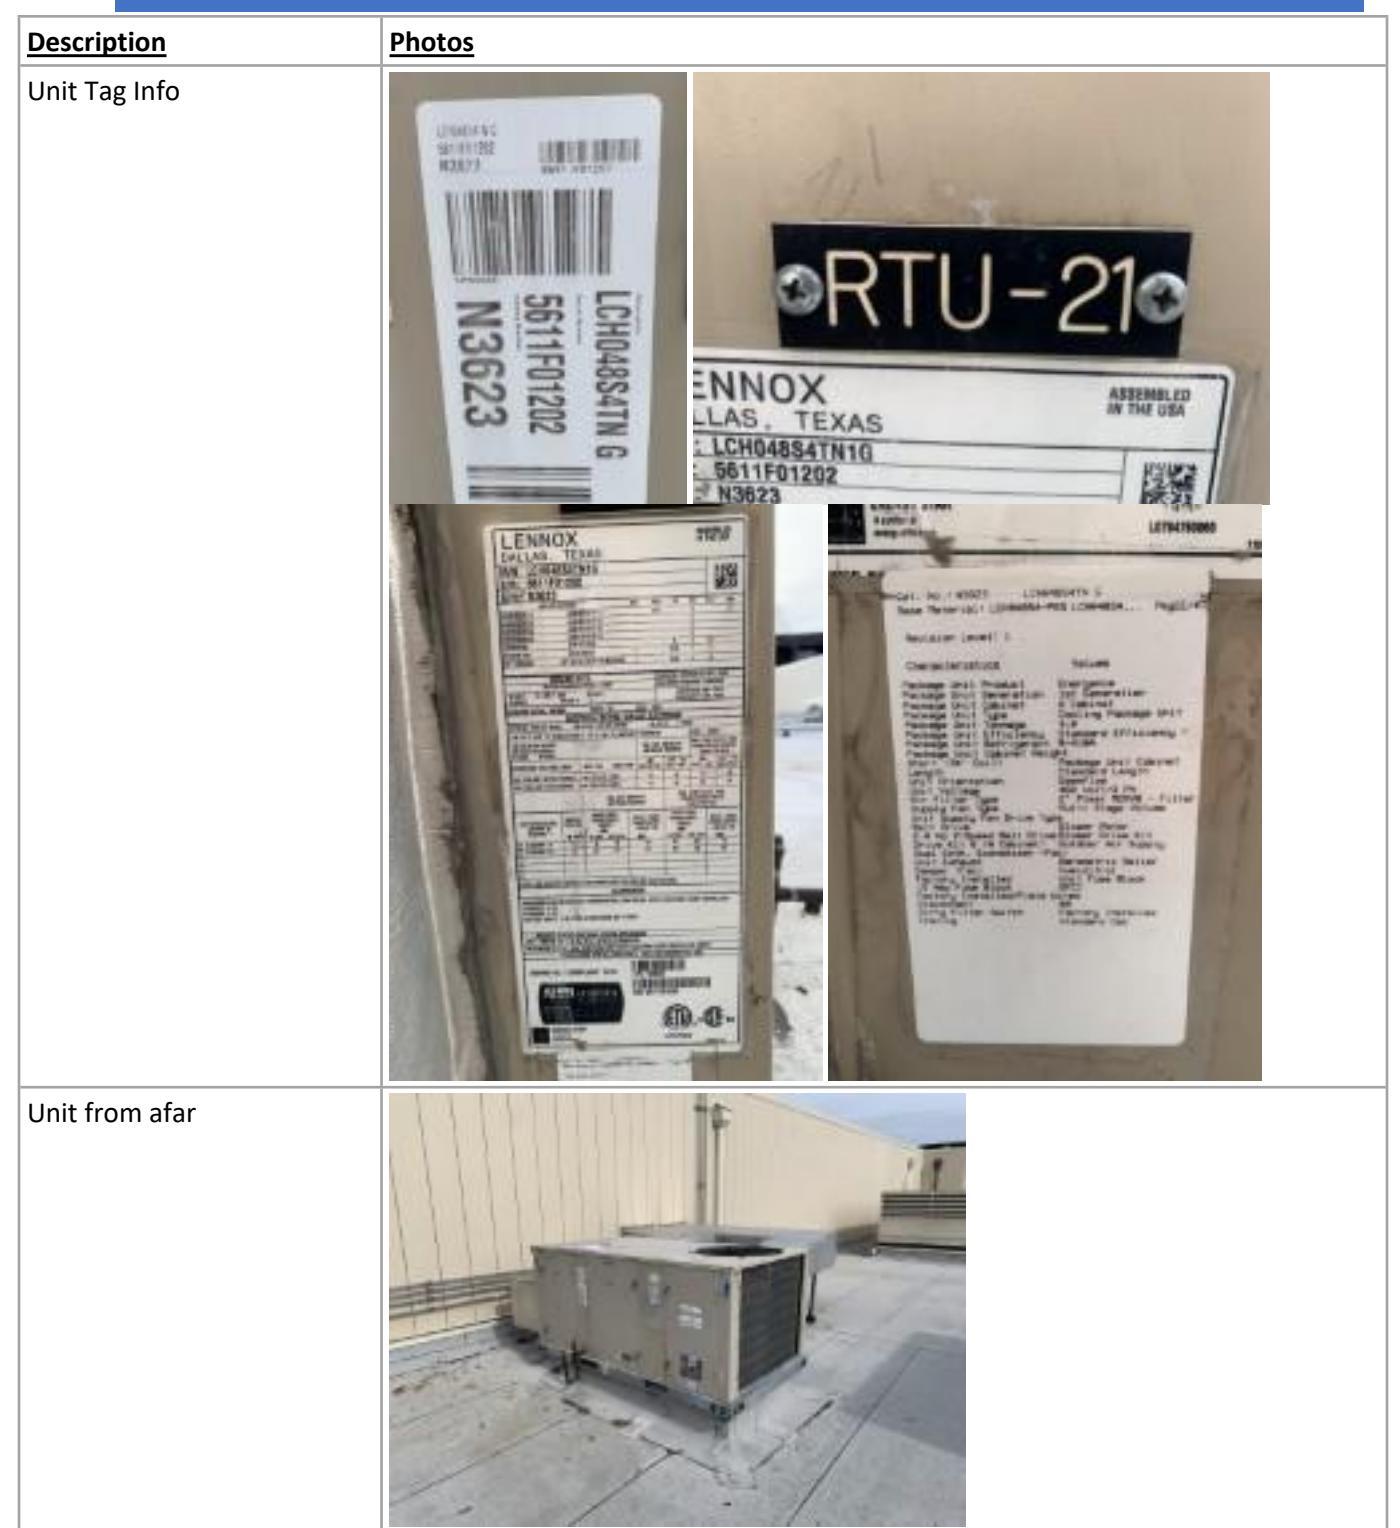
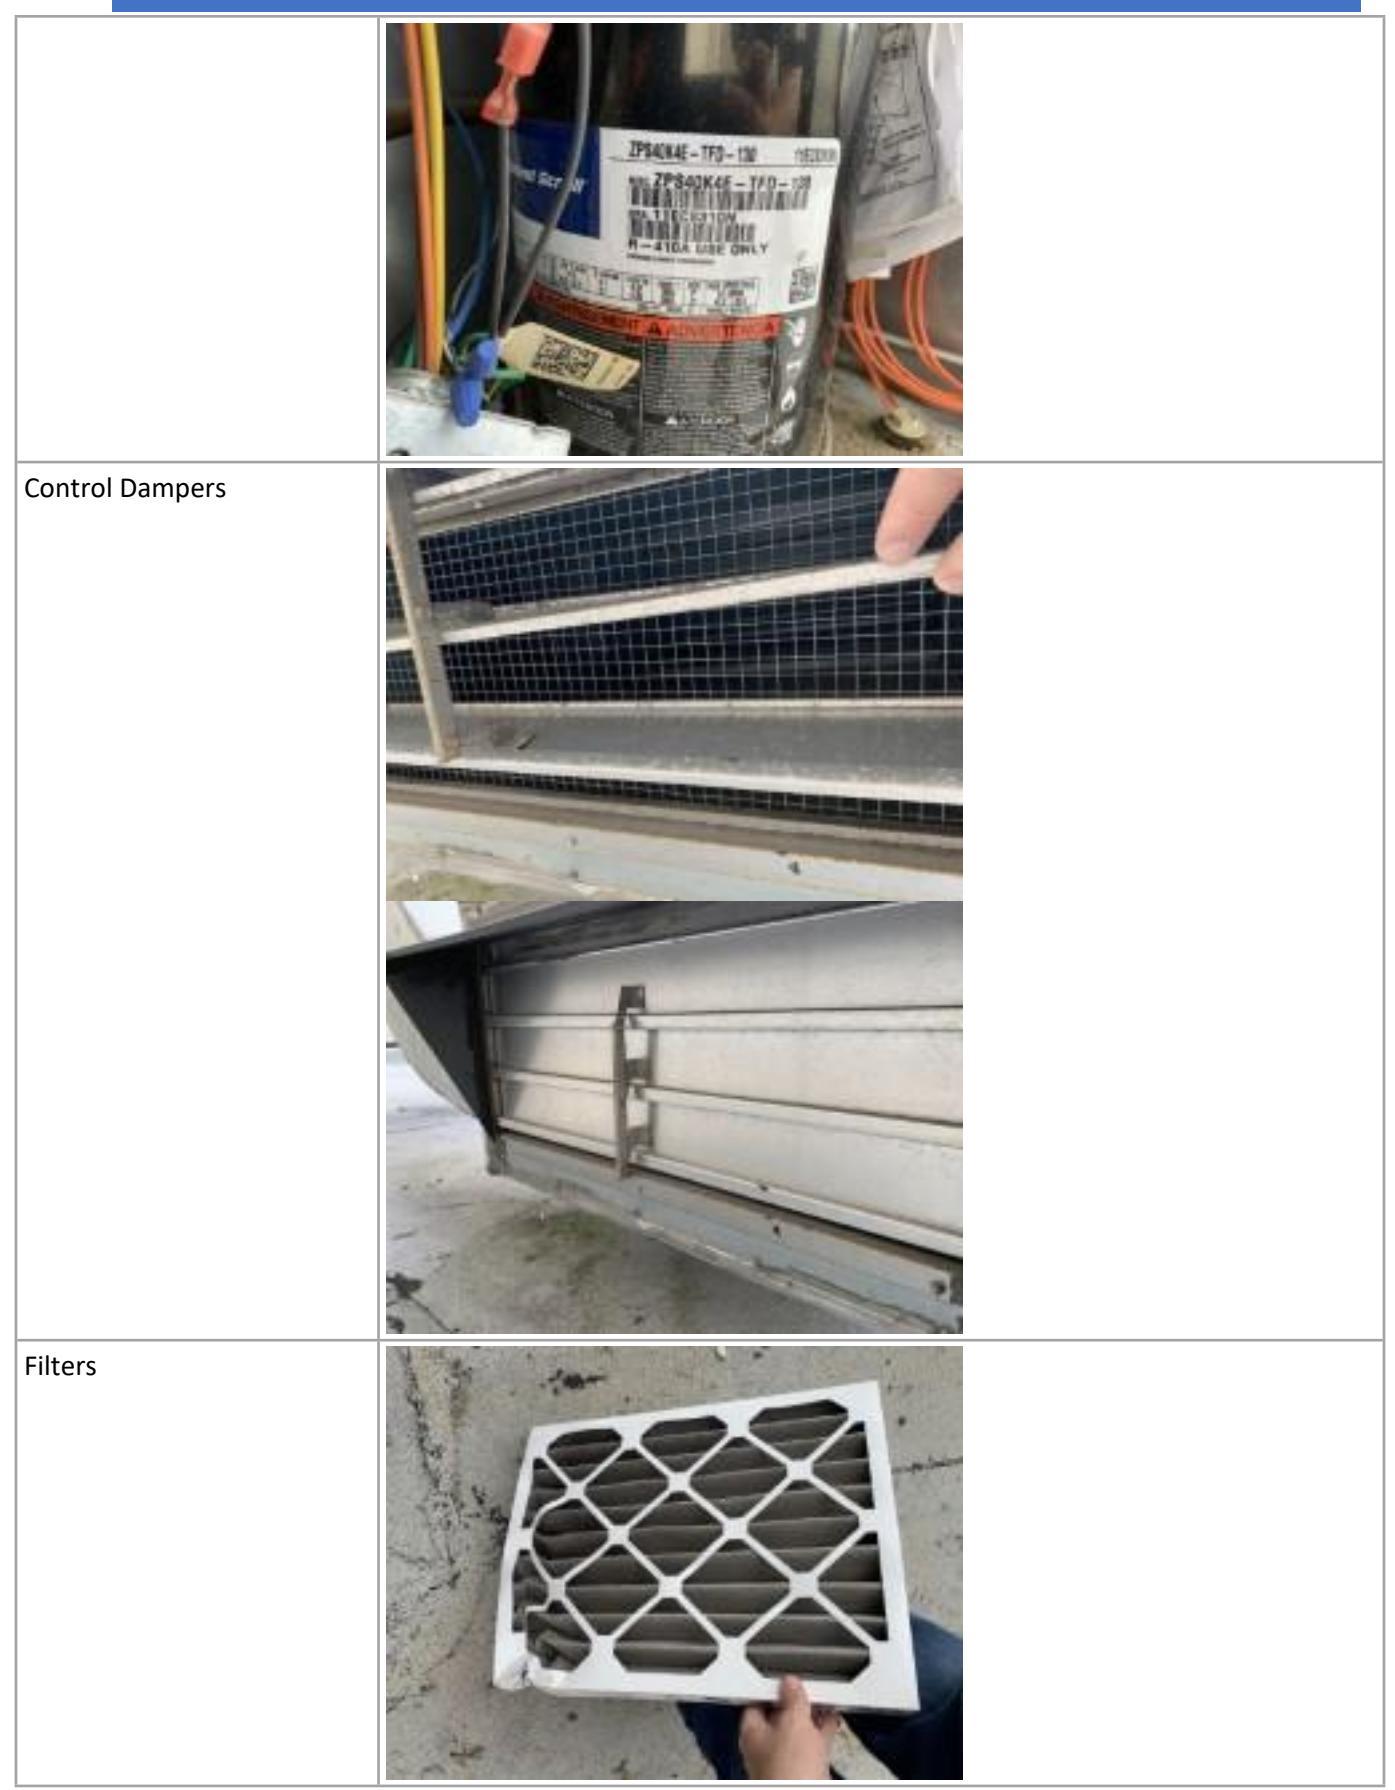
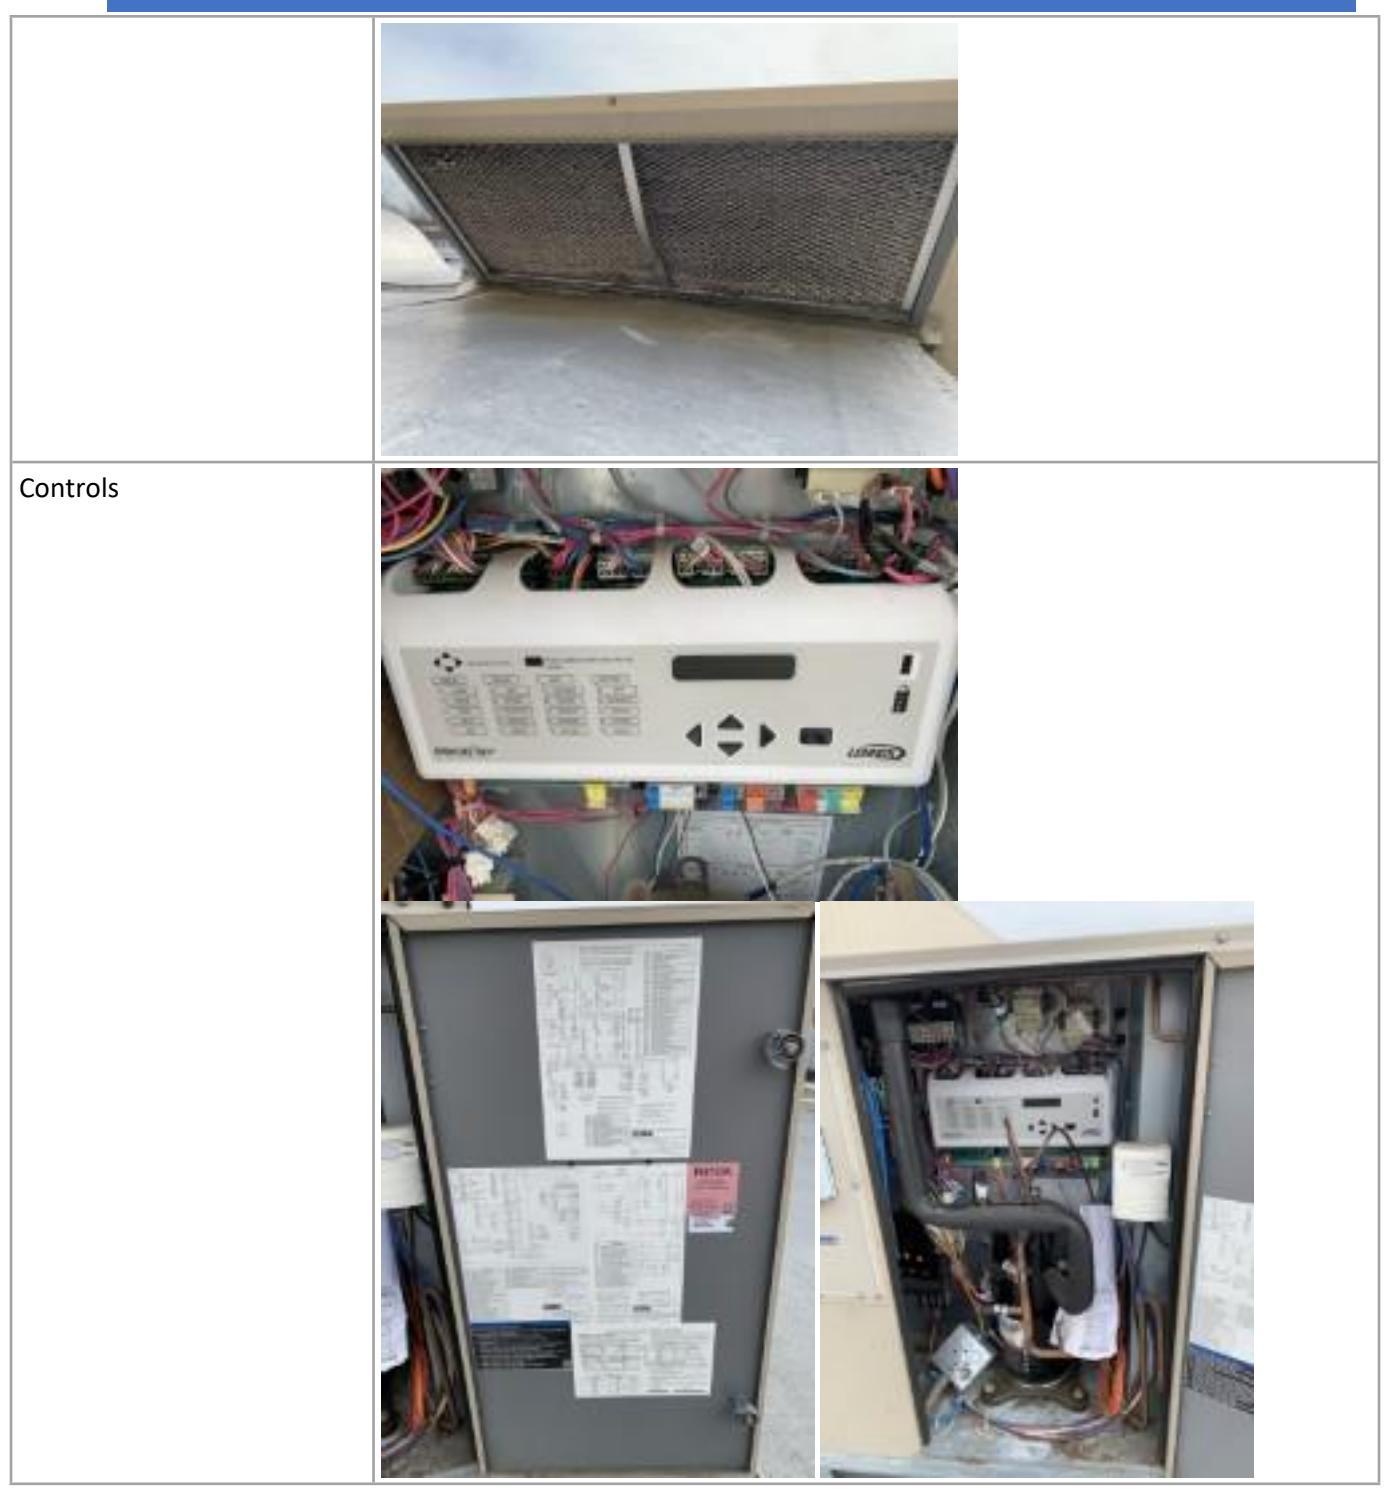
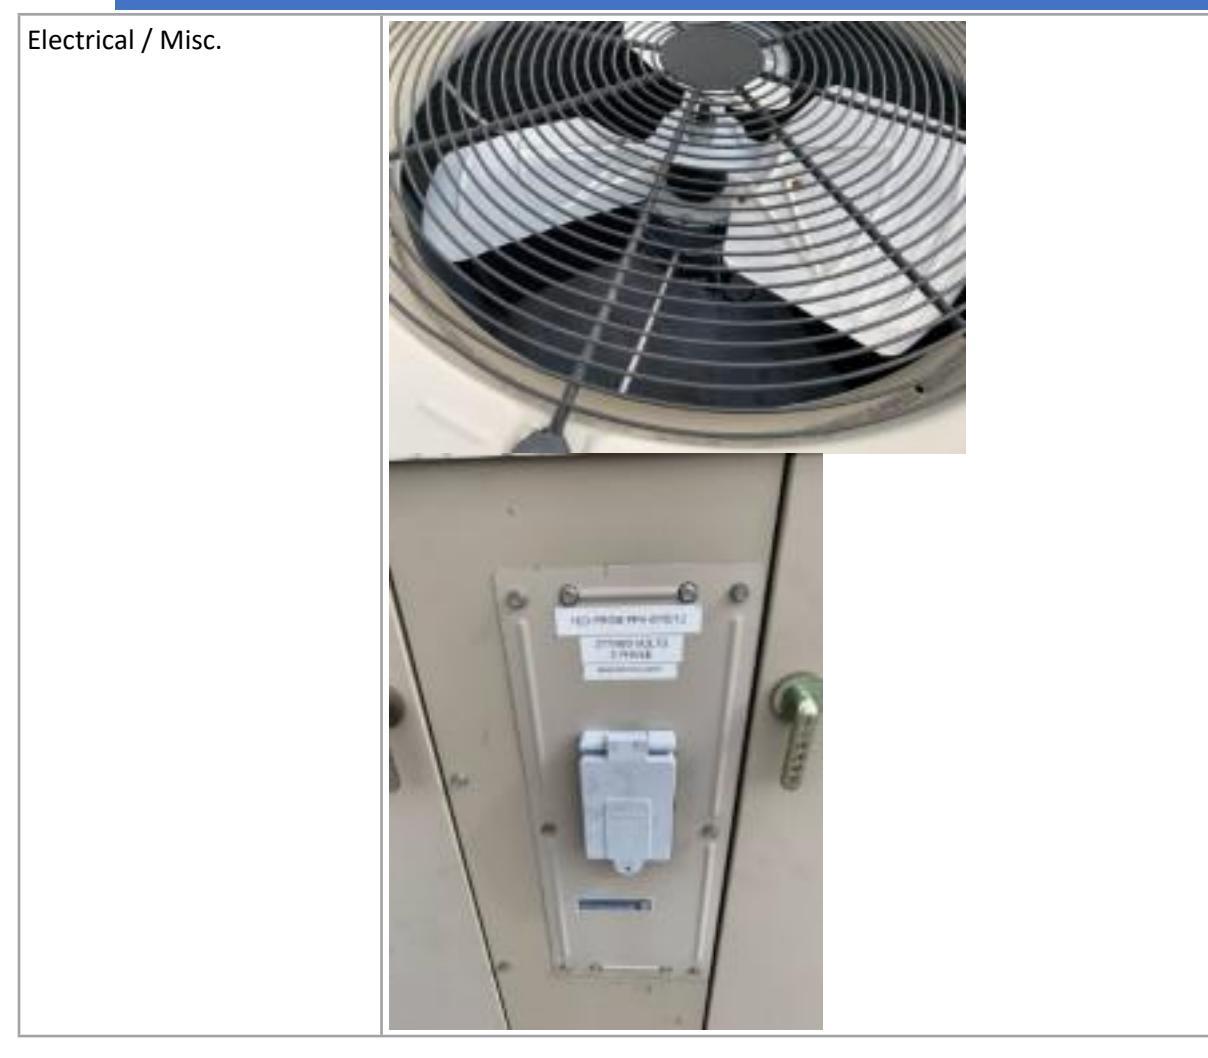
Unit Tag	RTU-21	Addition comments descriptions
Location	West Roof	
Serving	Keyboard Lab	
Config/Style	CV AHU, SF, w/ Economizer, HW, DX Cooling	
Mfr.	Lennox	
Model #	LCH048S4TN1G	
Serial #	5611F01202	C/N: N3623
Age (years)	13?	
System CFM	1120	
Max OA CFM	390	
V/Hz/Ph	460V / 60Hz / 3Ph	
SF Qty/HP	1, 2/0.89//1.66/0.74	Excessive vibration
SF VFD Data	460/400V / 2.6/1.8A / 60Hz	Misaligned fan belt pulley
RF Qty/HP	N/A	Relief backdraft damper with motorized MA/OA damper
RF VFD Data	N/A	
Filter Data (Size Quantity)	4x 16x20x2 MERV 13	
Filter Status	dirty	
Controls Type	Lennox packaged	
Controls Mfr.	Lennox Commercial	
Economizer		
CO ₂ DCV		
Damper Styles	Parallel blade	
Damper Status	Okay	
Heating Type	None, electric heat compatible	Hot gas reheat?
Heating Coil Condition	N/A	
Cooling Type	DX	
Cooling Coil Condition	Dirty, some fins missing	
CU Mfr.	Copeland Scroll	
CU Model	ZPS40K4E-TFD-130	R-410A
CU Serial	11EC8310N	
Drain Pan Status	Dirty but intact

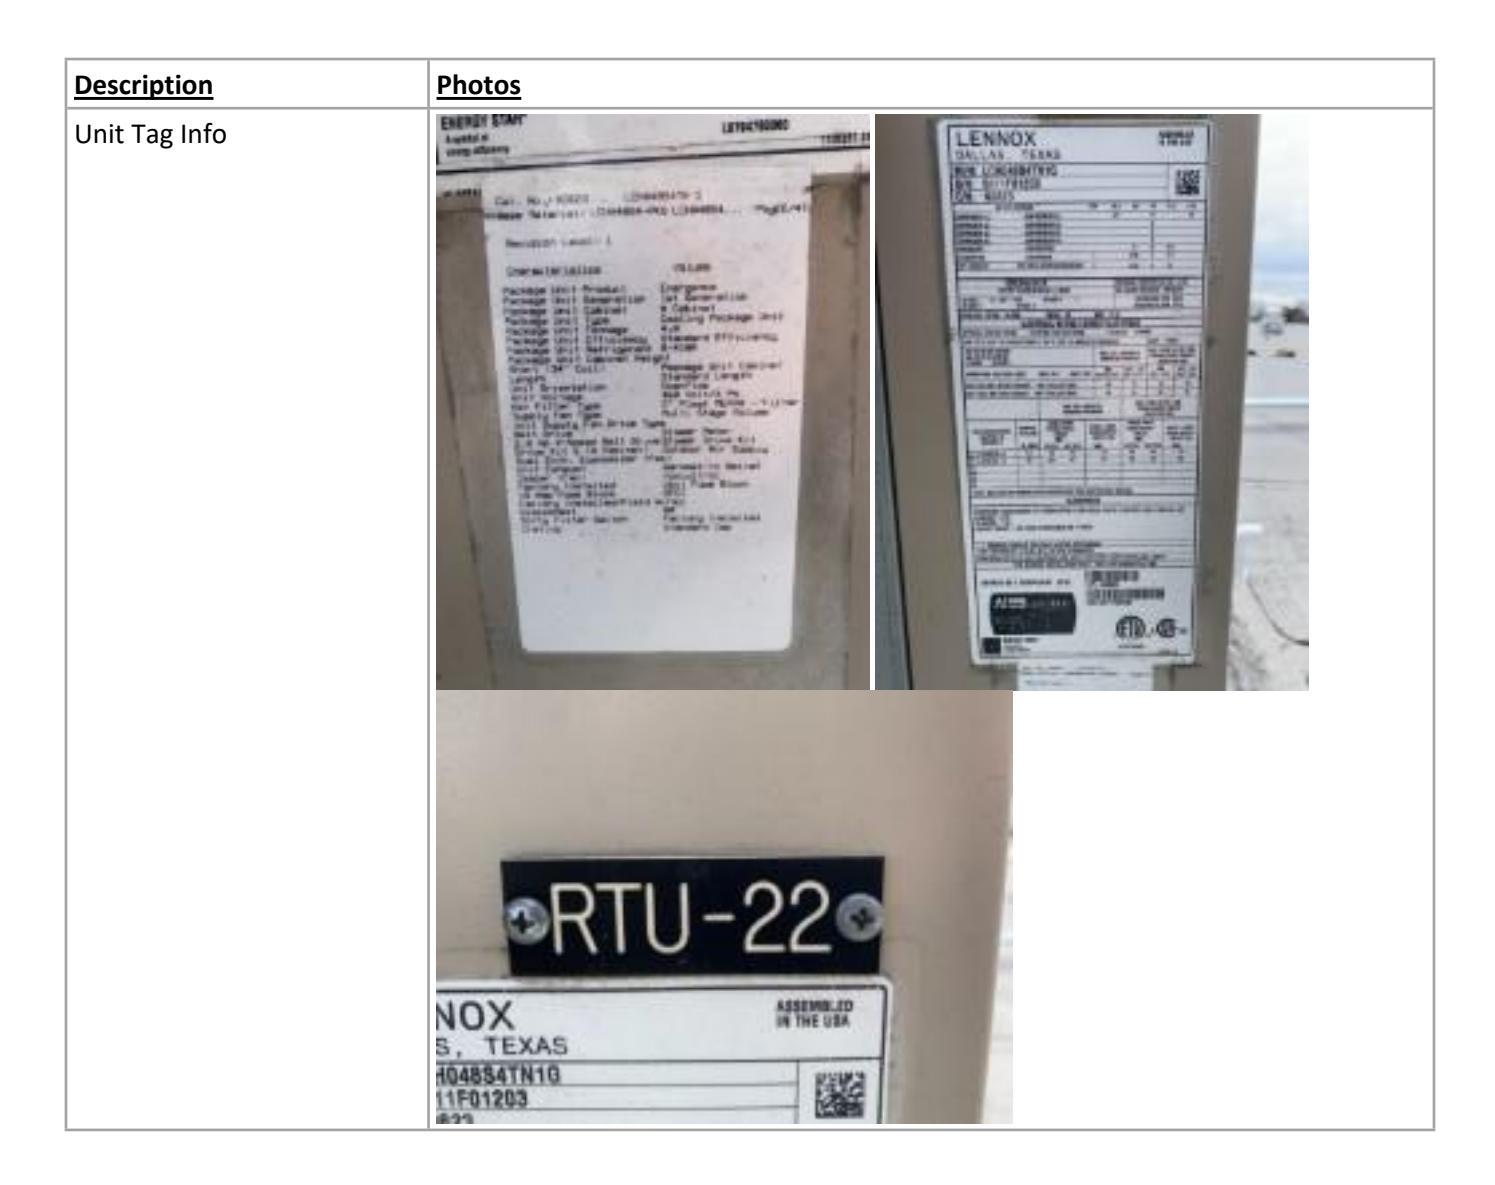
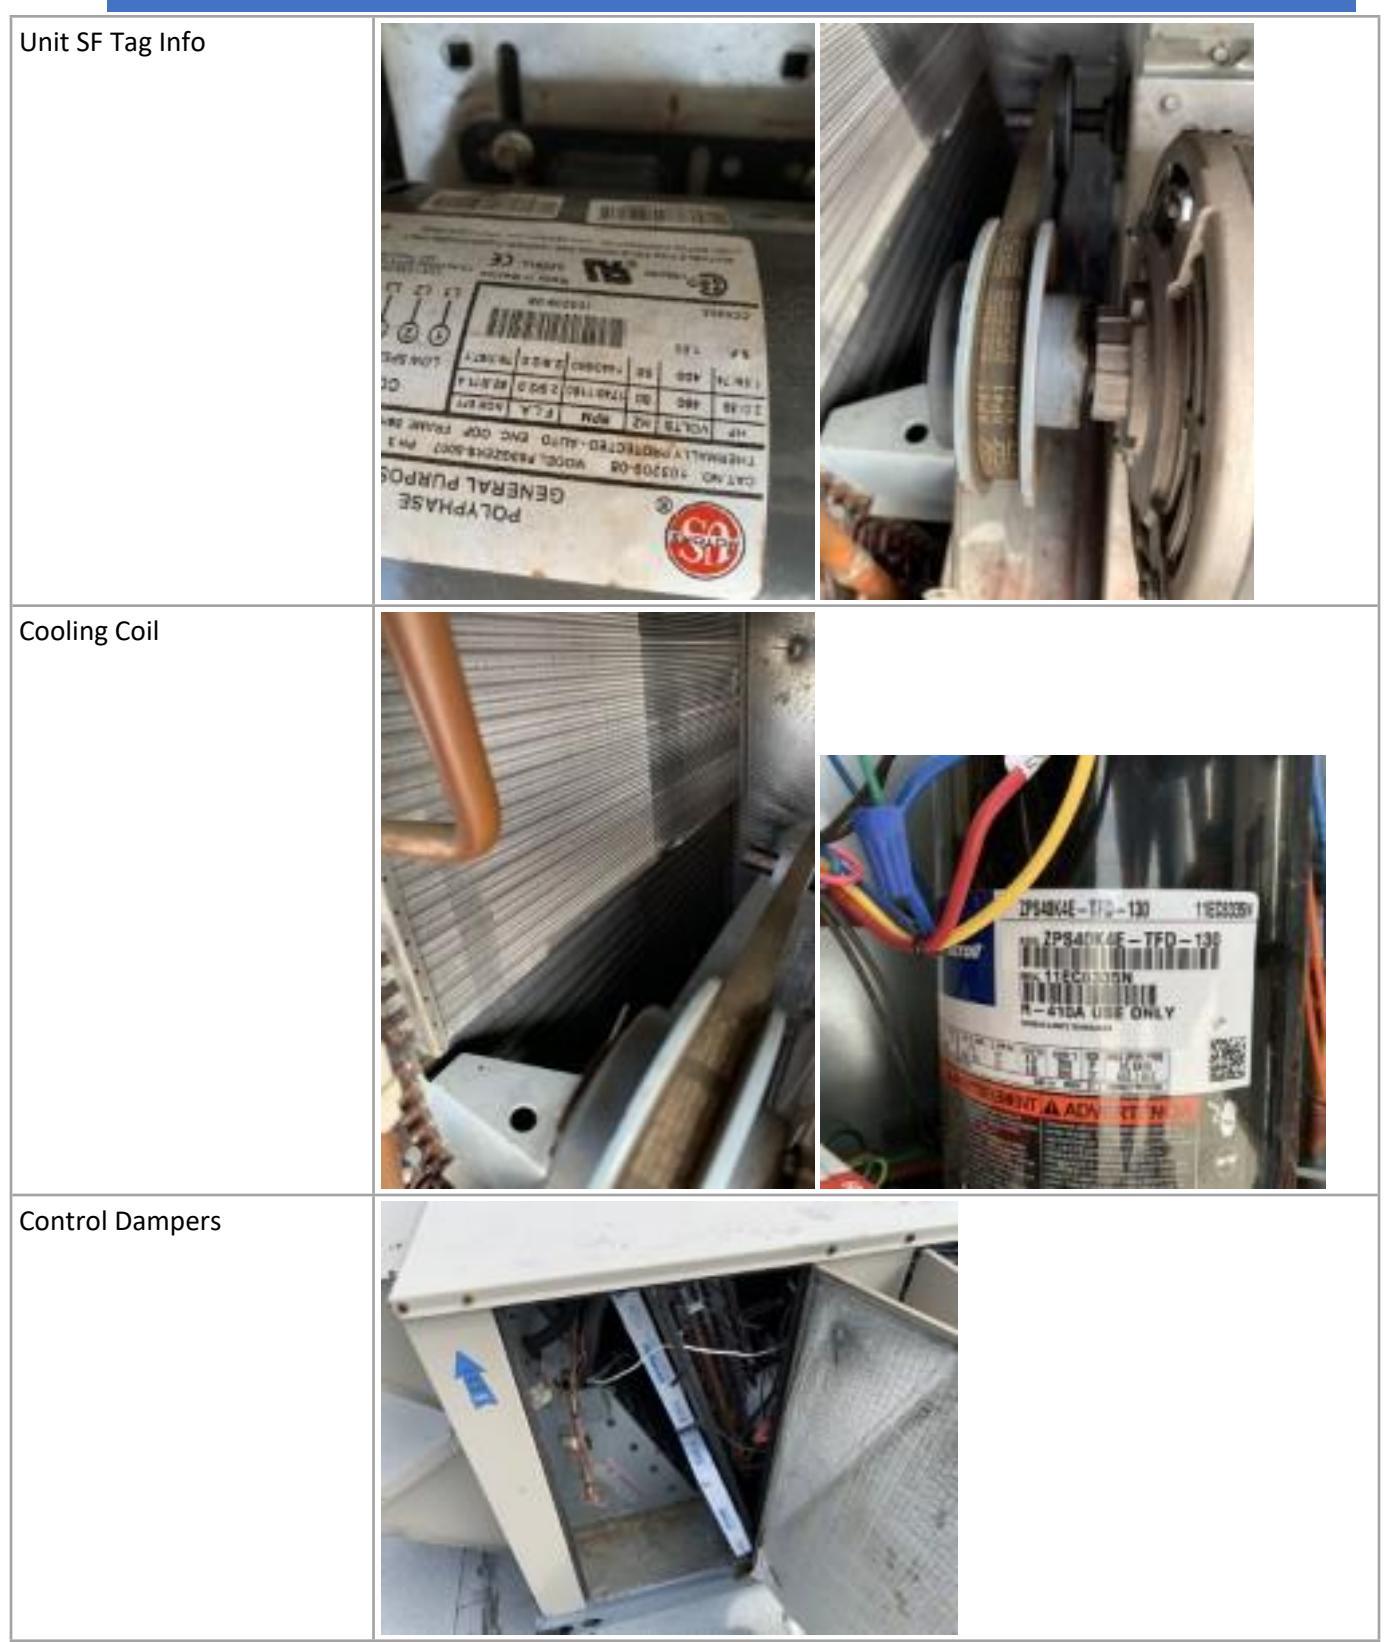
<u>Unit Tag</u>	RTU-22	Addition comments descriptions
Location	Center East Roof	
Serving	1 st Floor Offices	
Config/Style	CV AHU, SF, w/ Economizer, HW, DX Cooling	Found OFF and in alarm
Mfr.	Lennox	
Model #	LCH048S4TN1G	
Serial #	5611F01203	C/N: N3623
Age (years)	13?	
System CFM	1120	
Max OA CFM	390	
V/Hz/Ph	460V / 60Hz / 3Ph	
SF Qty/HP	1, 2.0	
SF VFD Data	460V / 2.0A / 60Hz	
RF Qty/HP	N/A	
RF VFD Data	N/A	
Filter Data (Size Quantity)	4x 16x20x2	
Filter Status	Very clean	Unit hasn't run or has run very little since the previous filter change
Controls Type	Lennox packaged	
Controls Mfr.	Lennox Commercial	
Economizer	Partial, relief damper	
CO ₂ DCV		
Damper Styles	Parallel blade	
Damper Status	Issue with closure on RA	Wall-mountable t-stat found wired and suspended in the RA duct section, presumably to control the unit based on "space" conditions rather than from a sensor down below. In theory this could work, but in practice it prevents the dampers from closing fully. The wire is quite damaged

CU Model	ZPS40K4E-TFD-130	
CU Serial	11EC8335N	
Drain Pan Status	Okay	
Notes:
