Holland Hill Elementary School

Fairfield Public Schools Recommissioning (RCx) and Testing, Adjusting, & Balancing (TAB) Study van Zelm Project # 2020102.00 (15-HHES)

August 08, 2022

FAIRFIELD PUBLIC SCHOOLS RECOMMISSIONING (RCX) AND TESTING, ADJUSTING, & BALANCING (TAB) STUDY

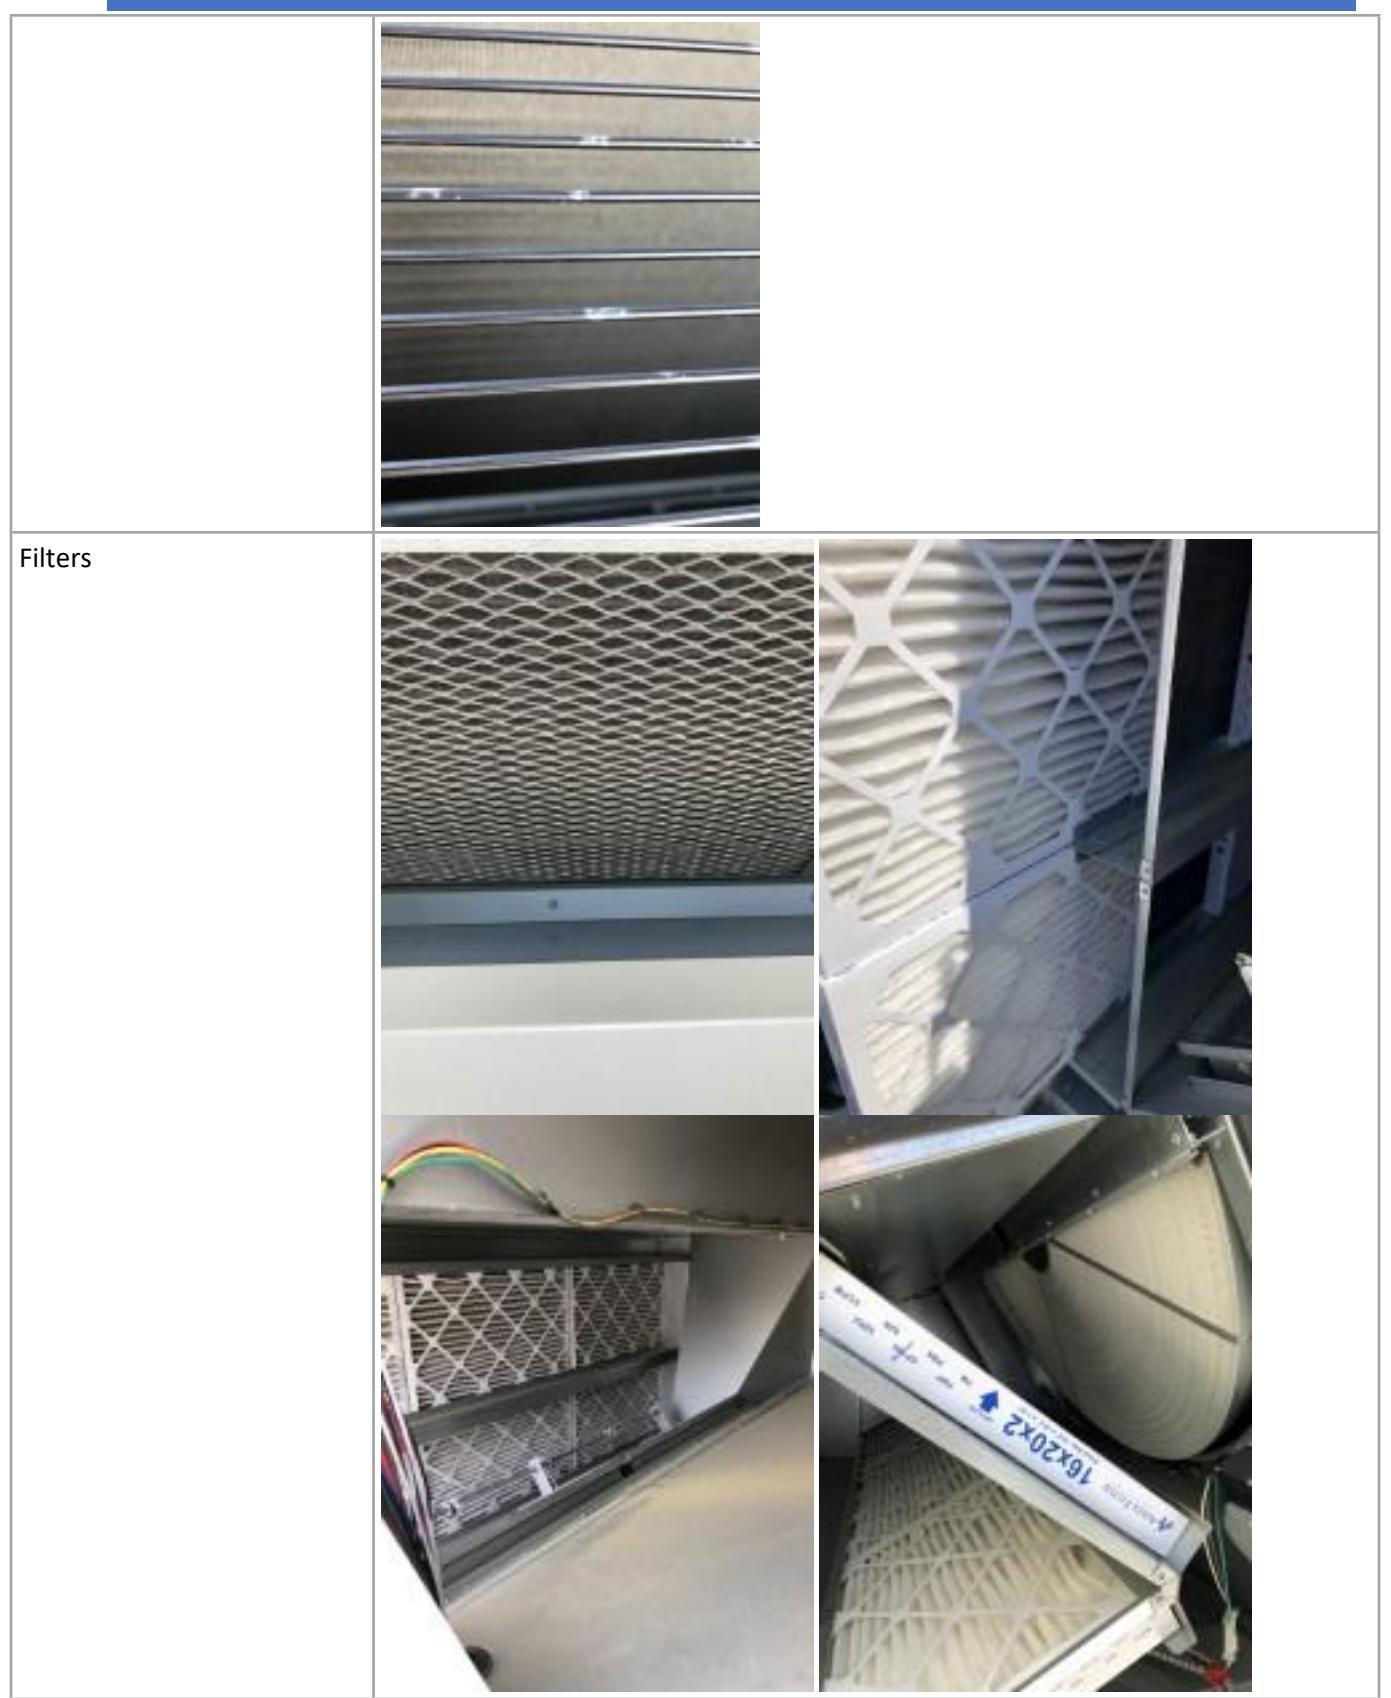
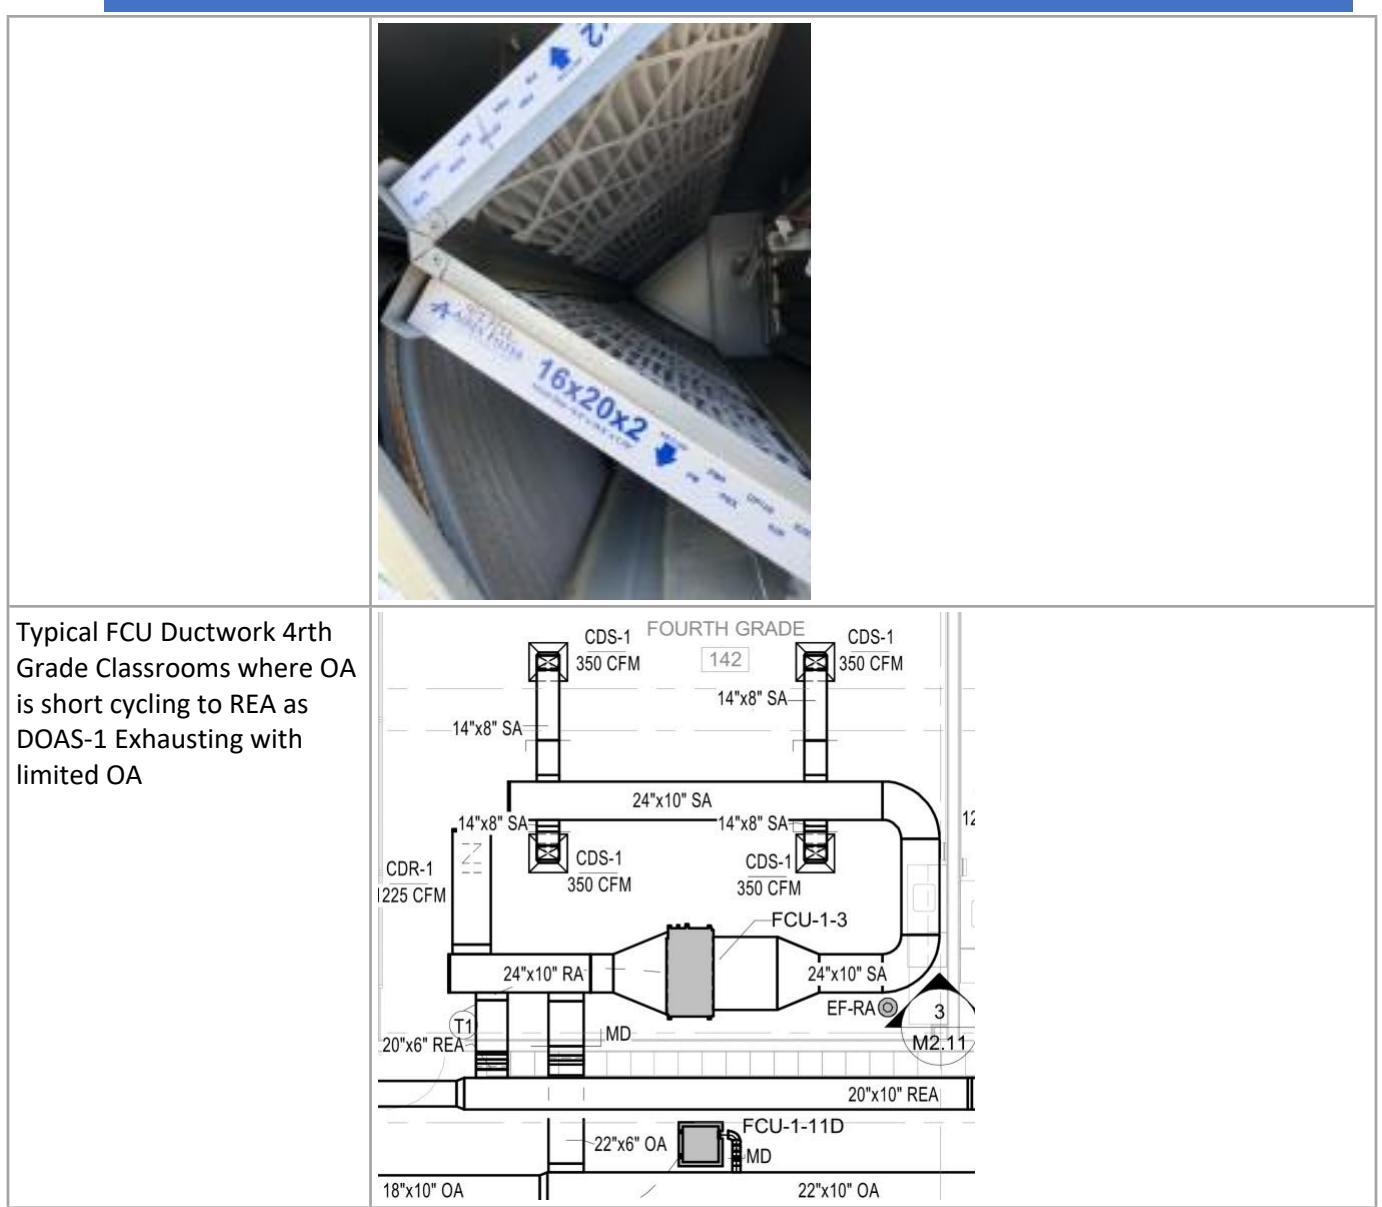
<u>Unit Tag</u>	DOAS-2	Addition comments descriptions
Date: 5-5-22	Auditor: REA	
Location	West 3 rd Grade Roof	
Serving	3 rd Grade	
Config/Style	Rooftop SF/RF Gas Heat, DX cooling, ERW	
Mfr.	Trane	
Model #	OAGD180A3-C1B400CC-A1G00AL6CC-D42B0C5BO	
Serial #	OA276188-2-1	
Age (years)	10/2018	
System CFM	4350	
Max OA CFM	4350	
V/Hz/Ph	208/60/3	
SF Qty/HP	(2) 4.08	
SF VFD Data	ECM Direct drive	
PE Qty/HP	(2) 4.08	
RF VFD Data	ECM Direct drive	
Filter Data (Size Quantity)	(2) 16x20x2 (4) 16x25x2 (2) 16x20x2 (4) 16x25x2 (4) 16x20x2	
Filter Status	Clean 4/27/22	
Controls Type	Factory DDC	
Controls Mfr.	Trane	
Economizer	100% OA	
CO ₂ DCV	Νο	
Damper Styles	Parallel blade	
Damper Status	Good Belimo actuators	
Heating Type	Gas	
Heating Coil Condition	Burner	
Cooling Type	DX Twin Compressors	
Cooling Coil Condition	Reheat dirty, both coils should get washed	
Wheel	Semco Mod. UWCH-46-1-0-1-B-0-0	
Ser.	72954-2/PJ49128 9/17/2018	
Drain Pan Status	OKxdr5

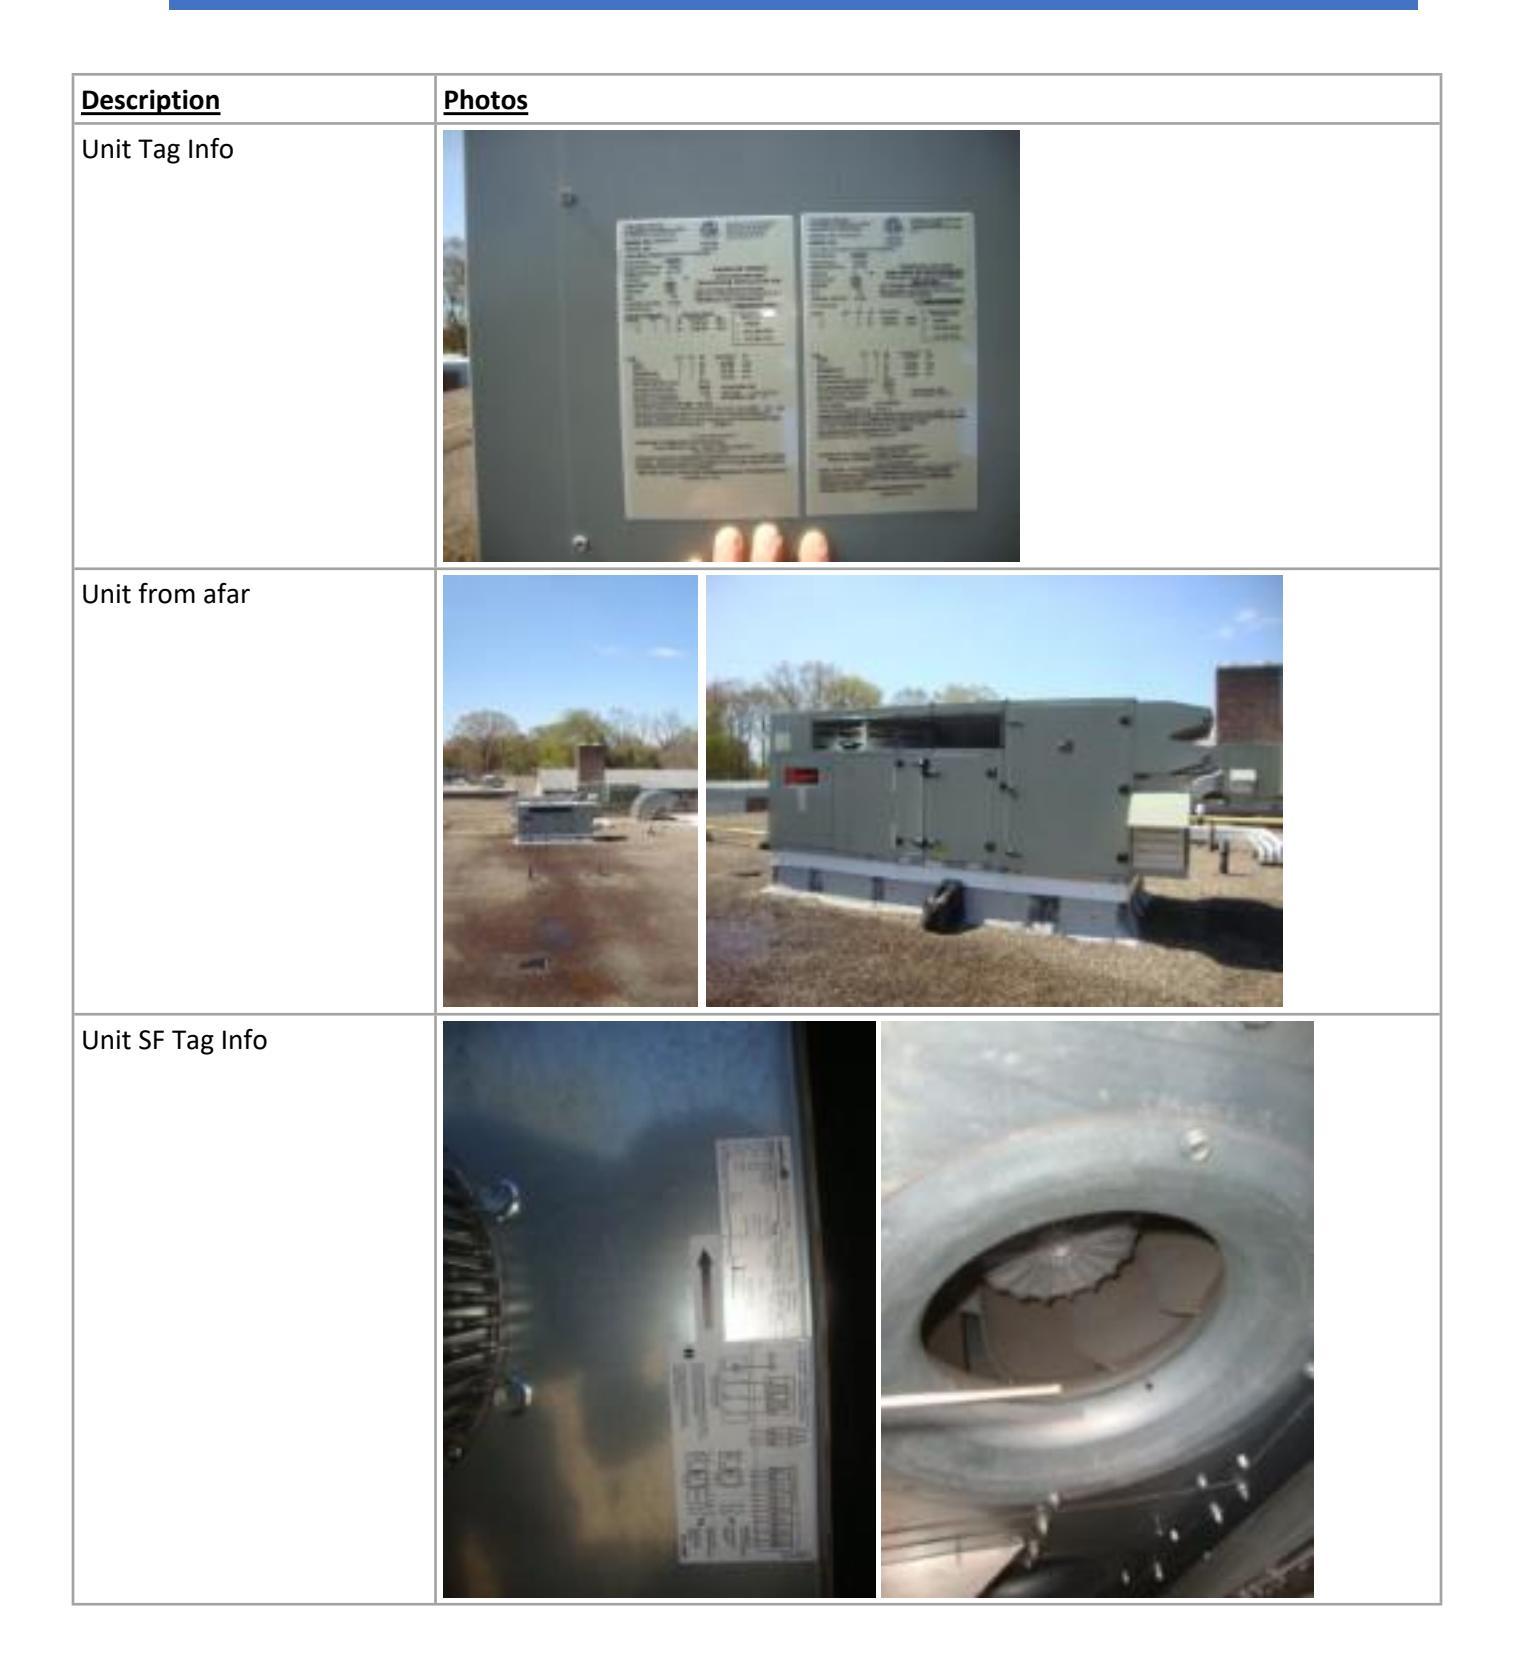
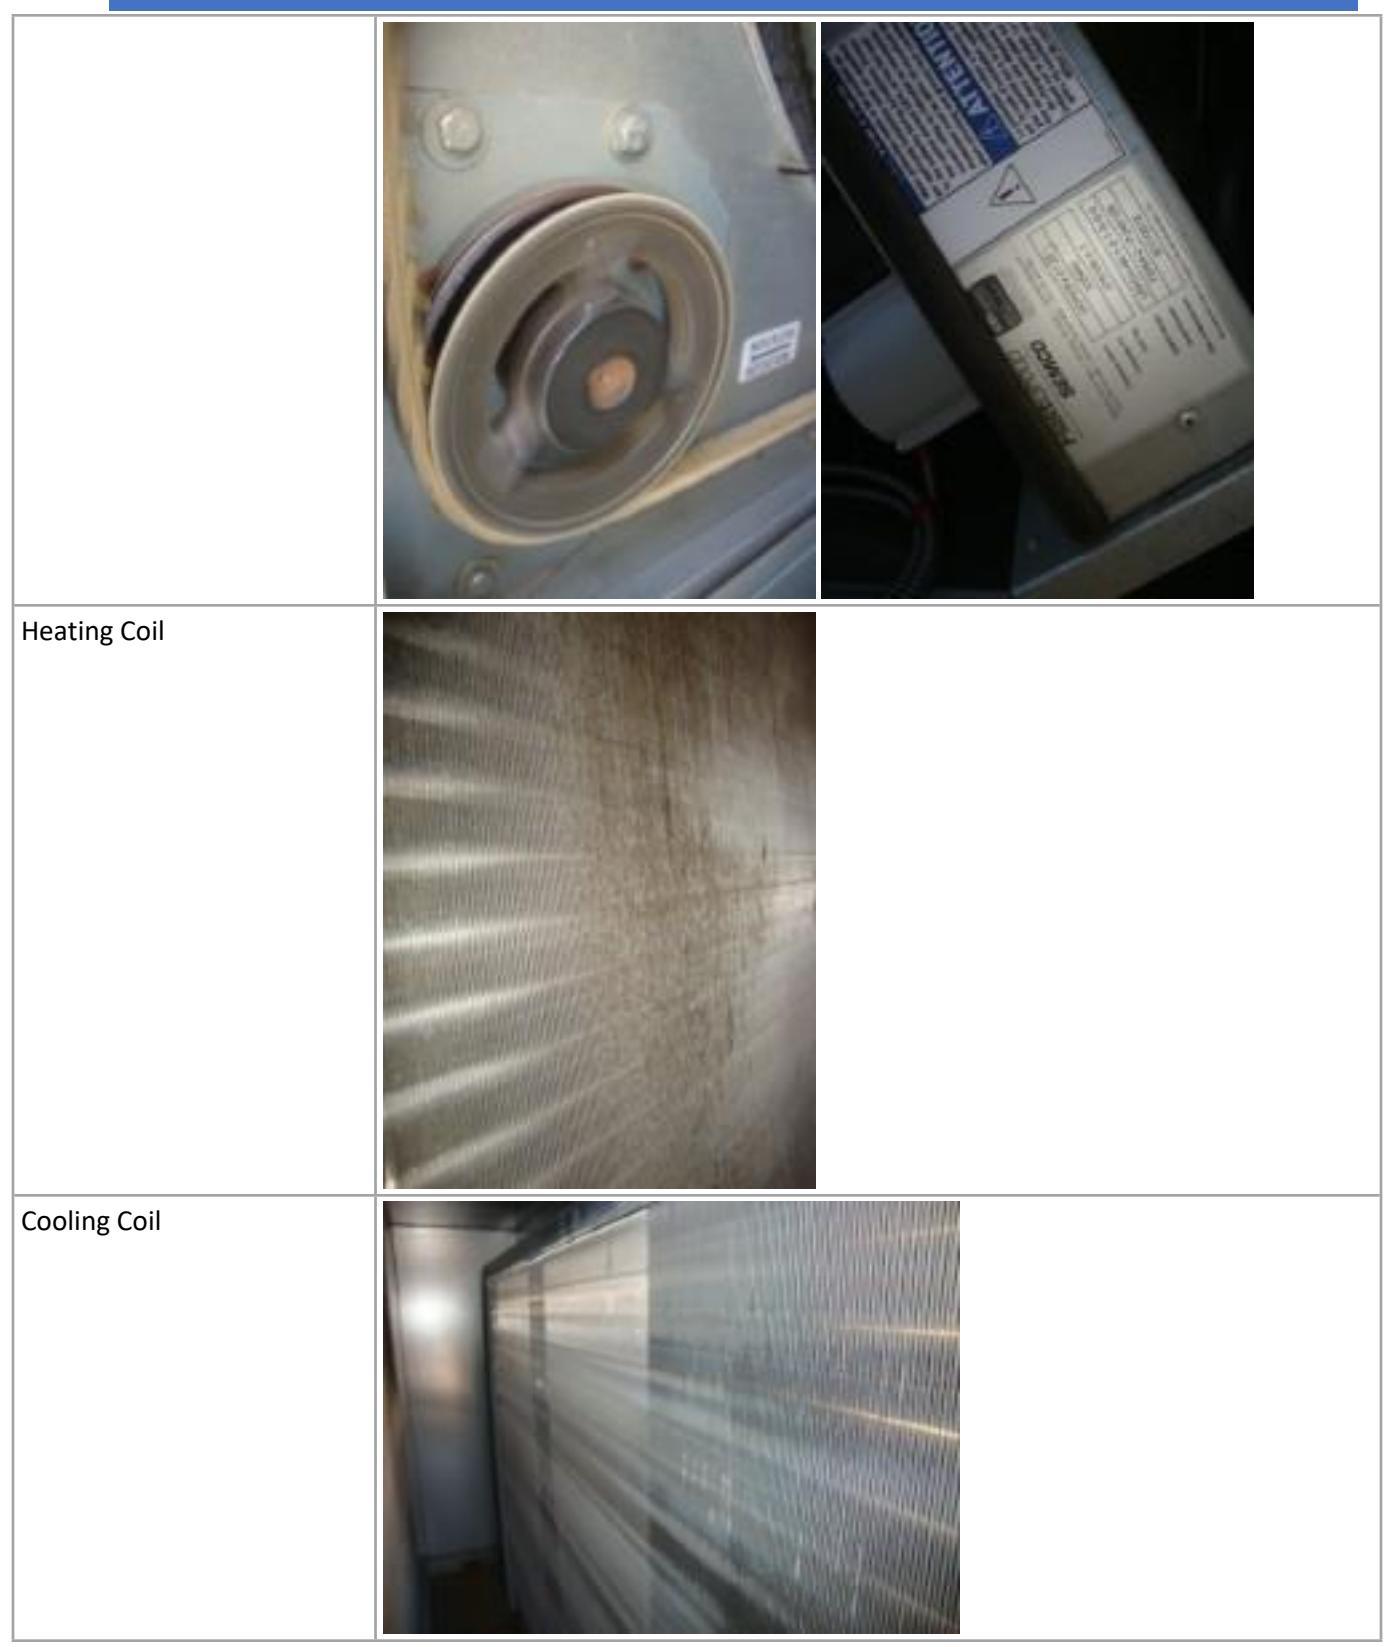
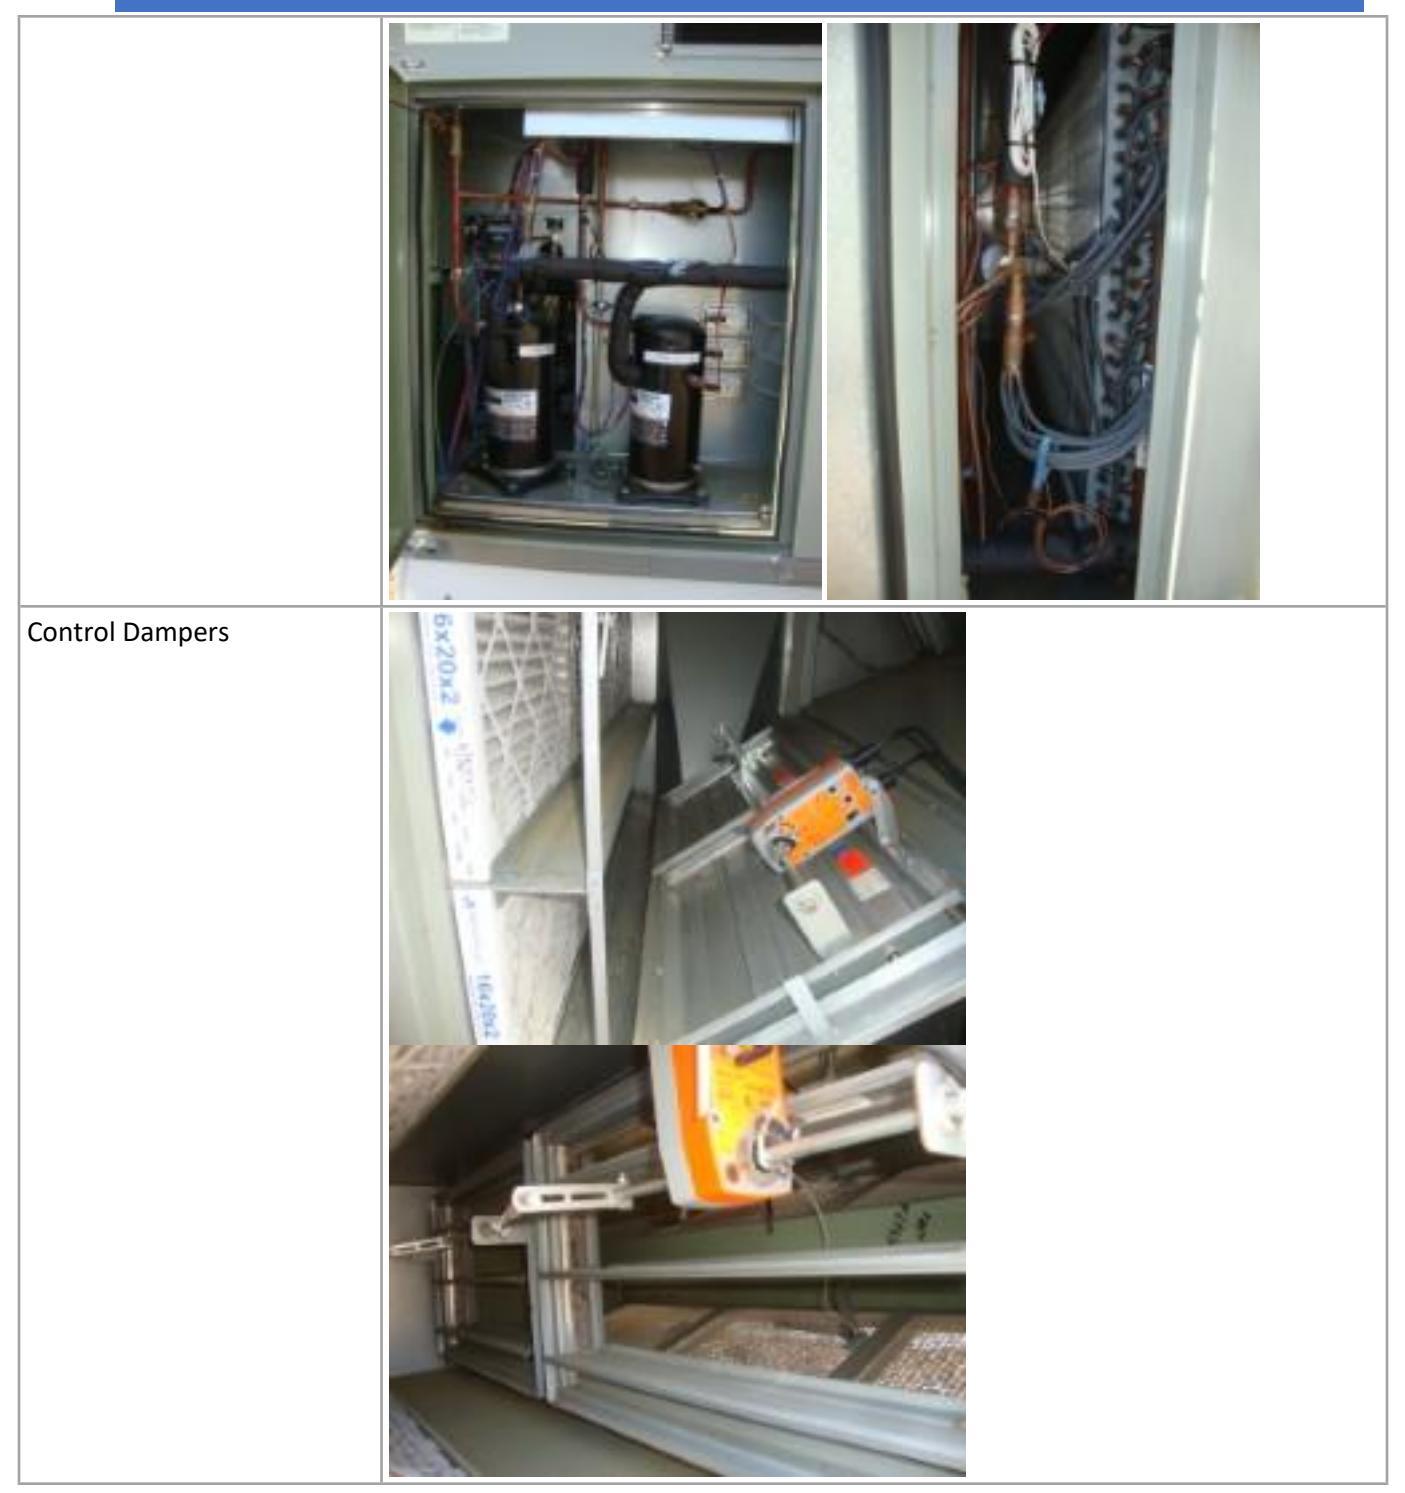
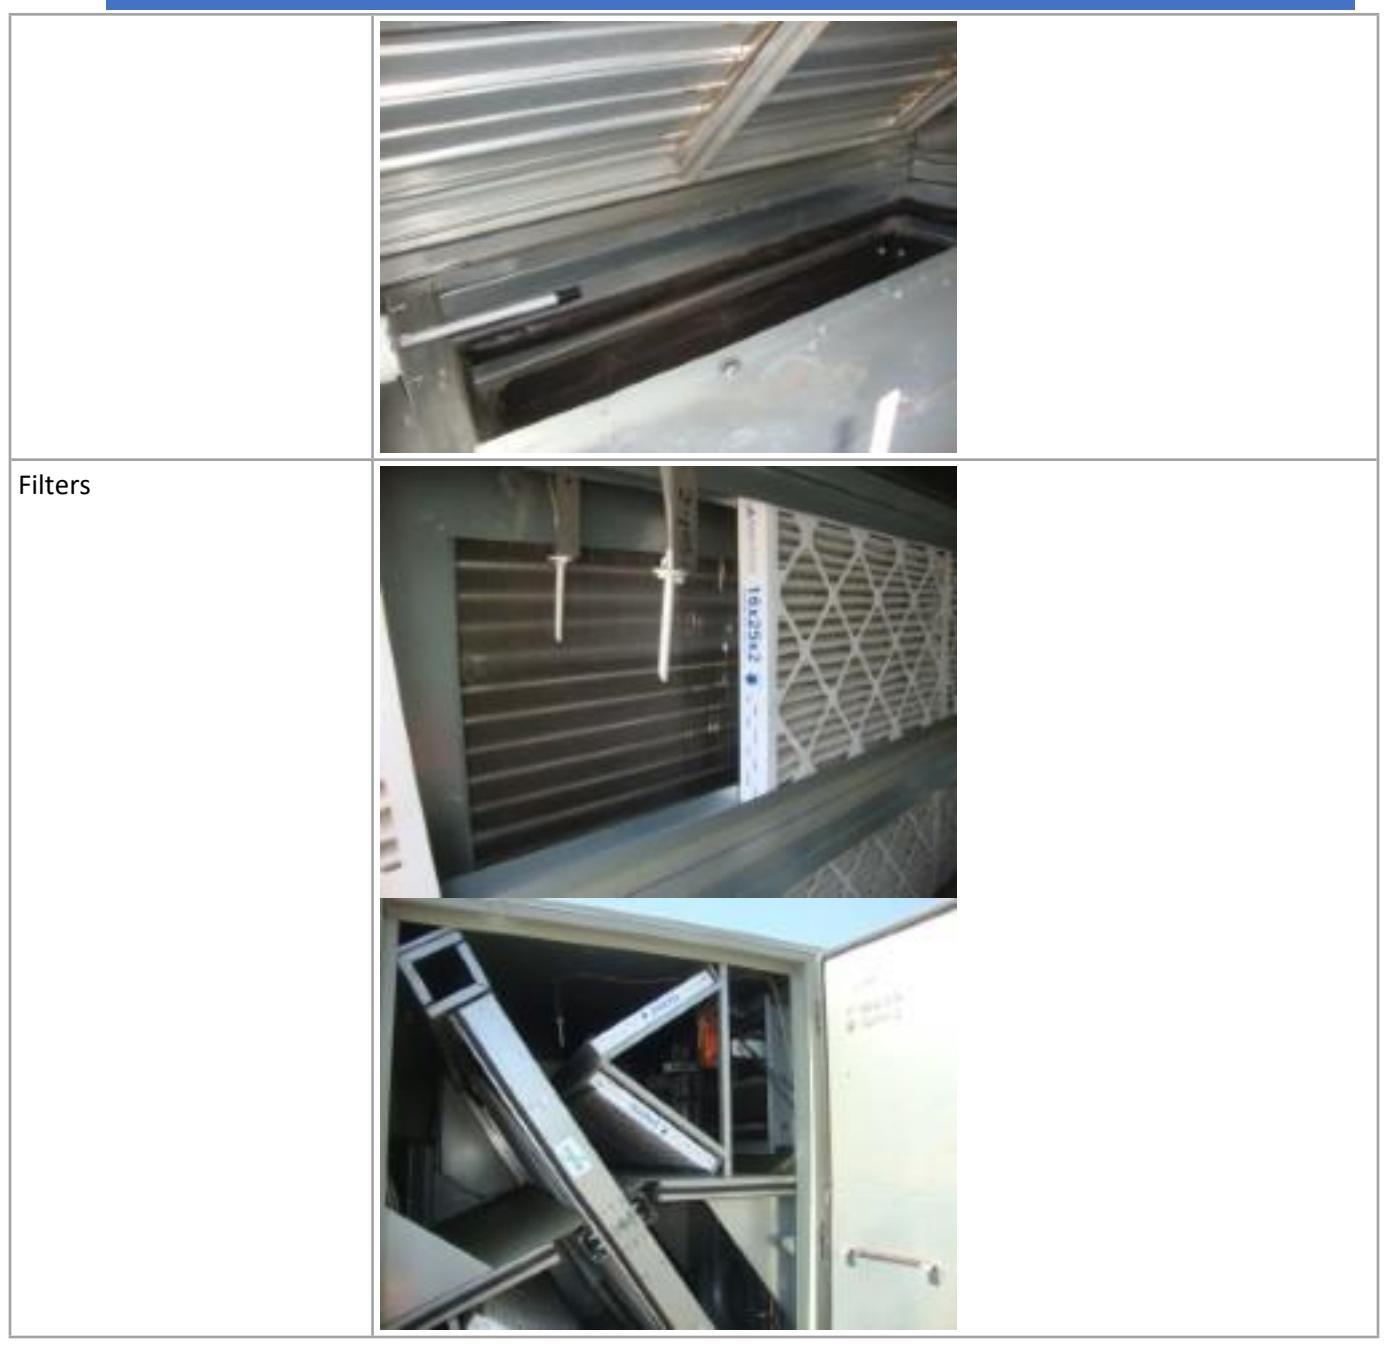
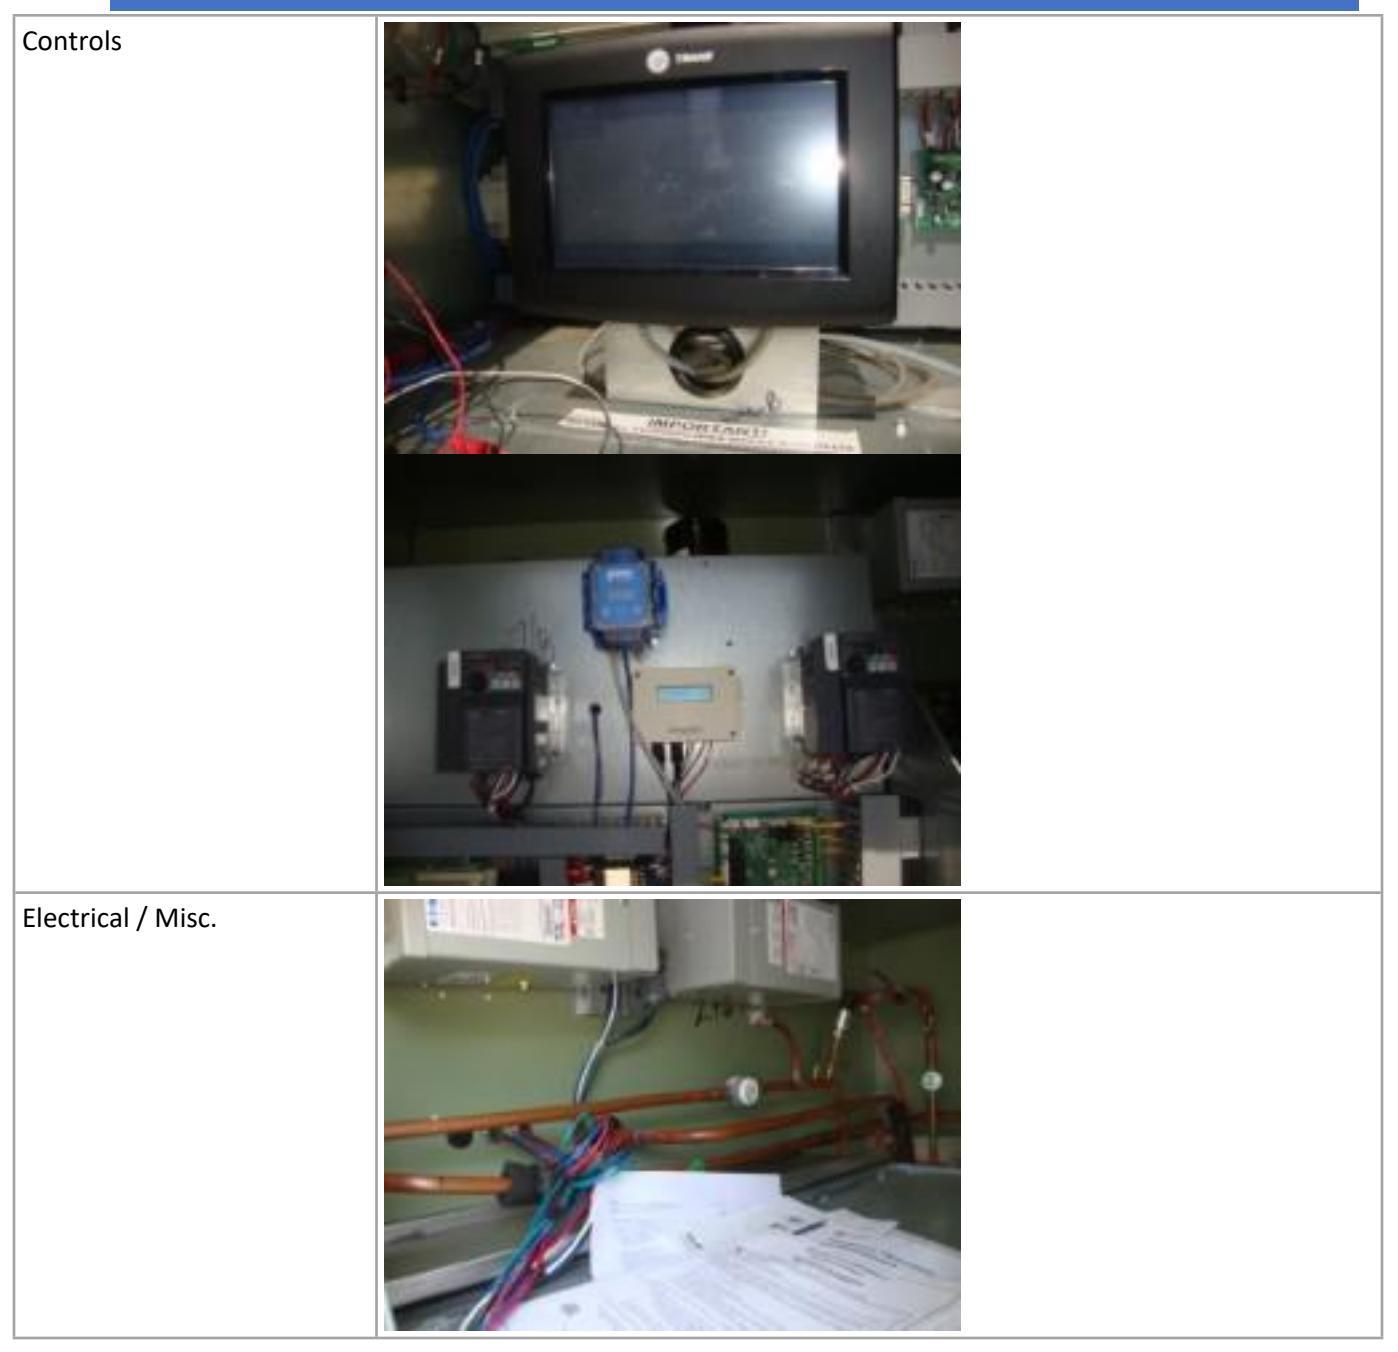
<u>Unit Tag</u>	DOAS-3	Addition comments descriptions
Date: 5-5-22	Auditor RCM	
Location	South Kindergarten Roof	
Serving	Kindergarten/Admin	
Config/Style	Rooftop SF/RF Gas Heat, DX cooling, ERW	
Mfr.	Trane	
Model #	OAGD-210A3-C1B400CC-A1G00AF6CC-D41B0C5B0	
Serial #	0A276188-3-1	
Age (years)	2019	
System CFM	4940	
Max OA CFM	4940	
V/Hz/Ph	208/60/3	
SF Qty/HP	(2) 4 HP Equivalent	
SF VFD Data	ECM<	
RF Qty/HP	4 HP Equivalent	
RF VFD Data	ECM	
Filter Data (Size Quantity)	(6) 16 X 20 X 2, (4) 16 X 25 X 2	ERW ODA Same Size & Quantity ERW EXH Same Size & Quantity

(6) 16 X 25 X .5 Metal Pre	
Filter Status	Clean	Changed 4-27-21
Controls Type	Packaged Trane with BAS BACnet interface	
Controls Mfr.	Alerton BAS	
Economizer	100% OA	
CO ₂ DCV	No	
Damper Styles		
Damper Status		
Heating Type	Gas	
Heating Coil Condition	Gas Heat 250 MBH Heating Output	
Cooling Type	DX Scroll (2)	
Cooling Coil Condition	Clean	
Drain Pan Status	Clean	Condensate Trap broken off needs replacement
Notes:	In Economizer mode with ERW=Off, ERW Bypass=Open, Exhaust=On, ODA=100%, RA <10%.

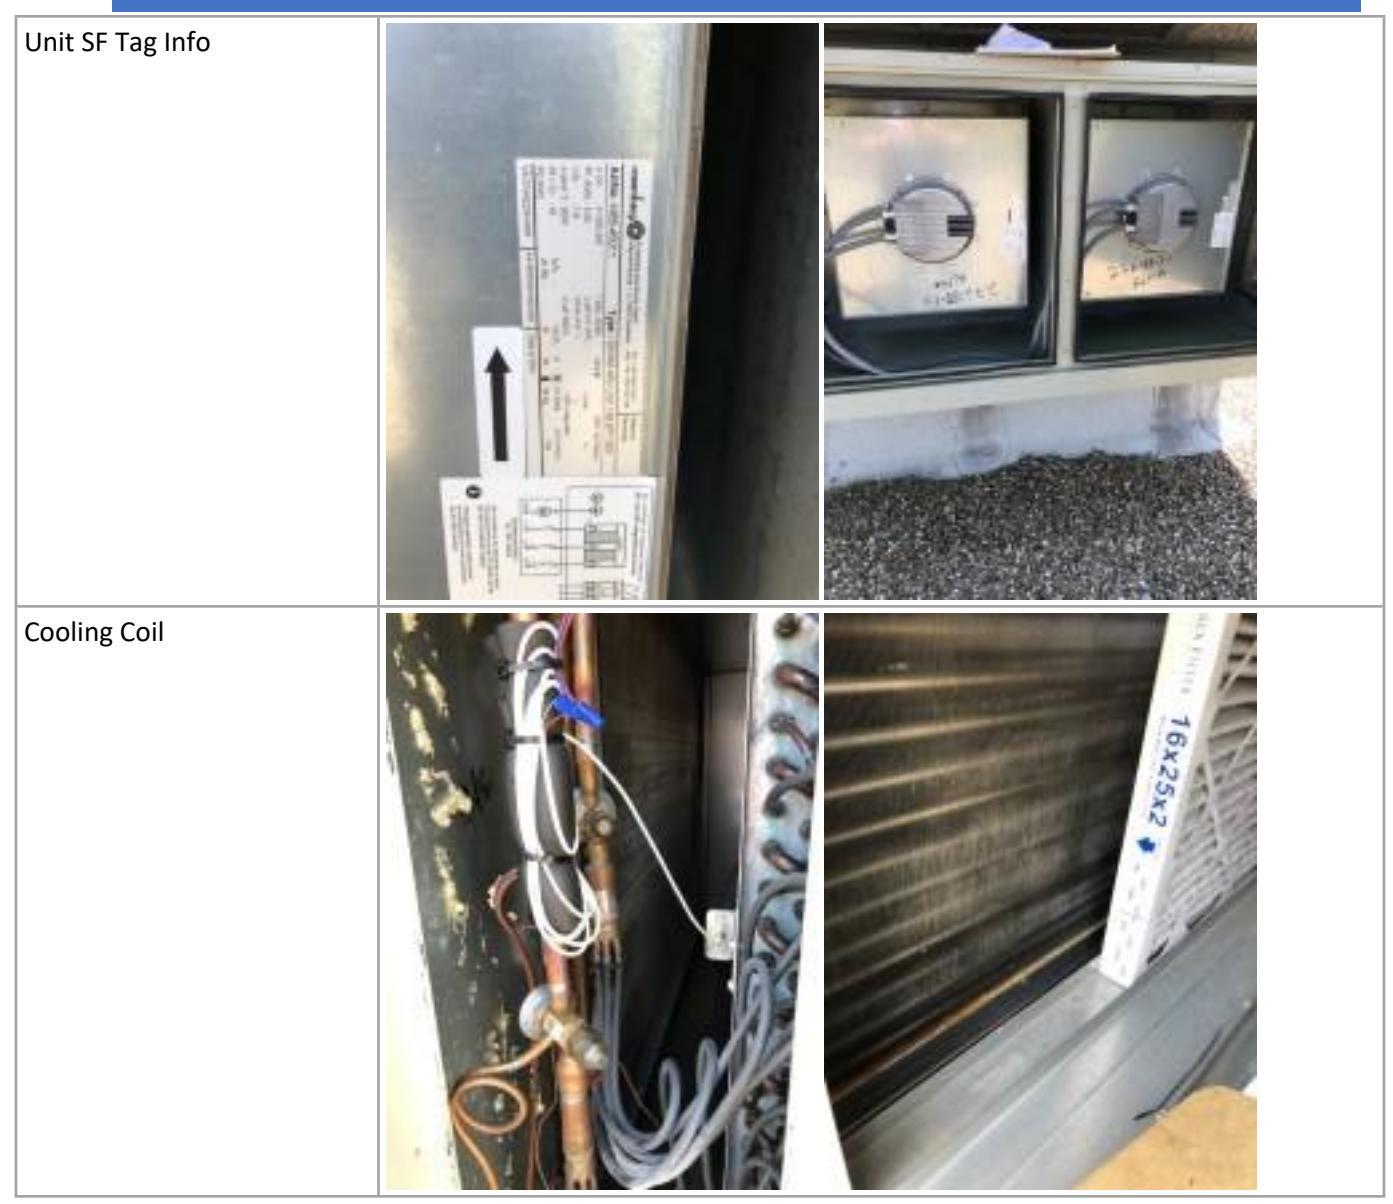
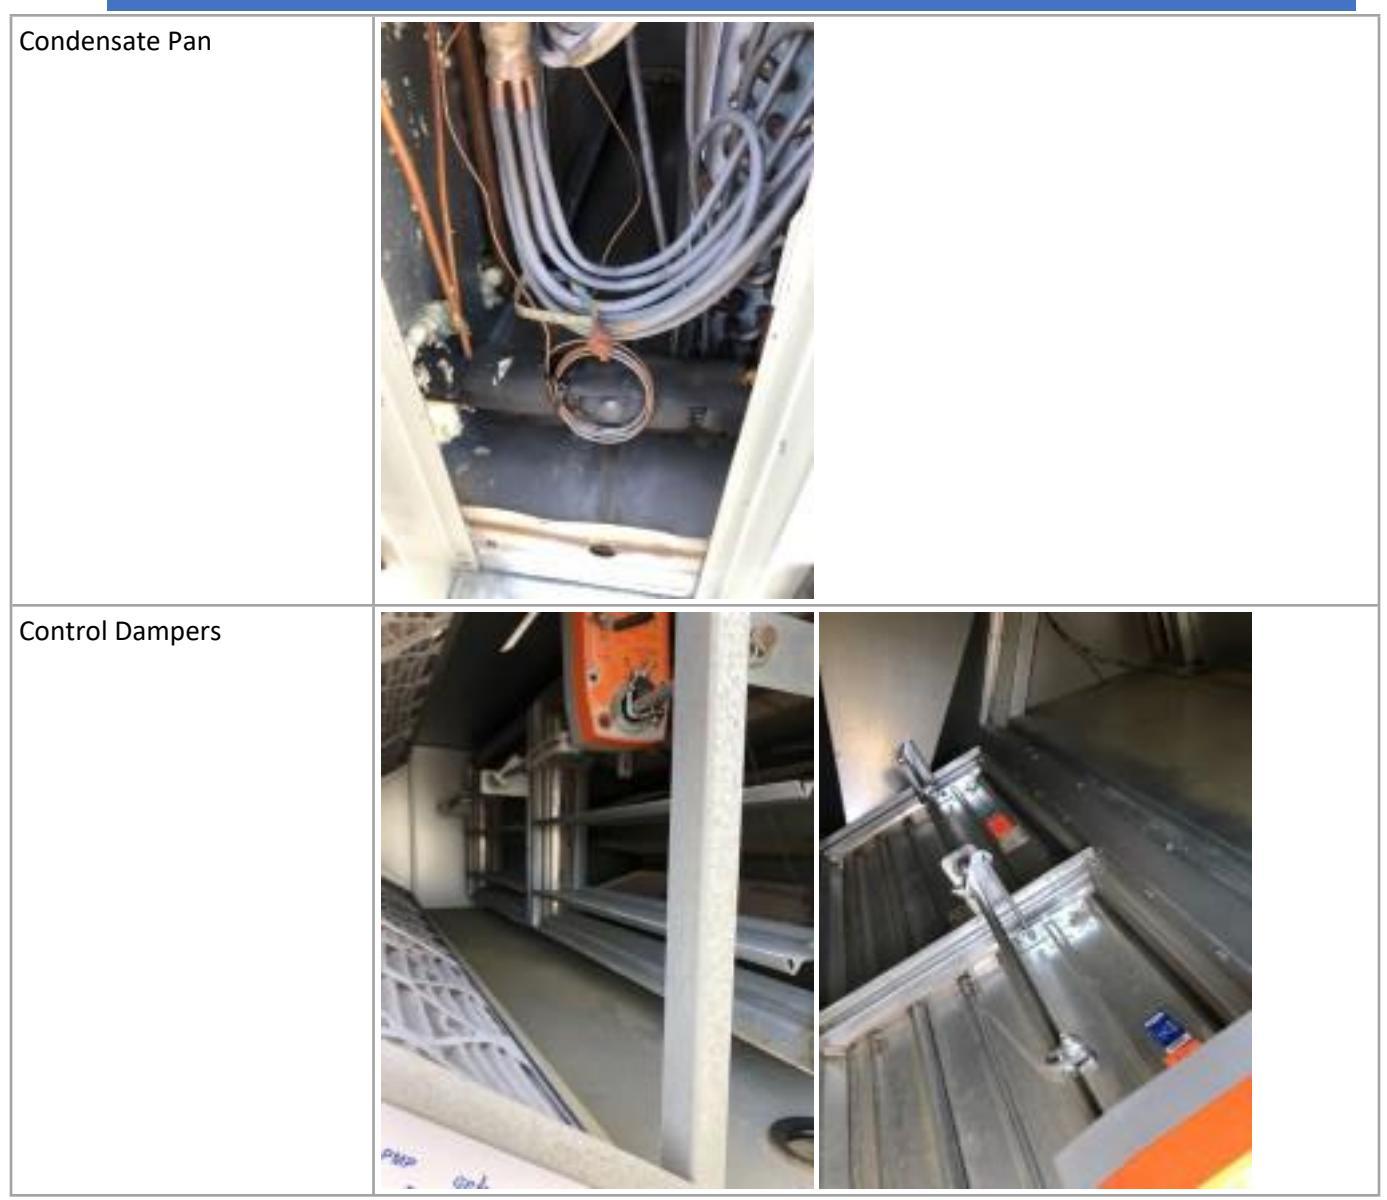
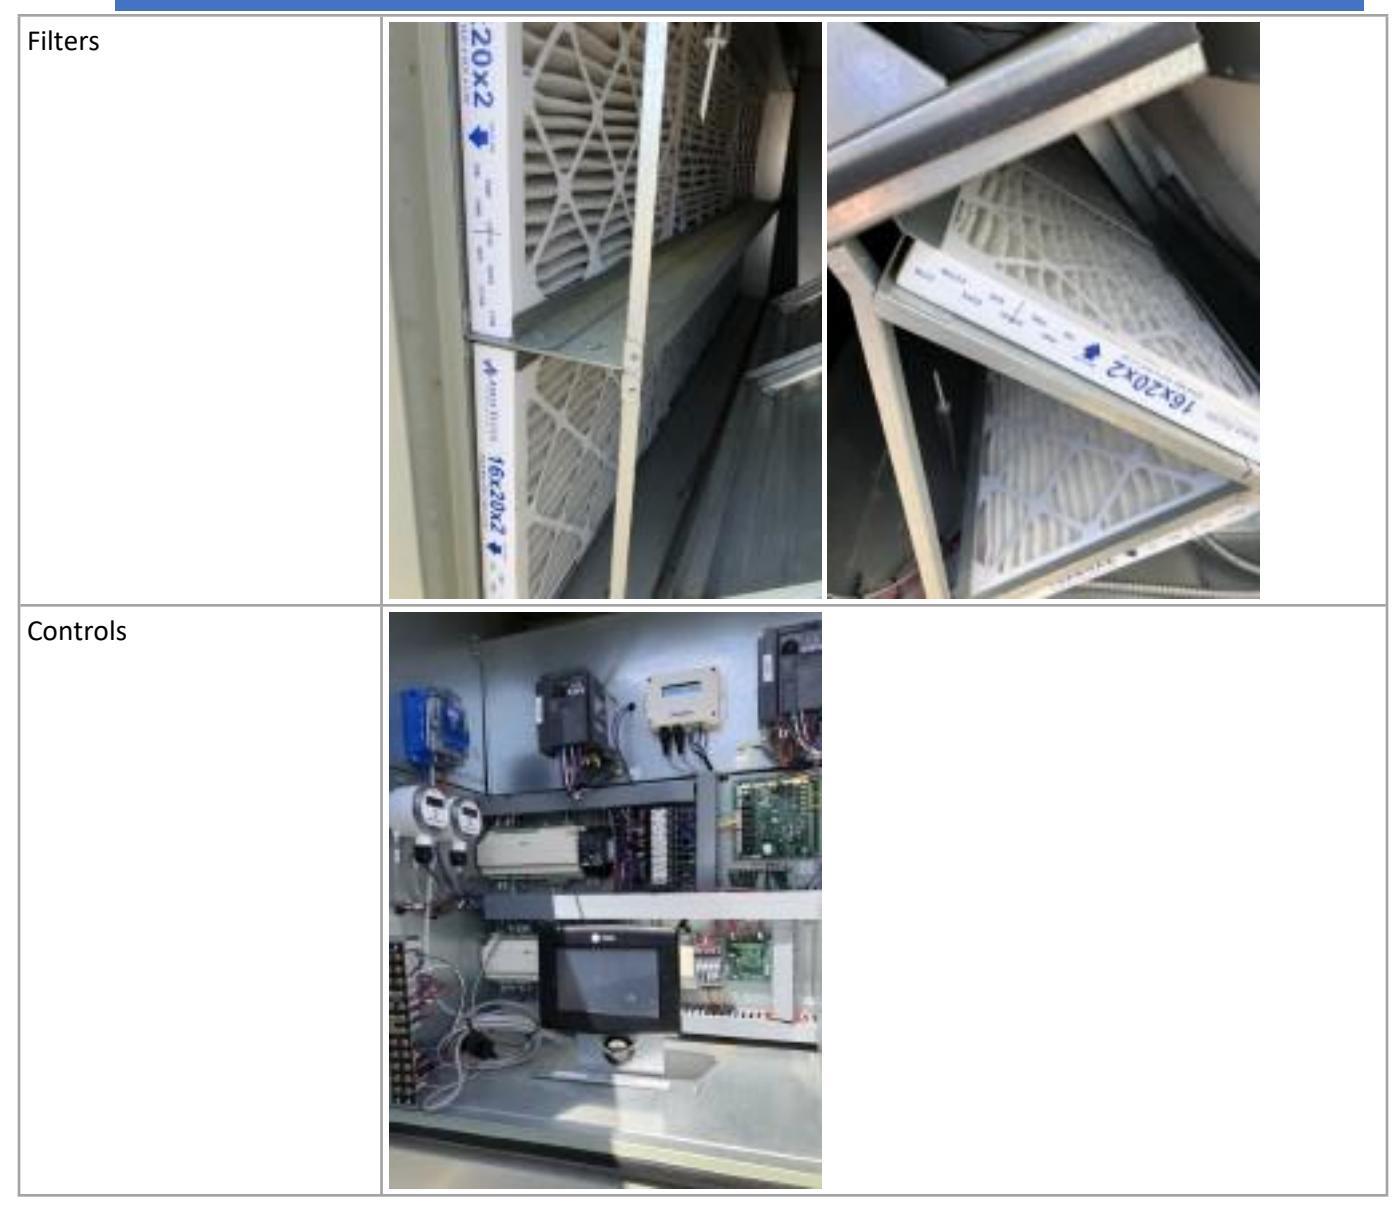
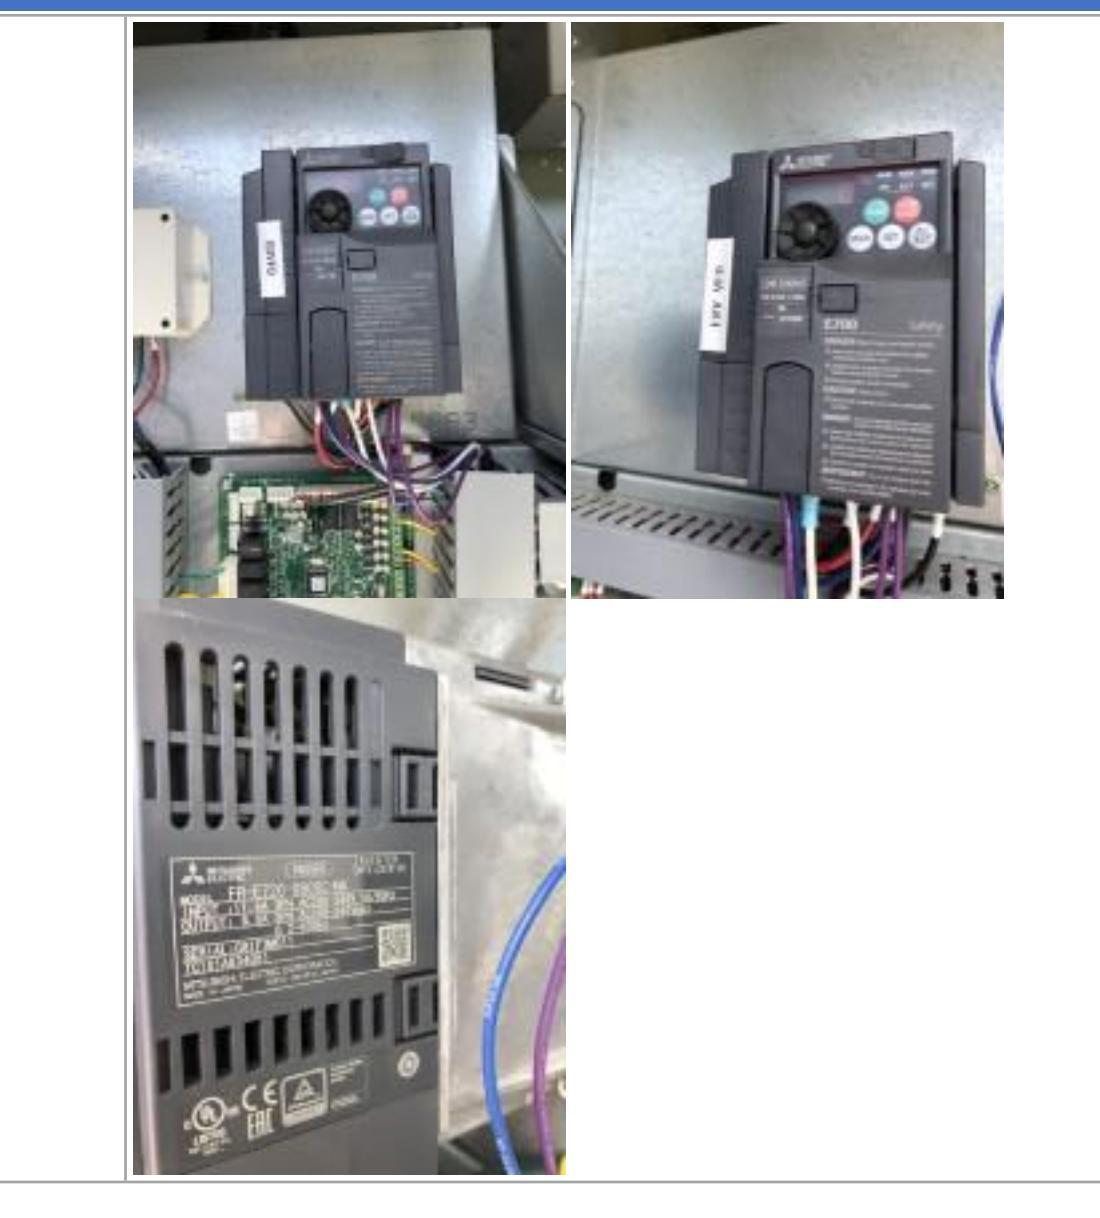
<u>Unit Tag</u>	<u>RTU-1</u>	Addition comments descriptions
Date: 5-5-22	Auditor: REA	
Location	North Roof	
Serving	153 Gymnasium	
Config/Style	Rooftop SF/RF Gas Heat, DX cooling, ERW	
Mfr.	Trane	
Model #	OADG010C1-CAB10AF00-G1AGC1AD1- 41A40B03A-A00C00AB0-AA1A000A0-0	
Serial #	OA276188-4-2	
Age (years)	10/2018	
System CFM	3960	
Max OA CFM	1250	
V/Hz/Ph	208-230/60/3	
SF Qty/HP	(1) 3.0 Direct Drive	
SF VFD Data	VFD	
PE Qty/HP	(1) 1.5 Direct Drive	
RF VFD Data	VFD	
Filter Data (Size Quantity)	(4) 24x24x2 (2) 12x24x2 DX (6) 20x20x2 ODA (6) 20x20x2-RA Wheel	
Filter Status	ОК 4/27/22	
Controls Type	Factory DDC	
Controls Mfr.	Trane	
Economizer	Available	
CO ₂ DCV		
Damper Styles	Parallel	
Damper Status	ОК	
Heating Type	Gas	
Heating Coil Condition	Burner	
Cooling Type	DX Dual Compressors 1 Scroll digital	
Cooling Coil Condition	Grease on Reheat, wash coils	
Wheel	Semco	
Drain Pan Status	Rusty color	
Notes:
