Holland Hill Elementary School

Fairfield Public Schools Recommissioning (RCx) and Testing, Adjusting, & Balancing (TAB) Study van Zelm Project # 2020102.00 (15-HHES)

August 08, 2022

FAIRFIELD PUBLIC SCHOOLS RECOMMISSIONING (RCX) AND TESTING, ADJUSTING, & BALANCING (TAB) STUDY

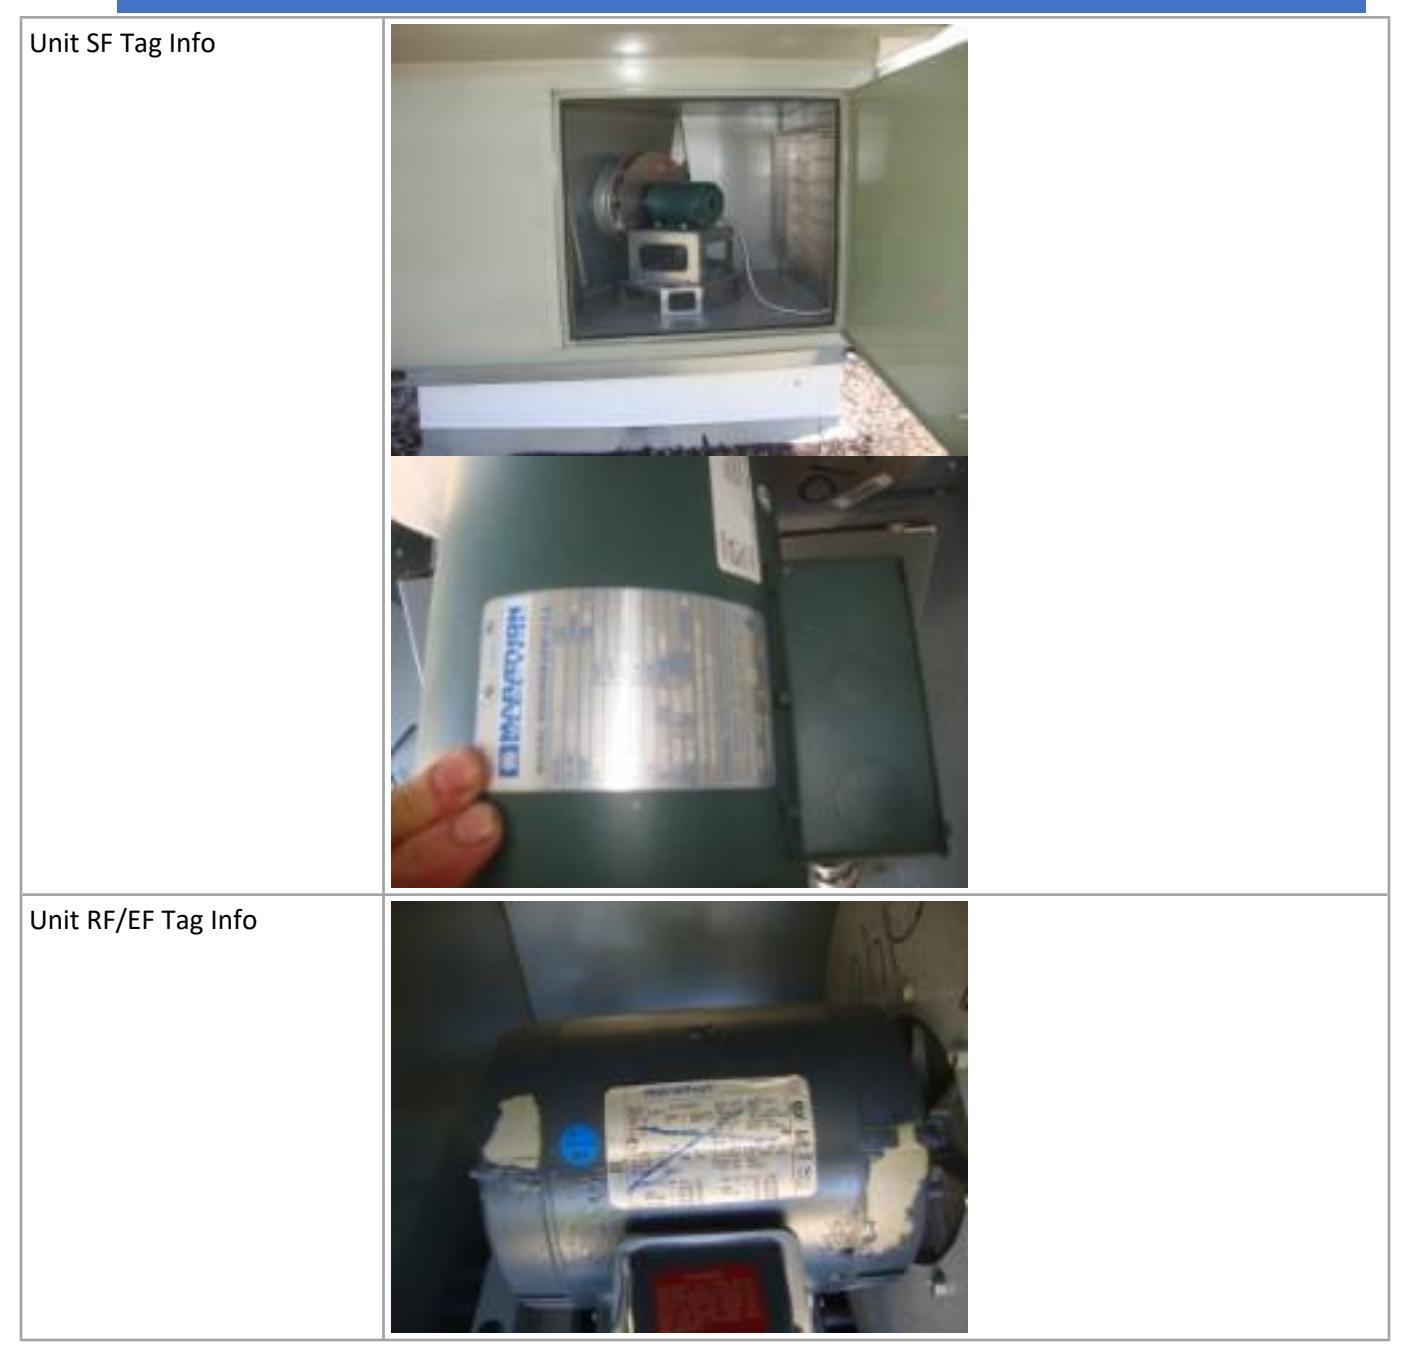
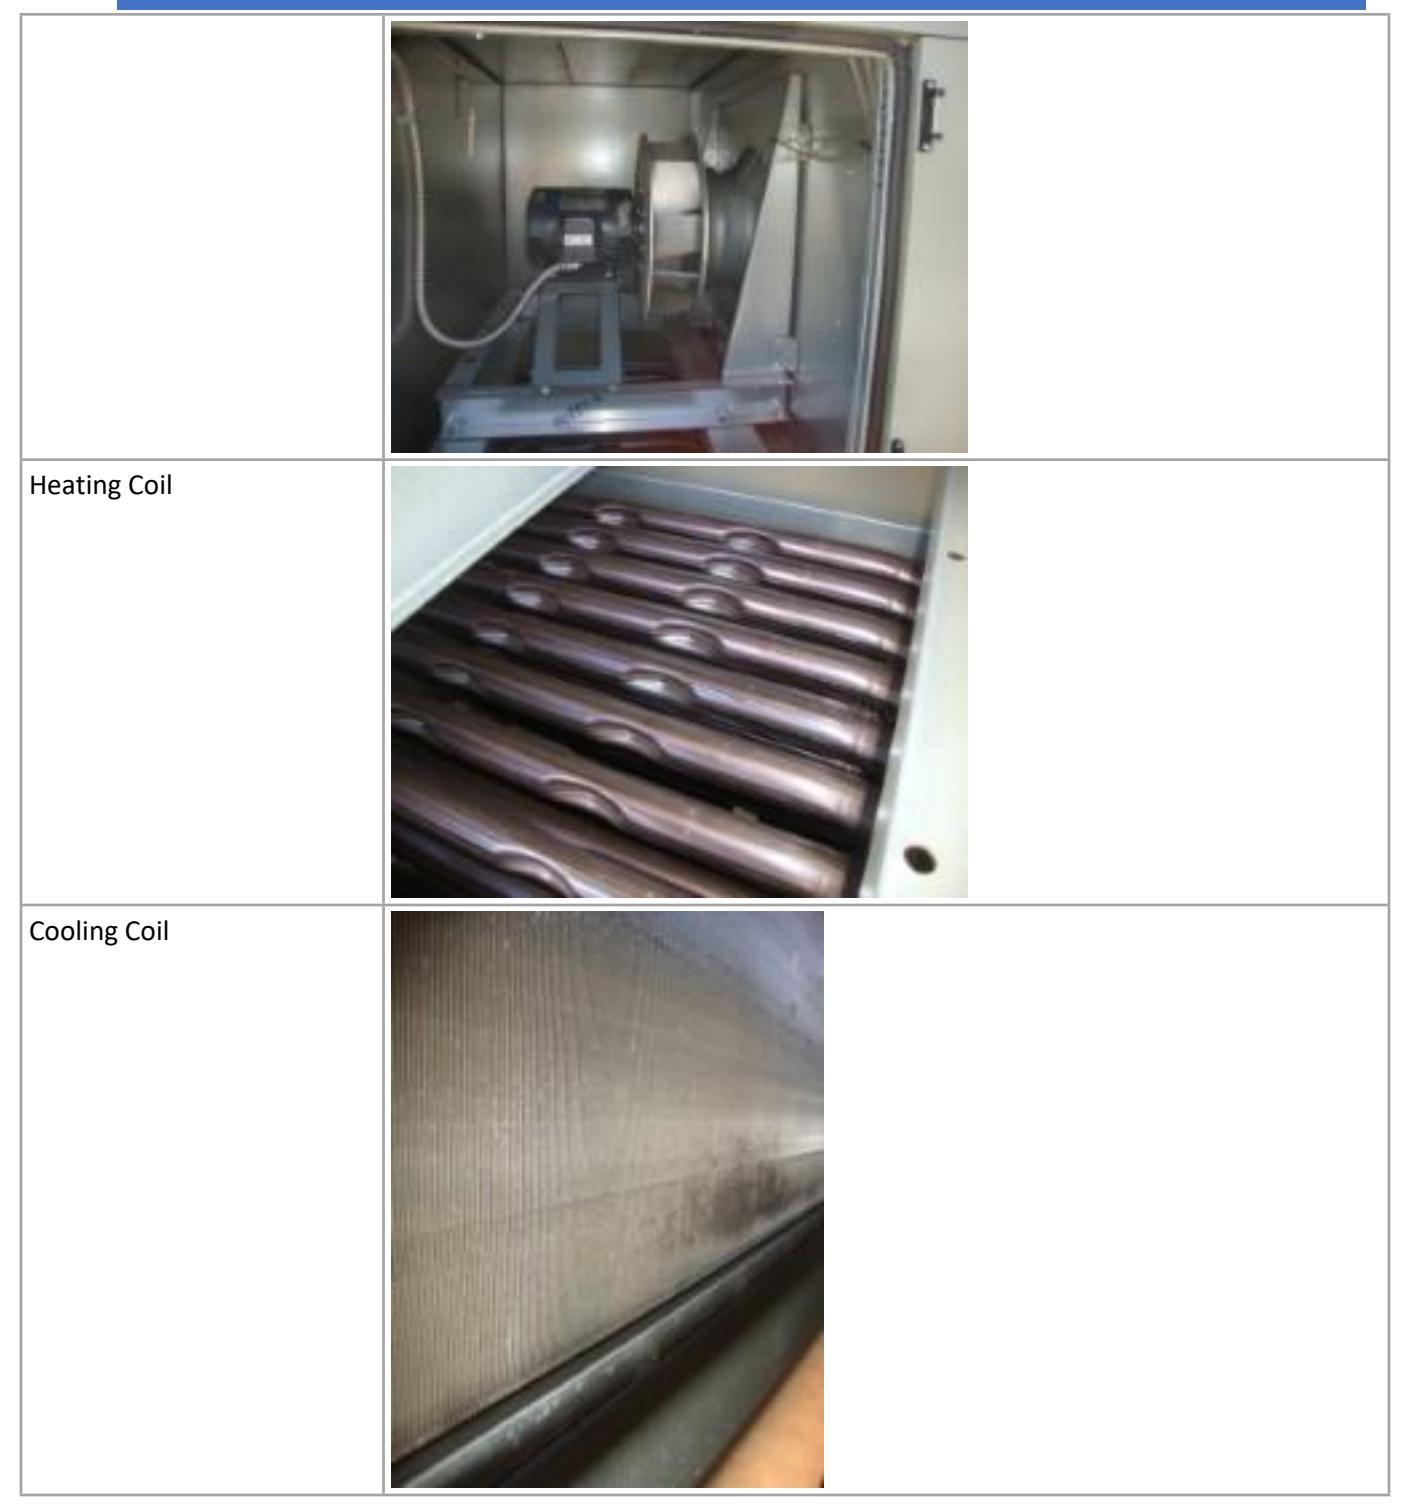
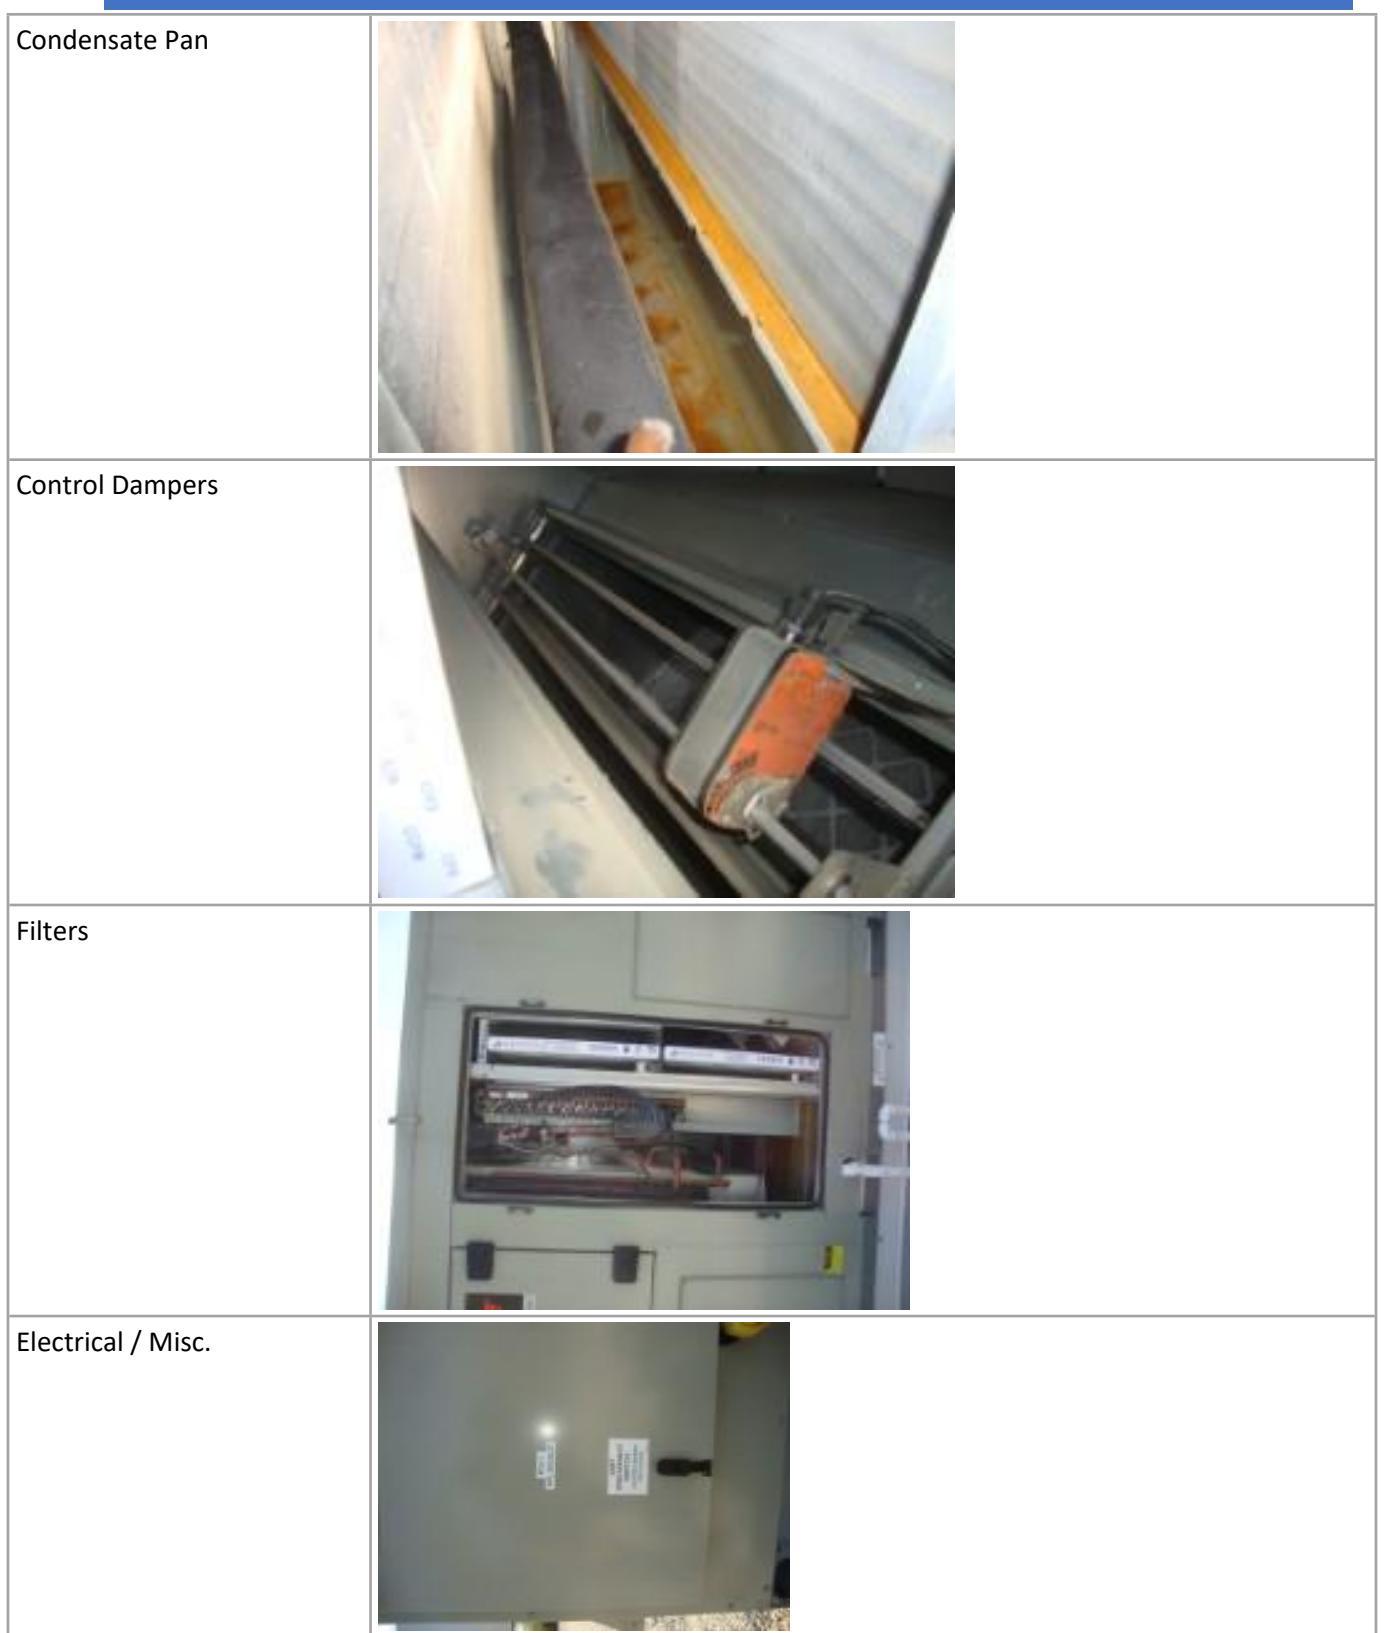
Open	RTU-2	Safety	The electrical non-metallic conduit to unit is not fastened securely, which makes it subject to damage as well as becoming a potential trip hazard
	Open	RTU-3	Cleaning	The cooling coil piping has some minor corrosion near the header

<u>Unit Tag</u>	RTU-2	Addition comments descriptions
Date: 5-5-22	Auditor: RCM	
Location	Middle Roof	
Serving	120 All-Purpose Room	
Config/Style	Rooftop SF/RF Gas Heat, DX cooling, ERW	
Mfr.	Trane	
Model #	0ADG012F1-CAB10AG00-J1AJC1AC1-41A40B03A- A00C00AB0-AA1A00A0	
Serial #	0A276188-5-1	
Age (years)	2019	
System CFM	5170	
Max OA CFM	1700	
V/Hz/Ph	208/60/3	
SF Qty/HP	5 HP	
SF VFD Data		
RF Qty/HP	1.5 HP Exh	
RF VFD Data		
Filter Data (Size Quantity)	(6) 18 X 24 X 2 SA, (6) 20 X 20 X 2 RA & ODA	
Filter Status	Clean 4-27-22	
Controls Type	Trane with BAS integration	
Controls Mfr.	Alerton BAS	
Economizer	Yes	
CO ₂ DCV	No	
Damper Styles		
Damper Status	Clean	
Heating Type	Gas Modulating	
Heating Coil Condition	250 MBH Output Modulation	
Cooling Type	DX Digital Scroll and Dx	
Cooling Coil Condition	Clean	
Drain Pan Status	Clean	
Notes:	Unit access doors very heavy and not hinged set up on dunnage. Access requires standing on Ductwork. Noted Electrical non-metallic conduit

to unit (not Main) not fastened and subject to	
damage and trip hazard

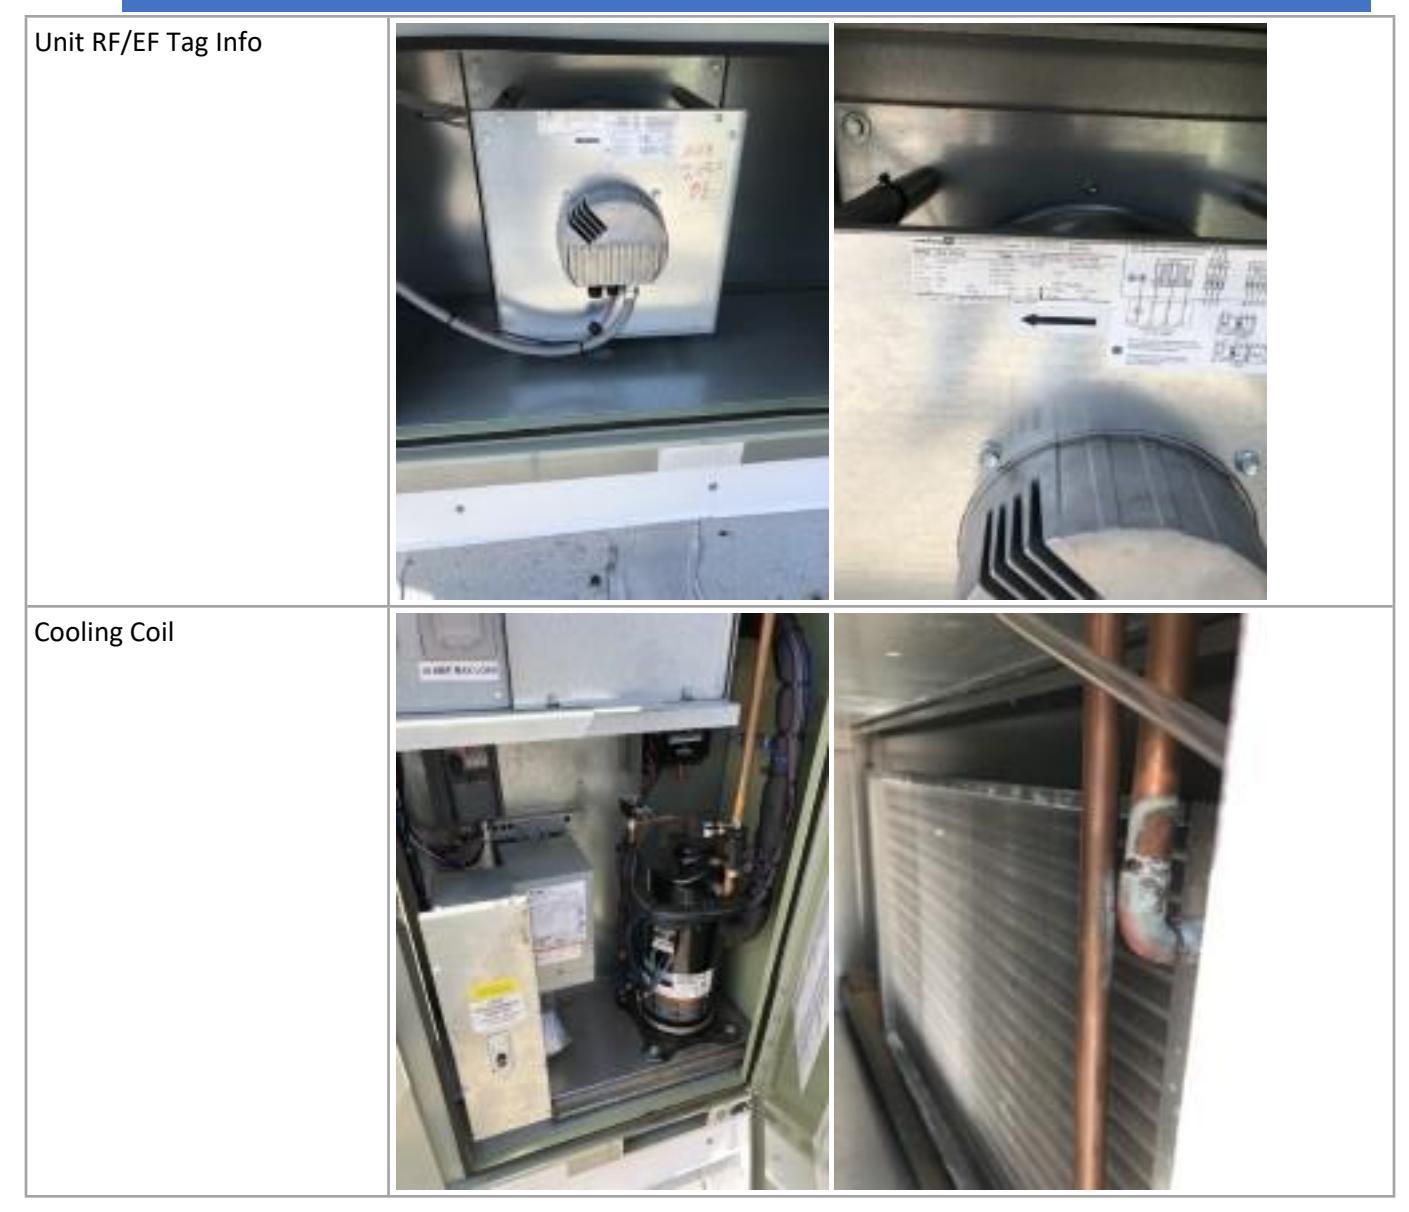
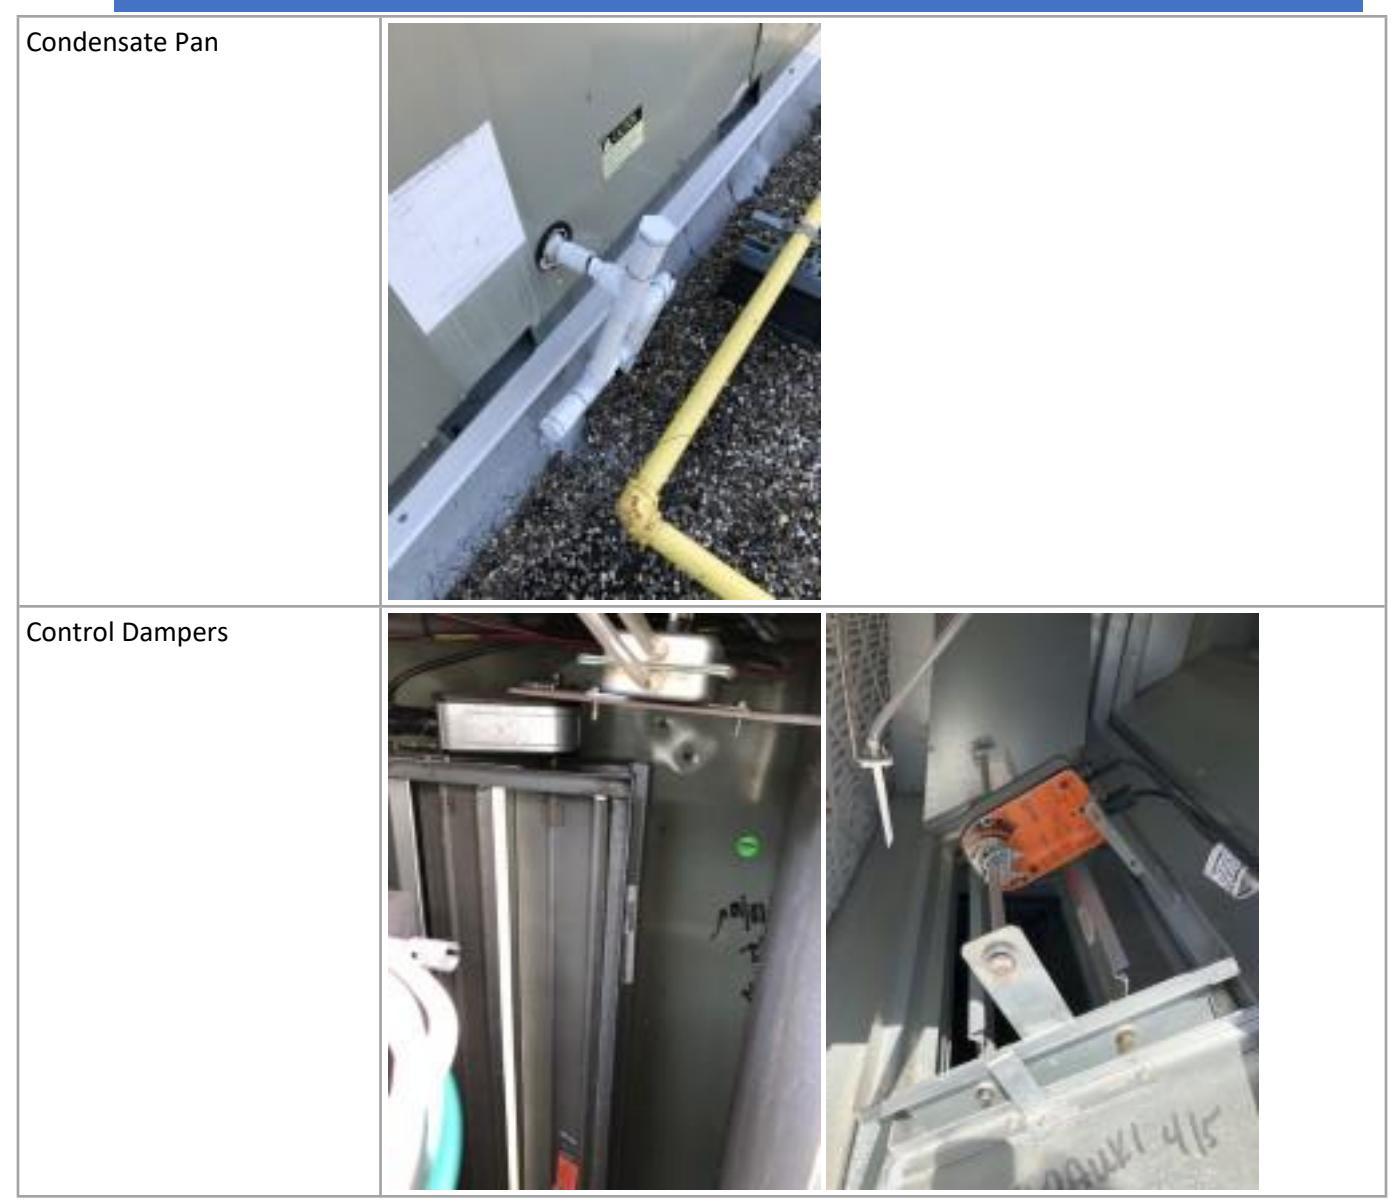
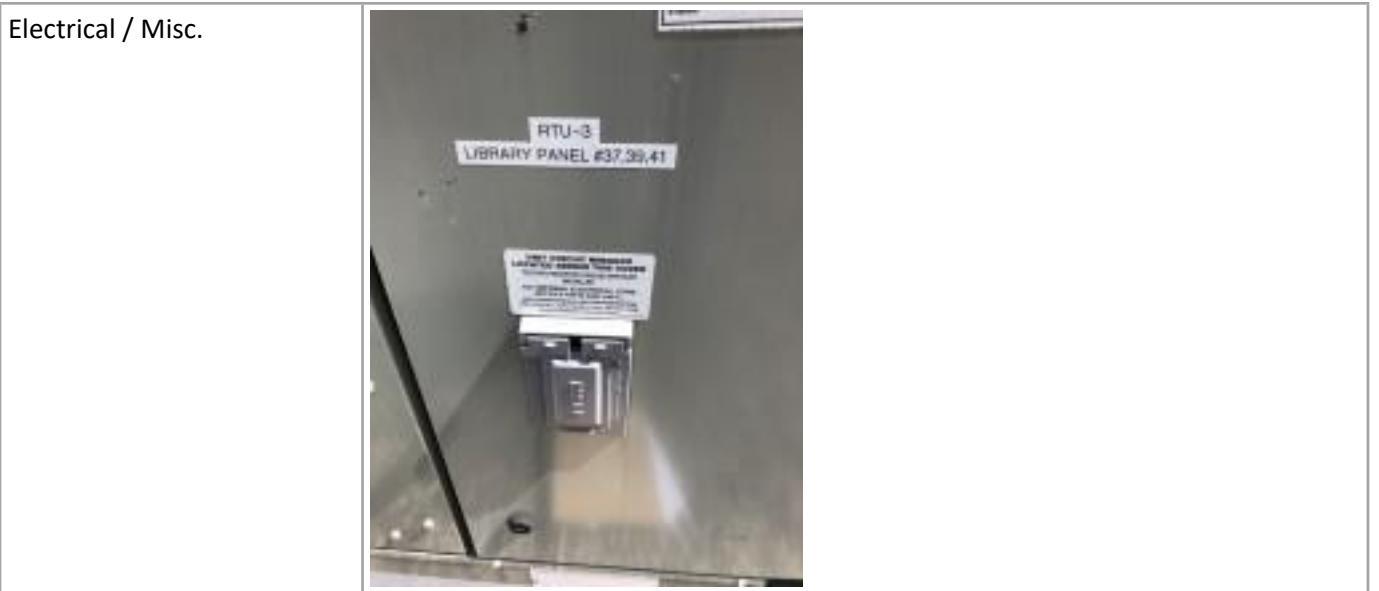
<u>Unit Tag</u>	RTU-3	Addition comments descriptions
Date: 5-5-22	Auditor: RCM	
Location	South Roof	
Serving	132 Library/Media Center	
Config/Style	Rooftop SF/RF Gas Heat, DX cooling, ERW	
Mfr.	Trane	
Model #	0ABD036A3-C1B400AB-A1C00BG6AB-D12B0C4B0	
Serial #	0A276188-6-1	
Age (years)	2019	
System CFM	1430	Display reading 1,758 CFM @ 65%
Max OA CFM	785	
V/Hz/Ph	208-60/3	
SF Qty/HP	2	
SF VFD Data	ECM	
PE Qty/HP	2	
PE VFD Data	Mitsubishi D700 Series	
Filter Data (Size Quantity)	Main / OA / Exh.: (2) 20 X 24 X 2	
Filter Status	Clean	
Controls Type	Trane Package with BAS interface	
Controls Mfr.	Alerton BAS	
Economizer	Yes	
CO ₂ DCV	No	
Damper Styles		
Damper Status	Good 20% Min setpoint	
Heating Type	Gas Heat Modulating 100 MBH Output	
Heating Coil Condition		
Cooling Type	DX single scroll compressor	
Cooling Coil Condition	Clean	
Drain Pan Status		
Notes:	ERW Semco UWCH-30-1-0-1-B00
