# Jennings Elementary School 31 Palm Drive

# Fairfield Public Schools Recommissioning (RCx) and Testing, Adjusting, & Balancing (TAB) Study

van Zelm Project # 2020102.00 (10-JES) October 07, 2022

# **Jennings Elementary School**

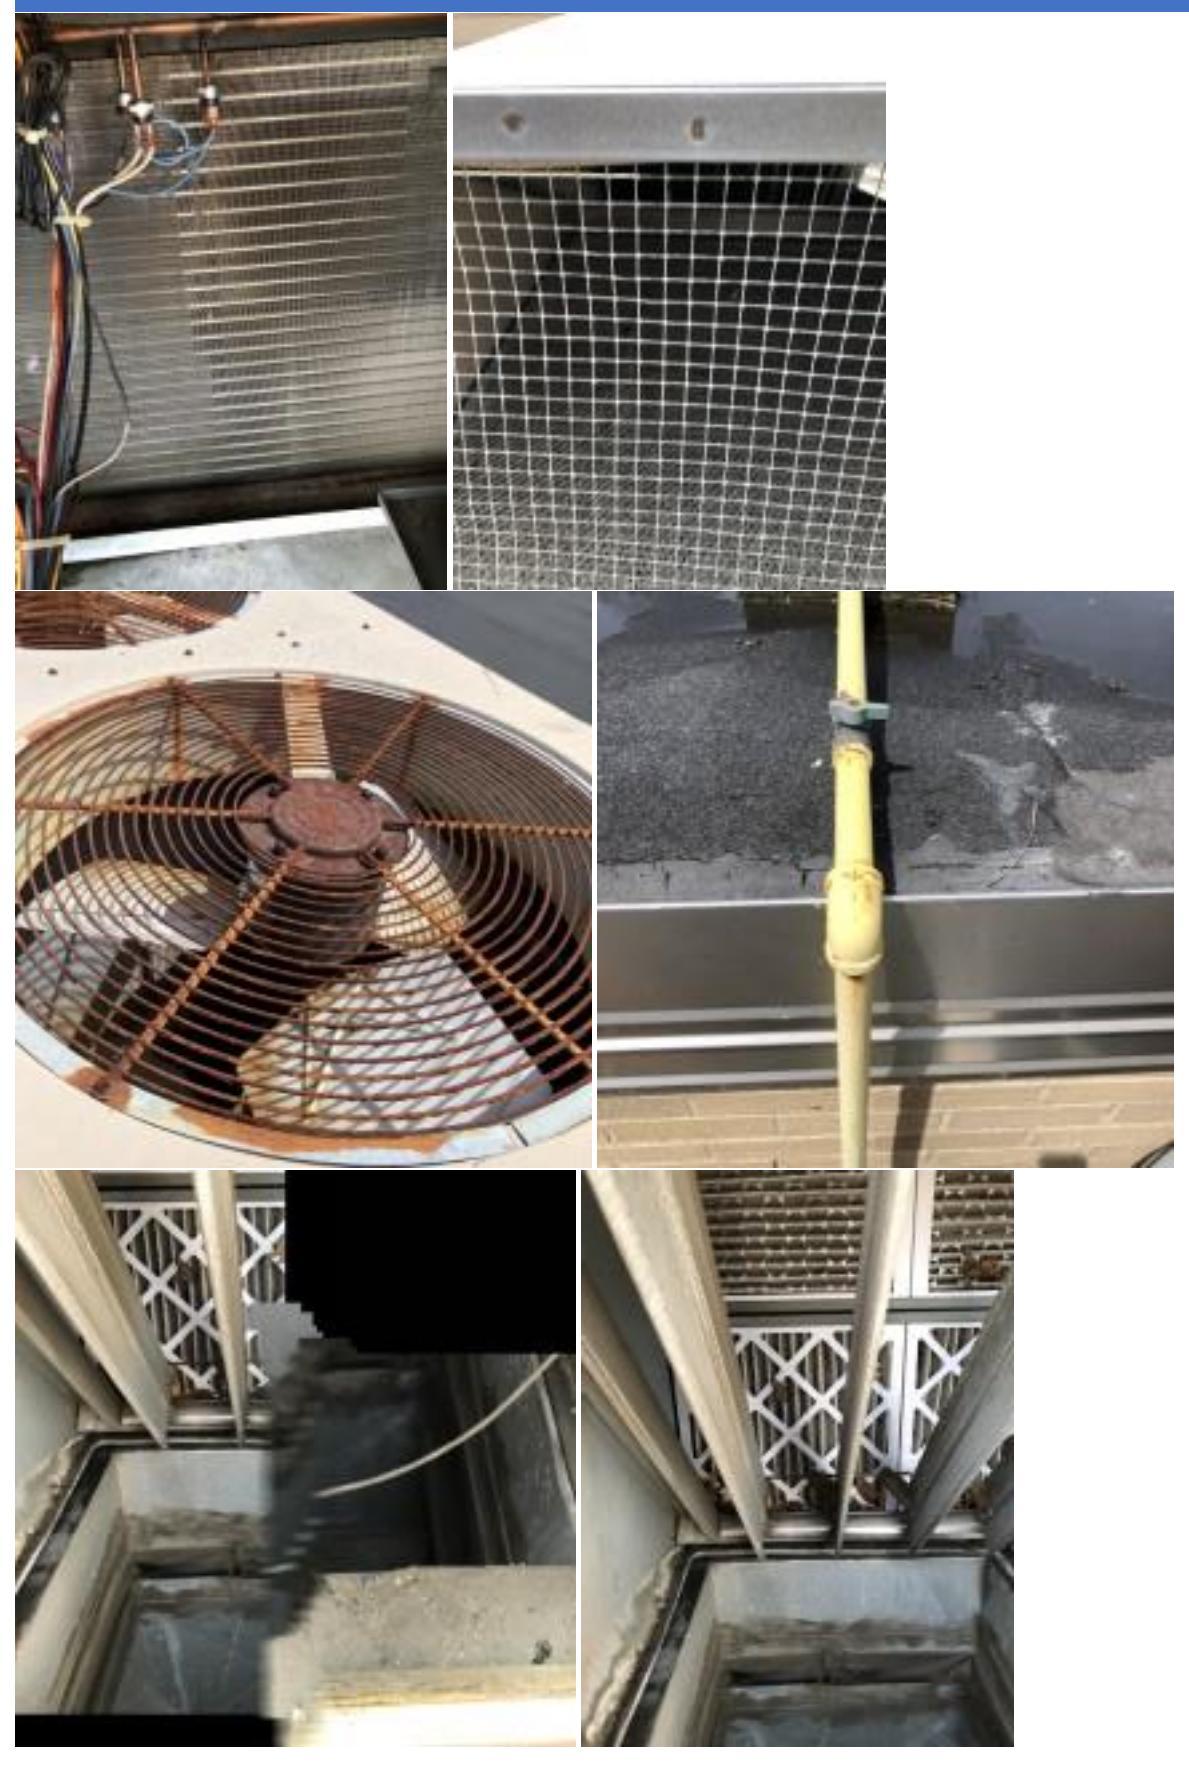
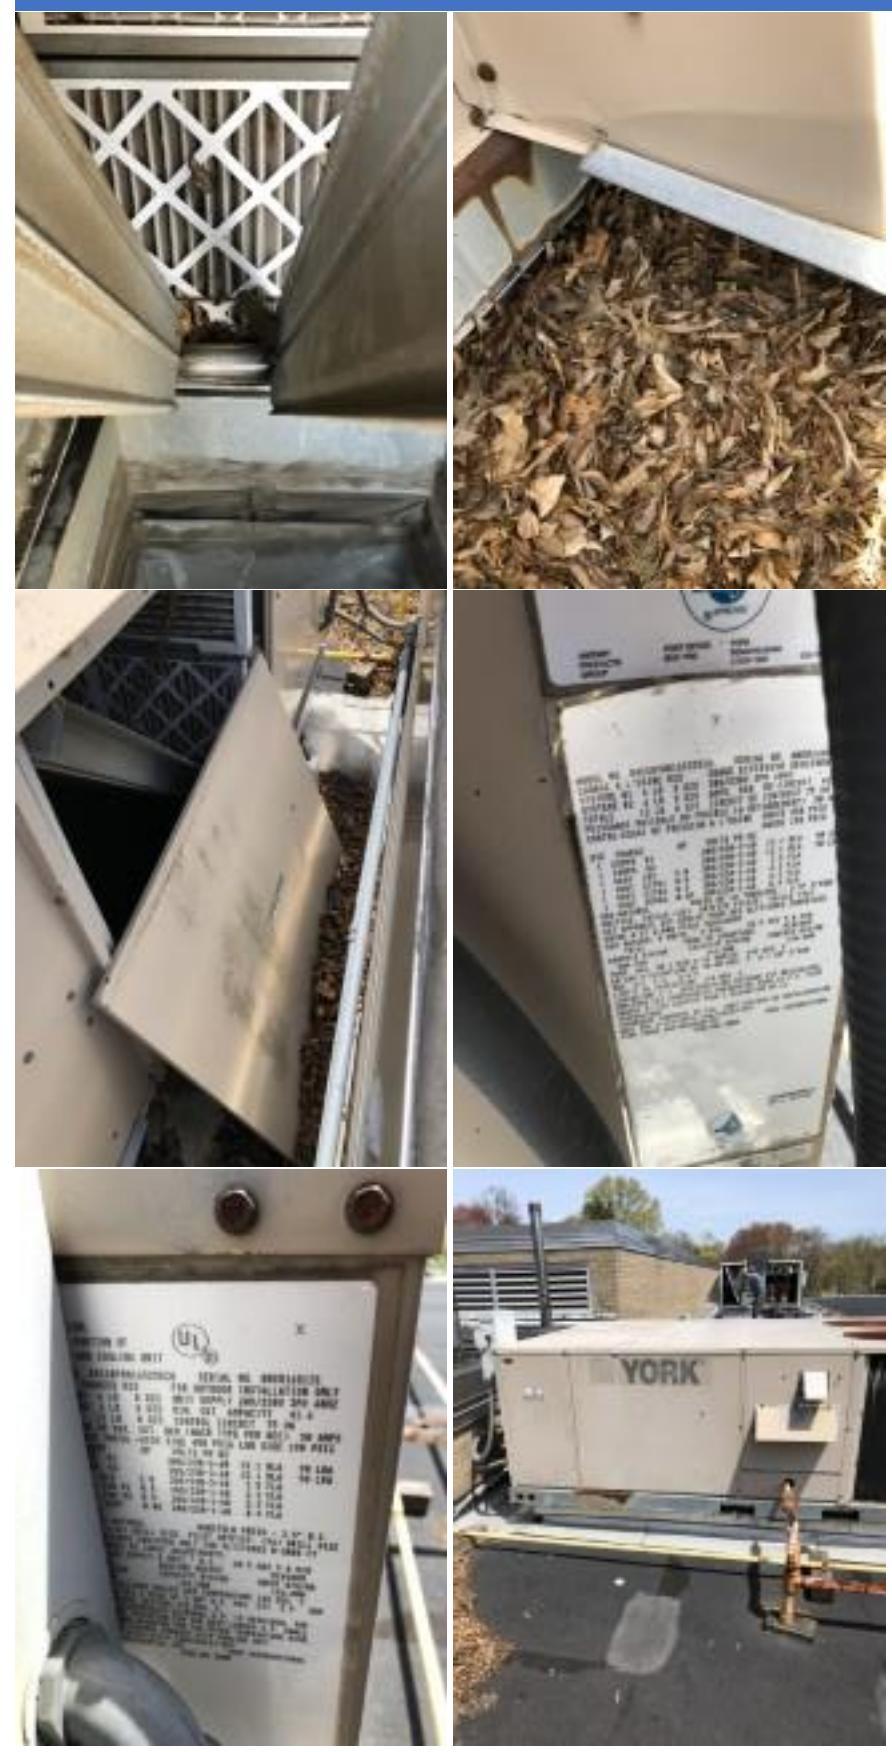
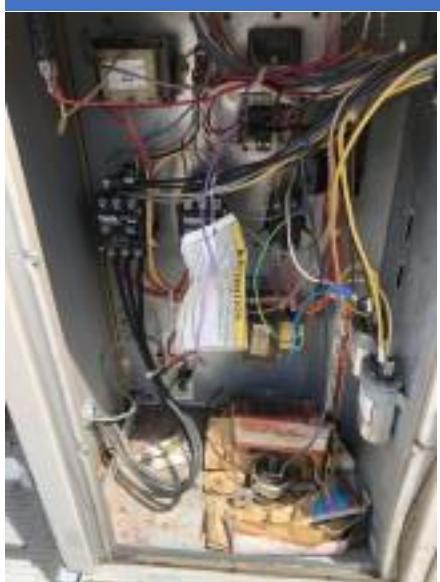
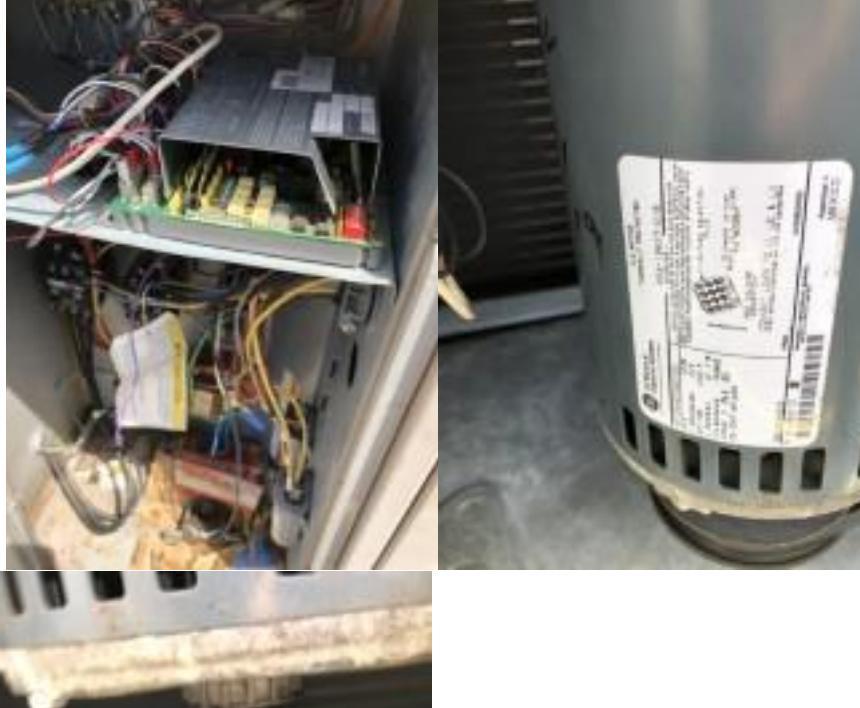
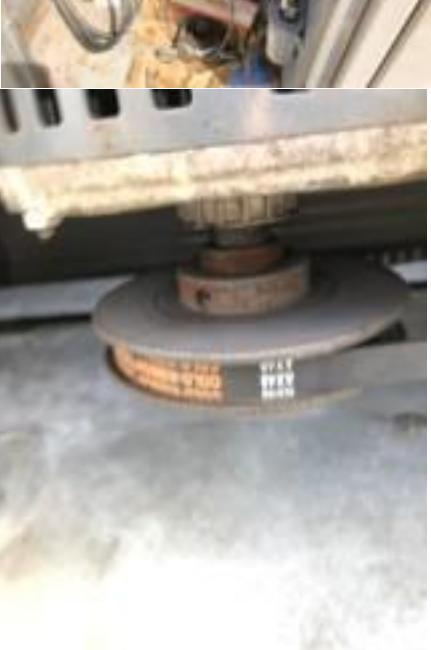
Unit Tag	AC-1	Addition comments descriptions
Location	Office Area Roof	
Serving	Main Offices	
Config/Style	Gas / Air Conditioning Unit	
Mfr.	York	
Model #	D4CG890N16525ECA	
Serial #	NNGM168131	
Age (years)	+15	
System CFM		
Max OA CFM	Minimum	
V/Hz/Ph	208/230 3 Phase	
SF Qty/HP	2 HP	Belt AX 48
SF VFD Data	NA	
Filter Data (Size Quantity)	(30 12 x 16 x 2, (3) 16 x 16 x 2	Changed 4-27
Filter Status	Filters have leaves on media due to side panel left off while changing filters	
Controls Type	Conventional with BAS interface	
Controls Mfr.	JCI	
Economizer	NA Inoperative	
CO <sub>2</sub> DCV	No	
Damper Styles	Mfg. Flapper	
Damper Status	Dampers not operative	
Heating Type	Gas	
Heating Coil Condition	Average	
Cooling Type	DX 1 stage	
Cooling Coil Condition	Moderately dirty. Unit showing signs of external rust and corrosion	
CU Mfr.		
CU Model		
CU Serial		
Drain Pan Status	Should be cleaned	
Notes:	Generally, not in good operational condition. Unit need good internal cleaning as filter access side panel was not fastened and leaves entered unit

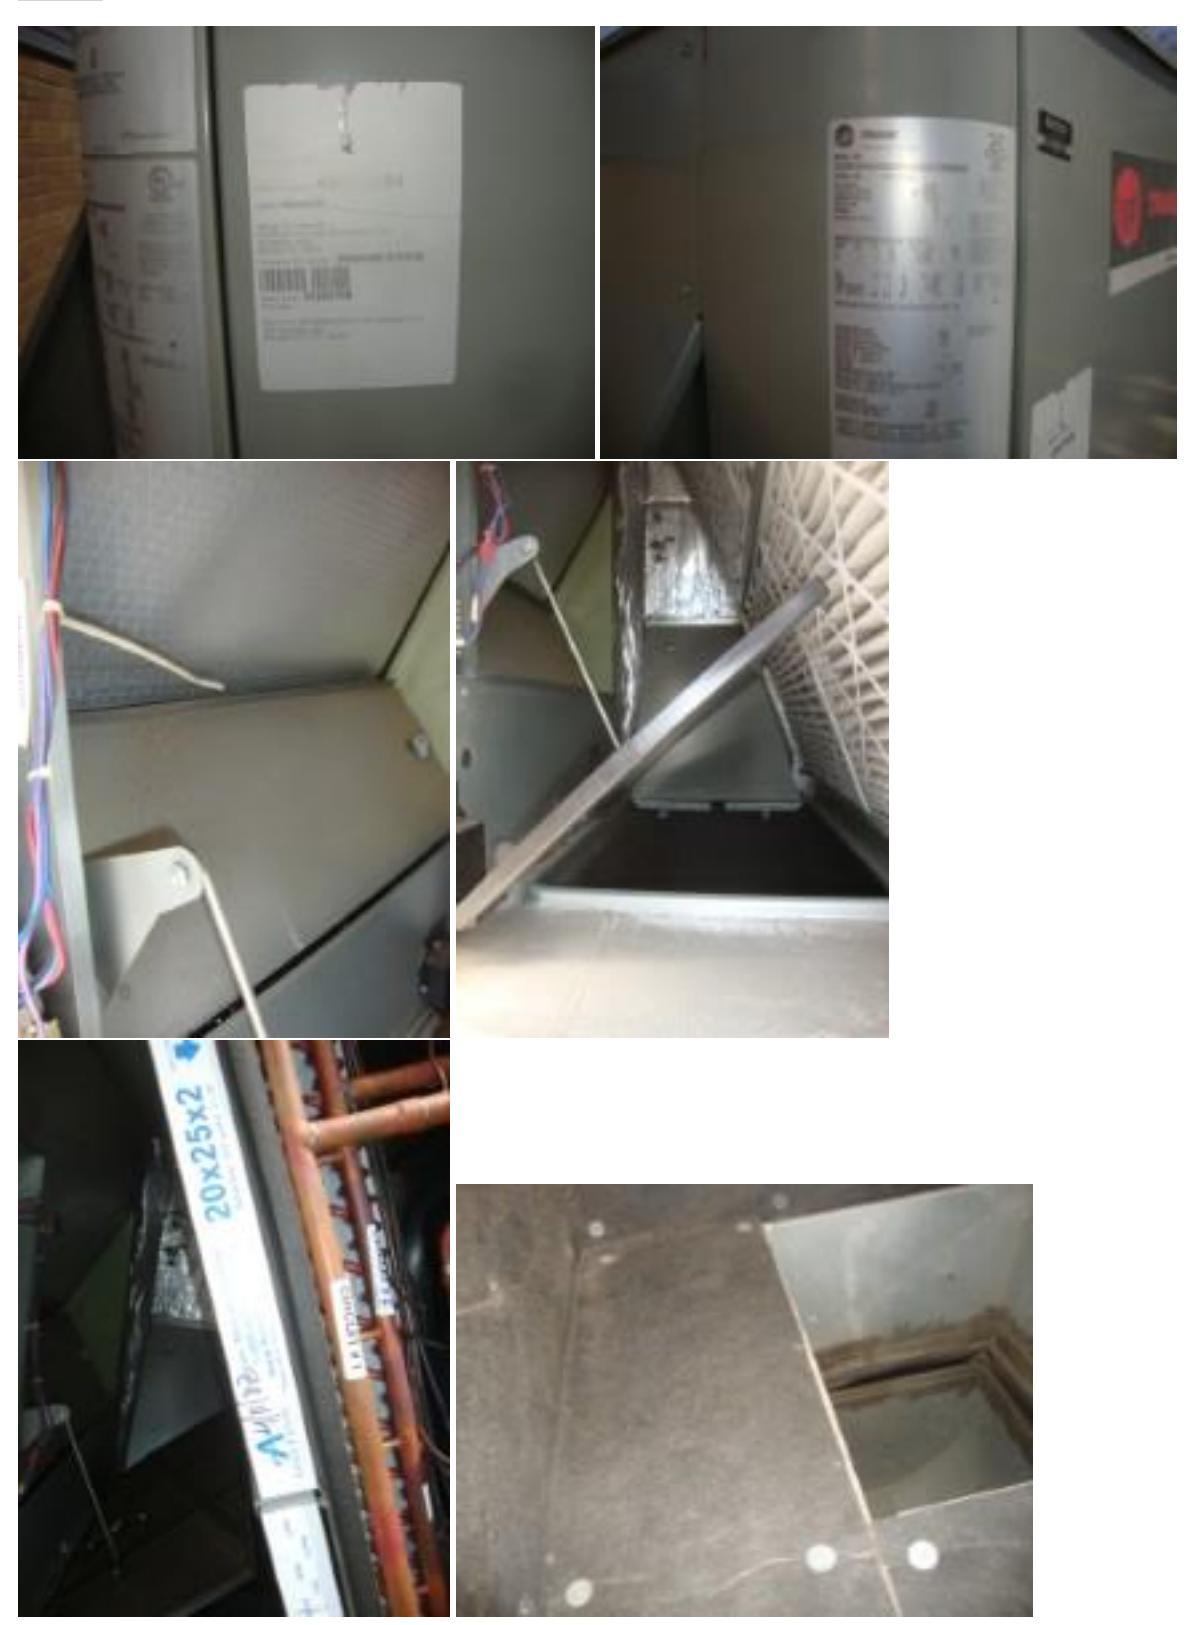
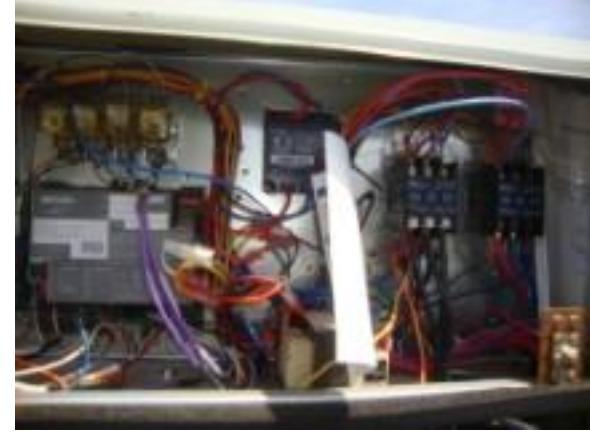
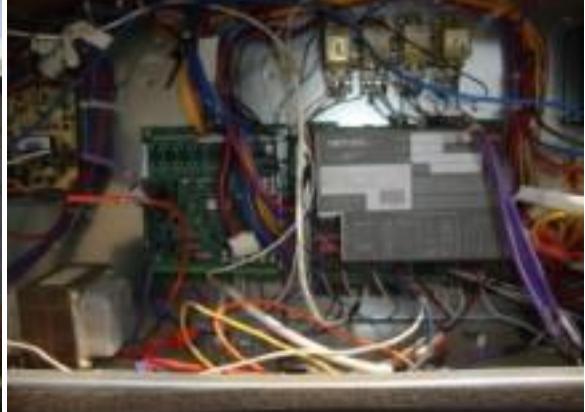
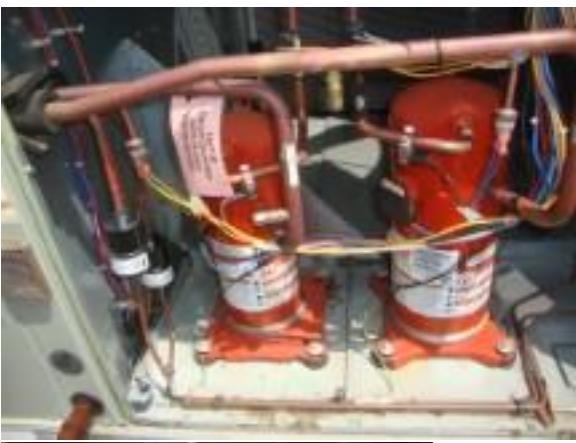
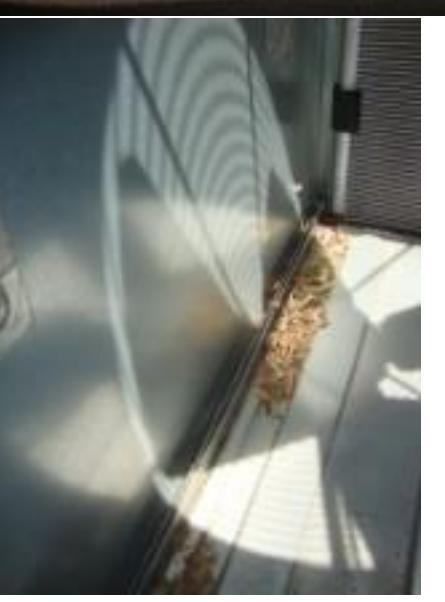
Unit Tag	AC-2	Addition comments descriptions
Location	Library Roof	
Serving	Library/Media Center	
Config/Style	Gas DX	
Mfr.	Trane Precedent	
Model #	YHC092F3RHAOH0	
Serial #	161311106L	
Age (years)	3/20/2018	
System CFM		
Max OA CFM		
V/Hz/Ph	208-230/60/3	
SF Qty/HP	3.8	
SF VFD Data	ECM	
RF Qty/HP	N/A	
RF VFD Data	N/A	
Filter Data (Size Quantity)	(4) 20x25x2	
Filter Status	Clean 4/11/22	
Controls Type	Factory DDC Metasys	
Controls Mfr.	Trane	
Economizer	Available	
CO <sub>2</sub> DCV		
Damper Styles	Factory Flap	
Damper Status	ОК	
Heating Type	Gas	
Heating Coil Condition	Burner	
Cooling Type	DX Twin compressor	
Cooling Coil Condition	Could use a wash	
Drain Pan Status	ОК	
Notes:	O.A. Hood metal filters very dirty, large PD. Debris in condensing unit section	Photos

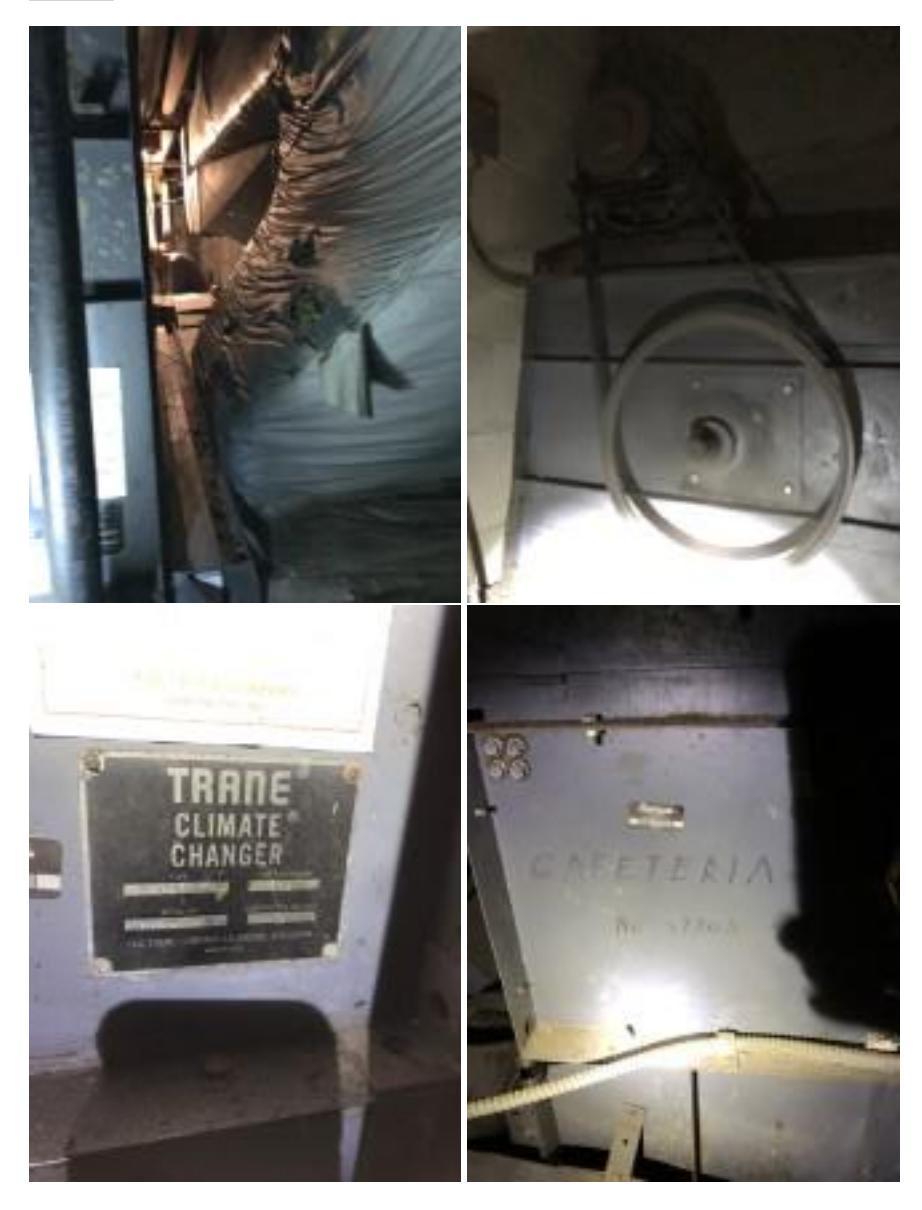
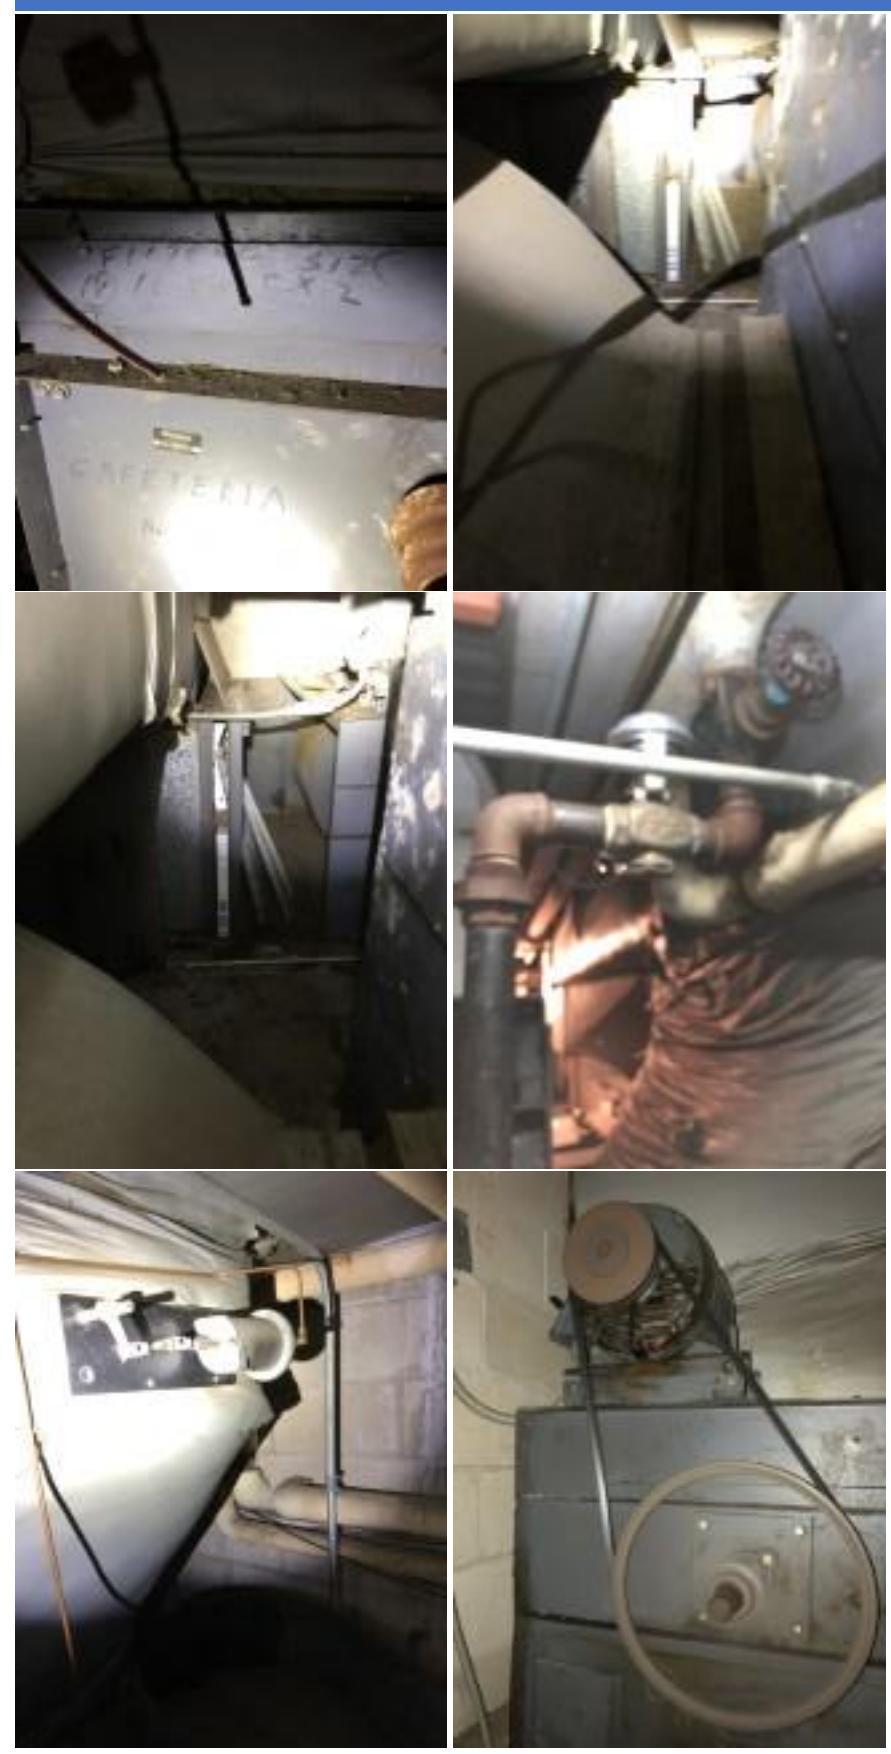
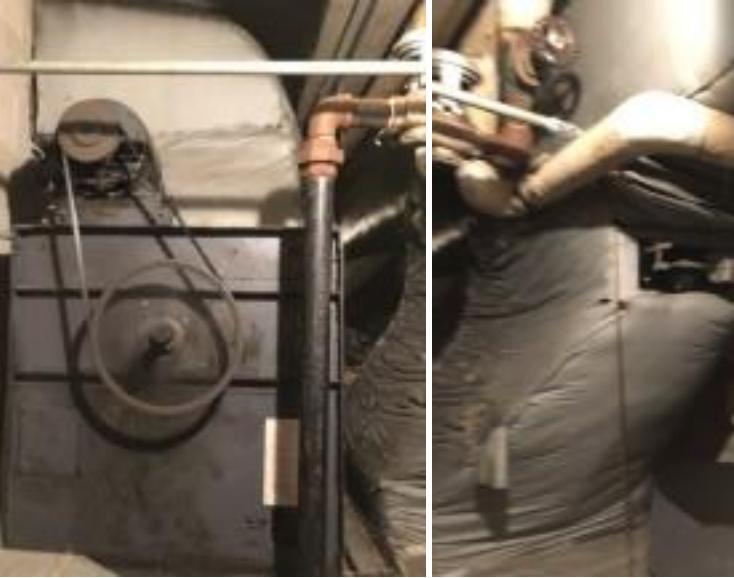
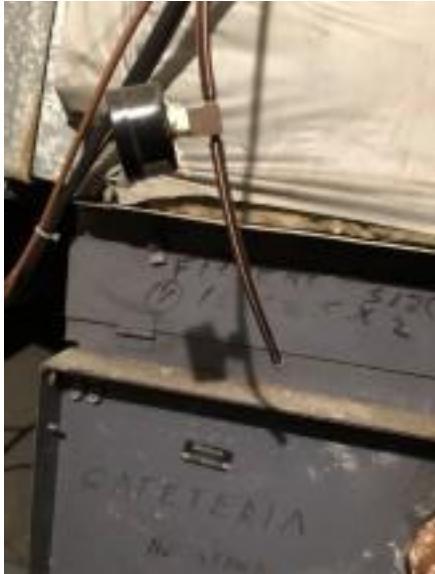
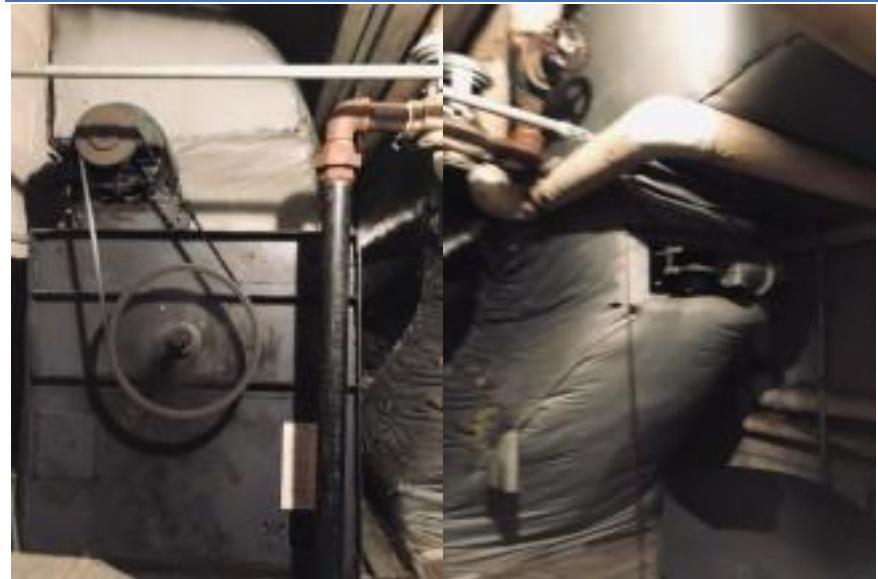
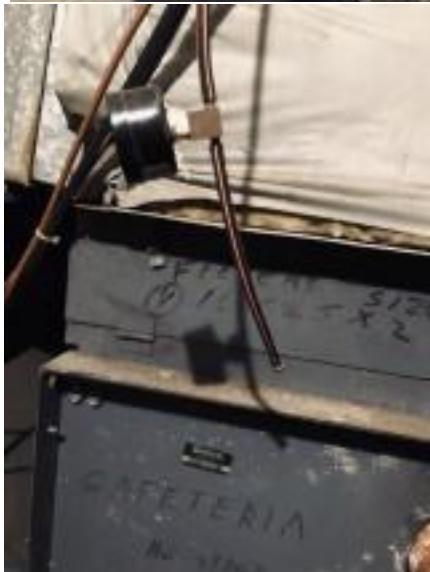
Unit Tag	HV-2	Addition comments descriptions
Location	Mezzanine	
Serving	Main Office	
Config/Style	Heating and Ventilation Unit, Climate Changer	
Mfr.	Trane	
Model #	Type L-17	
Serial #	К1003693	
Age (years)		
System CFM		
Max OA CFM		
V/Hz/Ph	208-230/60/3	
SF Qty/HP	(1) Unknown	
SF VFD Data	N/A-Starter constant speed	
RF Qty/HP	(1) Unknown	
RF VFD Data	N/A-Starter constant speed	
Filter Data (Size Quantity)	(XX) 16x22x12	
Filter Status	Clean, difficult to access	
Controls Type	Pneumatic	
Controls Mfr.		
Economizer		
CO <sub>2</sub> DCV		
Damper Styles	Duct Mounted, no access	
Damper Status	Unknown	
Heating Type	Hot Water	
Heating Coil Condition	Dirty	
Cooling Type	N/A	
Cooling Coil Condition	N/A	
Drain Pan Status	N/A	
Notes:	Units are beyond their useful life and should be replaced. Inline return fan appears to have not run in a long time. Belt rusted in place

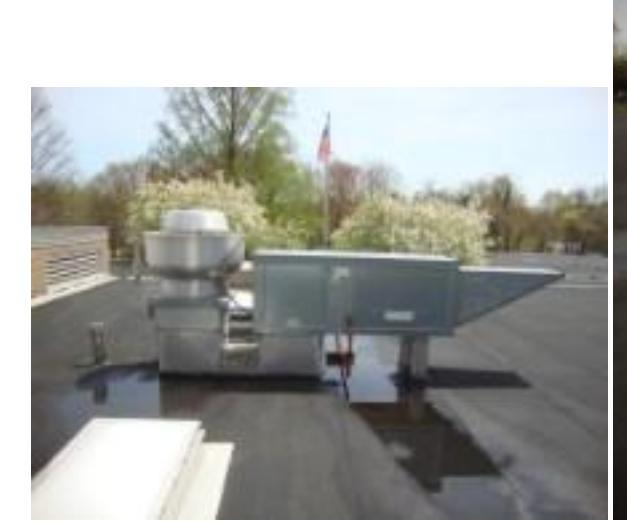
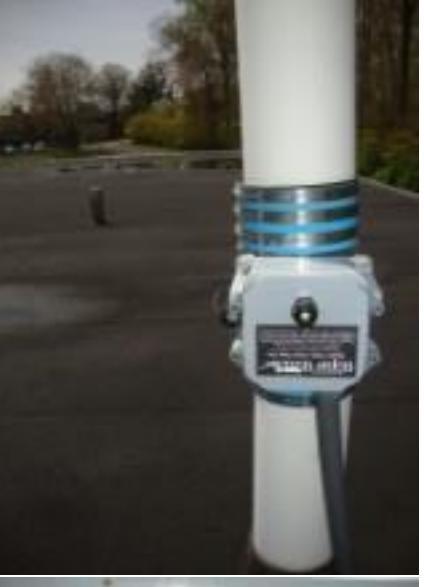
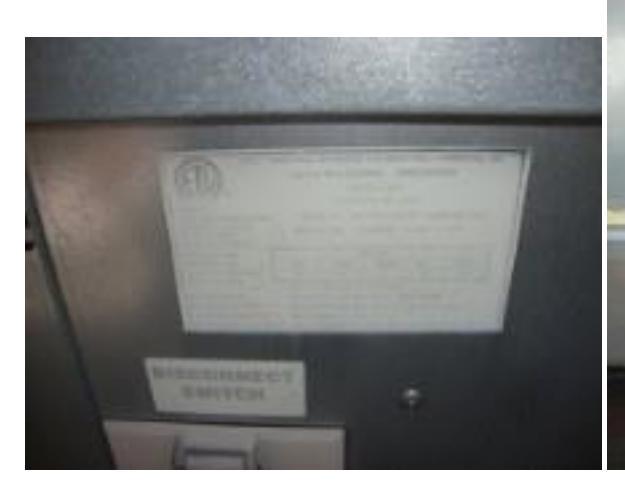
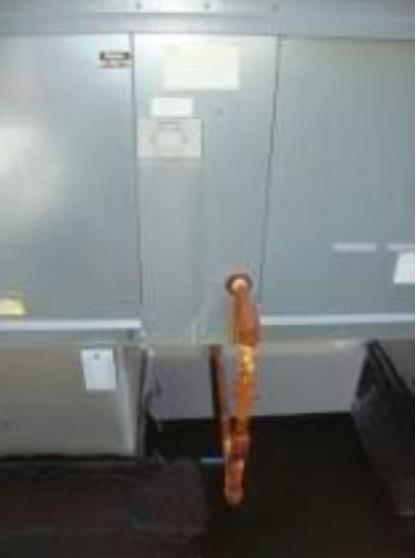
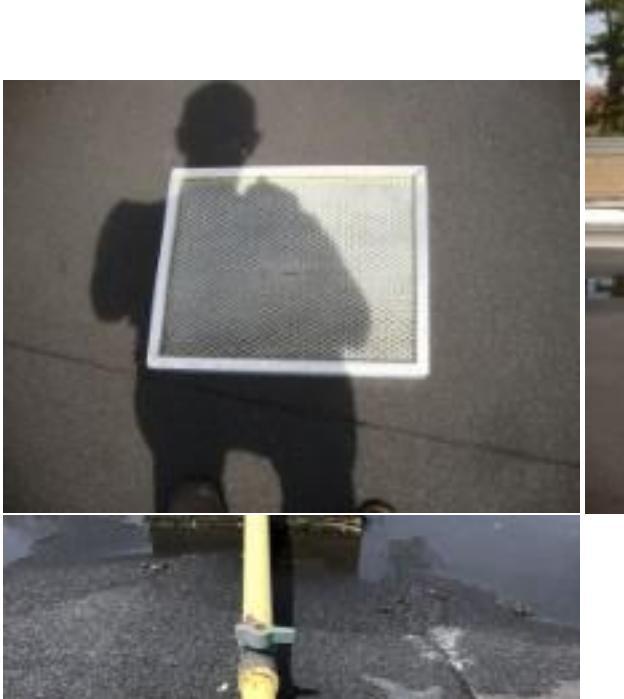
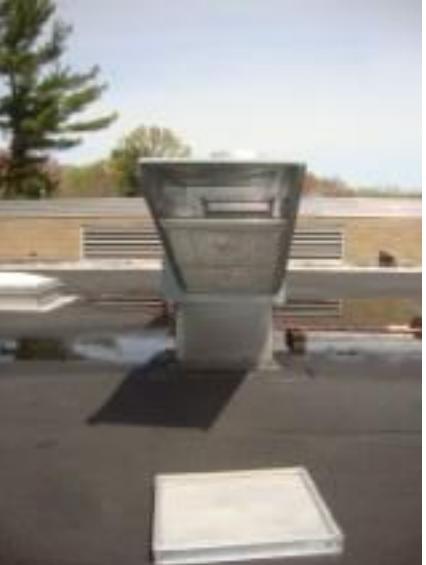
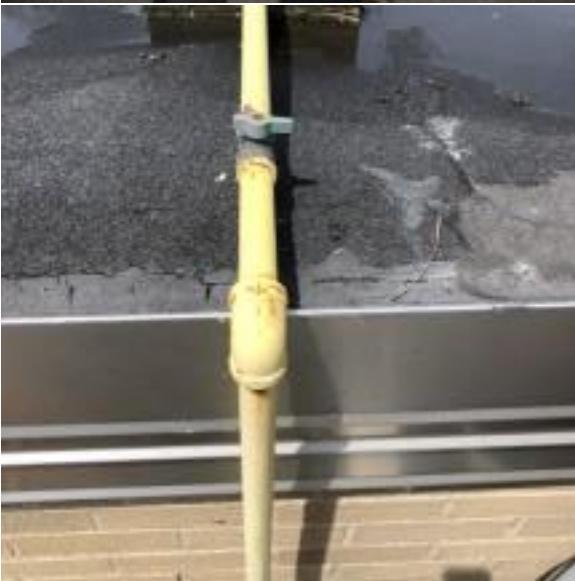
Unit Tag	MAU-1	Addition comments descriptions
Location	Kitchen Roof	Unit Gas OFF
Serving	Kitchen Make-up	
Config/Style	Heating and Ventilation Unit	
Mfr.	Captive Aire Systems	
Model #	NRTP-A-NHMUA1-12-G10-NCA16FA	
Job #	267088	
Age (years)	7-30-2004	
System CFM		
Max OA CFM		
V/Hz/Ph	230/60/1	
SF Qty/HP	(1) 1.5	
SF VFD Data	Unknown	
RF Qty/HP	Unknown	
RF VFD Data	Unknown	
Filter Data (Size Quantity)	(3) 16x16-2 Aluminum Filters	
Filter Status	Dirty	
Controls Type	Factory	
Controls Mfr.		
Economizer	N/A	
CO <sub>2</sub> DCV	N/A	
Damper Styles	Parallel	
Damper Status	Unknown	
Heating Type	Gas	Gas Valved off
Heating Coil Condition	Burner	
Cooling Type	N/A	
Cooling Coil Condition	N/A	
Drain Pan Status		
Notes:	Functionality unknown

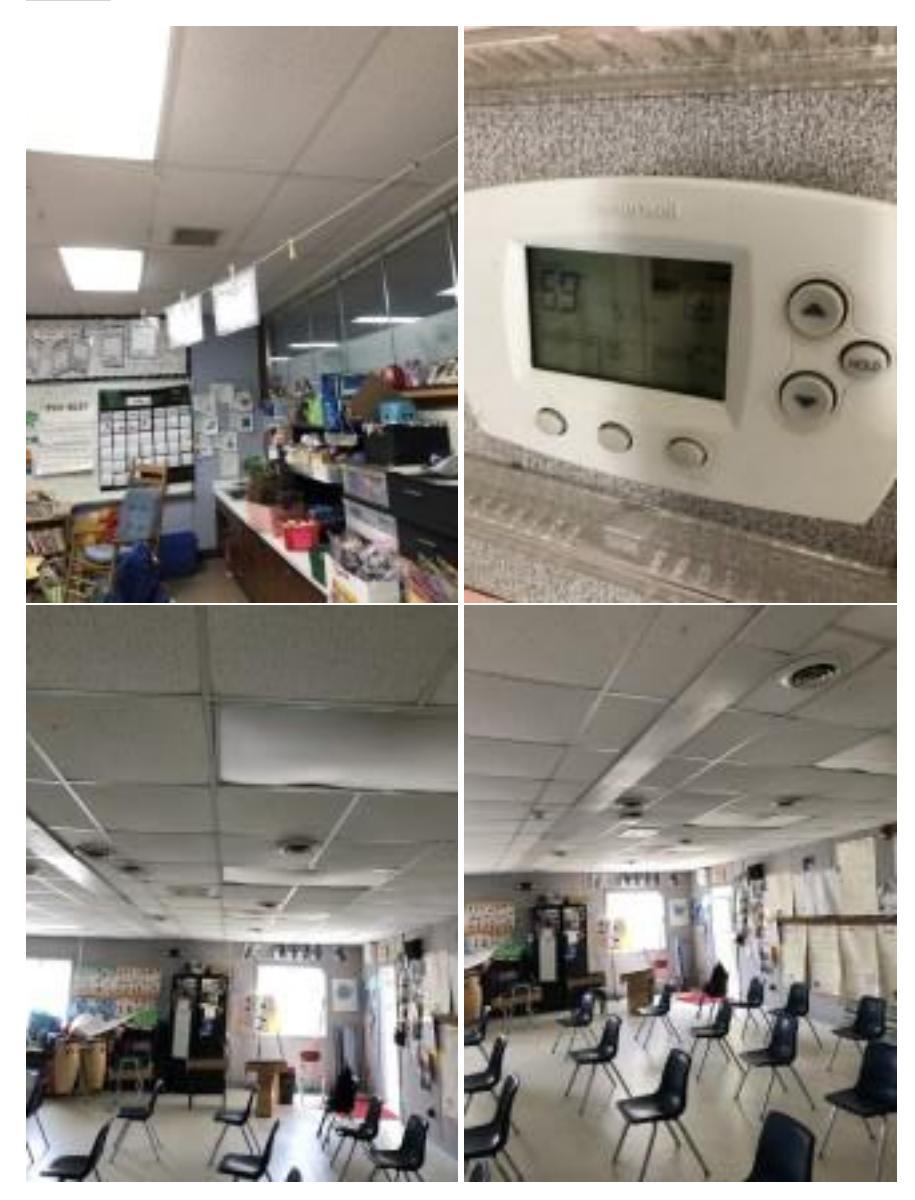
Unit Tag	RTU X	Addition comments descriptions
Location	Temp Building Roof	
Serving	Temp Classroom	
Config/Style	Heat pump Unit	
Mfr.		
Model #		
Serial #		
Age (years)	+10	
System CFM		
Max OA CFM		
V/Hz/Ph		
SF Qty/HP		
SF VFD Data		
RF Qty/HP		
RF VFD Data		
Filter Data (Size Quantity)		
Filter Status		
Controls Type	Conventional thermostat	
Controls Mfr.		
Economizer		
CO <sub>2</sub> DCV		
Damper Styles		
Damper Status		
Heating Type		
Heating Coil Condition		
Cooling Type		
Cooling Coil Condition		
CU Mfr.		
CU Model		
CU Serial		
Drain Pan Status		
Notes:	No ladder available for access but space was being mechanically cooled	Seemed a bit stuffy in space
