Subject: Addendum 4, Bid FB-25-02, Camarillo Heights STEM Academy, Campus  
Fire Alarm Upgrades

RE: LIMITED LEAD-BASED PAINT SURVEY REPORT  
Camarillo Heights Elementary School  
Boys and Girls Restroom  
Camarillo, California

**Asbestos Survey for  
Camarillo Heights ES  
35 Catalina Drive  
Camarillo, California**

RE: ASBESTOS SURVEY REPORT FOR  
Camarillo Heights ES  
35 Catalina Drive  
Camarillo, California

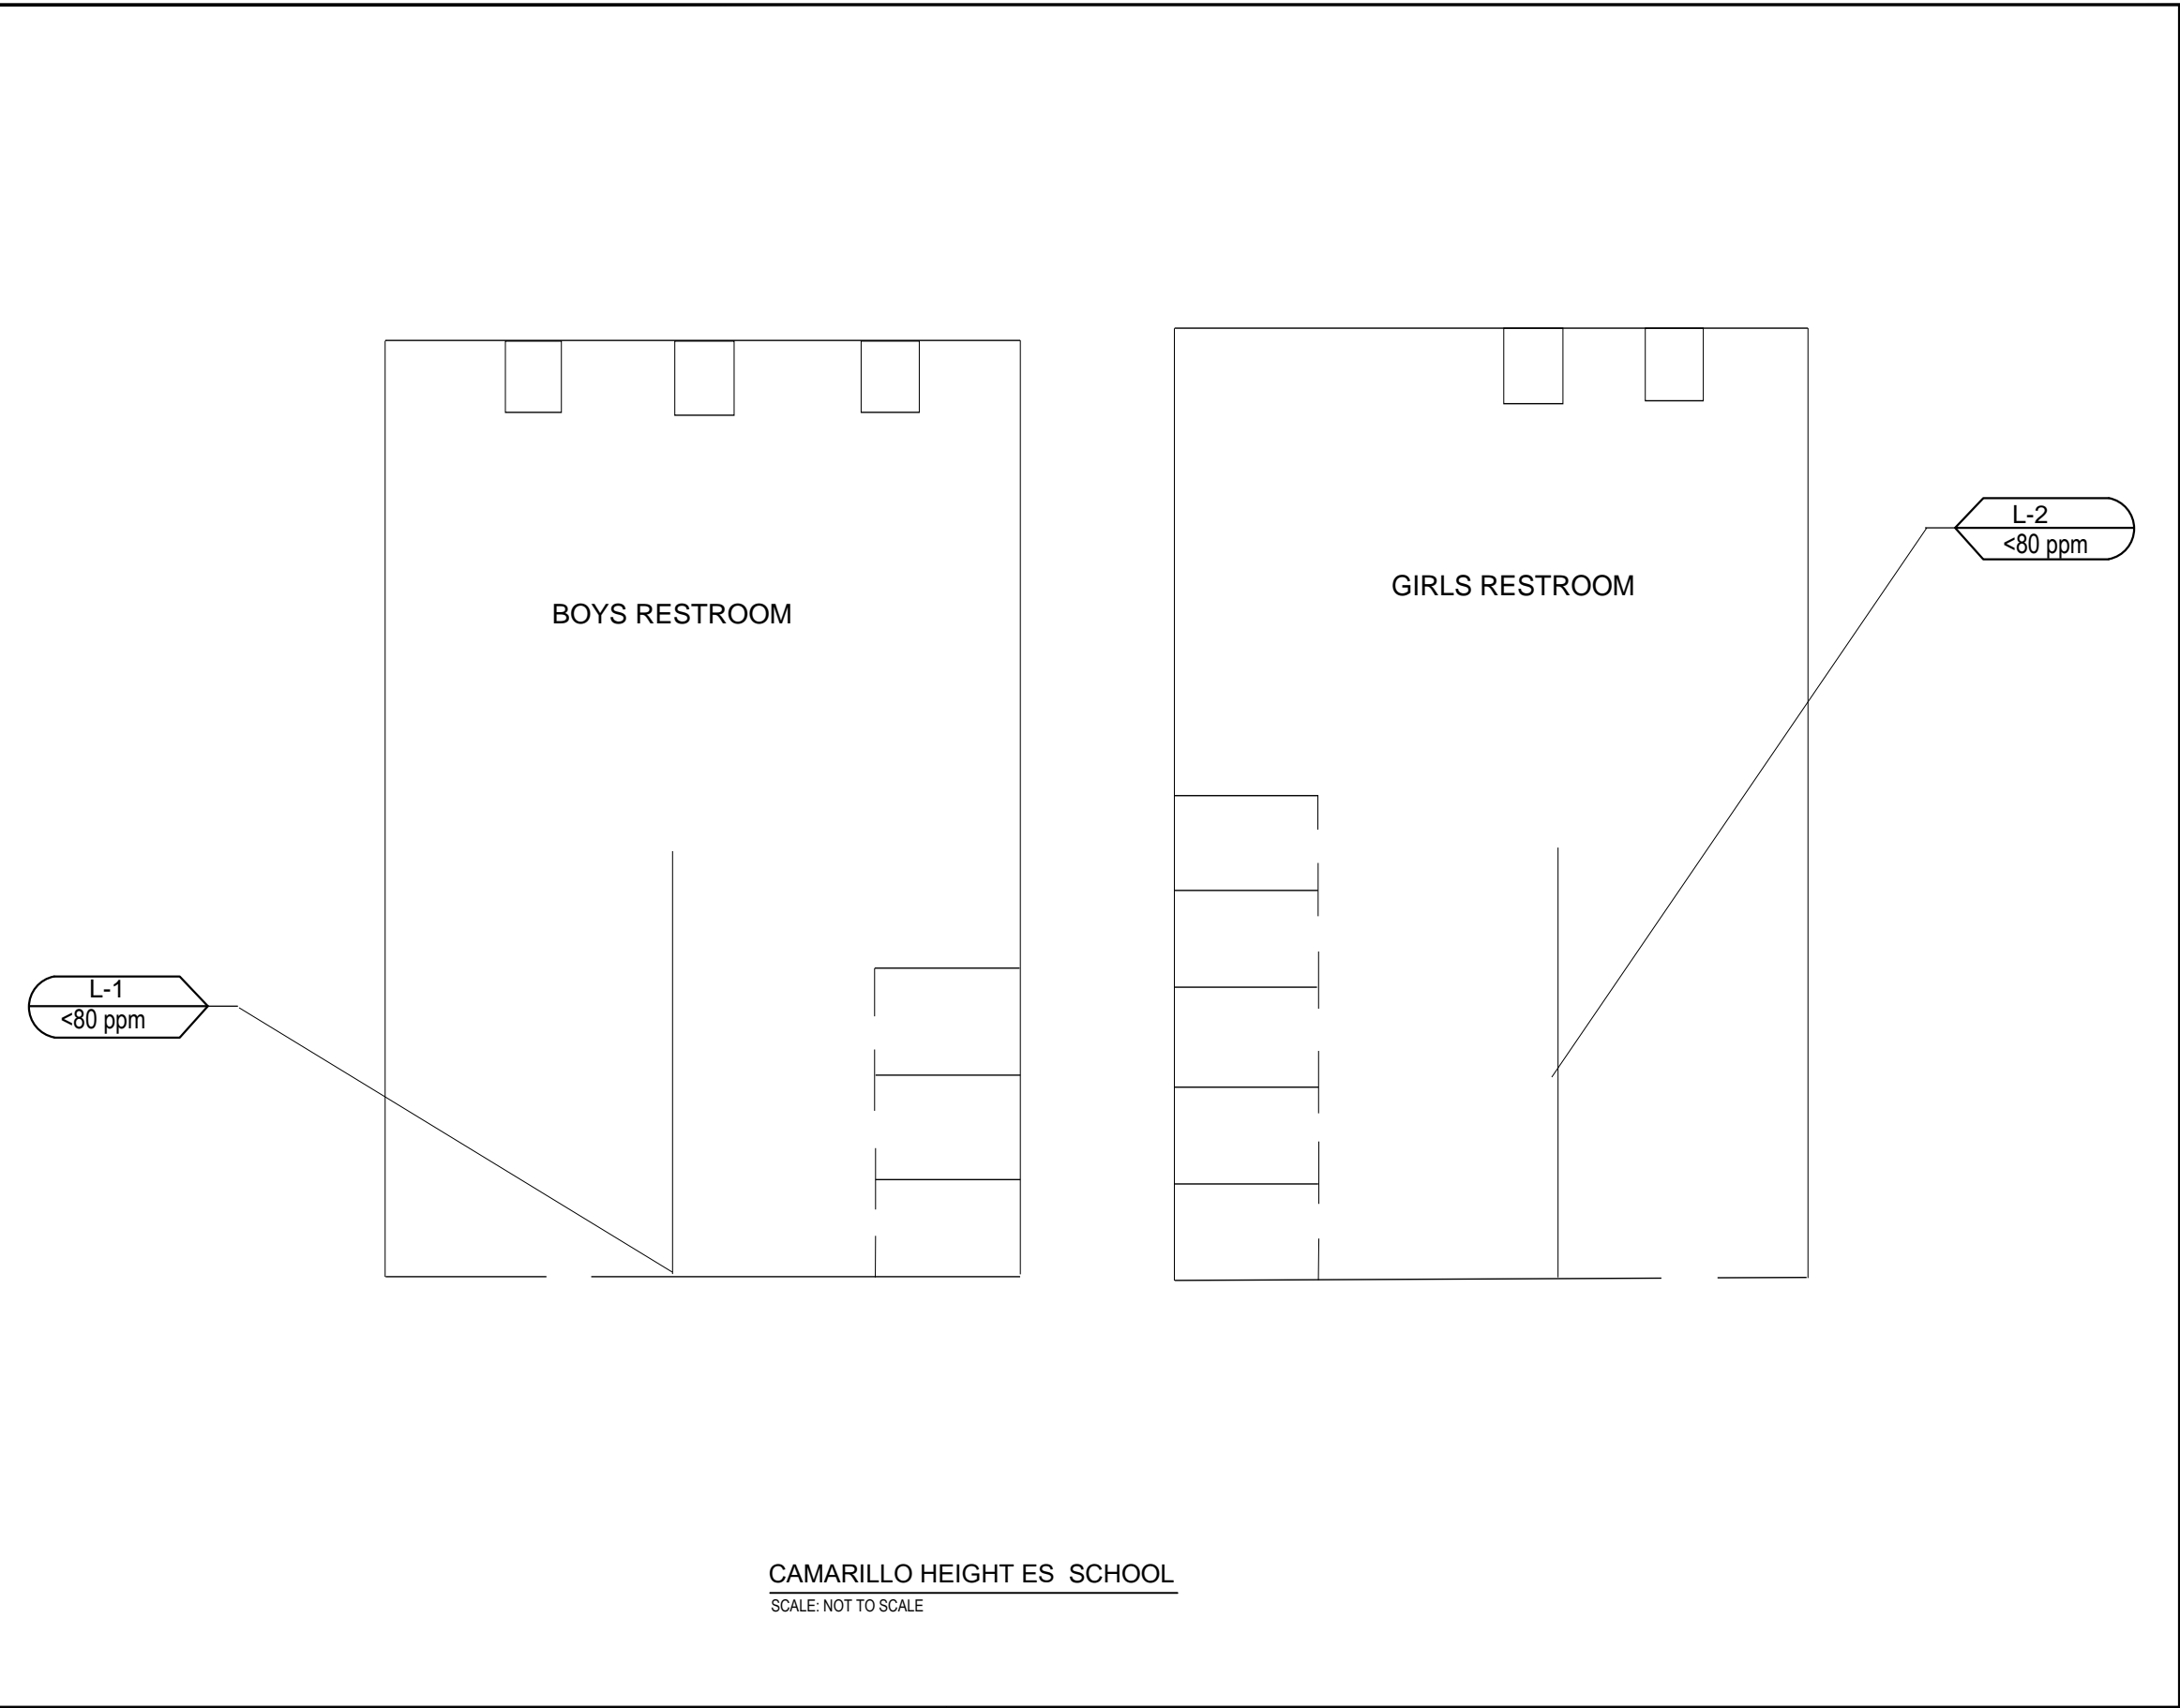
CAMARILLO HEIGHTS - BOYS BATHROOM  
ASBESTOS SURVEY FLOOR PLAN

Sample Number	Location	Component Sampled	Color	Result (ppm)	Result %Wt
1	Boys Restroom - Wall	Ceramic Tile	Beige	<80	<0.008
2	Girls Restroom – Wall	Ceramic Tile	Beige	<80	<0.008

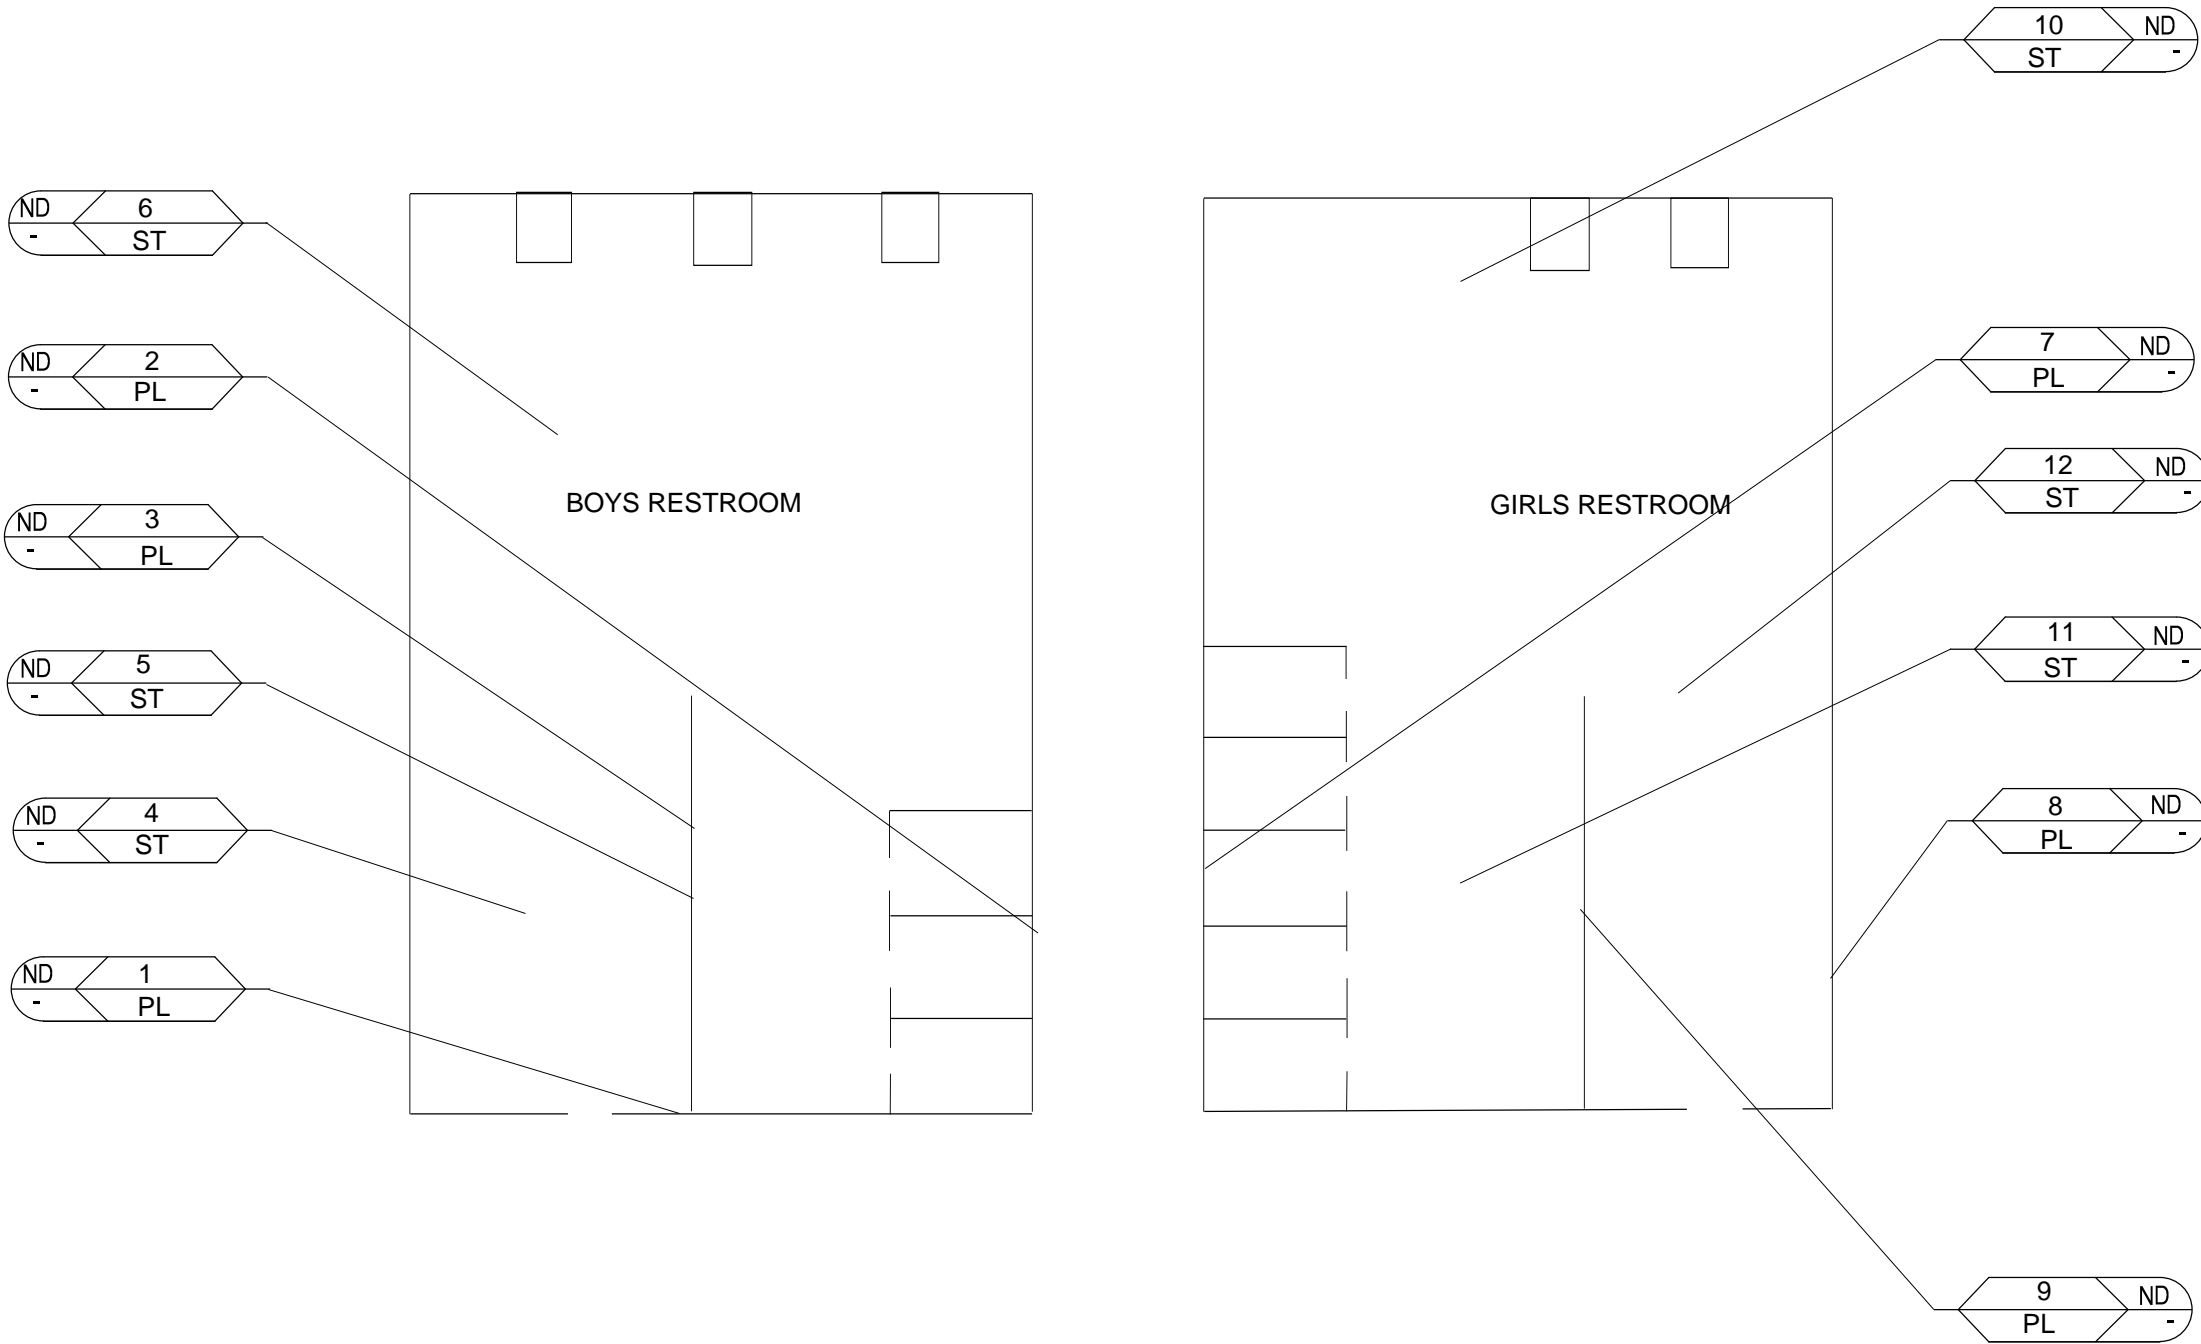
CAMARILLO HEIGHT ES SCHOOL

Sample #	Material Sampled	Sample Location	Quantity	Analytical Results	Friability	Condition	Air Erosion	Contact	Vibration
1	Plaster	Building 600/ Boys Restroom		ND		Intact			
2	Plaster	Building 600/ Boys Restroom		ND		Intact			
3	Plaster	Building 600/ Boys Restroom		ND		Intact			
4	Grey Grout	Building 600/ Boys Restroom		ND		Intact			
5	Grey Grout	Building 600/ Boys Restroom		ND		Intact			
6	Grey Grout	Building 600/ Boys Restroom		ND		Intact			
7	Plaster	Building 600/ Girls Restroom		ND		Intact			
8	Plaster	Building 600/ Girls Restroom		ND		Intact			
9	Plaster	Building 600/ Girls Restroom		ND		Intact			
10	Grey Grout	Building 600/ Girls Restroom		ND		Intact			
11	Grey Grout	Building 600/ Girls Restroom		ND		Intact			
12	Grey Grout	Building 600/ Girls Restroom		ND		Intact
