BUCKEYE LOCAL SCHOOL DISTRICT Building Assessment & Condition Review

Building Assessment & Condition Review March 2025

CPL Architects and Engineers, Inc 111 Front Street Berea, Ohio 44017

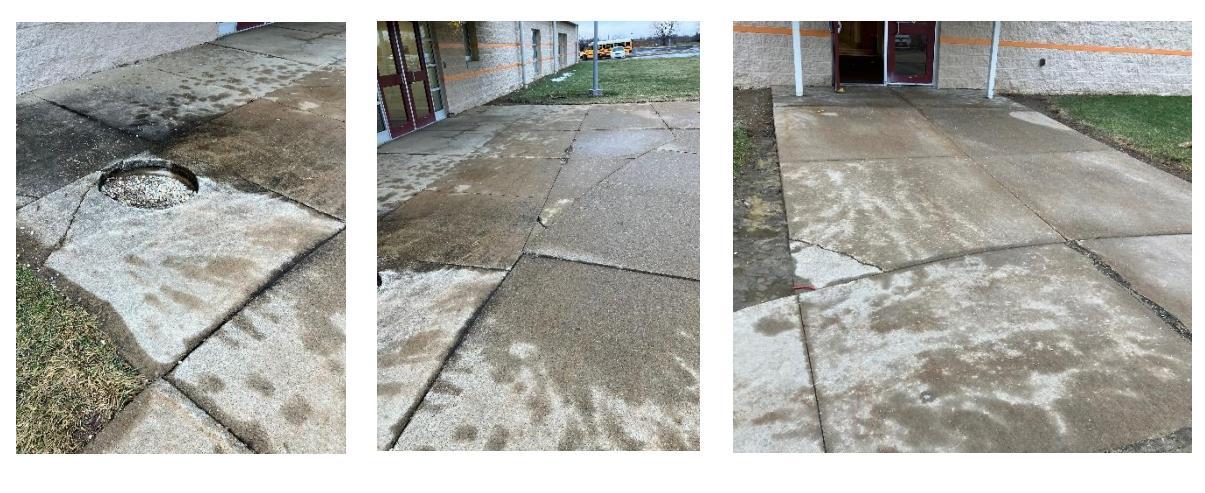
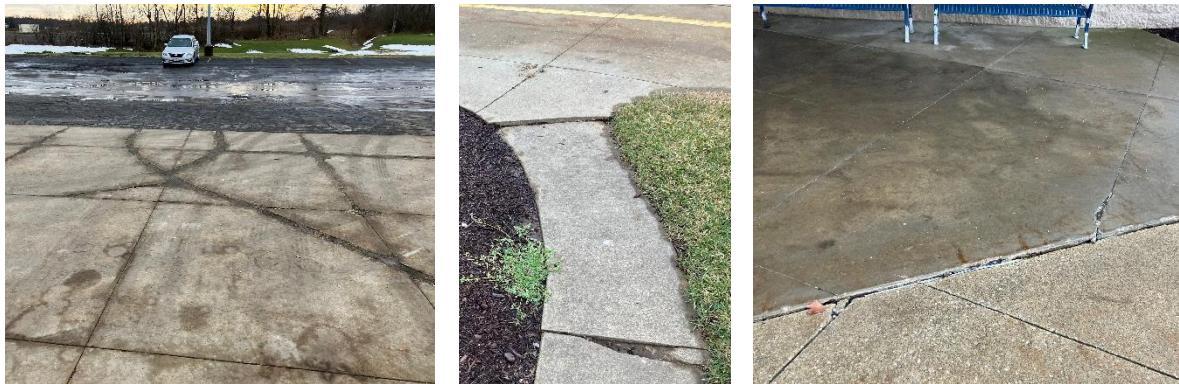
There are approximately 52,900 square feet of concrete walks at the perimeter of the building and into the parking lot. Most concrete walks are in good condition but there are areas that need maintenance, such as crack repair, joint repair, minor spot repairs, and leveling. Some concrete walks need full-depth removal and replacement. The perimeter fence around the playgrounds are damaged in various places. Concrete curbs lined the concrete walks and parking lots and were in good condition however some areas are damaged or spalling from age.

Currently there are approximately 355 linear feet of existing curbing that need to be replaced. These sections of the curb have missing sections, large cracks, have sunken or are completely missing.

- Repair damaged or spalling concrete curbs
- Replace concrete and gravel drainage enclosures at canopy downspouts
- Replace cracked or settled concrete entrances and walks
- Seal minor concrete cracks to prevent further damage
- Replace/repair fences

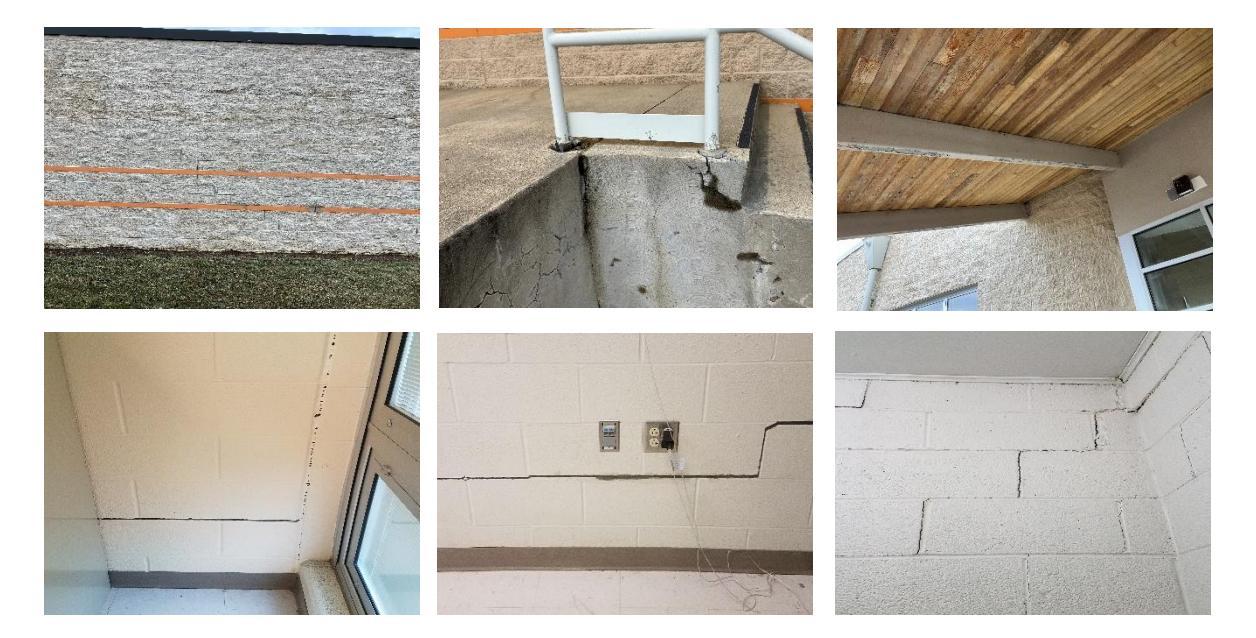
Exterior - The façade was composed of concrete masonry and face brick. Multiple cracked bricks were observed on the masonry façade. All observed steel lintels and posts were in good condition but showed signs of corrosion.

Interior – Cracks were observed on the slab-on-grade concrete floors. Multiple vertical, horizontal, and step-cracks were found on CMU walls of the building, particularly at joints between exterior and interior walls. Step cracks were present on load-bearing CMU walls.

- Grout and seal concrete floor slab cracks.
- Tuckpoint deteriorated mortar joints.
- Clean and coat structural steel showing signs of corrosion with corrosion inhibiting paint.
- Partial depth concrete floor repairs

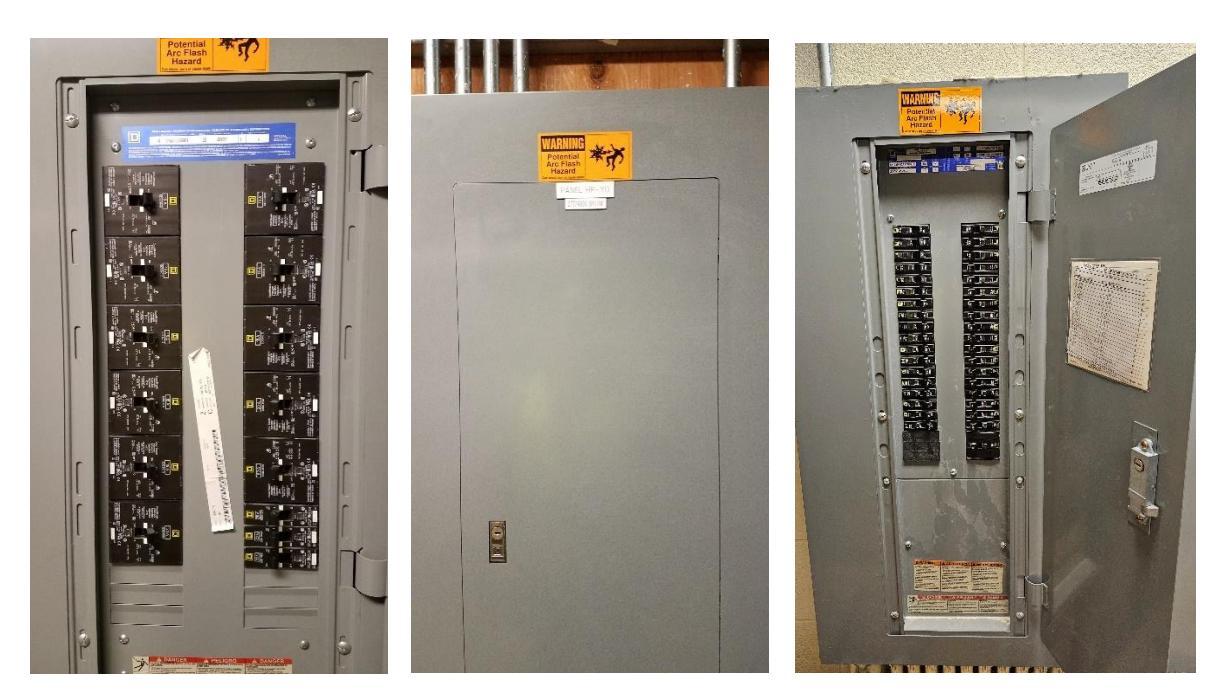
The general condition of the distribution panels and branch circuit panels are in very good condition. Electrical rooms and closets are all secured, orderly, dry and have adequate ventilation. Branch 277/480V and 120/208V 3-Phase circuit panels are located throughout the building and are in good condition.

Typical Condition of panels.

- Perform immediate manufacturer recommended maintenance on all distribution and branch circuit panelboards. This should include removal of covers, visual inspections, and at a minimum the cleaning of any debris that has built up over the years within the gear. Based on testing results, replacement of outdated equipment can be decided on. A feasibility study can be completed to assist with the decision.
- It is recommended that testing of the building grounding electrode system be performed.
- Repair all broken floor boxes

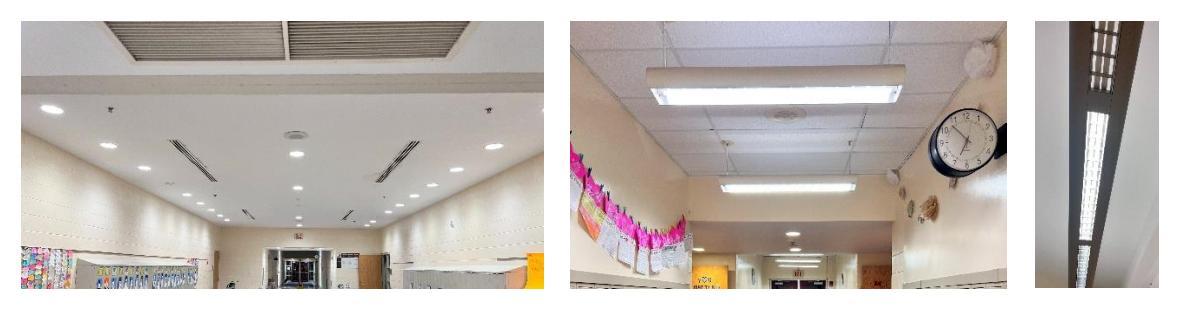
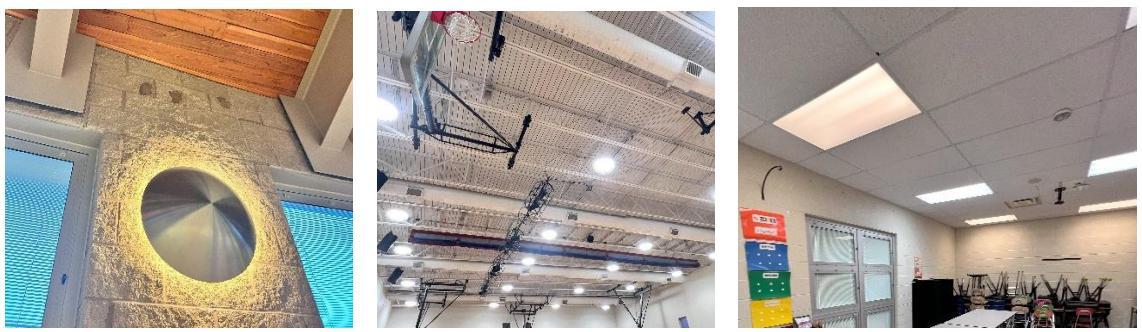
Light fixtures are a mix of florescent and LED. There are some lamps or ballast failures present.

Typical Condition of Light Fixtures

- Within three years, install new occupancy/vacancy dual tech sensors, daylight harvesting, and dimming controls as required by the current IECC and ASHRAE 90.1 energy codes enforced by the State of Ohio.

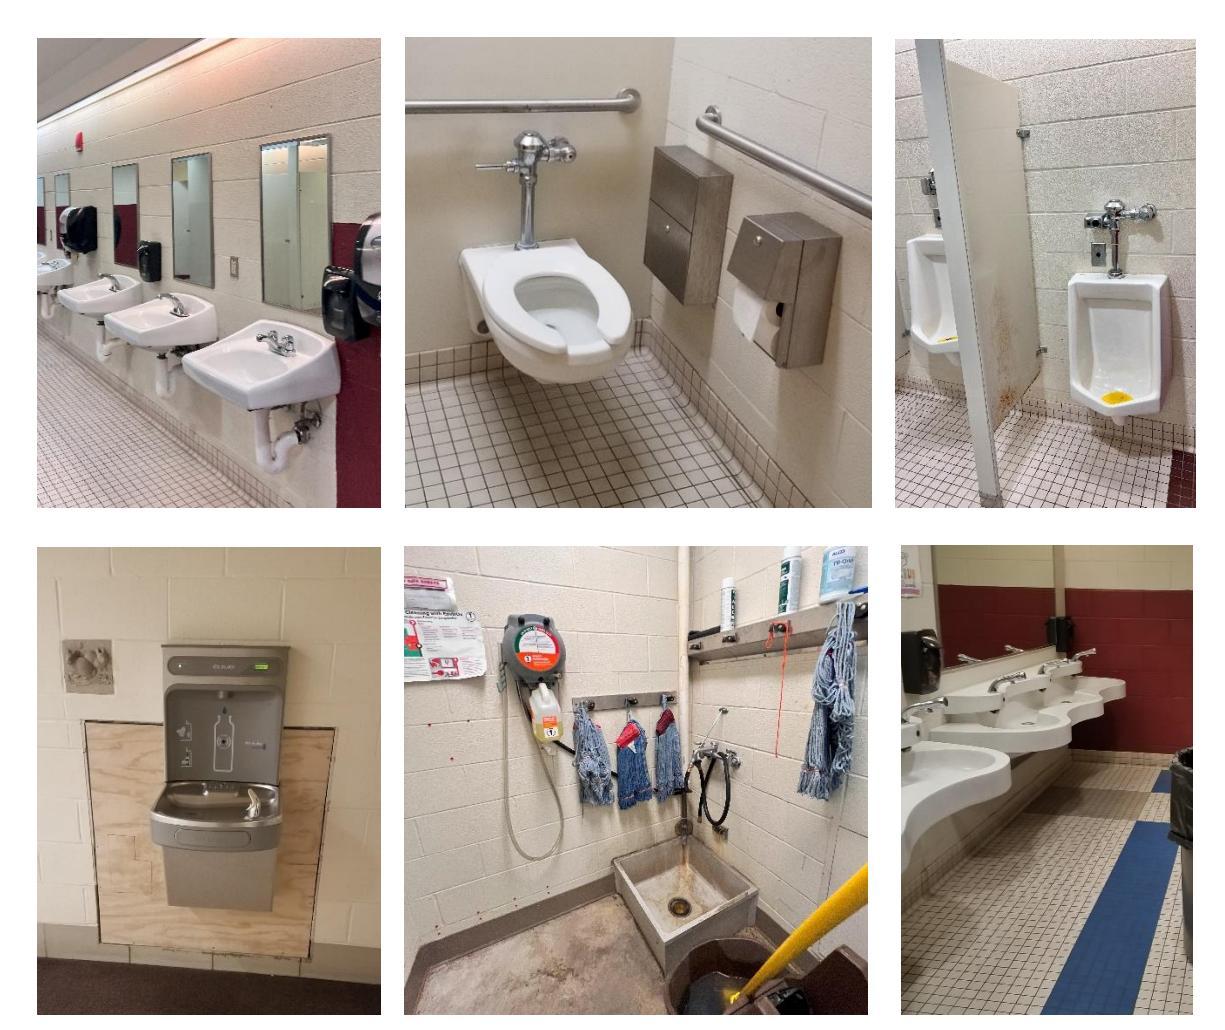
Typical Condition of Plumbing Fixtures

- Routinely test operation of all fixtures. Replace any fixtures that are not operating as intended.
- Replace corroded water heater

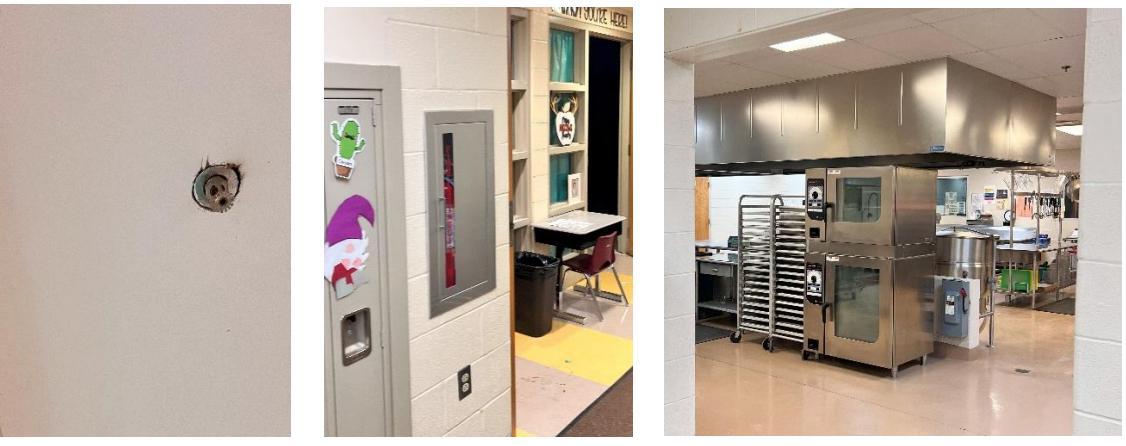
Typical Fire Suppression Devices

- Replace missing or damaged escutcheons at sprinkler head locations throughout
- As the facility performs annual inspections it is imperative to address inspection deficiencies as soon as possible. Items such as missing escutcheons can impact sprinkler operation and negate the protection provided depending on the severity of the various deficiencies.

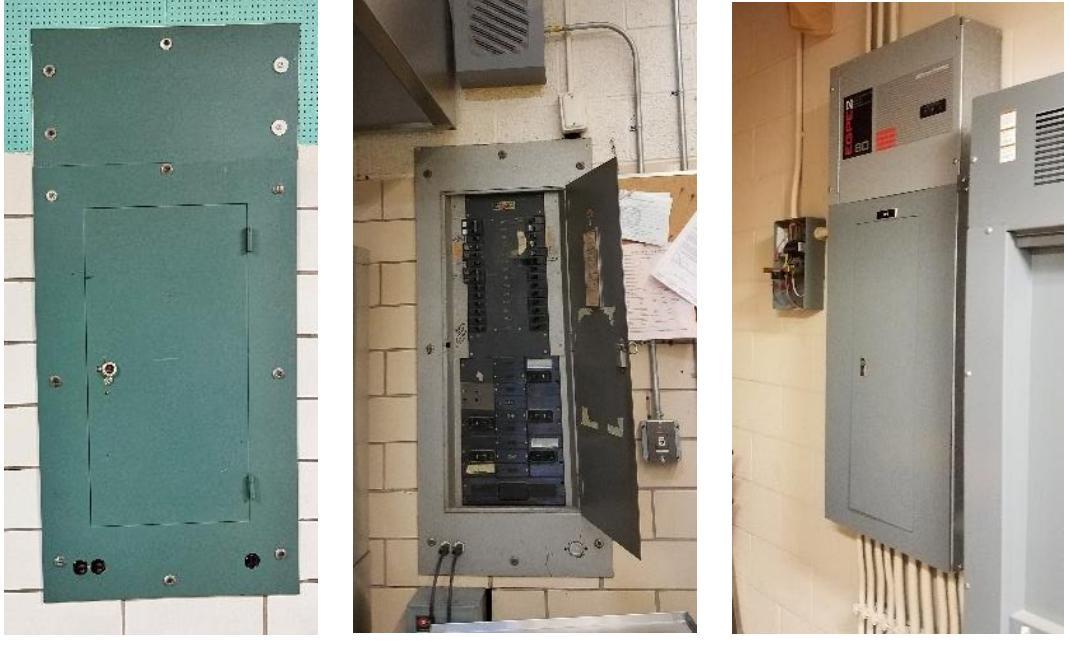
Due to the building's age, there is a lack of outlets for today's use of technology. Extension cords are used heavily and create potential tripping and fire hazards. Additional outlets would improve the functionality and safety of the users. Light fixtures are a mix of incandescent, florescent, and LED; multiple lights were not operational, likely due to burnt out lamps. In the original building, multiple electrical were not operational and did not provide power. Branch 120/208V 3-Phase circuit panels are located throughout the building and are in fair condition.

Typical Condition of panels.

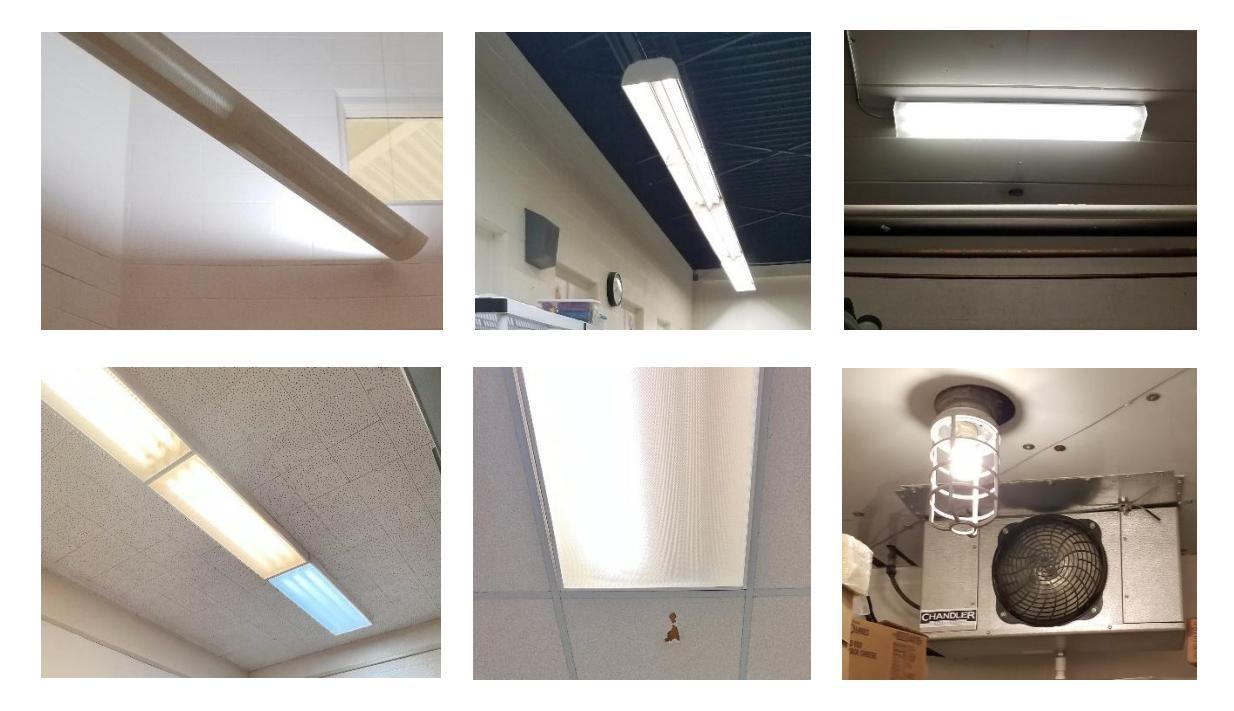
Typical Condition of Light Fixtures

- Within three years, install new occupancy/vacancy dual tech sensors, daylight harvesting, and dimming controls as required by the current IECC and ASHRAE 90.1 energy codes enforced by the State of Ohio.

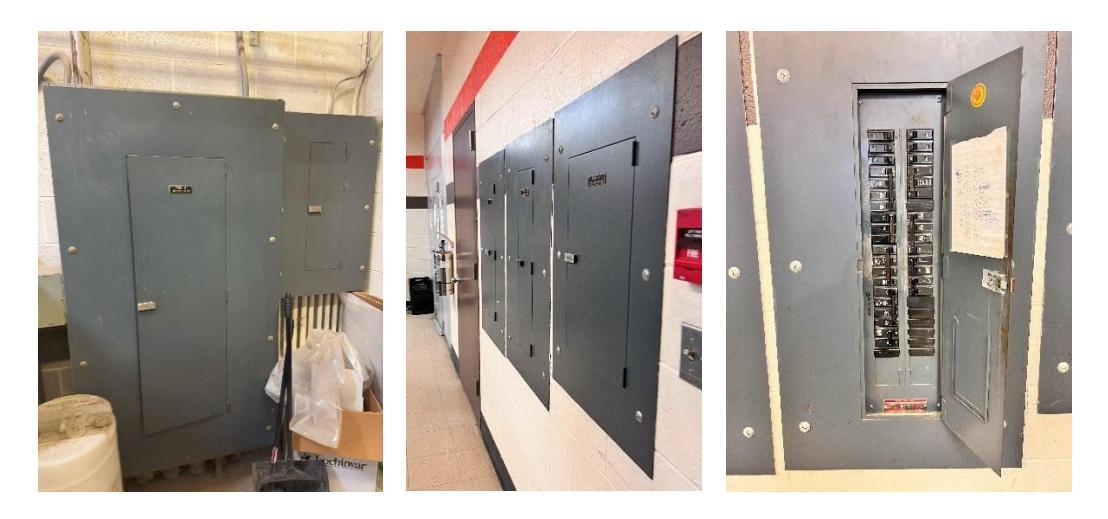
The general condition of the distribution panels and branch circuit panels are in good condition. Electrical rooms and closets are secured, orderly, dry and have adequate ventilation. Electrical equipment is operational however most are of the age of the building and require attention.

Typical Condition of equipment.

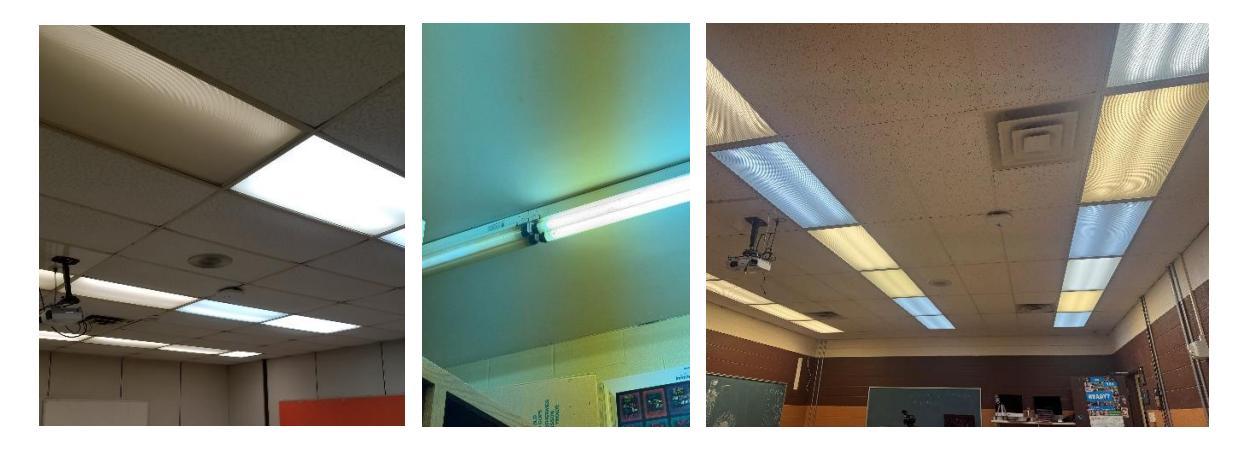
Typical Condition of Light Fixtures

- As funds allow, retrofit luminaires with LED lamps. Assess luminaire lenses in all rooms and replace acrylic lenses that are sagging or damaged with new prismatic lenses that have a minimum thickness of .125. This will eliminate the risk of a sagging lens falling out of the luminaire housing.
- Replace surface-mounted fluorescent luminaires with LED luminaires before 30% of the ballasts fail. Design new lighting to comply with lighting levels recommended by national standards for educational institutions.
- Within three years, install new occupancy/vacancy dual tech sensors, daylight harvesting, and dimming controls as required by the current IECC and ASHRAE 90.1 energy codes enforced by the State of Ohio.

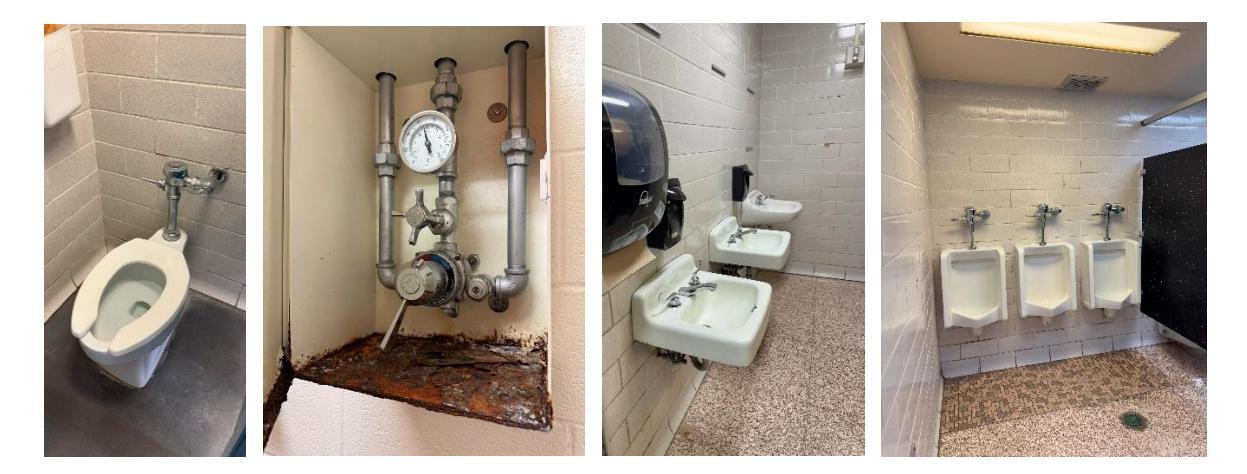
Typical Condition of Plumbing Fixtures

- Routinely test operation of all fixtures. Replace any fixtures that are not operating as intended.
- Consider replacement of dated or worn fixtures throughout.

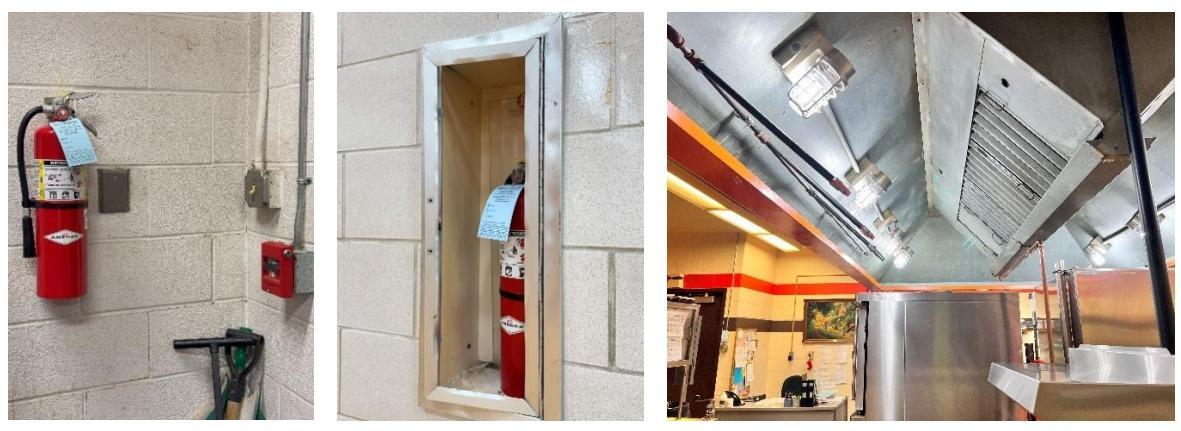
Typical Fire Suppression Devices

- As the facility performs annual inspections it is imperative to address inspection deficiencies as soon as possible.
- Install sprinkler system throughout building to meet current life safety requirements.

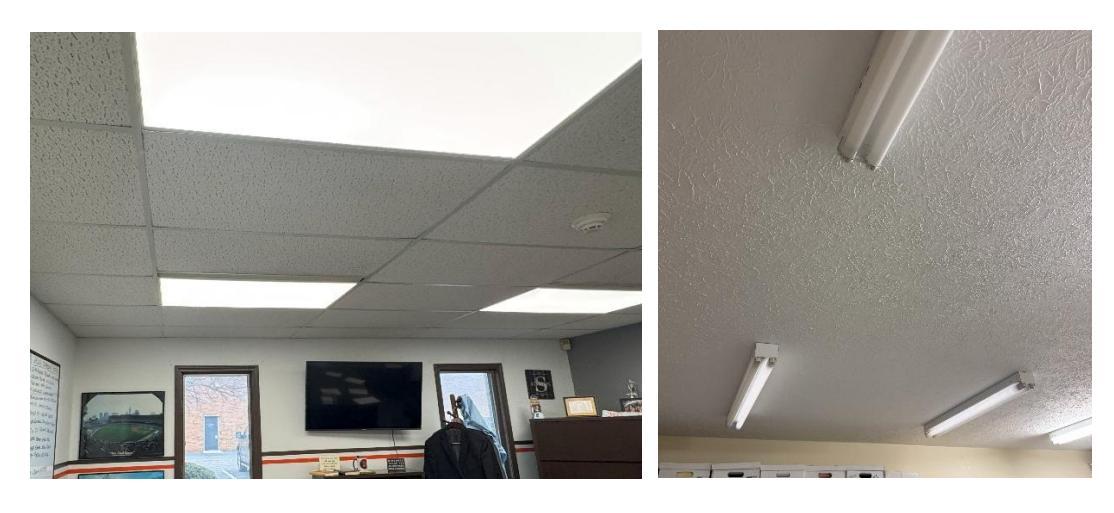
Typical Condition of Light Fixtures

- As funds allow, retrofit luminaires with LED lamps. Assess luminaire lenses in all rooms and replace acrylic lenses that are sagging or damaged with new prismatic lenses that have a minimum thickness of .125. This will eliminate the risk of a sagging lens falling out of the luminaire housing.
- Replace surface-mounted fluorescent luminaires with LED luminaires before 30% of the ballasts fail. Design new lighting to comply with lighting levels recommended by national standards for educational institutions.
- Within three years, install new occupancy/vacancy dual tech sensors, daylight harvesting, and dimming controls as required by the current IECC and ASHRAE 90.1 energy codes enforced by the State of Ohio.

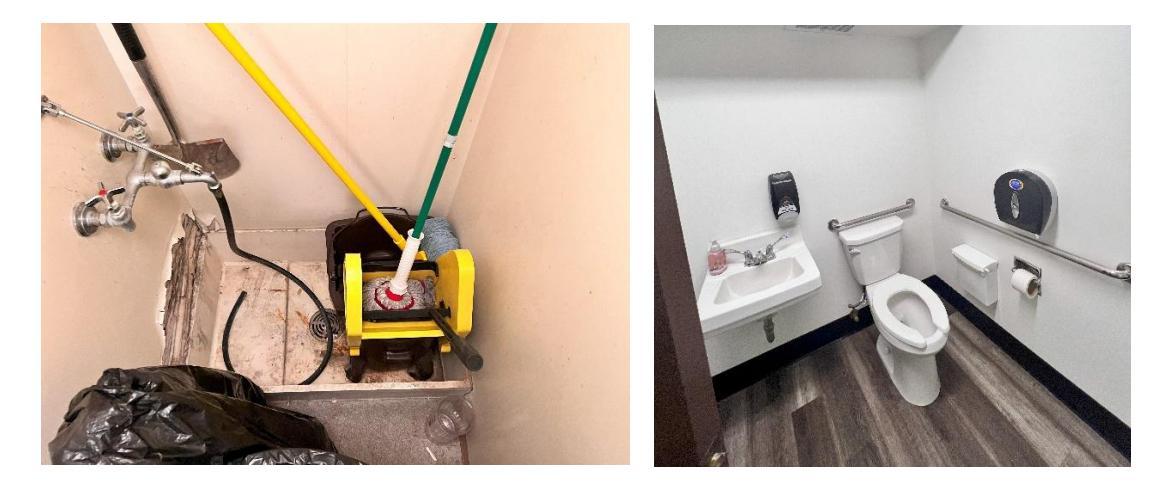
Typical Condition of Plumbing Fixtures

- Routinely test operation of all fixtures. Replace any fixtures that are not operating as intended.
- Consider replacement of dated or worn fixtures throughout.

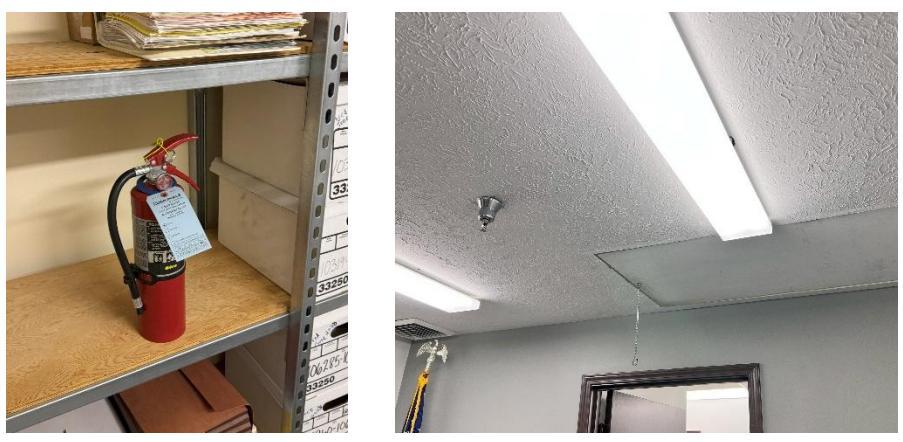
Typical Fire Suppression Devices

• As the facility performs annual inspections it is imperative to address inspection deficiencies as soon as possible.

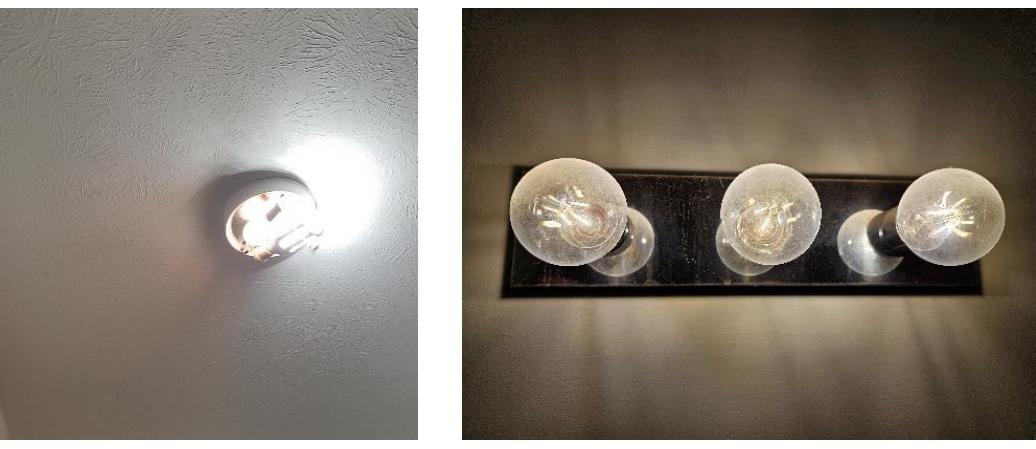
Typical Condition of Light Fixtures

- As funds allow, retrofit luminaires with LED lamps.
- Replace incandescent or fluorescent bulbs with LEDs.
- Install missing lenses on light fixtures.
- Within three years, install new occupancy/vacancy dual tech sensors, daylight harvesting, and dimming controls as required by the current IECC and ASHRAE 90.1 energy codes enforced by the State of Ohio.

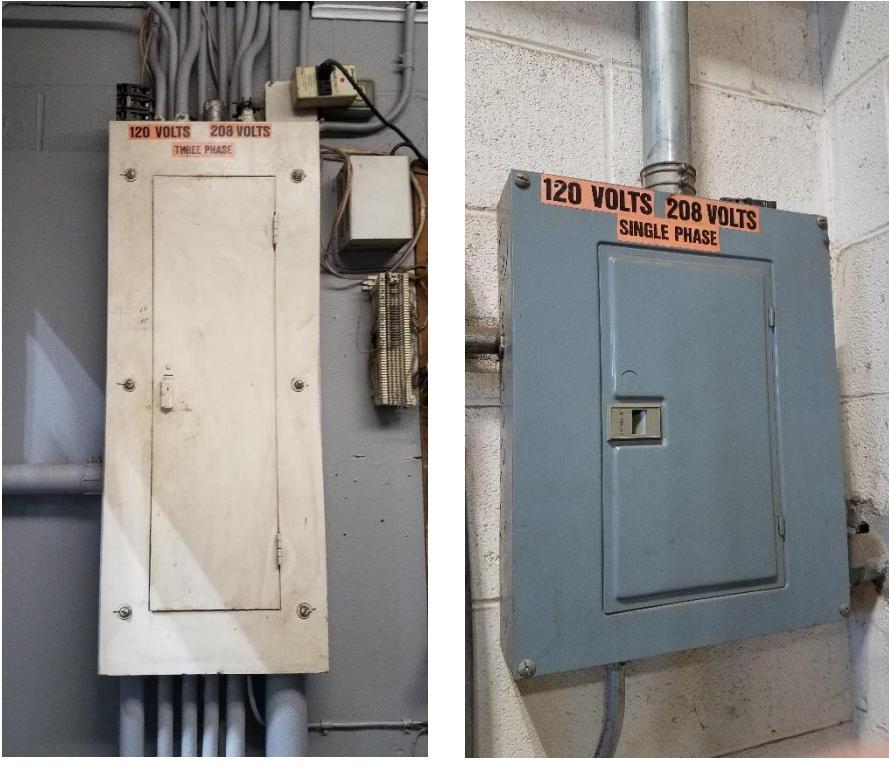
Light fixtures are a mix of florescent, and LED; some lights were not operational, likely due to burnt out lamps. A branch 120/208V 3-Phase circuit panel is located in the utility closet and is in fair to poor condition. This panel experiences water intrusion during precipitation events and is reported to come up through the conduit in the concrete slab. A branch 120/208V Single Phase circuit panel is located outside the utility closet and was observed to be in good condition.

Typical Condition of panels

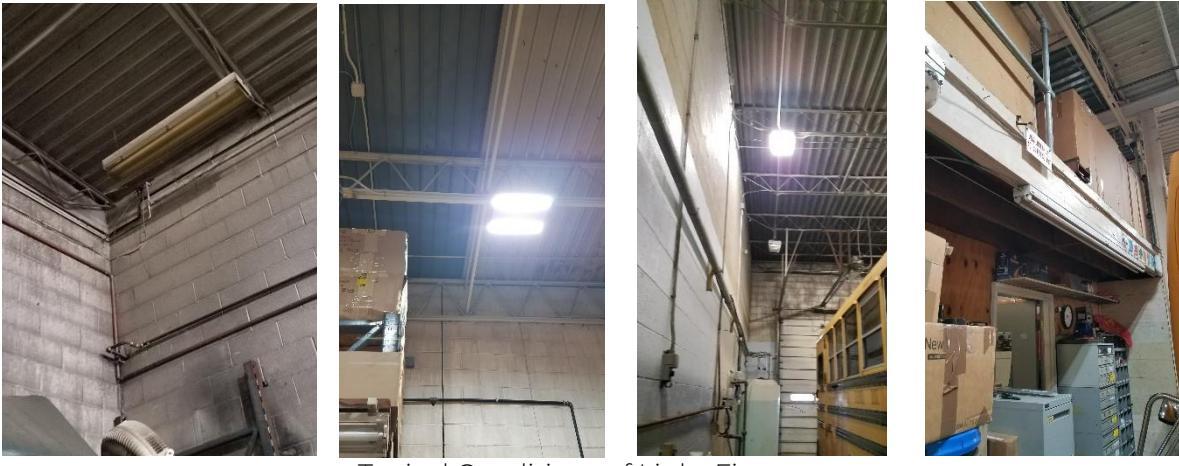
Typical Conditions of Light Fixtures

• As funds allow, retrofit remaining fluorescent luminaires with LED lamps and fixtures.

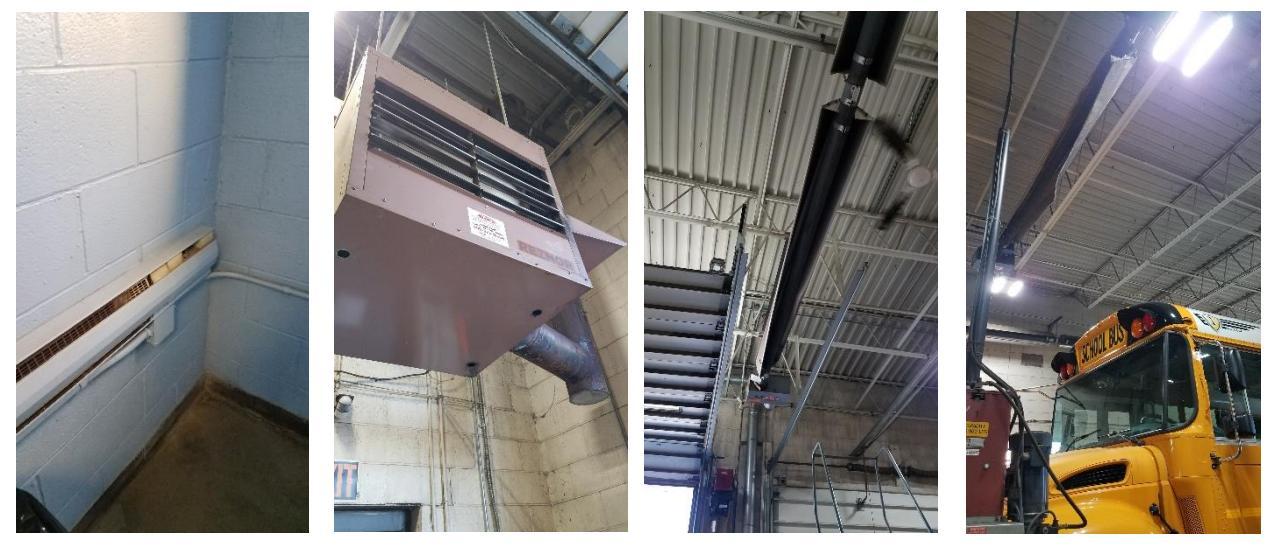
Typical Condition of Mechanical Fixtures

- Replace the damaged infrared tube heater reflector
- Install a Cooling system
- Install an exhaust system that brings the building to modern code. Repair garages shall be mechanically ventilated- with the ventilation system controlled at the entrance to the garage.
- Upgrade the restroom heater.

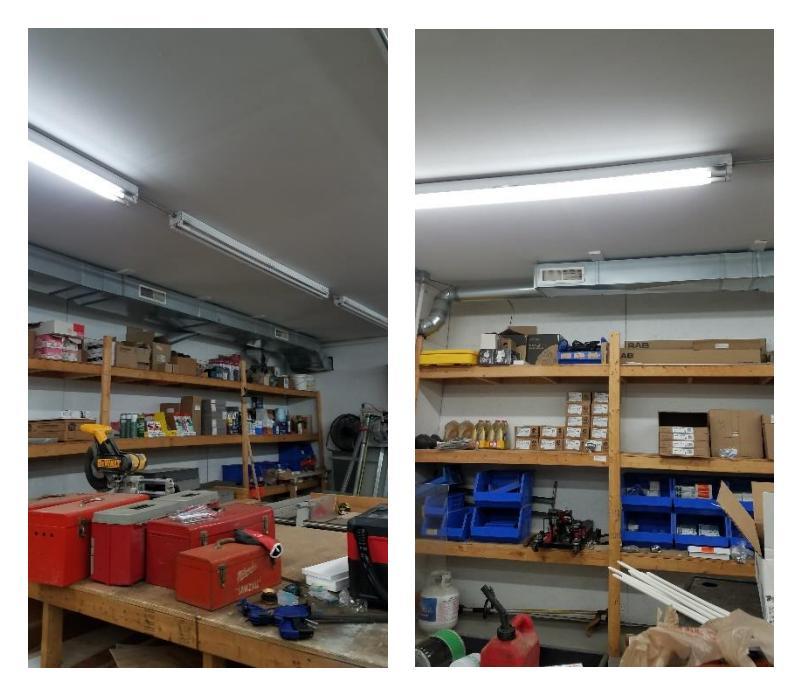
Typical Condition of Light Fixtures

- Replace surface-mounted fluorescent luminaires with LED luminaires before 30% of the ballasts fail.
- Replace burnt out lamps

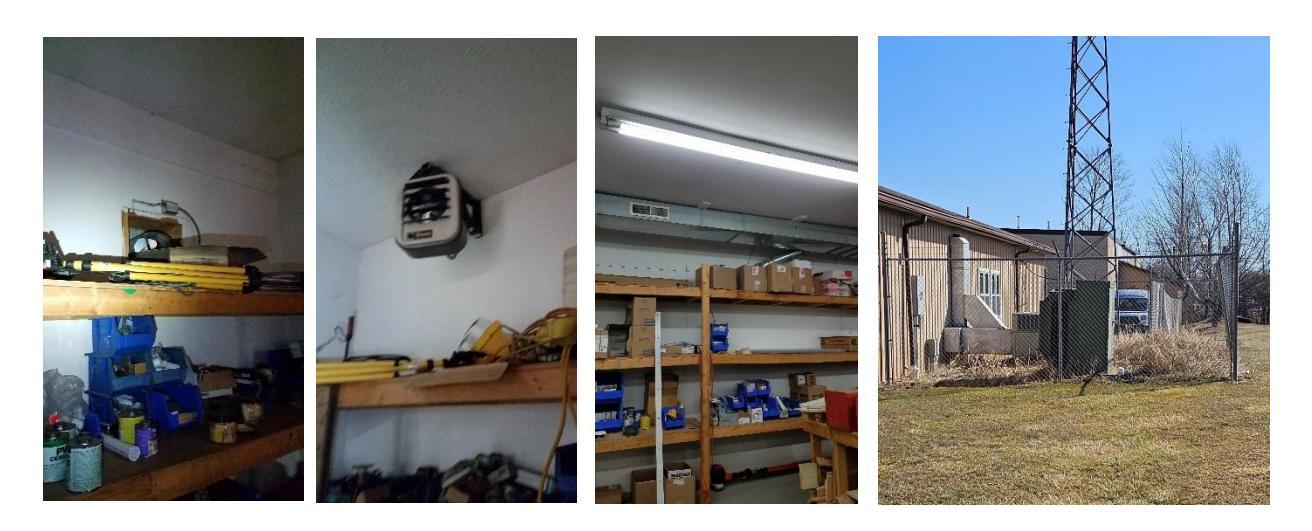
Typical Condition of Mechanical Systems

• Ensure proper interval maintenance of all mechanical equipment.

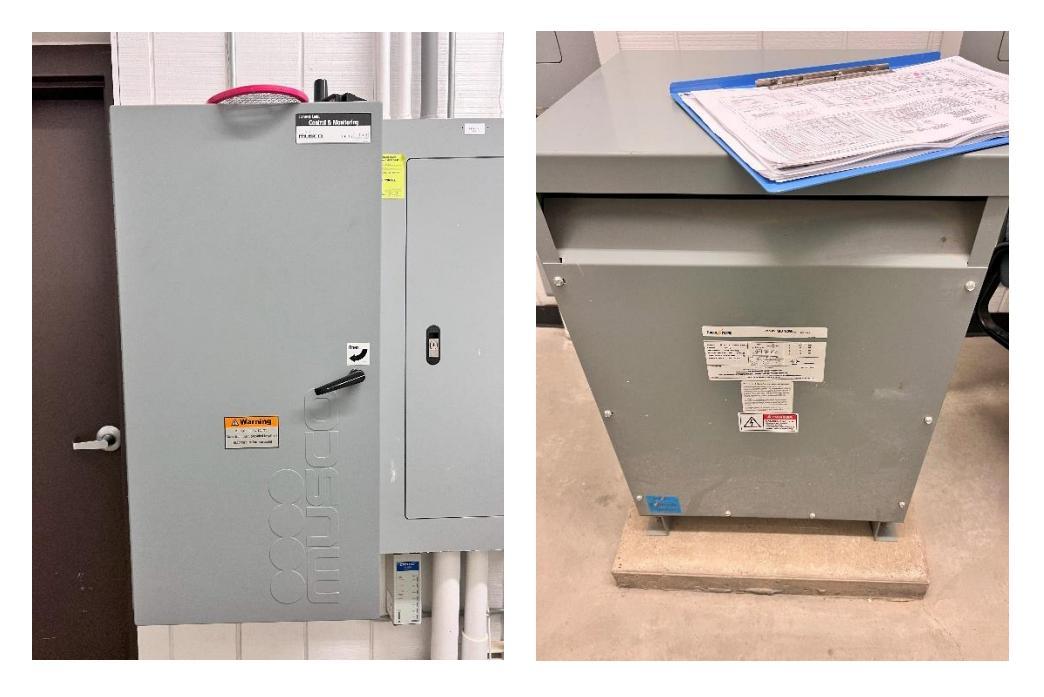
The general condition of the distribution panels and branch circuit panels varies between good to very good condition. Electrical rooms and closets are secured, orderly, dry and have adequate ventilation. Electrical equipment are operational while most are of the age of the building and require routine maintenance.

Typical Condition of equipment.

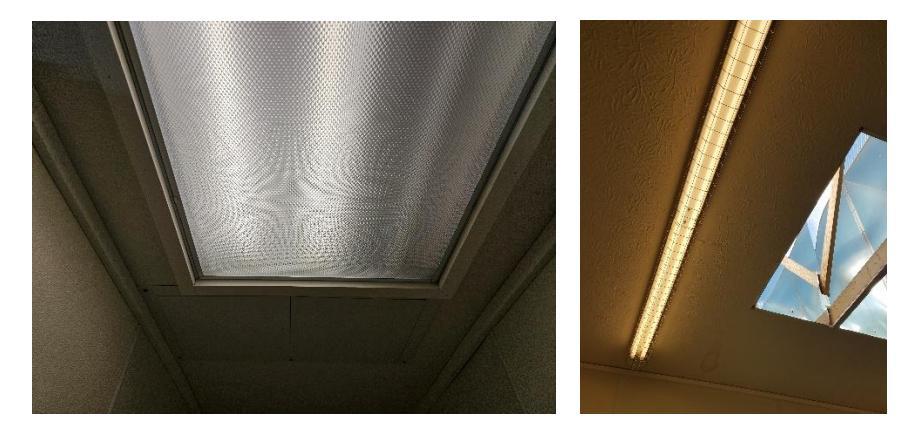
Typical Condition of Light Fixtures

- As funds allow, retrofit luminaires with LED lamps. Assess luminaire lenses in all rooms and replace acrylic lenses that are sagging or damaged with new prismatic lenses that have a minimum thickness of .125. This will eliminate the risk of a sagging lens falling out of the luminaire housing.
- Replace surface-mounted fluorescent luminaires with LED luminaires before 30% of the ballasts fail. Design new lighting to comply with lighting levels recommended by national standards for educational institutions.
- Within three years, install new occupancy/vacancy dual tech sensors, daylight harvesting, and dimming controls as required by the current IECC and ASHRAE 90.1 energy codes enforced by the State of Ohio.

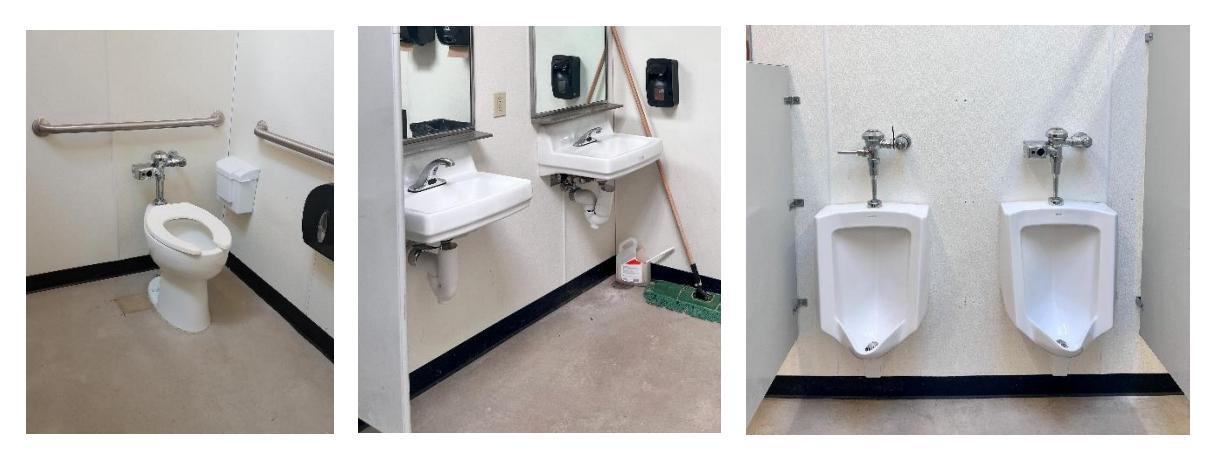
Typical Condition of Plumbing Fixtures

• Routinely test operation of all fixtures. Replace any fixtures that are not operating as intended.

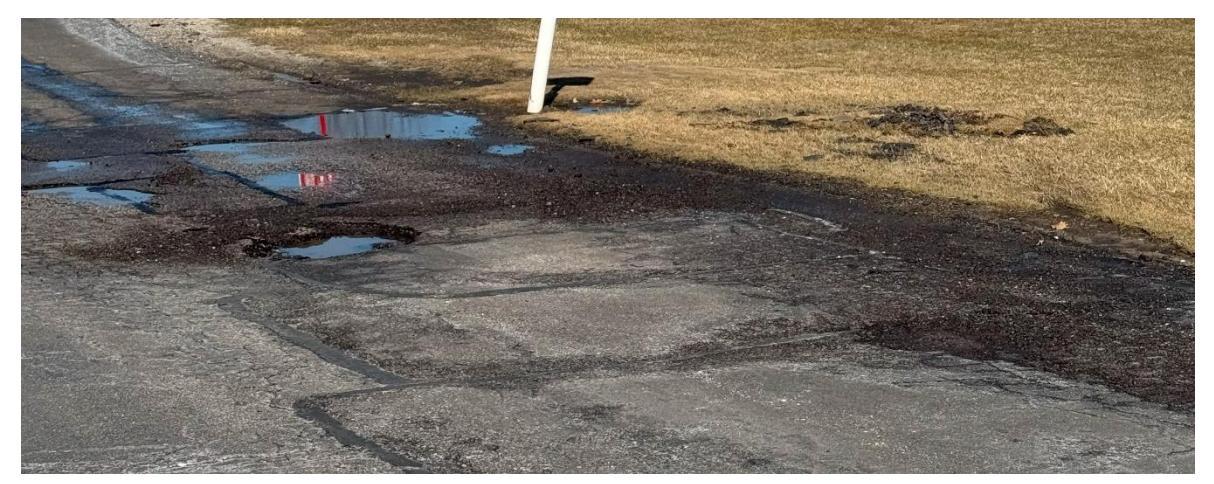
Asphalt pavements throughout the campus will need repairs ranging from simple crack sealing to full depth replacement. For the most damaged sections of pavement there are approximately 120,785 square feet of full depth asphalt pavement replacement or new full depth pavement in lieu of gravel.

Typ. Full depth asphalt replacement

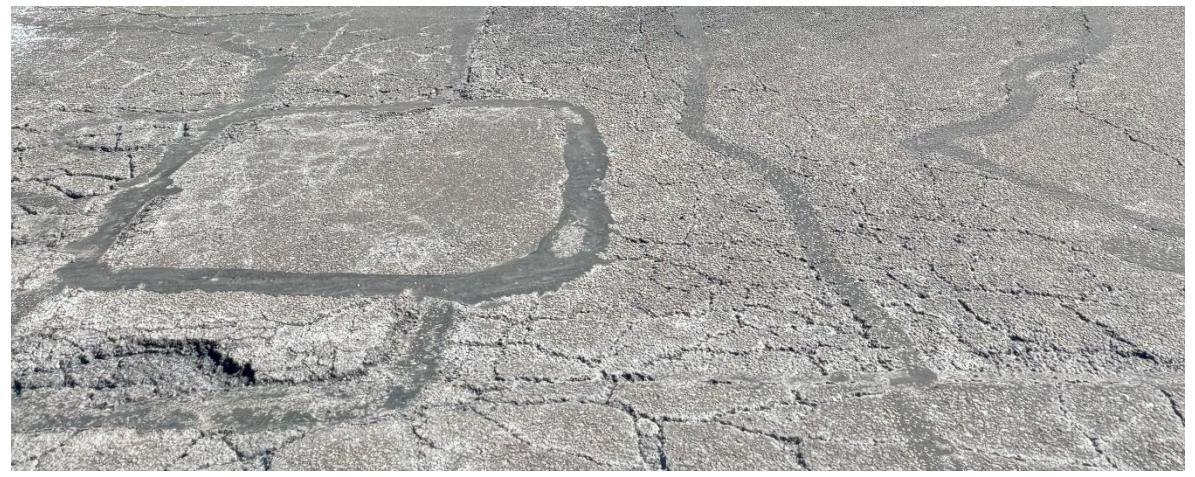
With the large amount of asphalt pavement, there is a need for a large amount of asphalt fill and fill repairs. Throughout the loop road and many parking lots, there is approximately 395,925 square feet of asphalt mill and fill. These repairs will help lengthen the extent of the pavement service life of the asphalt.

Typ. Asphalt mill & fill

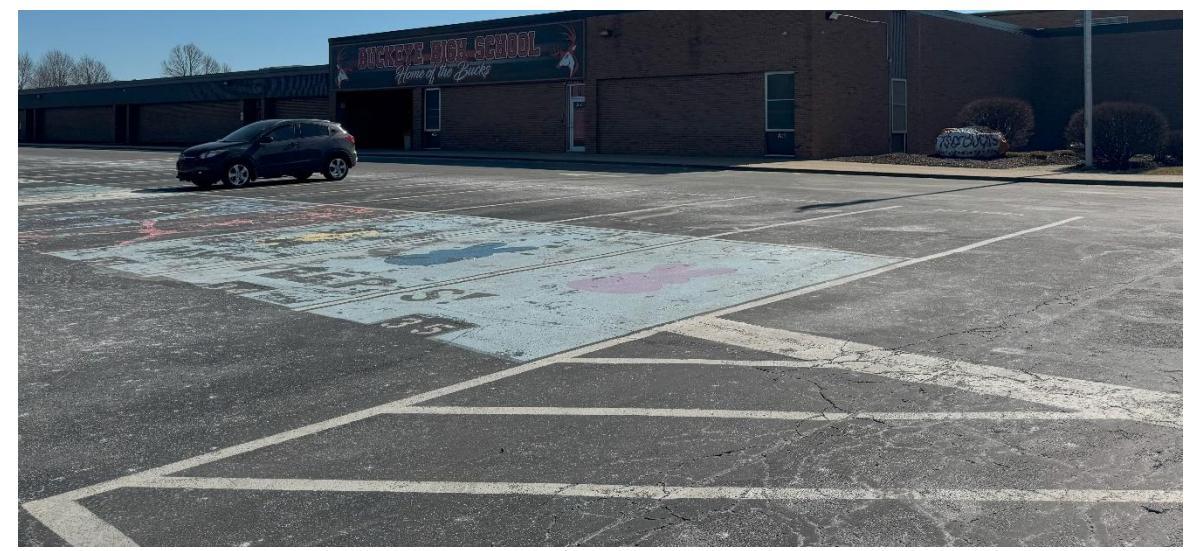
Portions of the existing asphalt pavements are in good condition but do have several cracks. These existing cracks currently are an aesthetics issue. However, without proper maintenance and repair, these minor cracks will continue to deteriorate and widen and will need more attention in the coming years. If left unchecked, these cracks can provide pathways for water to seep into the walk subbase and structurally weaken the pavement system. There are approximately 429,570 square feet of asphalt crack seal and seal coating needed. These joints have already begun to fail and if left untreated, these joints will continue to grow in width and could eventually lead to pavement failures. As the seal coating degrades over time, it is anticipated that eventual mill and fill will be required of approximately the same square footage.

Typ. Crack sealing and coating

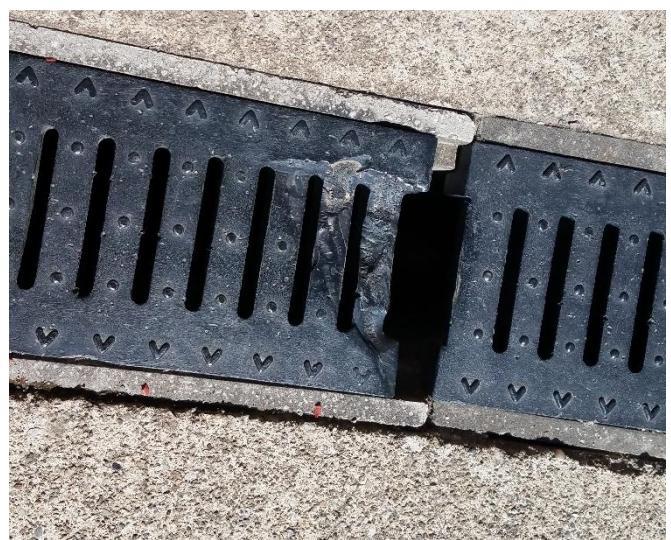
The trench drains range from good to very good condition. The trench drain at the Field House needs to have the cover replaced to prevent further damage and tripping hazard.

Trench drain cover to be replaced

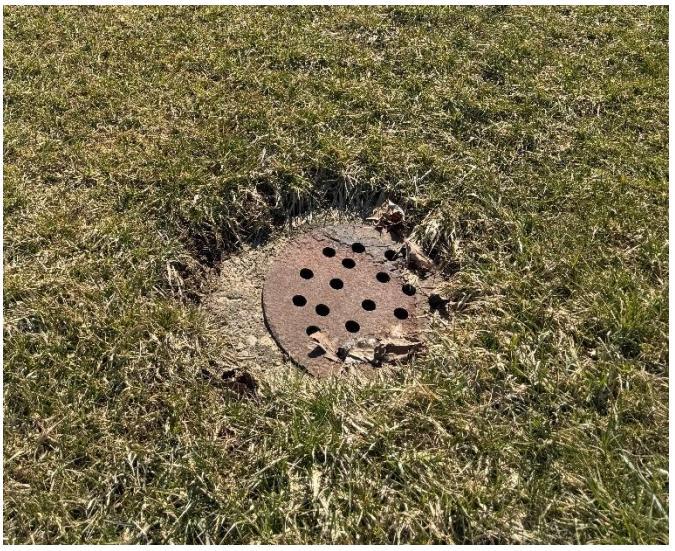
There are catch basins and inlets in the campus storm sewer network. The inlets to the storm sewer network are mostly in good condition. One storm inlet grate needs to be cleared of vegetation at the Junior Varsity Baseball Field

Frame and grate to be cleared
