| FIVE-YEAR CAPITAL FACILITIES PLAN | | | | | | | | | | | | | | | | |
| District Name: | Onteora CSD | | | <div>ITEM NUMBER LEGEND</div> <div>BLDG BCS# ITEM BCS YR.</div> <div>FES - 067 - 01 - 21 [00 is no BCS #]</div> | | <div>SYSTEM TYPE</div> <div>HS - Health &amp; Safety</div> <div>ST - Structure</div> <div>EE - Energy Efficiency</div> <div>AP - Asset Preservation</div> | | <div>SYSTEM RATING</div> <div>E - Excellent</div> <div>S - Satisfactory</div> <div>U - Unsatisfactory</div> <div>NF - Non-Functioning</div> <div>CF - Critical Failure</div> | | <div>COST TYPE</div> <div>NEW - New Construction</div> <div>ADD - Addition</div> <div>ALT - Alterations</div> <div>MSR - Major System Replacement</div> <div>REP - Repair</div> <div>ENG - Energy</div> <div>MNT - Maintenance</div> | | Y* - Must be part of larger building project | | <div></div> <div>Clark Patterson Lee</div> <div>ARCHITECTURE ENGINEERING PLANNING</div> | | |
| Facility Name: | High School/Middle School | | | | | | | | | | | | | | | |

## 2020 BUILDING CONDITION SURVEY - 2020

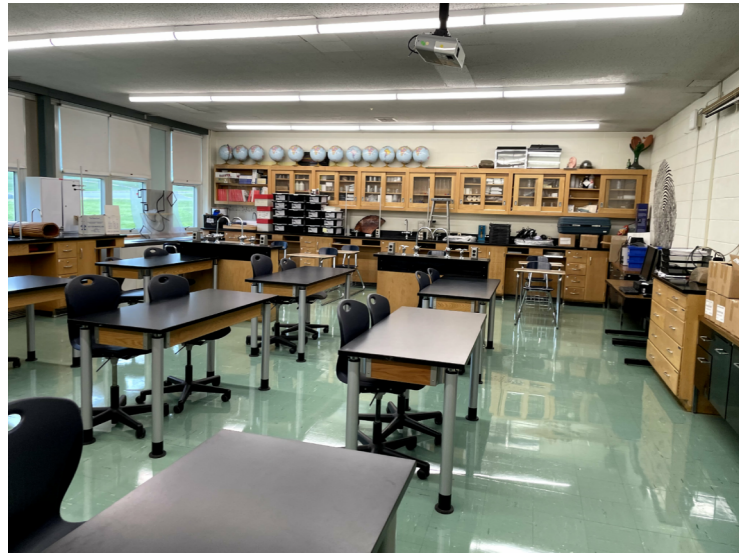
(A1) TYPICAL

| FIVE-YEAR CAPITAL FACILITIES PLAN | | | | | | | | | | | | | | | | |
|---|---|---|---|---|---|---|---|---|---|---|---|---|---|---|---|--|
| HSMS-000-01-21 | 1 | AP | S | Science Rooms | Gut rehab 3 Science Rooms and Laboratory spaces. | A1 | REP/ALT | Y | | | \$ 2,300,000 | \$ 230,000 | \$ 460,000 | \$ 230,000 | \$ 3,220,000 | |

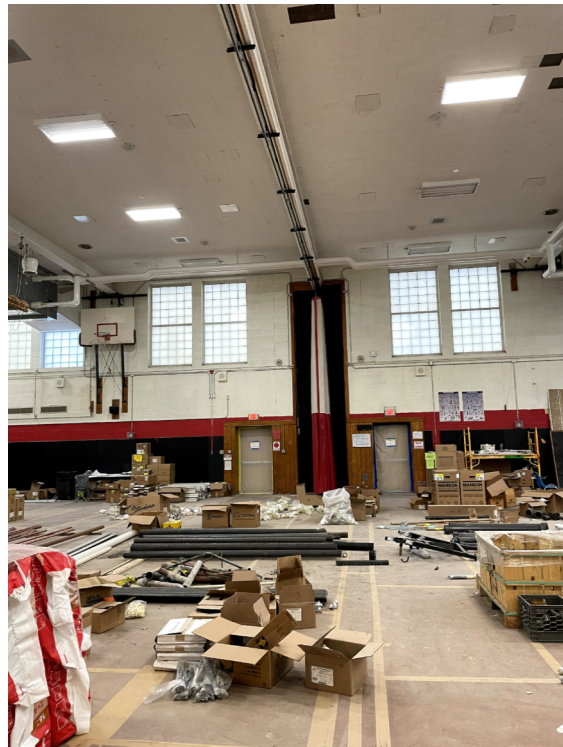
(A2)

| FIVE-YEAR CAPITAL FACILITIES PLAN | | | | | | | | | | | | | | | | |
|---|---|---|---|---|---|---|---|---|---|---|---|---|---|---|---|--|
| HSMS-000-02-21 | 1 | AP | S | Original Gymnasium | Renovate 'original' Gymnasium finishes, lighting and associated items. | A2 | REP/ALT | Y | | | \$ 100,000 | \$ 10,000 | \$ 20,000 | \$ 10,000 | \$ 140,000 | |

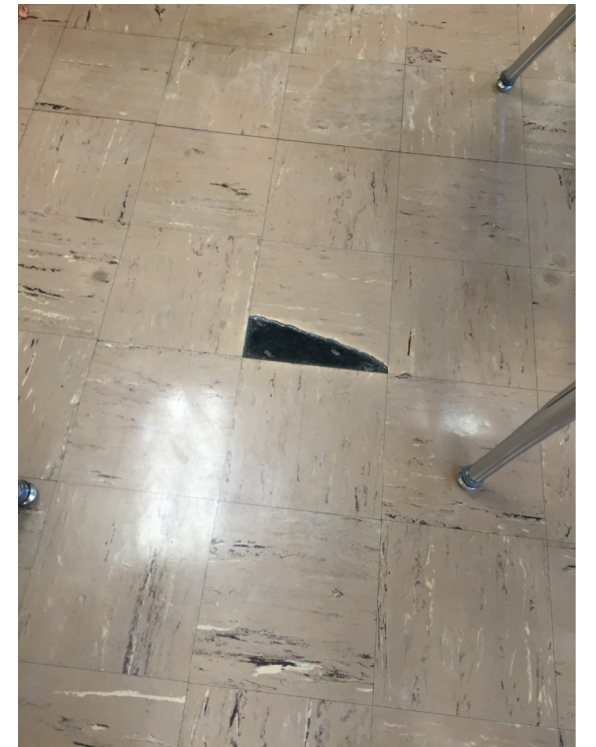
(A4) TYPICAL

| FIVE-YEAR CAPITAL FACILITIES PLAN | | | | | | | | | | | | | | | | |
|---|---|---|---|---|---|---|---|---|---|---|---|---|---|---|---|--|
| HSMS-077-01-21 | 1 | AP/HS | S | VAT | VAT throughout the building some is damaged (District currently working on abatement project) (10,000 sf rolling basis). Define immediate problem spaces to be done. | A4 | MSR | Y | | | \$ 138,000 | \$ 13,800 | \$ 27,600 | \$ 13,800 | \$ 193,200 | |

77f. Comments: VAT throughout building, some is damaged. District is currently working on abateme

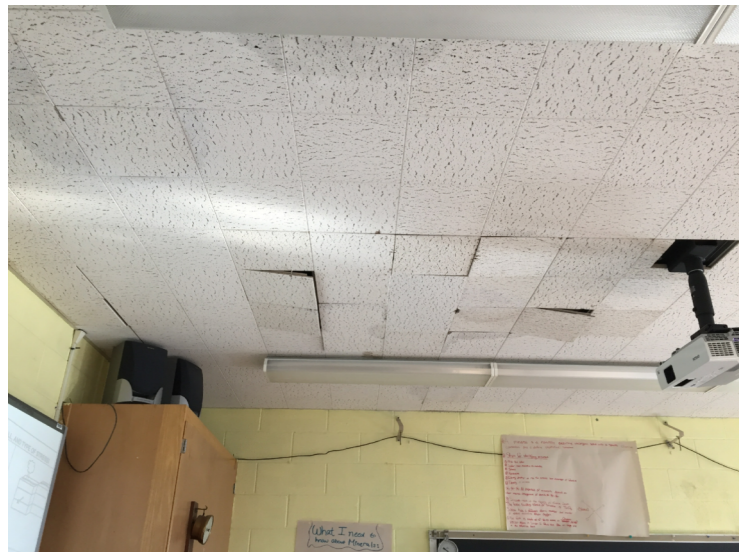
(A5) TYPICAL

| FIVE-YEAR CAPITAL FACILITIES PLAN | | | | | | | | | | | | | | | | |
|---|---|---|---|---|---|---|---|---|---|---|---|---|---|---|---|--|
| HSMS-080-01-21 | 1 | HS | U | Ceiling System Replacement | Spline ceiling falling apart, replace ceiling systems (30,000 sf). Define immediate problem spaces. | A5 | MSR | Y | | | \$ 506,000 | \$ 50,600 | \$ 101,200 | \$ 50,600 | \$ 708,400 | |

80e. Comments: Spline ceilings are falling apart, replace ceiling systems.

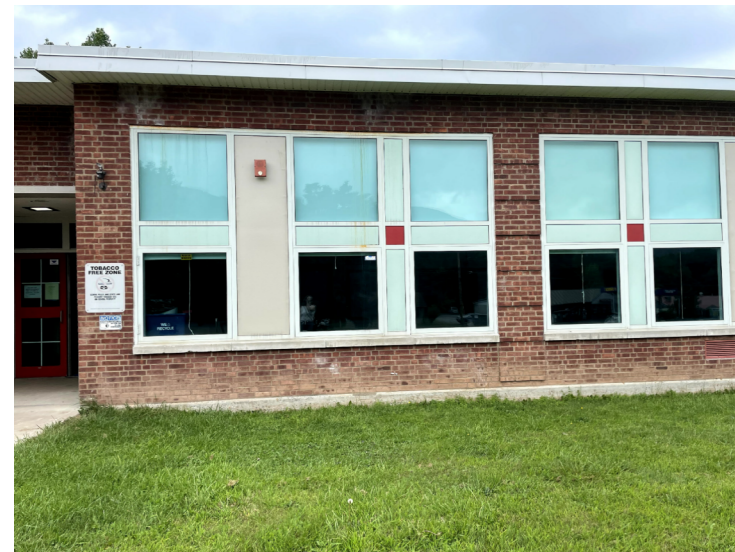
(A7)

| HSMS-072-01-21 | 5 | EE | S | Window Panels | Replace damaged panels @ west façade | | | | A7 | REP | Y* | | \$ 5,900 | \$ 590 | \$ 1,180 | \$ 590 | \$ 8,260 | | | | | | |

72g. Comments: Replace damaged panels at west facade.

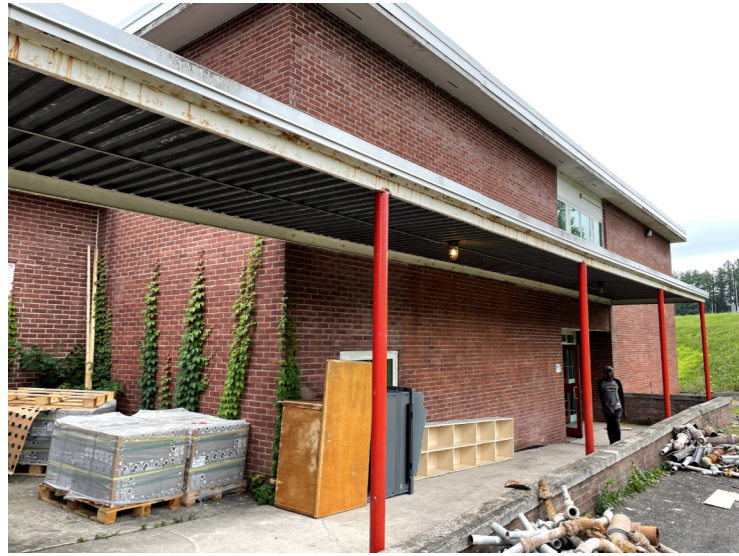
| FIVE-YEAR CAPITAL FACILITIES PLAN | | | | | | | | | | | | | | | | |
|---|---|---|---|---|---|---|---|---|---|---|---|---|---|---|---|--|
| HSMS-066-02-21 | 1 | ST | U | Rusting support columns | Repair/replace columns @ canopy at rear of building | A9 | REP/ALT | Y* | | | \$ 23,000 | \$ 2,300 | \$ 4,600 | \$ 2,300 | \$ 32,200 | |

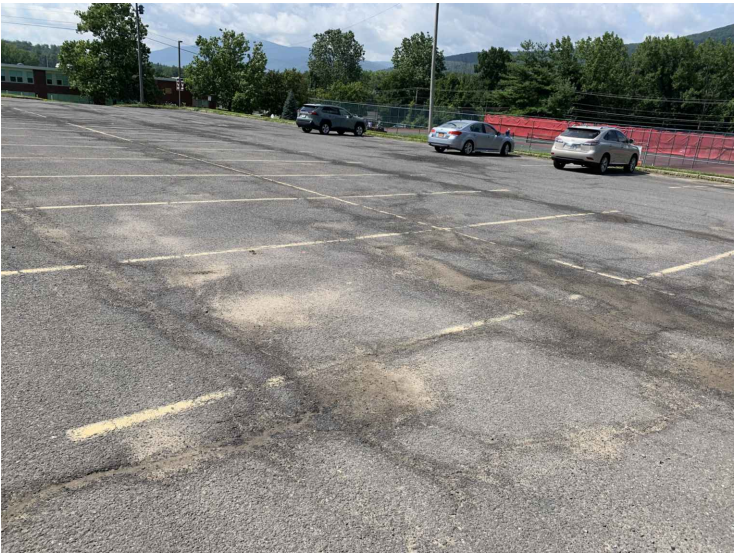
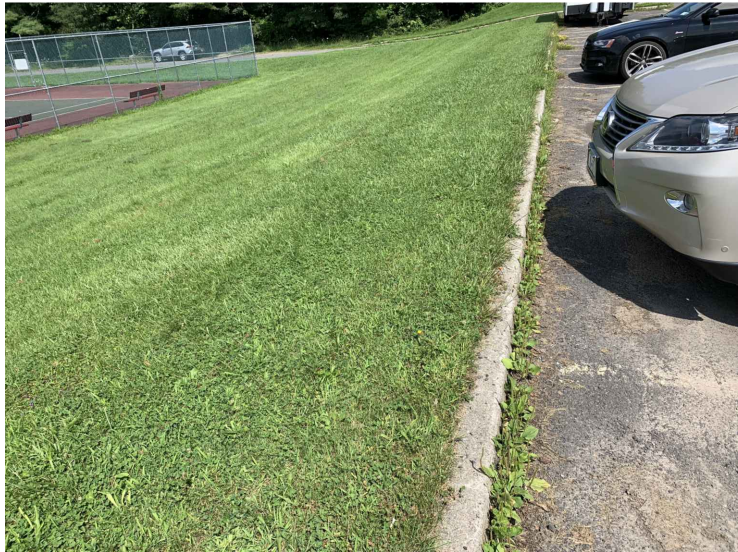
| FIVE-YEAR CAPITAL FACILITIES PLAN | | | | | | | | | | | | | | | | |
|---|---|---|---|---|---|---|---|---|---|---|---|---|---|---|---|--|
| HSMS-055-01-21 | 1 | AP | S | Lower Parking Lot | Replace lower parking lot by Tennis Court (full depth); remove and install new concrete curb. | C4 & C5 | REP | Y* | | | \$ 686,000 | \$ 68,600 | \$ 137,200 | \$ 68,600 | \$ 960,400 | |

55f. Comments: Full depth asphalt and curb replacement of tennis court parking lot; Full depth asphalt

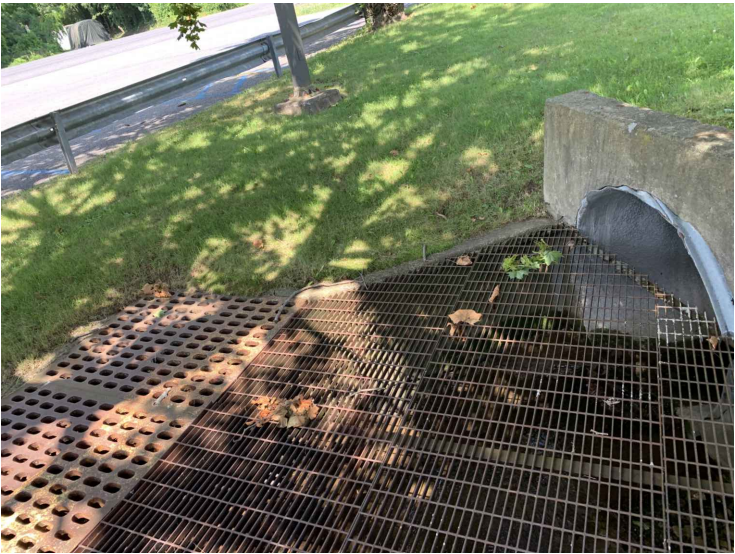
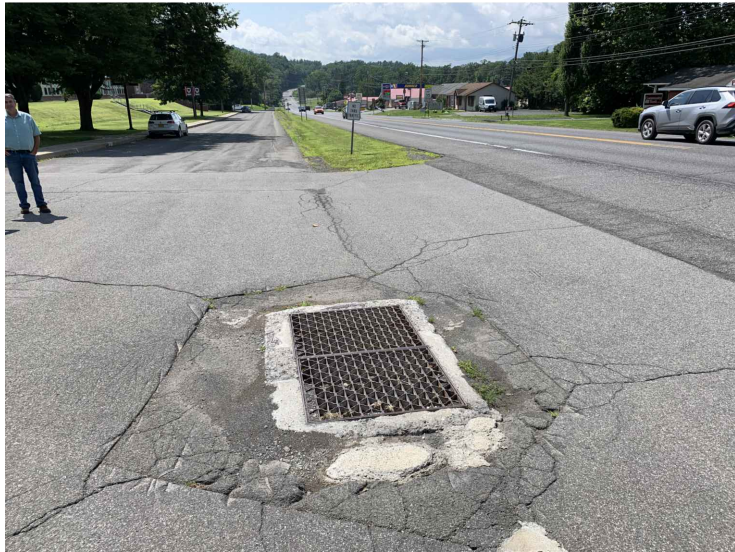
| FIVE-YEAR CAPITAL FACILITIES PLAN | | | | | | | | | | | | | | | | |
|---|---|---|---|---|---|---|---|---|---|---|---|---|---|---|---|--|
| HSMS-045-01-21 | 1 | AP | S | Drainage investigation | Drainage investigation; new structure and grading of parking lot/bus loop as needed. | C12 & C13 | REP/MSR | Y* | | | \$ 120,000 | \$ 12,000 | \$ 24,000 | \$ 12,000 | \$ 168,000 | |

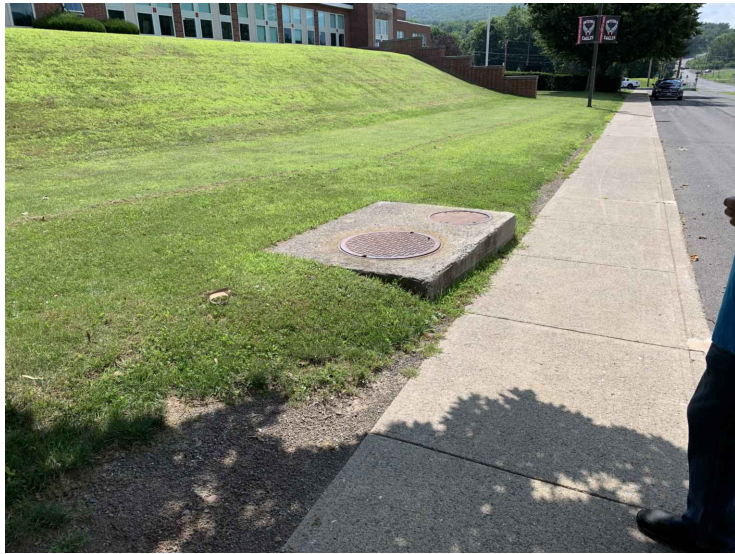
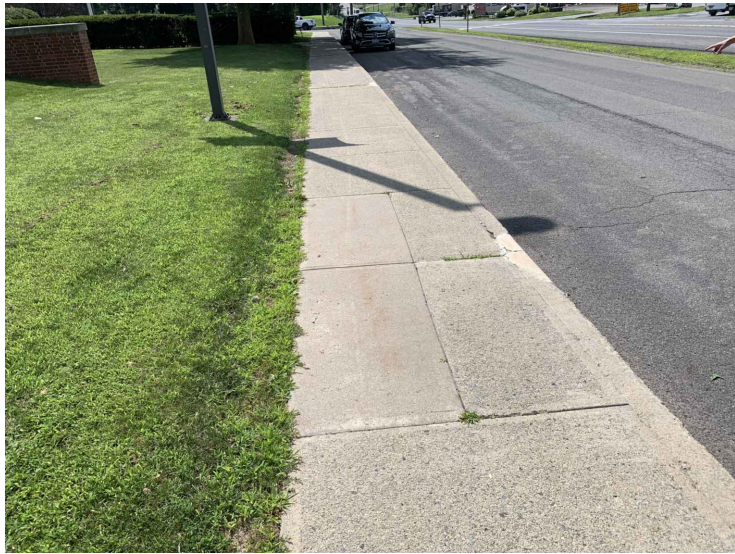
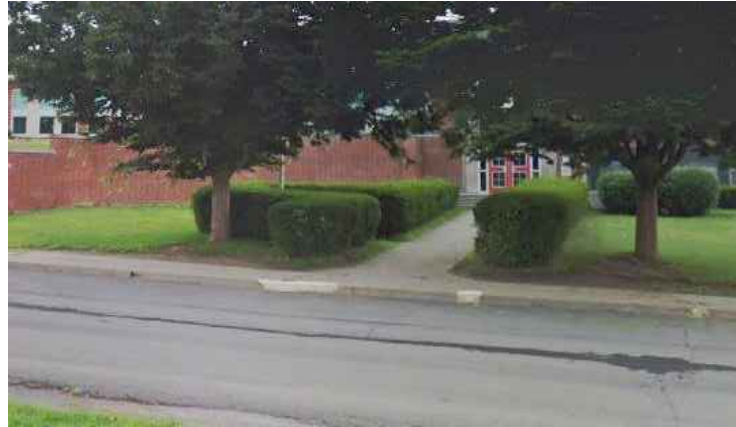
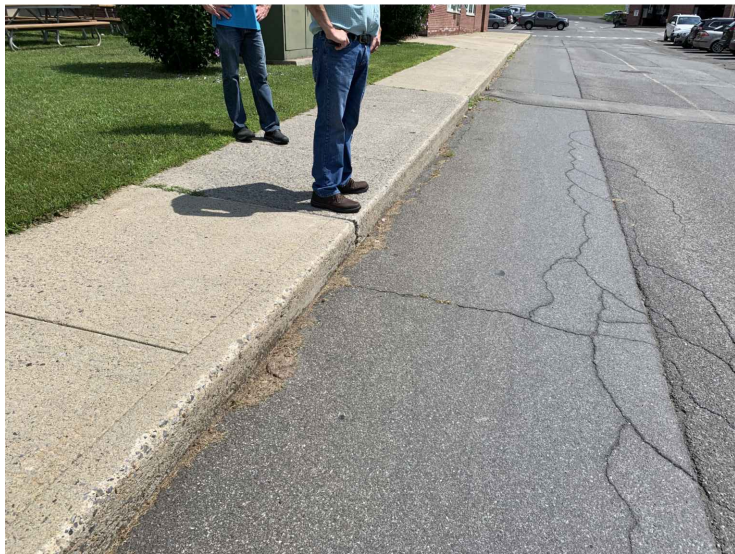
| FIVE-YEAR CAPITAL FACILITIES PLAN | | | | | | | | | | | | | | | | |
|---|---|---|---|---|---|---|---|---|---|---|---|---|---|---|---|--|
| HSMS-056-01-21 | 1 | AP | S | Bus Loop Concrete Curb and Well Lid | Replace integral concrete curb and sidewalk in bus loop, around building, and concrete sidewalk to entrance of building; Replace well lid. | C17, C18,C19, & C21 | REP | Y* | | | \$ 289,000 | \$ 28,900 | \$ 57,800 | \$ 28,900 | \$ 404,600 | |

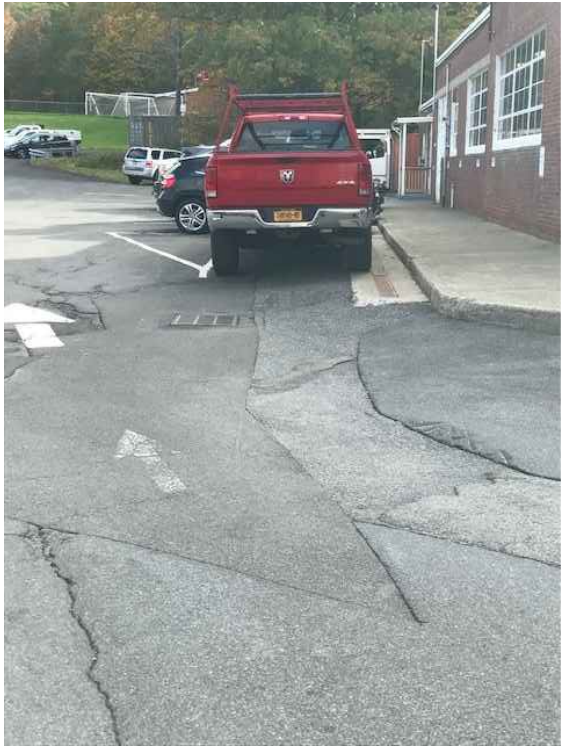
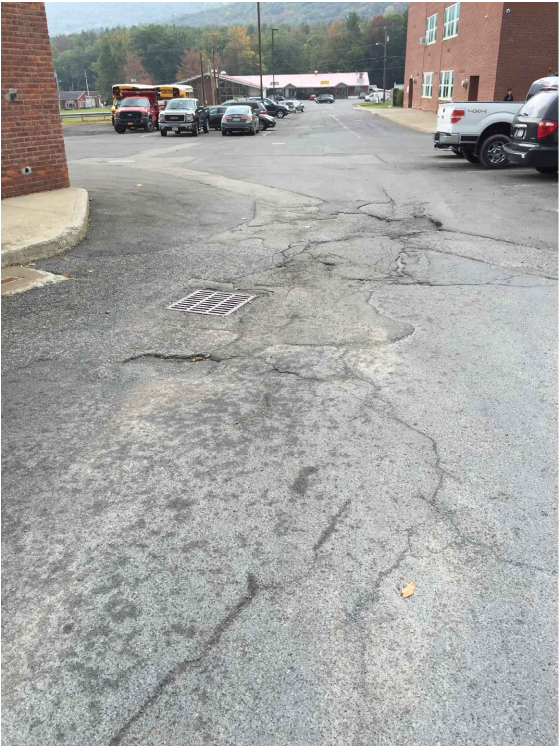
| FIVE-YEAR CAPITAL FACILITIES PLAN | | | | | | | | | | | | | | | | |
|---|---|---|---|---|---|---|---|---|---|---|---|---|---|---|---|--|
| HSMS-044-01-21 | 1 | AP | S | Catch Basins | Remove and install new catch basins; investigate connection lines between drainage structures | C38 & C39 | MSR | Y* | | | \$ 48,000 | \$ 4,800 | \$ 9,600 | \$ 4,800 | \$ 67,200 | |
