Subject: **Addendum 3, Bid FB-26-08, Restroom Remodel, Phase 1, Santa Rosa Technology Magnet Elementary School**

**Asbestos Survey for  
Santa Rosa Tech Magnet School  
13282 Santa Rosa Rd,  
Camarillo, California 93012**

### **ASBESTOS SURVEY REPORT** **SANTA ROSA TECH MAGNET SCHOOL** **CAMARILLO, CALIFORNIA 93012**

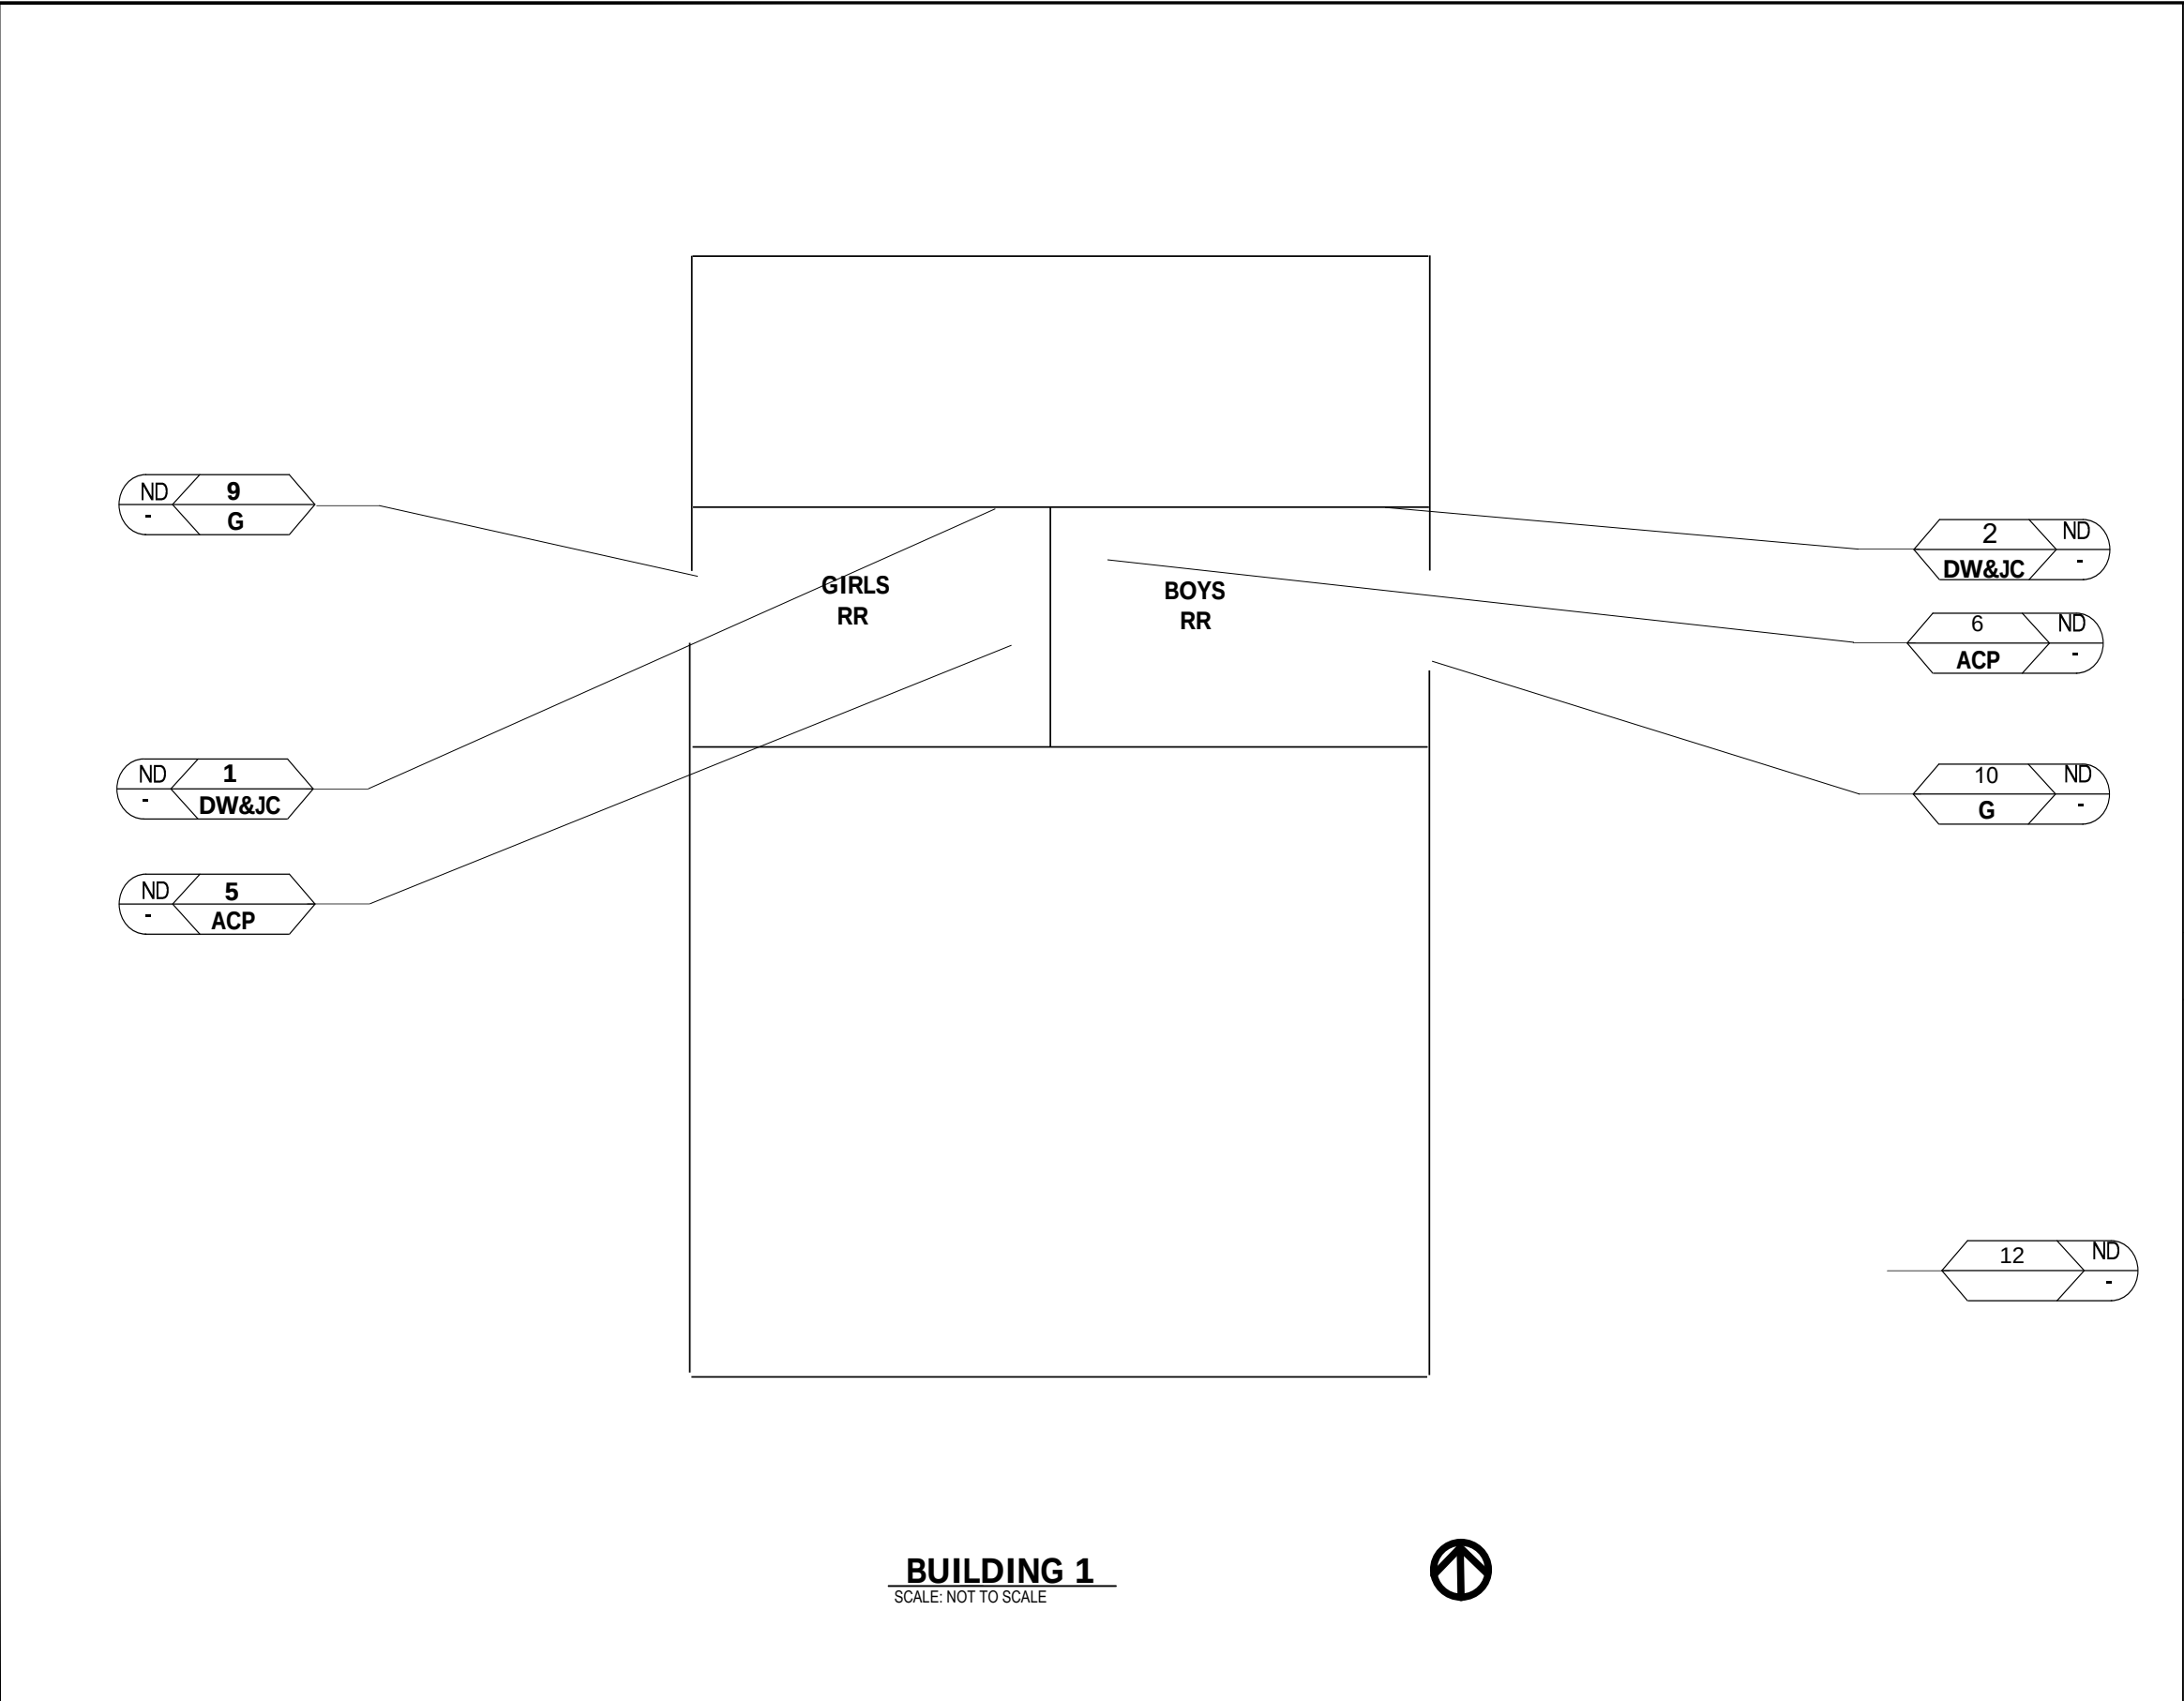
**BUILDING 1**  
SCALE: NOT TO SCALE

Asbestos was not detected in any of the materials sampled by TC.

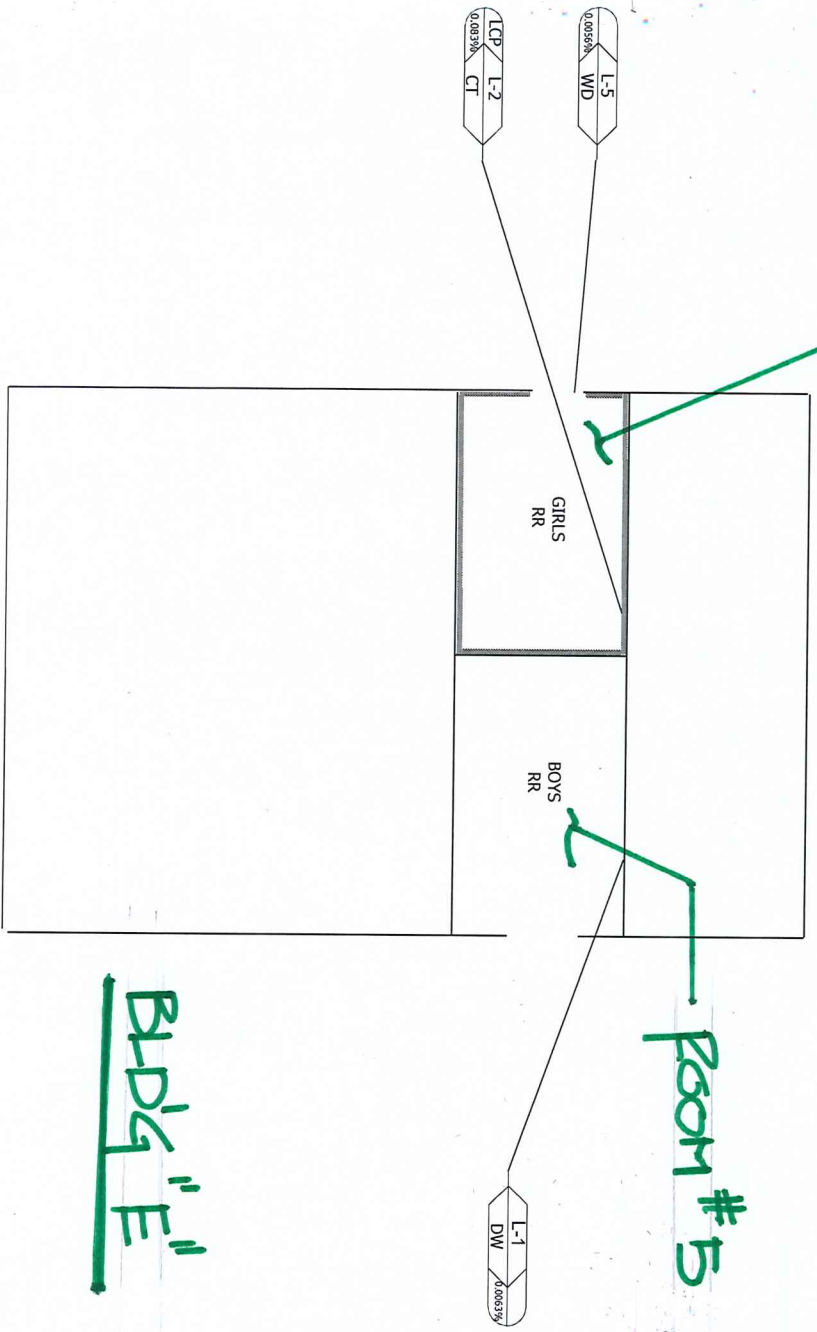
**BUILDING 1**  
SCALE: NOT TO SCALE

One of the coatings sampled had lead concentrations greater than 600 mg/Kg (ppm) or 0.06% by weight. According to Title 8 CCR, Section 1532.1(d)(4), only coatings with lead concentrations above 600 mg/Kg (ppm) or 0.06% by weight are deemed a positive initial determination and pose a potential health hazard to workers who disturb them. Additionally, Section 1532.1(d) (2) identifies tasks that regulate worker actions where any lead is present. The contractor must determine whether any of these tasks will be performed and institute the appropriate safety measures under this regulation to protect its workers.

| MATERIAL | QTY | DESCRIPTION |
|---|---|---|
| | | CERAMIC TILE ON WALLS CONTAINING 830ppm Lead |

TC recommends that any disturbance of these coatings be performed in accordance with the requirements of Title 8, California Code of Regulations (CCR), and Section 1532.1. The employer of any workers disturbing these coatings must perform an Exposure Assessment in accordance with Section 1532.1(d) to determine if workers disturbing these coatings will be exposed to airborne lead concentrations in excess of the Action Level or Permissible Exposure Limit (PEL) for lead and what, if any, provisions of Section 1532.1 will govern the disturbance of these coatings.
