AD-15489-001

Project: 2026 Midfield High School Reroofing Project  
Midfield, Alabama

## ADDENDUM NO. ONE

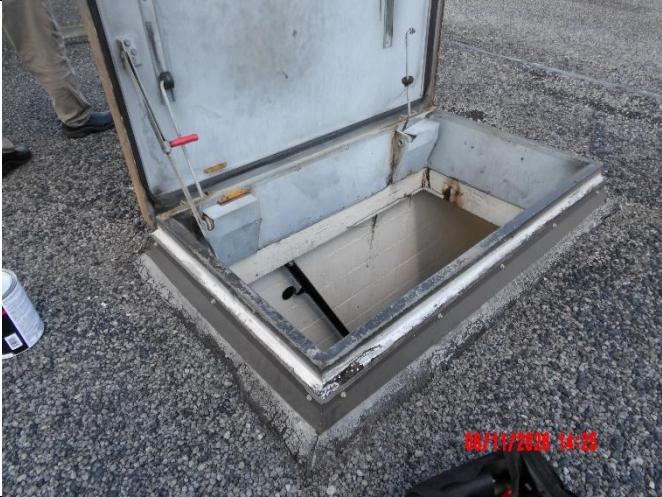
| # | Location & Description | Condition Photo |
|---|---|---|
| 1 | View of the Roof Hatch. The Scope of Work includes the replacement of the sealant at the top of the cap flashing using DowSil™ 795 or approved equal sealant tooled into place and protective roof silicone coating at the modified bitumen base flashings. | |

2. Replace the sealant at the top edge of the existing cap slashing at the Roof Hatch using DowSil™ 795 or approved equal sealant tooled into place. Prep and clean the joint prior to tooling the sealant into place. Restore the base flashings at the Roof Hatch curb in the same manner as listed above. Wet aggregate blast the Roof Hatch. Prep, solvent clean and apply two (2) coats of the specified high zinc paint.

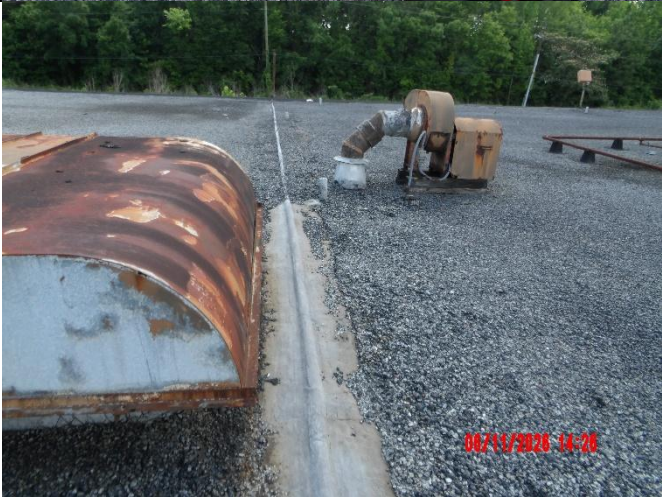
| # | Location & Description | Condition Photo |
|---|---|---|
| 2 | Another view of the straight flange roof expansion joint. See the Scope of Work. | |

17. The existing roof expansion joints are constructed with a straight flange type with neoprene bellows. The expansion joints need to be restored. **The Contractor is to include one-hundred (100) linear feet of expansion joint repair performed in the following manner:**
- a. On both sides of the straight flange expansion joint, spud the existing flood coat and aggregate for an area of approximately nine-inches (9") in width, removing the flood coat and aggregate.
  - b. Prep, clean and apply a three (3) course repair using the Coal Tar Roof Cement, the Asphalt Type IV Glass Fibers and another layer of Coal Tar Roof Cement.
  - c. At each of the expansion joint laps and miters, install neoprene rubber set in roof cement.
  - d. At the repaired and spudded area, apply a flood coat of the Coal Tar Pitch Flexible Compound, distribute loose slag aggregate while fluid and add

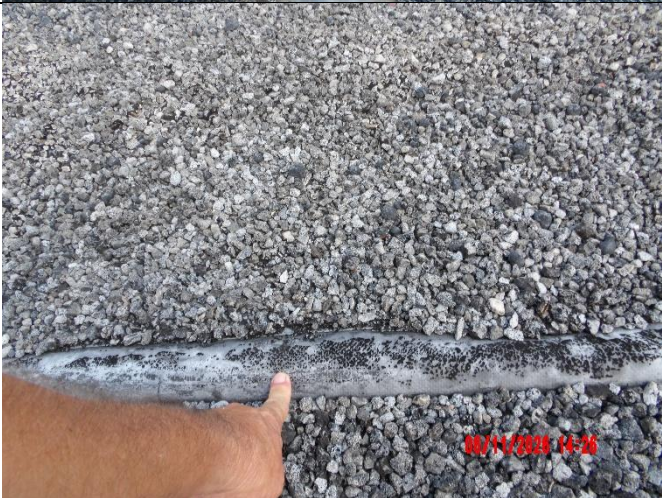
| # | Location & Description | Condition Photo |
|---|---|---|
| 3 | Downward view of the straight flange neoprene bellows roof expansion joint which needs to be restored at various locations. | |

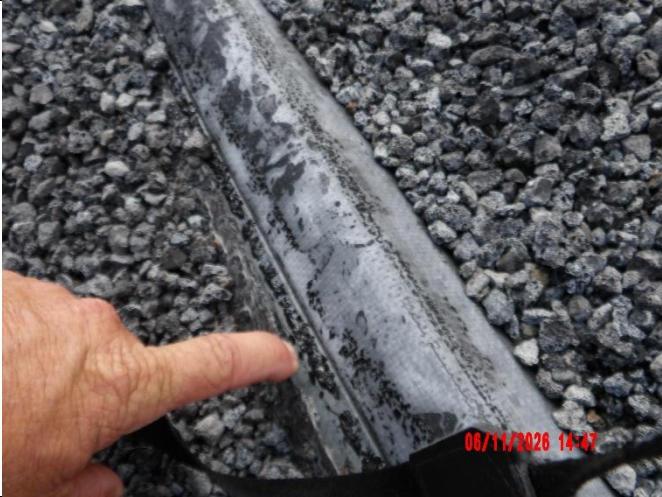
| # | Location & Description | Condition Photo |
|---|---|---|
| 4 | Typical view of the straight flange expansion joint neoprene bellows. Prep and apply silicone mastic at the exposed portion of the bellows. | |

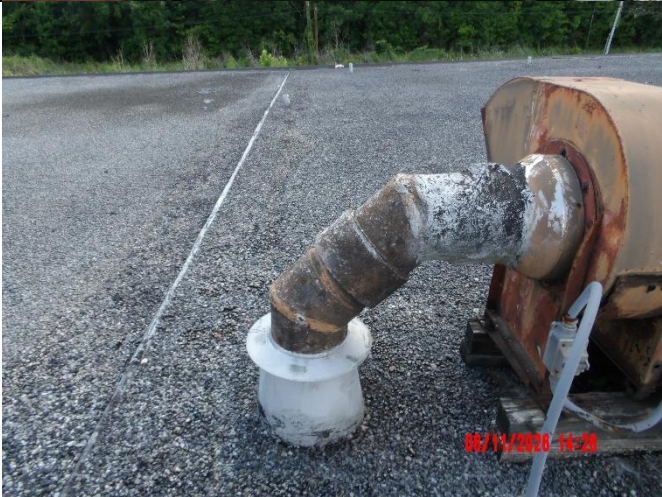
| # | Location & Description | Condition Photo |
|---|---|---|
| 5 | View of the rooftop equipment. Prep, the metal duct and apply silicone mastic at the joints and silicone coating over the elbow. Power wash with wet aggregate blast to remove the excess rust at the mechanical unit. Allow dry time. Apply the specified high zinc coating. | |

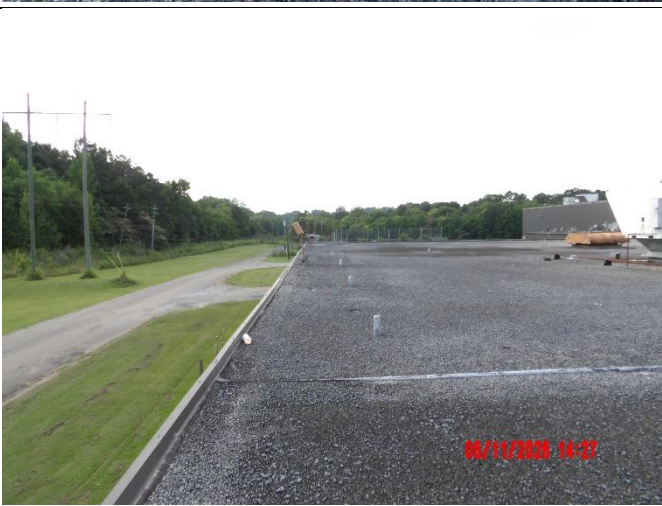
| # | Location & Description | Condition Photo |
|---|---|---|
| 6 | Typical view of the roof perimeter with raised edge. Prep and apply the silicone mastic at the base flashing laps and scuppers. Apply silicone coating over the entire modified bitumen base flashing exposed surface. | |

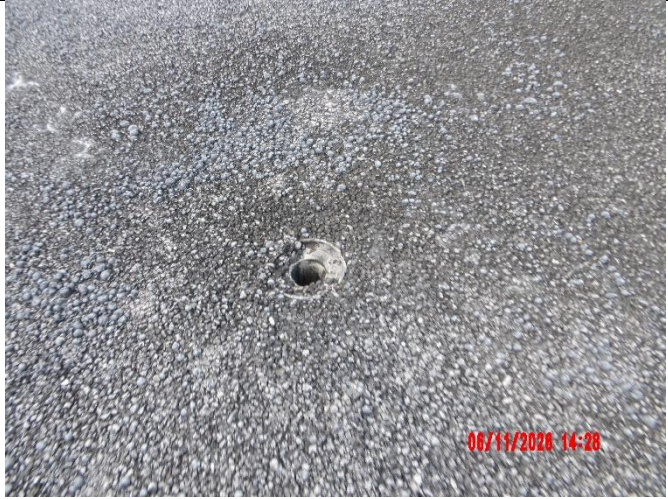
| # | Location & Description | Condition Photo |
|---|---|---|
| 7 | Remove the gravel inside the drain collar. Prep and apply two coats of the specified silicone coating inside the drain collar and where it joins the leader. | |

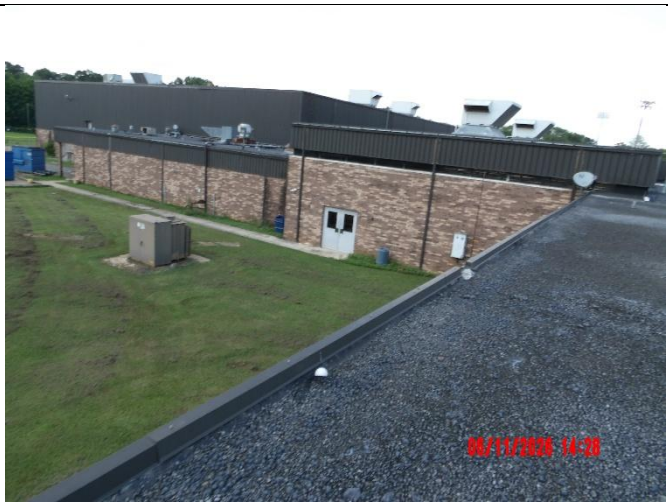
| # | Location & Description | Condition Photo |
|---|---|---|
| 8 | Another typical view of the roof perimeter with raised edge. Prep and apply the silicone mastic at the base flashing laps and scuppers. Apply silicone coating over the entire modified bitumen base flashing exposed surface. | |

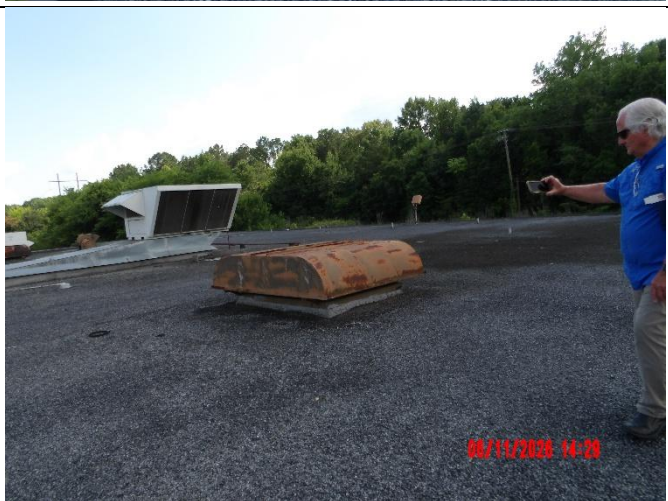
| # | Location & Description | Condition Photo |
|---|---|---|
| 9 | With wet aggregate blast, power-wash the mechanical fans to help remove excess rust. Allow dry time and apply two (2) coats of the specified high zinc aluminum paint. | |

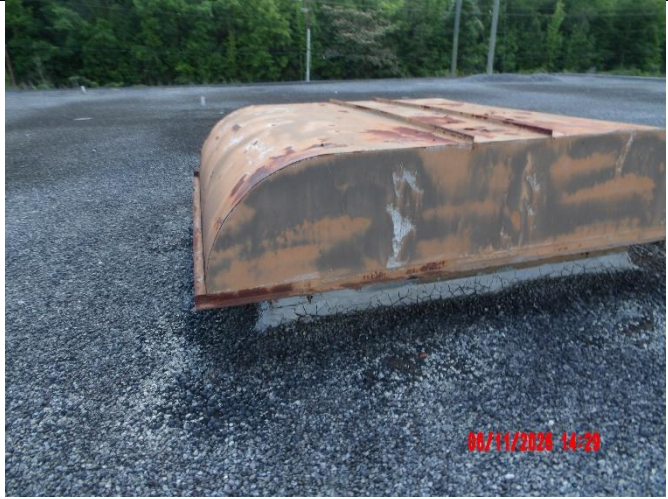
| # | Location & Description | Condition Photo |
|---|---|---|
| 10 | Typical view of the mechanical curbs. Prep and apply silicone mastic at the base flashing laps and coat the entire exposed surface of the base flashing with the specified silicone coating system. | |

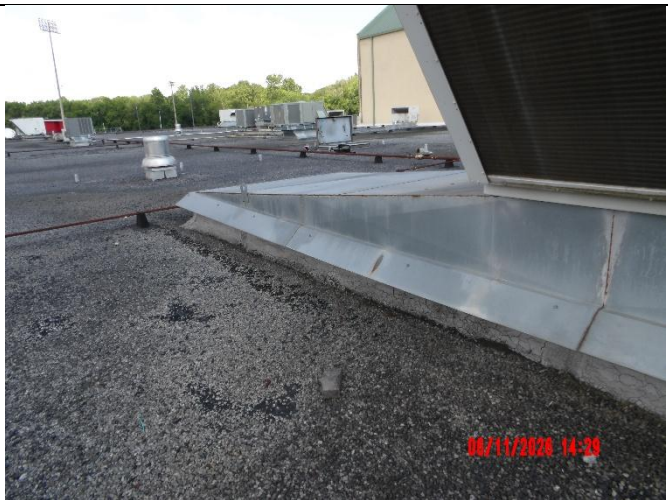
| # | Location & Description | Condition Photo |
|---|---|---|
| 11 | Another typical view of the mechanical curbs. Prep and apply silicone mastic at the base flashing laps and coat the entire exposed surface of the base flashing with silicone coating system. | |

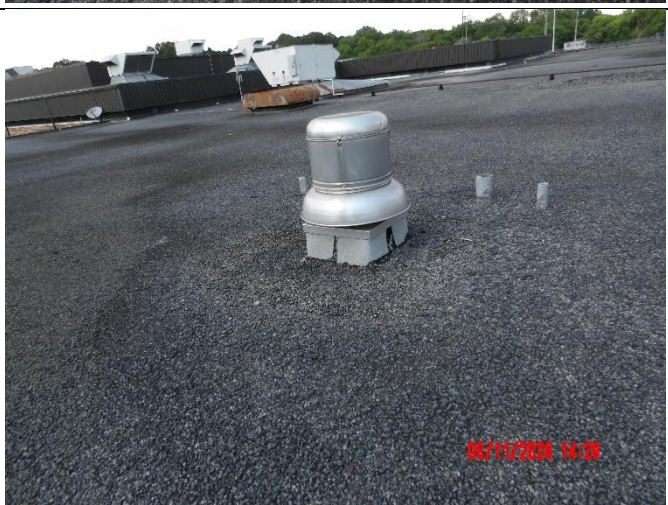
| # | Location & Description | Condition Photo |
|---|---|---|
| 12 | Typical view of the exhaust fan curbs. Prep and apply silicone mastic at the base flashing laps and silicone coating system at entire exposed surface of the modified bitumen base flashings.<br>Replace the fasteners securing the fan using noncorrosive wood grip fasteners with neoprene washers. | |

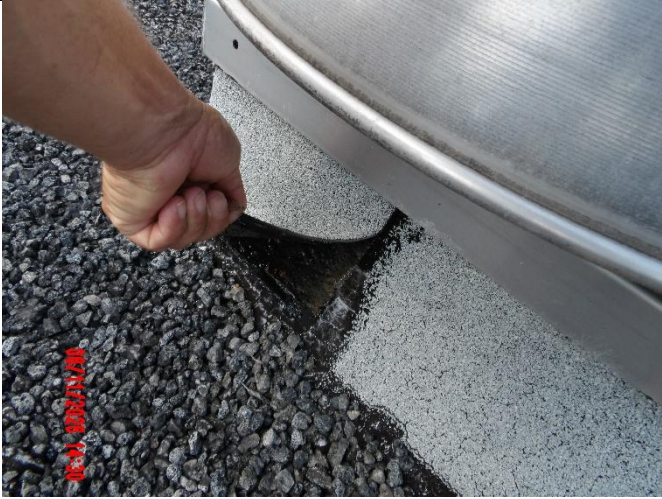
| # | Location & Description | Condition Photo |
|---|---|---|
| 13 | Where the base flashing laps are open, prep and apply silicone mastic between the laps and the top surface of the laps prior to coating the base flashings with the specified silicone coating system. | |

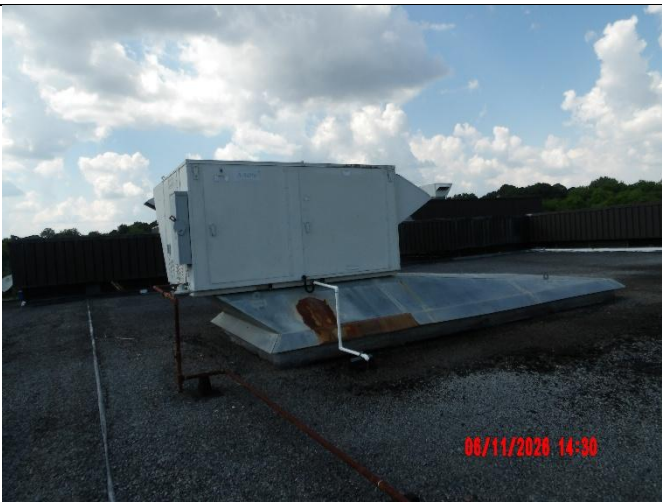
| # | Location & Description | Condition Photo |
|---|---|---|
| 14 | With wet aggregate blast, power-wash the mechanical curb to remove the excess rust. Allow dry time. Apply two (2) coats of the specified high zinc paint to rust areas. | |

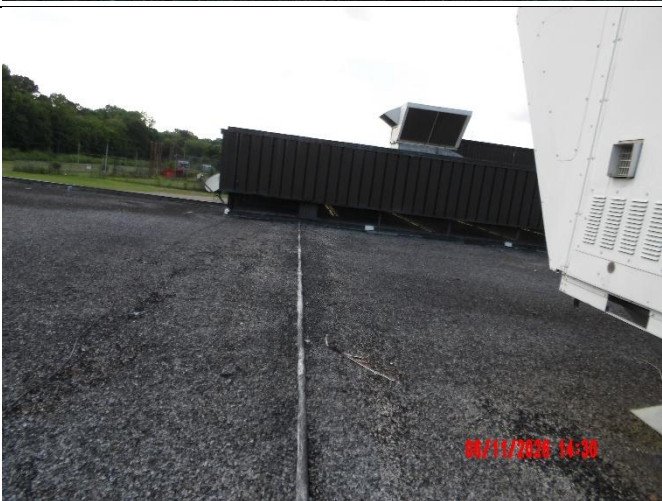
| # | Location & Description | Condition Photo |
|---|---|---|
| 15 | Another typical view of the straight flange expansion joint which needs to be restored. See the Scope of Work for linear footage allowance. | |

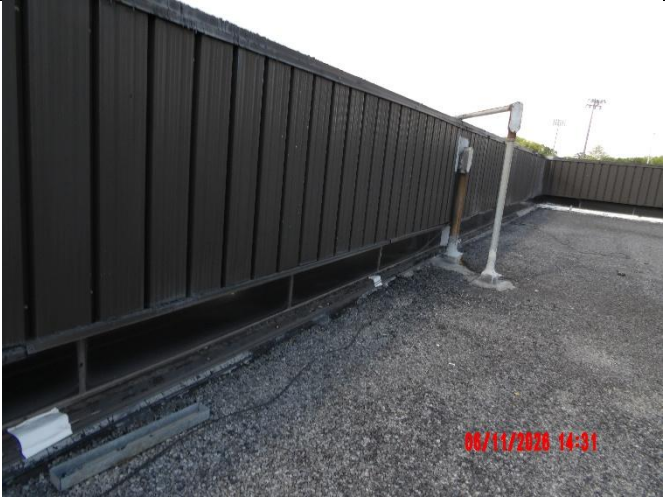
| # | Location & Description | Condition Photo |
|---|---|---|
| 16 | Typical view of the base of the wall at the Library. Restore the base flashings using silicone mastic at the laps and a silicone coating system at the base flashing exposed surface. Replace the cap flashing. Wet seal the glazing / glass units. | |

16. At the base of the Library Clerestory Windows perform the following:
- a. Repair the base flashings in the same manner noted for the roof curbs above.

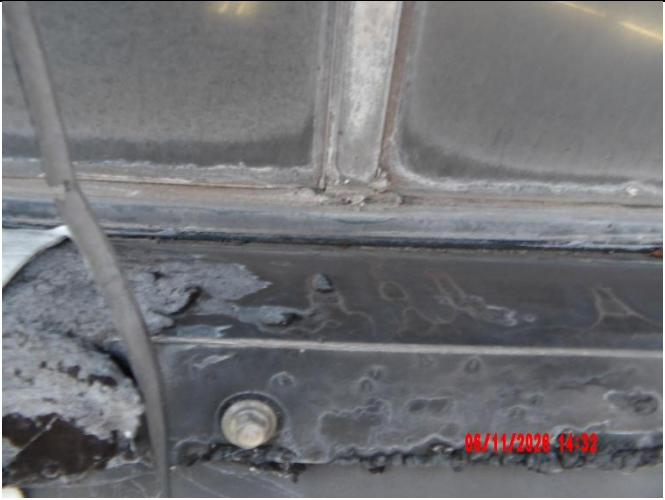
| # | Location & Description | Condition Photo |
|---|---|---|
| 17 | Typical view of the Library storefront / window system. Replace the sealants using DowSil™ 795 or approved equal sealant to create a wet seal system. | |

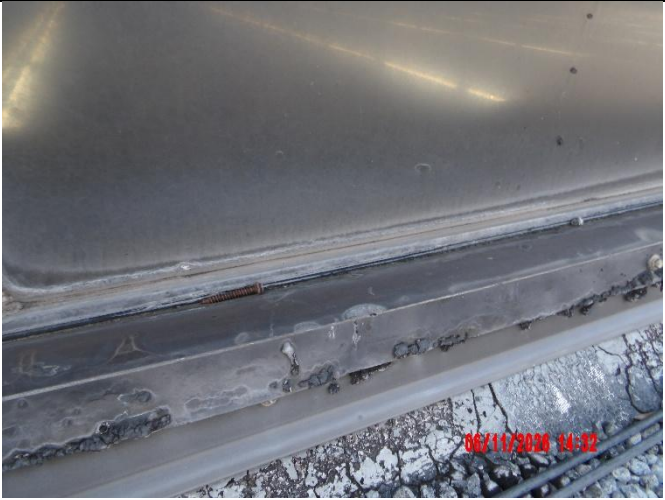
| # | Location & Description | Condition Photo |
|---|---|---|
| 18 | Typical view of the Library storefront / window system. Replace the sealant to create a wet seal system using DowSil™ 795 or approved equal sealant. | |

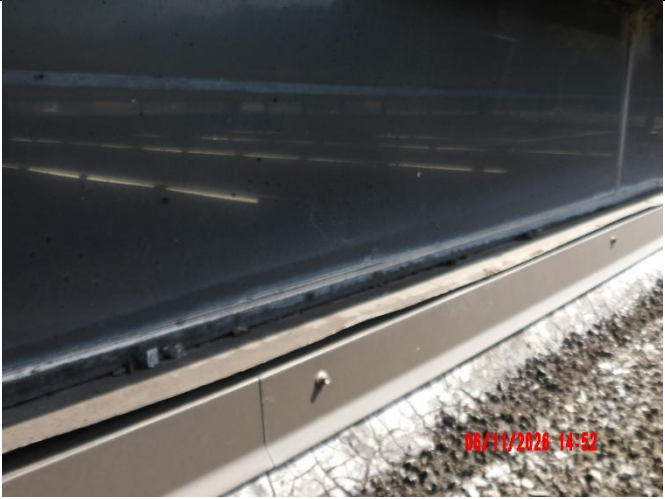
| # | Location & Description | Condition Photo |
|---|---|---|
| 19 | Another typical view of the Library clerestory windowsills. Replace the cap flashing using new 24-ga. prefinished cap flashing. Secure the cap flashing using prefinished noncorrosive wood grip fasteners with neoprene washers. Install oversized backer rod and sealant between the windowsills and cap flashings. Wet seal the window system. | |

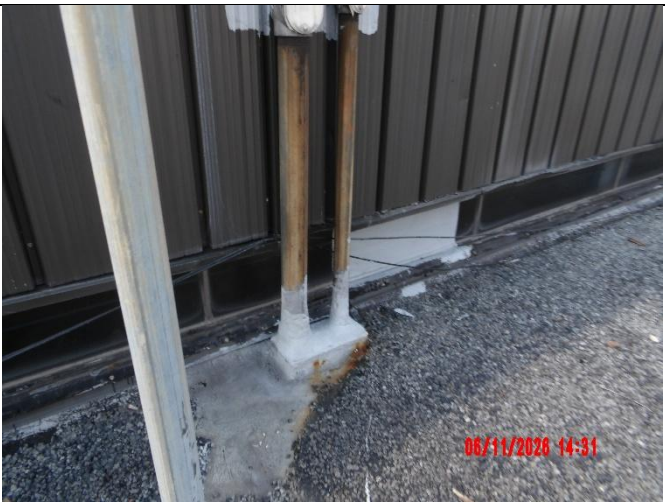
| # | Location & Description | Condition Photo |
|---|---|---|
| 20 | Scope of Work includes the replacement of the pitch pockets with new GAF M-Curb™ Pitch Pocket System or approve equal with pourable sealer. | |

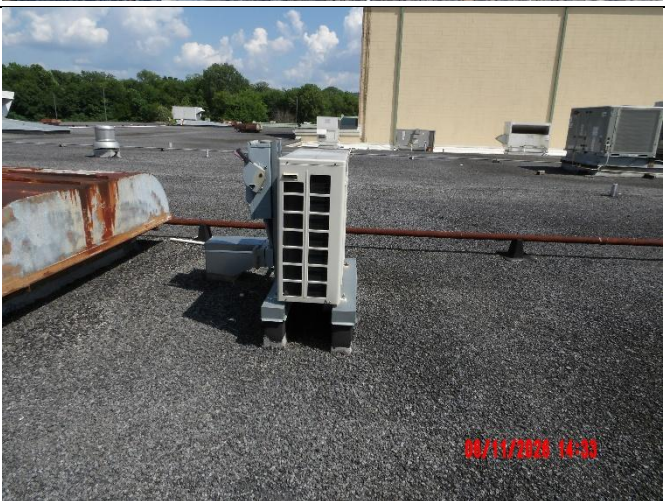
| # | Location & Description | Condition Photo |
|---|---|---|
| 21 | Typical view of the equipment curbs supporting the mechanical units. Restore the base flashing using silicone mastic at laps and miters and silicone coatings over the entire exposed surface of the base flashings. | |

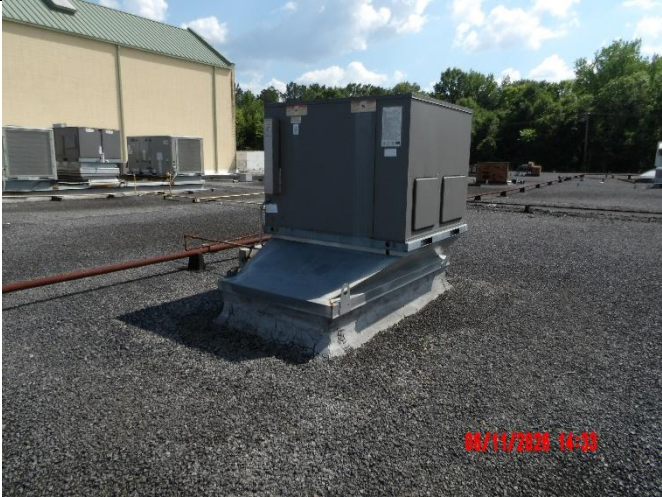
| # | Location & Description | Condition Photo |
|---|---|---|
| 22 | Another typical view of the equipment curbs supporting the mechanical units. Restore the base flashing using silicone mastic at laps and miters and silicone coatings over the entire exposed surface of the base flashings. | |

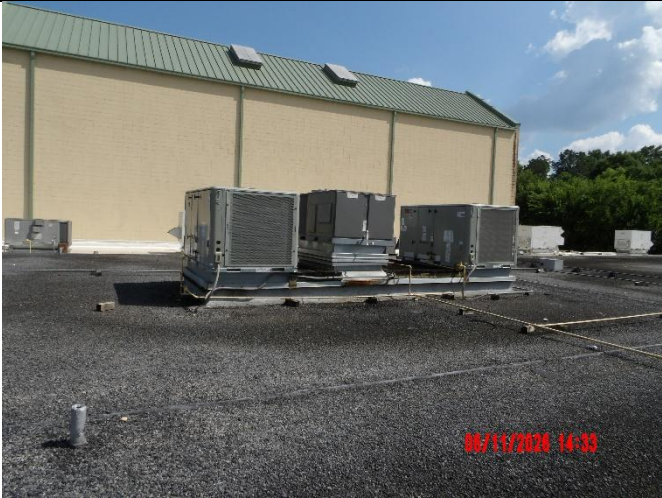
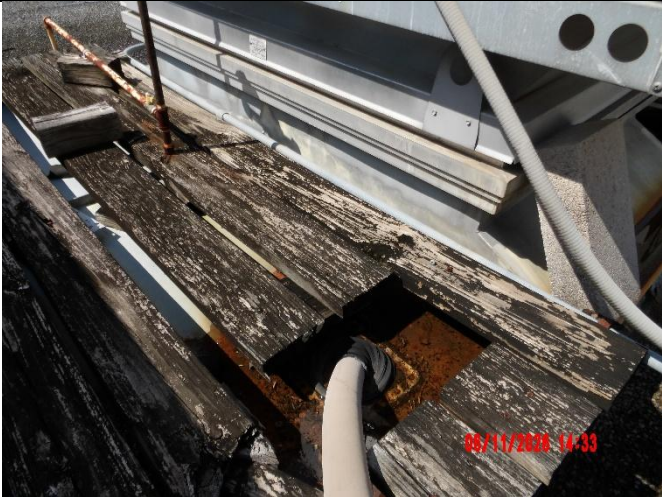
| # | Location & Description | Condition Photo |
|---|---|---|
| 23 | View of the mechanical curb supporting three (3) mechanical units. See the next photo. | |
| 24 | Remove the wood and power wash with wet aggregate blast at the top of the metal cover.<br>Apply two (2) coats of the specified high zinc paint to the entire metal cover. Apply silicone mastic where conduits join the curb. | |

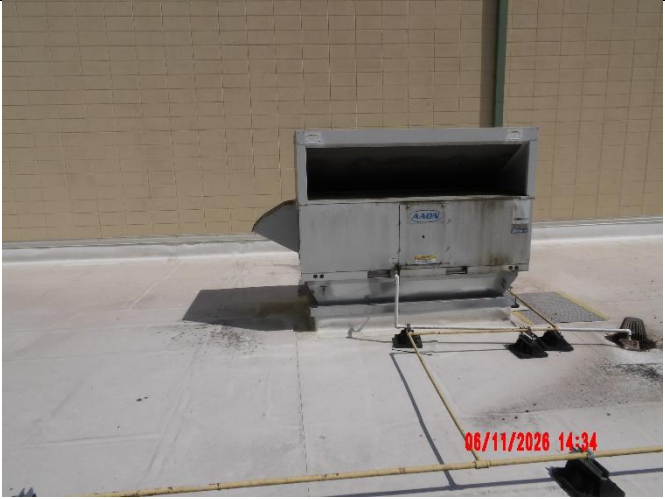
| # | Location & Description | Condition Photo |
|---|---|---|
| 25 | <p>The Scope of Work includes adding a 24-ga. prefinished or .032 mill finished aluminum cap flashing at the new Auditorium Addition mechanical curbs. Secure using noncorrosive wood grip screws spaced at 12" on center and 4" from the corners.</p> <p>Roof restoration does not include the upper Auditorium roof area.</p> | |

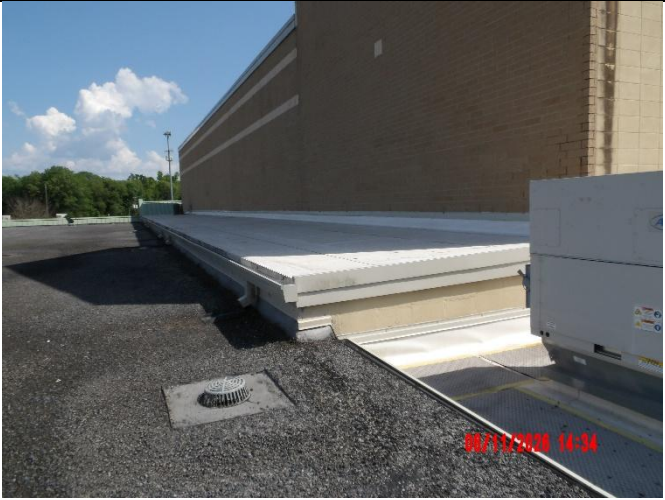
| # | Location & Description | Condition Photo |
|---|---|---|
| 26 | <p>The Scope of Work includes the replacement of the sealant at the Auditorium Addition where the cap flashing is surface mounted to the CMU. Replace the sealant using DowSil™ 795 or approved equal sealant.</p> | |

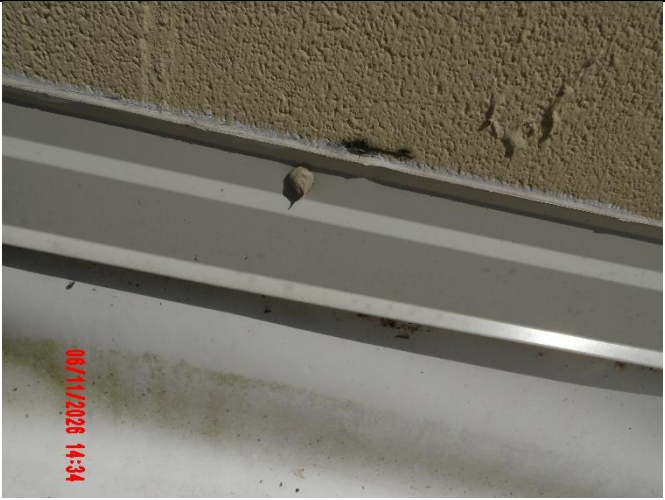
| # | Location & Description | Condition Photo |
|---|---|---|
| 27 | <p>Typical view of where the surface mounted cap flashing joins the painted CMU and fastener heads. Replace the sealant using DowSil™ 795 or approved equal sealant in an aesthetically pleasing color.</p> | |

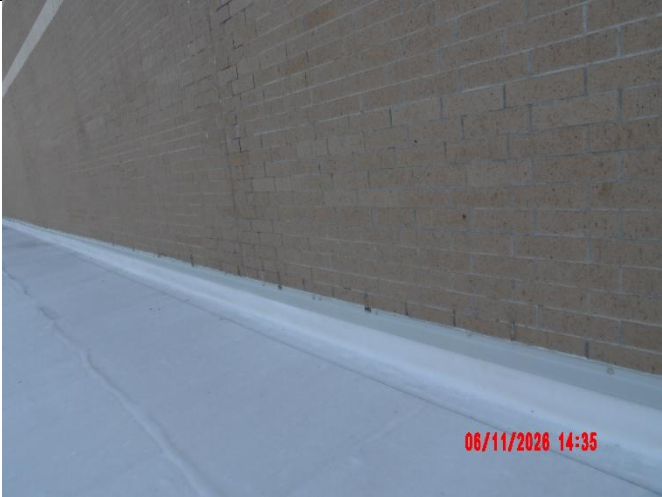
| # | Location & Description | Condition Photo |
|---|---|---|
| 28 | Typical view of the cap flashing at the masonry. The cap flashing needs to be replaced. See the next photo. | A photograph showing a white cap flashing installed on a brick wall. The flashing is slightly raised and does not sit flush against the wall. A red timestamp '06/11/2026 14:35' is visible in the bottom right corner. |

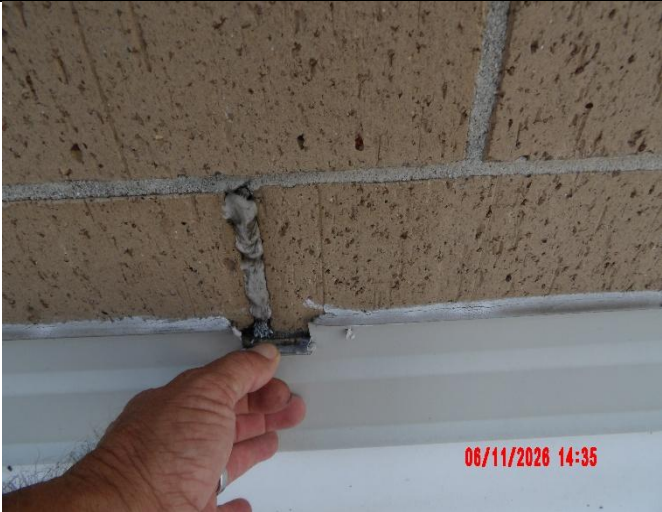
| # | Location & Description | Condition Photo |
|---|---|---|
| 29 | View of the Auditorium Addition. Replace the surface mounted cap flashing at the masonry. Secure the top of the TPO membrane using a T-bar and sealant. Install 24-ga. prefinished cap flashing using butyl tape and DowSil™ 795 or approved equal sealant at the top edge. The existing cap is installed in a too high position at the through-wall flashing weeps. Install the new cap flashing below the weep line. | A close-up photograph of a hand pointing to the top edge of a white cap flashing where it meets a brick wall. The flashing is installed too high, above the weep line. A red timestamp '06/11/2026 14:35' is visible in the bottom right corner. |

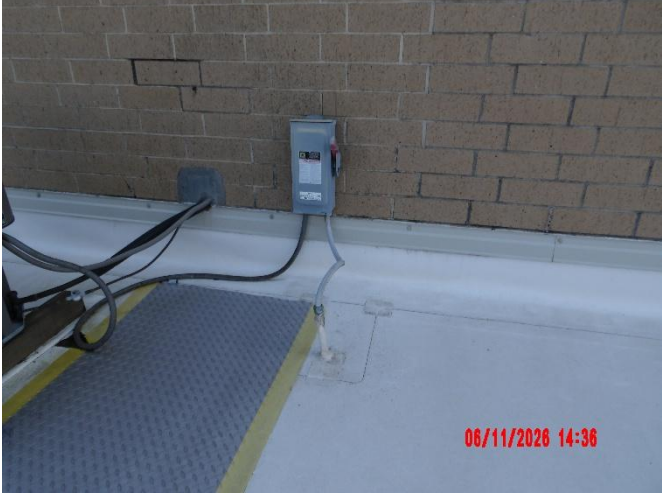
| # | Location & Description | Condition Photo |
|---|---|---|
| 30 | The Scope of Work at the Auditorium roofing system includes the replacement of the sealant at the penetrations at the exterior walls above the adjoining roofing system. Install oversized backer rod and sealant at the tops and sides of the electrical boxes. | A photograph showing an electrical box mounted on a brick wall above a white roofline. The box is secured with a metal strap. A red timestamp '06/11/2026 14:36' is visible in the bottom right corner. |

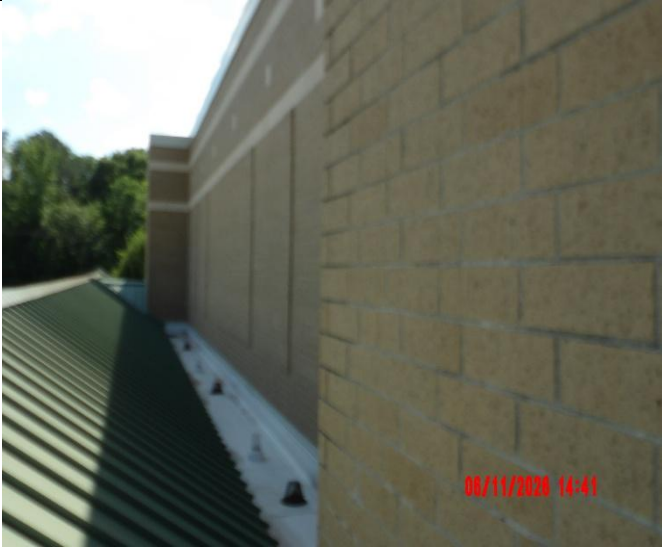
| # | Location & Description | Condition Photo |
|---|---|---|
| 31 | View of where the front roof area of the Auditorium joins the rise wall. Replace the sealant at the top edge of the cap flashing using DowSil™ 795 or approved equal sealant. Low-pressure-wash the masonry from the top of the cap flashing (approximately 2-3 feet) to the through-wall flashing. Allow dry time. Apply Protectosil® Chem-Trete® BSM 400 or approved equal water repellent treatment in a two-coat wet-on-wet method. | |

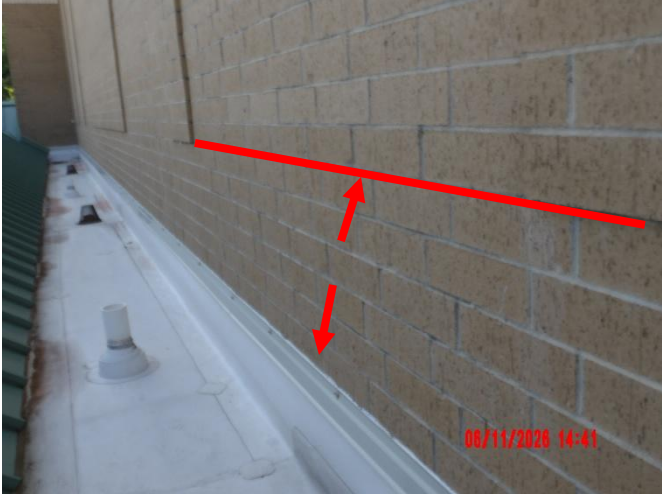
| # | Location & Description | Condition Photo |
|---|---|---|
| 32 | Closer view of the previous photo. Replace the sealant at the top edge of the cap flashing using DowSil™ 795 or approved equal sealant. Low-pressure-wash the masonry from the top of the cap to the through-wall flashing. Allow dry time. Apply Protectosil® Chem-Trete® BSM 400 or approved equal water repellent treatment in a two-coat wet-on-wet method. | |

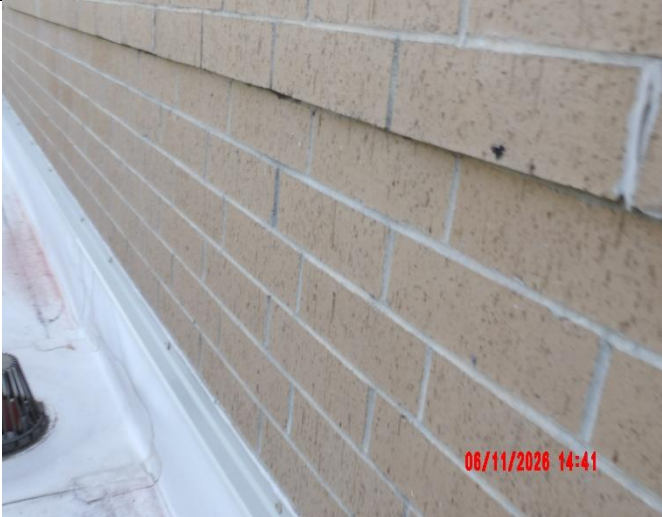
| # | Location & Description | Condition Photo |
|---|---|---|
| 33 | Another closer view of the previous photo. Replace the sealant at the top edge of the cap flashing using DowSil™ 795 or approved equal sealant. Low-pressure-wash the masonry from the top of the cap to the through-wall flashing. Allow dry time. Apply Protectosil® Chem-Trete® BSM 400 or approved equal water repellent treatment in a two-coat wet-on-wet method. | |

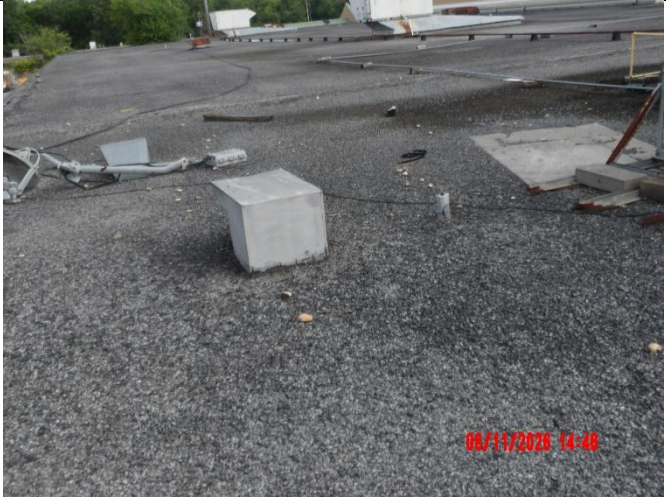
| # | Location & Description | Condition Photo |
|---|---|---|
| 34 | Typical view of the metal hoods. Prep, clean and apply silicone mastic at the metal hood joints. Apply silicone coating at the entire base of the metal hood area. Replace the fasteners using noncorrosive wood grip fasteners with neoprene washers. | |

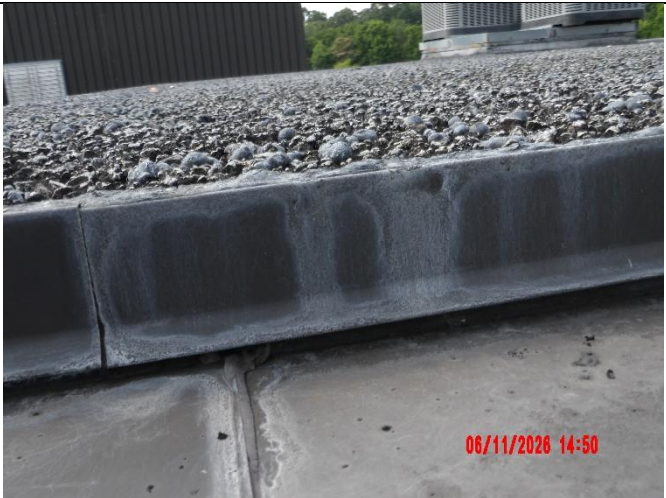
| # | Location & Description | Condition Photo |
|---|---|---|
| 35 | Typical view of the gravel stop joints. Spud the area approximately 8" x 8". Prep, clean and incorporate a three-course repair using tar roofing cement and embedded fabric. Cover the repair area using coal tar pitch compound, loose aggregate and "Gray" granules. | |

12. Where noted and where the existing gravel stop joints have split the existing roofing system, spud the existing flood coat and aggregate at each joint for an area of approximately nine-inches by nine-inches (9"x9") and perform the following:
  - a. Prep and clean the spudded area.
  - b. Apply a three (3) course repair using the Coal Tar Roof Cement, the Asphalt Type IV Glass Fibers and another layer of Coal Tar Roof Cement.
  - c. Over the gravel stop repaired and spudded area, apply a flood coat of the Coal Tar Pitch Flexible Compound, distribute loose slag aggregate while fluid and add additional “Gray” granules to help provide full UV protective coverage over the compound.

13. At the gravel stops where the felts and flood coat have split perform the following:
  - a. Spud the existing flood coat and aggregate for an area of approximately nine-inches in width, removing the flood coat and aggregate.
  - b. Prep, clean and apply a three (3) course repair using the Coal Tar Roof Cement, the Asphalt Type IV Glass Fibers and another layer of Coal Tar Roof Cement.
  - c. At the repaired and spudded area, apply a flood coat of the Coal Tar Pitch Flexible Compound, distribute loose slag aggregate while fluid and add additional “Gray” granules to help provide full UV protective coverage over the

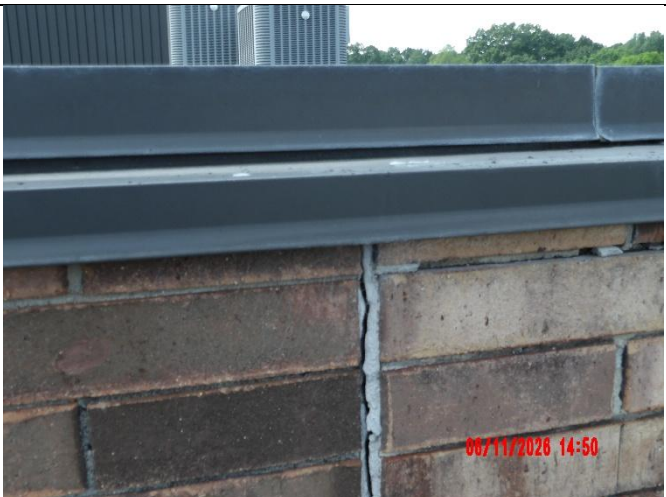
| # | Location & Description | Condition Photo |
|---|---|---|
| 36 | Typical view of the metal fascia joint at the northeast roof perimeter of the Band Room. Clean and seal the joint with "Medium Bronze" DowSil™ 795 or approved equal sealant. See the next photo. | |

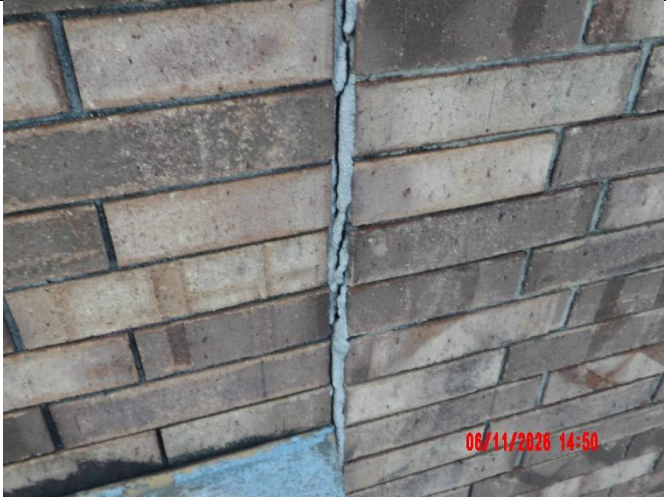
| # | Location & Description | Condition Photo |
|---|---|---|
| 37 | Where it joins the roofing system, replace the sealant at the Band Room masonry wall using oversized backer rod and DowSil™ 795 or approved equal sealant. | |

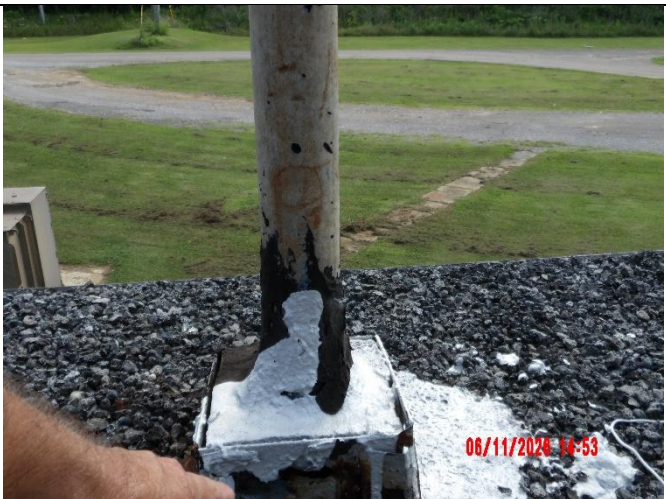
| # | Location & Description | Condition Photo |
|---|---|---|
| 39 | Typical view of the existing pitch pockets. Spud the perimeter of the penetrations pockets, remove the pitch pockets, solvent clean the existing felts and install new GAF M-Curb™ Pitch Pocket Systems with pourable sealant in accordance with the Manufacturer's guidelines. | |

7. Apply the Durapax™ Coal Tar Pitch Compound where the roof mat was spudded at the penetration pocket perimeter. While fluid, embed loose slag aggregate.
8. Distribute additional “Gray” granules on the flood coat and aggregate to help provide full UV coverage of/over the compound. If repairs are needed at the spudded areas, prep, clean and install a three (3) course Durapax™ Tar Roof Cement embedding the Durapax™ Asphalt Type IV Glass Fibers in the base coat with a full coat of the roofing cement prior to the application of the Coal Tar Pitch Compound.

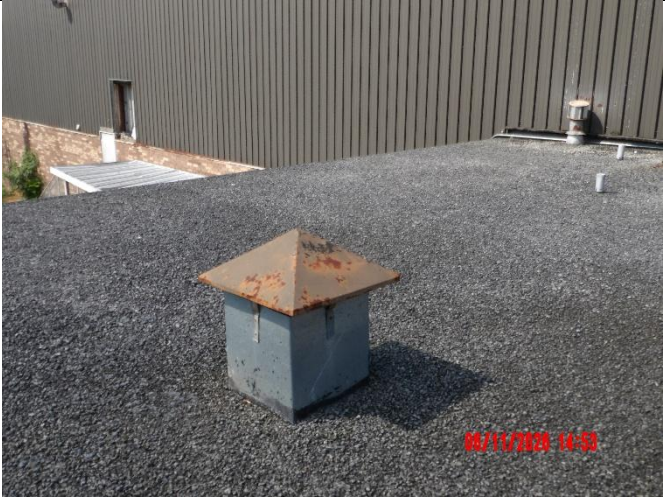
| # | Location & Description | Condition Photo |
|---|---|---|
| 40 | View of a roof top vent. Wet aggregate blast to remove excess rust. Allow dry time. Coat with two (2) coats of the high zinc paint as specified. | |

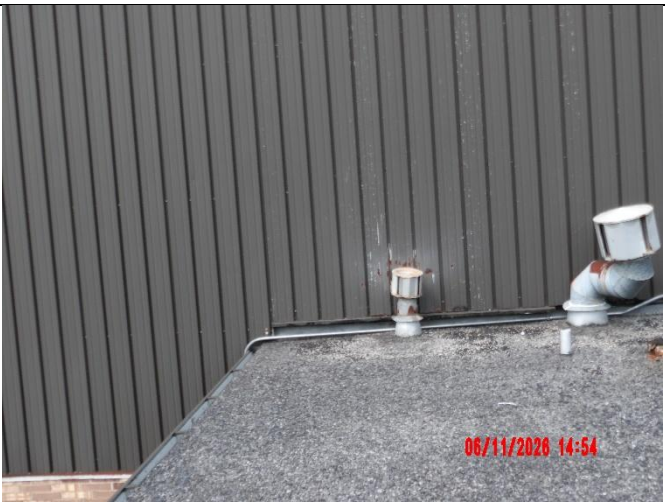
| # | Location & Description | Condition Photo |
|---|---|---|
| 41 | <p>At the base of the heater vents solvent clean the lap and apply silicone mastic at the lap and silicone coating at the base of the heater vent.</p> <p>Replace the sealant at the storm collar using "Gray" DowSil™ 795 or approved equal sealant.</p> <p>At the heater vents wire brush the surface rust, solvent clean and apply two (2) coats of the specified aluminum paint.</p> | |

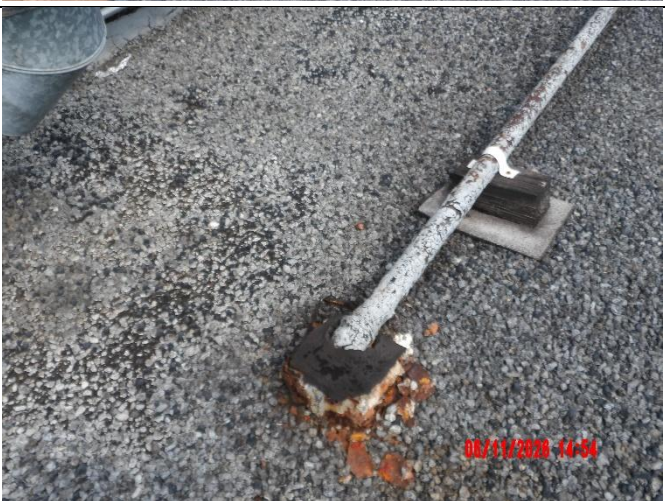
| # | Location & Description | Condition Photo |
|---|---|---|
| 42 | Another typical view of a pitch pocket. Spud the perimeter of the pitch pocket, remove the pitch pocket, solvent clean the existing felts and install the new GAF M-Curb™ Pitch Pocket System with pourable sealant in accordance with the Manufacturer's guidelines. | |

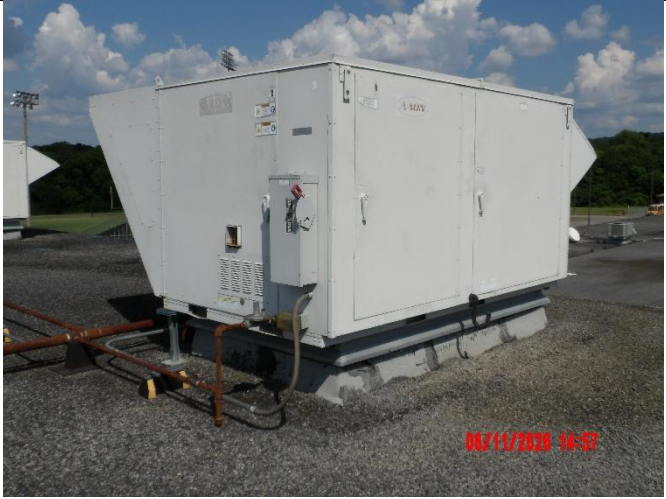
| # | Location & Description | Condition Photo |
|---|---|---|
| 43 | Typical view of one (1) of the RTUs. Prep the laps and apply silicone mastic between the base flashing laps, at the tops of the base flashings and at the miters. Apply silicone coating at the exposed modified bitumen base flashings. | |

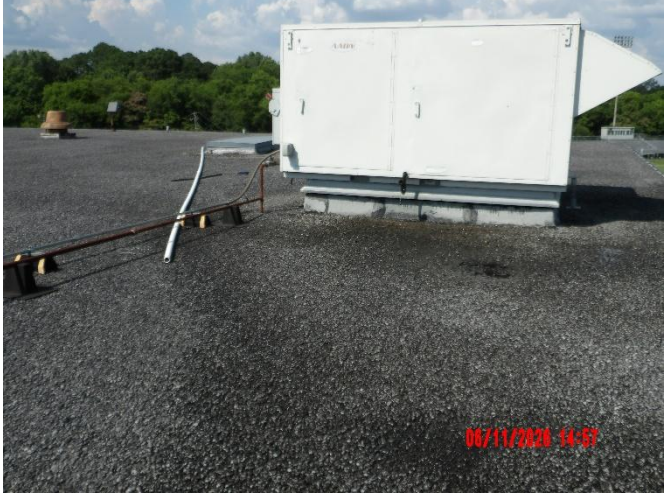
| # | Location & Description | Condition Photo |
|---|---|---|
| 44 | At each of the roof top curbs add .032 mill finished aluminum cap flashing. Secure the flashings using noncorrosive wood grip fasteners with neoprene washers at 12" on center and 4" from the corners. Install cap with laps and lapped miters. | |

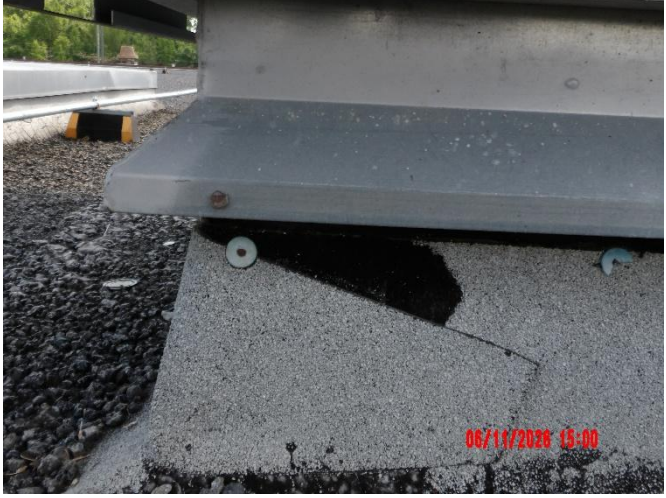
| # | Location & Description | Condition Photo |
|---|---|---|
| 45 | Typical view of some of the base flashing laps and top edges. Apply silicone mastic between the laps and at the tops of the laps and the tops of the base flashings. Install aluminum cap flashings. Secure using fasteners with neoprene washers. | |

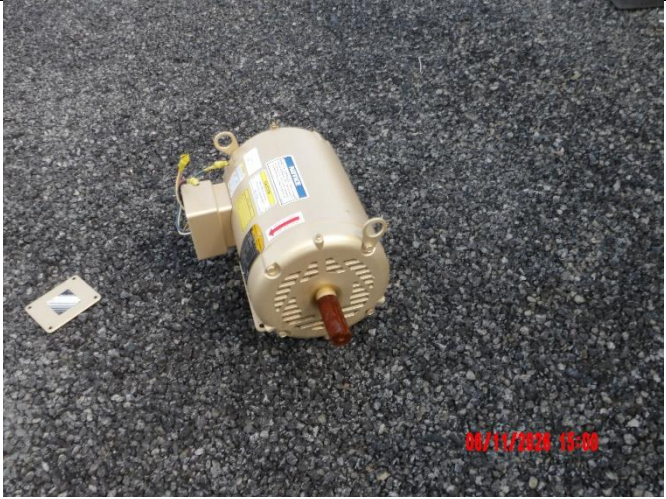
| # | Location & Description | Condition Photo |
|---|---|---|
| 46 | Remove the abandoned compressor from the roof area. | |

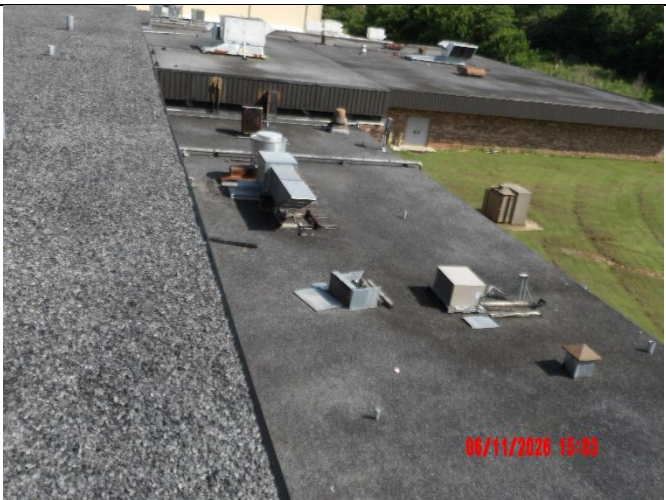
| # | Location & Description | Condition Photo |
|---|---|---|
| 47 | Remove the abandoned equipment from the roof areas and dispose of properly. | |

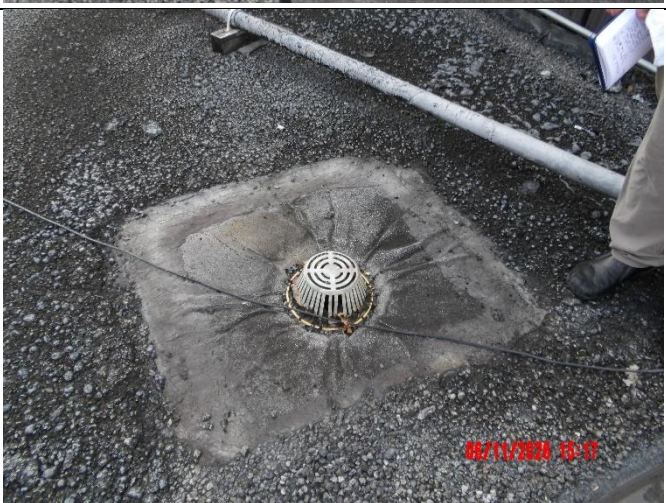
| # | Location & Description | Condition Photo |
|---|---|---|
| 48 | <p>Typical view of some of the roof drains. Coat the modified bitumen cap sheet with two coats of the specified silicone roof coating.</p> <p>HCI recommends clearing the roof drains of debris a minimum of twice per year.</p> | |

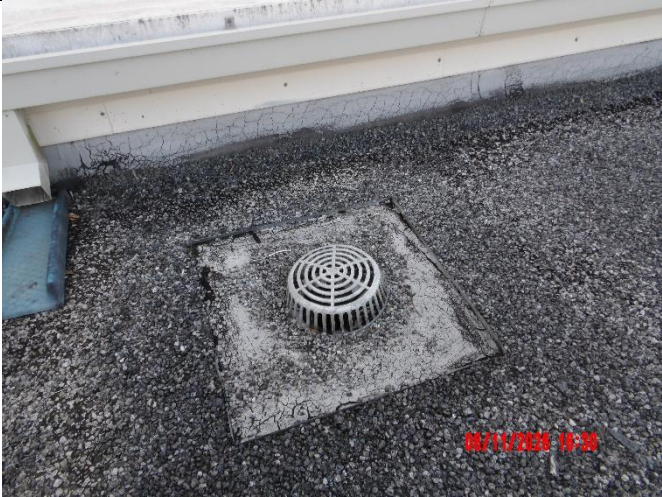
| # | Location & Description | Condition Photo |
|---|---|---|
| 49 | Typical view of one of the roof drains. Remove the loose aggregate. Prep, clean and apply silicone mastic at any fractures followed with two (2) full coat of the specified silicone coating. | |

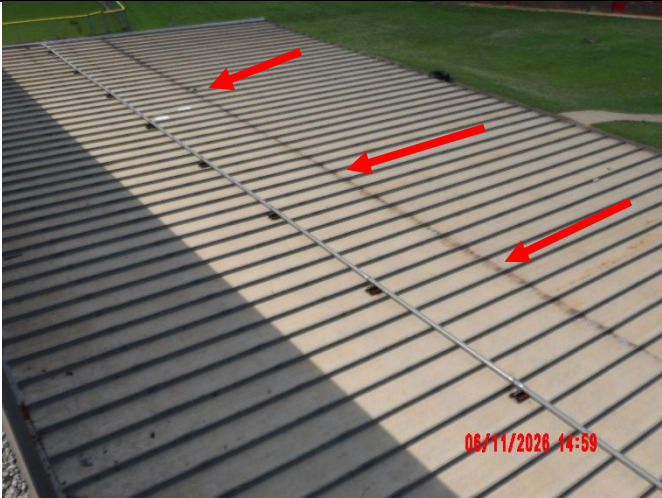
| # | Location & Description | Condition Photo |
|---|---|---|
| 50 | View of the Field House metal roofing system. Low-pressure-wash the metal roof panel end lap. Install specified silicone mastic at the entire end lap. Hand tighten all exposed fasteners at the roof area. Replace stripped or missing fasteners using #17 screws with neoprene washers. | |

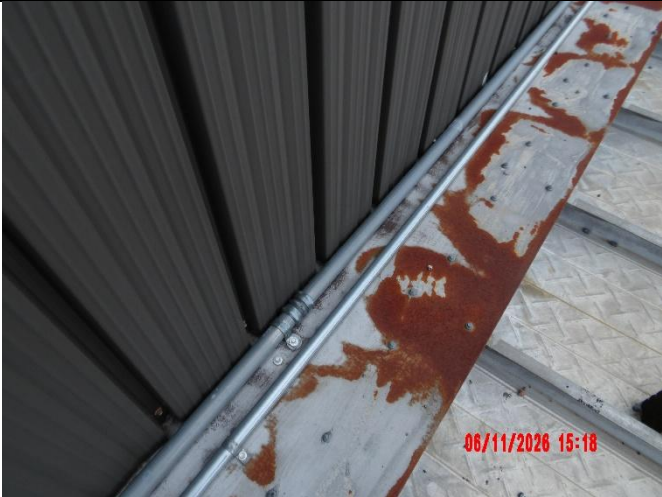
| # | Location & Description | Condition Photo |
|---|---|---|
| 51 | View of where the Field House metal roofing system joins the Gymnasium rise wall. Loosen the fasteners at the conduit clips. Solvent clean and install DowSil™ 795 or approved equal sealant prior to resealing the fasteners. | |

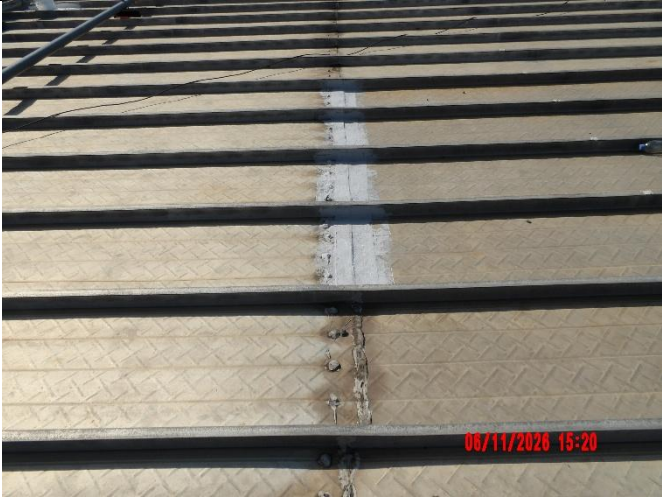
| # | Location & Description | Condition Photo |
|---|---|---|
| 52 | Closer view of the end laps at the metal roof panels. Hand tighten the fasteners. Replace stripped or missing fasteners using new #17 fasteners with neoprene washers. Remove the existing sealants. Prep, clean and apply silicone mastic at the laps, at the standing seam joints and at the fastener heads. | |

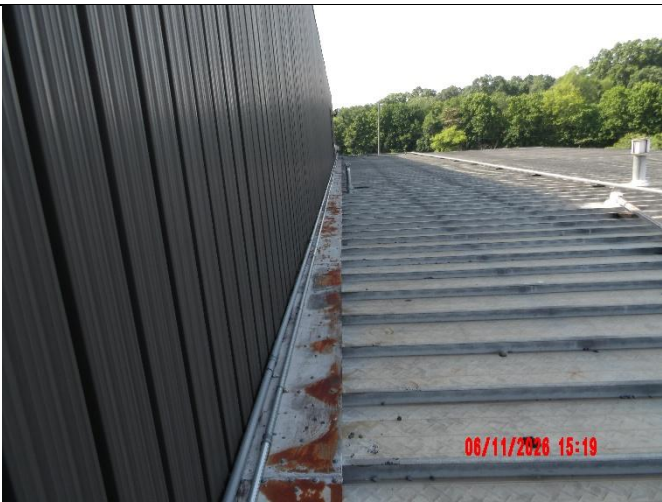
| # | Location & Description | Condition Photo |
|---|---|---|
| 53 | Another view of where the Field House metal roofing system joins the Gymnasium rise wall. Install sealant between the conduit clips and the metal flashing using DowSil™ 795 or approved equal sealant. Wet aggregate blast the surface rust areas at the cap flashing. Apply two (2) coats of the specified high zinc aluminum paint. | |
