AD-15489-001

Project: 2026 Midfield High School Reroofing Project  
Midfield, Alabama

## ADDENDUM NO. ONE

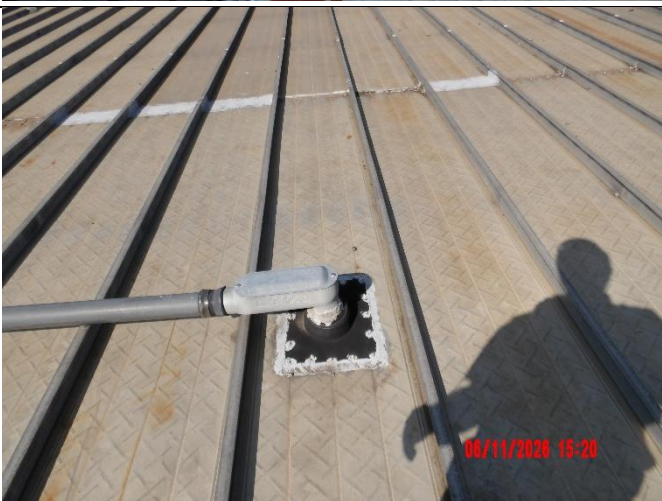
| # | Location & Description | Condition Photo |
|---|---|---|
| 54 | Typical view of the Field House metal roofing system penetrations. Replace the sealants using the specified silicone mastic. | |

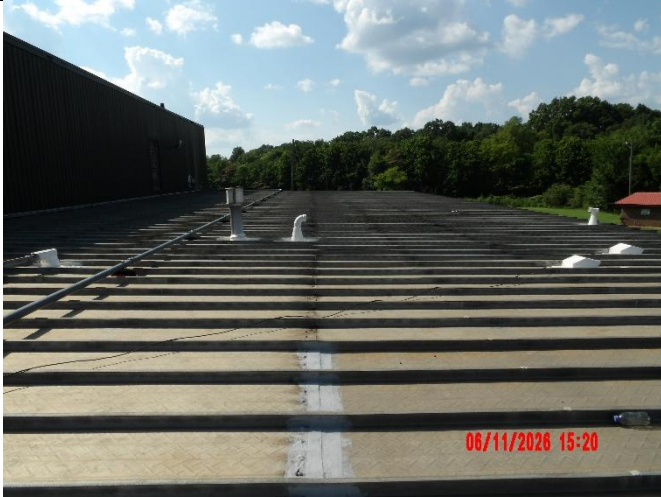
| # | Location & Description | Condition Photo |
|---|---|---|
| 55 | Typical view of the Field House roof penetrations. Replace the sealants at the base of the penetrations using silicone mastic. | |

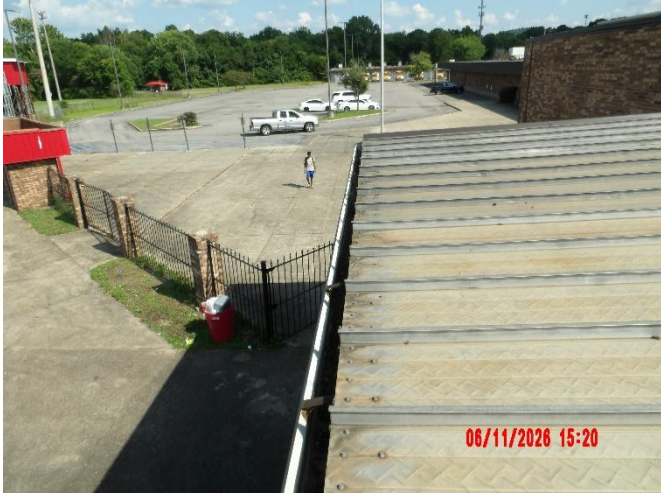
| # | Location & Description | Condition Photo |
|---|---|---|
| 56 | View of the gutter system at the Field House metal roofing system. Clear the gutter of debris. Hand tighten all exposed fasteners at the roof area. Replace stripped or missing fasteners using #17 screws with neoprene washers. | |

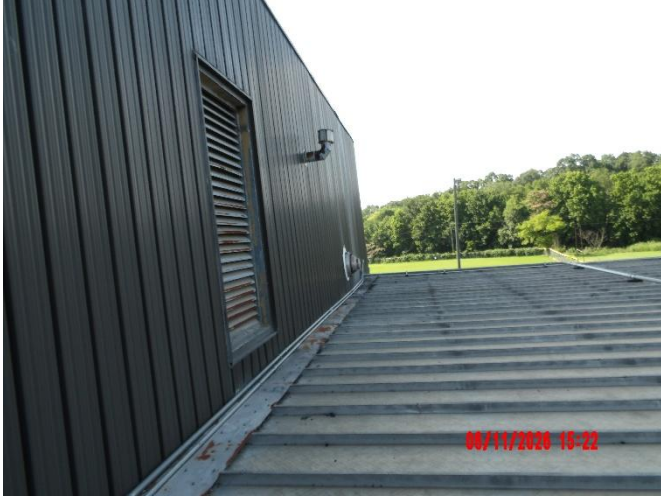
| # | Location & Description | Condition Photo |
|---|---|---|
| 57 | View of the Northeast Elevation of the Gymnasium. Replace the sealants at the louver perimeter and penetrations using DowSil™ 795 or approved equal sealant tooled into place. | |

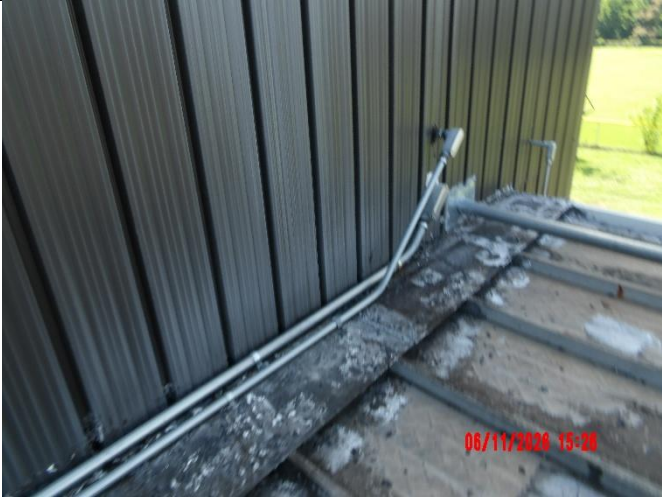
| # | Location & Description | Condition Photo |
|---|---|---|
| 58 | View of the Northeast Elevation of the Gymnasium. At the exterior wall, replace the sealants at the penetrations using DowSil™ 795 or approved equal sealant. | A photograph showing the exterior wall of a building with vertical corrugated metal siding. A horizontal metal pipe or conduit runs along the wall, and there is a penetration point where the sealant needs to be replaced. The date and time stamp '06/11/2026 15:26' is visible in the bottom right corner. |

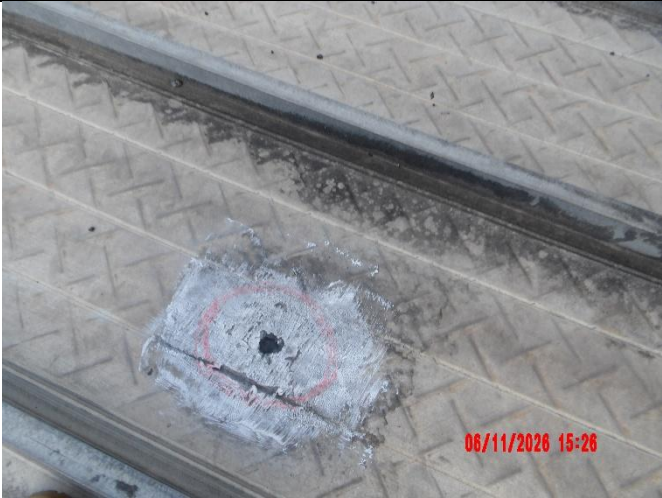
| # | Location & Description | Condition Photo |
|---|---|---|
| 59 | Typical view of previous repairs performed at the Field House metal roofing system. Prep, solvent clean and apply the specified silicone mastic at the previous repair areas. | A close-up photograph of a metal roofing system. A circular area of the roof is marked with a red circle, indicating a previous repair site. The date and time stamp '06/11/2026 15:26' is visible in the bottom right corner. |

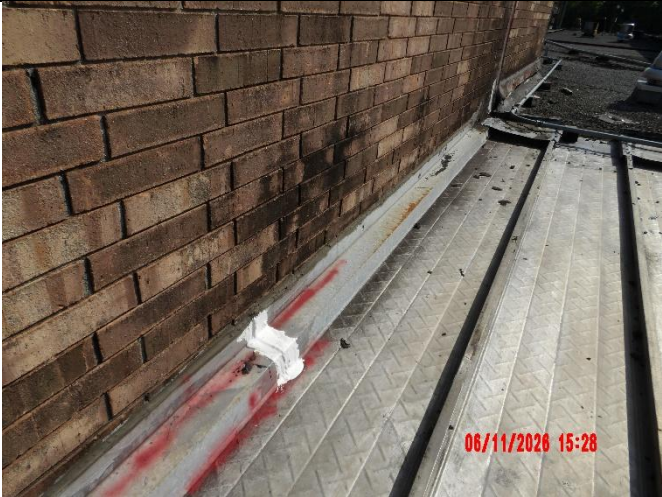
| # | Location & Description | Condition Photo |
|---|---|---|
| 60 | View of where the Field House metal roofing system joins the Band Room masonry wall. Replace the sealants at the top edge of the cap flashing using DowSil™ 795 or approved equal sealant. Replace the sealant at the laps using the specified silicone brush grade mastic. | A photograph showing the junction between a metal roofing system and a masonry wall. The roof is made of corrugated metal, and the wall is made of brick. A cap flashing is visible at the top edge of the roof, and there is a penetration point where the sealant needs to be replaced. The date and time stamp '06/11/2026 15:28' is visible in the bottom right corner. |

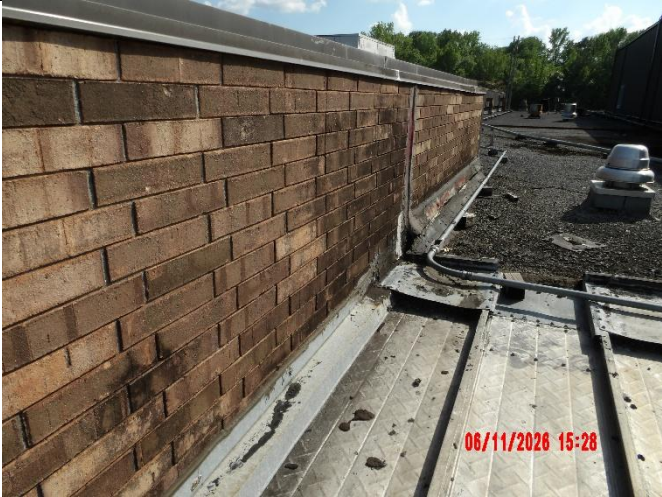
| # | Location & Description | Condition Photo |
|---|---|---|
| 61 | Replace the sealant at the masonry control joints adjacent to the roofs using DowSil™ 795 or approved equal sealant. | |

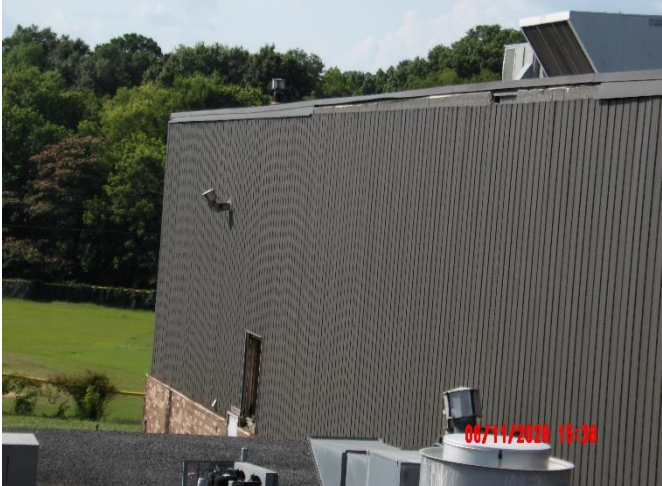
| # | Location & Description | Condition Photo |
|---|---|---|
| 62 | View of the West Elevation of the Gymnasium. Replace the fascia for the entire length of the West Elevation using a 24-ga. prefinished metal fascia with continuous 22-ga. lock strip with fasteners spaced at 6" on center. Secure the fascia at the existing gravel stop with prefinished noncorrosive wood grip fasteners with neoprene washers at 12" on center and 6" from the ends. Lap the fascia a minimum of 3" with sealant between each full lap. | |

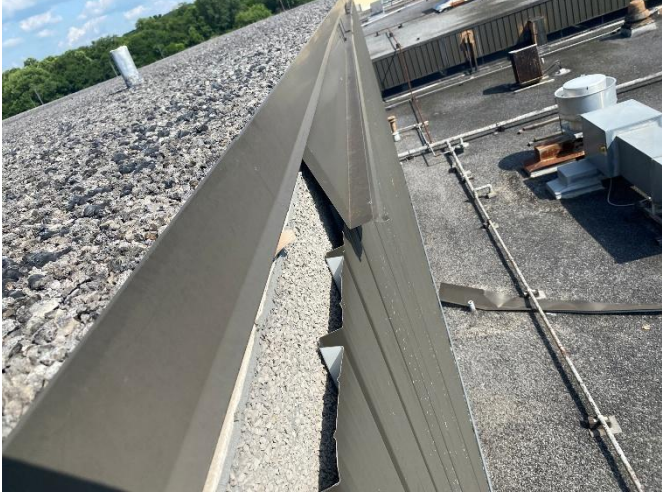
| # | Location & Description | Condition Photo |
|---|---|---|
| 63 | Closer view of the missing metal fascia at the West Elevation of the Gymnasium. The fascia needs to be replaced. | |

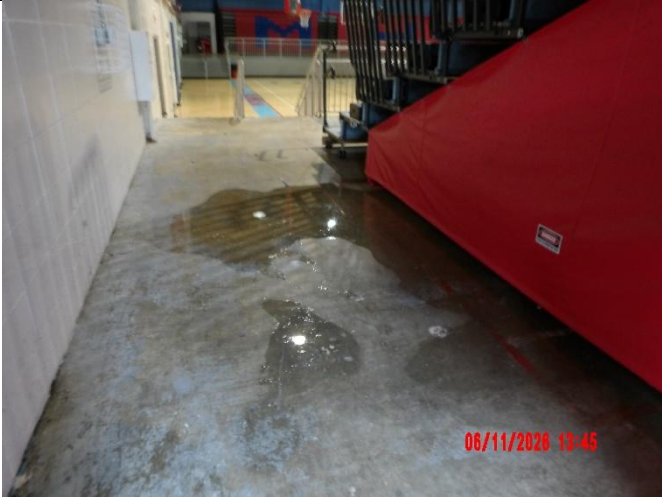
| # | Location & Description | Condition Photo |
|---|---|---|
| 64 | View of the active leak at the northeast corner of the Gymnasium. See the next two photos. | |

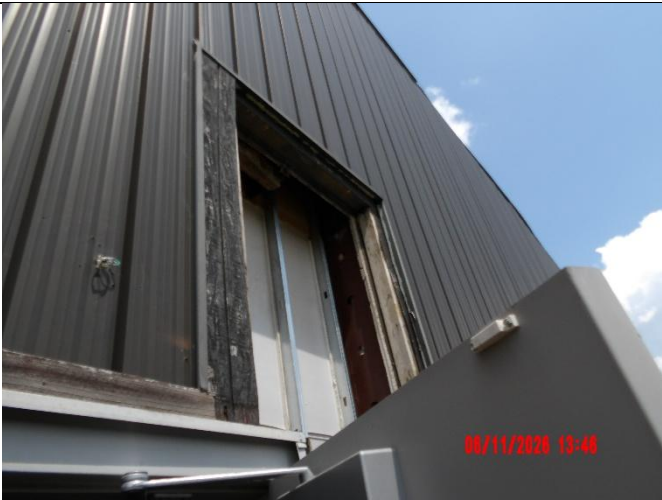
| # | Location & Description | Condition Photo |
|---|---|---|
| 65 | View of the missing exterior wall louver. Provide pricing in Alternate for new weatherproof louver to be installed with DowSil™ 795 or approved equal sealant at its perimeter. | |

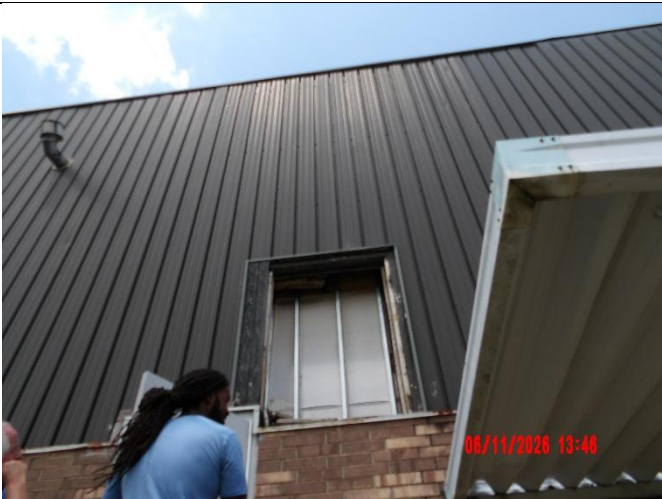
| # | Location & Description | Condition Photo |
|---|---|---|
| 66 | Another view of the missing exterior wall louver. Provide pricing in Alternate for new weatherproof louver to be installed with DowSil™ 795 or approved equal sealant at its perimeter. | |
