West Bloomfield School District
TMDL Sample Locations

RE: **Project # AE190001 WeBSD**
Total Maximum Daily Load (TMDL) Sampling Report
Administration Building

DRY WEATHER FIELD SCREENING REPORT

ILLICIT DISCHARGE ELIMINATION PROGRAM

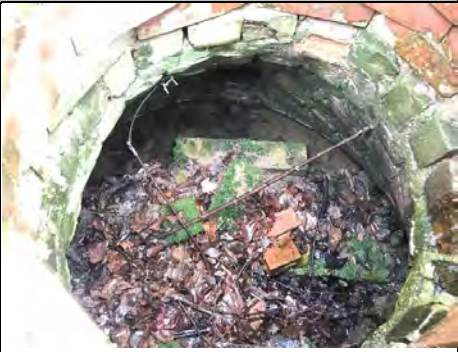
Observations:					
Standing Water Characteristics			Flow Characteristics		
Standing Water:	Yes	Flow Observed:	Yes, Trickle		
Color:	Clear	Source of Flow:	Upstream structures and rainfall		
Odor:	No	Velocity of Flow:	Trickle		
Suds:	No	Color of Flow:	Clear		
Staining:	No	Flow Odor:	No		
Oil Sheen:	No	Additional Comments: The outfall AMS-09.OP.OF was submerged in the receiving waters, so the representative upstream manhole AMS-02.MH was sampled to represent the outfall's phosphorus levels. Elevated phosphorus levels are likely due to decaying organic matter and potentially fertilizer.			
Sewage:	No				
Bacterial Sheen:	No				
Algae:	No				
Slimes:	No				
Abnormal Growth:	No

Sample ID And Information	Lab Analysis:	Results:	TMDL Threshold:	Units:	Photo ID:
Sample ID:	pH:	8.27	6.5 - 9	pH units

Time Collected:	Temperature:	12.8	N/A	Celsius	
Last Rain Event:	E. coli:	N/A	300	CFU per 100mL	
Current Weather:	Total Phosphorus:	54	25	ug/L	
Sample Location Type:	Other:				
Total Rainfall (Inches)	Other:				
Other:					
Outfall Characterization:	Unlikely				
Sample sent to Lab:	Yes

Arch Environmental Group, Inc. recommends that the elevated locations AMS-02.MH and AMS-08.OP.OF be re-assessed each permit cycle to ascertain whether greater or reduced potential for phosphorus TMDL contribution has occurred. Additionally, these sites will be monitored annually during regularly scheduled Routine Storm sewer Structural Inspections for changes in conditions or site activities.

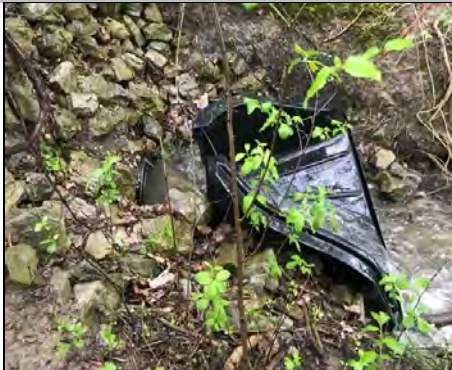
Observations:						
Standing Water Characteristics			Flow Characteristics			
Standing Water:	Yes	Flow Observed:	Yes, Continous			
Color:	Clear	Source of Flow:	Upstream structures			
Odor:	No	Velocity of Flow:	Substantial			
Suds:	No	Color of Flow:	Clear			
Staining:	No	Flow Odor	No			
Oil Sheen:	No	Additional Comments: Elevated phosphorus levels are likely due to decaying organic matter.				
Sewage:	No					
Bacterial Sheen:	No					
Algae:	No					
Slimes:	No					
Abnormal Growth:	No

Sample ID And Information	Lab Analysis:	Results:	TMDL Threshold:	Units:	Photo ID:
Sample ID:	pH:	8.67	6.5 - 9	pH units

Time Collected:	Temperature:	14.7	N/A	Celsius	
Last Rain Event:	E. coli:	N/A	300	CFU per 100mL	
Current Weather:	Total Phosphorus:	190	25	ug/L	
Screening Location Type:	Other:				
Total Rainfall (Inches):	Other:				
Outfall Characterization:	Other:				
Sample sent to Lab:	Yes

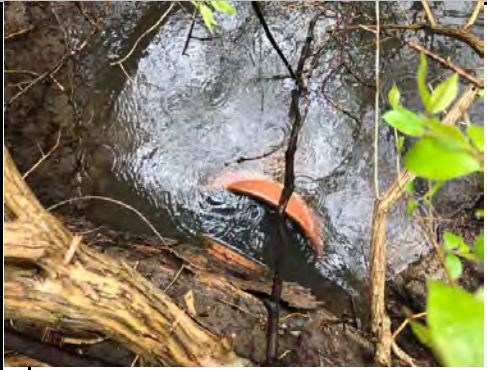
Observations:						
Standing Water Characteristics			Flow Characteristics			
Standing Water:	Yes	Flow Observed:	Yes, Continous			
Color:	Clear	Source of Flow:	DOH-16.CB and rainfall			
Odor:	No	Velocity of Flow:	Slow			
Suds:	No	Color of Flow:	Clear			
Staining:	No	Flow Odor	No			
Oil Sheen:	No	Additional Comments:				
Sewage:	No					
Bacterial Sheen:	No					
Algae:	No					
Slimes:	No					
Abnormal Growth:	No

Sample ID And Information		Lab Analysis:	Results:	TMDL Thre:	Units:	Photo ID:
Sample ID:	DOH-07.OP.OF.TMDL	pH:	8.25	6.5 - 9	pH units

Time Collected:	9:50	Temperature:	11.5	N/A	Celsius	
Last Rain Event:	< 48 Hours	E. coli:	478.60	300	CFU per 100mL	
Current Weather:	Rain	Total Phosphorus:	N/A			
Screening Location Type:	Open Pipe Outlet	Other:				
Total Rainfall (Inches):	0.9"	Other:				
Other:		Other:				
Outfall Characterization:	Unlikely					
Sample sent to Lab:	Yes

Arch Environmental Group, Inc. recommends that the elevated locations DOH-07.OP.OF, DOH-08.OP.OF and DOH-09.CB.DP be re-assessed each permit cycle to ascertain whether greater or reduced potential for E. coli TMDL contribution has occurred. Additionally, these sites will be monitored annually during regularly scheduled BMP structural inspections for changes in conditions or site activities.

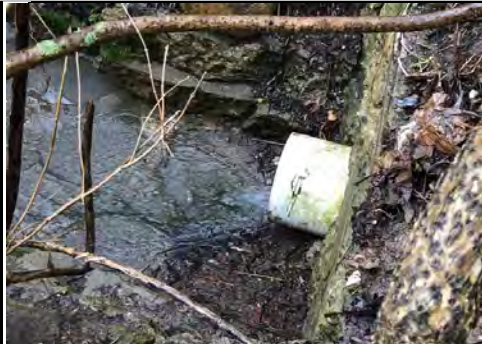
Observations:					
Standing Water Characteristics			Flow Characteristics		
Standing Water:	Yes	Flow Observed:	Yes, Continous		
Color:	Clear	Source of Flow:	DOH-15.CB and rainfall		
Odor:	No	Velocity of Flow:	Slow		
Suds:	No	Color of Flow:	Clear		
Staining:	No	Flow Odor:	No		
Oil Sheen:	No				
Sewage:	No				
Bacterial Sheen:	No				
Algae:	No				
Slimes:	No				
Abnormal Growth:	No				
		Additional Comments:

Sample ID And Information		Lab Analysis:	Results:	TMDL Thre:	Units:	Photo ID:
Sample ID:	DOH-08.OP.OF TMDL	pH:	8.25	6.5 - 9	pH units

Time Collected:	10:05	Temperature:	9.4	N/A	Celsius	
Last Rain Event:	< 48 Hours	E. coli:	456.9	300	CFU per 100mL	
Current Weather:	Rain	Total Phosphorus:	N/A			
Sample Location Type:	Open Pipe Outlet	Other:				
Total Rainfall (Inches)	0.9"	Other:				
		Other:				
Outfall Characterization:	Unlikely					
Sample sent to Lab:	Yes

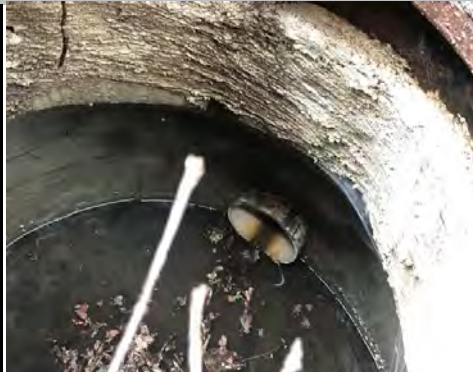
Observations:					
Standing Water Characteristics			Flow Characteristics		
Standing Water:	Yes	Flow Observed:	Yes, Continous		
Color:	Clear	Source of Flow:	DOH-11.CB, roof drain, trench		
Odor:	No	Velocity of Flow:	Slow		
Suds:	No	Color of Flow:	Clear		
Staining:	No	Flow Odor:	No		
Oil Sheen:	No				
Sewage:	No				
Bacterial Sheen:	No	Additional Comments:			
Algae:	No	On a slope, near a heavily wooded area			
Slimes:	No				
Abnormal Growth:	No

Sample ID And Information		Lab Analysis:	Results:	TMDL Thre:	Units:	Photo ID:
Sample ID:	DOH-09.CB.DP TMDL	pH:	8.1	6.5 - 9	pH units

Time Collected:	10:25	Temperature:	8.8	N/A	Celsius	
Last Rain Event:	< 48 Hours	E. coli:	422.5	300	CFU per 100mL	
Current Weather:	Rain	Total Phosphorus:	N/A			
Sample Location Type:	Catch Basin	Other:				
Total Rainfall (Inches):	0.9"	Other:				
Other:		Other:				
Outfall Characterization:	Unlikely					
Sample sent to Lab:	Yes

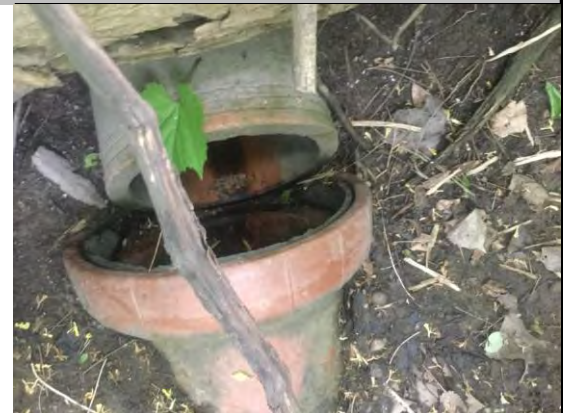
Standing Water:	Yes
Color:	Clear
Odor:	No
Suds:	No
Staining:	No
Oil Sheen:	No
Sewage:	No
Bacterial Sheen:	No
Algae:	No
Slimes:	No
Abnormal Growth:	No

Flow Observed:	No
Source of Flow:	N/A
Velocity of Flow:	N/A
Color of Flow:	N/A
Flow Odor:	N/A

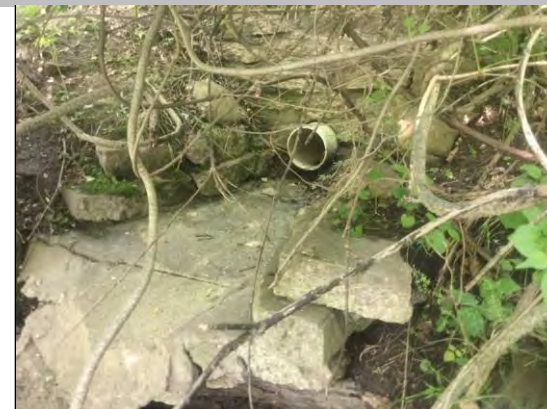
Standing Water:	No
Color:	N/A
Odor:	No
Suds:	No
Staining:	No
Oil Sheen:	No
Sewage:	No
Bacterial Sheen:	No
Algae:	No
Slimes:	No
Abnormal Growth:	No

Flow Observed:	No
Source of Flow:	N/A
Velocity of Flow:	N/A
Color of Flow:	N/A
Flow Odor	N/A

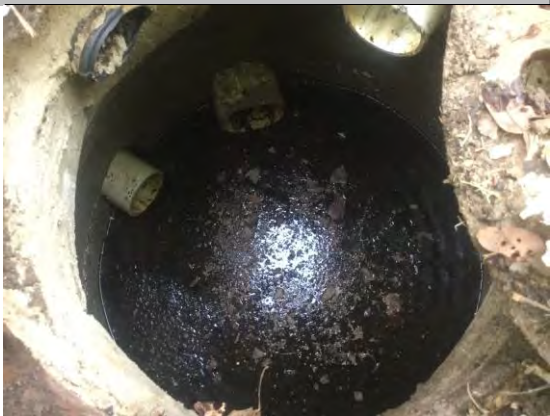
Observations:					
Standing Water Characteristics		Flow Characteristics		Maintenance	
Standing Water:	Yes	Flow Observed:	No	Cleaning:	Moderate
Color:	Clear	Source of Flow:	N/A	Blockages	No
Odor:	No	Velocity of Flow:	N/A	Structural Issues	No
Suds:	No	Color of Flow:	N/A	Structural Trend	Stable
Staining:	No	Flow Odor	N/A	Stenciling:	N/A
Oil Sheen:	No				
Sewage:	No				
Bacterial Sheen:	No				
Algae:	No				
Slimes:	No				
Abnormal Growth:	No				
		Additional Comments:

Sample ID And Information		Field Analysis:	Results:	Units:	Initials:	Photo ID:
Sample Collected?	No	pH:	N/A	pH units	LE/AS

Round:	3rd Round	Temperature:	N/A	Celsius	LE/AS	
Last Rain Event:	>72 Hours	Surfactants:	N/A	mg/L	LE/AS	
Current Weather:	Sun	Ammonia:	N/A	mg/L	LE/AS	
Screening Location Type:	Catch Basin	Chlorine:	N/A	mg/L	LE/AS	
Other Screening Activities Conducted:	No	Turbidity:	N/A	NTU	LE/AS	
Outfall Characterization:	Unlikely	Conductivity:	N/A	uohm/cm	LE/AS	
Sample sent to Lab:						
		Equipment Calibration:				
		Date:	Cal. By:

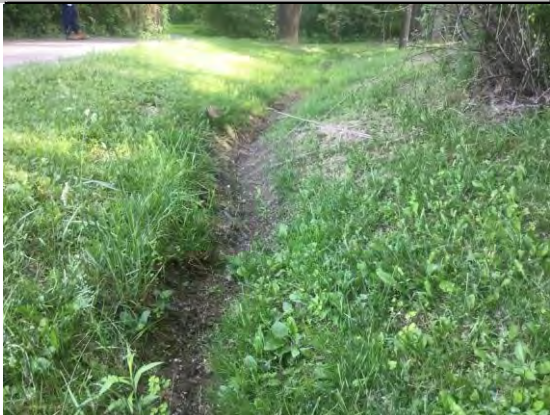
Observations:					
Standing Water Characteristics		Flow Characteristics		Maintenance	
Standing Water:	No	Flow Observed:	No	Cleaning:	No
Color:	N/A	Source of Flow:	N/A	Blockages:	No
Odor:	No	Velocity of Flow:	N/A	Structural Issues:	No
Suds:	No	Color of Flow:	N/A	Structural Trend:	Stable
Staining:	No	Flow Odor:	N/A	Stenciling:	N/A
Oil Sheen:	No	Additional Comments:			
Sewage:	No				
Bacterial Sheen:	No				
Algae:	No				
Slimes:	No				
Abnormal Growth:	No

Sample ID And Information	Field Analysis:	Results:	Units:	Initials:	Photo ID:
Sample Collected?	pH:	N/A	pH units	LE/AS

Round:	Temperature:	N/A	Celsius	LE/AS	
Last Rain Event:	Surfactants:	N/A	mg/L	LE/AS	
Current Weather:	Ammonia:	N/A	mg/L	LE/AS	
Sample Location Type:	Chlorine:	N/A	mg/L	LE/AS	
Other Screening Activities	Turbidity:	N/A	NTU	LE/AS	
Conducted:	Conductivity:	N/A	uohm/cm	LE/AS	
Outfall Characterization:	Equipment Calibration:				
Sample sent to Lab:	Date:	Cal. By:

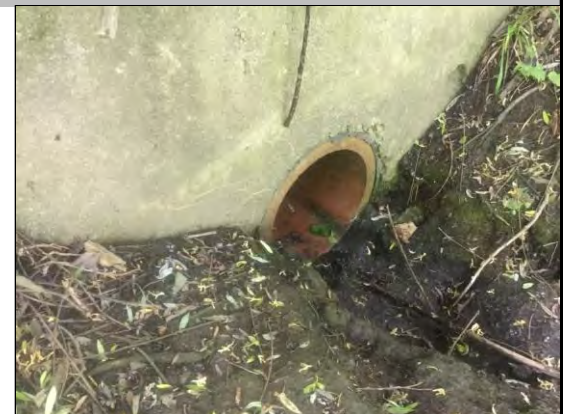
Standing Water:	No
Color:	N/A
Odor:	No
Suds:	No
Staining:	No
Oil Sheen:	No
Sewage:	No
Bacterial Sheen:	No
Algae:	No
Slimes:	No
Abnormal Growth:	No

Flow Observed:	No
Source of Flow:	N/A
Velocity of Flow:	N/A
Color of Flow:	N/A
Flow Odor:	N/A

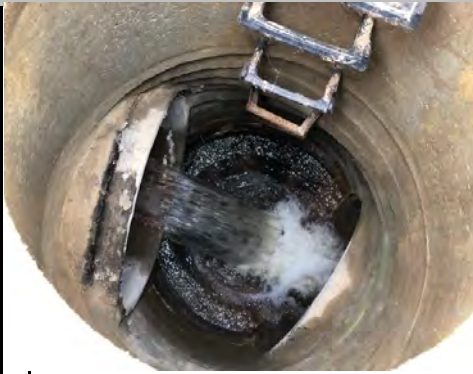
Observations:					
Standing Water Characteristics	Flow Characteristics	Additional Comments: Geese and other animal feces from the grassy fields and upstream stormwater conveyance channels are a likely source of e. coli levels.			
Standing Water:	Yes			Flow Observed:	Yes, Continous
Color:	Clear			Source of Flow:	OLK-01.SCC
Odor:	No			Velocity of Flow:	Substantial
Suds:	No			Color of Flow:	Clear
Staining:	No			Flow Odor	No
Oil Sheen:	No				
Sewage:	No				
Bacterial Sheen:	No				
Algae:	No				
Slimes:	No				
Abnormal Growth:	No

Sample ID And Information	Lab Analysis:	Results:	TMDL Thre:	Units:	Photo ID:
Sample ID:	pH:	8	6.5 - 9	pH units

Time Collected:	Temperature:	10.8	N/A	Celsius	
Last Rain Event:	E. coli:	1,299.70	300	CFU per 100mL	
Current Weather:	Total Phosphorus:	N/A	N/A	ug/L	
Screening Location Type:	Other:				
Total Rainfall (Inches):	Other:				
Outfall Characterization:	Other:				
Sample sent to Lab:					
	Unlikely				
	Yes

Arch Environmental Group, Inc. recommends that the elevated location OLK-02.MH.DP be re-assessed each permit cycle to ascertain whether greater or reduced potential for E. coli TMDL contribution has occurred. Additionally, these sites will be monitored annually during regularly scheduled BMP structural inspections for changes in conditions or site activities.

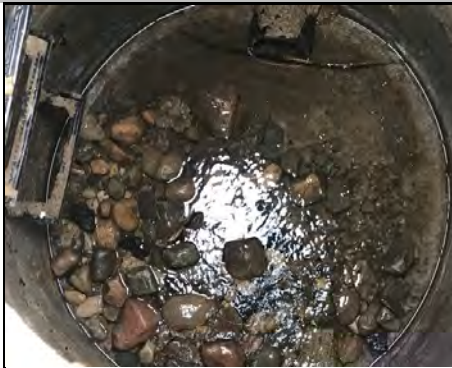
Sample ID And Information	Lab Analysis:	Results:	TMDL Threshold:	Units:	Photo ID:
Sample ID:	pH:	8.23	6.5 - 9	pH units

Time Collected:	Temperature:	12.3	N/A	Celsius	
Last Rain Event:	E. coli:	N/A	300	CFU per 100mL	
Current Weather:	Total Phosphorus:	41	25	ug/L	
Screening Location Type:	Other:				
Total Rainfall (Inches):	Other:				
Outfall Characterization:	Other:				
Sample sent to Lab:	Unlikely

Arch Environmental Group, Inc. recommends that the elevated location SCH-10.CB.DP be re-assessed each permit cycle to ascertain whether greater or reduced potential for phosphorus TMDL contribution has occurred. Additionally, these sites will be monitored annually during regularly scheduled Routine Storm sewer Structural Inspections for changes in conditions or site activities.

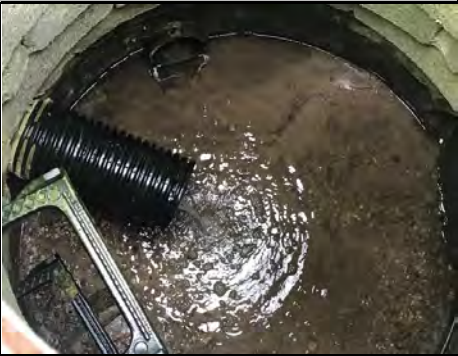
Sample ID And Information		Lab Analysis:	Results:	TMDL Threshold:	Units:	Photo ID:
Sample ID:	SCH-12.MH.DP TMDL	pH:	8.06	6.5 - 9	pH units

Time Collected:	11:30	Temperature:	12.3	N/A	Celsius	
Last Rain Event:	>72 Hours	E. coli:	N/A	300	CFU per 100mL	
Current Weather:	Rain	Total Phosphorus:	ND	25 ug/L	ug/L	
Sample Location Type:	Manhole	Other:				
Total Rainfall (Inches)	0.28"	Other:				
Other:		Other:				
Outfall Characterization:	Unlikely					
Sample sent to Lab:	Yes

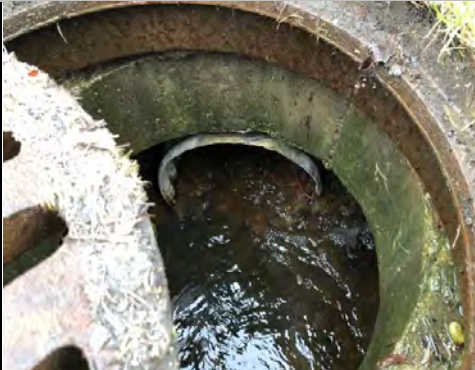
Observations:					
Standing Water Characteristics			Flow Characteristics		
Standing Water:	Yes	Flow Observed:	Yes, Continous		
Color:	Clear	Source of Flow:	12" line from Off-site		
Odor:	No	Velocity of Flow:	Moderate		
Suds:	No	Color of Flow:	Clear		
Staining:	No	Flow Odor	No		
Oil Sheen:	No				
Sewage:	No				
Bacterial Sheen:	No				
Algae:	No				
Slimes:	No				
Abnormal Growth:	No				
			Additional Comments:		
			The source of E. coli is likely geese/animal feces in surrounding grassy areas. The rainwater is coming from the schools stormwater system and a 12" line that originates from off-site. The 12" line from off-site is also a potential source of E. coli.

Sample ID And Information	Lab Analysis:	Results:	TMDL Threshold:	Units:	Photo ID:
Sample ID:	pH:	7.77	6.5 - 9	pH units

Time Collected:	Temperature:	10.7	N/A	Celsius	
Last Rain Event:	E. coli:	1,299.70	300	CFU per 100mL	
Current Weather:	Total Phosphorus:	N/A	N/A	ug/L	
Screening Location Type:	Other:				
Total Rainfall (Inches):	Other:				
Other:	Other:				
Outfall Characterization:	Unlikely				
Sample sent to Lab:

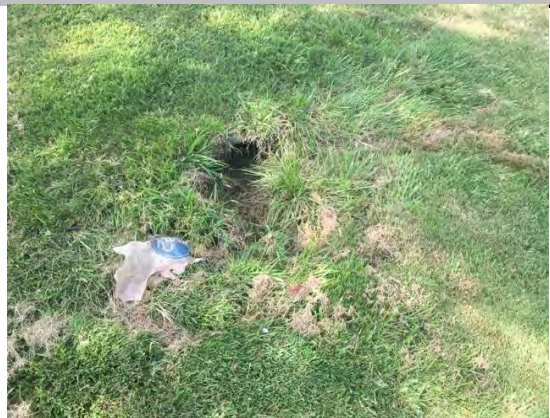
Observations:					
Standing Water Characteristics		Flow Characteristics		Maintenance	
Standing Water:	No	Flow Observed:	No	Cleaning:	Significant
Color:	N/A	Source of Flow:	N/A	Blockages	No
Odor:	No	Velocity of Flow:	N/A	Structural Issues	None
Suds:	No	Color of Flow:	N/A	Structural Trend	Stable
Staining:	No	Flow Odor:	N/A	Stenciling:	N/A
Oil Sheen:	No	Additional Comments:			
Sewage:	No				
Bacterial Sheen:	No				
Algae:	No				
Slimes:	No				
Abnormal Growth:	No

Sample ID And Information	Field Analysis:	Results:	Units:	Initials:	Photo ID:
Sample Collected?	pH:	N/A	pH units	N/A

Round:	Temperature:	N/A	Celsius	N/A	
Last Rain Event:	Surfactants:	N/A	mg/L	N/A	
Current Weather:	Ammonia:	N/A	mg/L	N/A	
Sample Location Type:	Chlorine:	N/A	mg/L	N/A	
Other Screening Activities	Turbidity:	N/A	NTU	N/A	
Conducted:	Conductivity:	N/A	uohm/cm	N/A	
Outfall Characterization:	Equipment Calibration:				
Sample sent to Lab:	Date:	N/A	Cal. By:	N/A

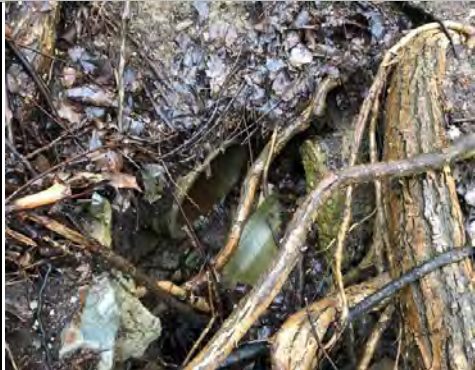
Observations:					
Standing Water Characteristics			Flow Characteristics		
Standing Water:	Yes	Flow Observed:	Yes, Continous		
Color:	Clear	Source of Flow:	WTB-25.CB, rainfall		
Odor:	No	Velocity of Flow:	Moderate		
Suds:	No	Color of Flow:	Clear		
Staining:	No	Flow Odor	No		
Oil Sheen:	No				
Sewage:	No				
Bacterial Sheen:	No				
Algae:	No				
Slimes:	No				
Abnormal Growth:	No				
		Additional Comments:

Sample ID And Information	Lab Analysis:	Results:	TMDL Threshold:	Units:	Photo ID:
Sample ID:	pH:	7.81	6.5 - 9	pH units

Time Collected:	Temperature:	10	N/A	Celsius	
Last Rain Event:	E. coli:	0	300	CFU per 100mL	
Current Weather:	Total Phosphorus:	N/A			
Screening Location Type:	Other:				
Total Rainfall (Inches):	Other:				
Outfall Characterization:	Other:				
Sample sent to Lab:

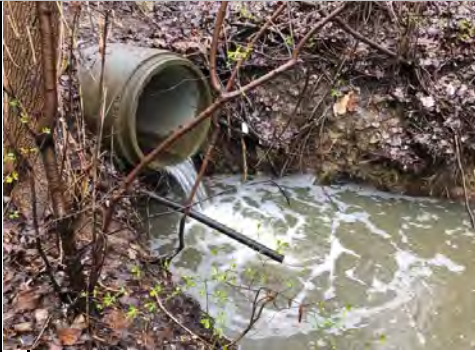
Sample ID And Information		Lab Analysis:	Results:	TMDL Threshold:	Units:	Photo ID:
Sample ID:	WTB-54.OP.OF.TMDL	pH:	8.5	6.5 - 9	pH units

Time Collected:	11:30	Temperature:	10.5	N/A	Celsius	
Last Rain Event:	< 48 Hours	E. coli:	218.7	300	CFU per 100mL	
Current Weather:	Rain	Total Phosphorus:	N/A			
Sample Location Type:	Open Pipe Outlet	Other:				
Total Rainfall (Inches)	0.9"	Other:				
		Other:				
Outfall Characterization:	Unlikely					
Sample sent to Lab:	Yes
