5.1 FACILITY CONDITION ASSESSMENT BARRETT ELEMENTARY SCHOOL

FACILITY CONDITION ASSESSMENT

895 Barrett Ave. Morgan Hill, Ca 95037 | barrett.mhusd.org

Year Built: 2001
 Year Modernized: none
 Student Population (2016 – 2017): 443
 Number of Classrooms: 25
 Number of Portables: 0
 Site Acreage: 9.64 acres
 Building Area: 47,845 square feet
 Academic Focus: None

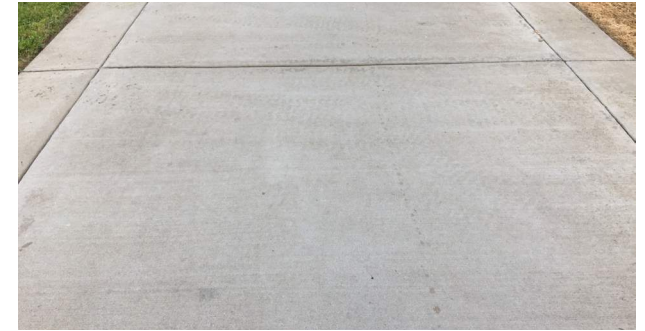
Typical Concrete Paving

Concrete Paving

Category [0]

- No issues were observed or reported.

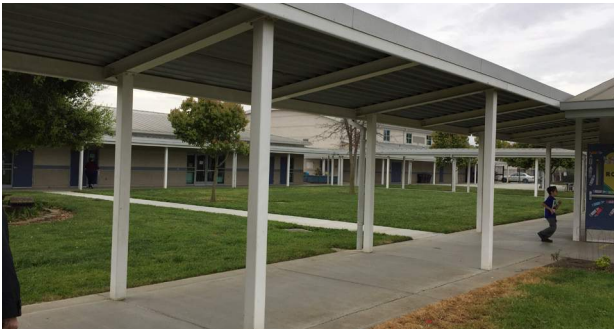
Covered Walkway

Covered Walkways

Category [0]

- No issues were observed or reported.

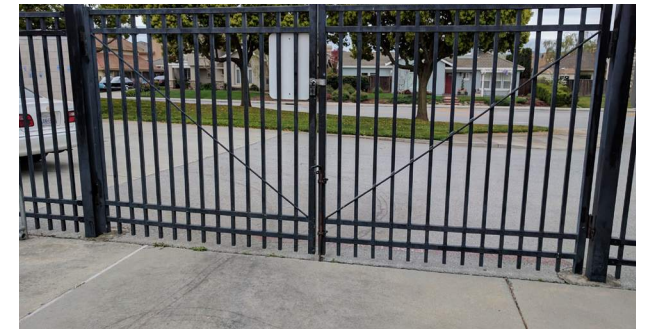
Security Fencing

Fencing & Gates

Category [0]

- Tube steel fencing and chain link are used to secure the school.
- No issues were observed or reported.

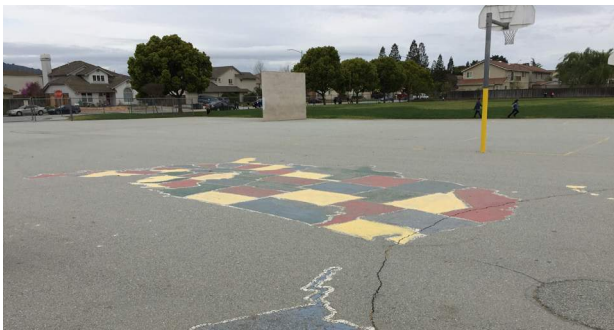
Hardcourts

- AC paving is experiencing normal wear and tear, cracking; need to be resurfaced and repainted in parking lots and hardcourts.

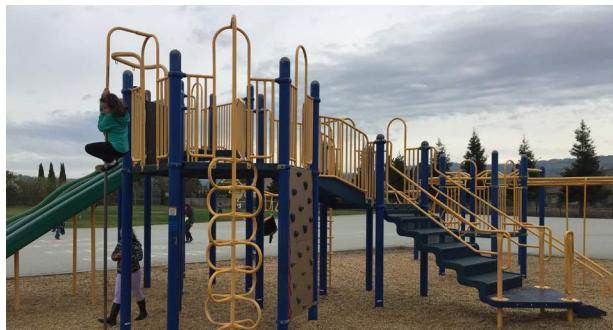
Play Structure

Play Structures

Category [3]

- Play structures are damaged; may need partial or full replacement.

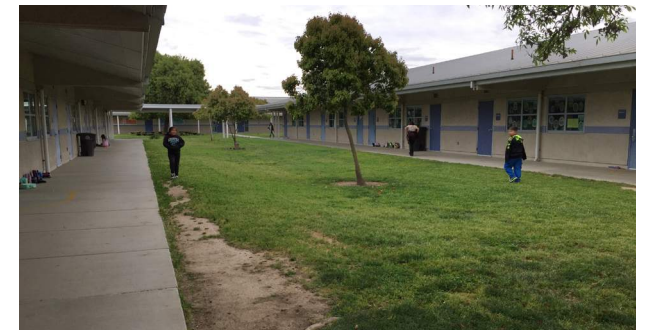
Landscaping

- Turf grass areas between classroom wings are in good condition and provide opportunity to add bench seating or other areas for student congregation.

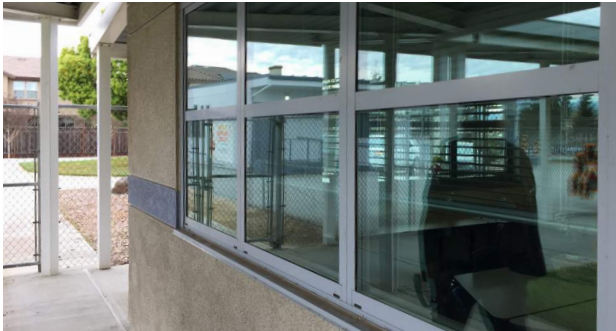
Windows

Category [0]

- No issues were observed or reported.

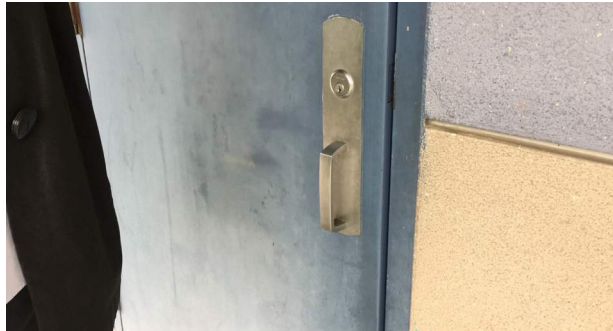
Exterior Door Hardware

- Paint at exterior doors is new however is showing extreme weathering/fading.
- Buildings are due for a new coat of paint.

- Aside from the faded paint mentioned above, the condition of the doors, frames, and hardware are good.

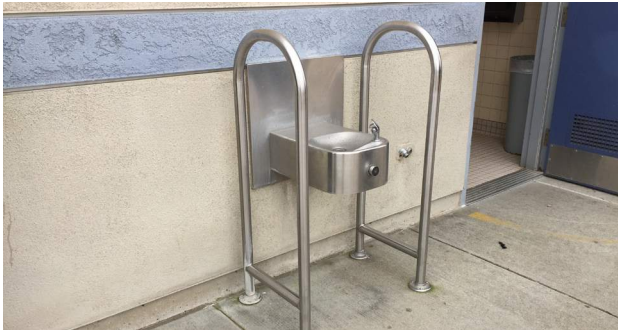
Drinking Fountain

Drinking Fountains

Category [5]

- Drinking fountains do not meet current code compliance. Complete replacement is recommended.

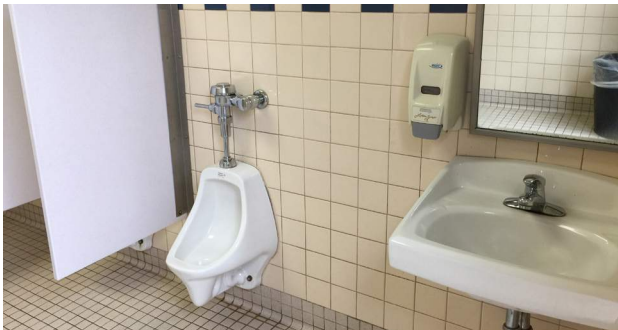
Restroom

Restrooms

Category [0]

- No issues were observed or reported.
