80 W. Central Ave. Morgan Hill, Ca 95037 | britton.mhusd.org

511 FACILITY CONDITION ASSESSMENT BRITTON MIDDLE SCHOOL

FACILITY CONDITION ASSESSMENT

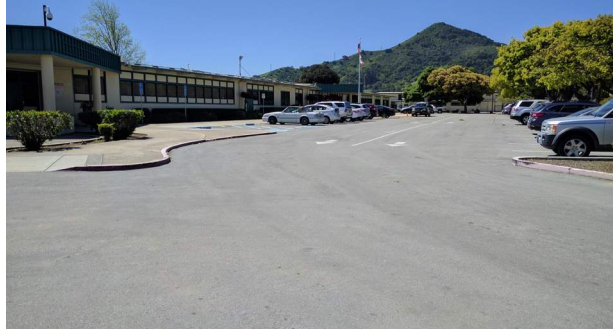
Parking

- General site parking is compliant. The stripes need general maintenance.

- No comments were made to the number of available parking.

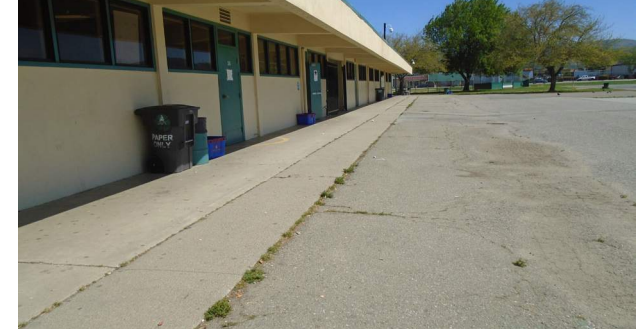
Typical Concrete Paving

- The existing paving throughout the campus is in poor condition, with areas in the play yard that are graveled or with patches that are in disrepair.

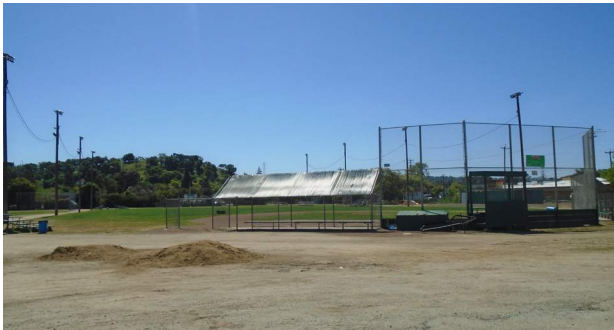
Playfields / Athletics

- The existing track has holes on the running surface.
- The gymnasium’s bleachers are damaged; the acoustic insulation in the roof is old.
- The boys and girls locker rooms are in good condition.
- The field bleachers seating boards are worn.

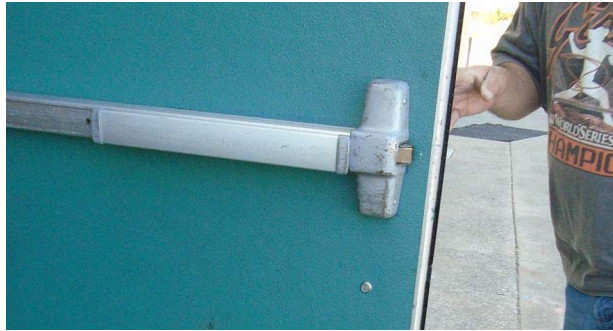
Exterior Door Hardware

- The doors to the gymnasium are heavy with no door stops to prop them open.

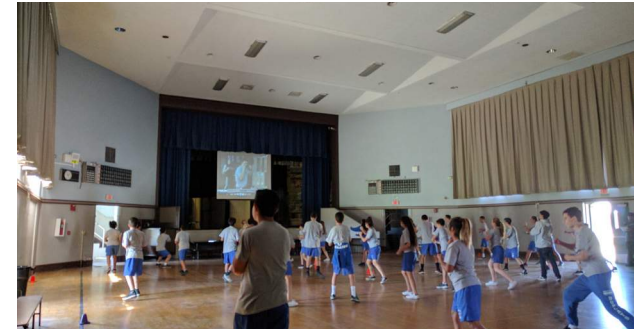
Auditorium

- The existing auditorium doesn't have built-in audio-visual equipment; has no bleachers; has non-functioning air-conditioning or heat; and the kitchen is original to the building.
- The existing gymnasium has acoustical insulation that falls from the ceiling; bleachers that are original to the building; no built-in projectors or screen with a questionable sound system; and is large enough to seat half the school.

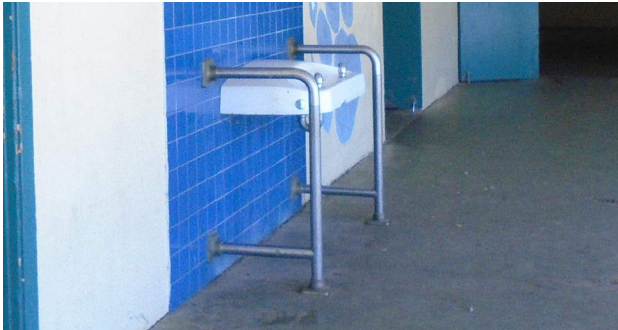
Drinking Fountain

- The drinking fountains servicing the gymnasium and locker rooms are compliant, while the main campus drinking fountains are non-compliant.

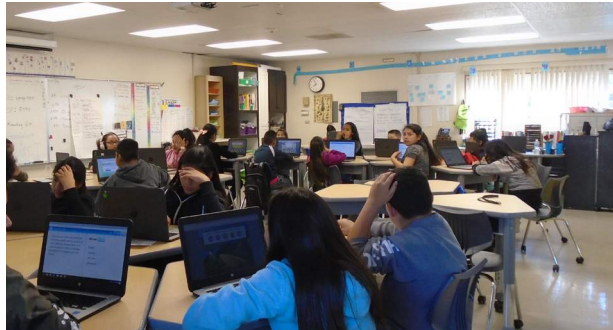
Typical Classroom

- Paint updates are needed in the auditorium building.
- The portables flooring have been damaged by roof leaks.
- The toilet rooms in the auditorium building are out of date.
- General classrooms flooring have some damage.
- The faculty breakroom and kitchen has damaged ceiling tiles and flooring.
- The finishes in the auditorium are in poor condition.
