FACILITY CONDITION ASSESSMENT

15600 Concord Circle, Morgan Hill, Ca 95037 | mhusd.org

517 DISTRICT OFFICE

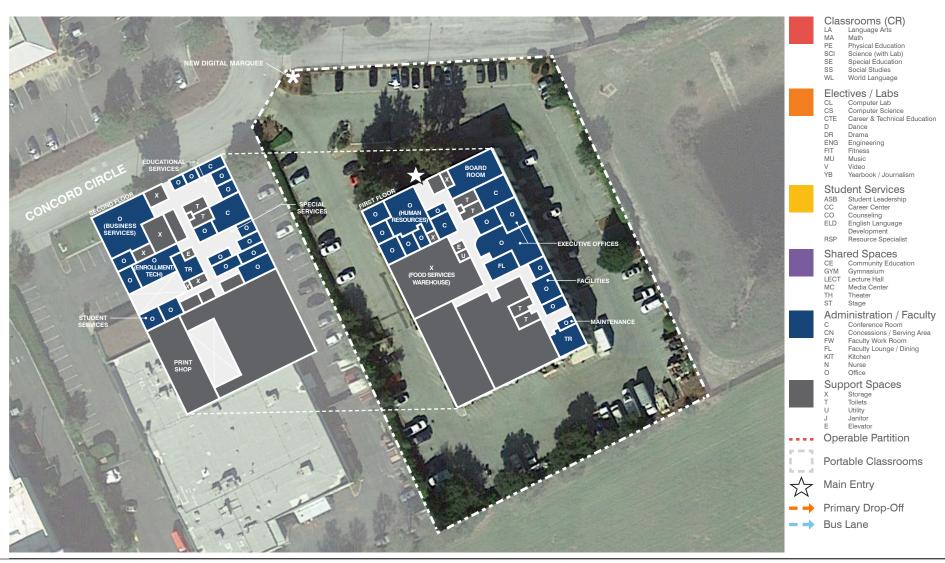
FACILITY CONDITION ASSESSMENT

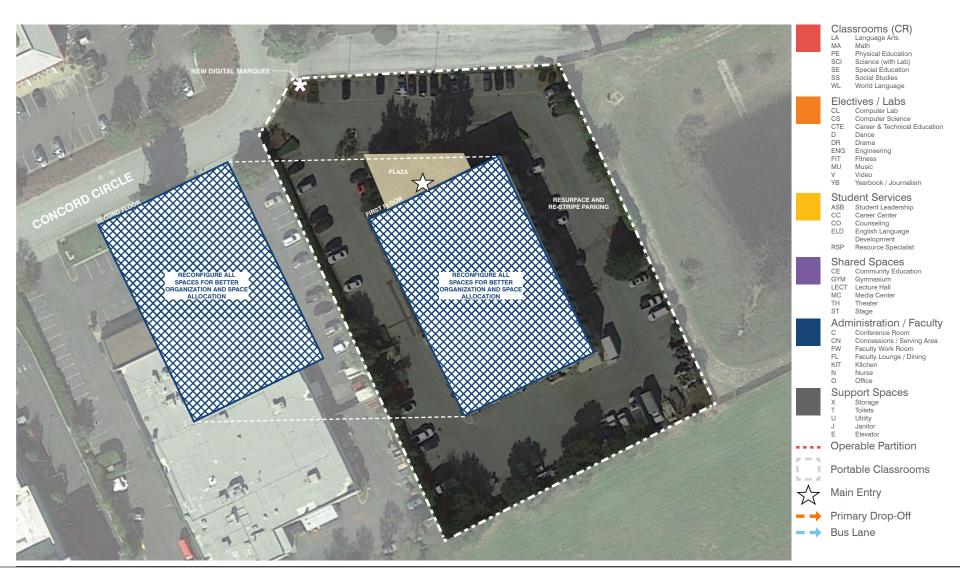
These costs reflect one option for the District Office. This option is to reconfigure the existing District Office building as shown in the diagram on the previous page.
