514 FACILITY CONDITION ASSESSMENT LIVE OAK HIGH SCHOOL

FACILITY CONDITION ASSESSMENT

1505 E Main Ave. Morgan Hill, Ca 95037 | liveoak.mhusd.org

Year Built: 1975
 Year Modernized: 1999 (restroom modernization, new roofs on 6 buildings)
 Student Population (2016 – 2017): 1,160
 Number of Classrooms: 68
 Number of Portables: 1
 Site Acreage:
 Building Area: 185,896 square feet
 Academic Focus:

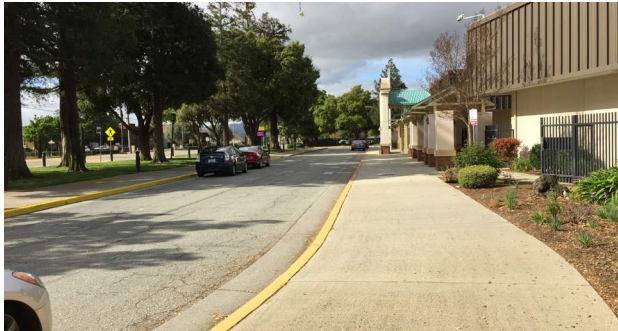
Drop-Off Lane

- The E Main Avenue turn-around lane is used for parking and drop-off during the day. This area needs to be kept clear for emergency vehicles, so a swing gate is desired that closes this loop from public access.

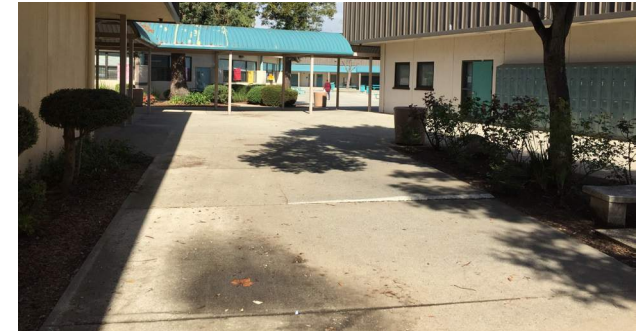
Typical Concrete Paving

- Concrete paving is in fair condition.

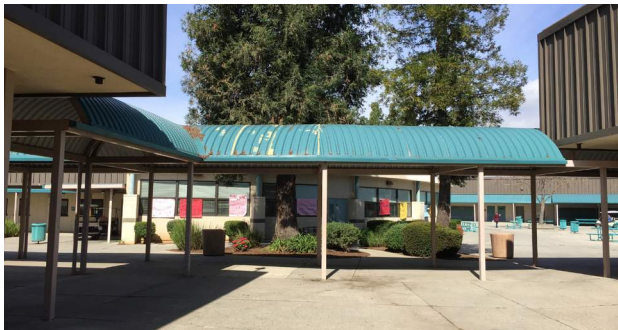
Covered Walkway

- Walkway covers are in fair condition, could use a new coat of paint.

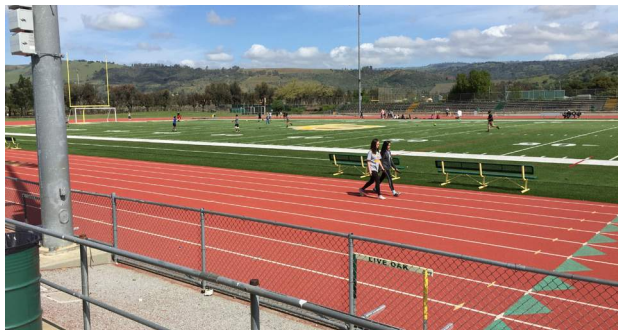
Playfields / Athletics

- The locker rooms are adequate.
- The pool was recently resurfaced.
- A new press box was added to the stadium in 2015.
- An expansion to the weight room, possibly with outdoor space, is desired.
- Tennis court surfacing is in poor condition and needs to be resurfaced.
- New bleachers are desired at the stadium.
- Better acoustics is desired at the large Gymnasium.
- The entrance to the stadium, between the parking lot to the track, is in poor condition. This area is paved with decomposed granite which gets muddy in rainy weather.

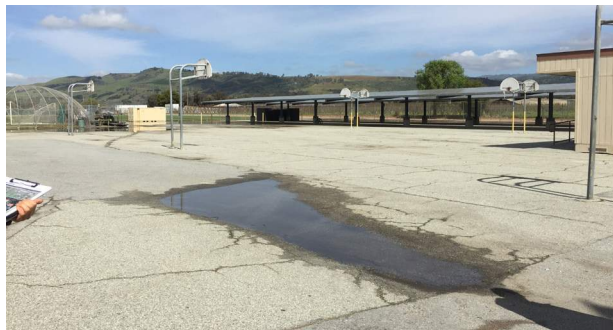
Hardcourts

- Areas of poor drainage were observed at the hardcourts near the small Gym.
- The area at the entrance to the stadium exhibits poor drainage.

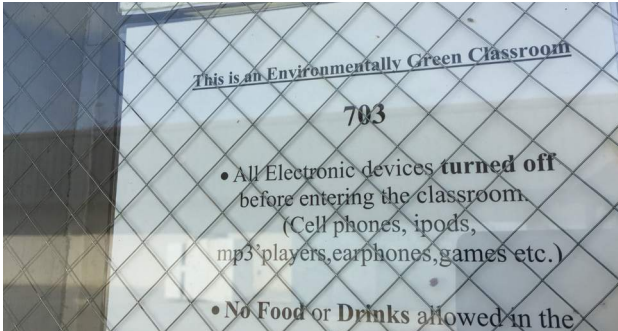
- Windows are original to the buildings; are single pane with wire glass.

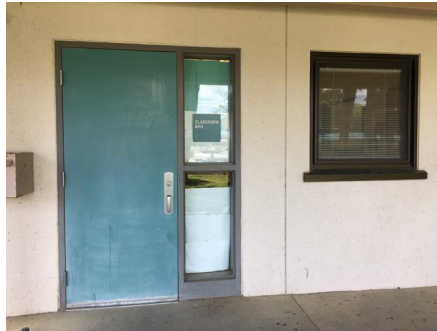
Exterior Door Hardware

- Doors may be original to the building, replacement is recommended.

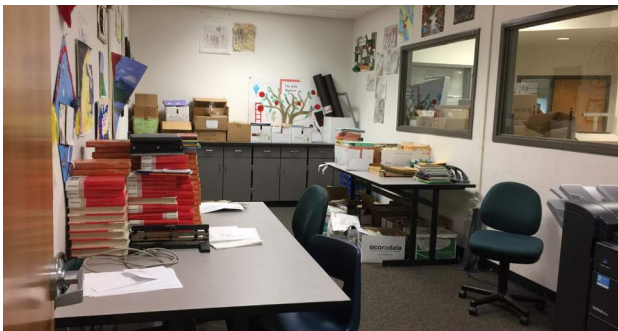
Staff Work Room / Lounge

- Food service and Faculty Lounge building is in poor condition and does not function well for its purpose.
- The center of each classroom building was designed to hold a conference room, restrooms, computer lab, storage, and a faculty prep area. These spaces have become storage areas (primarily) and are not well utilized.
- The kiln in the Ceramics room cannot be used due to poor ventilation.

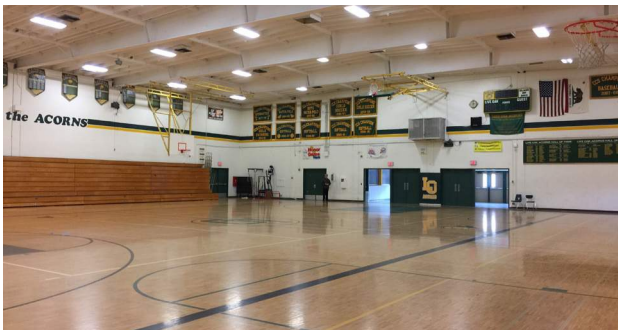
Gymnasium

- Roof leaks were reported in both Gymnasiums and are currently undergoing maintenance.

- Flooring in both Gymnasiums is in poor condition.
- Classroom interiors are dated and in fair to poor condition.
- Casework is in fair to poor condition.
- Ceiling tiles and flooring need to be replaced.

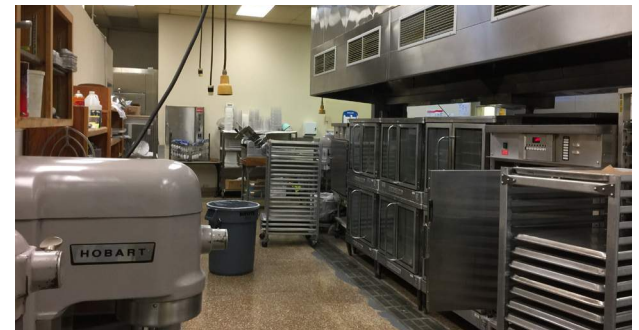
Kitchen

- The central kitchen needs upgrades/expansion in order to be fully operational.

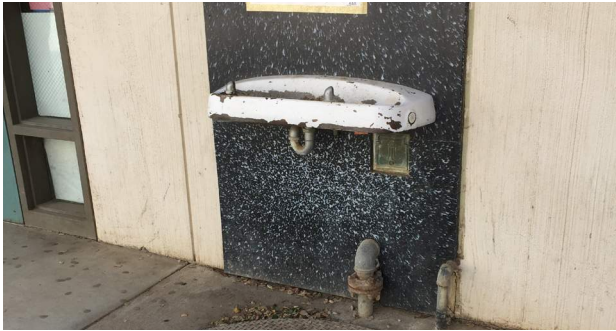
Drinking Fountain

- Drinking fountains are in poor condition and need to be replaced.

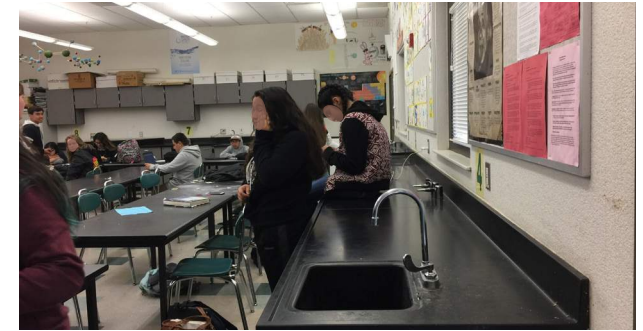
Science Lab

- Storage and classroom space to accommodate growing Visual and Performing Arts / Band programs.
- Athletics storage.
- Upgraded science labs for chemistry and physics. Upgrades to include fume hoods.
