March 2, 2020

Cardno  
6720 SW Macadam Avenue, Suite 200  
Portland, OR 97219

**Report of Pavement Engineering Services**  
Meadow Park Middle School Pavement Improvements  
14100 SW Downing Street  
Beaverton, Oregon  
GeoDesign Project: BeavSchool-60-01

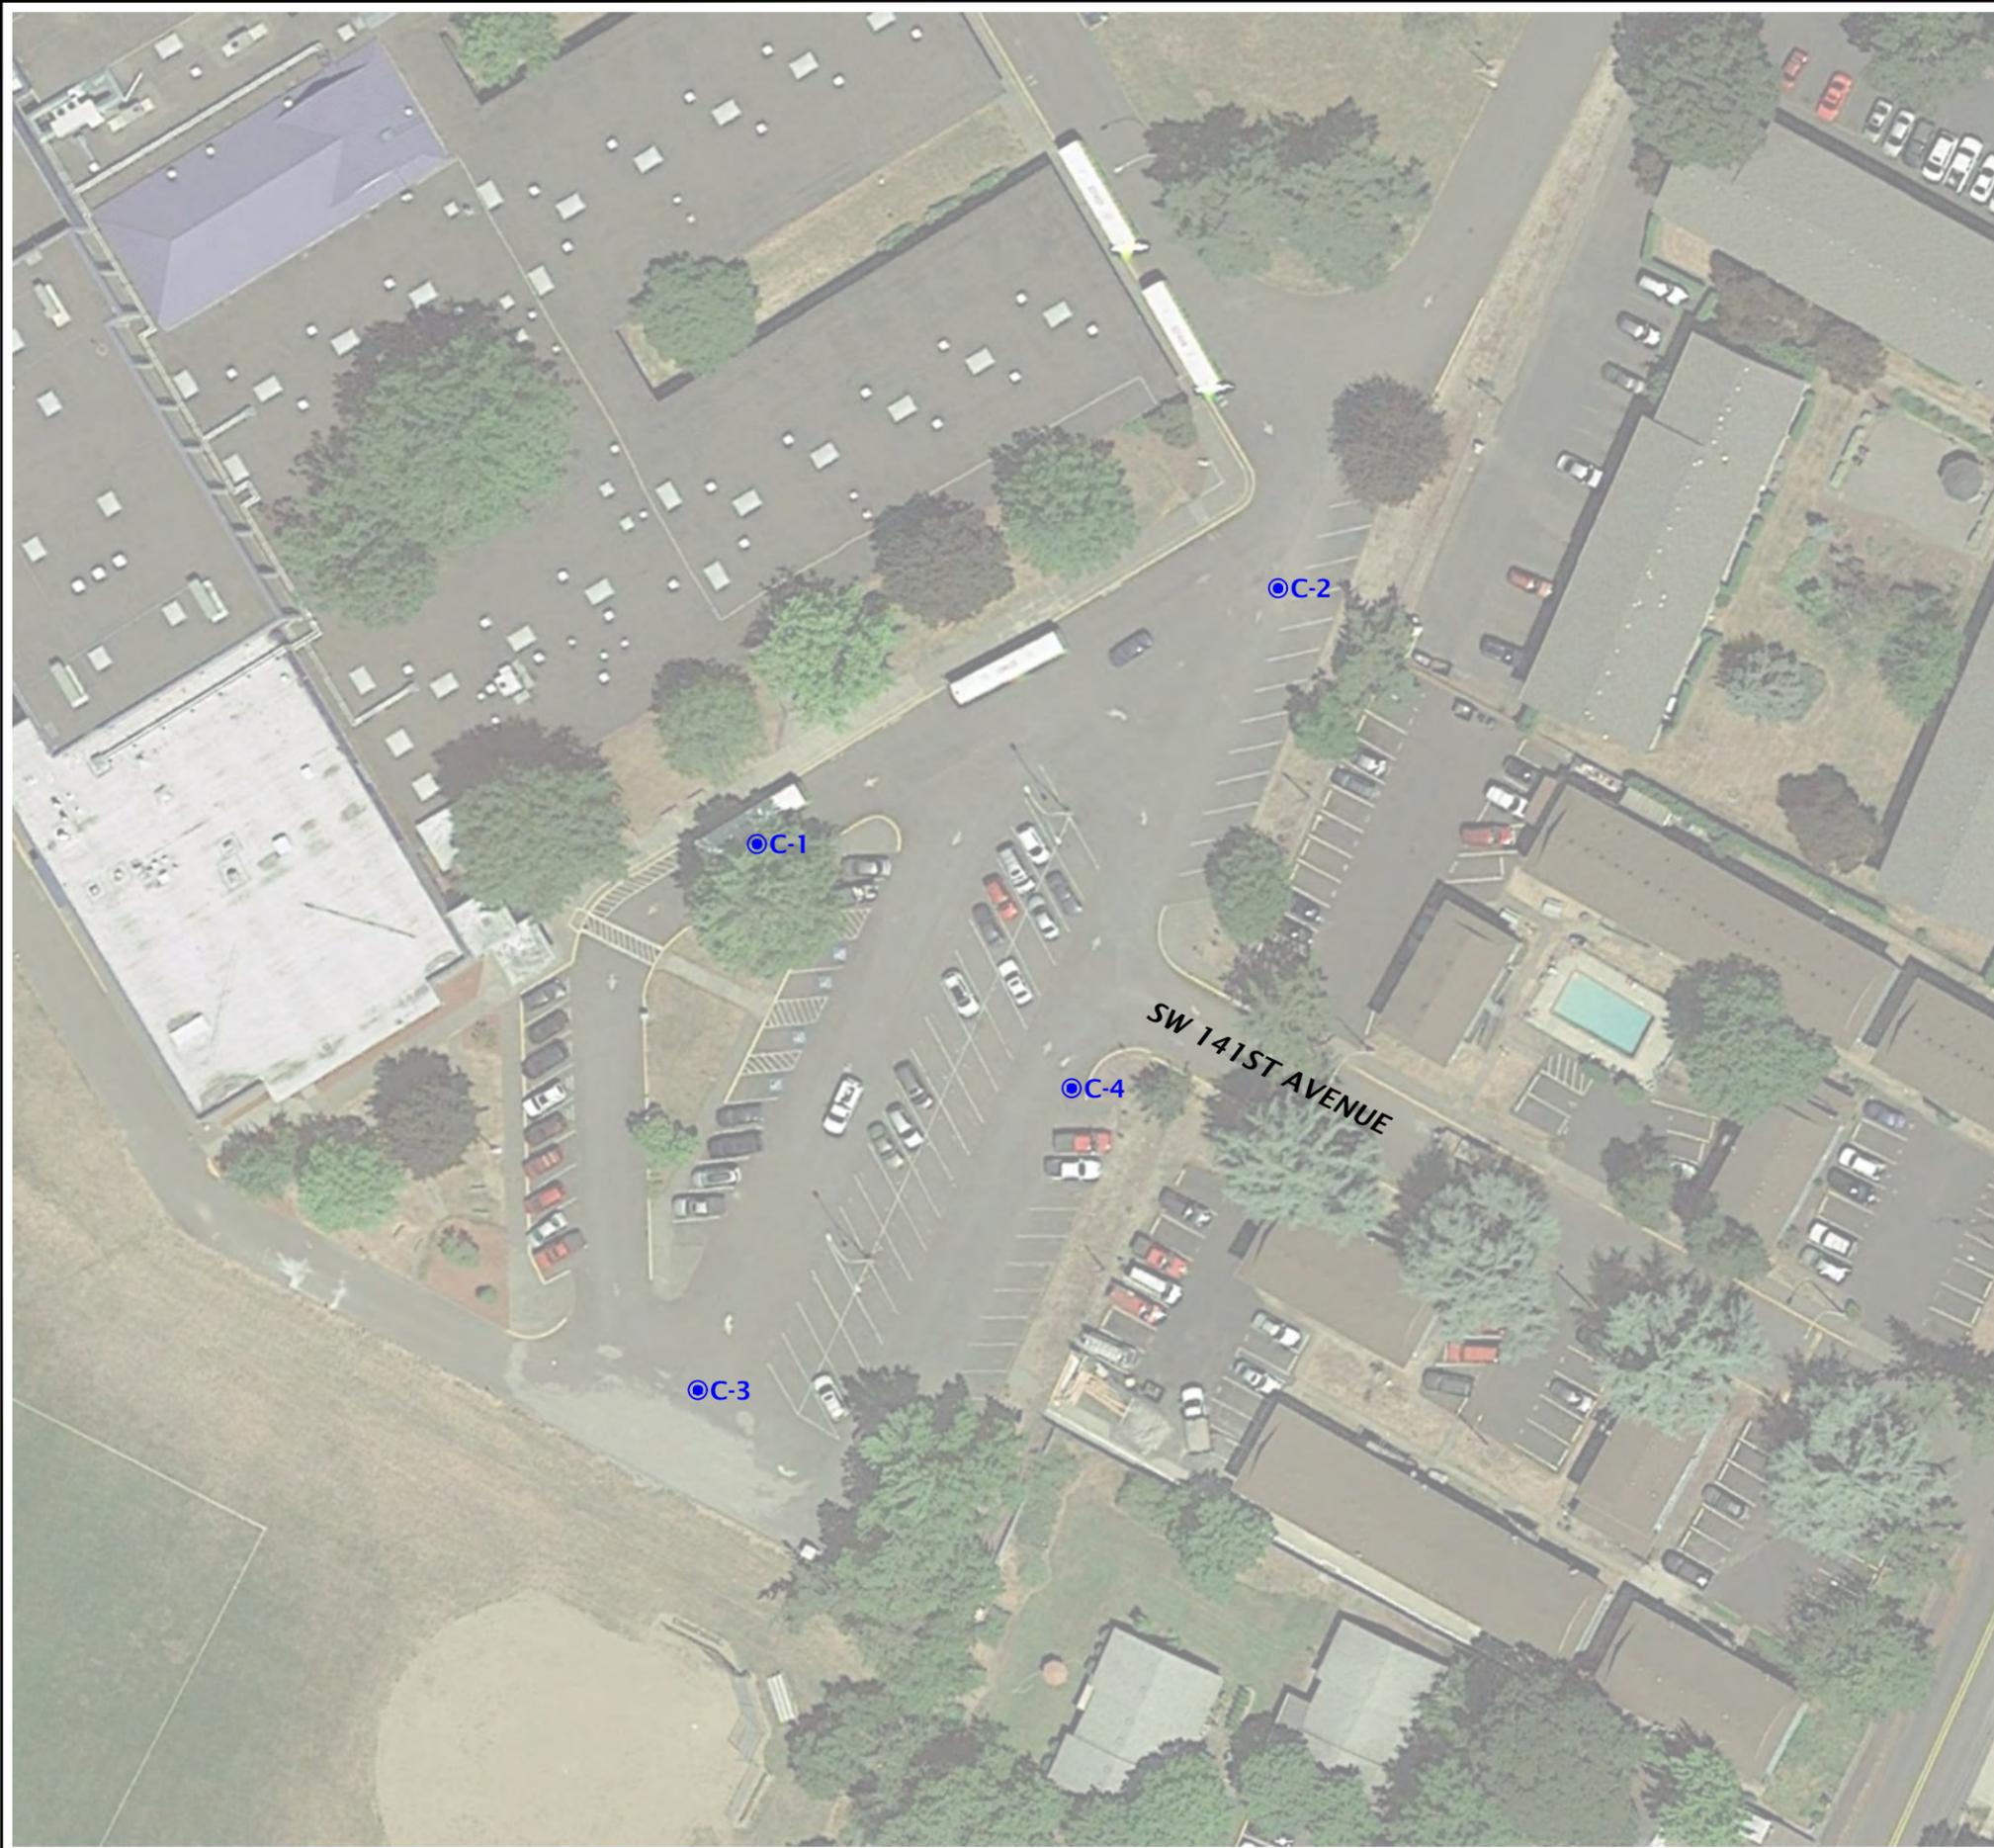
We explored the pavement and base conditions by drilling four core borings (C-1 through C-4) at the locations shown on Figure 2. Photographs of coring locations and cores are presented in the Attachment.

The project limits are the AC-paved area to the south of the middle school (see Figure 2). Currently, the paved area consists of delineated parking and drive isles with access to the north (off the corner of the building) and to the east along SW 141<sup>st</sup> Avenue. The pavement is in very poor to poor condition with significant medium to severe fatigue cracking and some potholes. Based on pavement grade changes, the drive isles appear to have been overlain in the past, while the parking areas appear to be approximately 1.5 to 2 inches lower in grade. In addition, we observed evidence of pavement overlay fabric in fatigued areas of the drive isles.

C-1 PAVEMENT CORE BORING

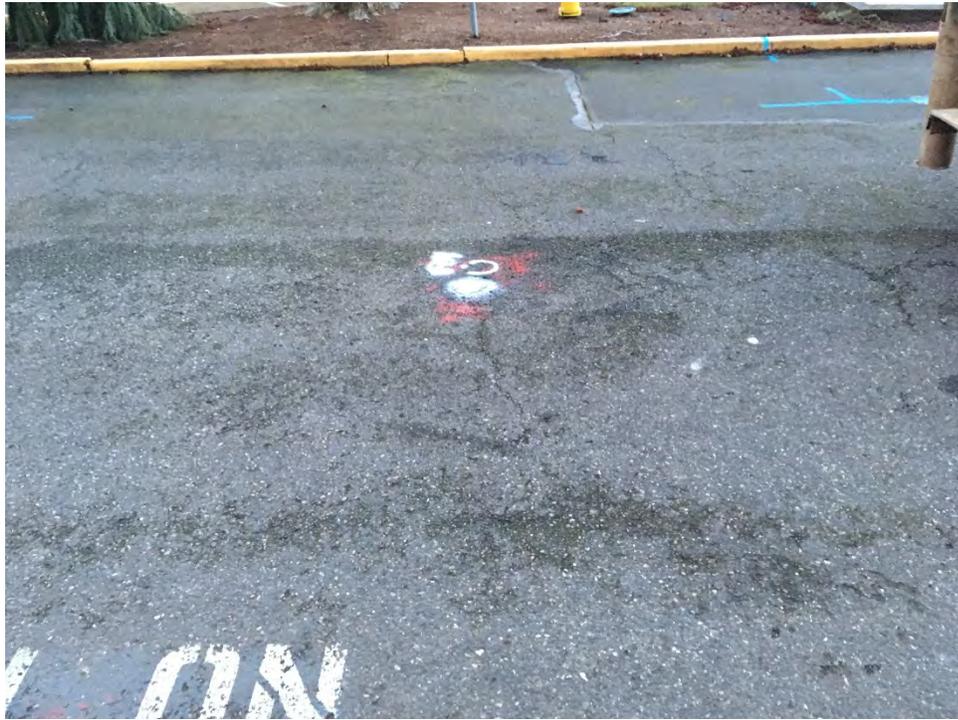
CORE LOCATION C-1.

Core Number	Layer Thickness (inches)	
	AC	Aggregate Base
C-1	4.8	6.2
C-2	4.5	5.5
C-3	2.3	8.7
C-4	4.5	5.7

<b>Core Number</b>	<b>Cracking Zone (inches)</b>	<b>Stripping Zone (inches)</b>	<b>Other Distress (inches)</b>
C-1	0 to 1.8	None	Delamination 1.8 and 2.7
C-2	0 to 4.5	None	Severe fatigue
C-3	0 to 2.3	None	Severe fatigue
C-4	0 to 4.3	None	Severe fatigue

Based on the results of our subsurface explorations, DCP testing, and analyses, it is our opinion that the existing pavement is in very poor to poor condition and should be reconstructed. We understand, however, that the school district is not interested in reconstruction due to budget constraints and the school district's desire is to grind the existing AC to the top of the aggregate base and pave with 4.0 inches of new AC.

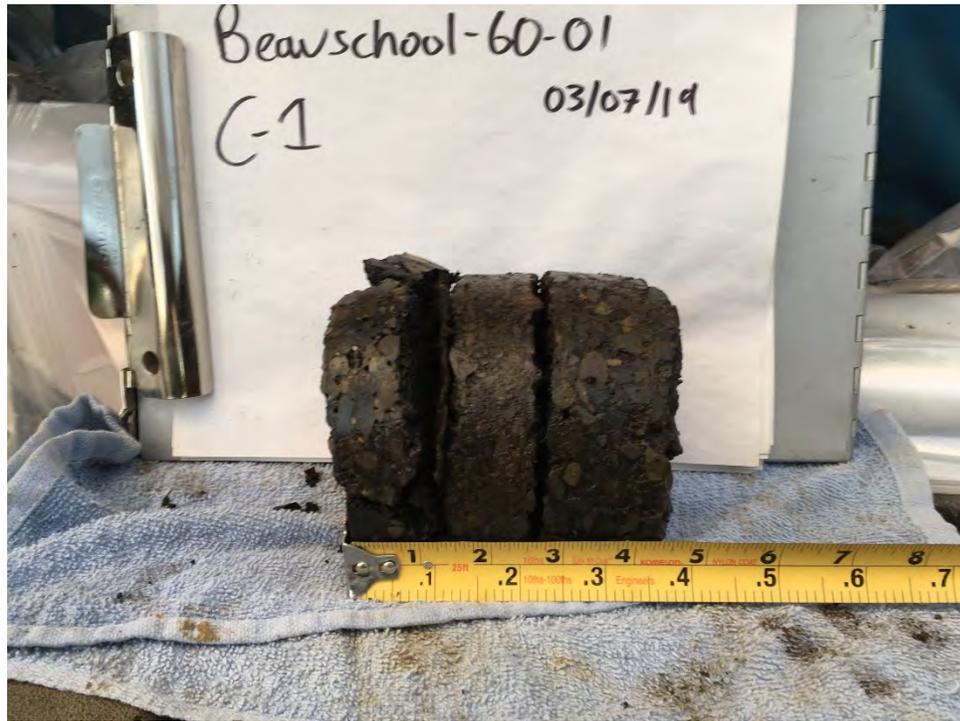
CORE C-1.

Paving fabric was observed at C-1 and C-3, approximately 1.8 inches below the pavement surface.
