Bingham

7618 Wyandotte

Kansas City, Missouri 64114

BUILDING/SITE ASSESSMENT: Building is structurally sound and in fair overall condition, but the building envelop is in need of extensive repairs. The sprawling plan and numerous stairs provide excellent circulation and opportunities for multiple tenants or mixed-use although the building size and layout are not readily adaptable for multi-family housing. The building condition and the large floor plate make this a potential candidate for demolition. The site's size and location present opportunities for new development (mixed use or commercial), however, any redevelopment of the building or new construction would need to be sensitive to the impact on the residential neighborhood south and east of the building. The large play fields north and south of the building offer opportunities for community use of the grounds, particularly for recreational activities.

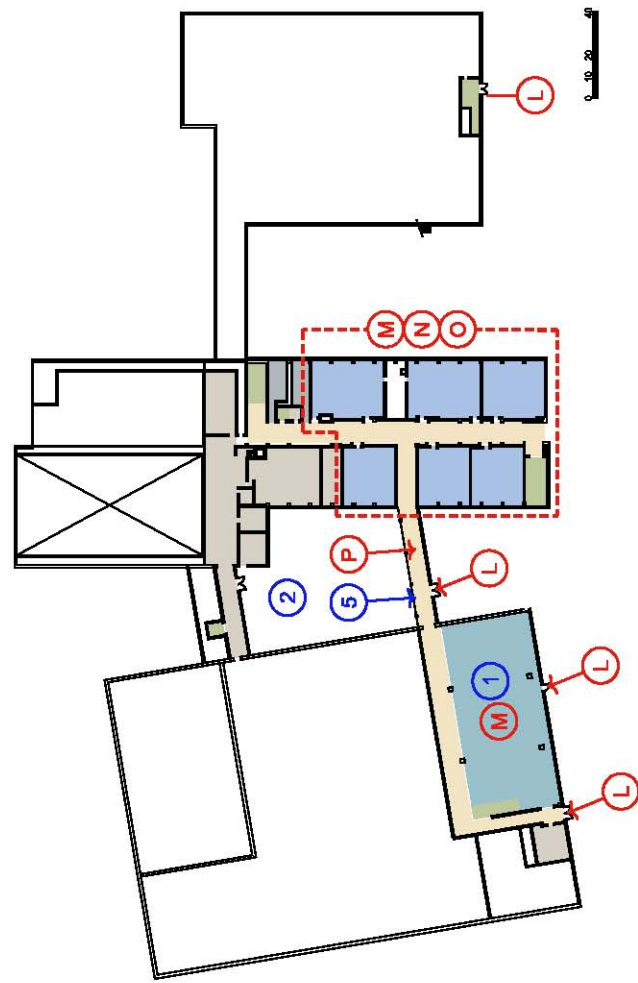
Basement

1. Former pool
2. Courtyard
3. Trophy case
4. Not used
5. Glazed corridor
6. Vault
7. Display case
8. Auditorium with folded plate ceiling structure
9. Classrooms with built-in work stations

- A. Water stain on ceiling
- B. Hollow metal curtain wall system is rusted and deteriorated typical
- C. Damaged masonry
- D. Damaged concrete
- E. Damaged soffit
- F. Mold odor
- G. Roof leak
- H. Peeling paint on canopy
- I. Damaged downspouts
- J. Peeling paint on foundation
- K. Graffiti
- L. Hollow metal entry doors typically in poor condition
- M. Water damaged ceilings
- N. Water damaged floor
- O. Mold present
- P. Plant growth present

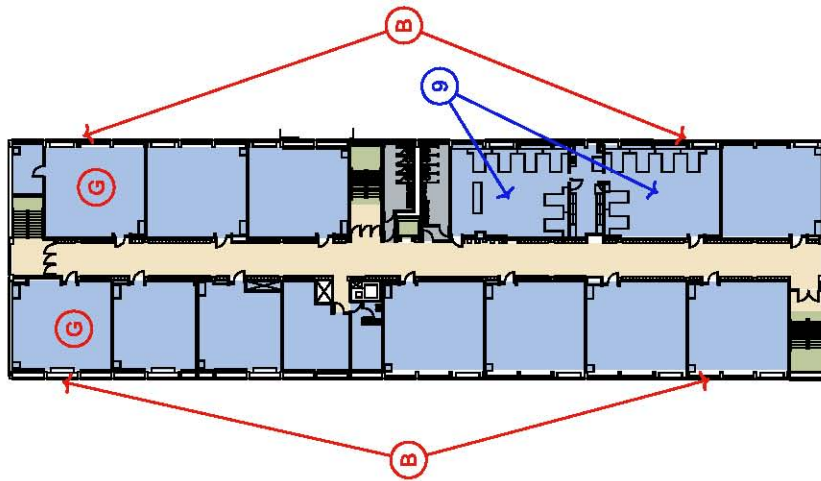
Second Floor

1. Former pool
2. Courtyard
3. Trophy case
4. Not used
5. Glazed corridor
6. Vault
7. Display case
8. Auditorium with folded plate ceiling structure
9. Classrooms with built-in work stations

- A. Water stain on ceiling
- B. Hollow metal curtain wall system is rusted and deteriorated typical
- C. Damaged masonry
- D. Damaged concrete
- E. Damaged soffit
- F. Mold odor
- G. Roof leak
- H. Peeling paint on canopy
- I. Damaged downspouts
- J. Peeling paint on foundation
- K. Graffiti
- L. Hollow metal entry doors typically in poor condition
- M. Water damaged ceilings
- N. Water damaged floor
- O. Mold present
- P. Plant growth present
