REUSE STRATEGY AND ACTION PLAN

BLENHEIM SCHOOL SITE

2411 E. 70th Terrace Kansas City, Missouri 64132

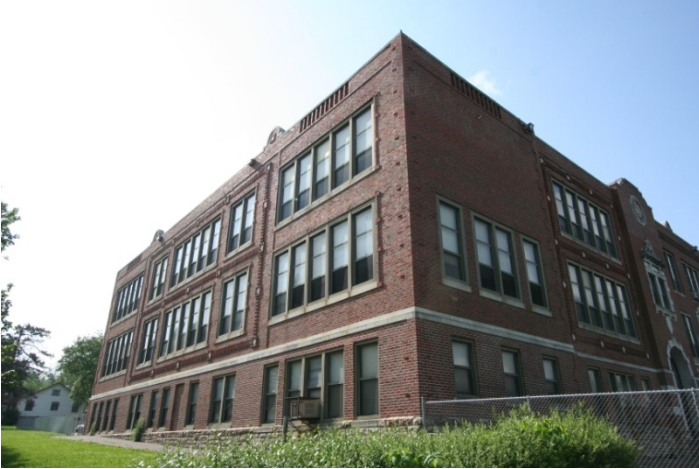
- Exterior Wall Construction: Tapestry brick with rusticated limestone foundation/water table and cast stone trim. Details include quoins, buttress-like pilasters, patterned brick work, and cast stone medallions. Masonry is generally in good condition. Some areas of damage and possible leaning of the parapet were noted on the northwest corner. Some spalling of cast stone above east elevation entrance. Limited areas requiring repointing.

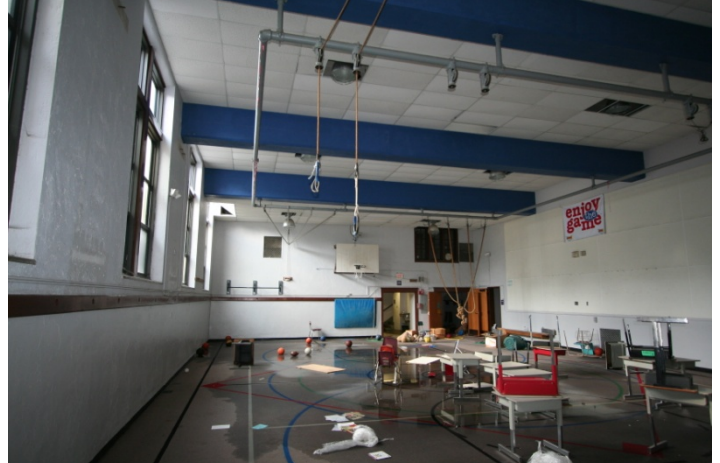
Gymnasium

- Very damp building. At the time of the site visit, water had flooded the gym through a window well. Peeling paint was also evident in many locations.
- Plaster had failed above a window in one classroom. This may be the result of failing roof, corroded window lintels and/or spalled brick or cast stone trim.
- Upper portion of brick chimney has multiple cracks.
